Expertise

Protocol number: 46905077  
Order No. / Reference: 26644143  
Inspection date: 5 Aug 2026

| Manufacturer: Opel | Model: Astra 1.5 D Start/Stop Sports Tourer Business Edition |
| VIN: W0VBD8EV7N8043958 | |

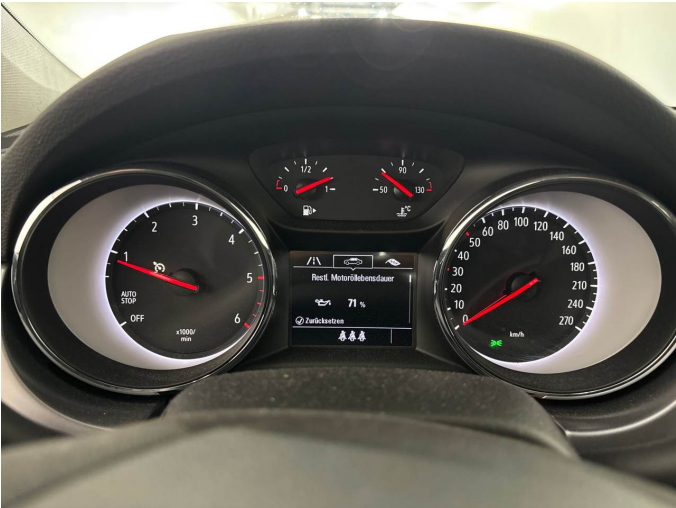
| Vehicle details | |
|---|---|
| Mileage (Read) | 51,415 km |

Figure 7: Instrument cluster

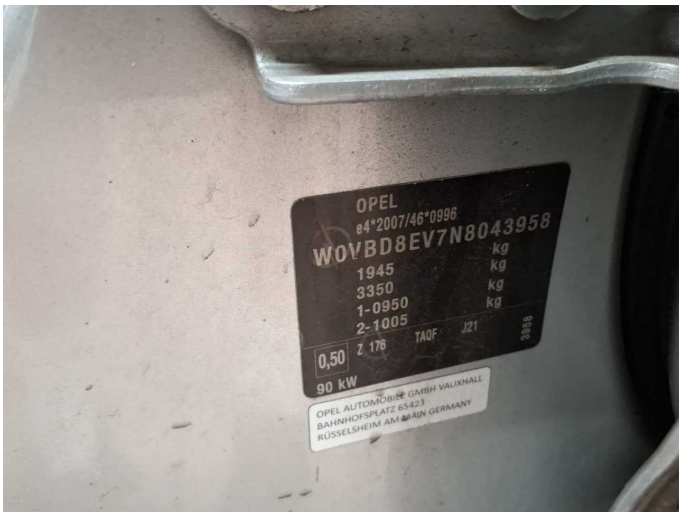
| VIN comparison | The vehicle identification number (VIN) was read from the vehicle and its conformity with the submitted documents was confirmed by the undersigned during the inspection. |

Figure 12: VIN

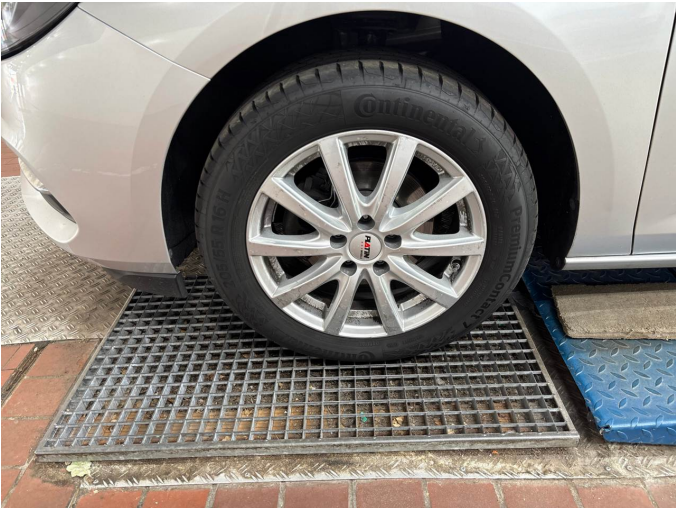
| # | Tyre size | Type of tyre | Manufacturer | Tread depth |
|---|---|---|---|---|
| 1) | 205/55 R16 91H | Summer tyres on Light alloy | Continental | 7mm / 7mm |
| 2) | 205/55 R16 91H | Summer tyres on Light alloy | Continental | 8mm / 8mm |

Figure 13: Mounted tyres

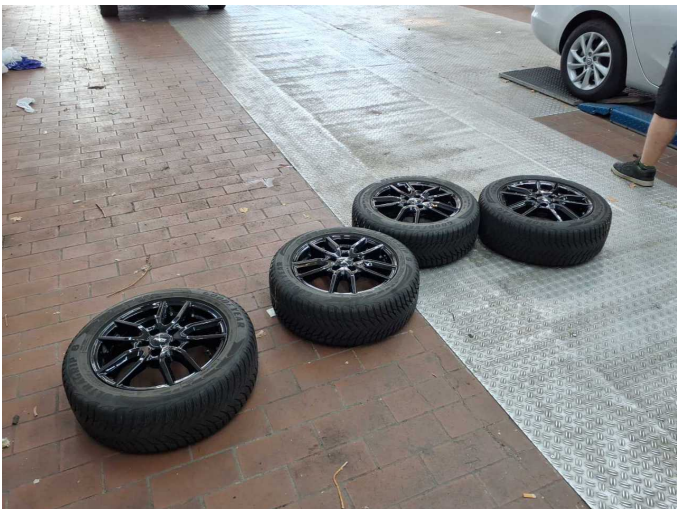
| # | Tyre size | Type of tyre | Manufacturer | Tread depth |
|---|---|---|---|---|
| 1) | 205/55 R16 91H | Winter tyres on Light alloy | Goodyear | 5mm / 5mm |
| 2) | 205/55 R16 91H | Winter tyres on Light alloy | Goodyear | 6mm / 6mm |

Sommerradsatz und Winterradsatz sind Zubehörfelgen verbaut. Über diese lag zum Besichtigungszeitpunkt kein Nachweis über die Zulässigkeit vor.

Figure 18: Additional tyres

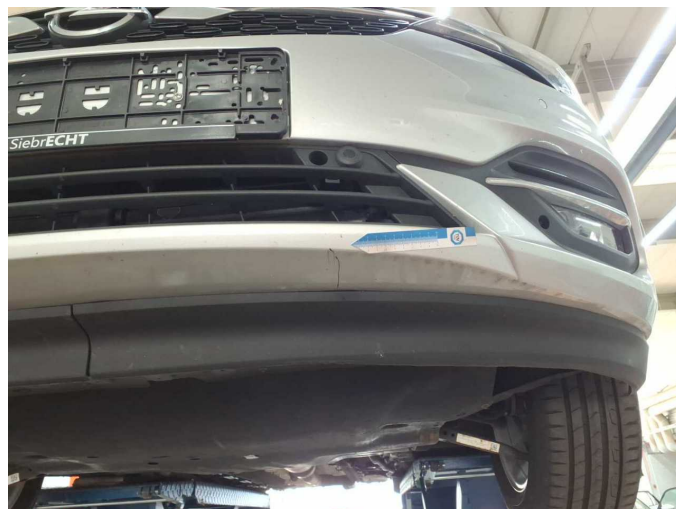
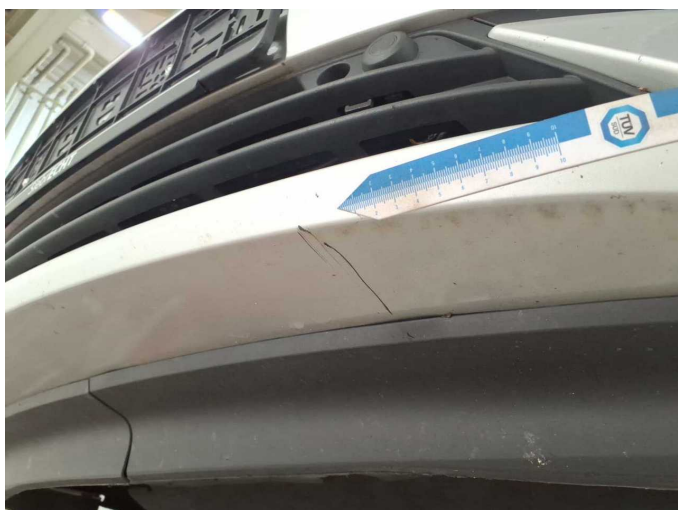
| No. | Component group | Description |
|---|---|---|
| 1 | Front bumper | Spoiler - Scratch(es) - Smart repair |

**Damage 1:** Front bumper: Spoiler - Scratch(es) - Smart repair

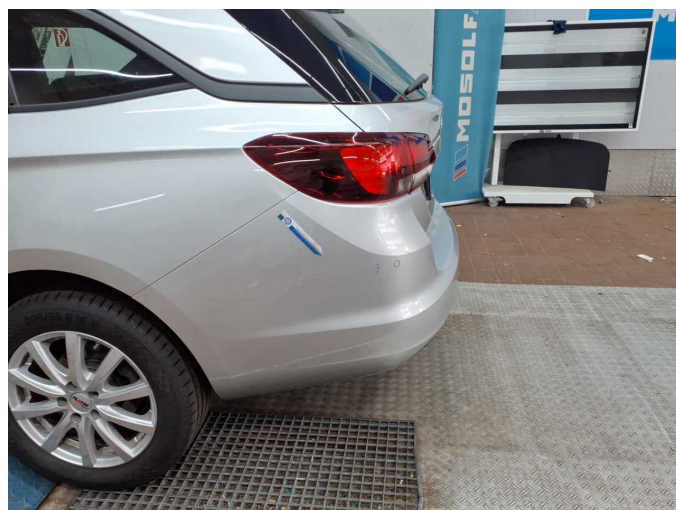
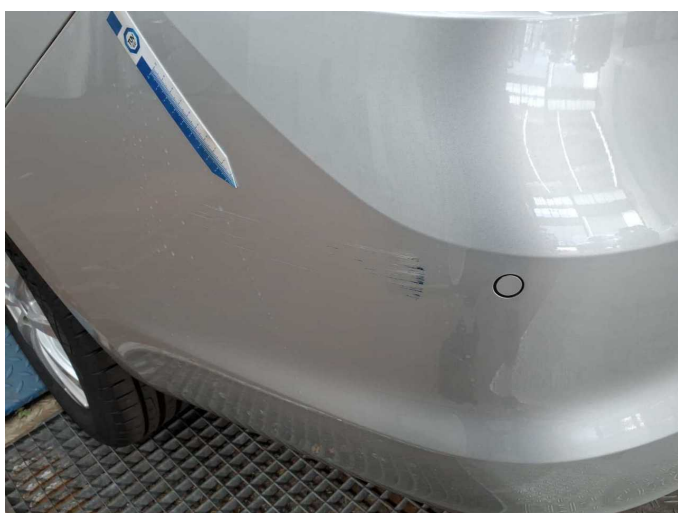
| No. | Component group | Description |
|---|---|---|
| 2 | Rear bumper | Rear bumper - Scratch(es) - Paint |

**Damage 2:** Rear bumper: Rear bumper - Scratch(es) - Paint

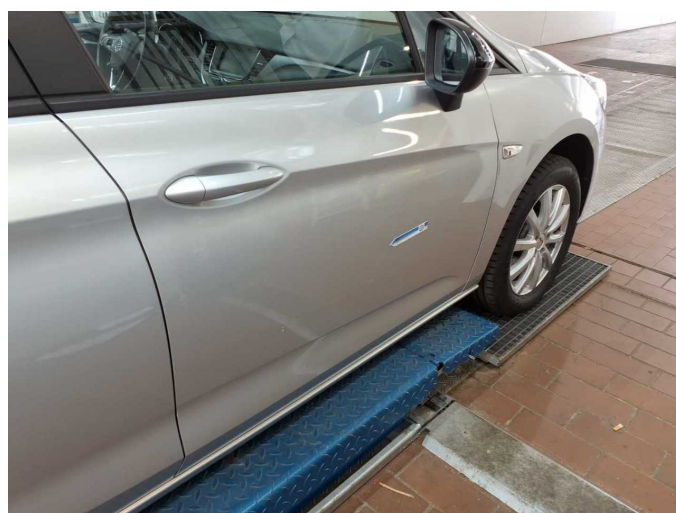
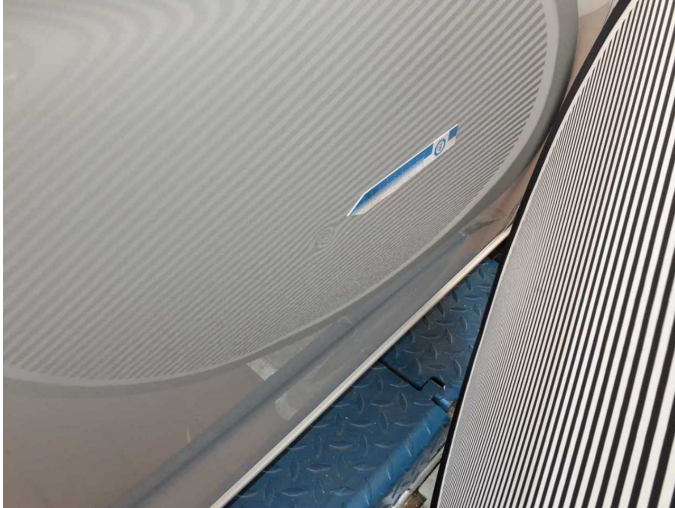
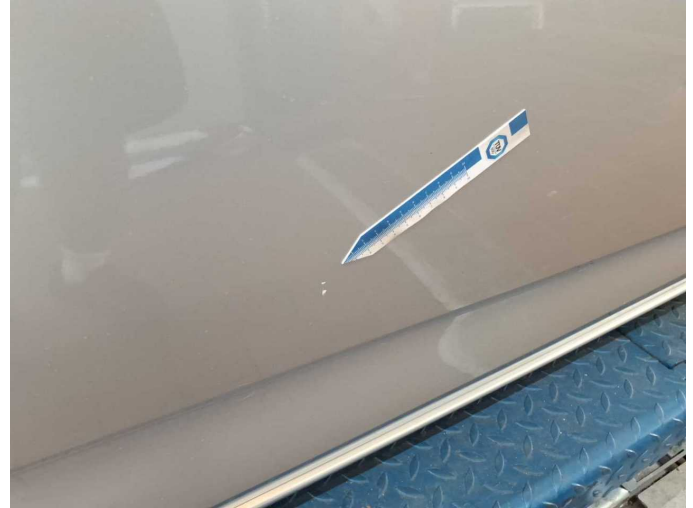
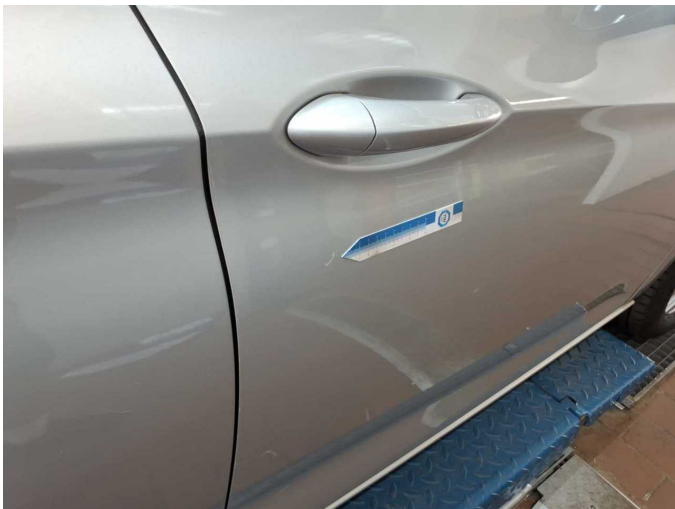
| No. | Component group | Description |
|---|---|---|
| 3 | Door - front right side | Door - Dent / paintcoat damage - Repair and paint |

**Damage 3:** Door - front right side: Door - Dent / paintcoat damage - Repair and paint

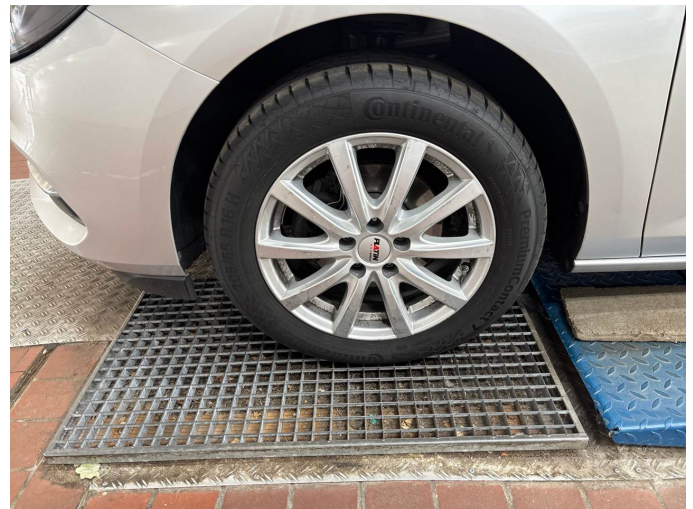
Wheel / tyres - Wheelset - complete (Originalfelgen)

**Missing part 1:** Wheel / tyres: Wheelset - complete (Originalfelgen) - Missing - Replace
