Expertise

Protocol number: 46466570  
Order No. / Reference: 26716125  
Inspection date: 9 Jul 2026

Manufacturer: Skoda  
VIN: TMBJW9NPXN7014208

Model: Superb Combi 1.4 TSI iv DSG L&K

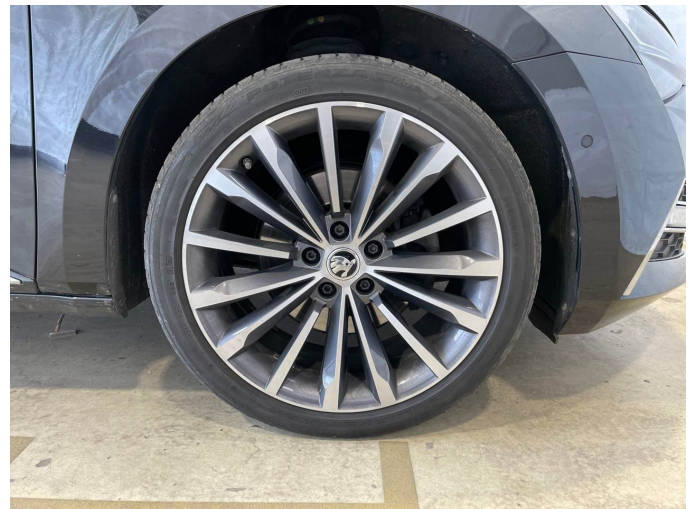
Figure 12: Mounted tyres

| # | Tyre size | Type of tyre | Manufacturer | Tread depth |
|---|---|---|---|---|
| 1) | 235/40 R19 96W | Summer tyres on Light alloy | Bridgestone | 3mm / 3mm |
| 2) | 235/40 R19 96W | Summer tyres on Light alloy | Bridgestone | 4mm / 3mm |

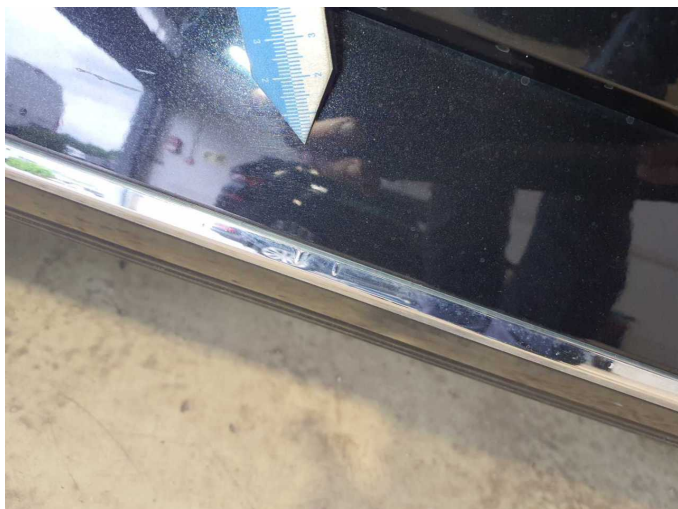
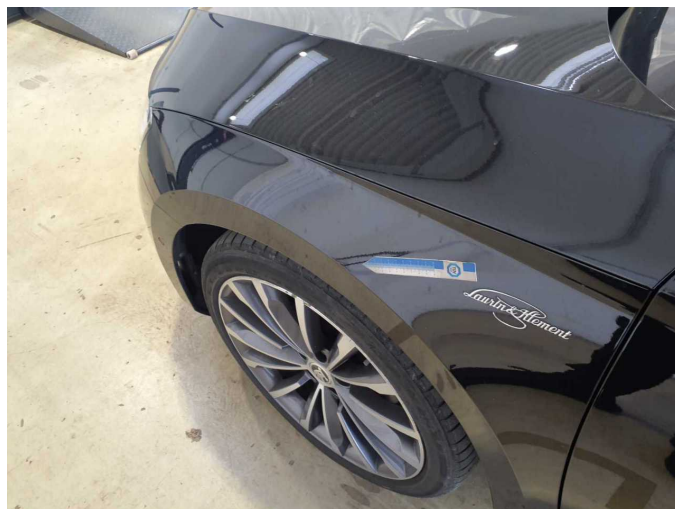
**Damage 1:** Door - rear right side: Brightware - lower - Scratch(es) - Loss in value

| No. | Component group | Description |
|---|---|---|
| 1 | Door - rear right side | Brightware - lower - Scratch(es) - Loss in value |

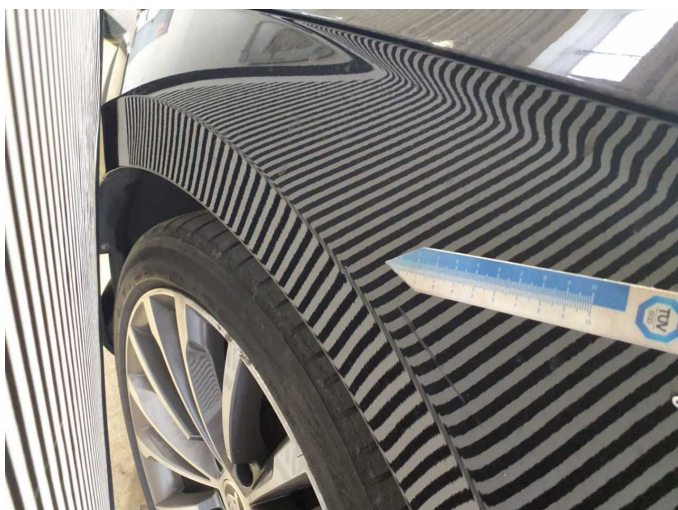
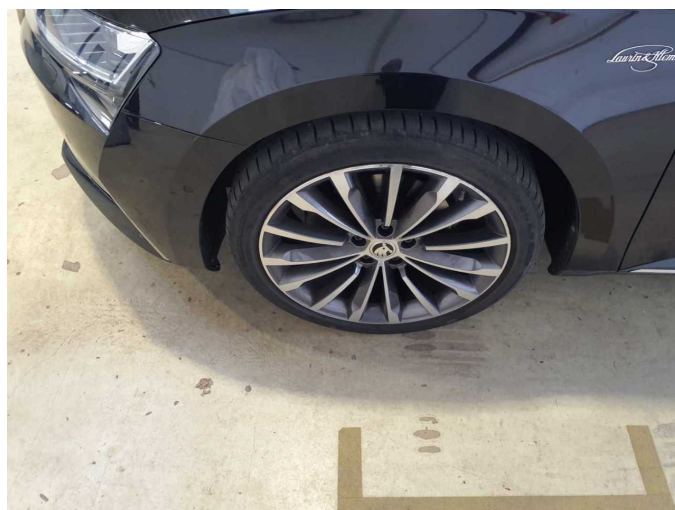
**Damage 2:** Mudguard - left side: Mudguard - left side - Dent / paintcoat damage - Smart repair

| No. | Component group | Description |
|---|---|---|
| 2 | Mudguard - left side | Mudguard - left side - Dent / paintcoat damage - Smart repair |

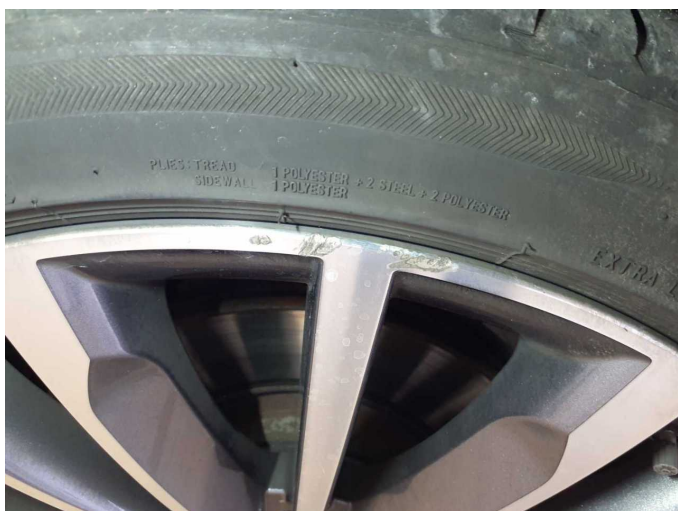
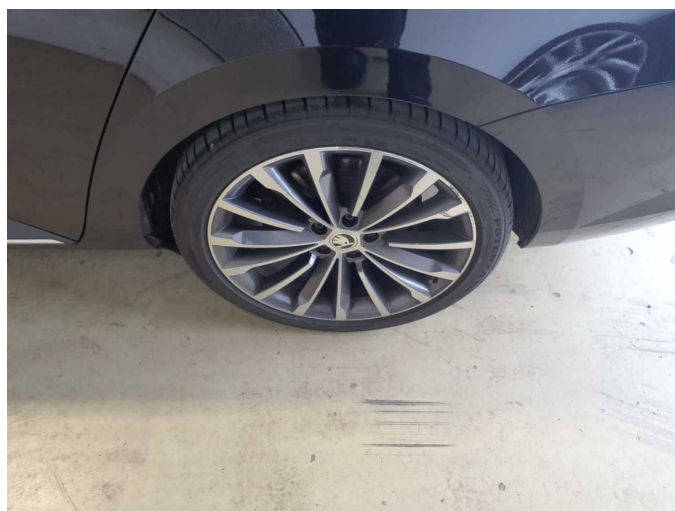
**Damage 3:** Wheel / tyres: Alloy rim - front left side - Scratch(es) - Loss in value

| No. | Component group | Description |
|---|---|---|
| 3 | Wheel / tyres | Alloy rim - front left side - Scratch(es) - Loss in value |

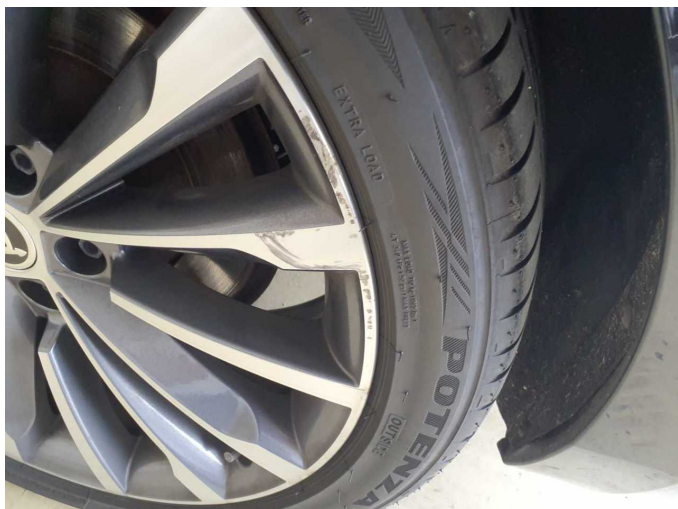
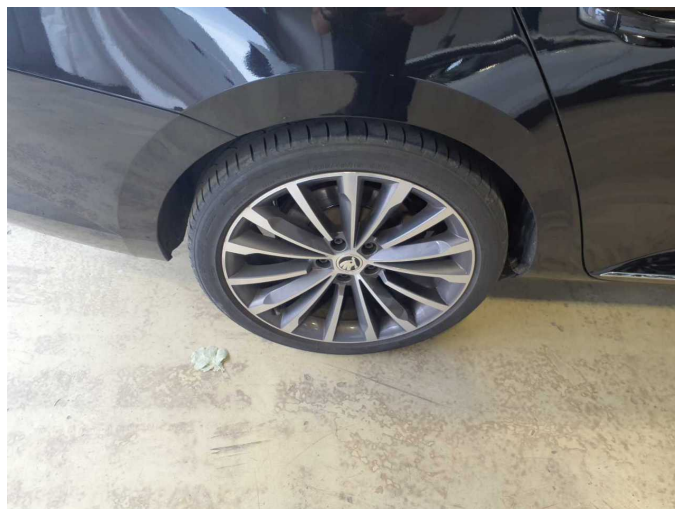
**Damage 4:** Wheel / tyres: Alloy rim - rear left side - Scratch(es) - Loss in value

| No. | Component group | Description |
|---|---|---|
| 4 | Wheel / tyres | Alloy rim - rear left side - Scratch(es) - Loss in value |

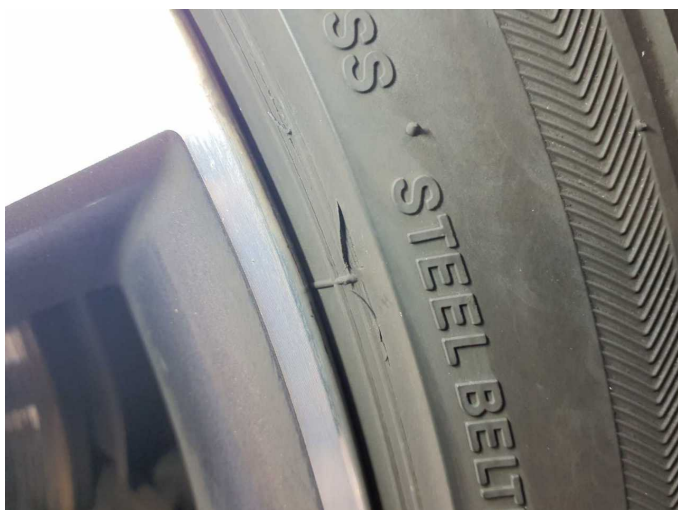
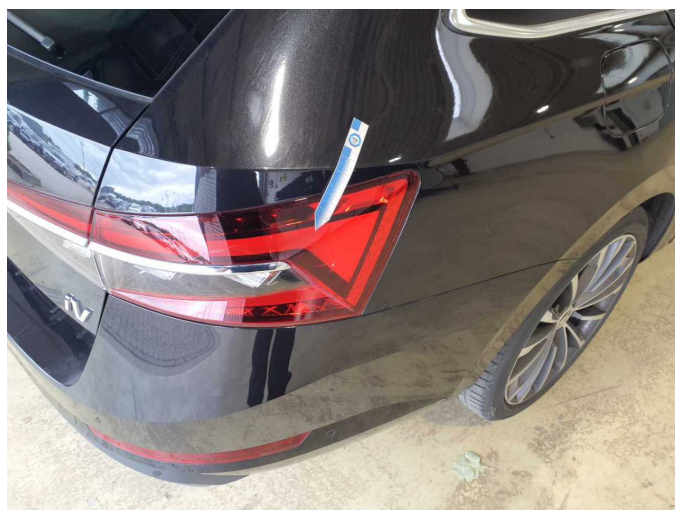
**Damage 5:** Wheel / tyres: Tyre - rear right side - Broken / torn - Replace

| No. | Component group | Description |
|---|---|---|
| 5 | Wheel / tyres | Tyre - rear right side - Broken / torn - Replace |

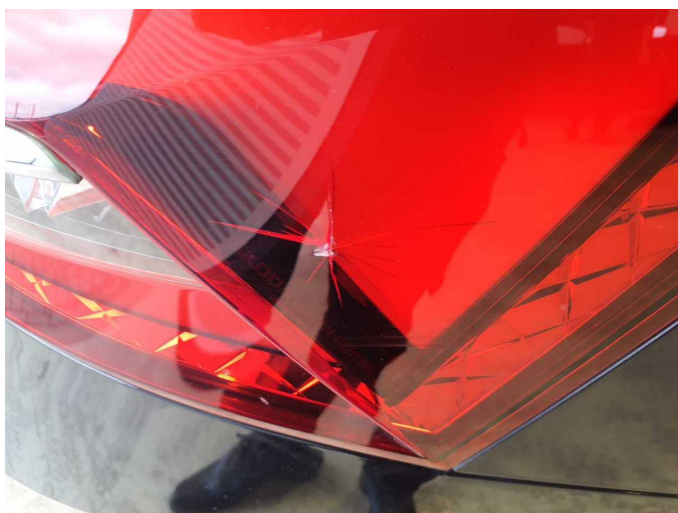
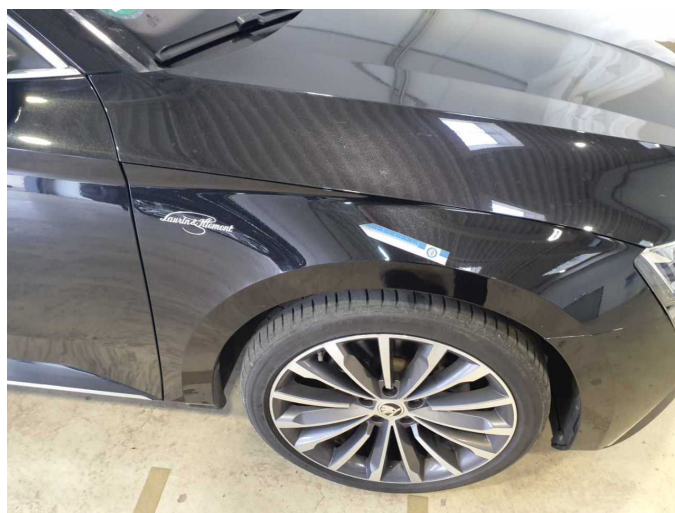
**Damage 6:** Tail light: Tail lamp - right side - Broken / torn - Replace

| No. | Component group | Description |
|---|---|---|
| 6 | Tail light | Tail lamp - right side - Broken / torn - Replace |

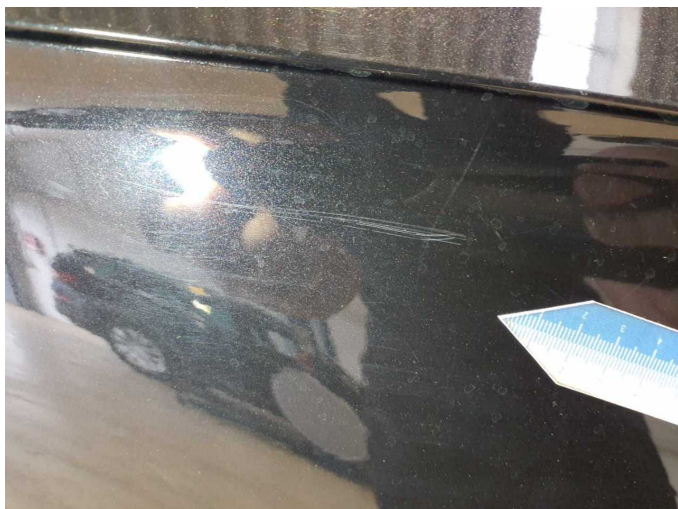
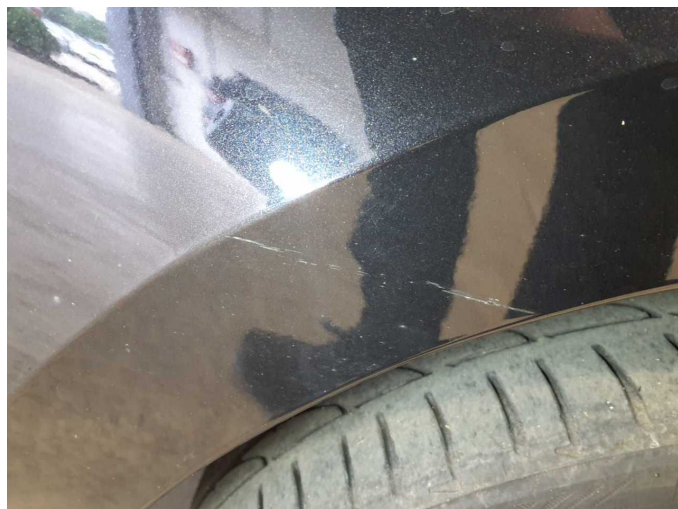
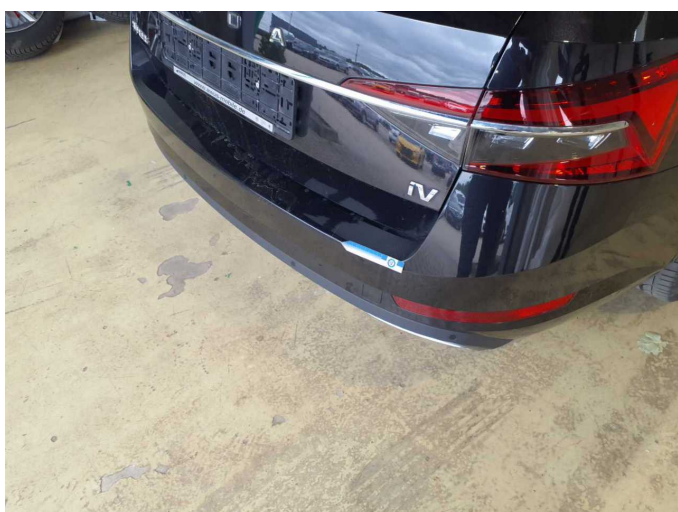
**Damage 7:** Mudguard - right side: Mudguard - right side - Scratch(es) - Paint

| No. | Component group | Description |
|---|---|---|
| 7 | Mudguard - right side | Mudguard - right side - Scratch(es) - Paint |

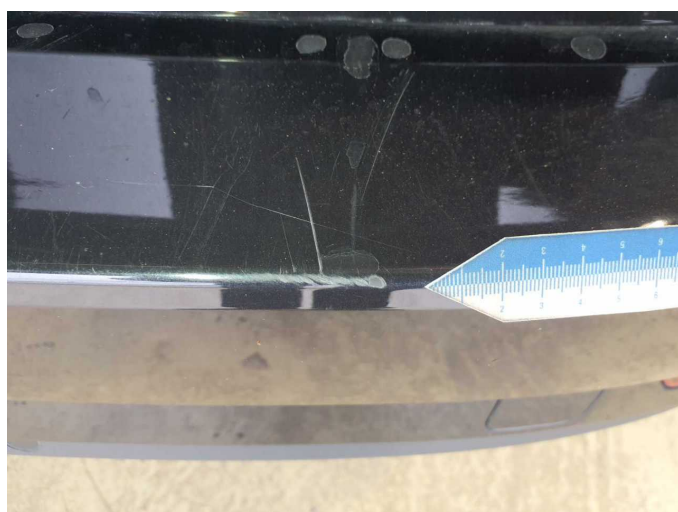
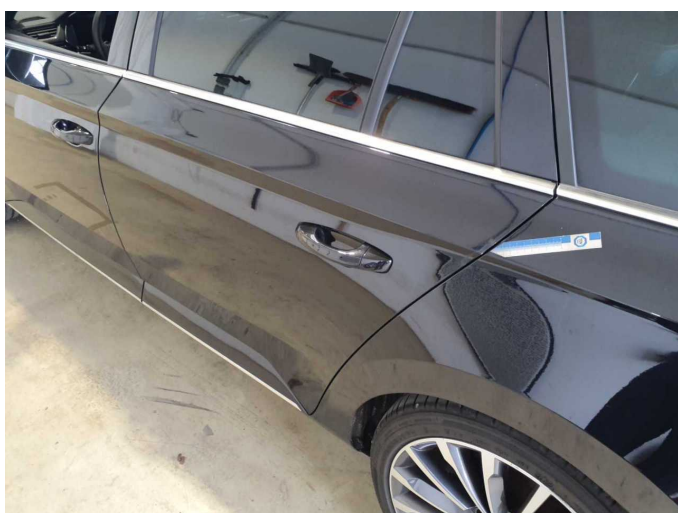
**Damage 8:** Rear bumper: Rear bumper - Scratch(es) - Paint

| No. | Component group | Description |
|---|---|---|
| 8 | Rear bumper | Rear bumper - Scratch(es) - Paint |

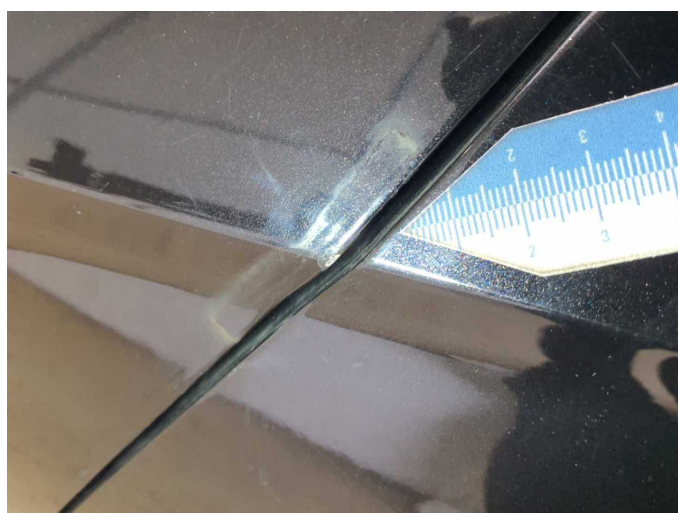
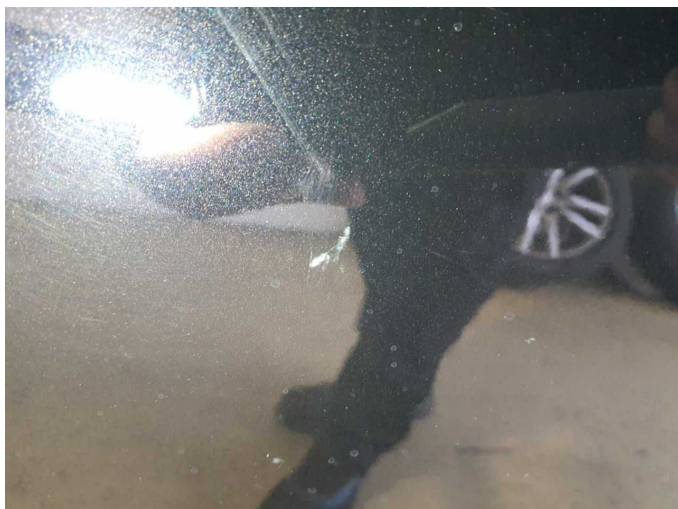
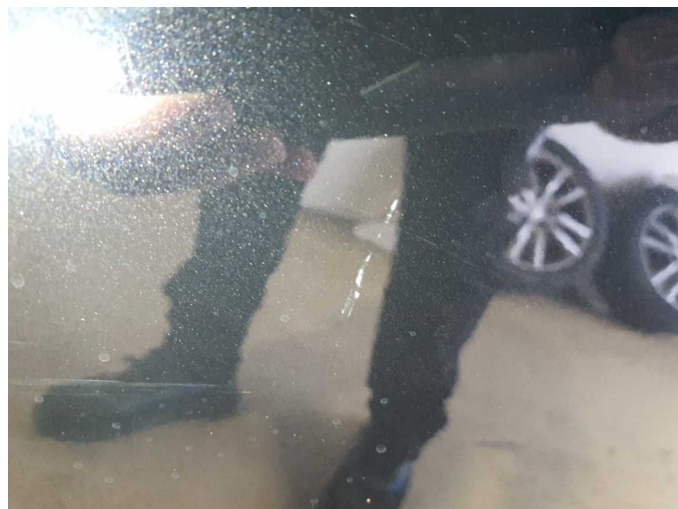
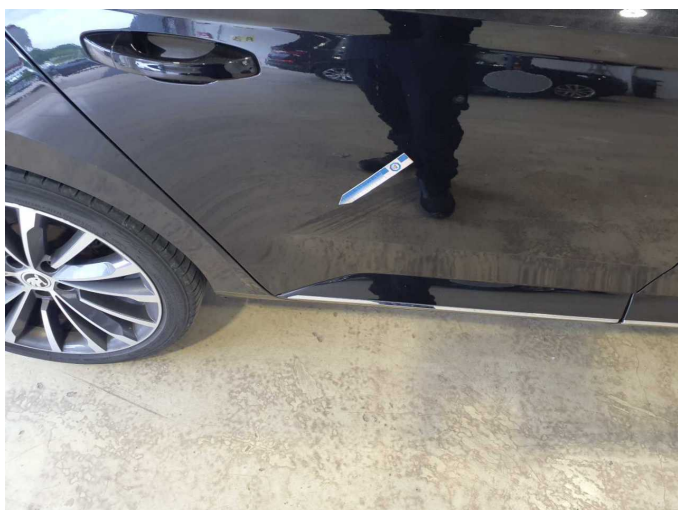
**Damage 9:** Door - rear left side: Door - Scratch(es) - Paint

| No. | Component group | Description |
|---|---|---|
| 9 | Door - rear left side | Door - Scratch(es) - Paint |

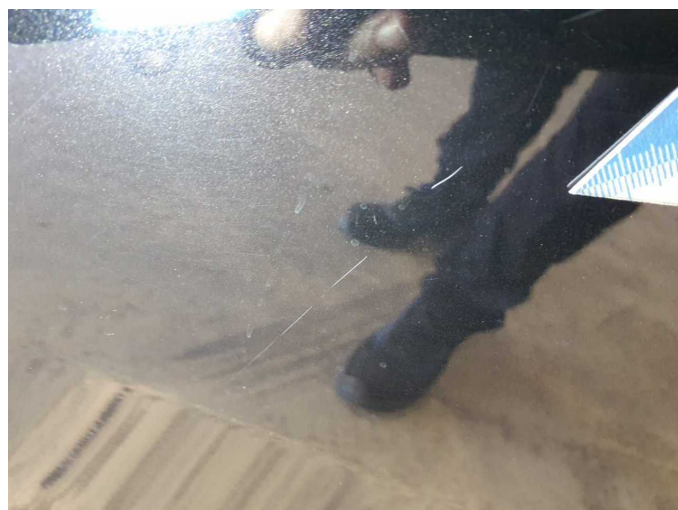
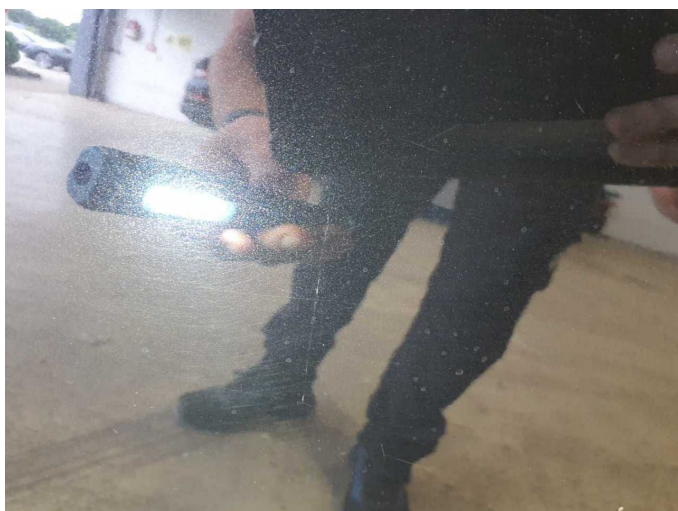
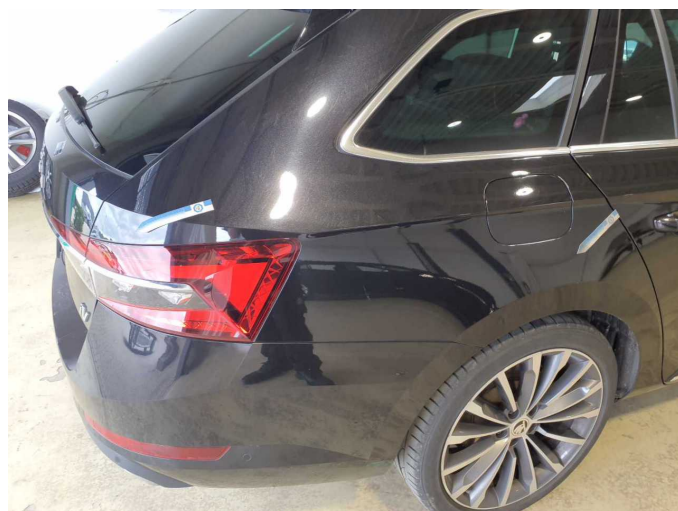
**Damage 10:** Door - rear right side: Door - Scratch(es) - Paint

| No. | Component group | Description |
|---|---|---|
| 10 | Door - rear right side | Door - Scratch(es) - Paint |

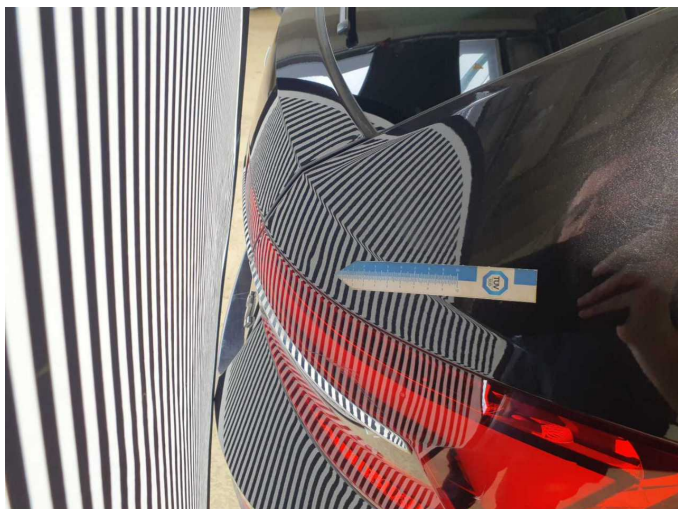
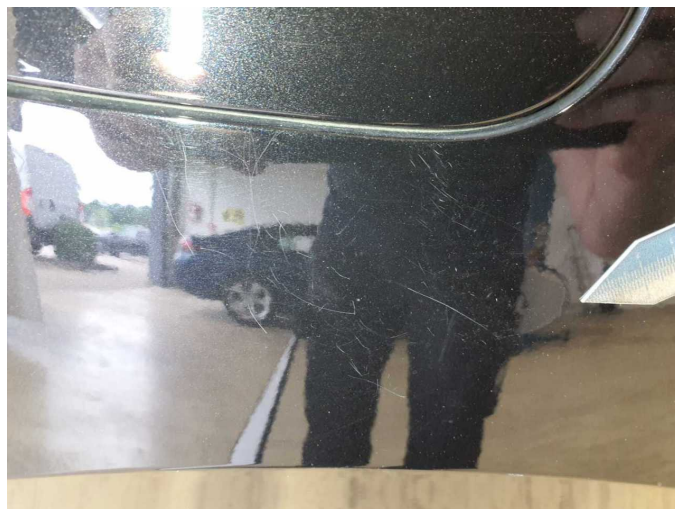
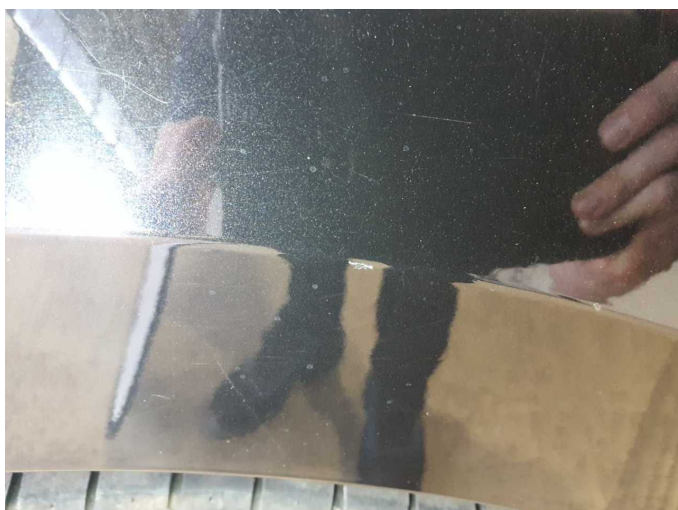
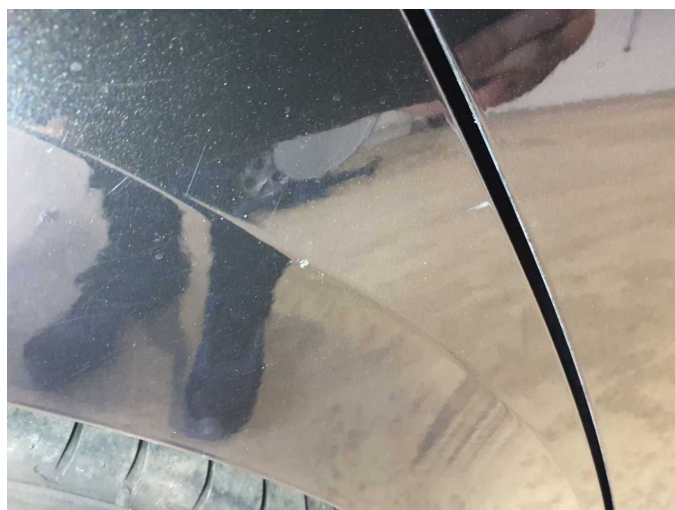
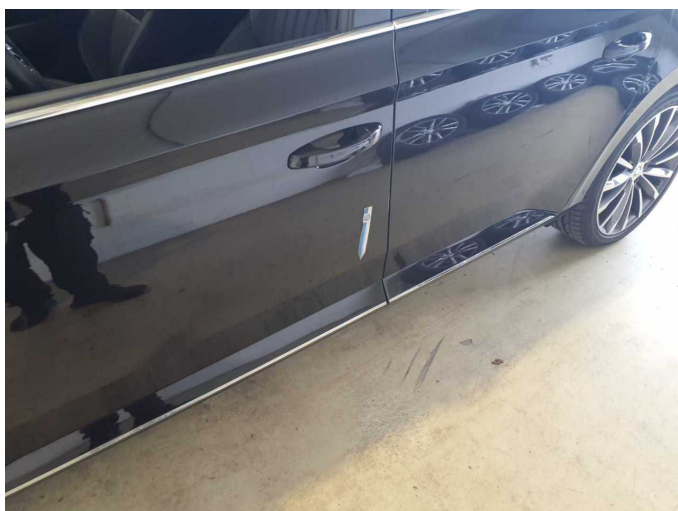
**Damage 11:** Side panel - rear right side: Side panel - Dent / paintcoat damage - Repair and paint

| No. | Component group | Description |
|---|---|---|
| 11 | Side panel - rear right side | Side panel - Dent / paintcoat damage - Repair and paint |

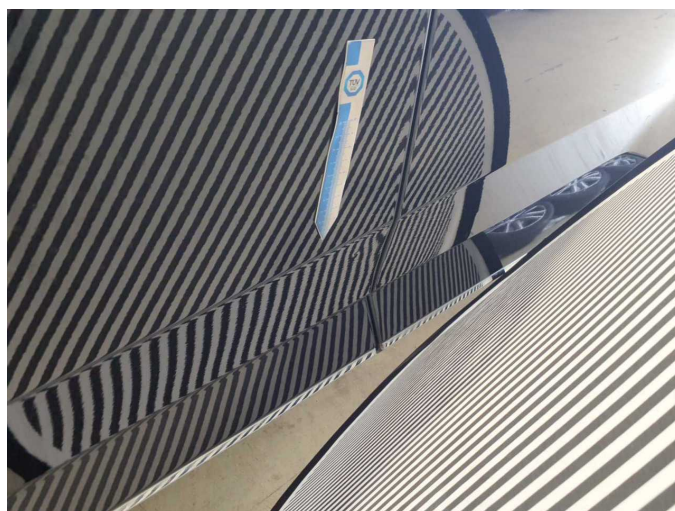
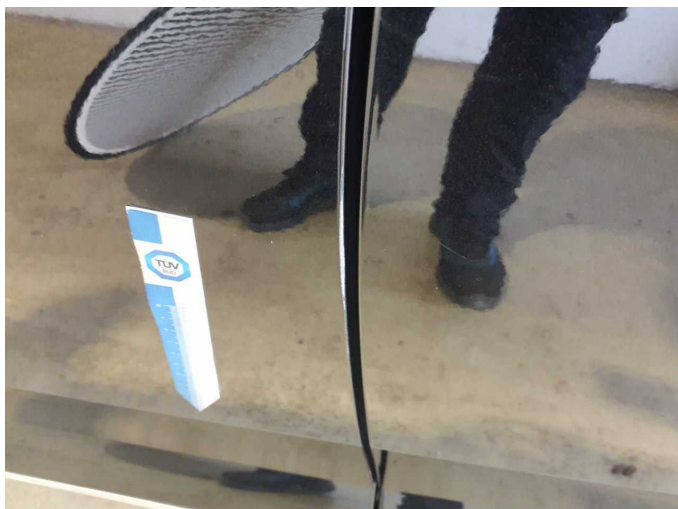
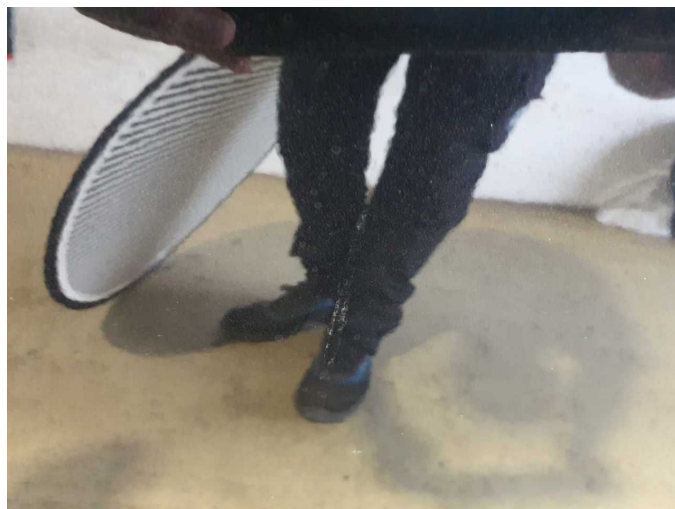
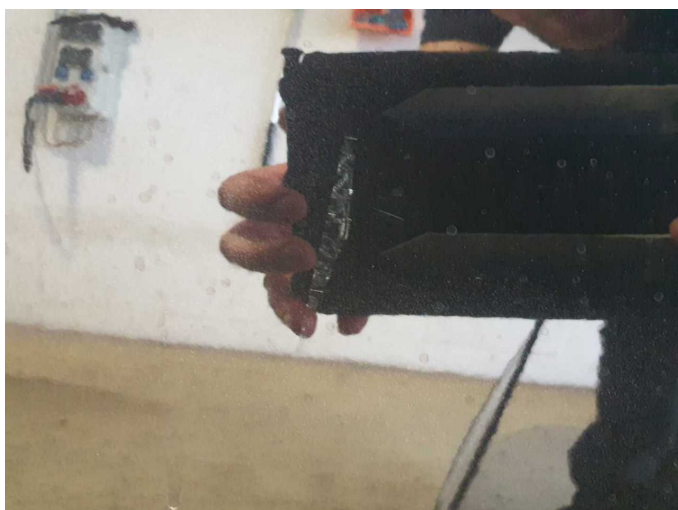
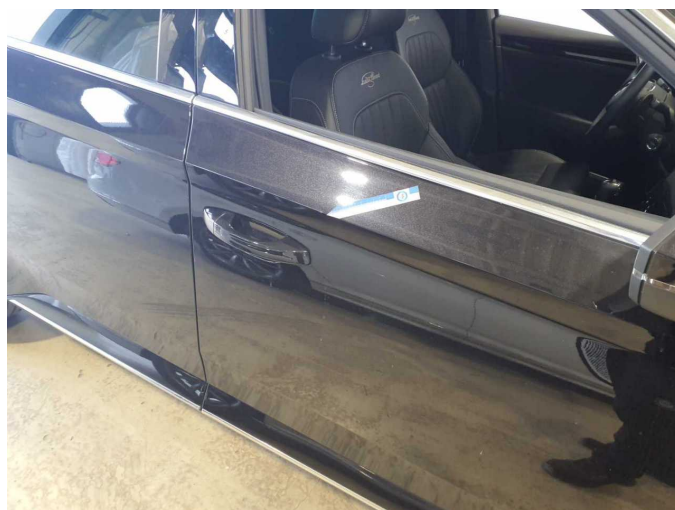
**Damage 12:** Door - front left side: Door - Dent / paintcoat damage - Repair and paint

| No. | Component group | Description |
|---|---|---|
| 12 | Door - front left side | Door - Dent / paintcoat damage - Repair and paint |

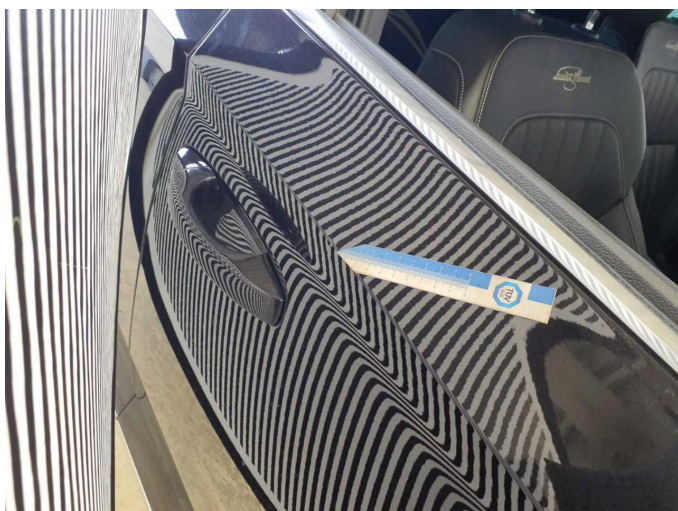
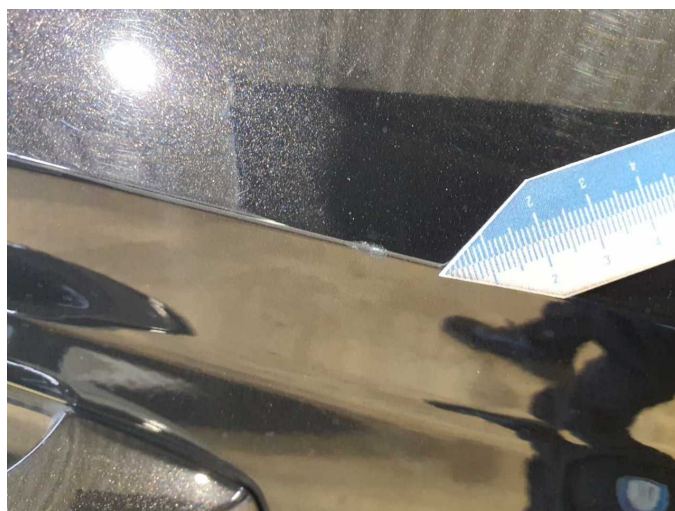
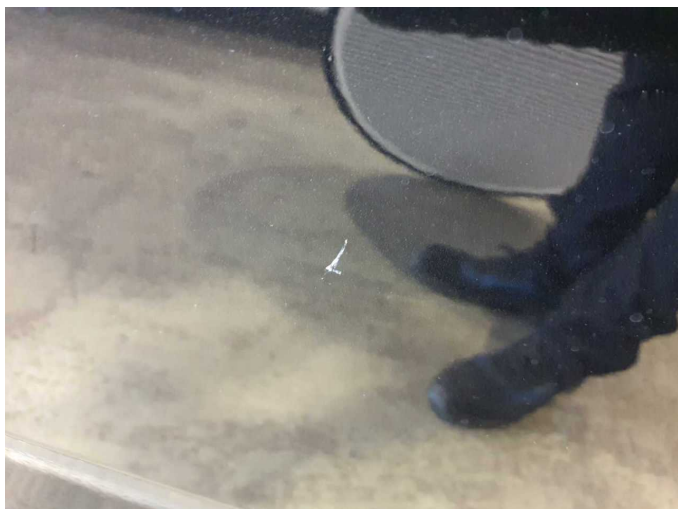
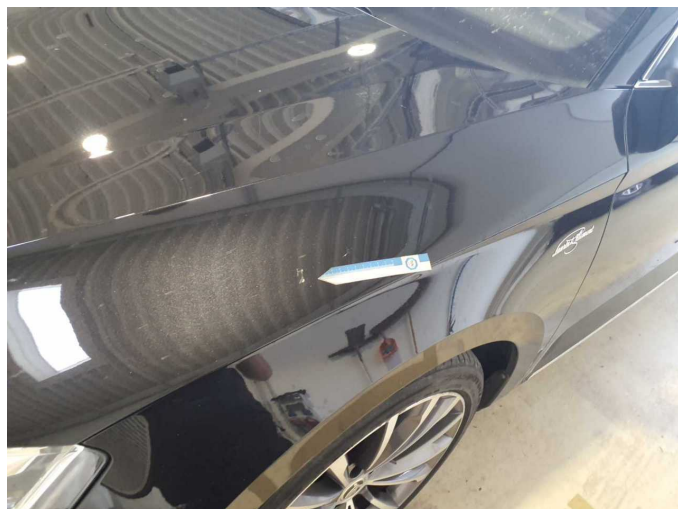
**Damage 13:** Door - front right side: Door - Dent / paintcoat damage - Repair and paint

| No. | Component group | Description |
|---|---|---|
| 13 | Door - front right side | Door - Dent / paintcoat damage - Repair and paint |

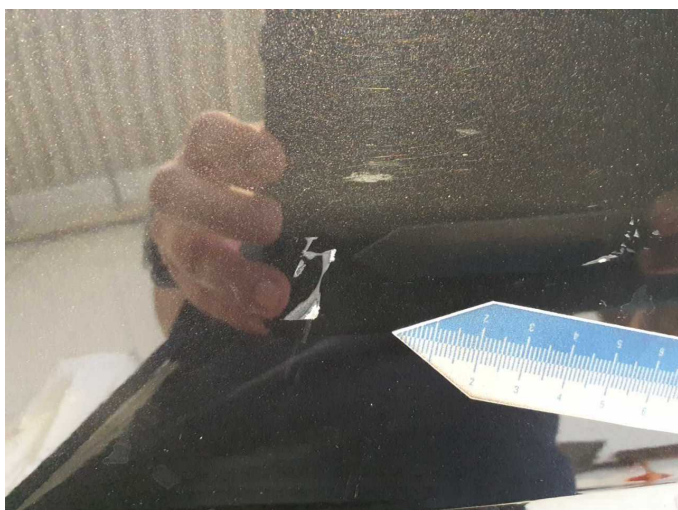
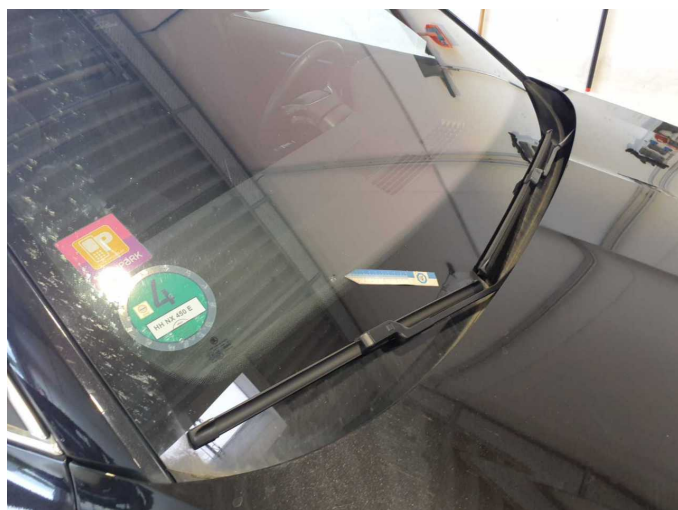
**Damage 14:** Bonnet: Bonnet - Scratch(es) - Paint

| No. | Component group | Description |
|---|---|---|
| 14 | Bonnet | Bonnet - Scratch(es) - Paint |

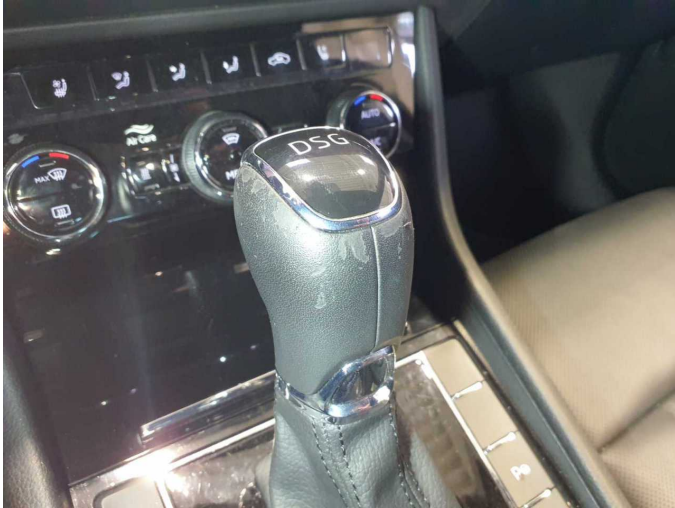
| No. | Component group | Description |
|---|---|---|
| 5 | Gearbox | Selector lever - Scratch(es) - No deduction |

**Wear and tear 5:** Gearbox: Selector lever - Scratch(es) - No deduction
