Expertise

Protocol number: 46316007  
Order No. / Reference: 26562342  
Inspection date: 29 Jun 2026

Manufacturer: Mercedes-Benz

Model: GLE 350 de 4Matic 9G-TRONIC Exclusive

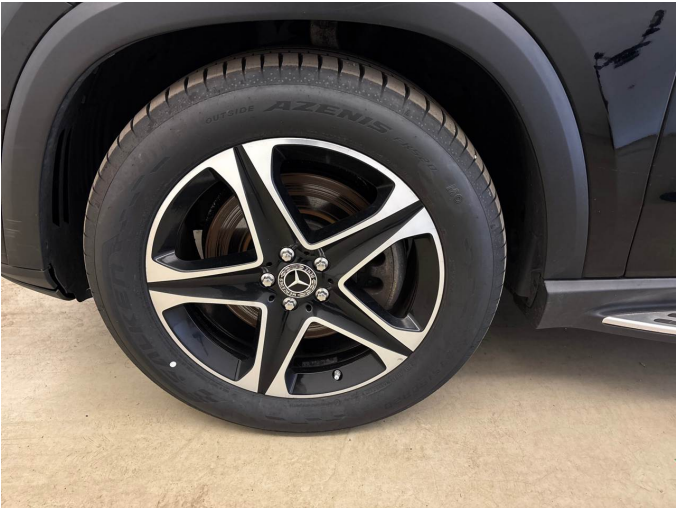
Figure 13: Mounted tyres

| # | Tyre size | Type of tyre | Manufacturer | Tread depth |
|---|---|---|---|---|
| 1) | 275/50 R20 113V | Summer tyres on Light alloy | Falken | 5mm / 5mm |
| 2) | 275/50 R20 113V | Summer tyres on Light alloy | Falken | 5mm / 5mm |

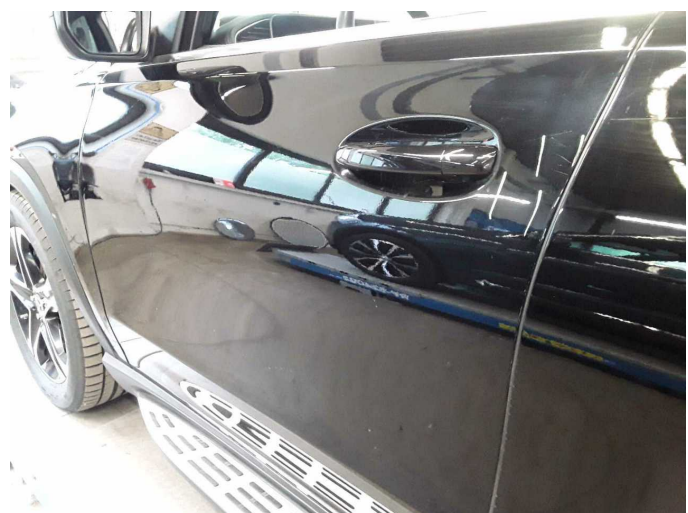
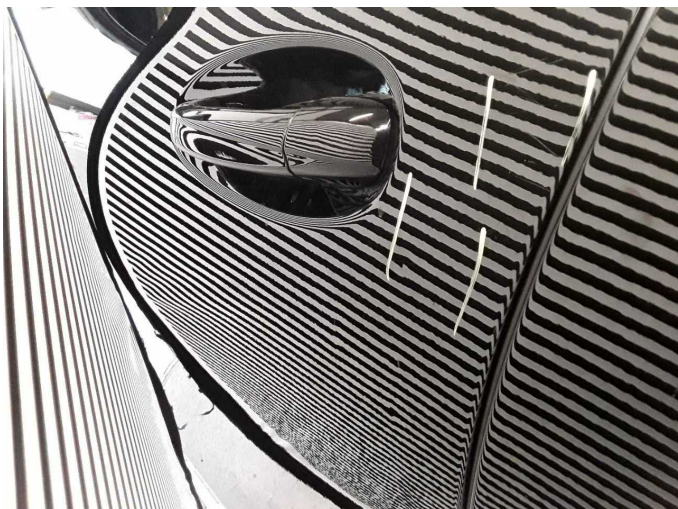
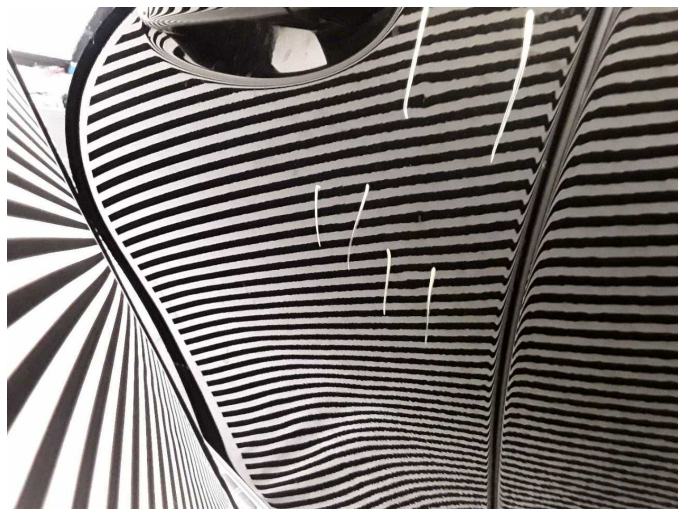
**Damage 2:** Door - front left side: Door - Dent / paintcoat damage - Repair and paint

| No. | Component group | Description |
|---|---|---|
| 2 | Door - front left side | Door - Dent / paintcoat damage - Repair and paint |

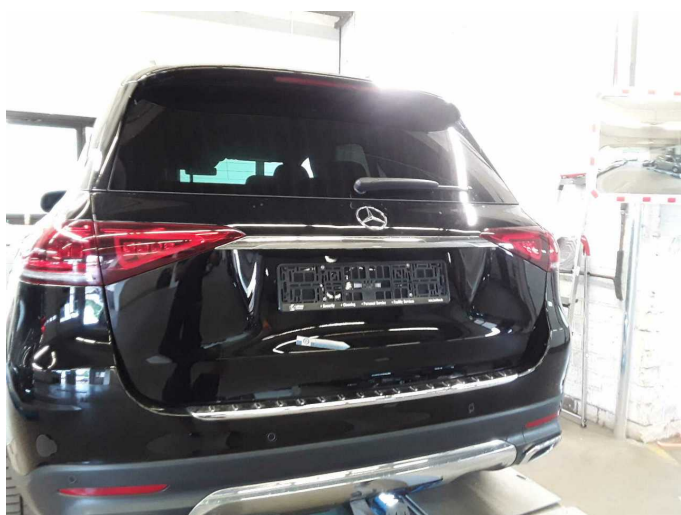
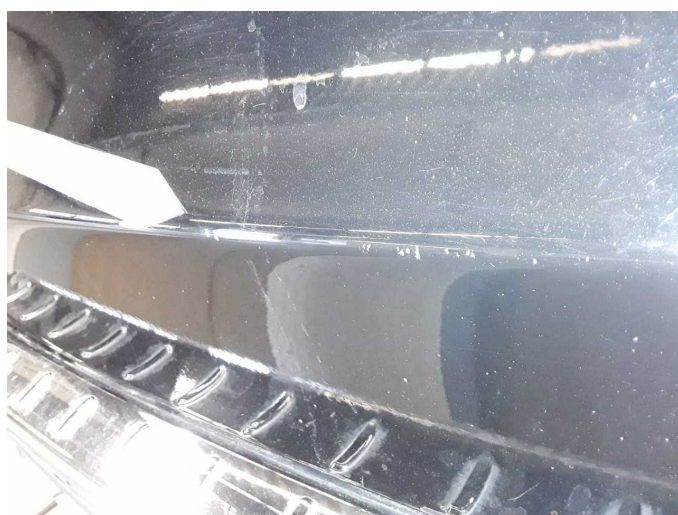
**Damage 3:** Boot lid / rear door: Boot lid - Scratch(es) - Paint

| No. | Component group | Description |
|---|---|---|
| 3 | Boot lid / rear door | Boot lid - Scratch(es) - Paint |

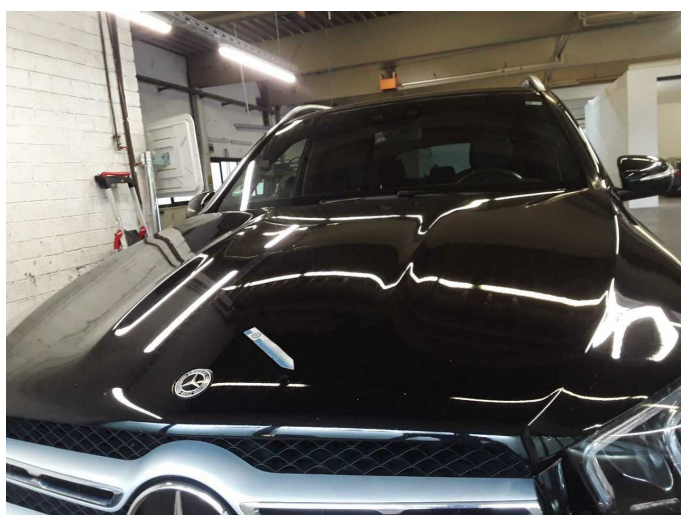
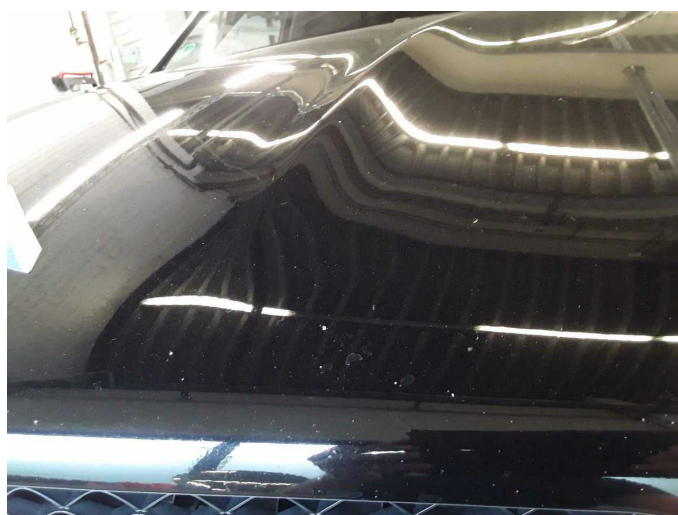
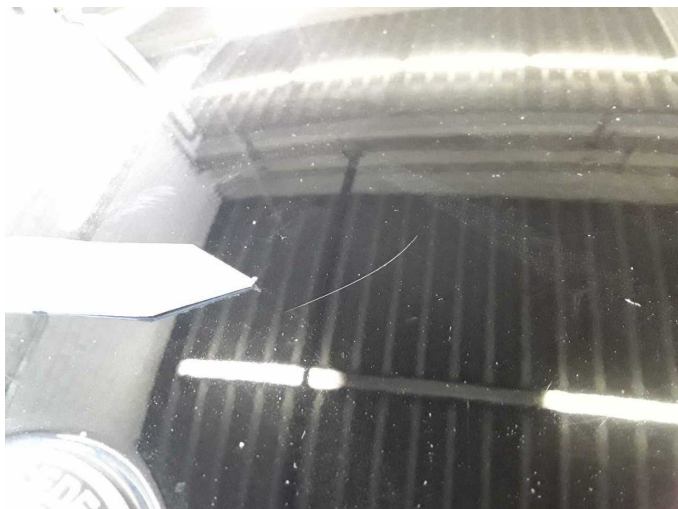
**Damage 4:** Bonnet: Bonnet - Scratch(es) - Paint

| No. | Component group | Description |
|---|---|---|
| 4 | Bonnet | Bonnet - Scratch(es) - Paint |

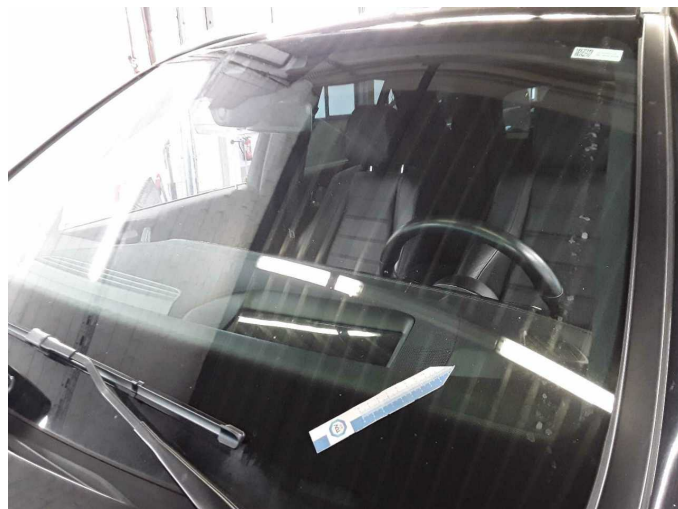
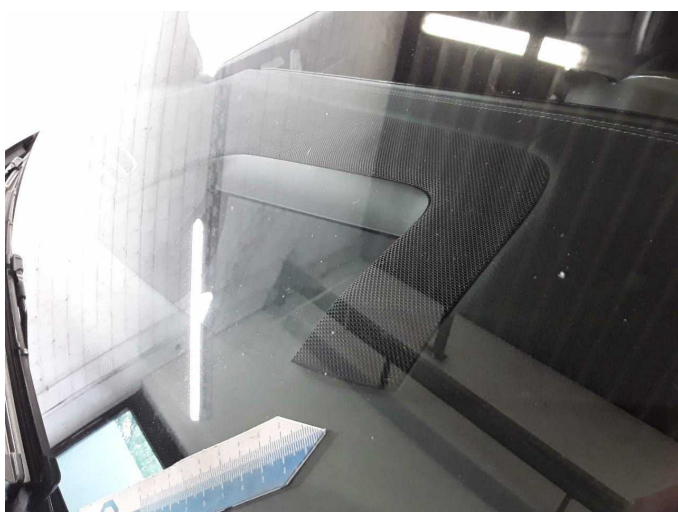
**Wear and tear 1:** Vehicle glazing: Windscreen - Stone chips - No deduction

| No. | Component group | Description |
|---|---|---|
| 1 | Vehicle glazing | Windscreen - Stone chips - No deduction |

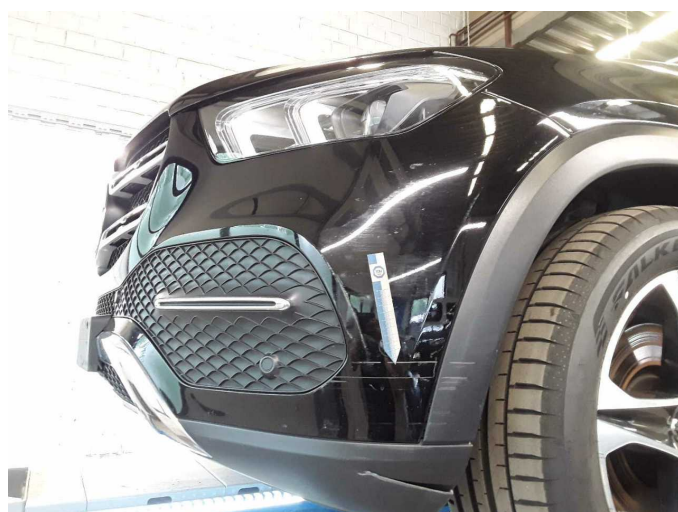
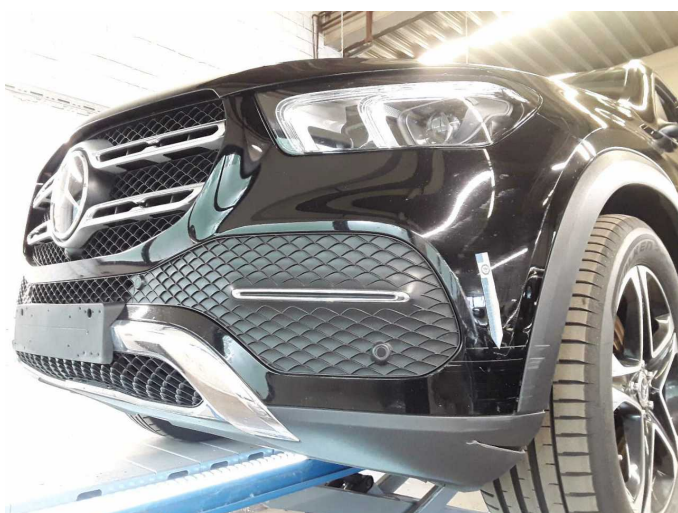
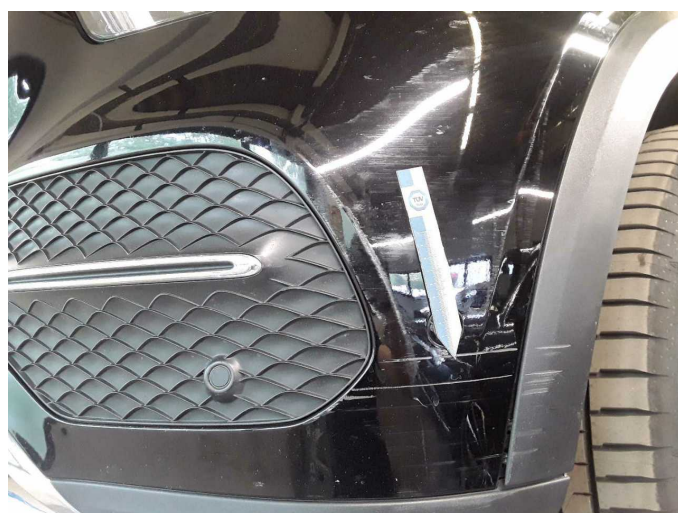
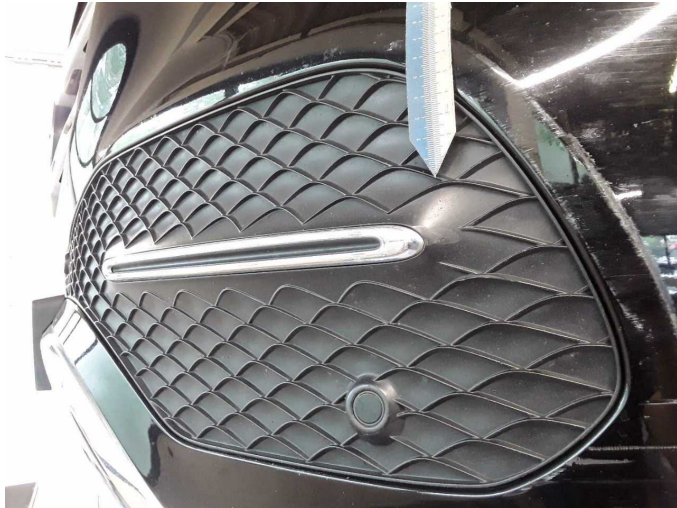
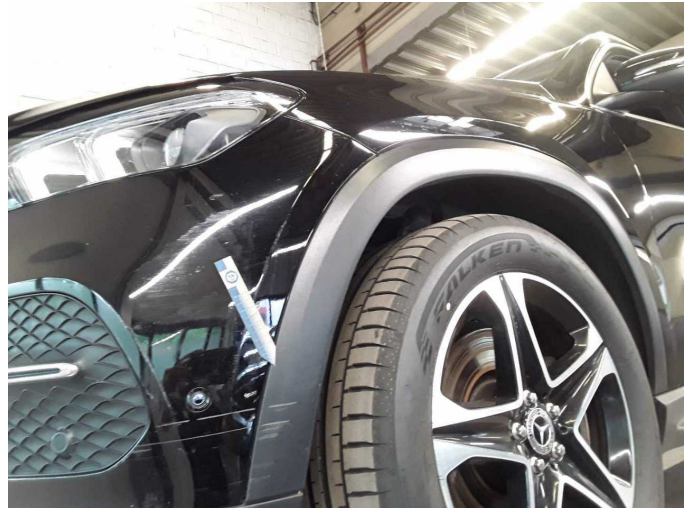
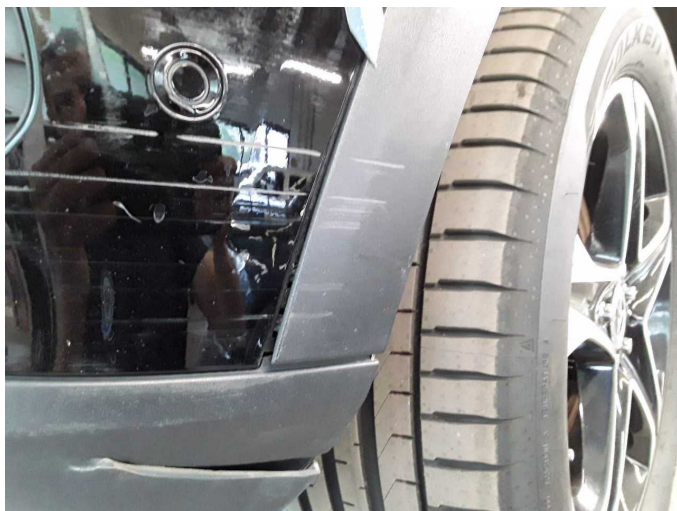
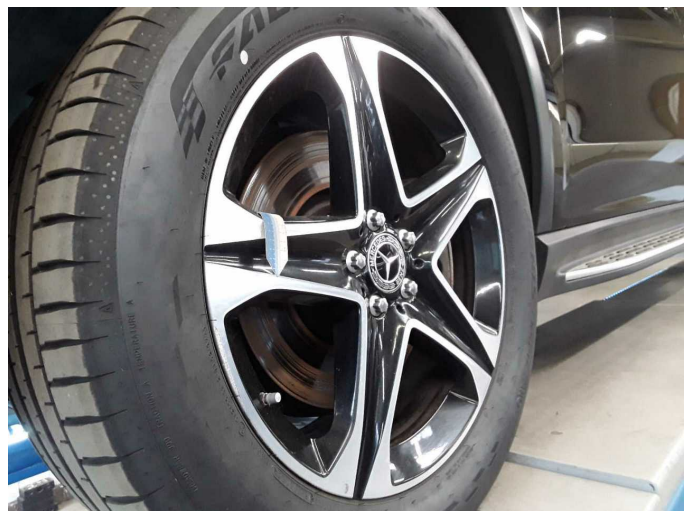
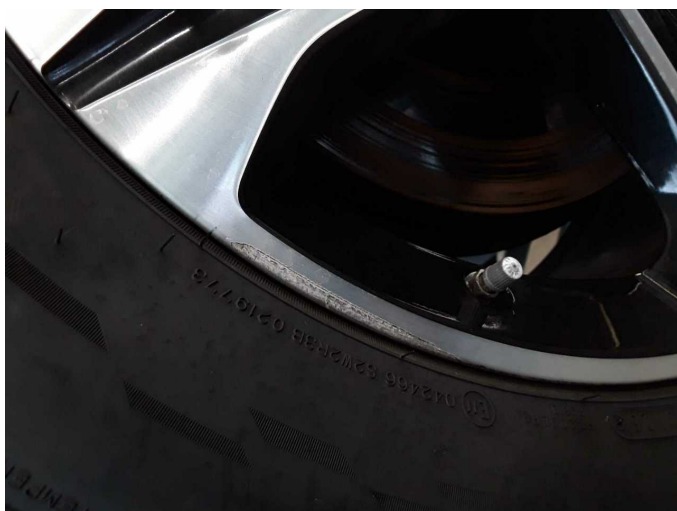
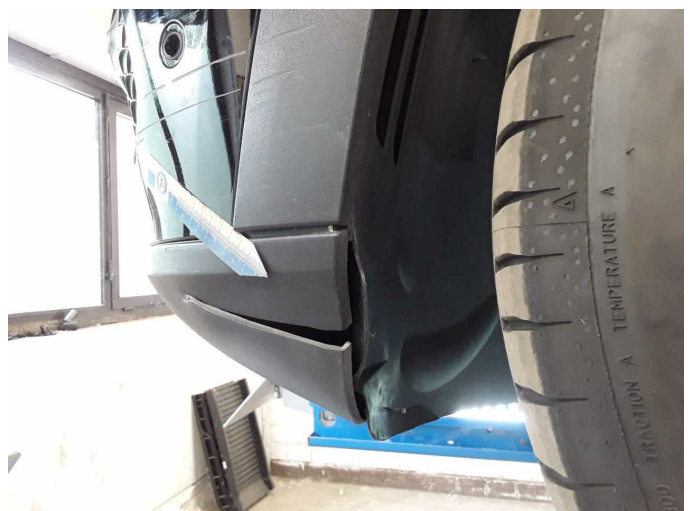
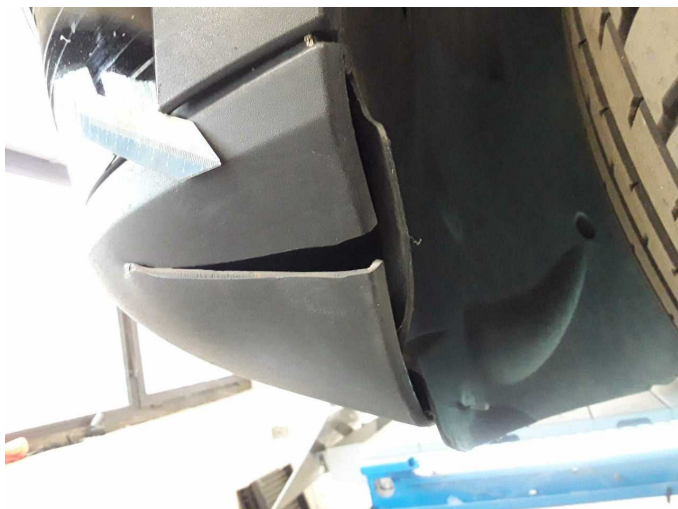
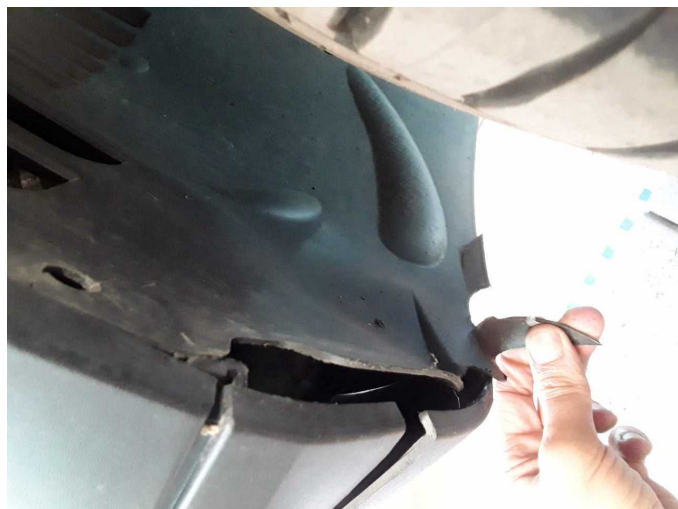
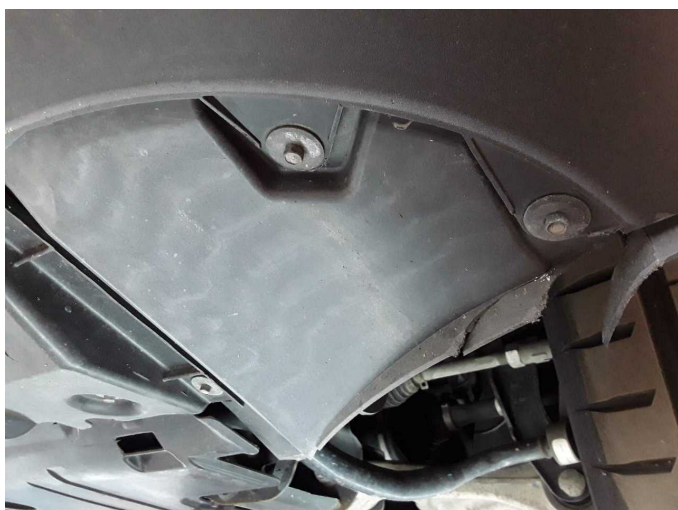
| No. | Accident |
|---|---|
| 1 | Front, Side - left, Underbody |

**Accident 1:** Front, Side - left, Underbody

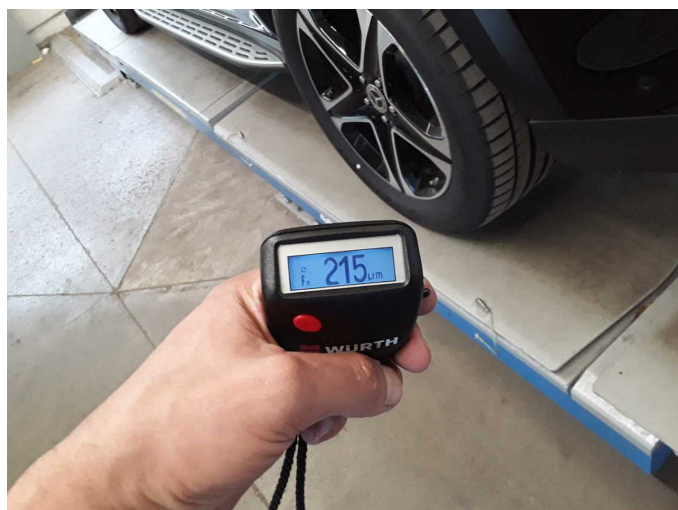
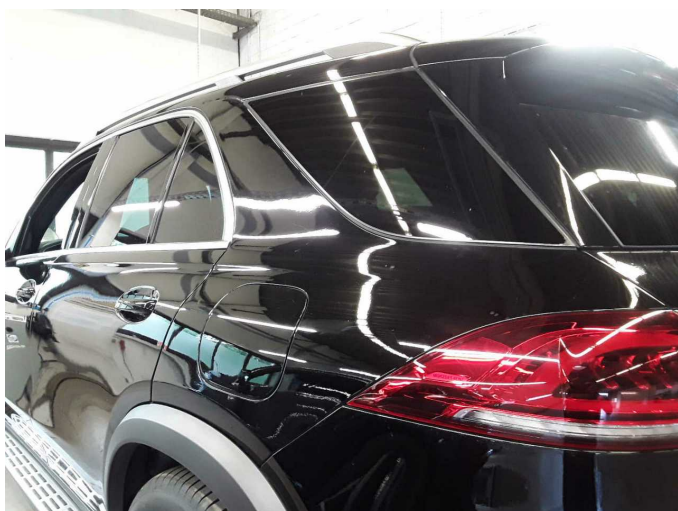
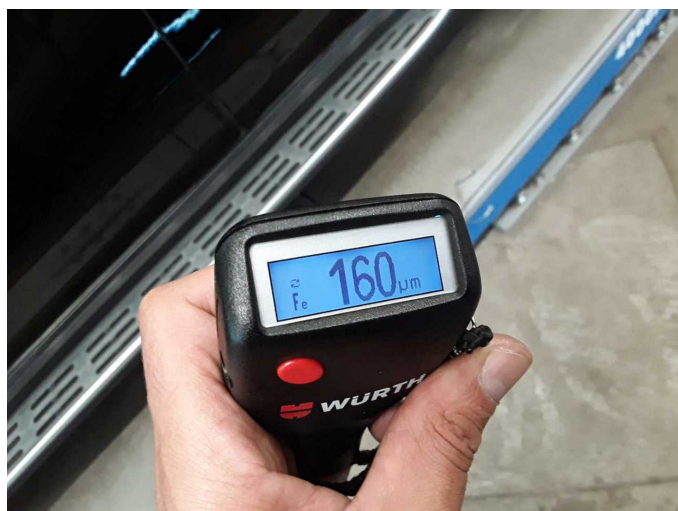
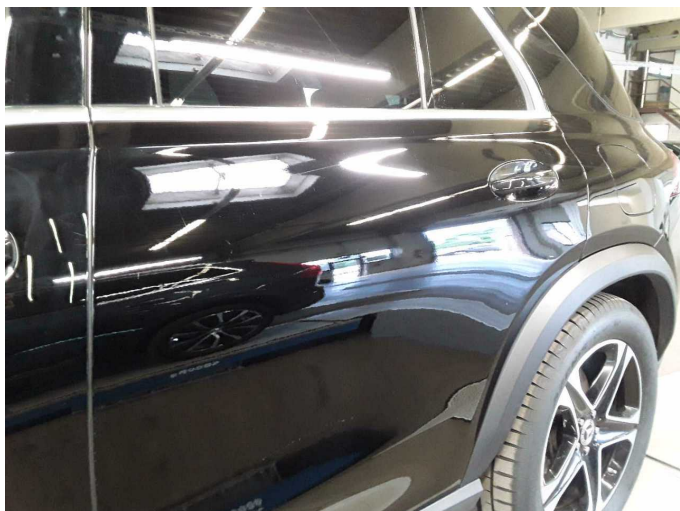
| No. | Repainting |
|---|---|
| 1 | Side panel - rear left side, Professionally carried out, Invoice of repair done Non-existent |

**Repainting 1:** Side panel - rear left side
