Protocol number: 46137565
Order No. / Reference: 26559125
Inspection date: 24 Jun 2026

Manufacturer: Opel

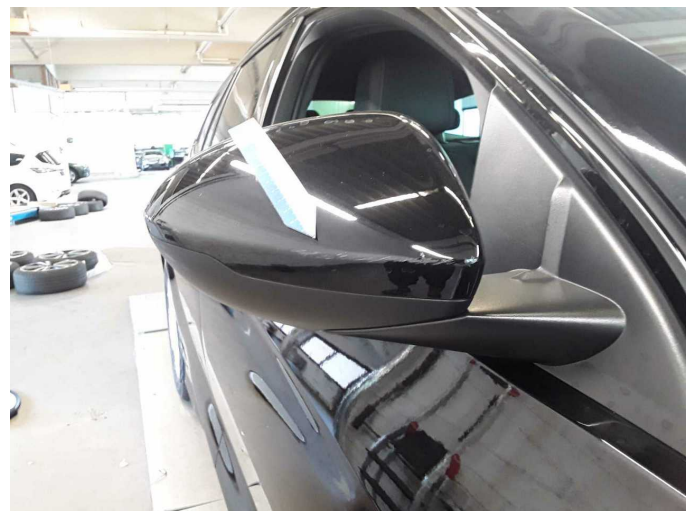
Damage 1: Wing mirror - right side: Cap - Scratched - Smart repair

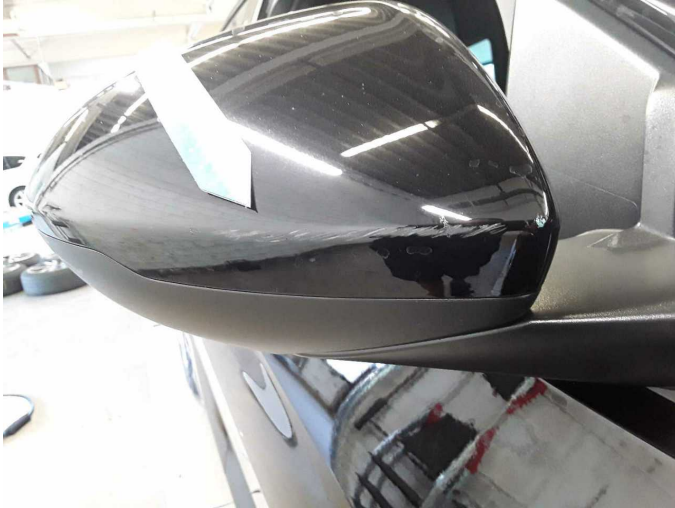
Damage 1: Wing mirror - right side: Cap - Scratched - Smart repair

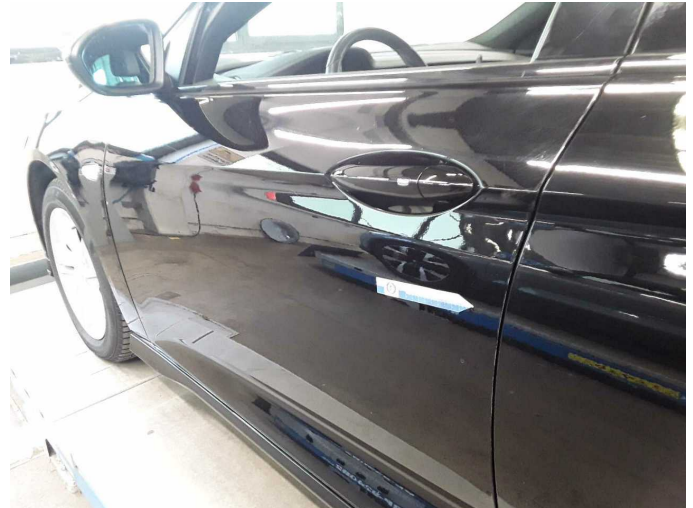
Damage 2: Door - front left side: Door - Scratch(es) - Smart repair

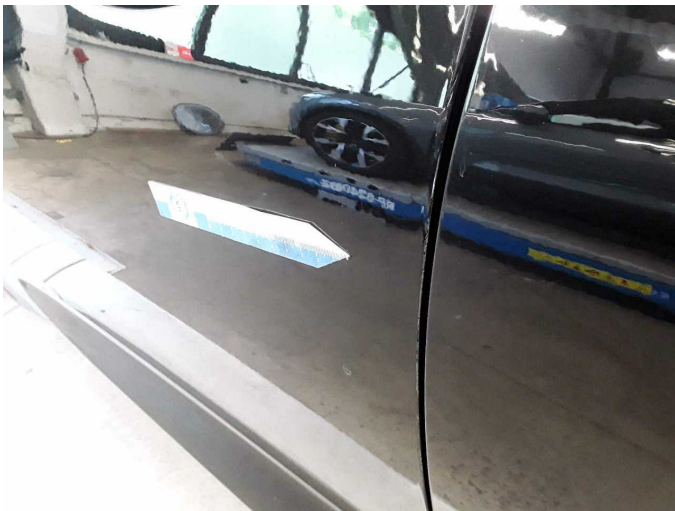
Damage 2: Door - front left side: Door - Scratch(es) - Smart repair

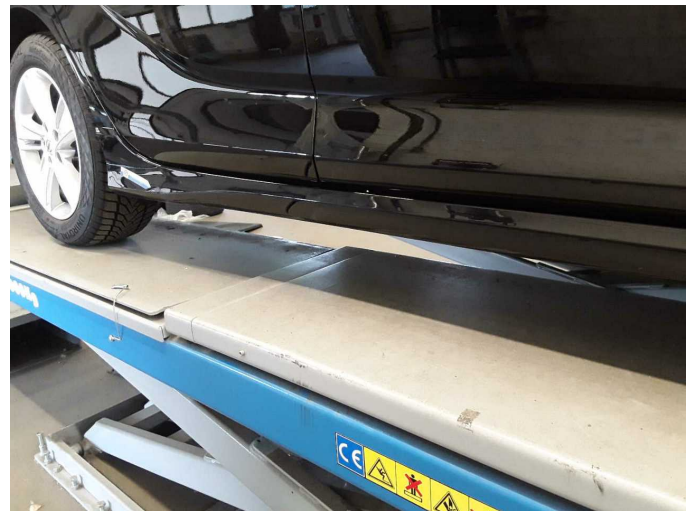
Damage 3: Sill - right side: Trim - Scratched - Smart repair

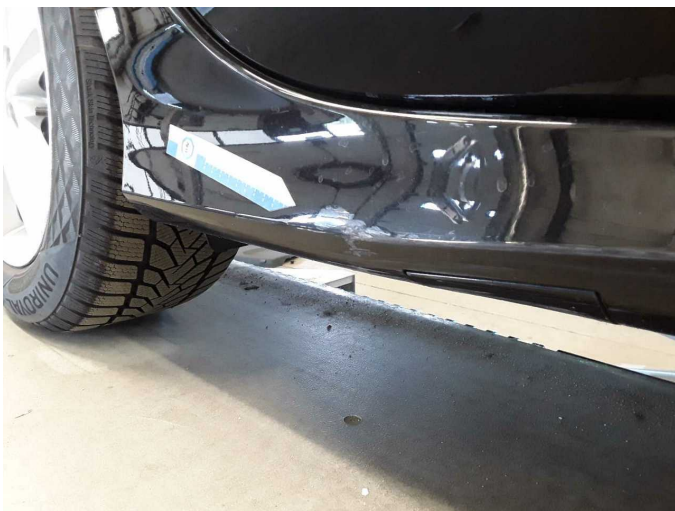
Damage 3: Sill - right side: Trim - Scratched - Smart repair

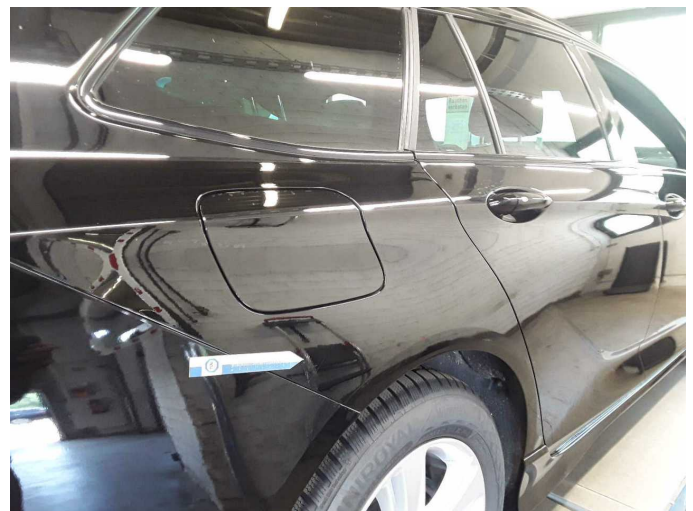
Damage 4: Side panel - rear right side: Side panel - Scratch(es) - Paint

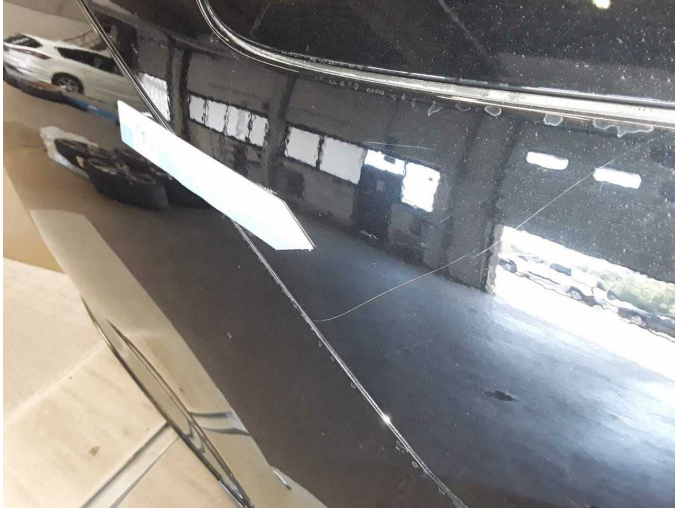
Damage 4: Side panel - rear right side: Side panel - Scratch(es) - Paint

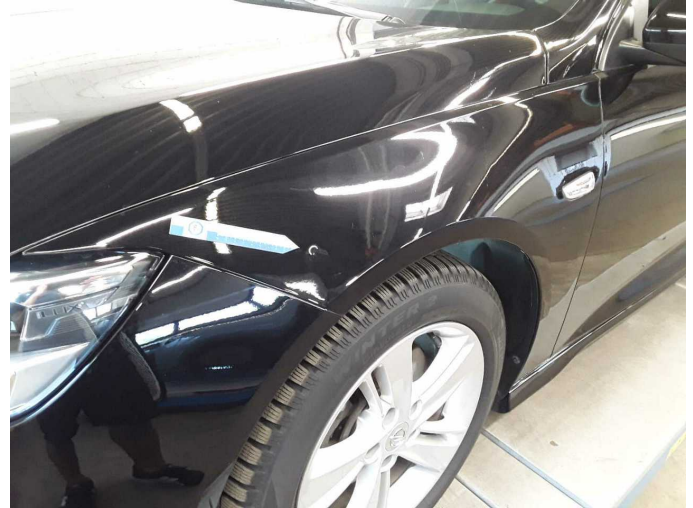
Damage 5: Mudguard - left side: Mudguard - left side - Deformed - Repair and paint

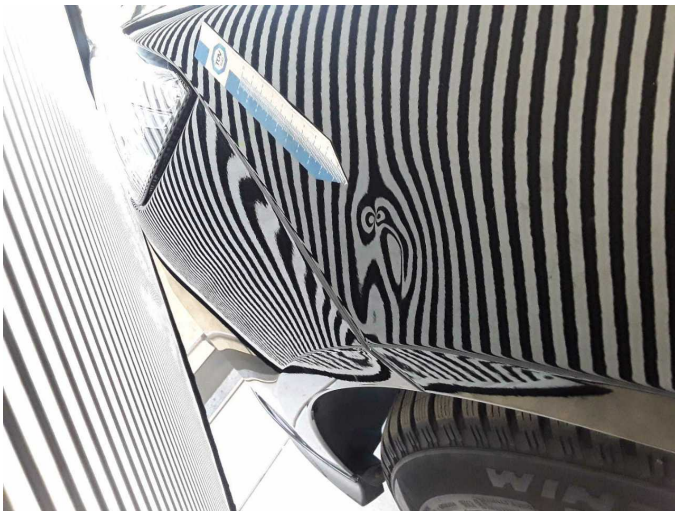
Damage 5: Mudguard - left side: Mudguard - left side - Deformed - Repair and paint

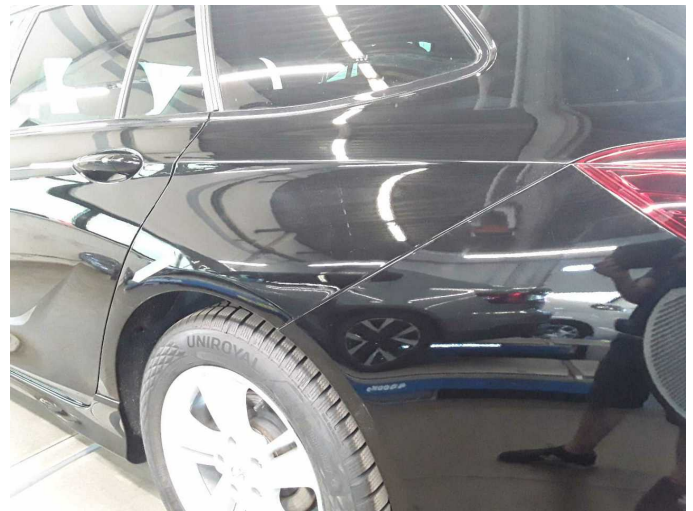
Damage 6: Side panel - rear left side: Side panel - Dent / paintcoat damage - Repair and paint

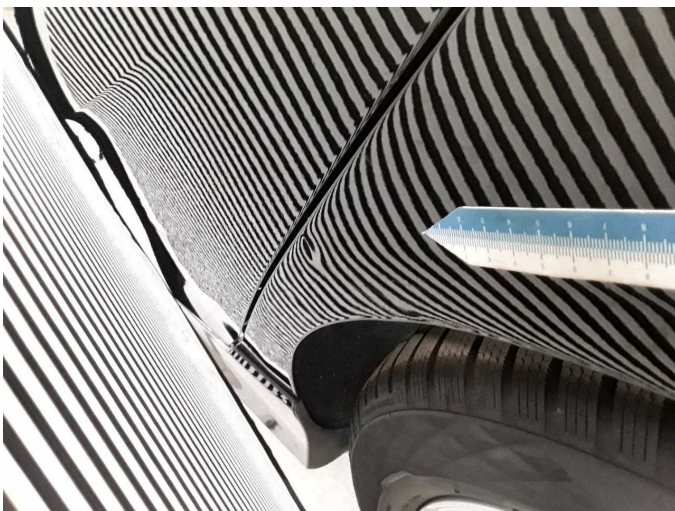
Damage 6: Side panel - rear left side: Side panel - Dent / paintcoat damage - Repair and paint

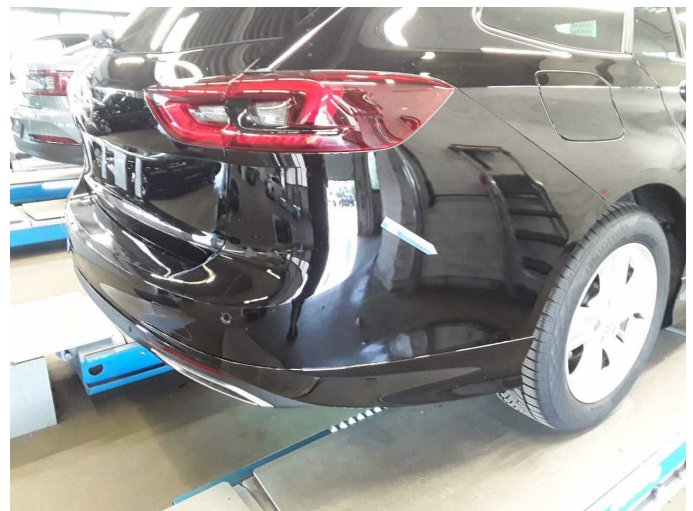
Damage 7: Rear bumper: Rear bumper - Scratch(es) - Paint

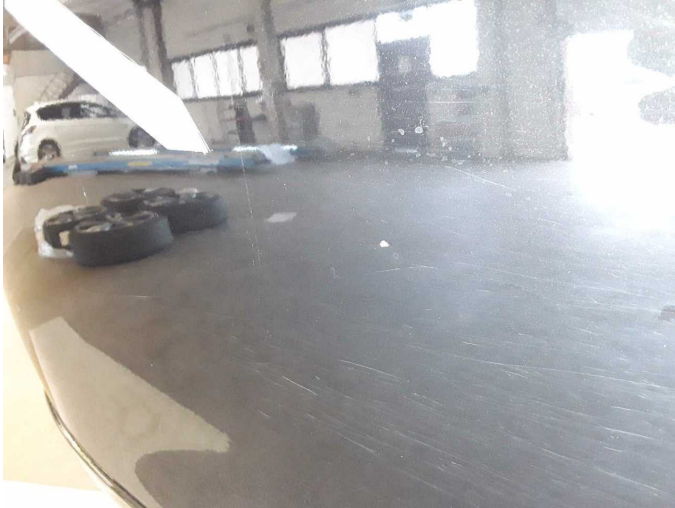
Damage 7: Rear bumper: Rear bumper - Scratch(es) - Paint

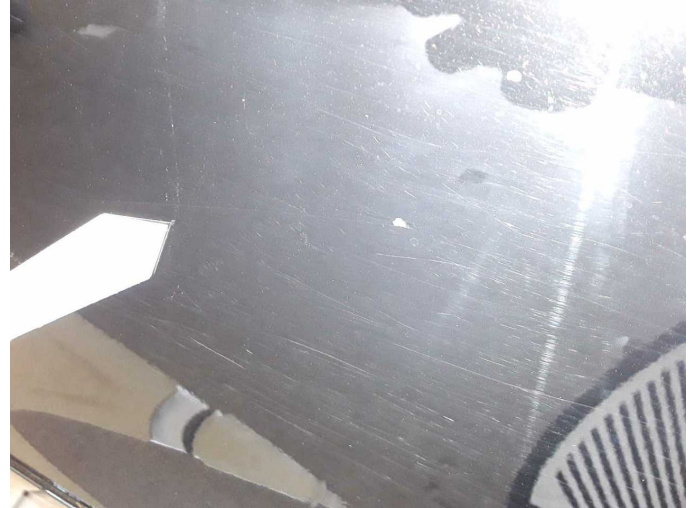
Damage 7: Rear bumper: Rear bumper - Scratch(es) - Paint

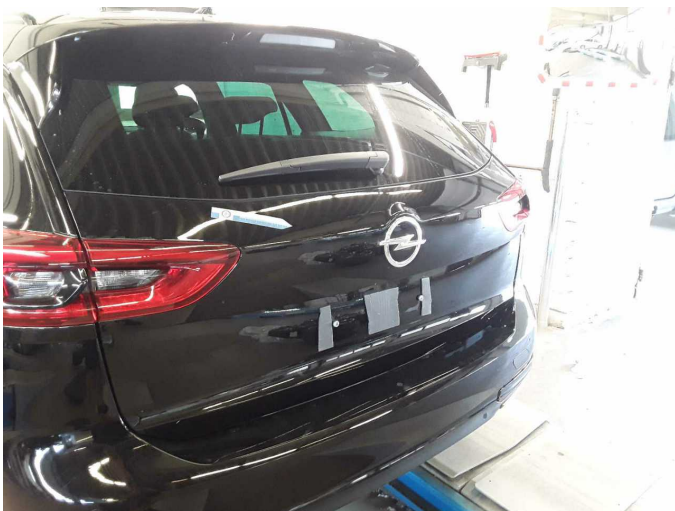
Damage 8: Boot lid / rear door: Boot lid - Dent / paintcoat damage - Repair and paint

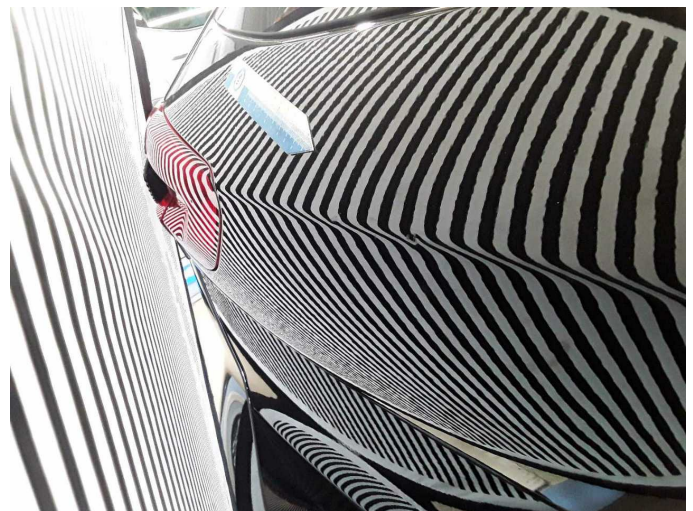
Damage 8: Boot lid / rear door: Boot lid - Dent / paintcoat damage - Repair and paint

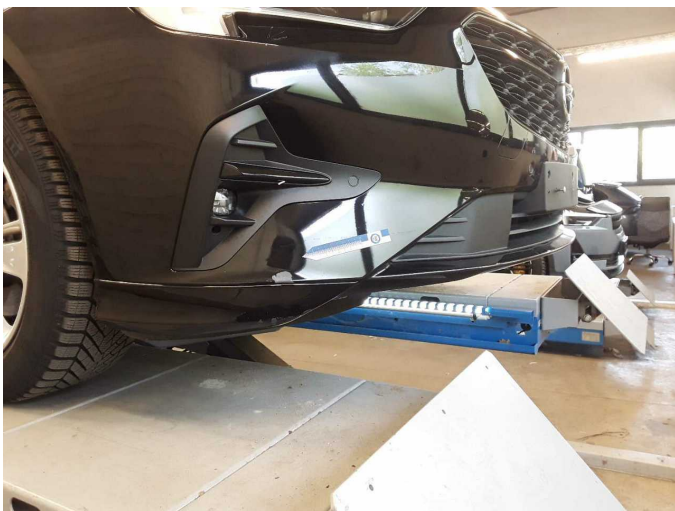
Damage 9: Front bumper: Front bumper - Deformed - Repair and paint

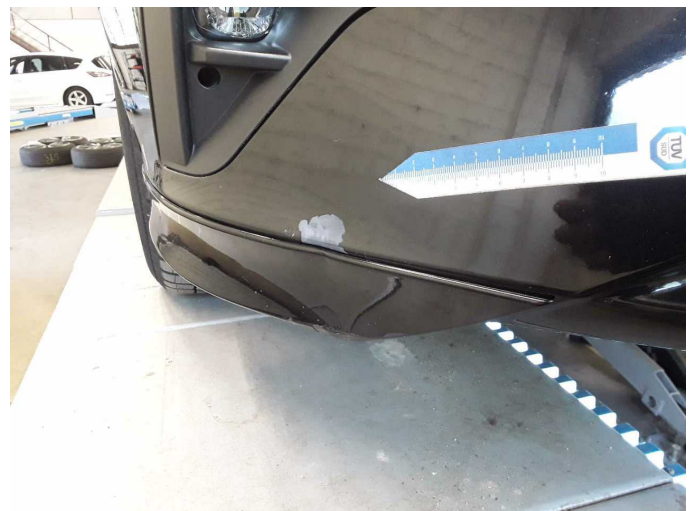
Damage 9: Front bumper: Front bumper - Deformed - Repair and paint

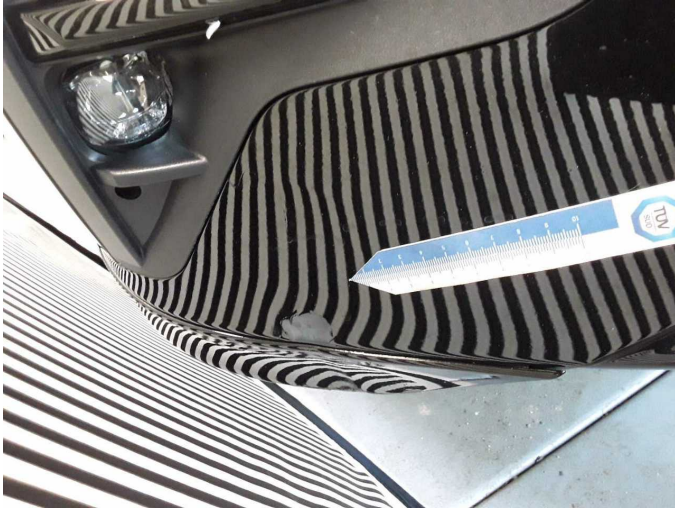
Damage 9: Front bumper: Front bumper - Deformed - Repair and paint

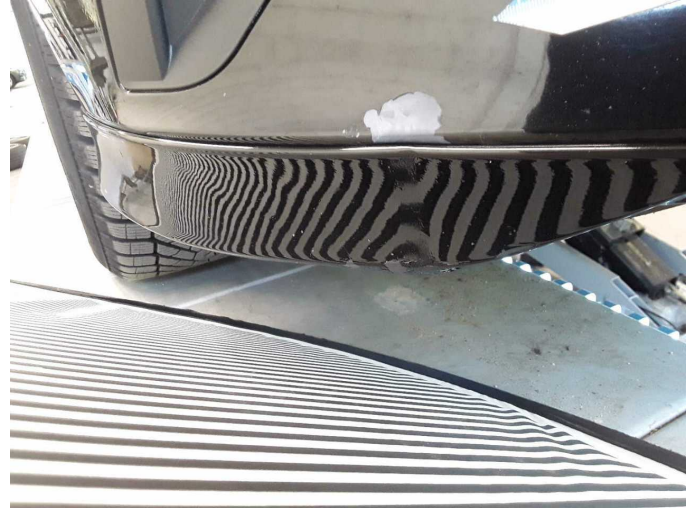
Damage 9: Front bumper: Front bumper - Deformed - Repair and paint

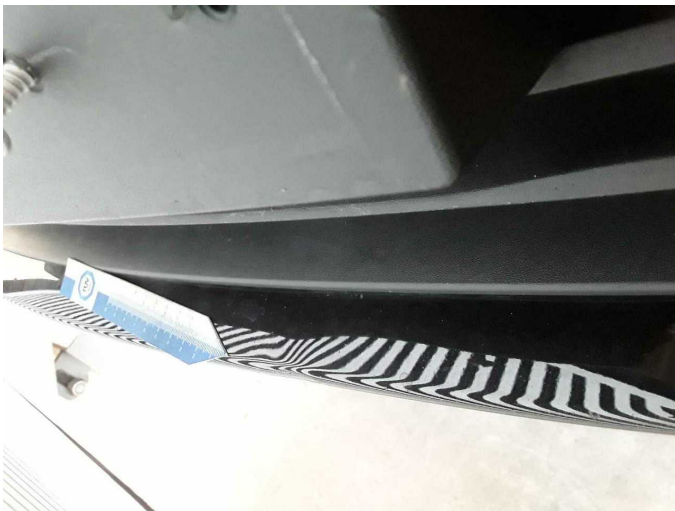
Damage 9: Front bumper: Front bumper - Deformed - Repair and paint

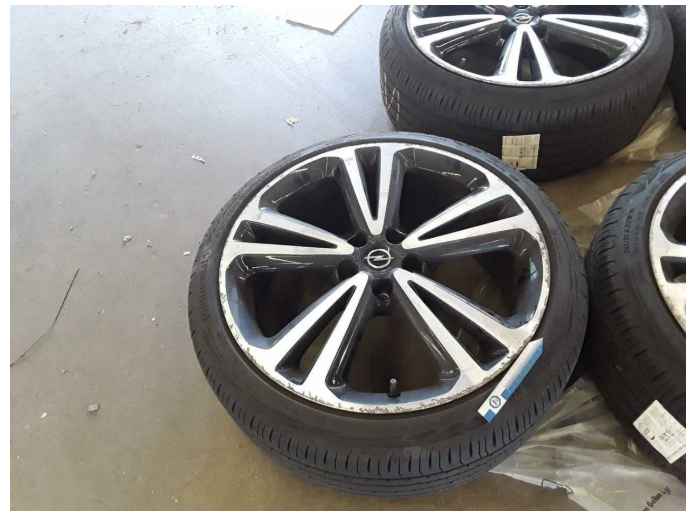
Damage 10: Wheel / tyres: Wheel rims - complete set (Materialabtrag) - Scratched - Replace

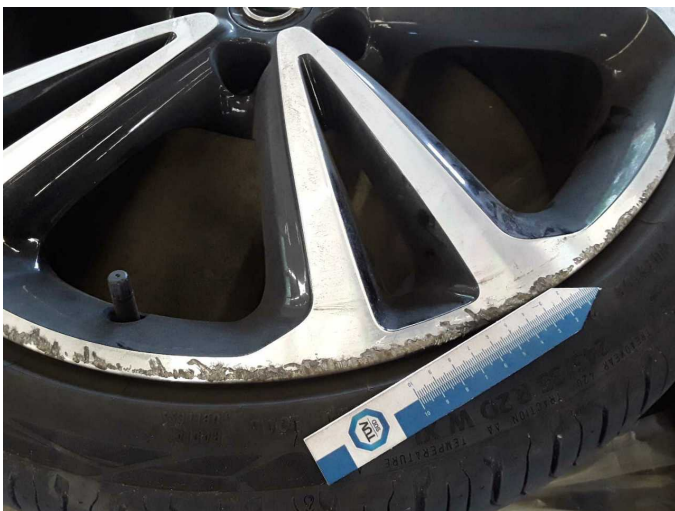
Damage 10: Wheel / tyres: Wheel rims - complete set (Materialabtrag) - Scratched - Replace

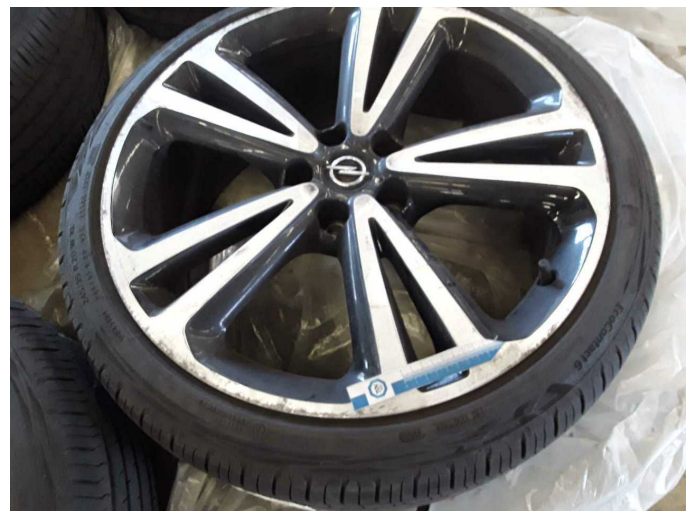
Damage 10: Wheel / tyres: Wheel rims - complete set (Materialabtrag) - Scratched - Replace

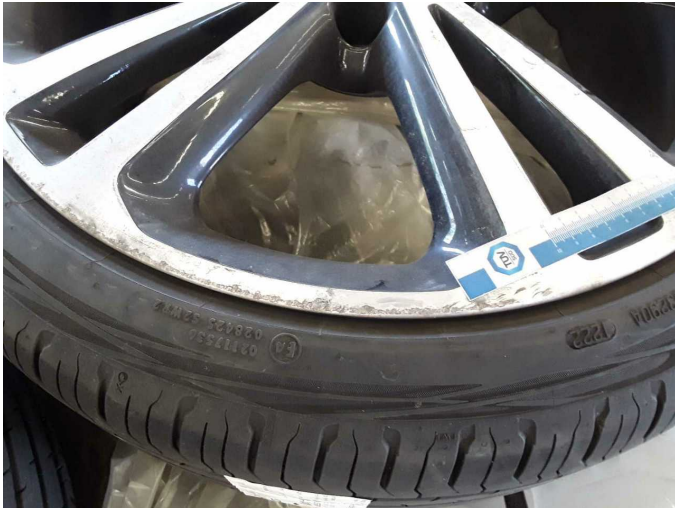
Damage 10: Wheel / tyres: Wheel rims - complete set (Materialabtrag) - Scratched - Replace

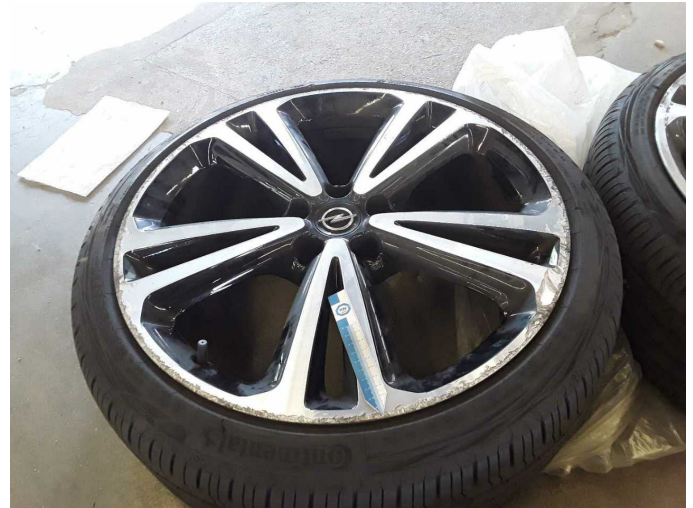
Damage 10: Wheel / tyres: Wheel rims - complete set (Materialabtrag) - Scratched - Replace

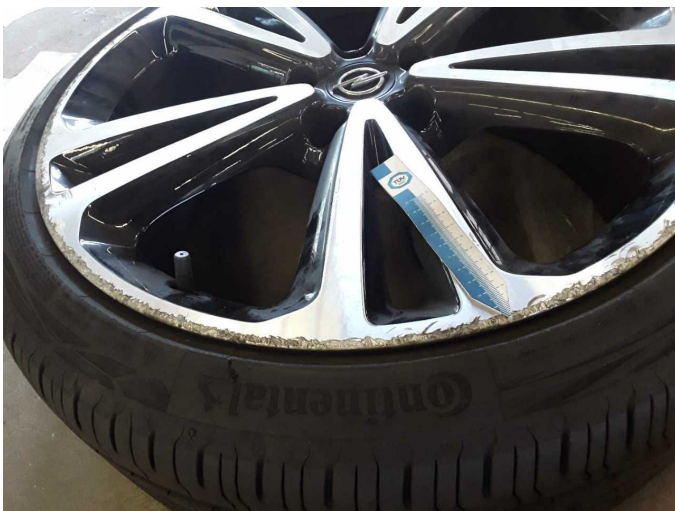
Damage 10: Wheel / tyres: Wheel rims - complete set (Materialabtrag) - Scratched - Replace

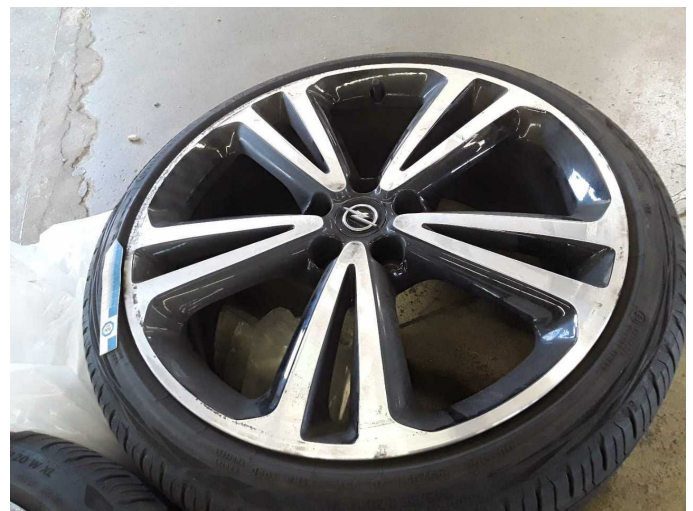
Damage 10: Wheel / tyres: Wheel rims - complete set (Materialabtrag) - Scratched - Replace

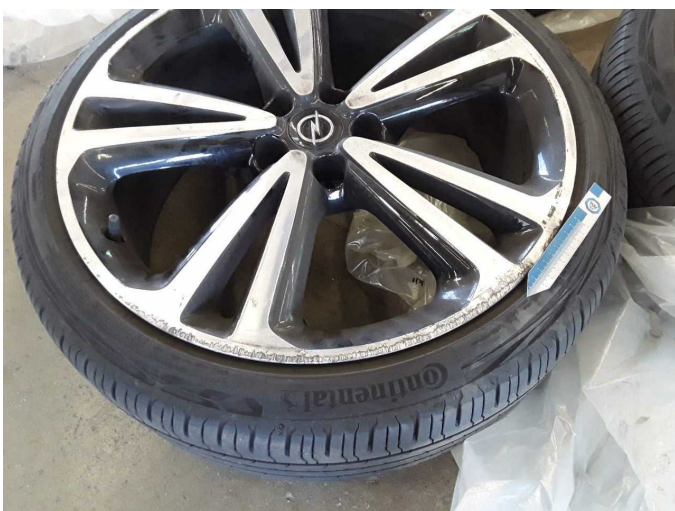
Damage 10: Wheel / tyres: Wheel rims - complete set (Materialabtrag) - Scratched - Replace

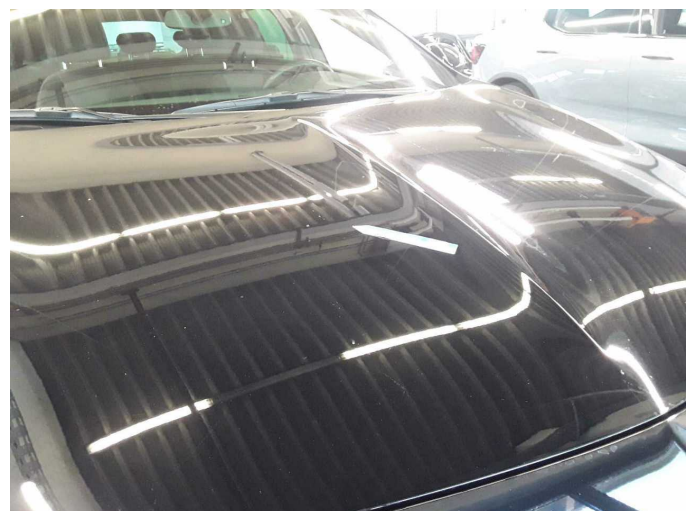
Wear and tear 1: Bonnet: Bonnet - Stone chips - No deduction

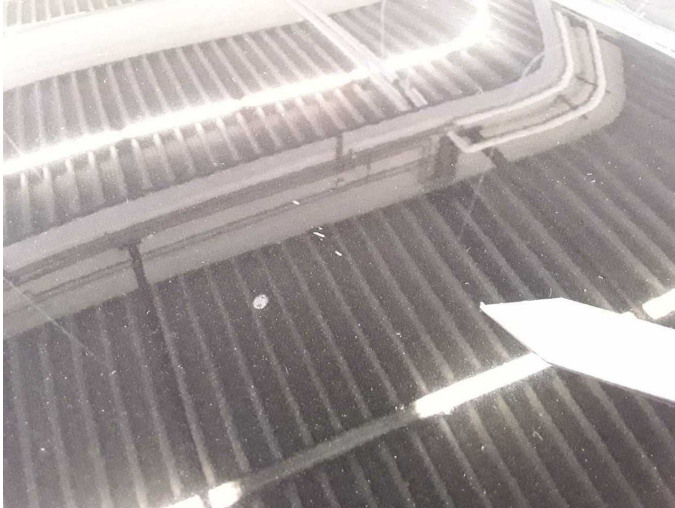
Wear and tear 1: Bonnet: Bonnet - Stone chips - No deduction

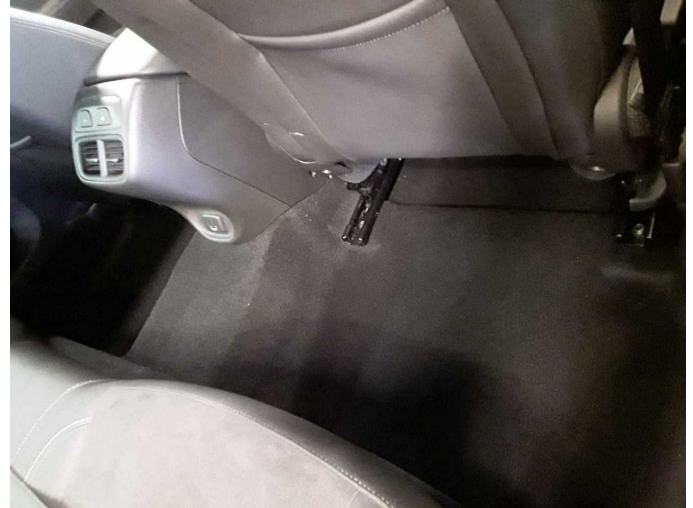
Missing part 1: Trim / covers: Floor mats - Missing - Replace

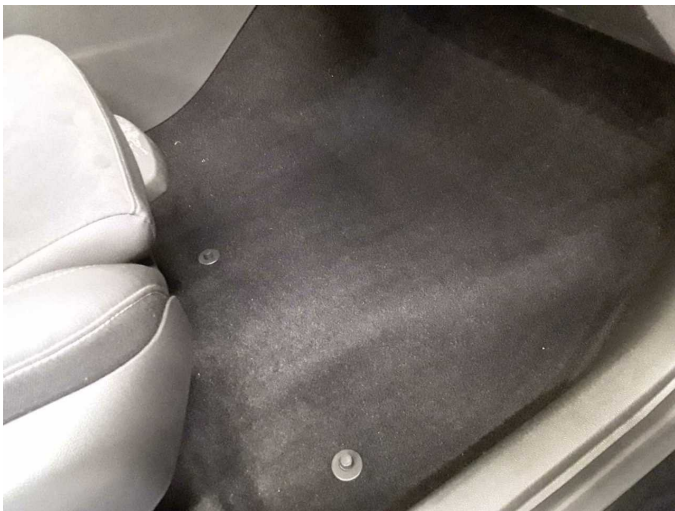
Missing part 1: Trim / covers: Floor mats - Missing - Replace

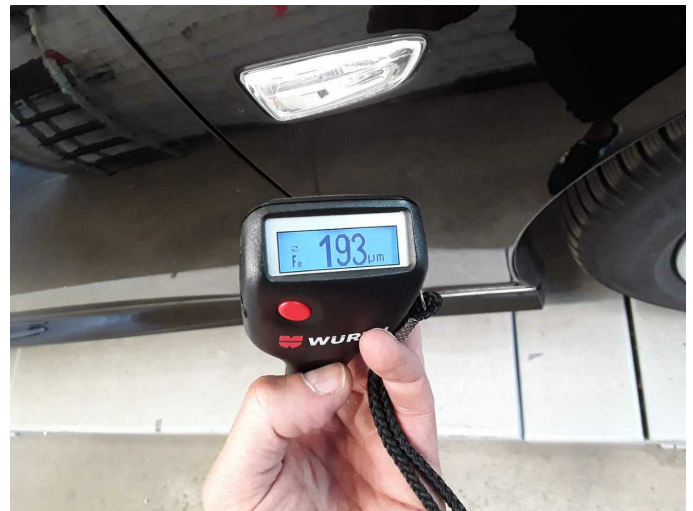
Repainting 1: Mudguard - left side, Mudguard - right side, Side panel - rear left side, Door - rear right side, Door - front left side, Door - front right side
