Expertise

Protocol number: 46824936  
Order No. / Reference: 26547006  
Inspection date: 31 Jul 2026

Manufacturer: Volvo

Model: XC60 B4 D Plus Dark

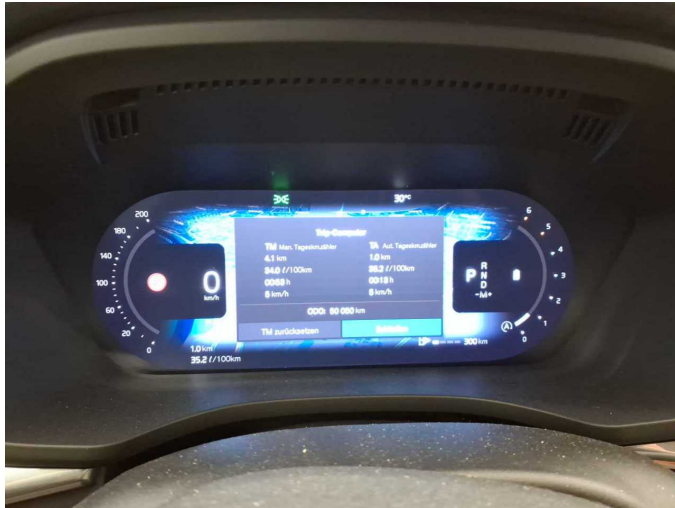
Figure 7: Instrument cluster

| Vehicle details | |
|---|---|
| Mileage (Read) | 50,050 km |

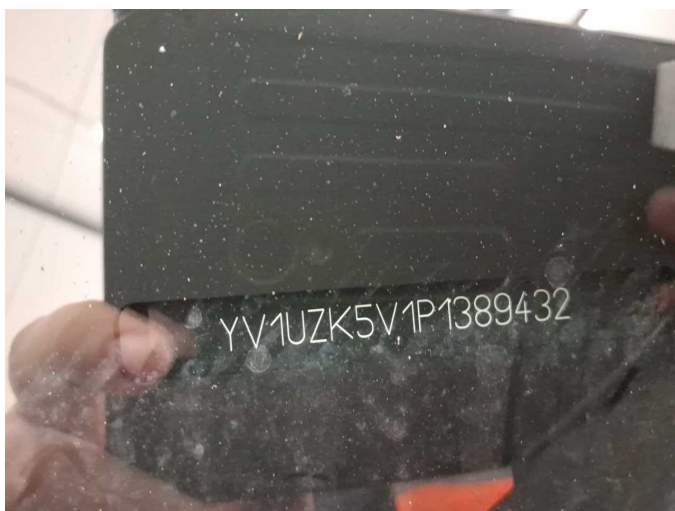
Figure 11: VIN

| VIN comparison | The vehicle identification number (VIN) was read from the vehicle and its conformity with the submitted documents was confirmed by the undersigned during the inspection. |

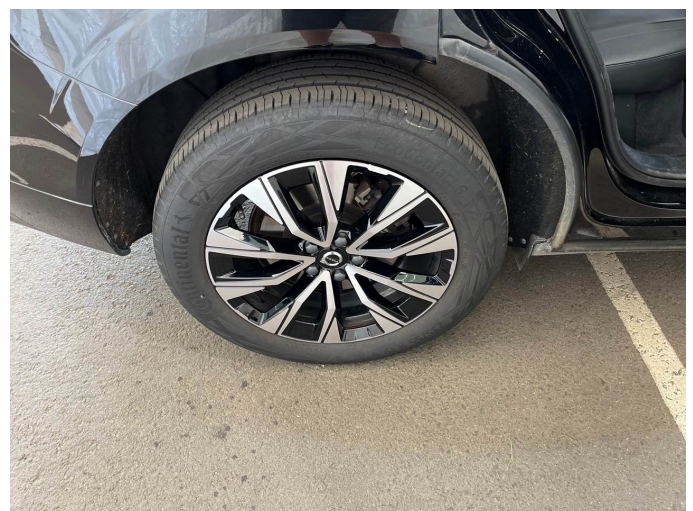
Figure 12: Mounted tyres

| Tyres | | | | |
|---|---|---|---|---|
| 1) | 235/55 R19 105V | Summer tyres on Light alloy | Continental | 4mm / 4mm |
| 2) | 235/55 R19 105V | Summer tyres on Light alloy | Continental | 5mm / 5mm |

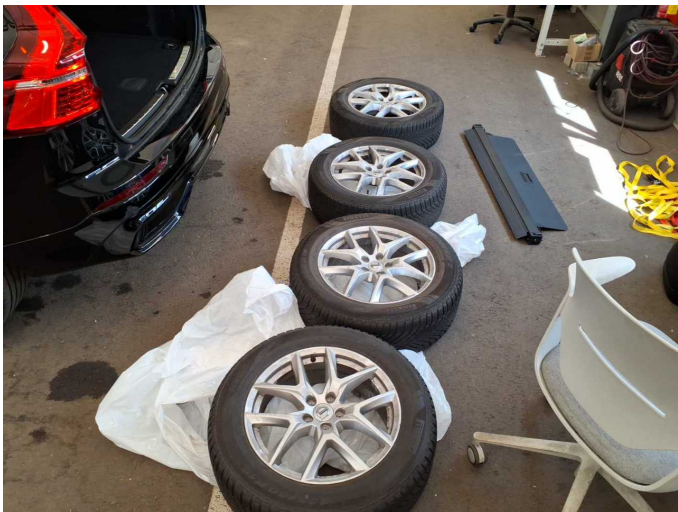
Figure 18: Additional tyres

| Tyres | | | | |
|---|---|---|---|---|
| 1) | 235/60 R18 107V | Winter tyres on Light alloy | Pirelli | 5mm / 5mm |
| 2) | 235/60 R18 107V | Winter tyres on Light alloy | Pirelli | 6mm / 6mm |

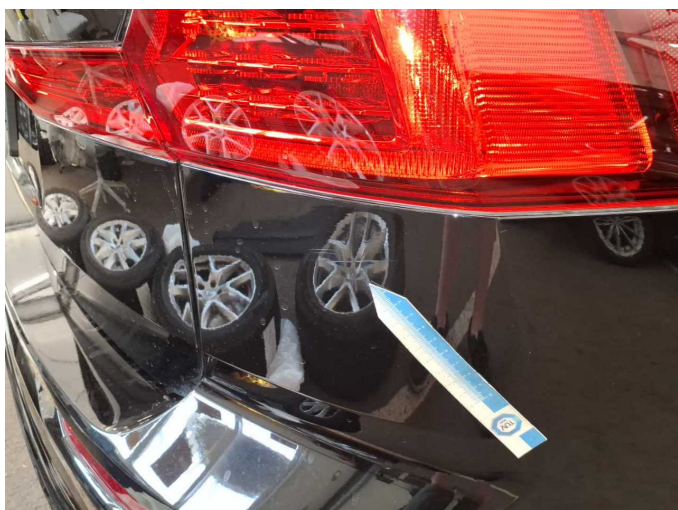
| No. | Component group | Description |
|---|---|---|
| 1 | Rear bumper | Rear bumper - Scratch(es) - Paint |

**Damage 1:** Rear bumper: Rear bumper - Scratch(es) - Paint

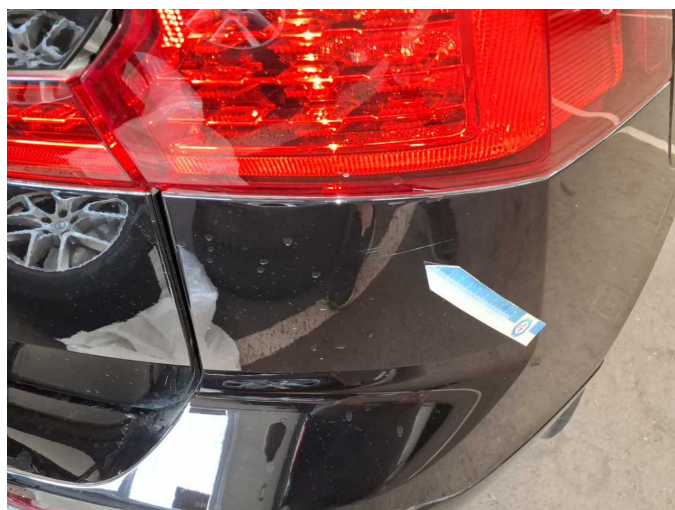
**Damage 1:** Rear bumper: Rear bumper - Scratch(es) - Paint

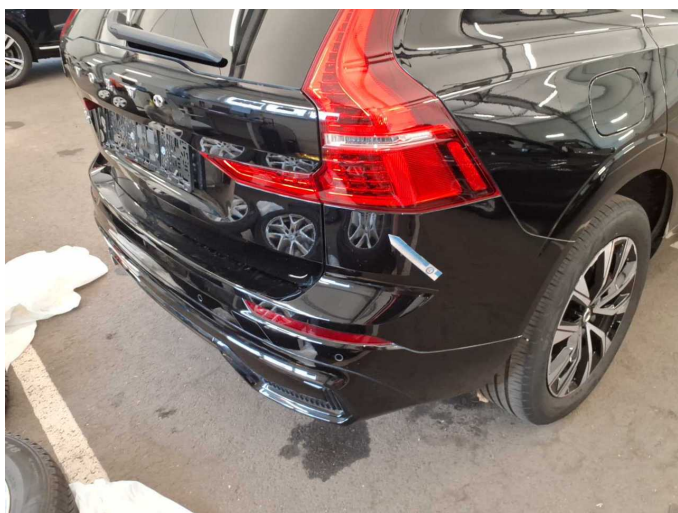
**Damage 1:** Rear bumper: Rear bumper - Scratch(es) - Paint

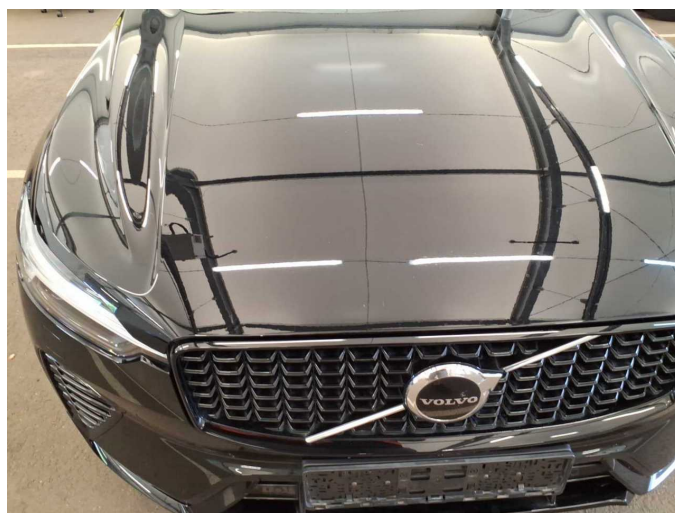
| No. | Component group | Description |
|---|---|---|
| 2 | Bonnet | Bonnet - Stone chips - No deduction |

**Wear and tear 2:** Bonnet: Bonnet - Stone chips - No deduction

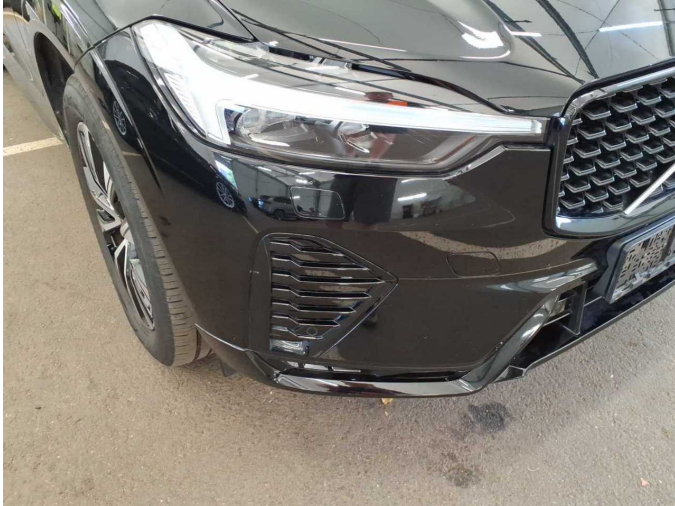
| No. | Component group | Description |
|---|---|---|
| 3 | Front bumper | Front bumper - Stone chips - No deduction |

**Wear and tear 3:** Front bumper: Front bumper - Stone chips - No deduction

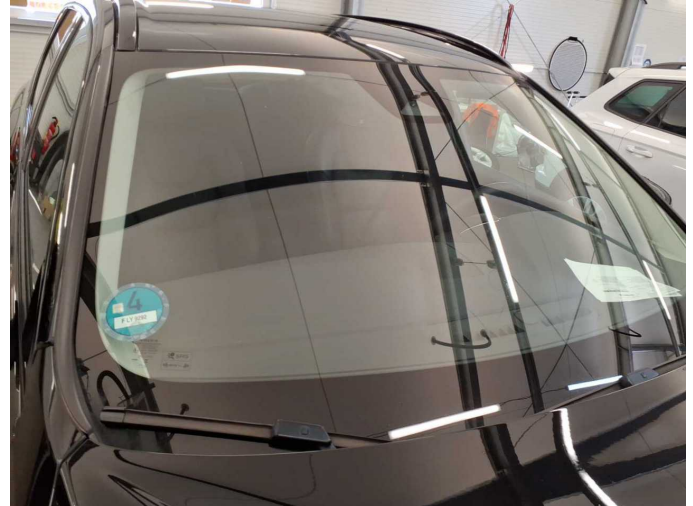
| No. | Component group | Description |
|---|---|---|
| 4 | Vehicle glazing | Windscreen - Stone chips - No deduction |

**Wear and tear 4:** Vehicle glazing: Windscreen - Stone chips - No deduction
