Expertise

Protocol number: 46347668  
Order No. / Reference: 26360122  
Inspection date: 6 Jul 2026

Manufacturer: Mercedes-Benz  
VIN: W1KAH0DB5PF123802

Model: C 200 d T 9G-TRONIC Avantgarde

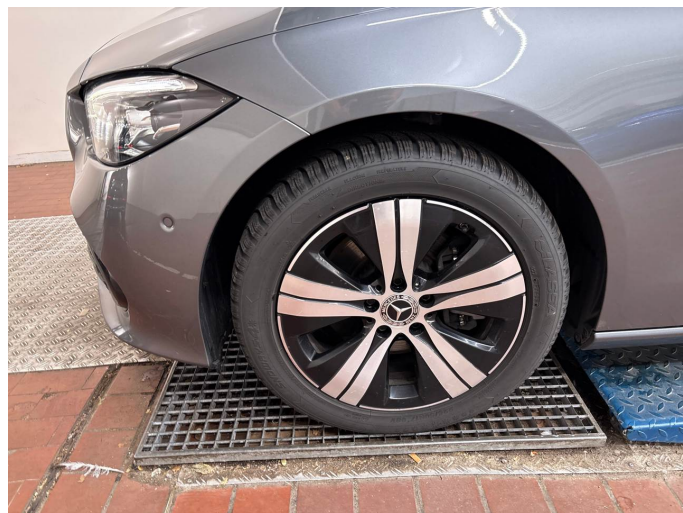
Figure 13: Mounted tyres

| # | Tyre size | Type of tyre | Manufacturer | Tread depth |
|---|---|---|---|---|
| 1) | 225/50 R17 98V | Winter tyres on Light alloy | Sonstige | 7mm / 7mm |
| 2) | 225/50 R17 98V | Winter tyres on Light alloy | Sonstige | 7mm / 7mm |

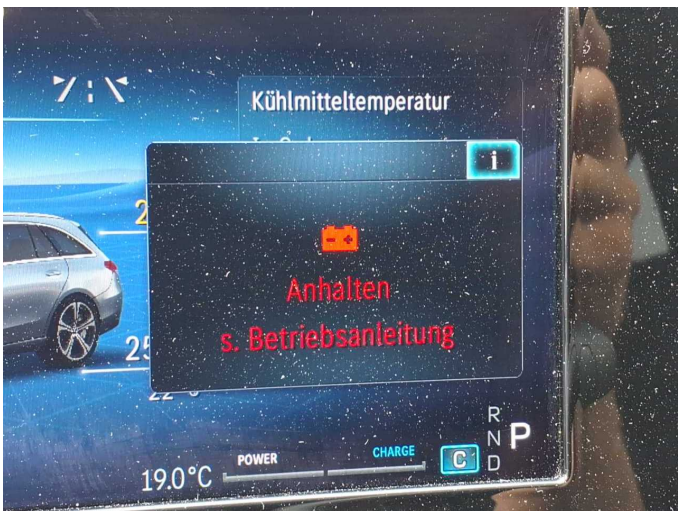
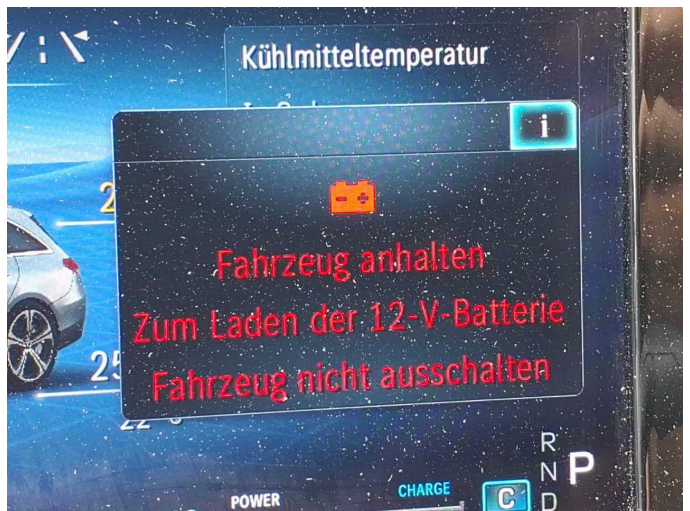
| No. | Component group | Description |
|---|---|---|
| 2 | Electrical system | Battery - Empty - Perform diagnosis |

Damage 2: Electrical system: Battery - Empty - Perform diagnosis

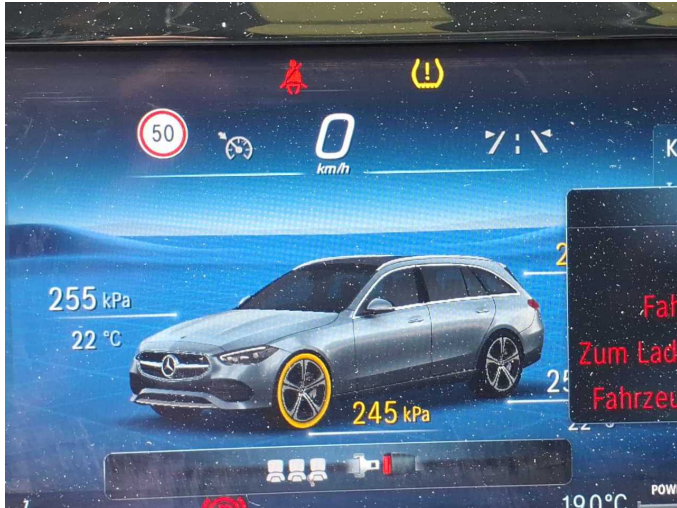
| No. | Component group | Description |
|---|---|---|
| 3 | Instrument panel | Indicator light (Reifendruckkontrollsystem) - on - Perform |

**Damage 3:** Instrument panel: Indicator light (Reifendruckkontrollsystem) - on - Perform

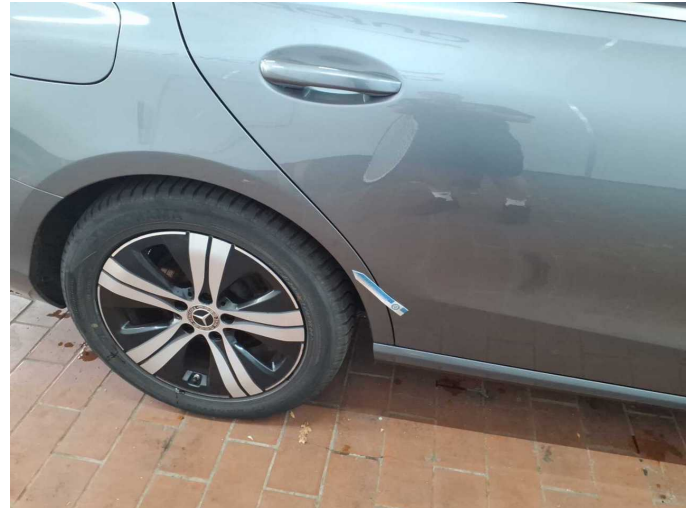
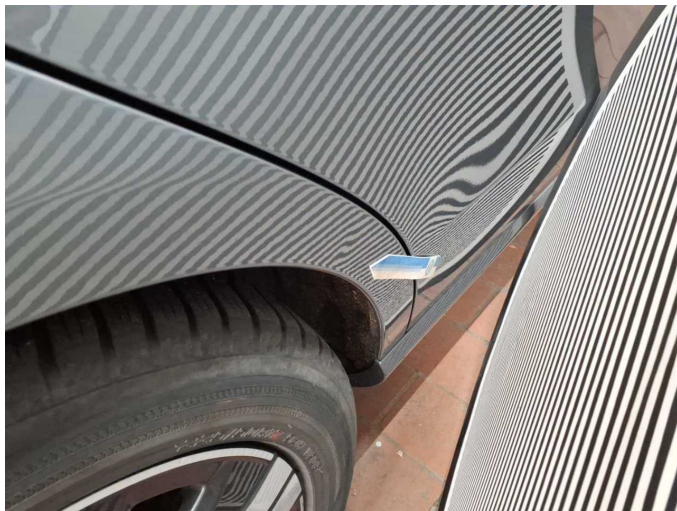
| No. | Component group | Description |
|---|---|---|
| 4 | Side panel - rear right side | Elbow - dent(s) - Clean |

**Damage 4:** Side panel - rear right side: Elbow - dent(s) - Clean

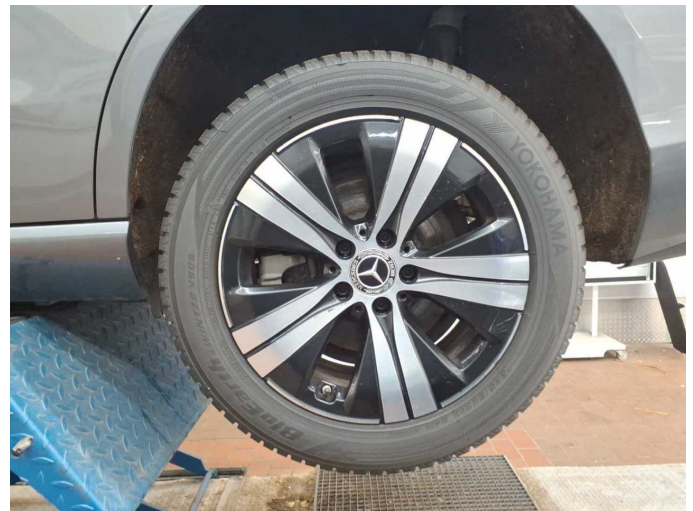
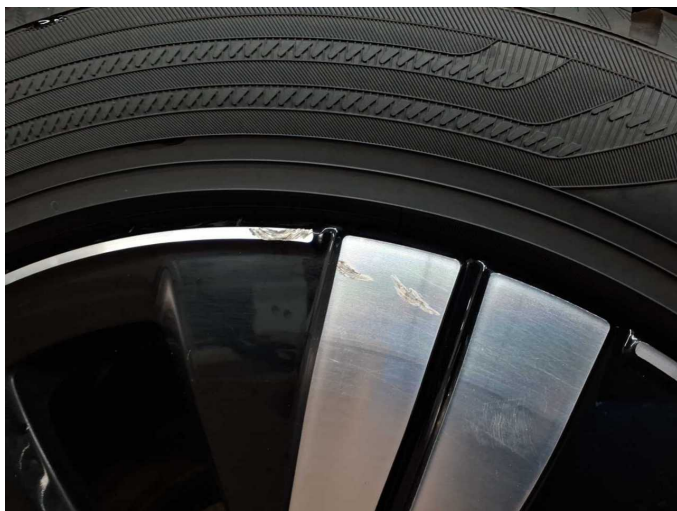
| No. | Component group | Description |
|---|---|---|
| 5 | Wheel / tyres | Alloy rim - rear left side - Scratch(es) - Loss in value |

**Damage 5:** Wheel / tyres: Alloy rim - rear left side - Scratch(es) - Loss in value

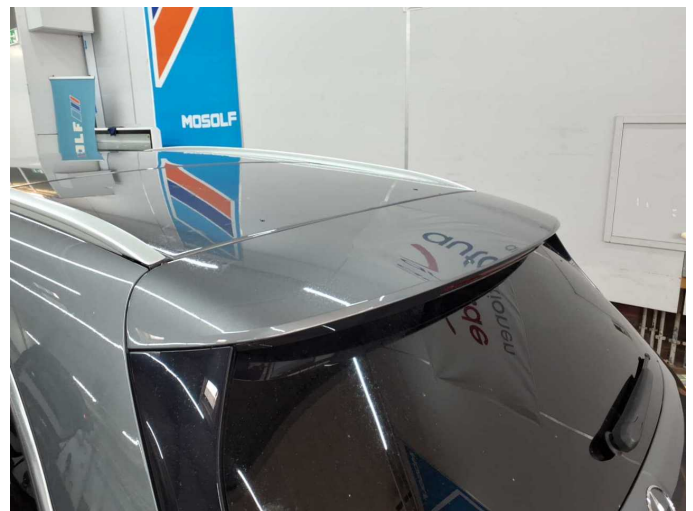
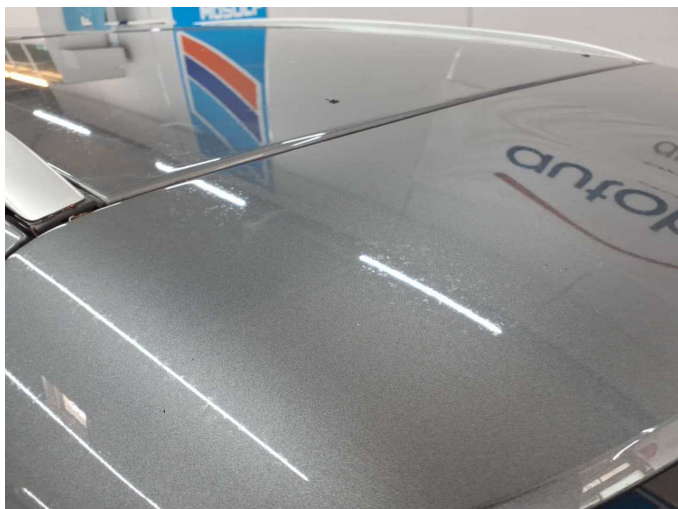
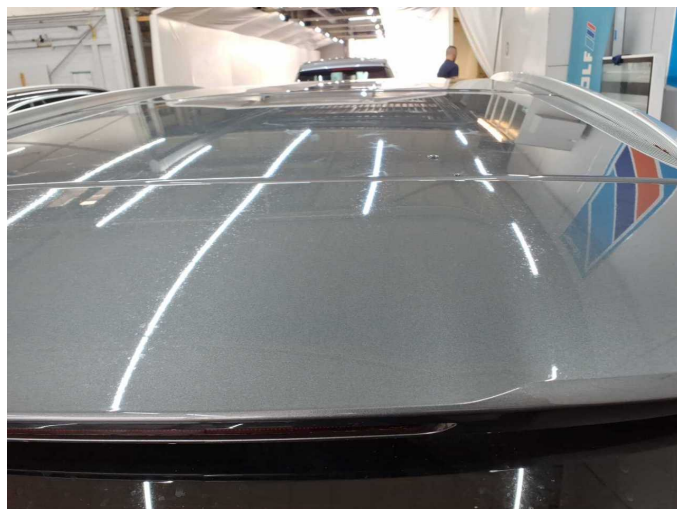
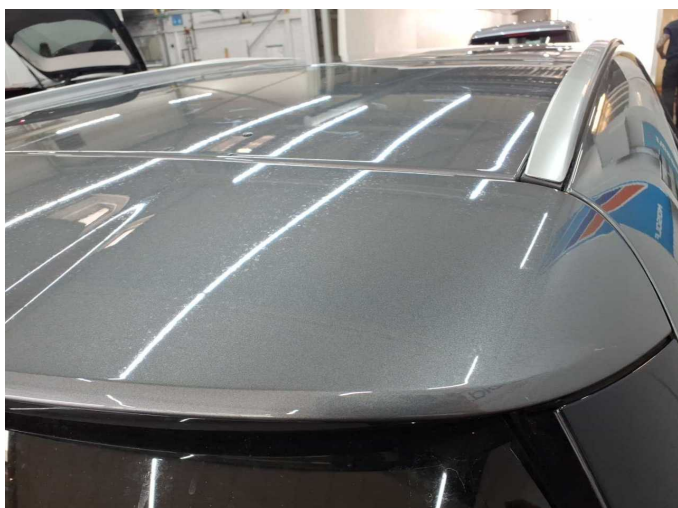
| No. | Component group | Description |
|---|---|---|
| 6 | Boot lid / rear door | Rear spoiler (Verätzungen) - Paint defect - Paint |

**Damage 6:** Boot lid / rear door: Rear spoiler (Verätzungen) - Paint defect - Paint

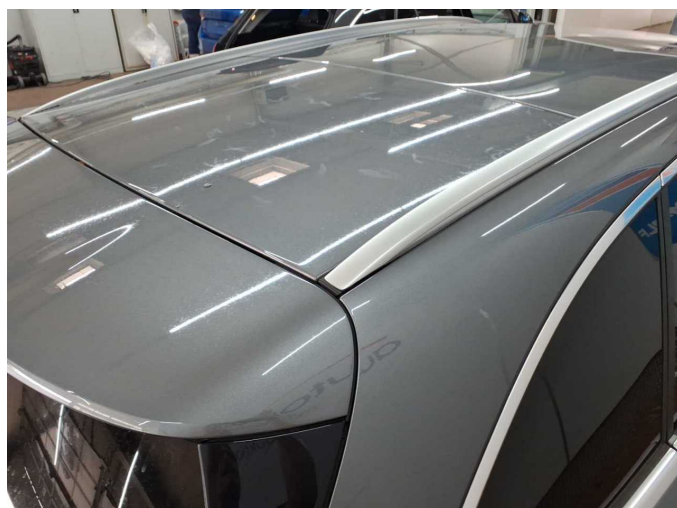
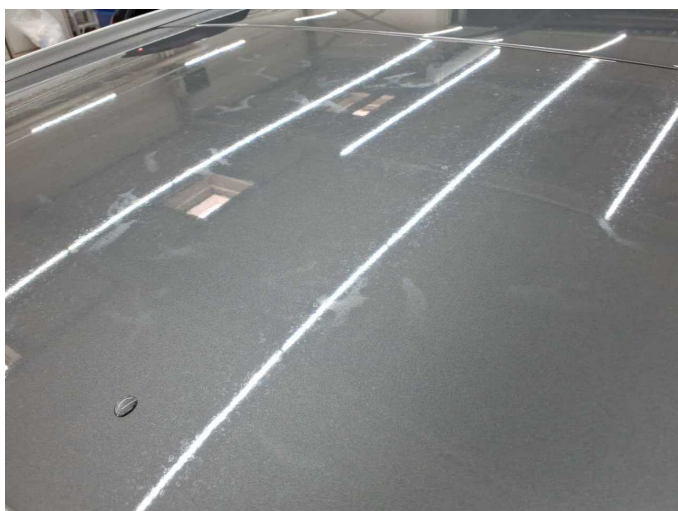
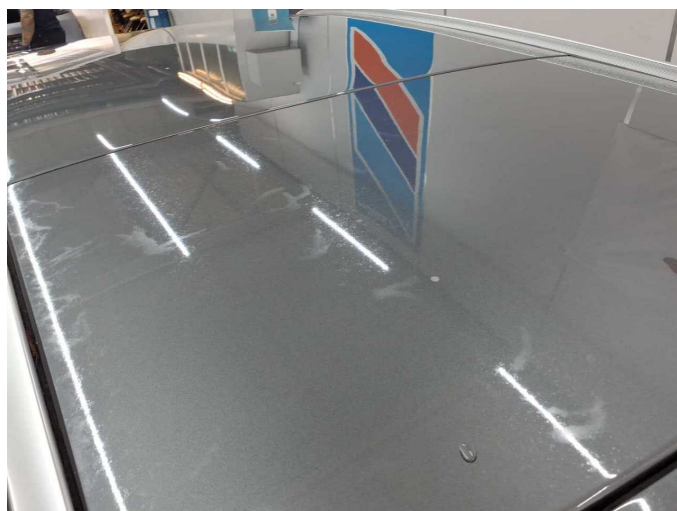
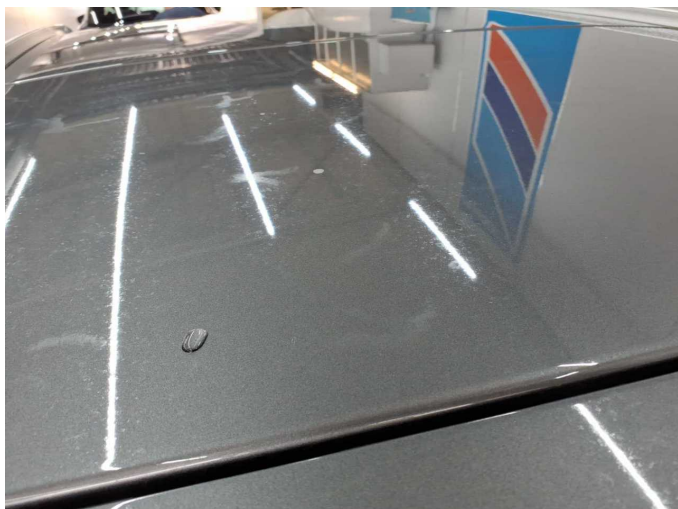
| No. | Component group | Description |
|---|---|---|
| 7 | Roof | Roof (Verätzungen) - Paint defect - Paint |

**Damage 7:** Roof: Roof (Verätzungen) - Paint defect - Paint

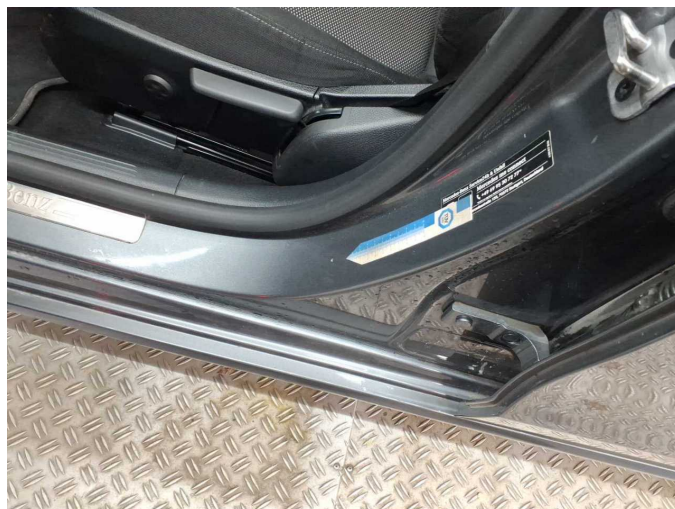
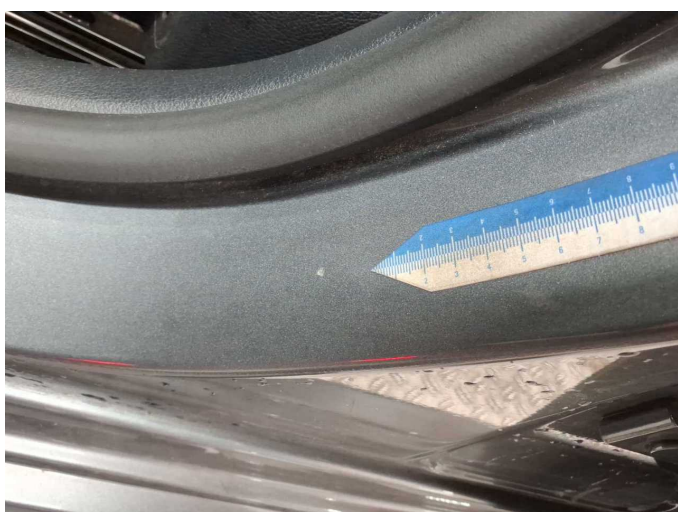
| No. | Component group | Description |
|---|---|---|
| 7 | Sill - left side | Sill - Scratch(es) - No deduction |

**Wear and tear 7:** Sill - left side: Sill - Scratch(es) - No deduction

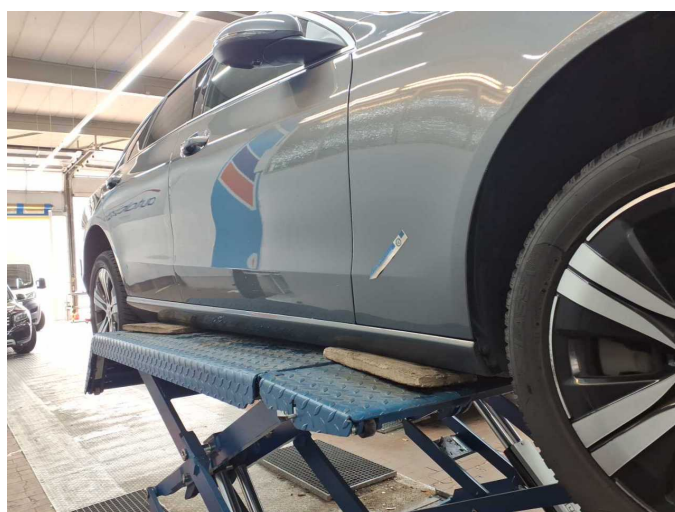
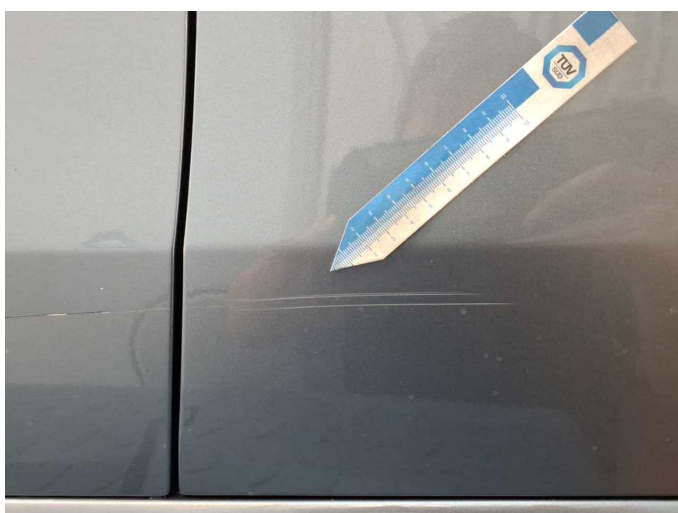
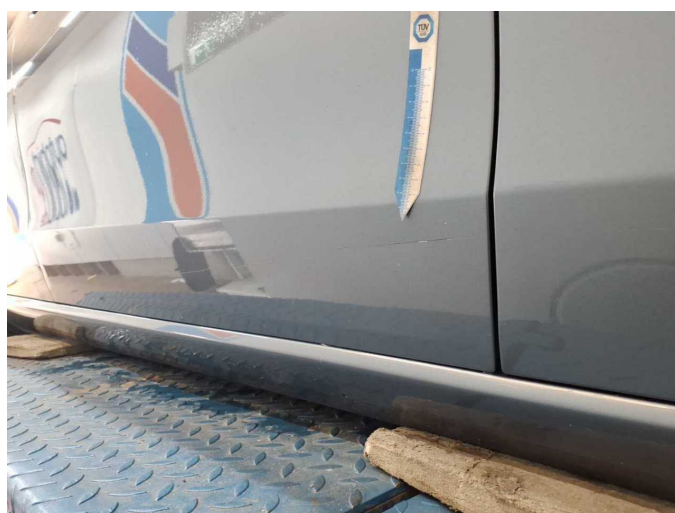
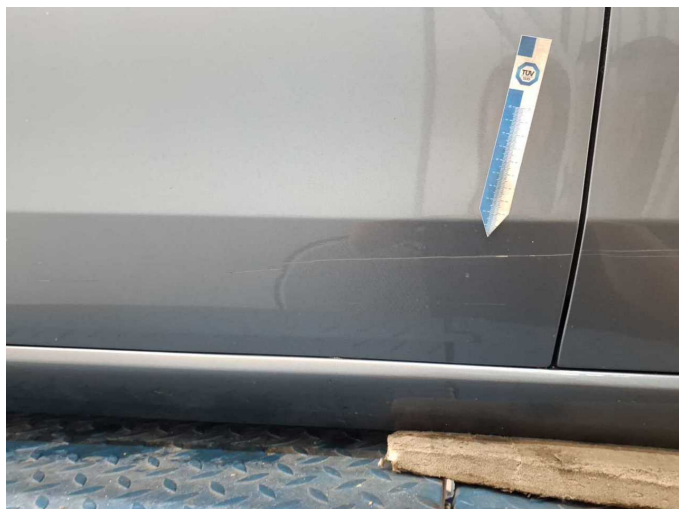
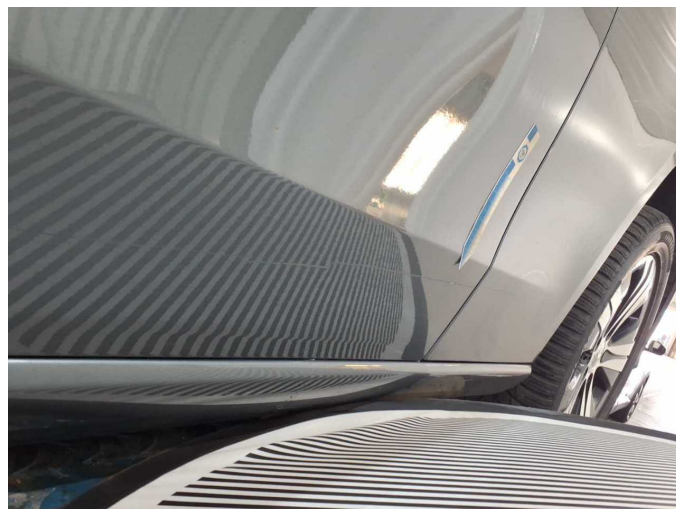
1 Side right

Non-repaired previous damages were found at the vehicle. The necessary repair costs are listed in the expert report or if necessary, are listed in detail in a separately enclosed repair cost calculation.

**Accident 1:** Side right

**Accident 1: Side right**
