Expertise

Protocol number: 46466390  
Order No. / Reference: 26573144  
Inspection date: 10 Jul 2026

Model: EQA 250+

VIN: W1N9N0CB1SJ167429

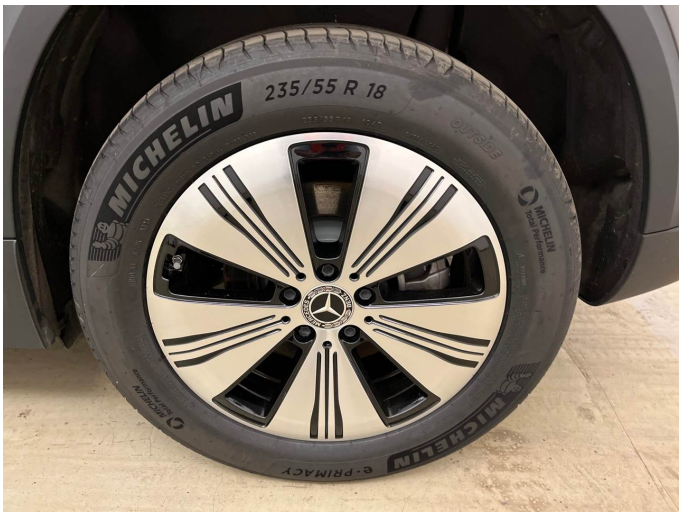
Figure 12: Mounted tyres

| # | Tyre size | Type of tyre | Manufacturer | Tread depth |
|---|---|---|---|---|
| 1) | 235/55 R18 104T | Summer tyres on Light alloy | Michelin | 6mm / 6mm |
| 2) | 235/55 R18 104T | Summer tyres on Light alloy | Michelin | 6mm / 6mm |

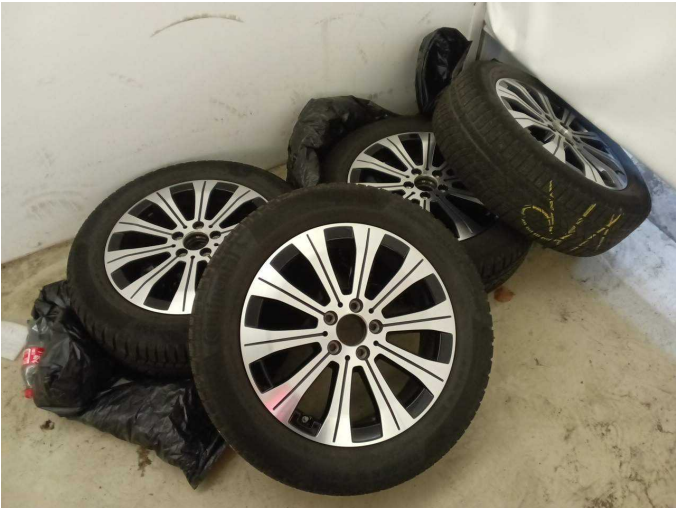
Figure 15: Additional tyres

| # | Tyre size | Type of tyre | Manufacturer | Tread depth |
|---|---|---|---|---|
| 1) | 215/60 R18 102T | Winter tyres on Light alloy | Continental | 3mm / 3mm |
| 2) | 215/60 R18 102T | Winter tyres on Light alloy | Continental | 4mm / 4mm |

| No. | Component group | Description |
|---|---|---|
| 6 | 2nd wheel set | 2 tyres - Worn - Replace |

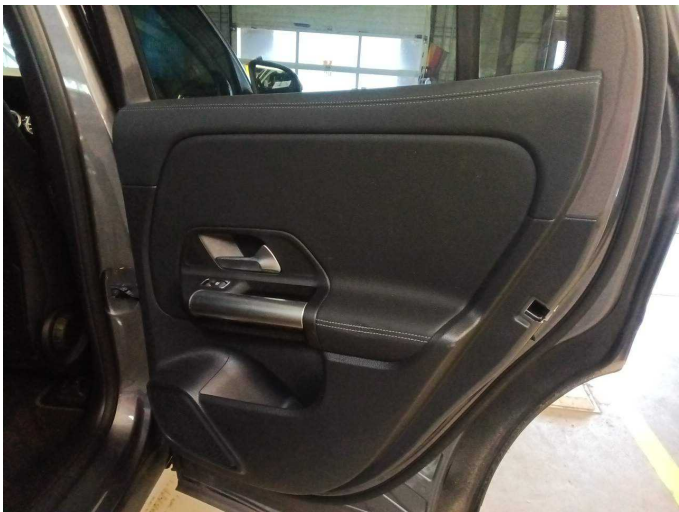
| No. | Component group | Description |
|---|---|---|
| 1 | Trim / covers | Door trim - rear right side - Scratch(es) - Smart repair |

Damage 1: Trim / covers: Door trim - rear right side - Scratch(es) - Smart repair

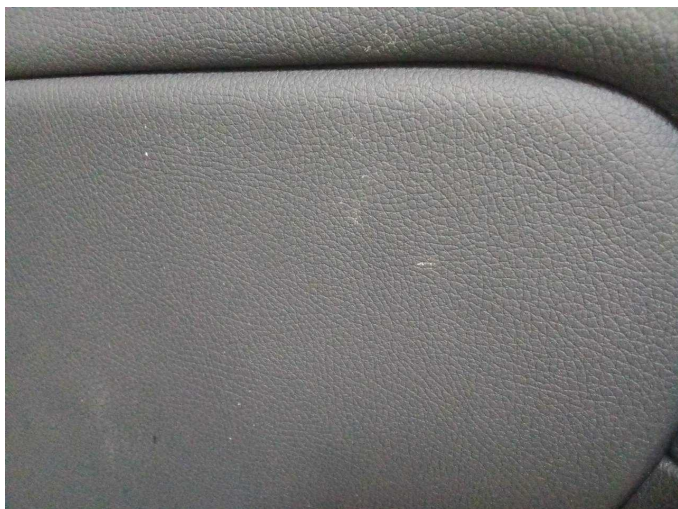
**Damage 1:** Trim / covers: Door trim - rear right side - Scratch(es) - Smart repair

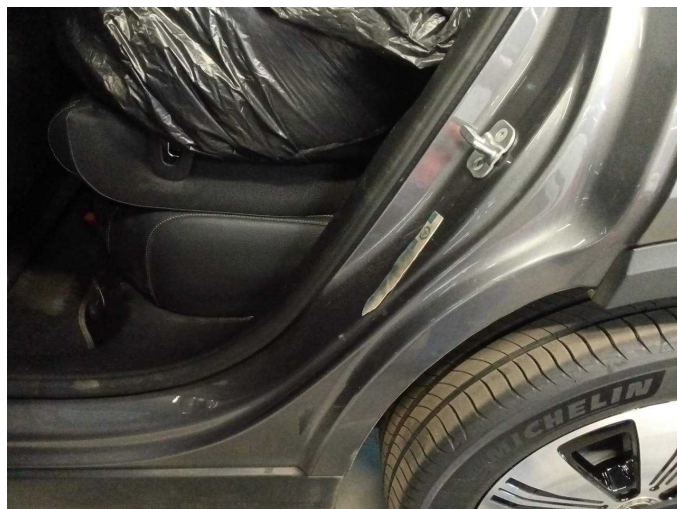
| No. | Component group | Description |
|---|---|---|
| 2 | Side panel - rear left side | Sill - Scratch(es) - Smart repair |

**Damage 2:** Side panel - rear left side: Sill - Scratch(es) - Smart repair

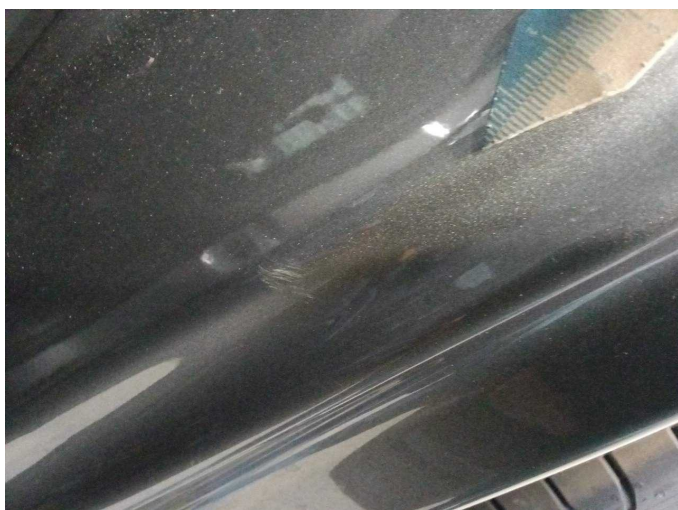
**Damage 2:** Side panel - rear left side: Sill - Scratch(es) - Smart repair

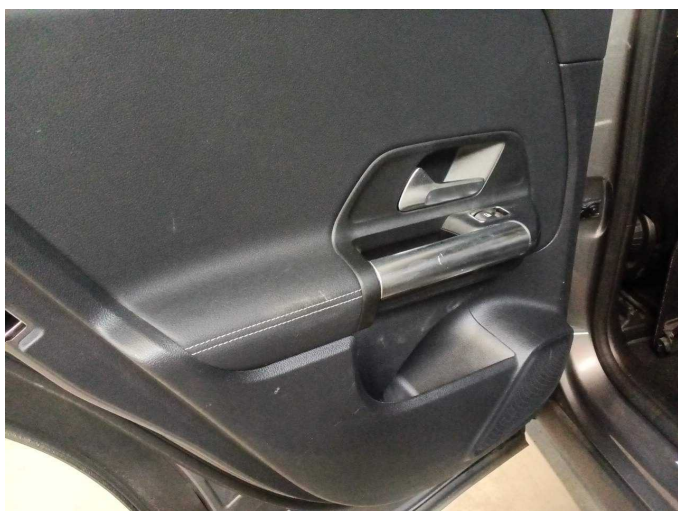
**Damage 3:** Door - rear left side: Handle - Scratch(es) - Smart repair

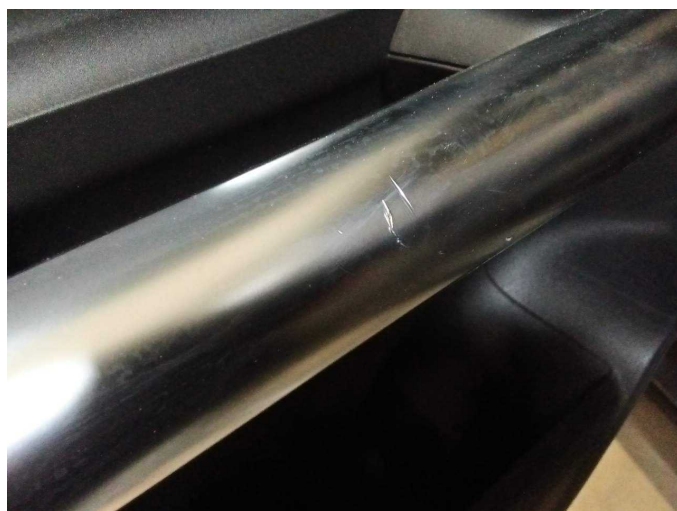
| No. | Component group | Description |
|---|---|---|
| 4 | Trim / covers | Door trim - rear left side - Scratch(es) - Smart repair |

**Damage 3:** Door - rear left side: Handle - Scratch(es) - Smart repair

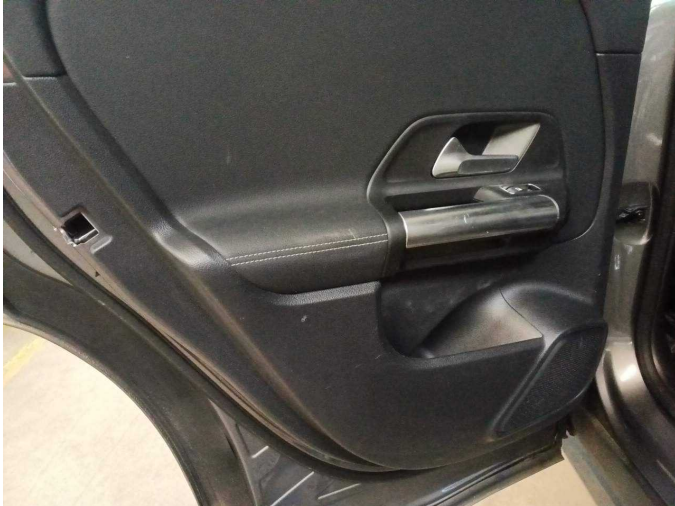
**Damage 4:** Trim / covers: Door trim - rear left side - Scratch(es) - Smart repair

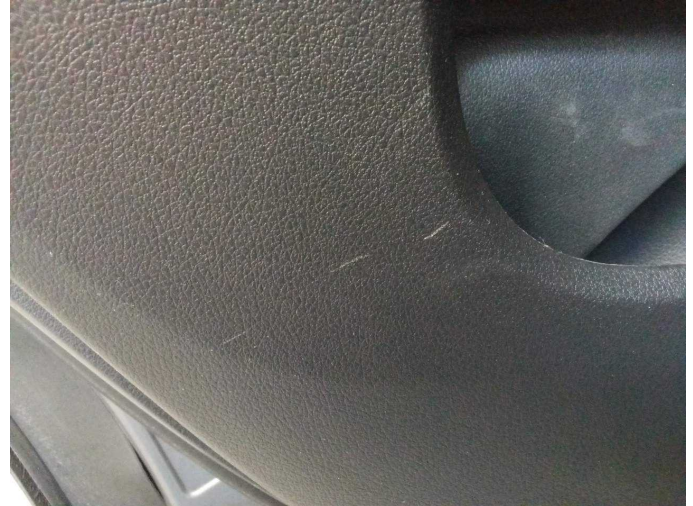
| No. | Component group | Description |
|---|---|---|
| 5 | Mudguard - right side | Wheel well extension - Scratch(es) - Replace |

**Damage 4:** Trim / covers: Door trim - rear left side - Scratch(es) - Smart repair

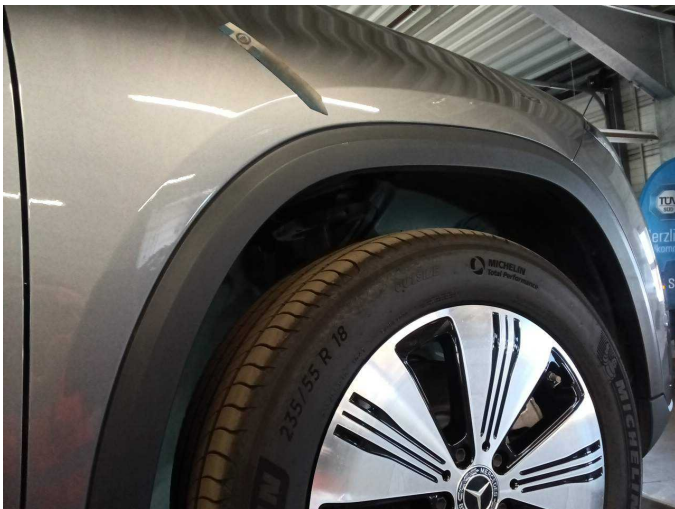
**Damage 5:** Mudguard - right side: Wheel well extension - Scratch(es) - Replace

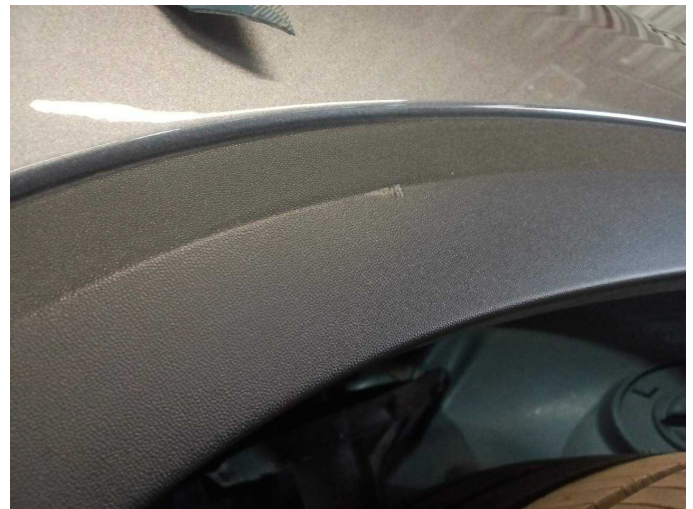
| No. | Component group | Description |
|---|---|---|
| 1 | Bonnet | Bonnet - Stone chips - No deduction |

**Damage 5:** Mudguard - right side: Wheel well extension - Scratch(es) - Replace

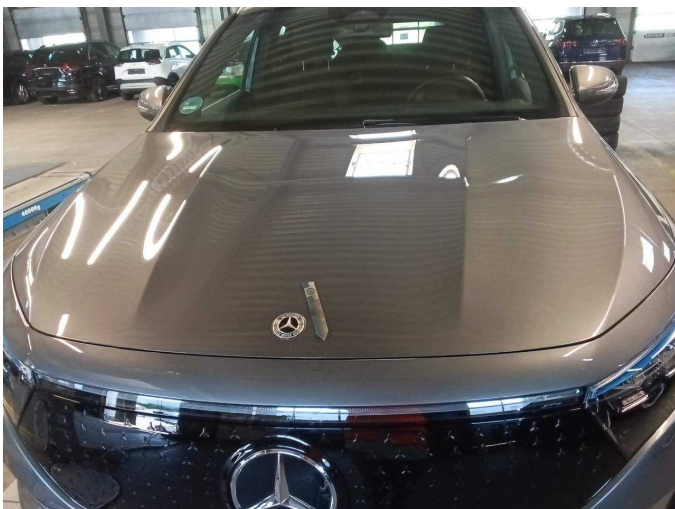
**Wear and tear 1:** Bonnet: Bonnet - Stone chips - No deduction

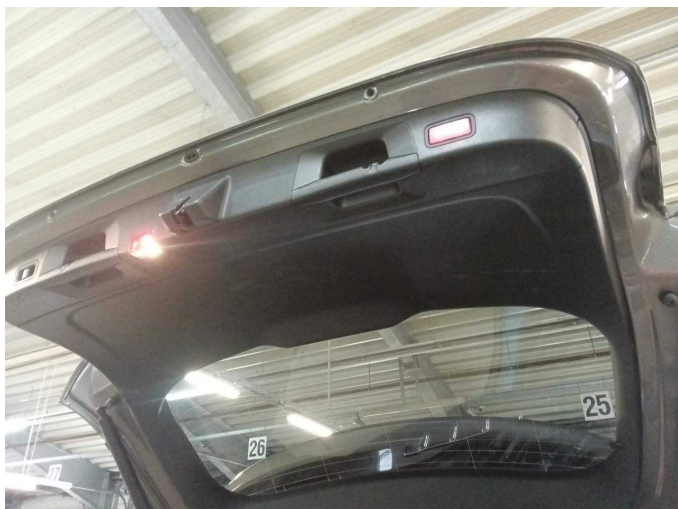
**Wear and tear 2:** Trim / covers: Boot lid - interior trim - Scratched - No deduction

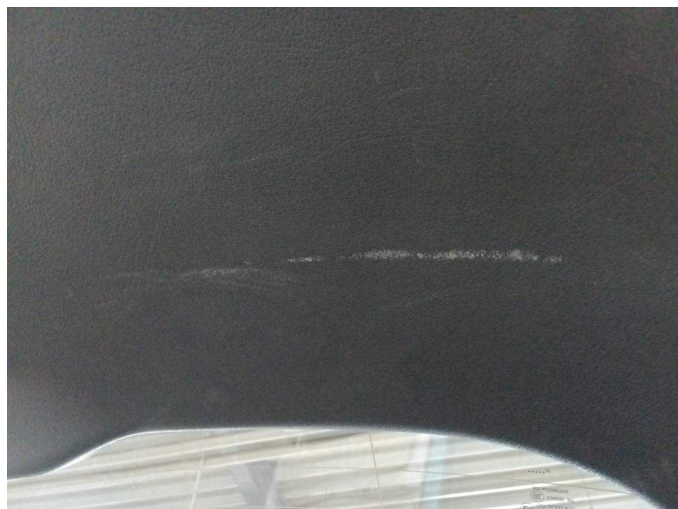
**Wear and tear 2:** Trim / covers: Boot lid - interior trim - Scratched - No deduction
