Expertise

Protocol number: 46445981  
Order No. / Reference: 26571161  
Inspection date: 10 Jul 2026

Manufacturer: Skoda  
VIN: TMBJR9NP7R7017810

Model: Superb Combi 2.0 TDI DSG Style

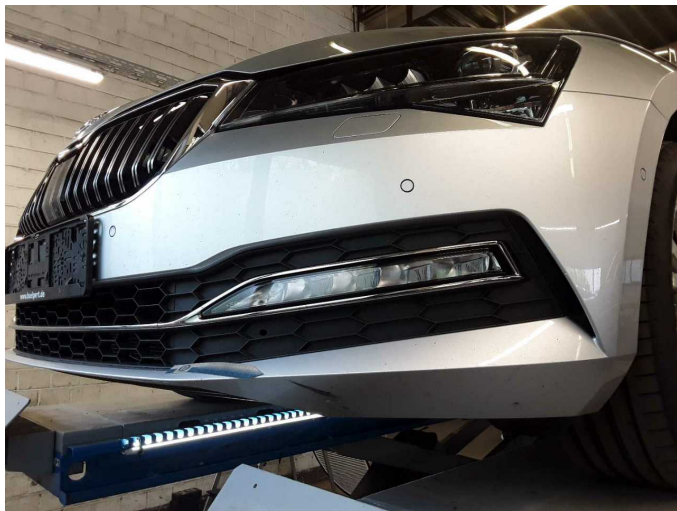
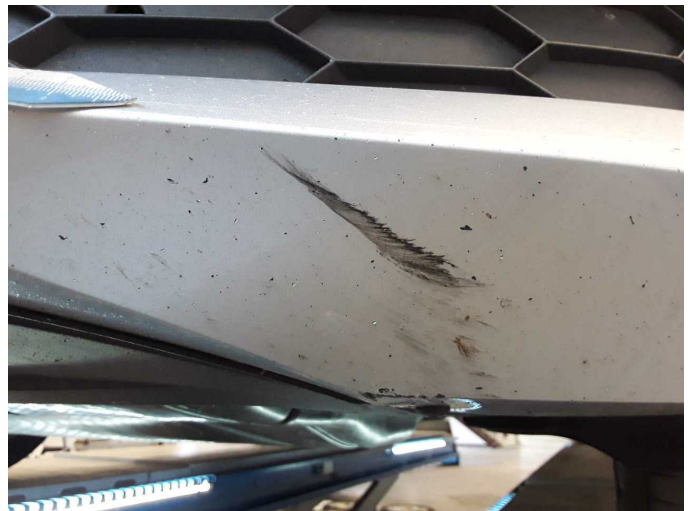
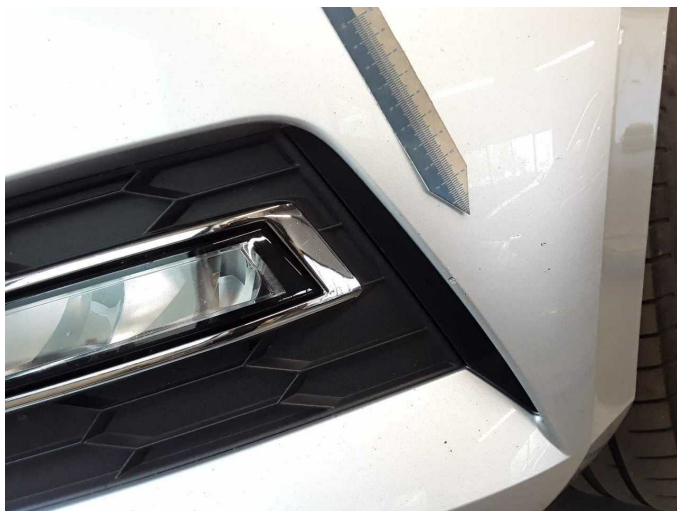
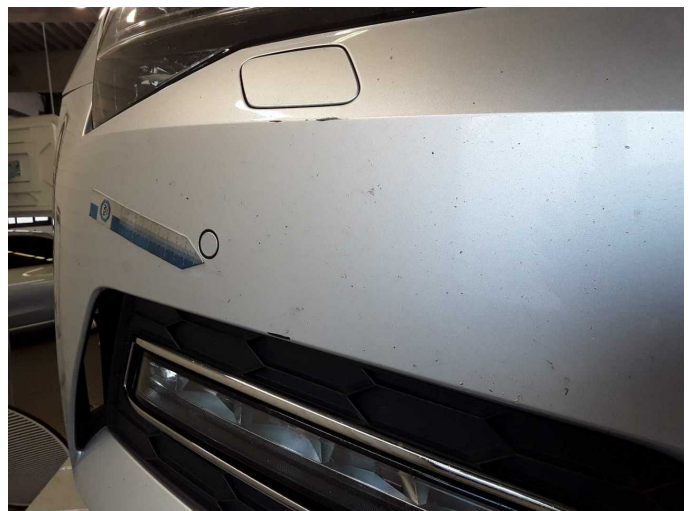
| No. | Component group | Description |
|---|---|---|
| 1 | Front bumper | Front bumper (in Unfallschaden berücksichtigt) - Scratched - Paint |

**Damage 1:** Front bumper: Front bumper (in Unfallschaden berücksichtigt)  
- Scratched - Paint

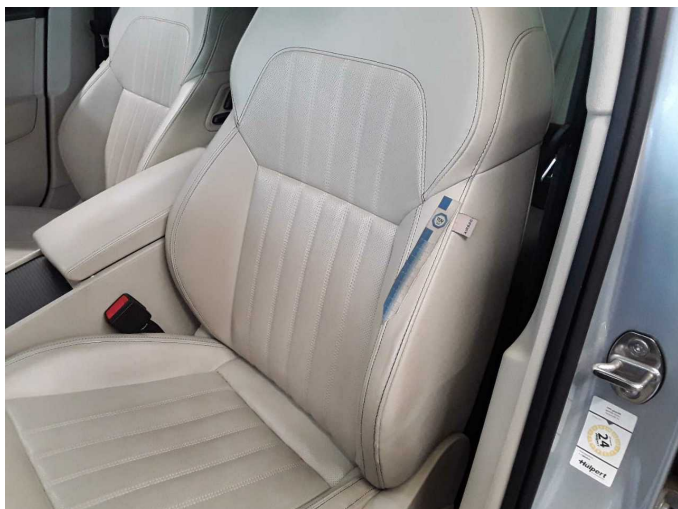
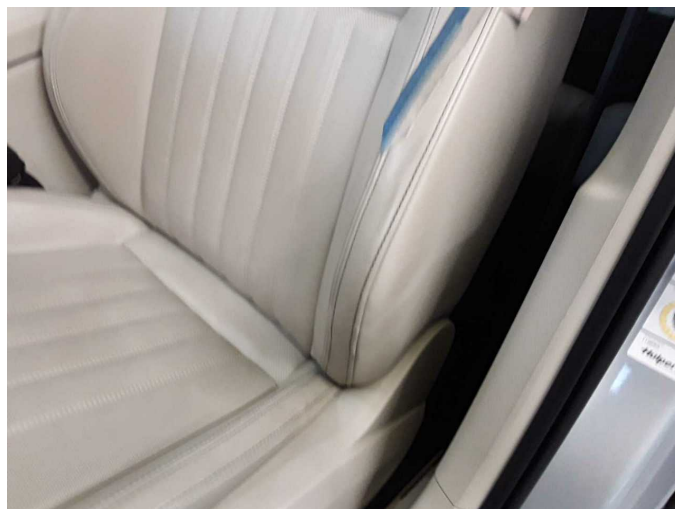
| No. | Component group | Description |
|---|---|---|
| 3 | Seat - front | Backrest cover - left side - Scratch(es) - Smart repair |

**Damage 3:** Seat - front: Backrest cover - left side - Scratch(es) - Smart repair

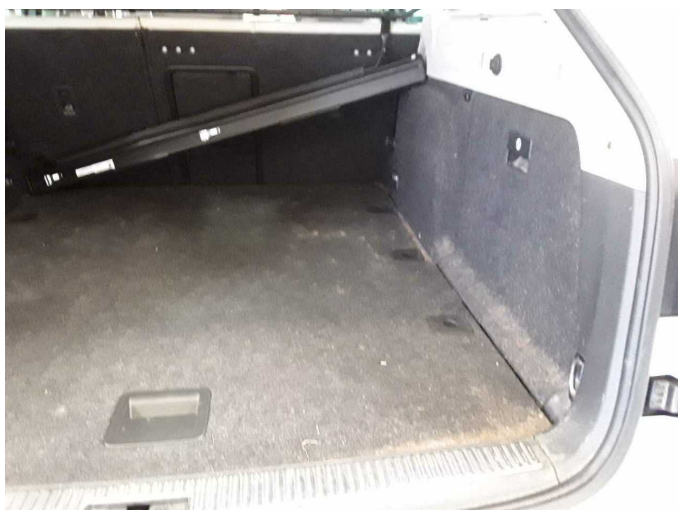
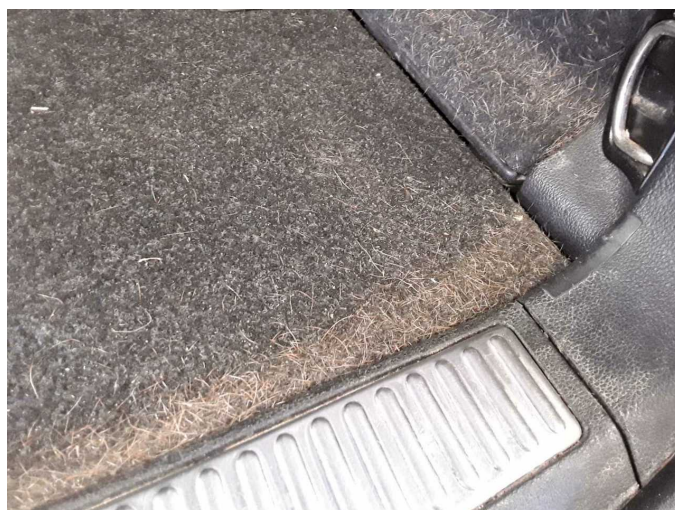
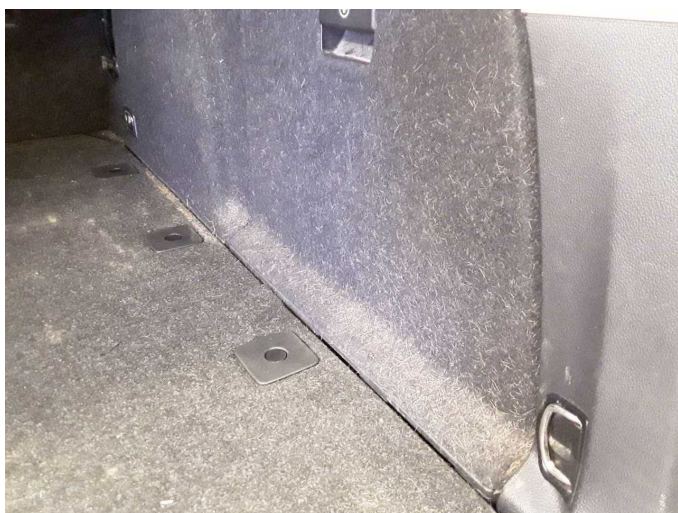
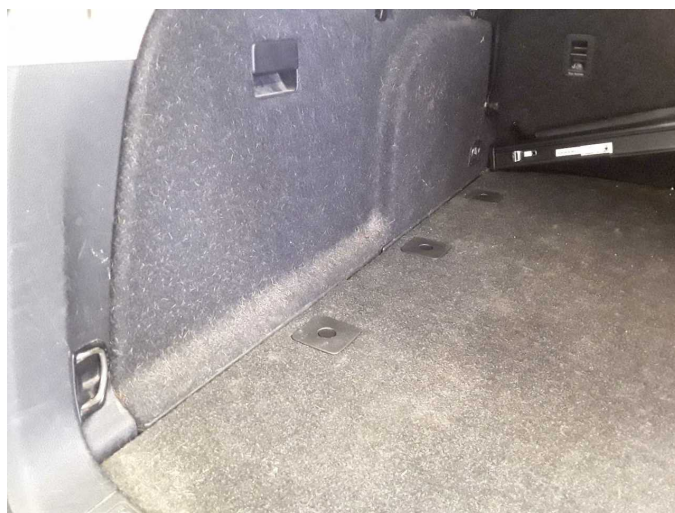
| No. | Component group | Description |
|---|---|---|
| 6 | Interior | Interior (Hundehaare) - Soiled - Conditioning |

**Damage 6:** Interior: Interior (Hundehaare) - Soiled - Conditioning

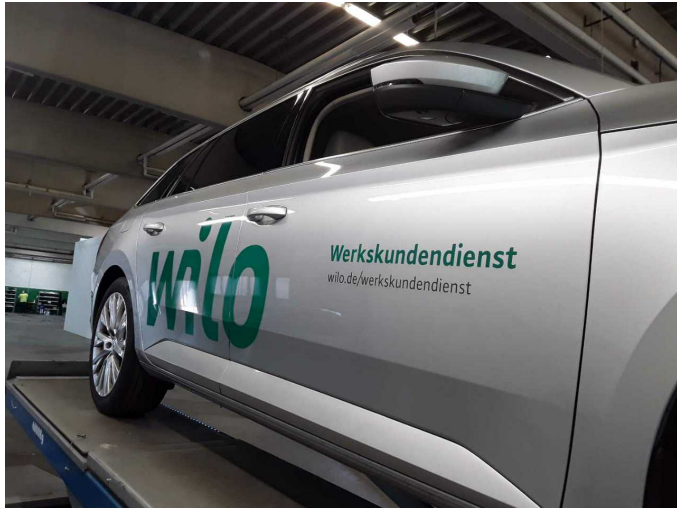
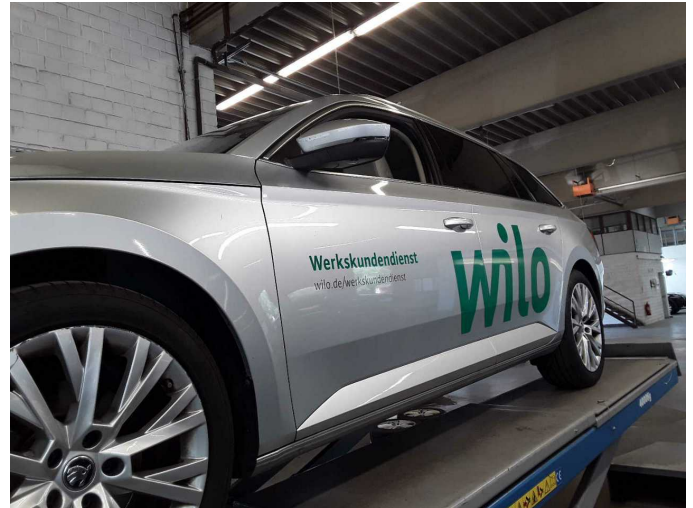
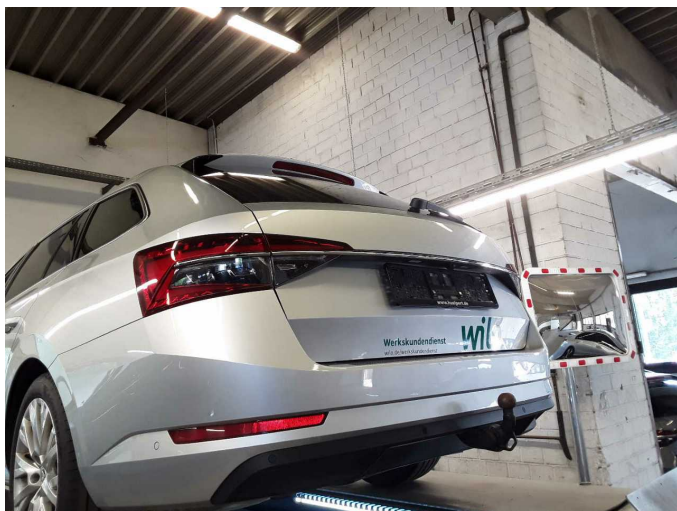
| No. | Component group | Description |
|---|---|---|
| 7 | Body | Body - Glued / labelled - De-glue / neutralise |

**Damage 7:** Body: Body - Glued / labelled - De-glue / neutralise

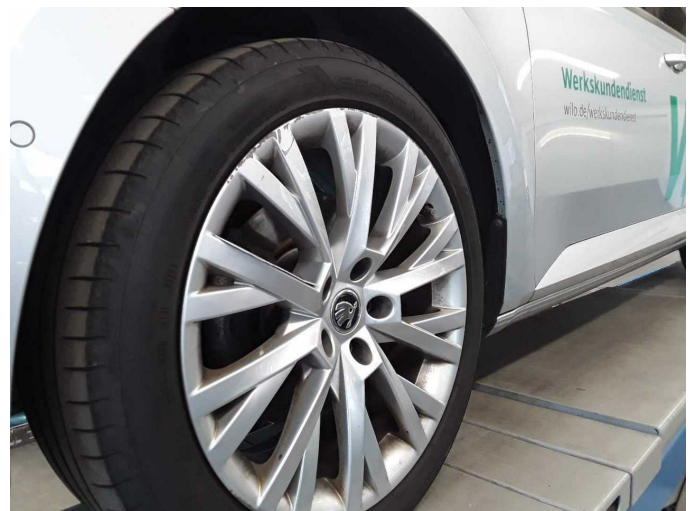
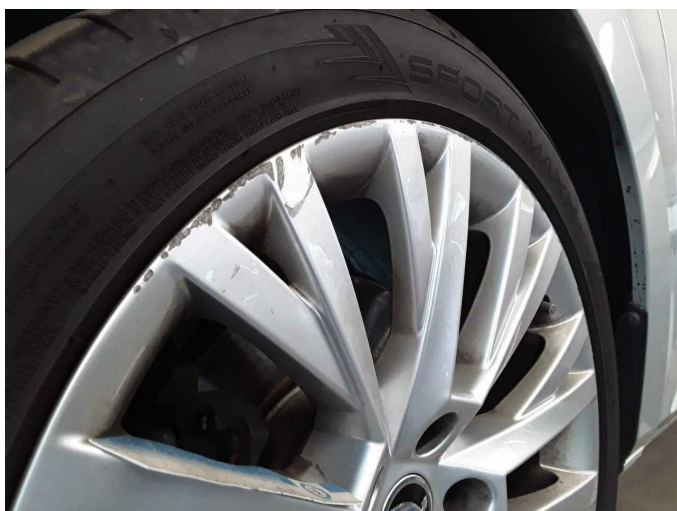
| No. | Component group | Description |
|---|---|---|
| 8 | Wheel / tyres | Alloy rim - front left side - Scratched - Replace |

**Damage 8:** Wheel / tyres: Alloy rim - front left side - Scratched - Replace

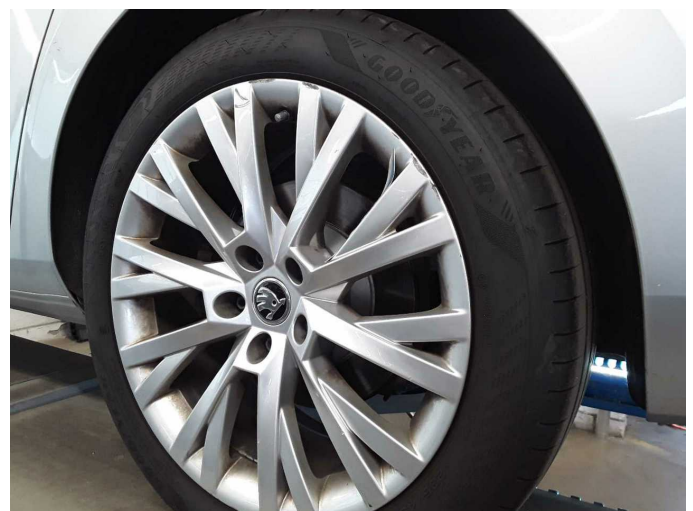
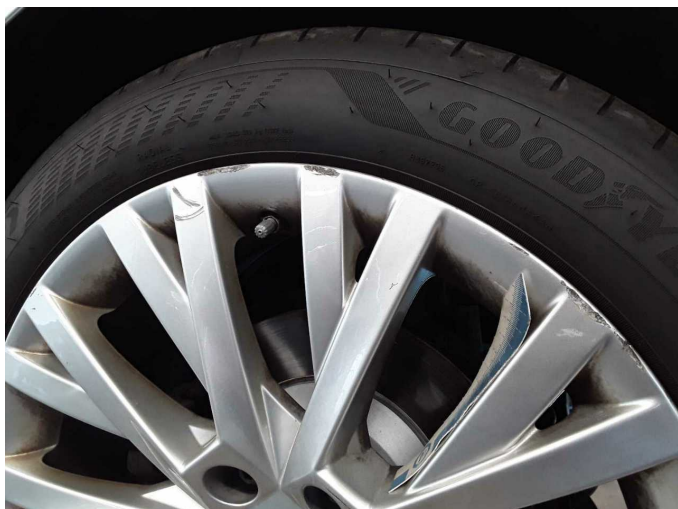
| No. | Component group | Description |
|---|---|---|
| 9 | Wheel / tyres | Alloy rim - rear left side - Scratched - Replace |

**Damage 9:** Wheel / tyres: Alloy rim - rear left side - Scratched - Replace

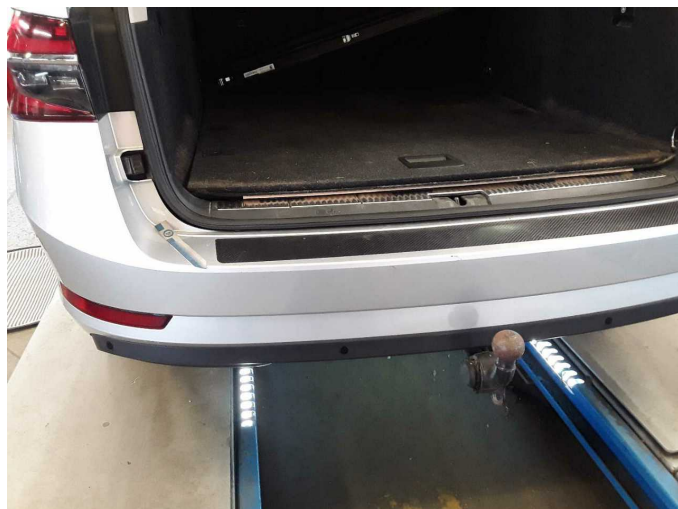
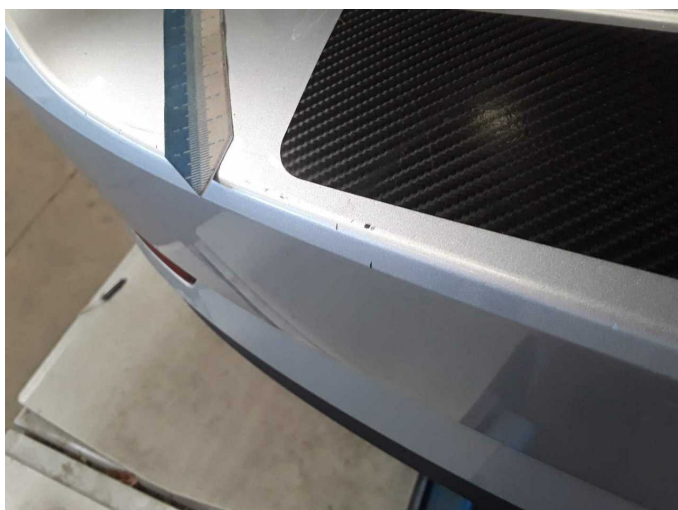
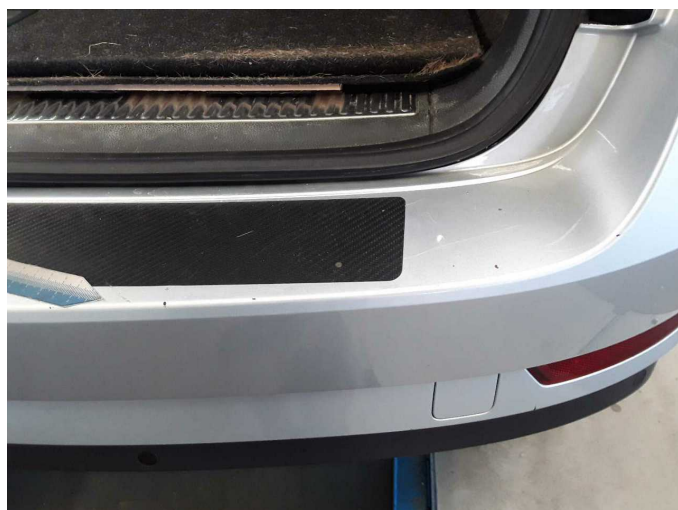
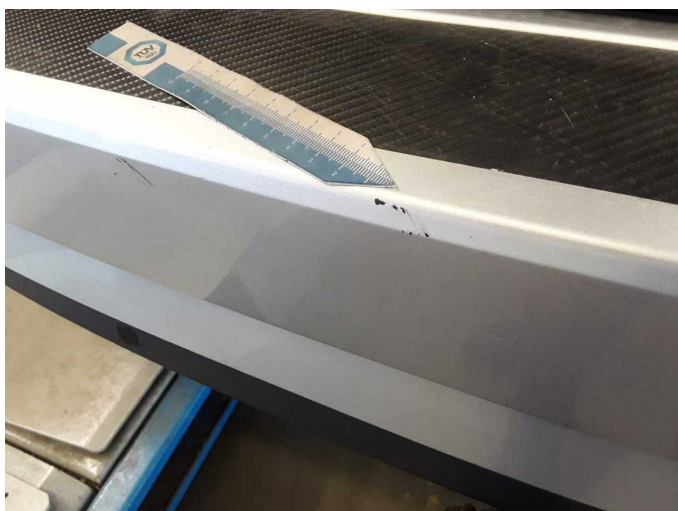
| No. | Component group | Description |
|---|---|---|
| 10 | Rear bumper | Rear bumper - Scratch(es) - Paint |

**Damage 10:** Rear bumper: Rear bumper - Scratch(es) - Paint

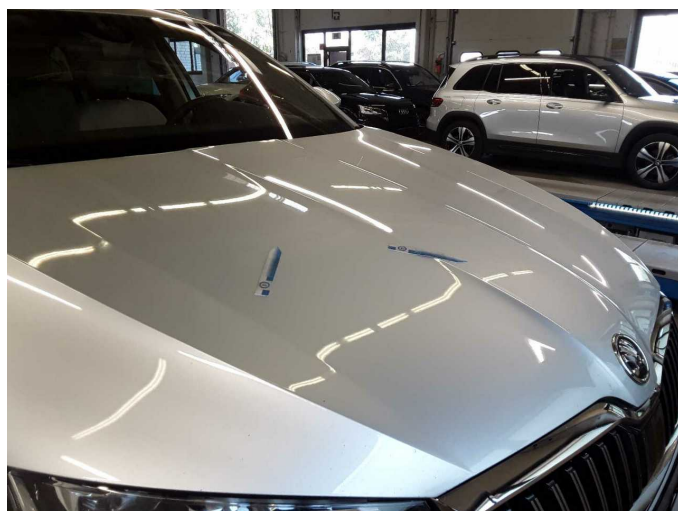
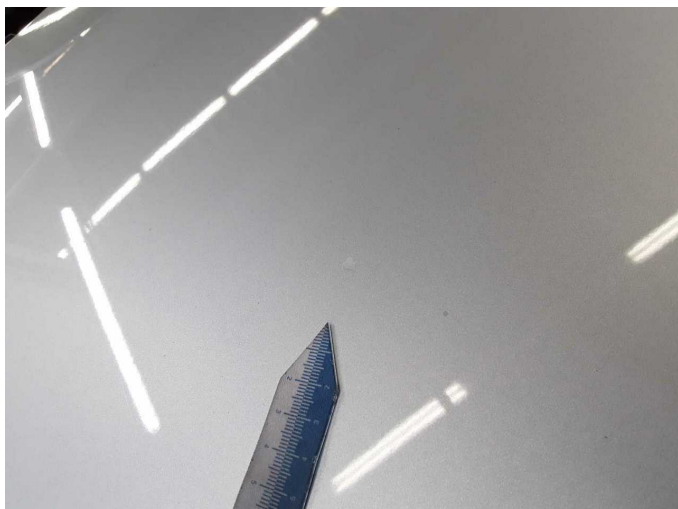
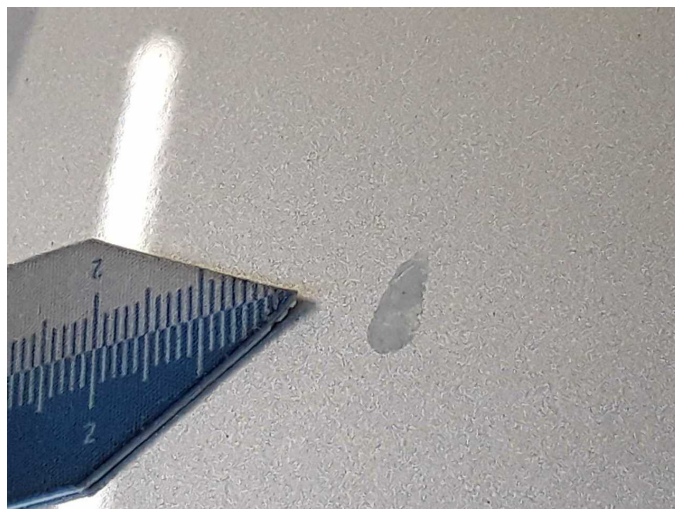
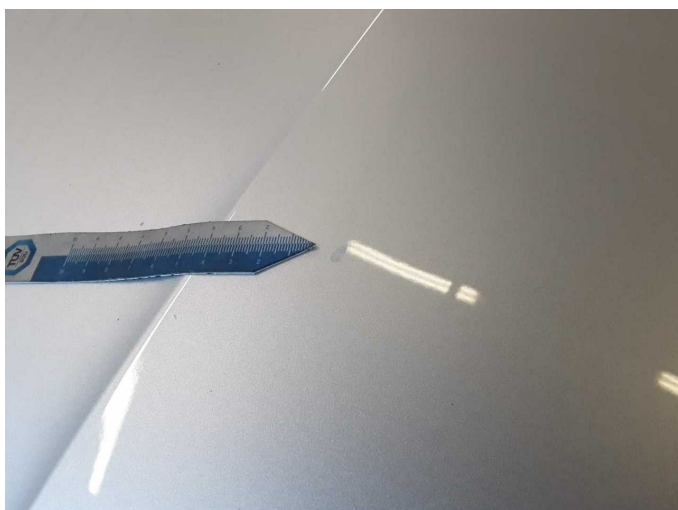
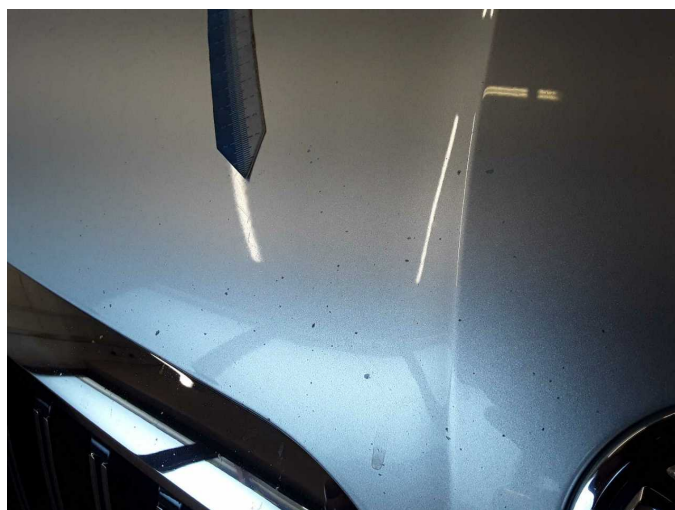
| No. | Component group | Description |
|---|---|---|
| 11 | Bonnet | Bonnet (Vermehrte steinschläge) - Stone chips - Paint |

**Damage 11:** Bonnet: Bonnet (Vermehrte steinschläge) - Stone chips - Paint

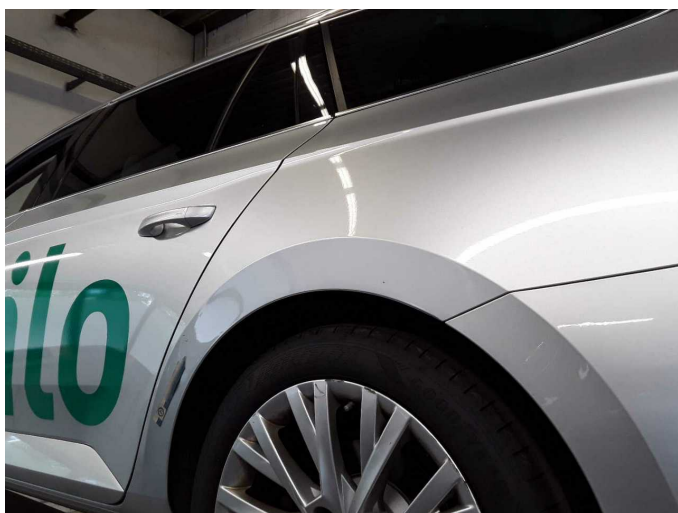
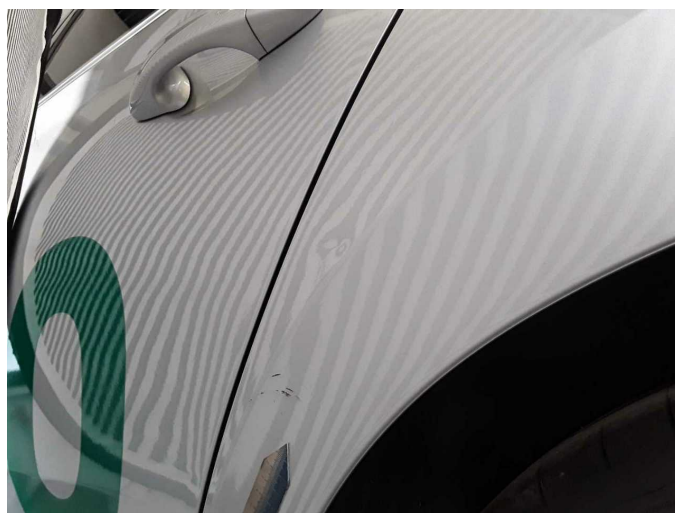
| No. | Component group | Description |
|---|---|---|
| 12 | Side panel - rear left side | Side panel - Dent / paintcoat damage - Repair and paint |

**Damage 12:** Side panel - rear left side: Side panel - Dent / paintcoat damage - Repair and paint

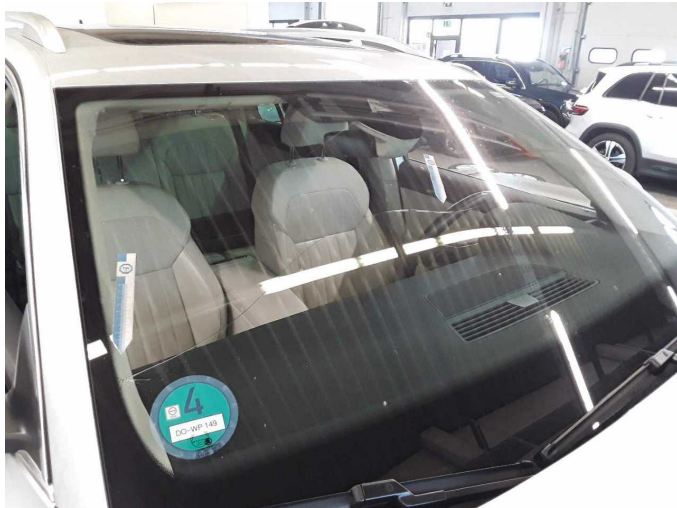
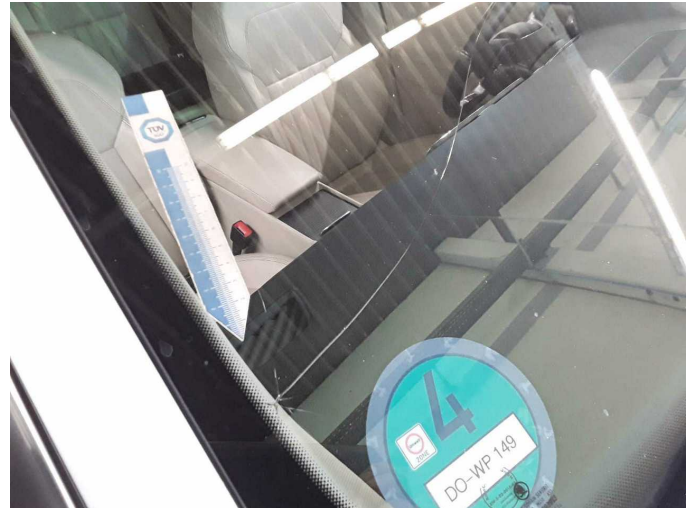
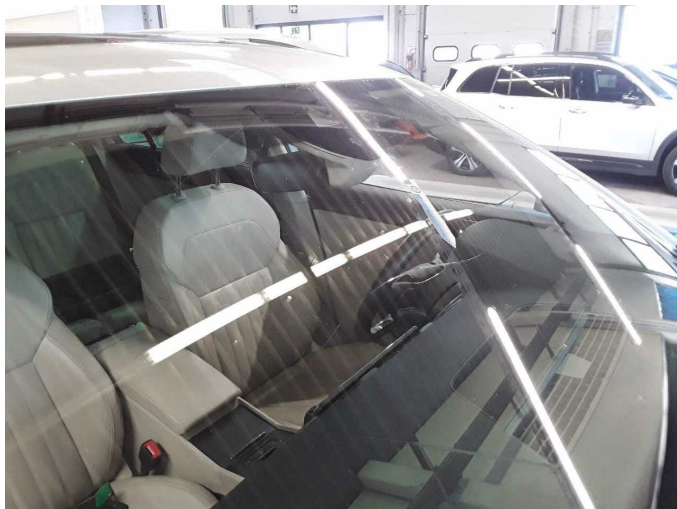
| No. | Component group | Description |
|---|---|---|
| 13 | Vehicle glazing | Windscreen - Broken / torn - Replace |

**Damage 13:** Vehicle glazing: Windscreen - Broken / torn - Replace

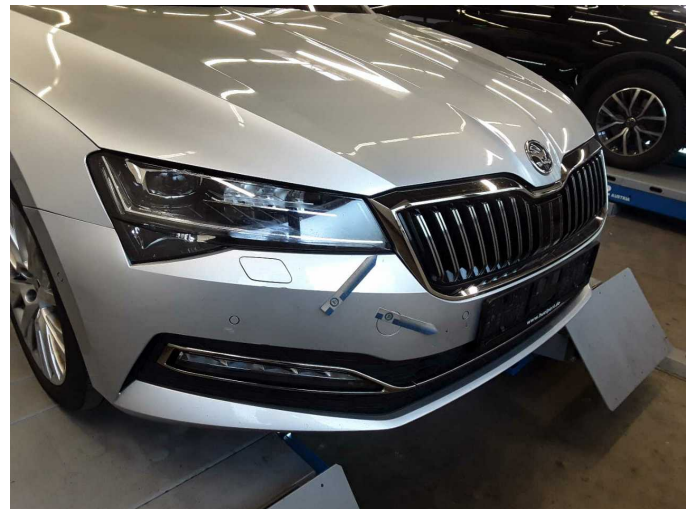
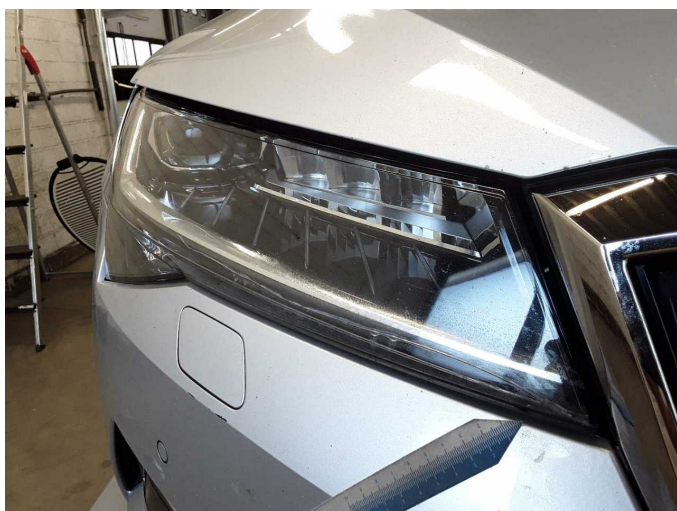
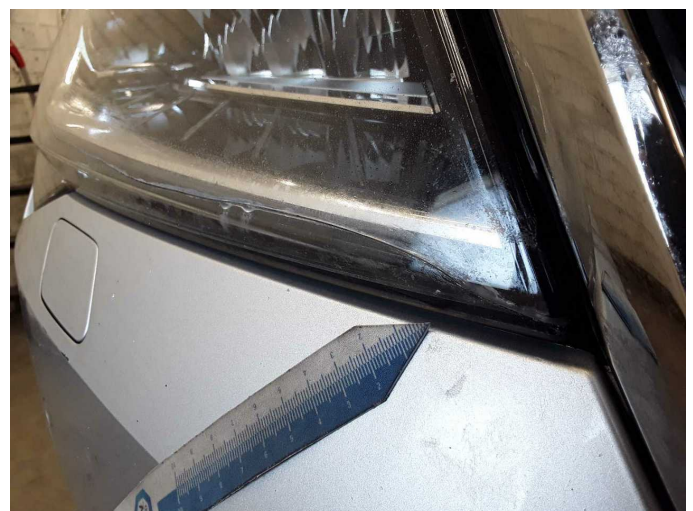
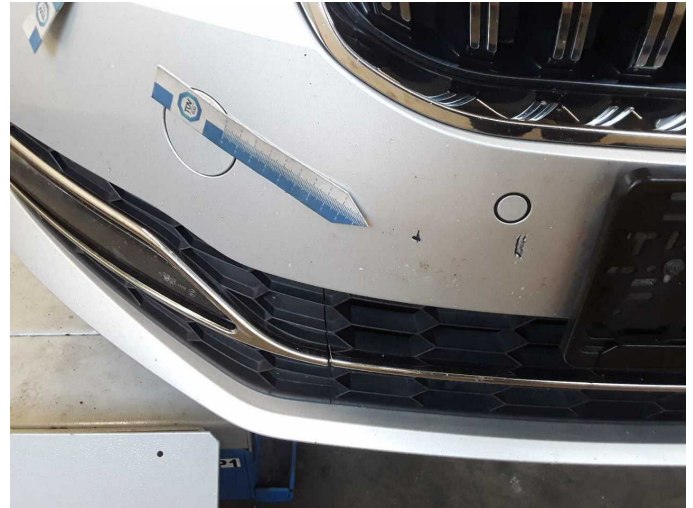
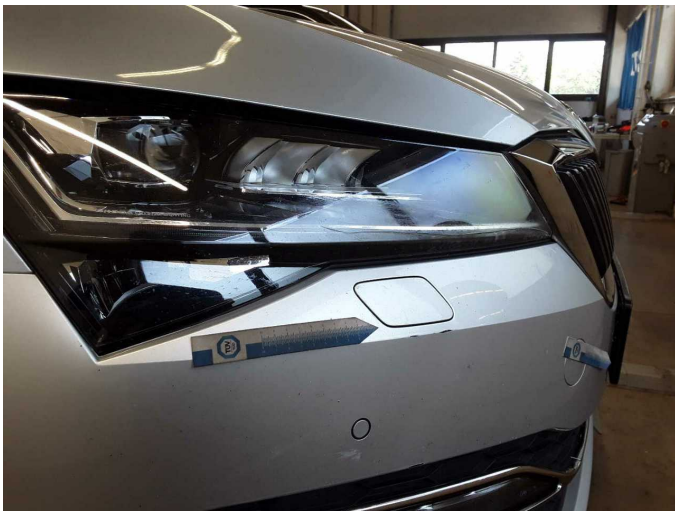
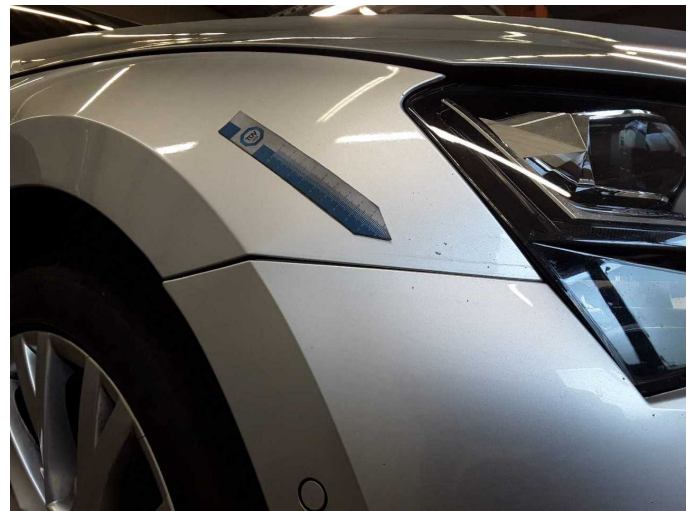
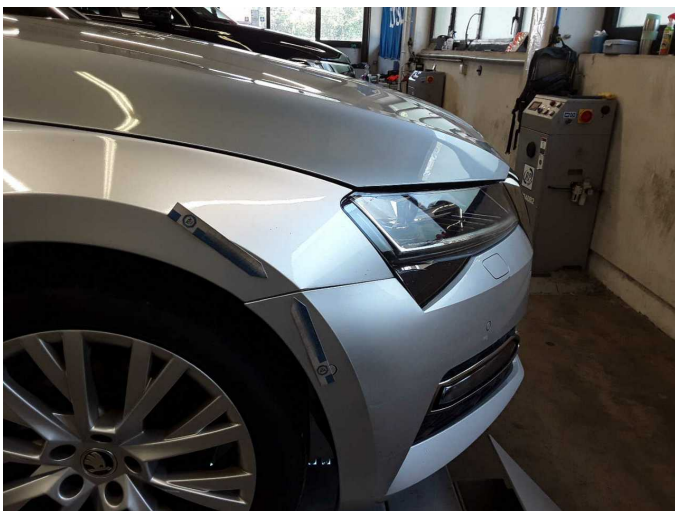
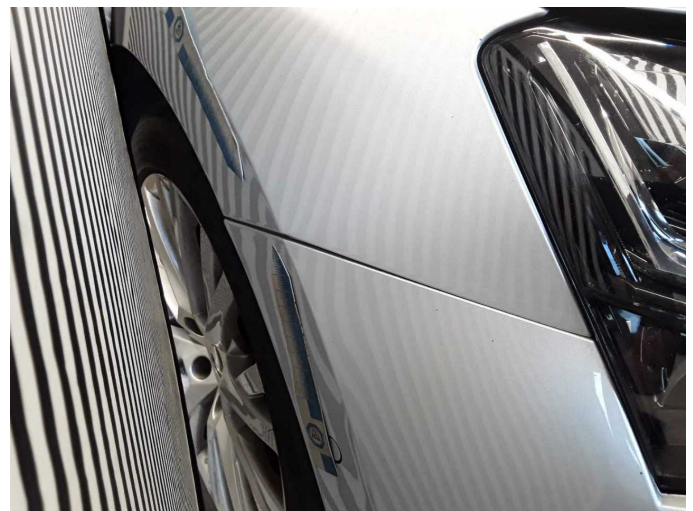
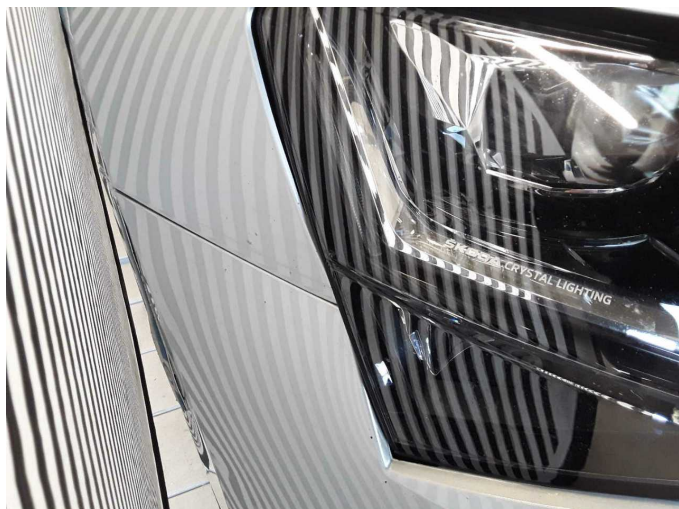
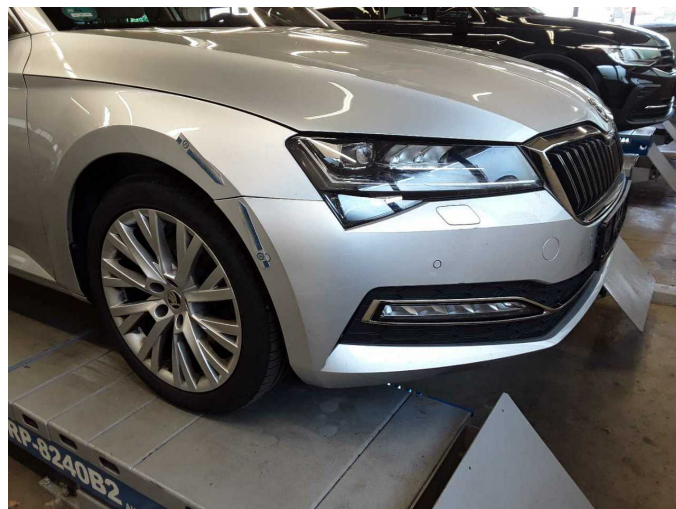
1 Front, Side right

**Accident 1:** Front, Side right

**Accident 1: Front, Side right**
