Expertise

Protocol number: 46119740  
Order No. / Reference: 26501052  
Inspection date: 23 Jun 2026

Model: Astra 1.2 Turbo Business Elegance

VIN: VXXKFPHNSLP1017828

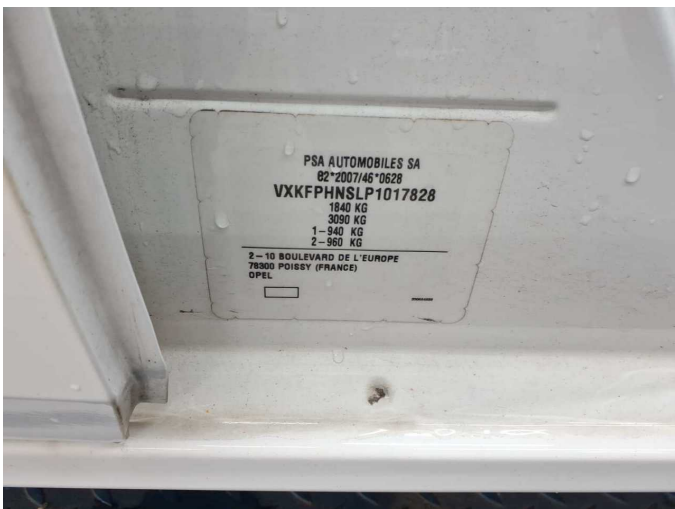
Figure 11: VIN

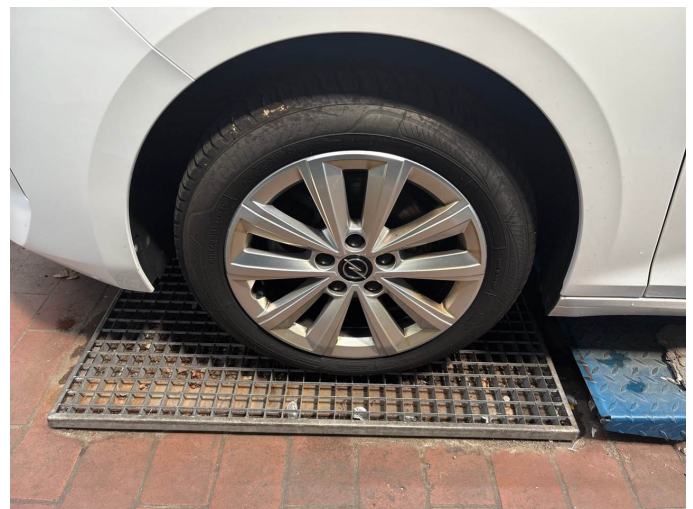
Figure 12: Mounted tyres

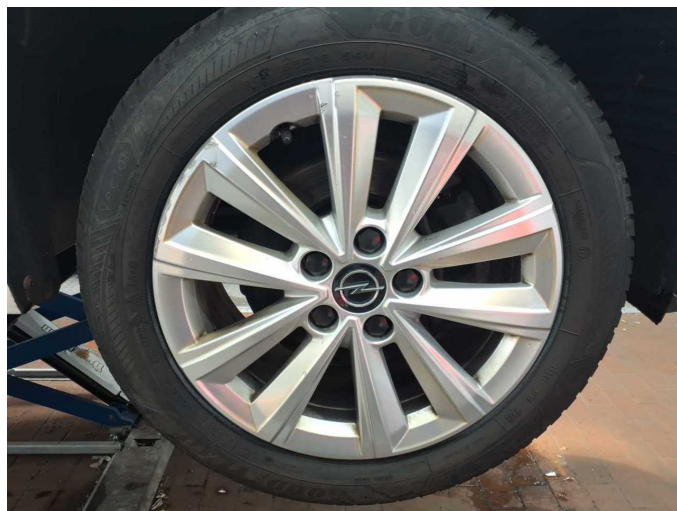
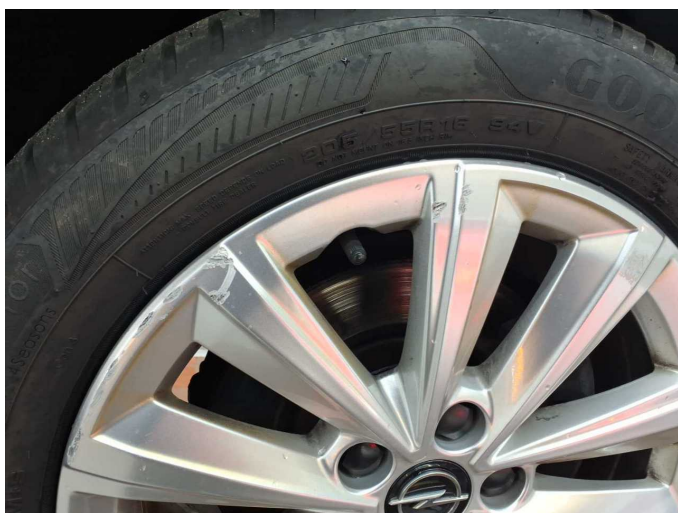
**Damage 1:** Wheel / tyres: Alloy rim - front right side - Scratched - Loss in value

| No. | Component group | Description |
|---|---|---|
| 1 | Wheel / tyres | Alloy rim - front right side - Scratched - Loss in value |

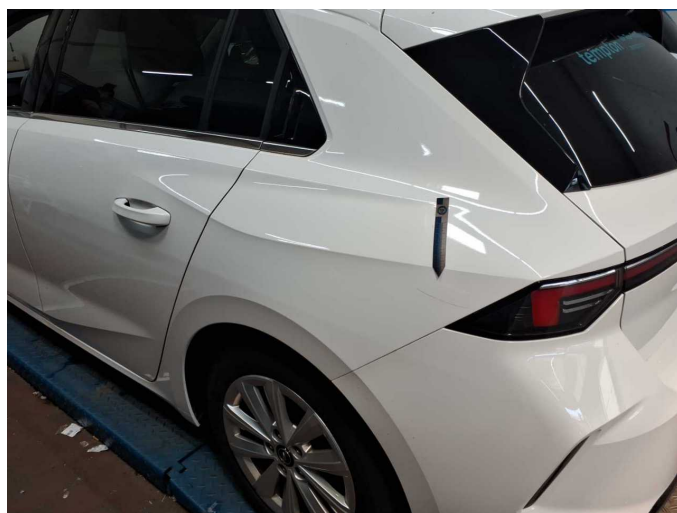
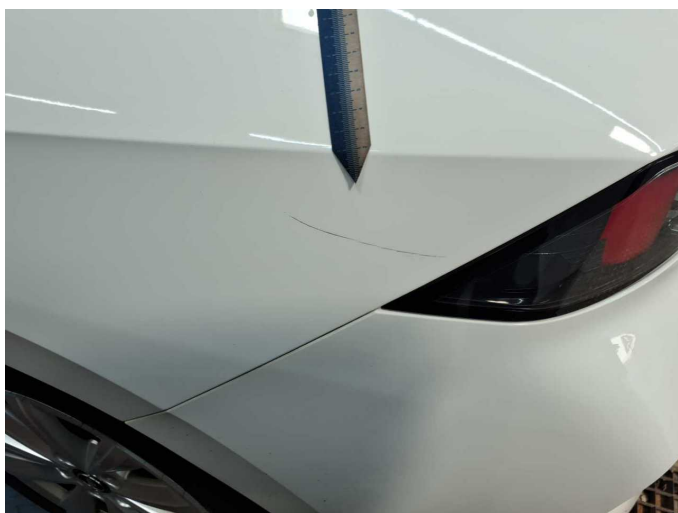
**Damage 2:** Side panel - rear left side: Side panel - Scratch(es) - Smart repair

| No. | Component group | Description |
|---|---|---|
| 2 | Side panel - rear left side | Side panel - Scratch(es) - Smart repair |
