Expertise

Protocol number: 46329322  
Order No. / Reference: 26581835  
Inspection date: 6 Jul 2026

| Manufacturer: Ford | Model: Grand Tourneo Connect 1.5 EcoBlue Start/Stop Trend |
| VIN: WF0UXXWPGUNS09427 | |

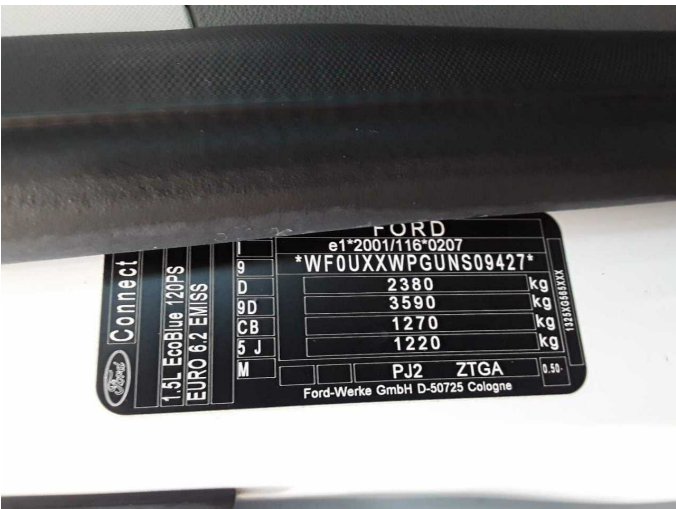
| VIN comparison | The vehicle identification number (VIN) was read from the vehicle and its conformity with the submitted documents was confirmed by the undersigned during the inspection. |

Figure 11: VIN

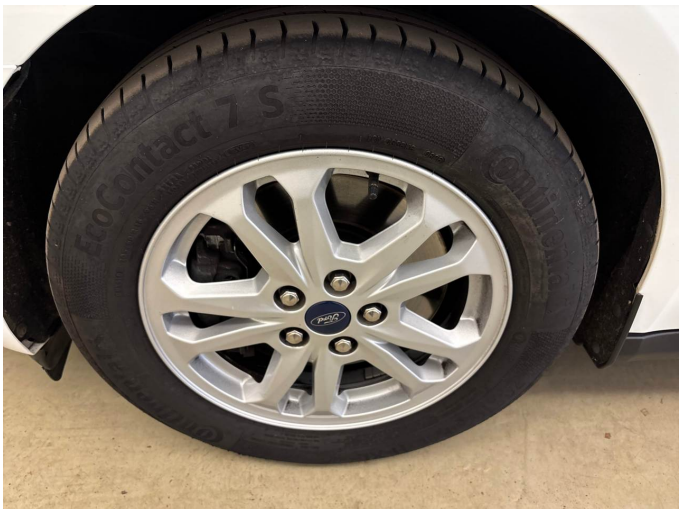
| # | Tyre size | Type of tyre | Manufacturer | Tread depth |
|---|---|---|---|---|
| 1) | 205/60 R16 96H | Summer tyres on Light alloy | Continental | 4mm / 4mm |
| 2) | 205/60 R16 96H | Summer tyres on Light alloy | Continental | 4mm / 4mm |

Figure 12: Mounted tyres

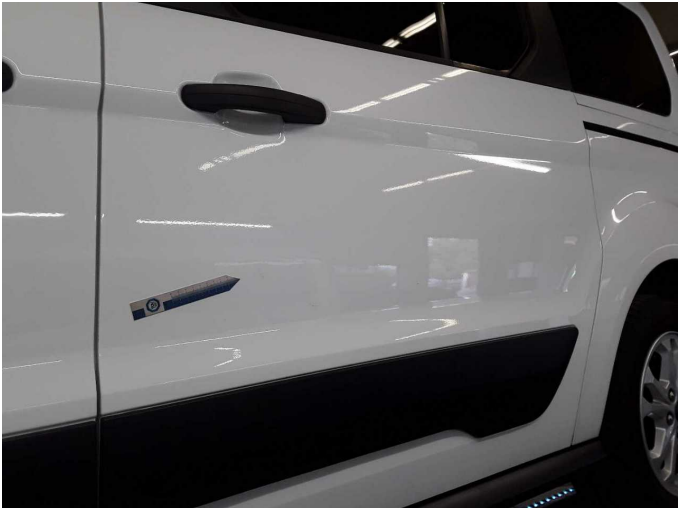
| No. | Component group | Description |
|---|---|---|
| 1 | Door - rear left side | Door - Dent / paintcoat damage - Smart repair |

Damage 1: Door - rear left side: Door - Dent / paintcoat damage - Smart repair

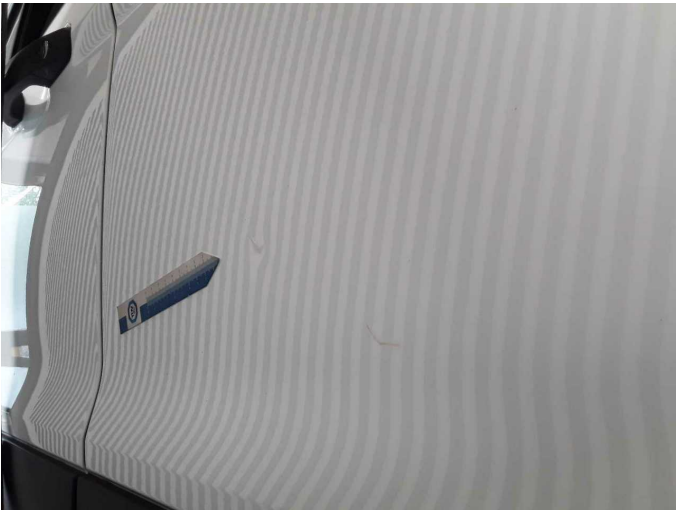
Damage 1: Door - rear left side: Door - Dent / paintcoat damage - Smart repair

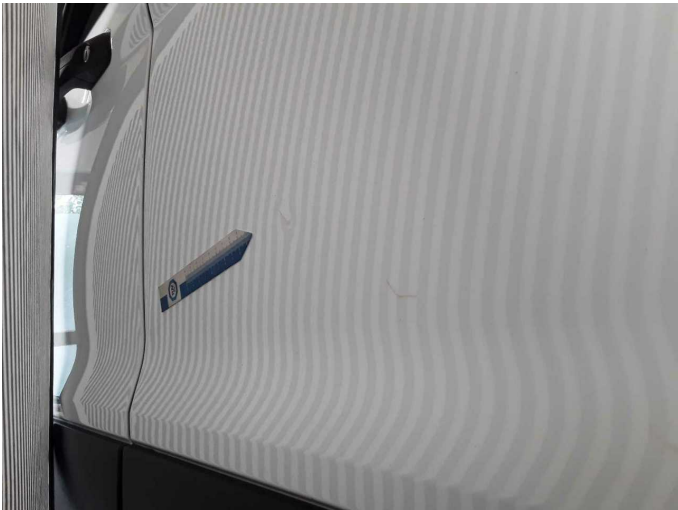
Damage 1: Door - rear left side: Door - Dent / paintcoat damage - Smart repair

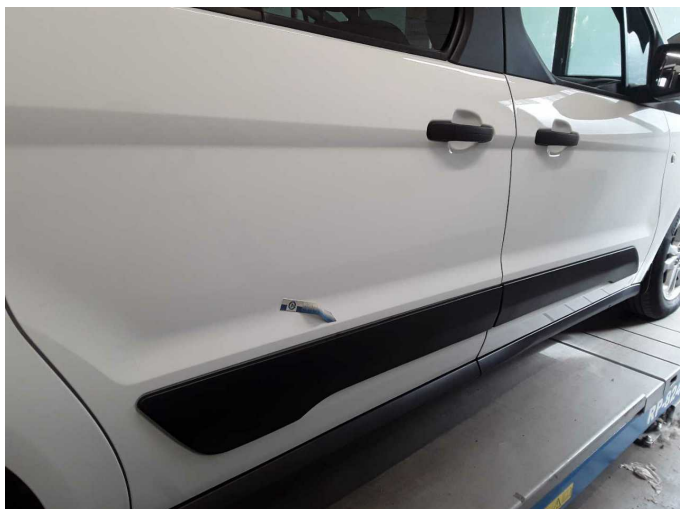
| No. | Component group | Description |
|---|---|---|
| 2 | Door - rear right side | Brightware - lower - Damaged - Replace |

**Damage 2:** Door - rear right side: Brightware - lower - Damaged - Replace

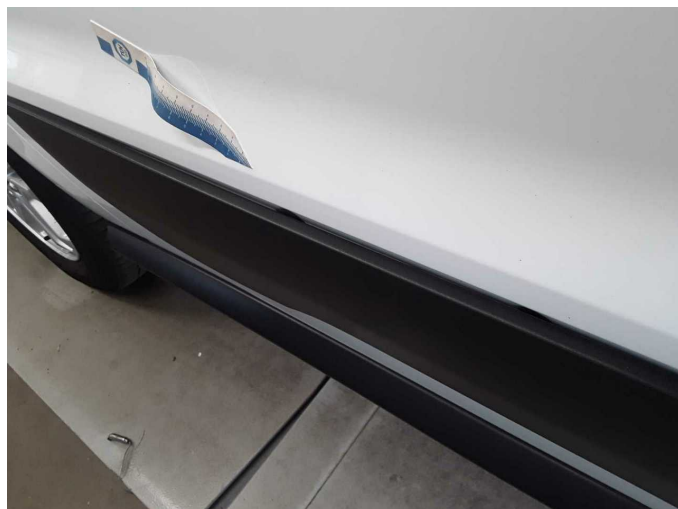
**Damage 2:** Door - rear right side: Brightware - lower - Damaged - Replace

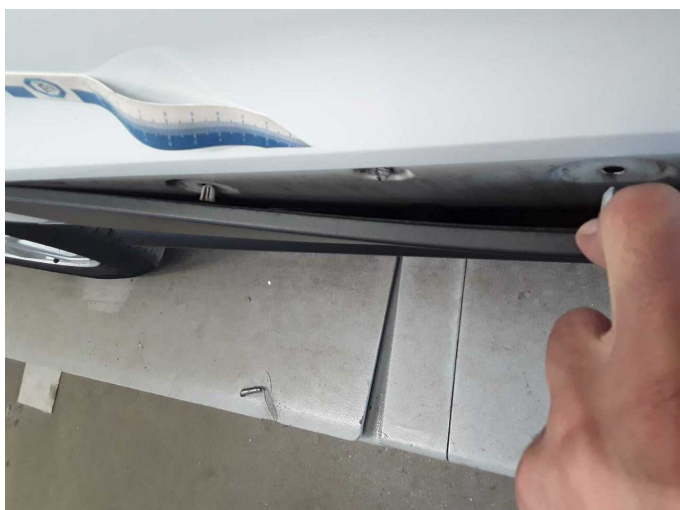
**Damage 2:** Door - rear right side: Brightware - lower - Damaged - Replace

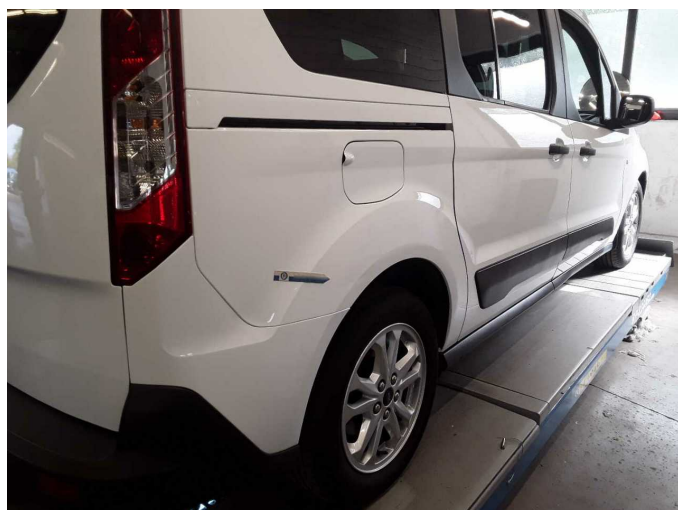
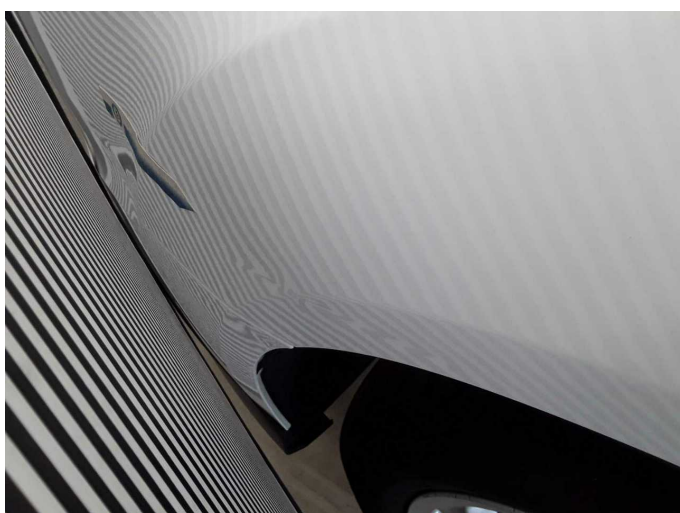
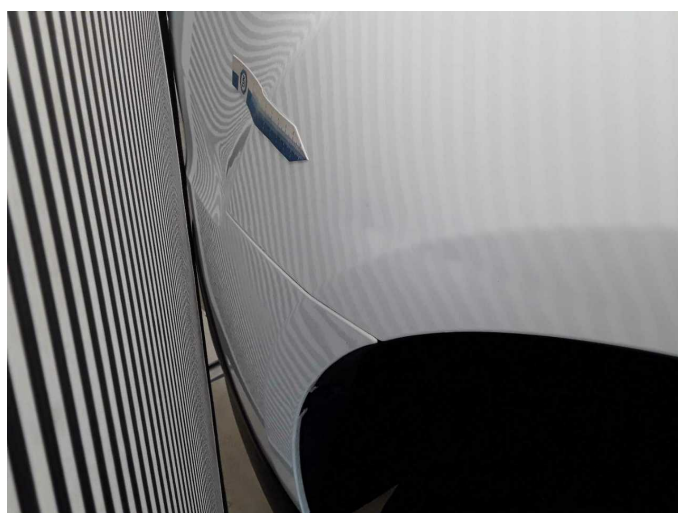
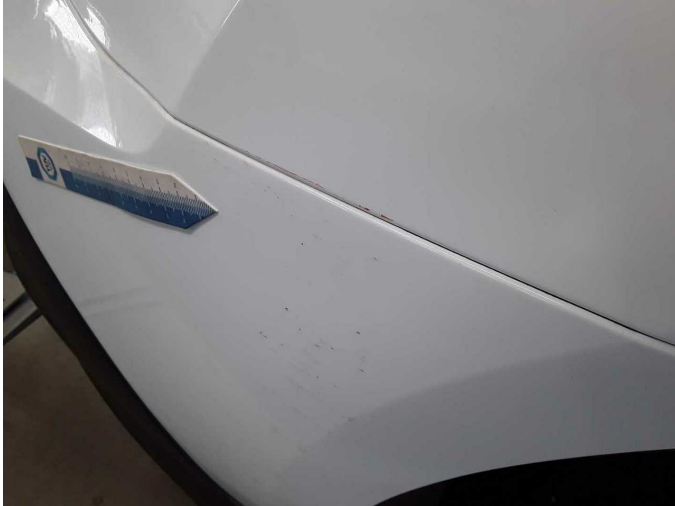
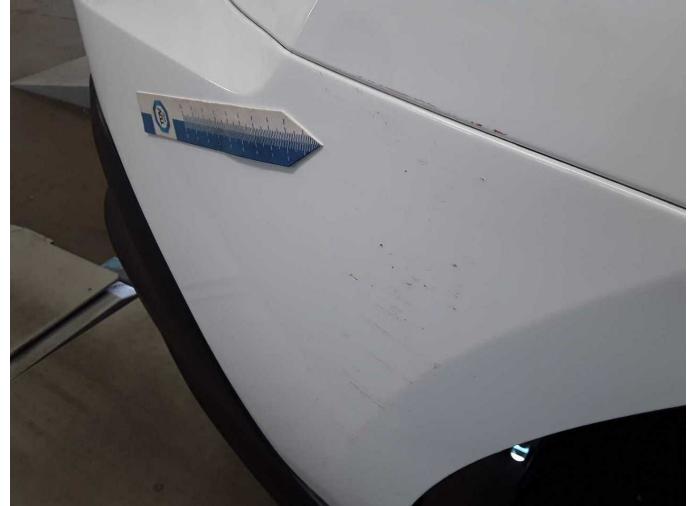
| No. | Previous damage | Extent of damage (Net) |
|---|---|---|
| 1 | Side right, Provided by user / customer, from 5 Sept 2023 | 2.870,84 € |

**Accident 1:** Side right

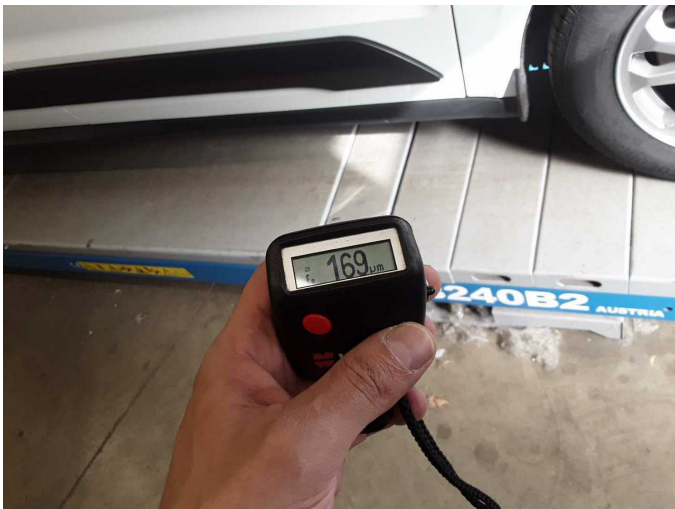
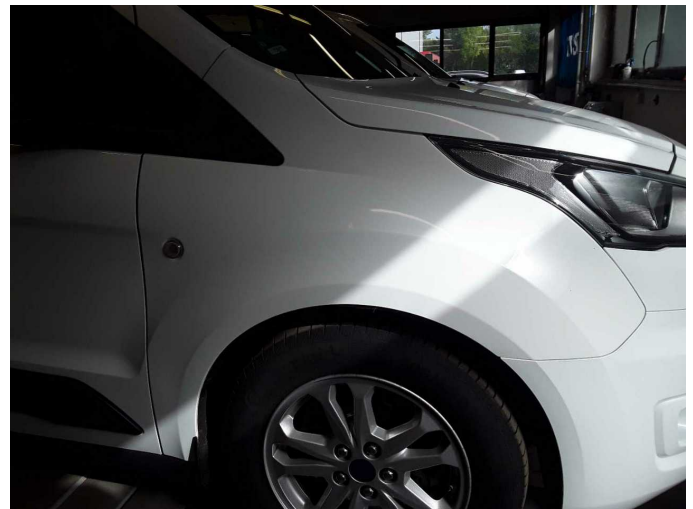
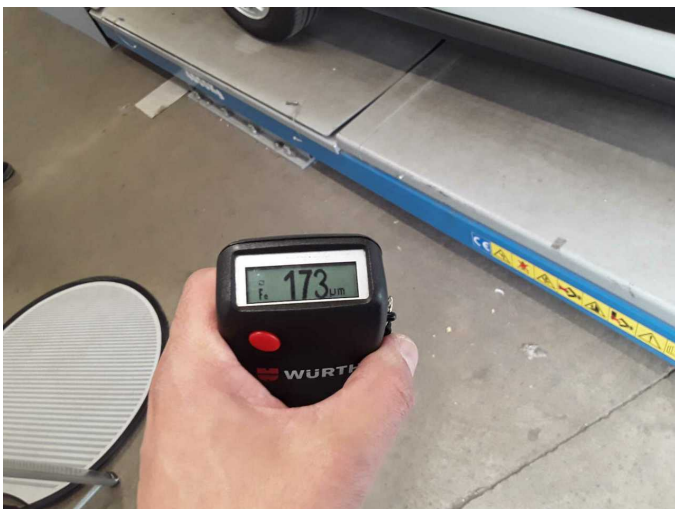
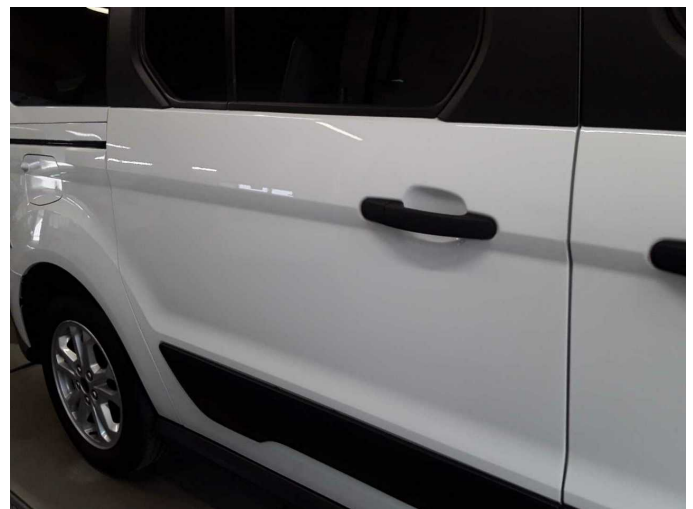
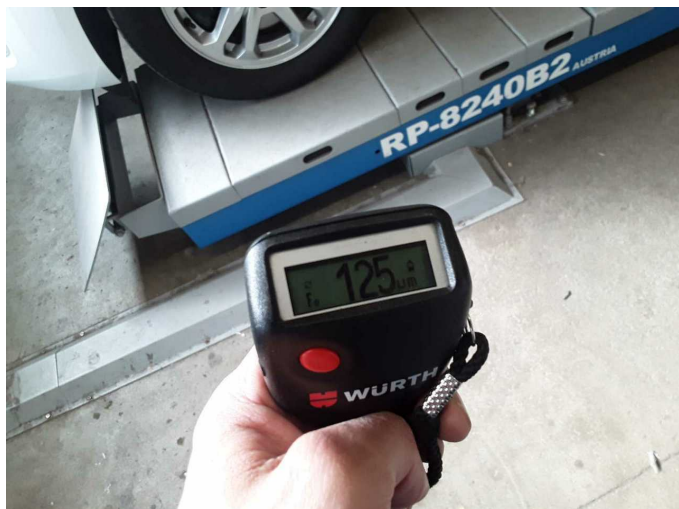
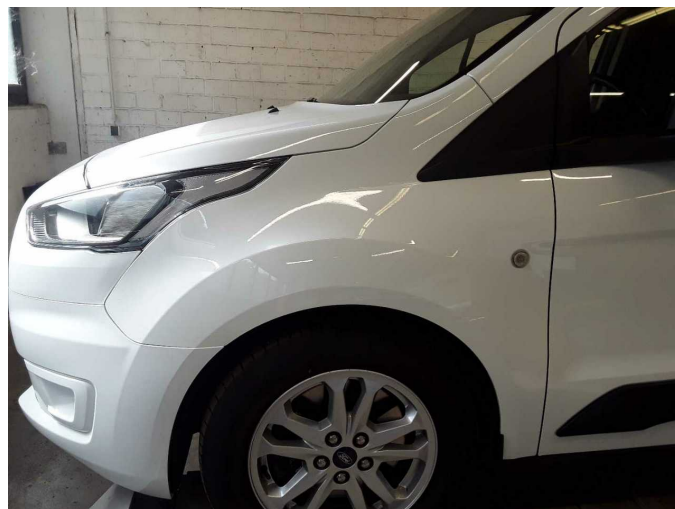
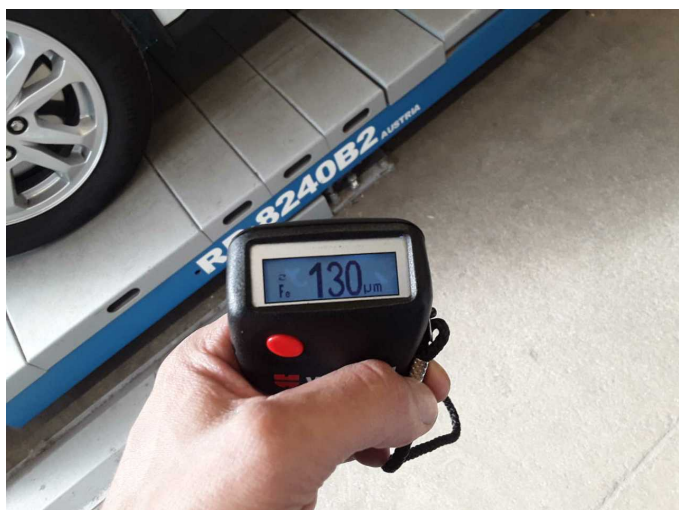
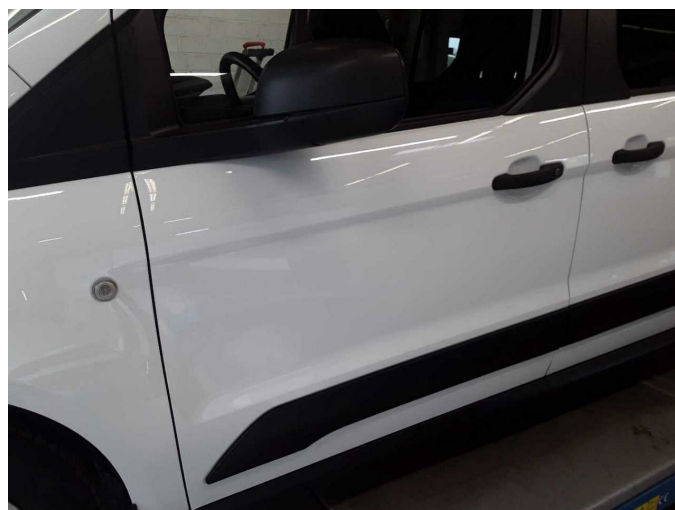
- 1 Mudguard - left side, Mudguard - right side, Door - rear right side, Door - front left side, Professionally carried out, Invoice of repair done Non-existent

**Repainting 1:** Mudguard - left side, Mudguard - right side, Door - rear right side, Door - front left side
