Expertise

Protocol number: 46131286
Order No. / Reference: 26453042
Inspection date: 19 Jun 2026

Manufacturer: Volkswagen

Model: Touareg 3.0 V6 e-Hybrid 4Motion Aut. R

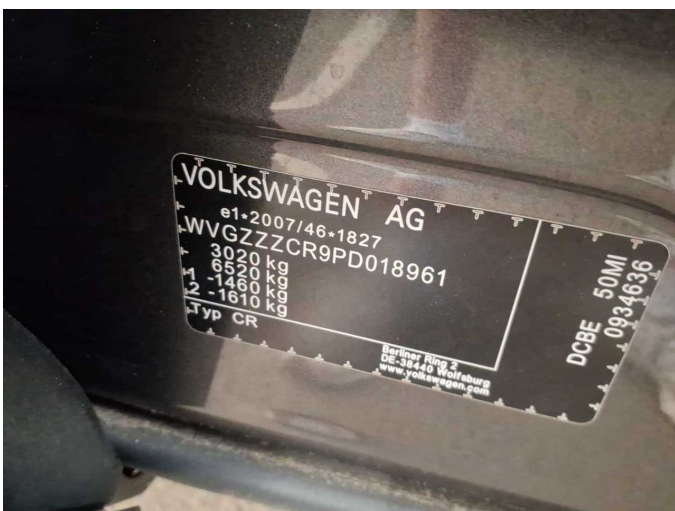
Figure 11: VIN

| VIN comparison | The vehicle identification number (VIN) was read from the vehicle and its conformity with the submitted documents was confirmed by the undersigned during the inspection. |

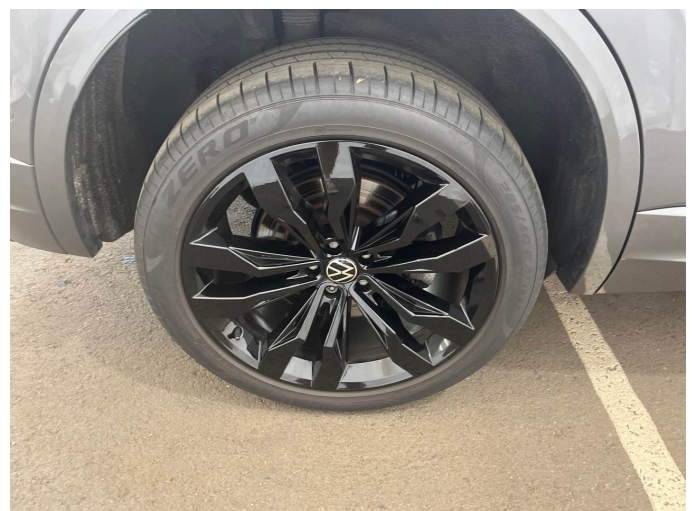
Figure 12: Mounted tyres

| Mounted tyres | | | | |
|---|---|---|---|---|
| 1) | 285/40 R21 109Y | Summer tyres on Light alloy | Pirelli | 6mm / 6mm |
| 2) | 285/40 R21 109Y | Summer tyres on Light alloy | Pirelli | 6mm / 6mm |

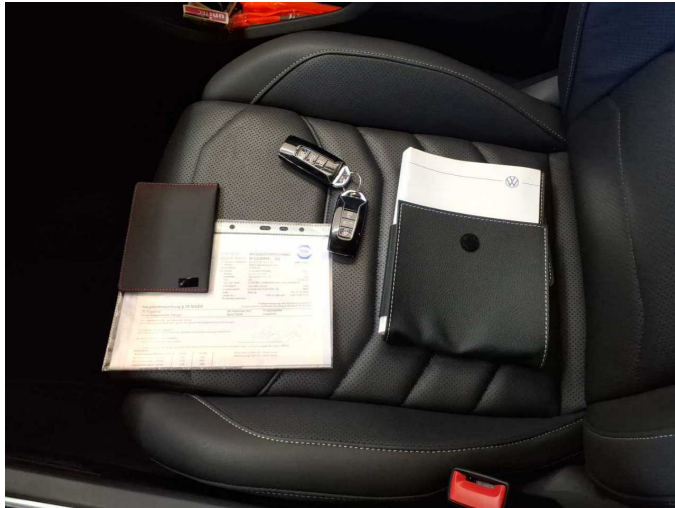
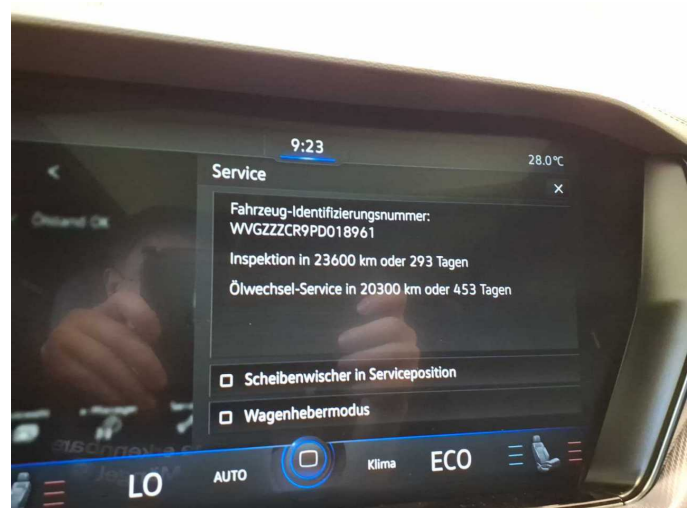
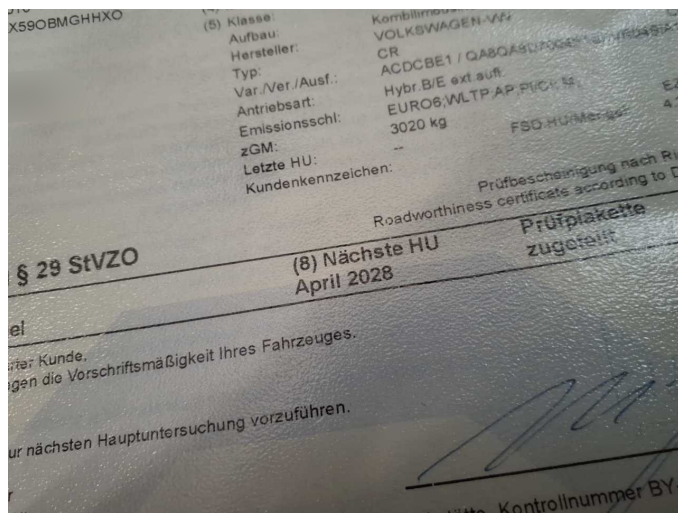
| Documents submitted | At the time of the inspection, the vehicle registration certificate Part 2 (title) was available, but the vehicle registration certificate Part 1 (document) was not. (Copy) |

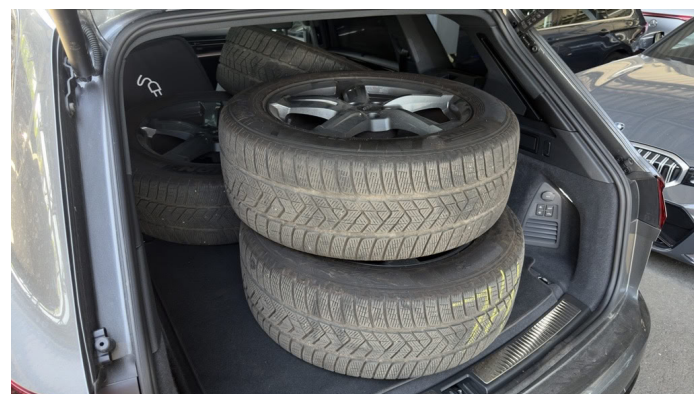
Figure 16: Additional tyres

| Mounted tyres | | | | |
|---|---|---|---|---|
| 1) | 255/55 R19 111H | Winter tyres on Light alloy | Pirelli | 6mm / 6mm |
| 2) | 255/55 R19 111H | Winter tyres on Light alloy | Pirelli | 6mm / 6mm |

- Die Unterbodenbesichtigung war nur ebenerdig & eingeschränkt möglich. Mehrkosten möglich.
- Der angegebene Winterradsatz ist kein Bestandteil des Auslieferungsumfangs.
- Ein Nachweis über die Zulässigkeit des beiliegenden Radsatzes wurde nicht erbracht.

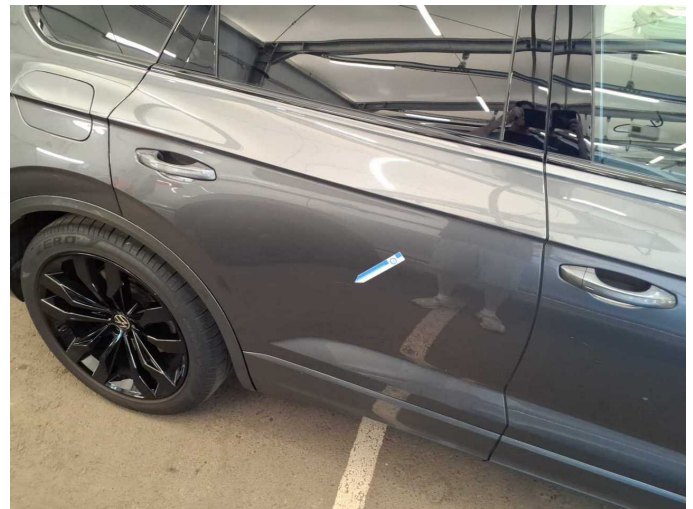
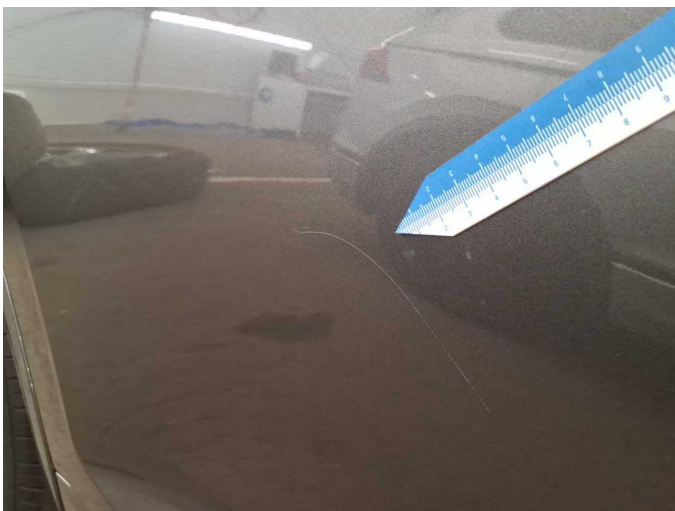
Damage 1: Door - rear right side: Door - Scratch(es) - Paint

| No. | Component group | Description |
|---|---|---|
| 1 | Door - rear right side | Door - Scratch(es) - Paint |

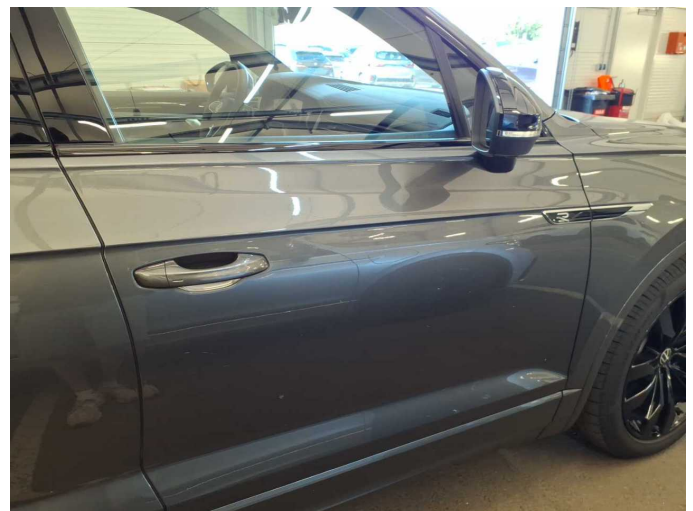
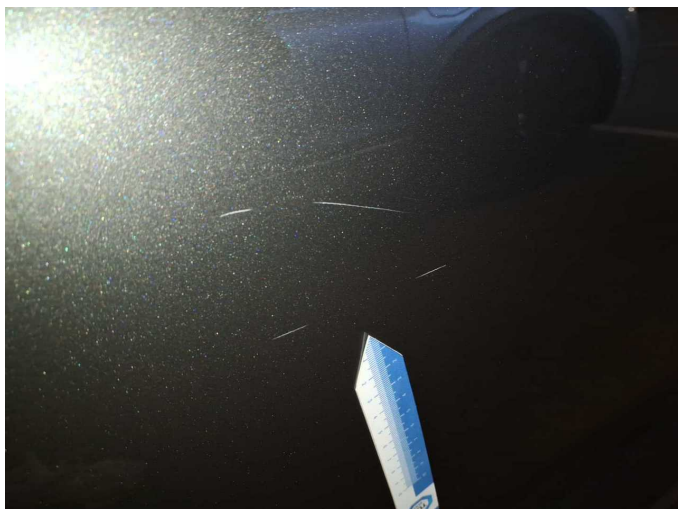
Damage 2: Door - front right side: Door - Scratch(es) - Paint

| No. | Component group | Description |
|---|---|---|
| 2 | Door - front right side | Door - Scratch(es) - Paint |
