Expertise

Protocol number: 45919539  
Order No. / Reference: 26570777  
Inspection date: 11 Jun 2026

Manufacturer: Mercedes-Benz

Model: GLB 200 7G-DCT Progressive Advanced

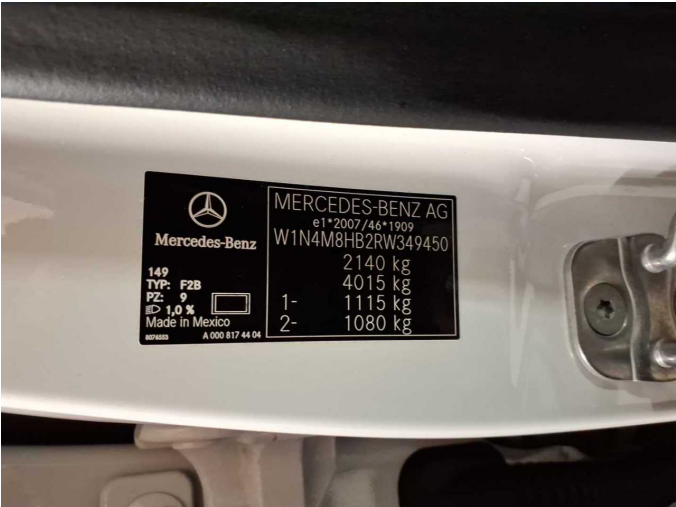
Figure 11: VIN

| VIN comparison | The vehicle identification number (VIN) was read from the vehicle and its conformity with the submitted documents was confirmed by the undersigned during the inspection. |

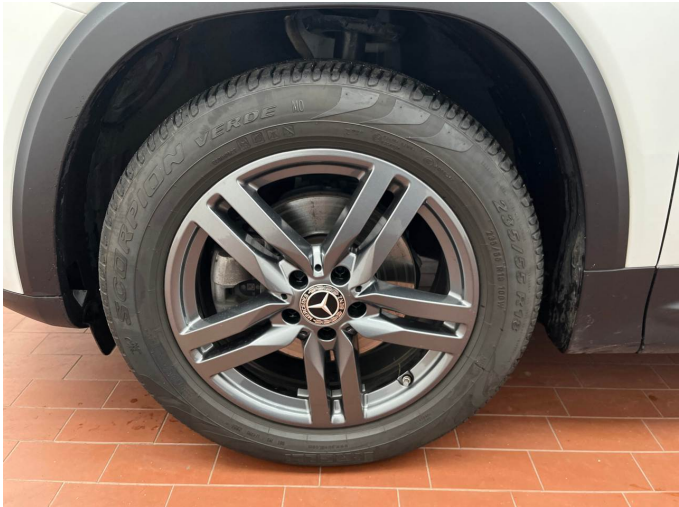
Figure 12: Mounted tyres

| # | Tyre size | Type of tyre | Manufacturer | Tread depth |
|---|---|---|---|---|
| 1) | 235/55 R18 100W | Summer tyres on Light alloy | Pirelli | 6mm / 6mm |
| 2) | 235/55 R18 100W | Summer tyres on Light alloy | Pirelli | 6mm / 6mm |

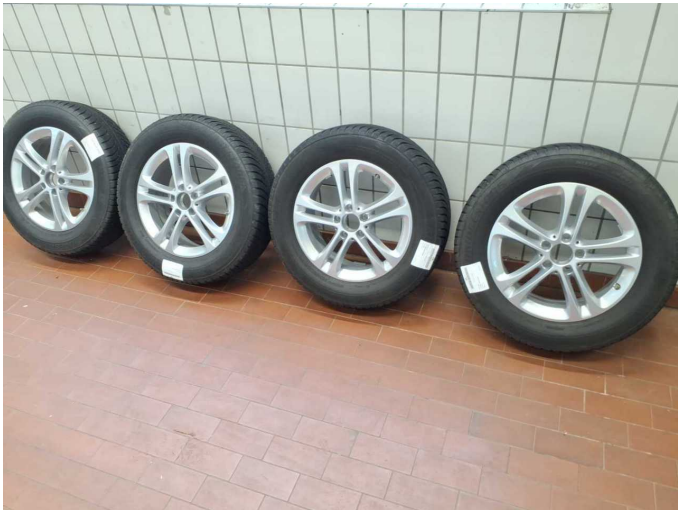
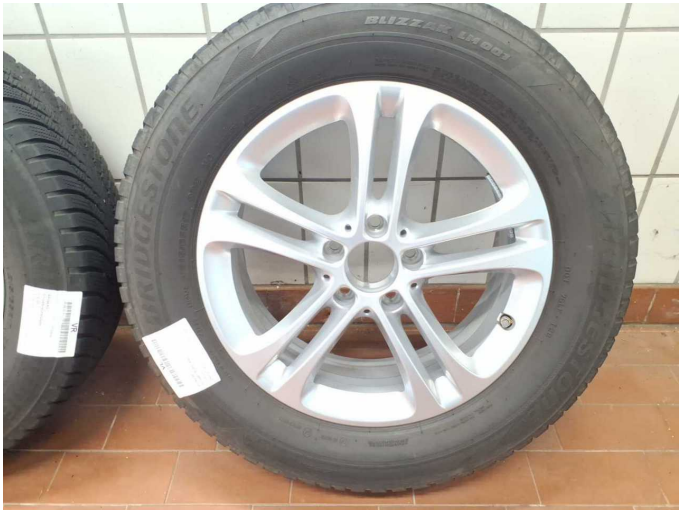
Figure 15: Additional tyres

| # | Tyre size | Type of tyre | Manufacturer | Tread depth |
|---|---|---|---|---|
| 1) | 215/65 R17 99H | Winter tyres on Light alloy | Bridgestone | 5mm / 5mm |
| 2) | 215/65 R17 99H | Winter tyres on Light alloy | Bridgestone | 6mm / 6mm |

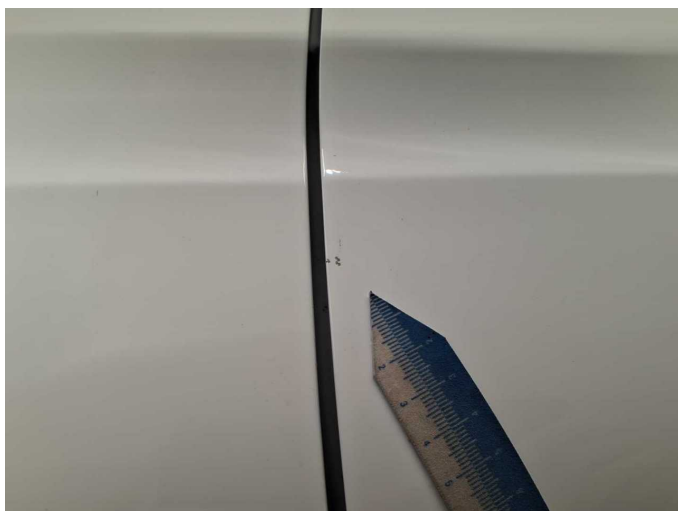
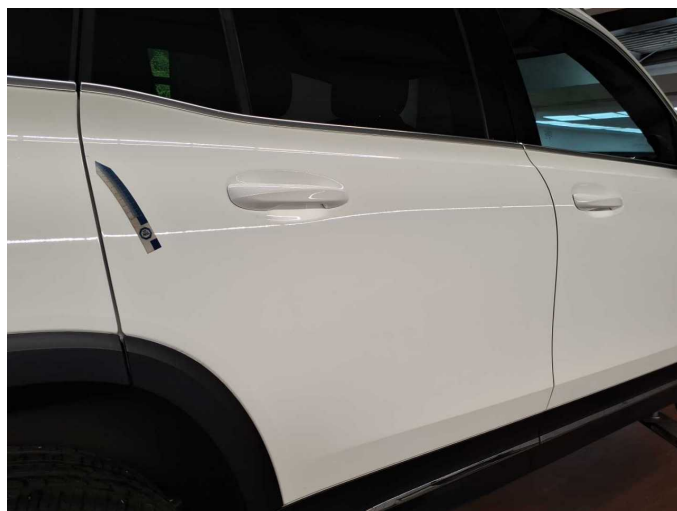
| No. | Component group | Description |
|---|---|---|
| 1 | Door - rear right side | Door - Scratch(es) - Cover / polish |

**Damage 1:** Door - rear right side: Door - Scratch(es) - Cover / polish

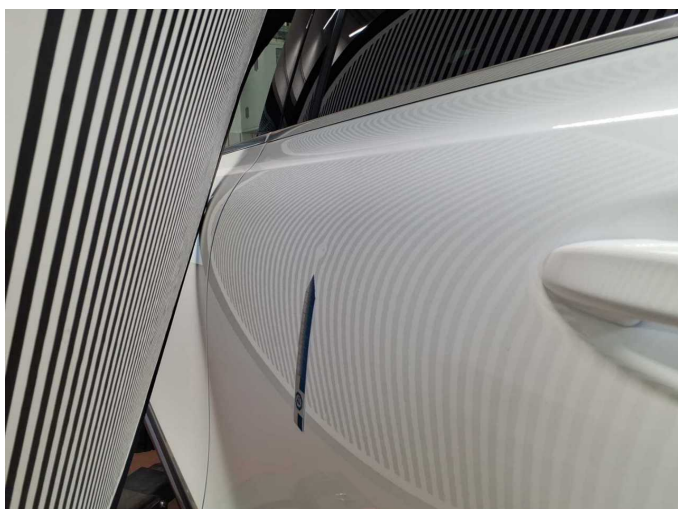
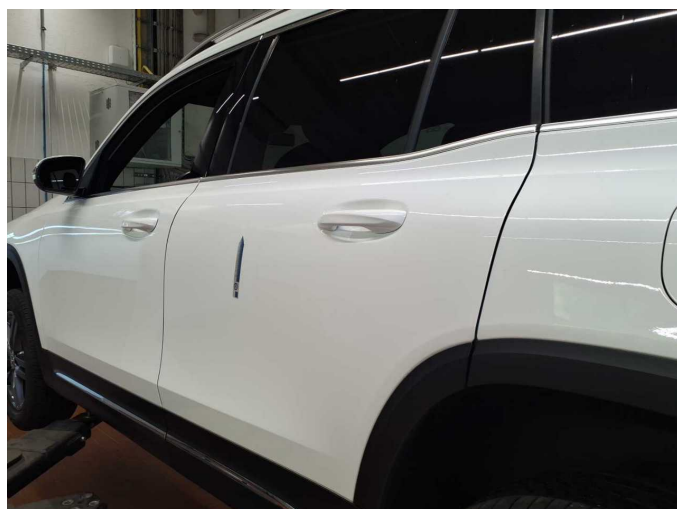
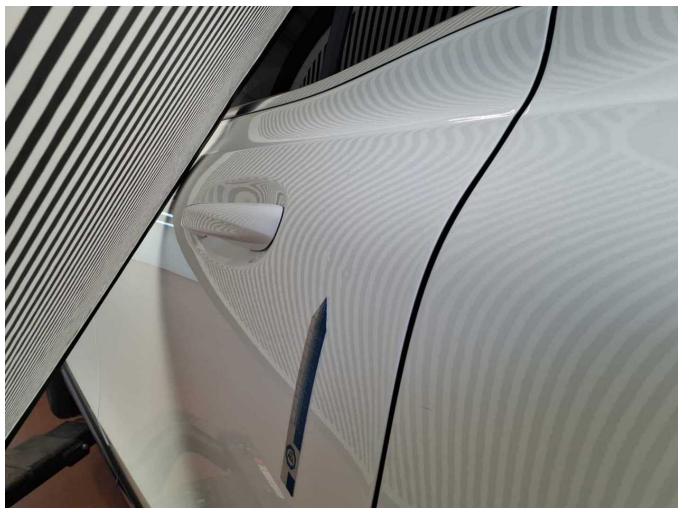
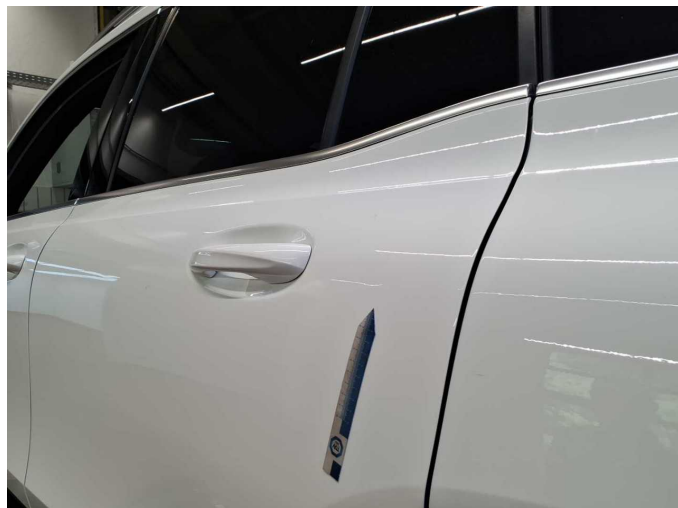
| No. | Component group | Description |
|---|---|---|
| 2 | Door - rear left side | Door - dent(s) - Smooth repair work |

**Damage 2:** Door - rear left side: Door - dent(s) - Smooth repair work

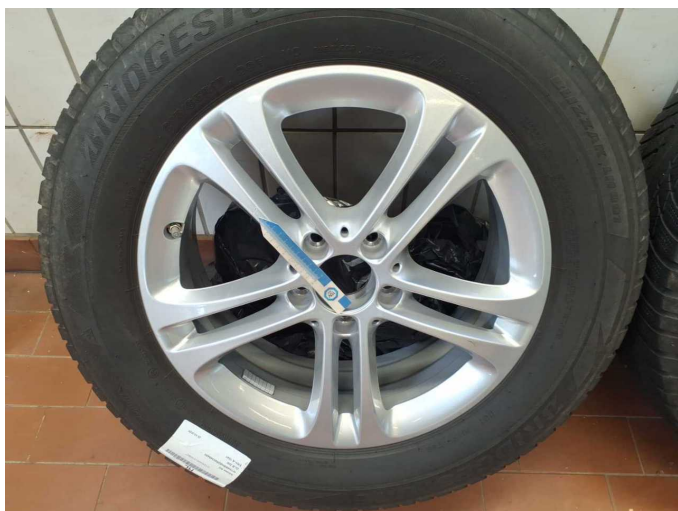
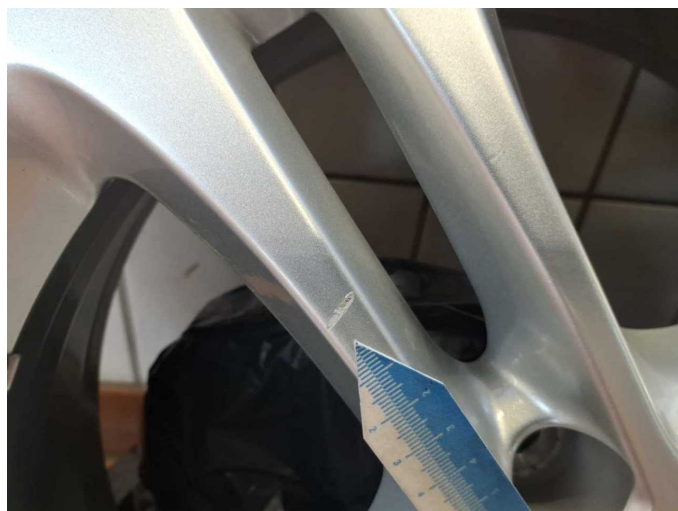
| No. | Component group | Description |
|---|---|---|
| 3 | 2nd wheel set | 1 alloy rim - Scratched - Loss in value |

**Damage 3:** 2nd wheel set: 1 alloy rim - Scratched - Loss in value

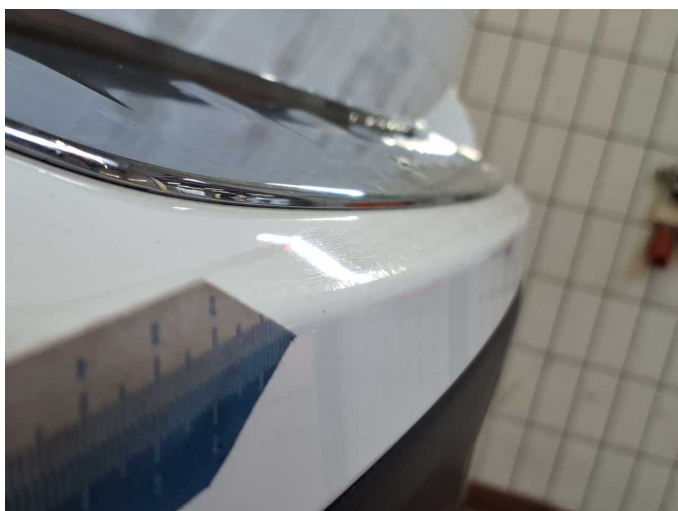
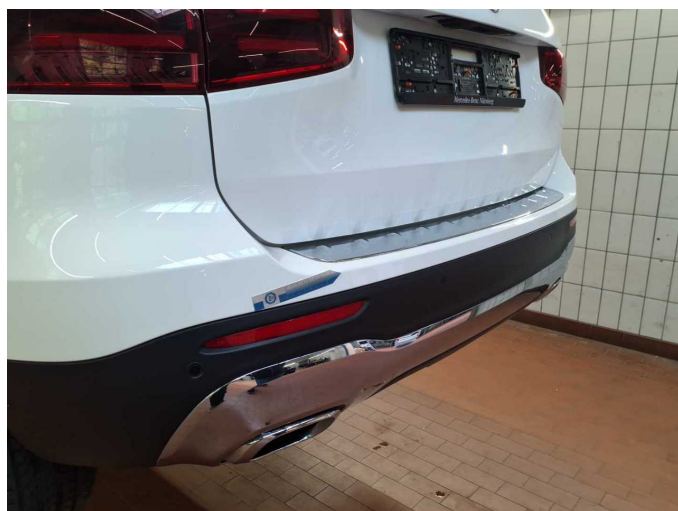
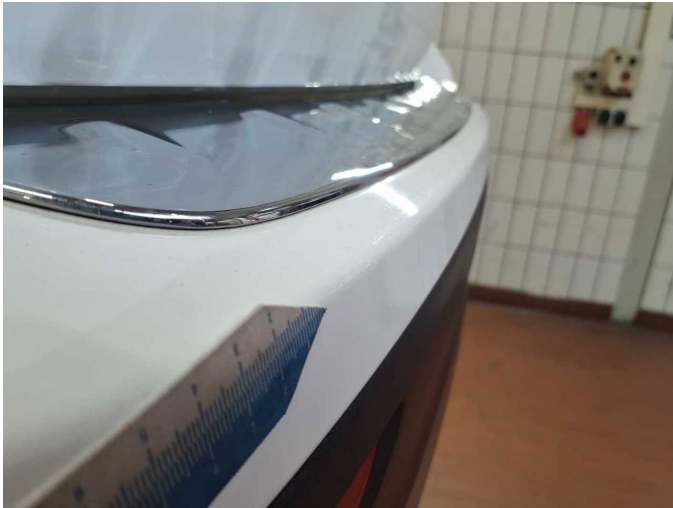
| No. | Component group | Description |
|---|---|---|
| 4 | Rear bumper | Rear bumper - Scratch(es) - Smart repair |

**Damage 4:** Rear bumper: Rear bumper - Scratch(es) - Smart repair
