Expertise

Protocol number: 46085103  
Order No. / Reference: 26411142  
Inspection date: 22 Jun 2026

Manufacturer: Volkswagen

Model: Tiguan Allspace 2.0 TDI SCR DSG Life

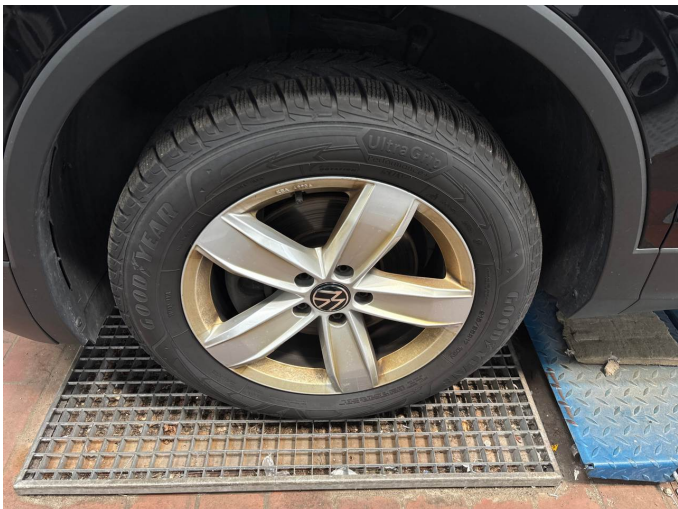
Figure 12: Mounted tyres

| # | Tyre size | Type of tyre | Manufacturer | Tread depth |
|---|---|---|---|---|
| 1) | 215/65 R17 103V | Winter tyres on Light alloy | Goodyear | 6mm / 6mm |
| 2) | 215/65 R17 103V | Winter tyres on Light alloy | Goodyear | 6mm / 6mm |

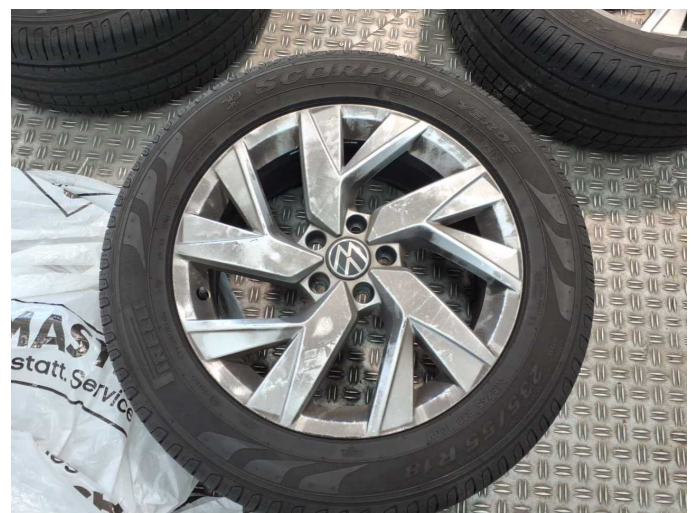
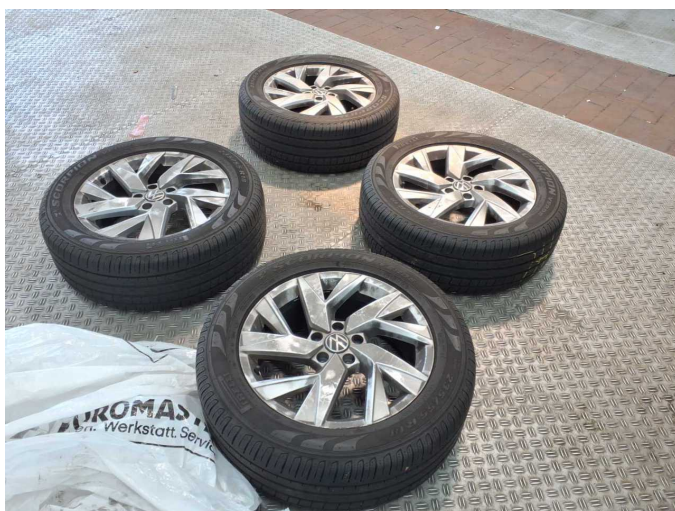
Figure 16: Additional tyres

| # | Tyre size | Type of tyre | Manufacturer | Tread depth |
|---|---|---|---|---|
| 1) | 235/55 R18 100V | Summer tyres on Light alloy | Pirelli | 4mm / 4mm |
| 2) | 235/55 R18 100V | Summer tyres on Light alloy | Pirelli | 4mm / 4mm |

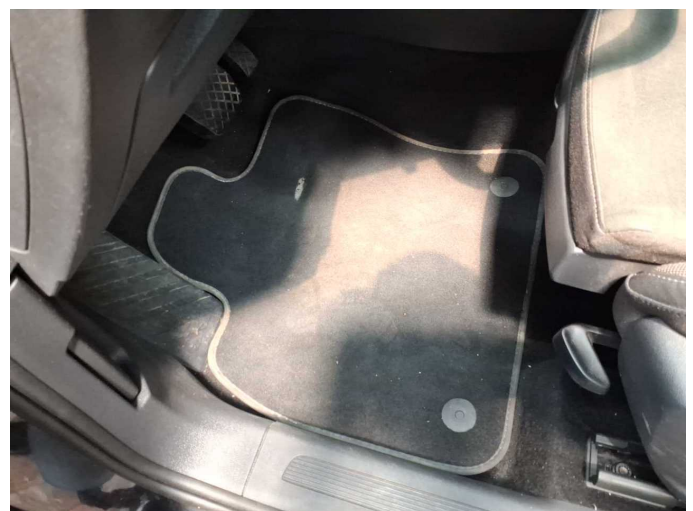
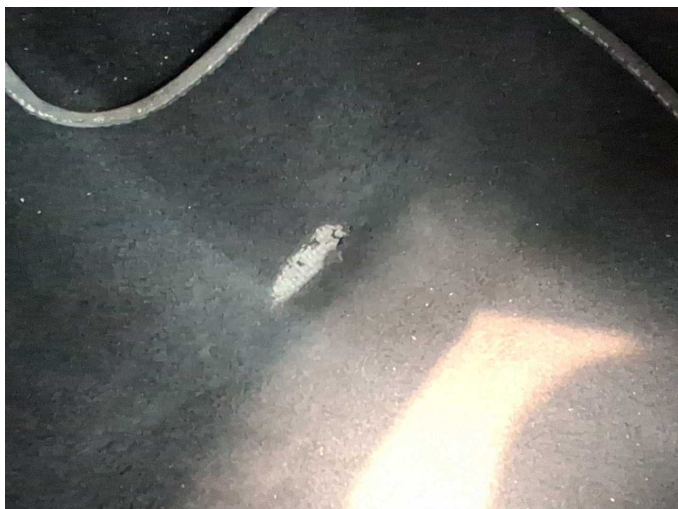
**Damage 1:** Trim / covers: Floor mats - Holes - Replace

| No. | Component group | Description |
|---|---|---|
| 1 | Trim / covers | Floor mats - Holes - Replace |

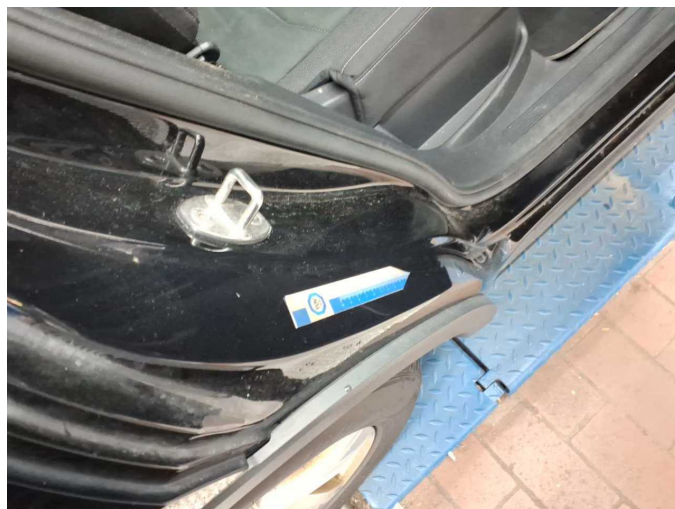
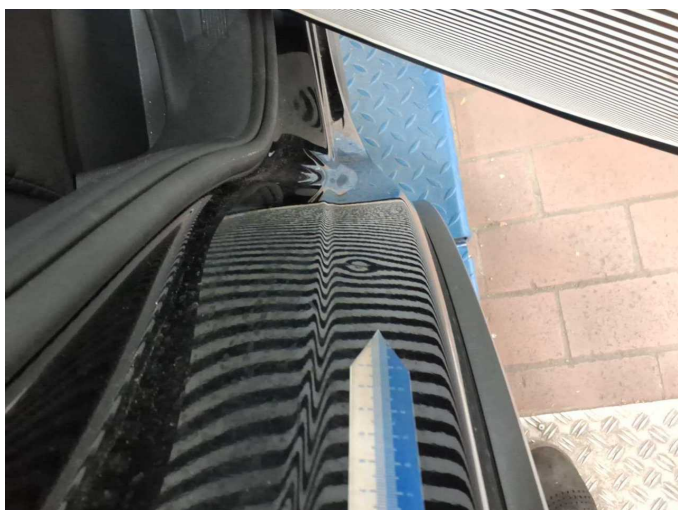
**Damage 2:** Side panel - rear right side: Sill - dent(s) - Smooth repair work

| No. | Component group | Description |
|---|---|---|
| 2 | Side panel - rear right side | Sill - dent(s) - Smooth repair work |

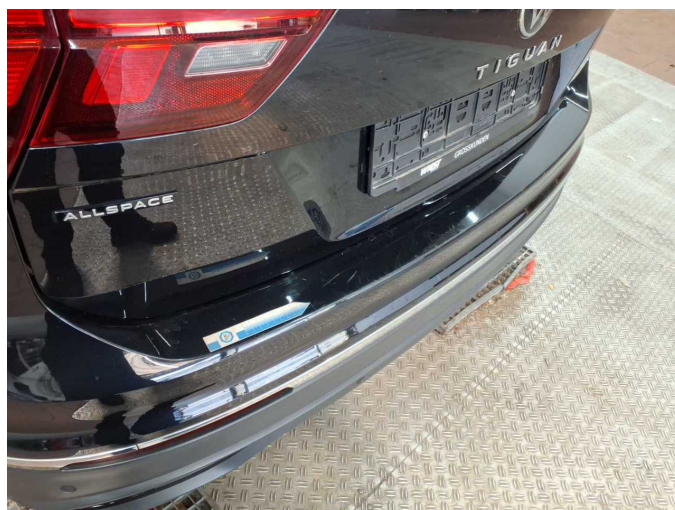
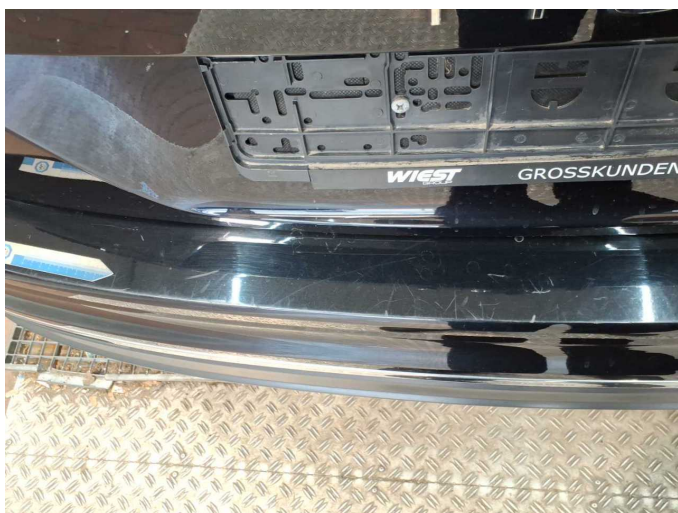
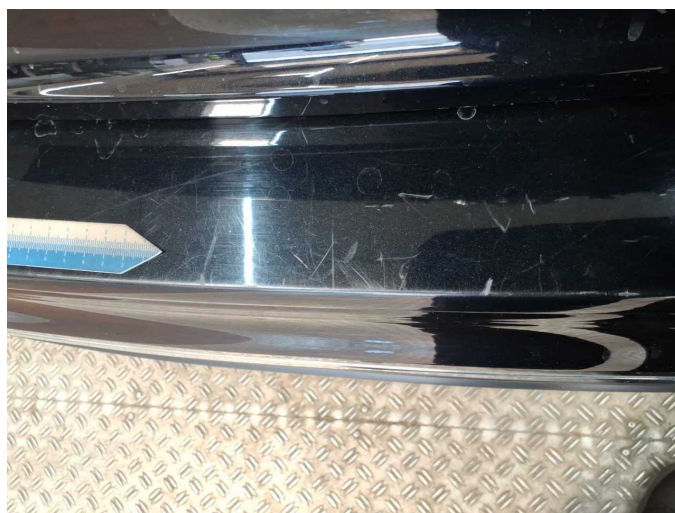
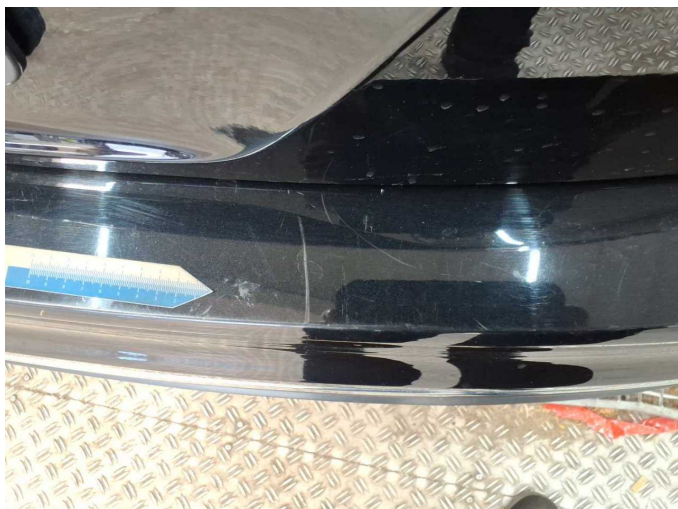
**Damage 3:** Rear bumper: Rear bumper (Ladekante) - Scratch(es) - Paint

| No. | Component group | Description |
|---|---|---|
| 3 | Rear bumper | Rear bumper (Ladekante) - Scratch(es) - Paint |

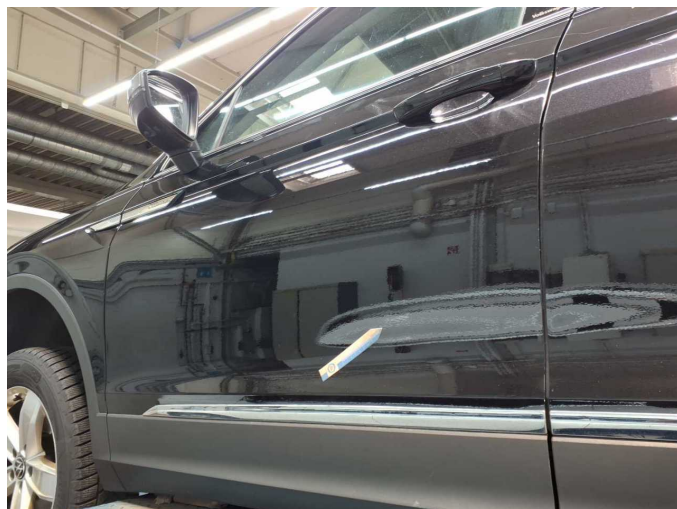
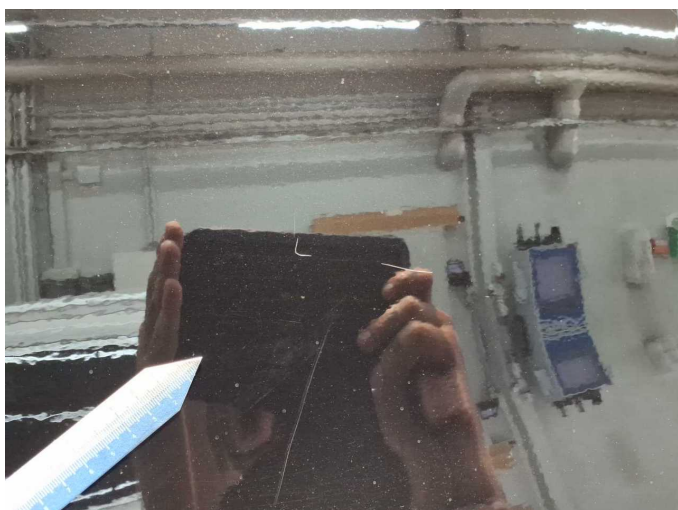
**Damage 4:** Door - front left side: Door - Scratch(es) - Paint

| No. | Component group | Description |
|---|---|---|
| 4 | Door - front left side | Door - Scratch(es) - Paint |

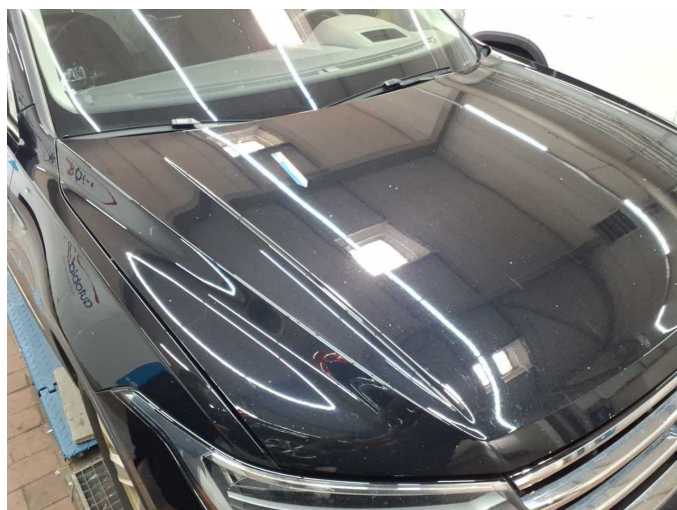
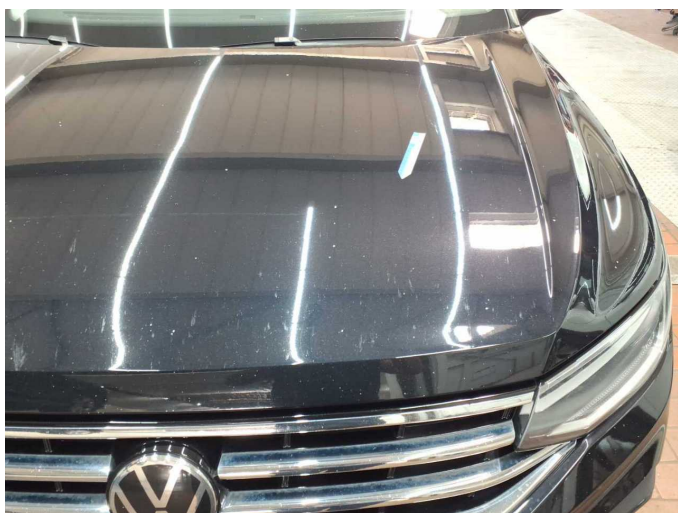
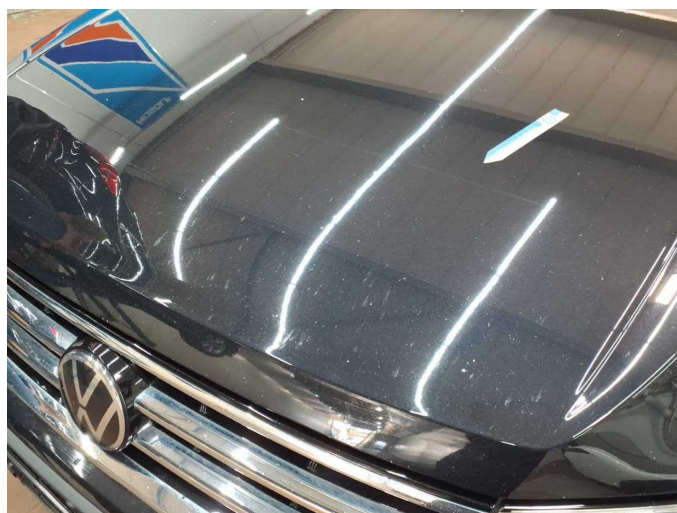
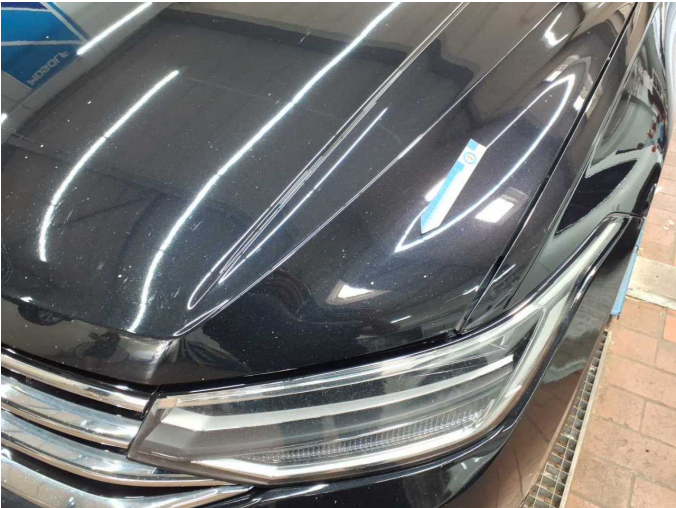
**Damage 5:** Bonnet: Bonnet - Stone chips - Paint

Damage 5: Bonnet: Bonnet - Stone chips - Paint

| No. | Component group | Description |
|---|---|---|
| 5 | Bonnet | Bonnet - Stone chips - Paint |

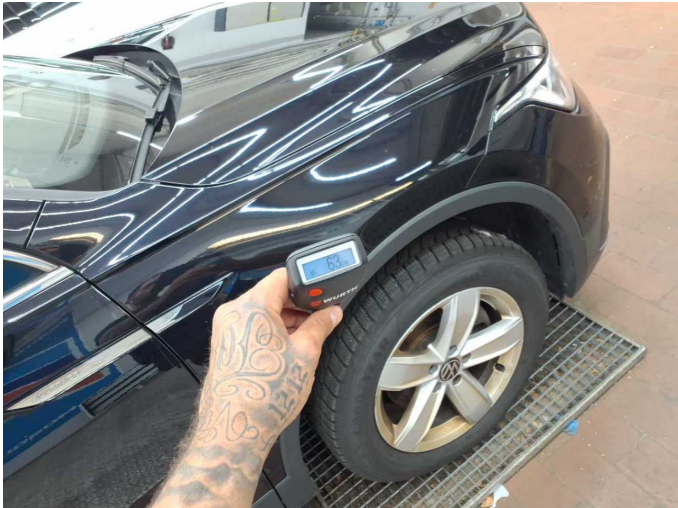
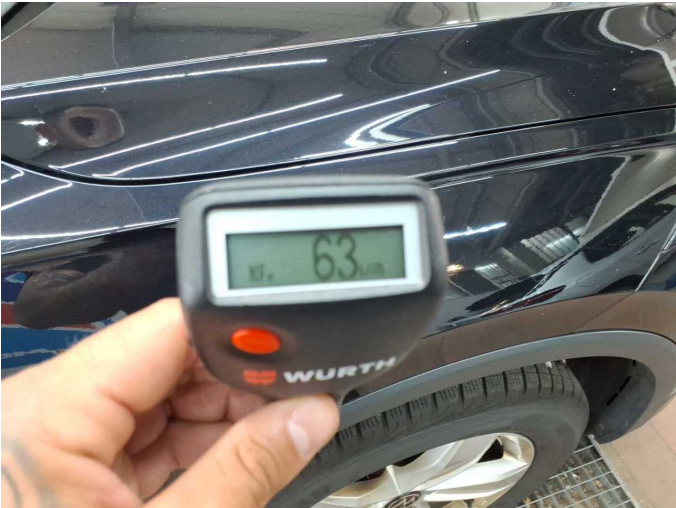
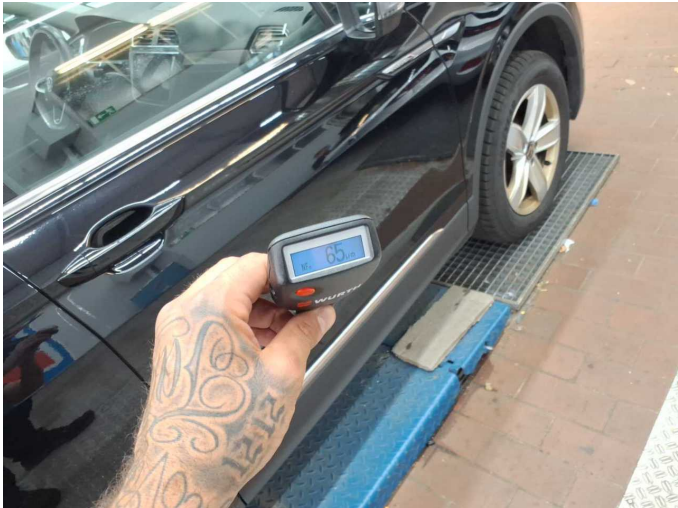
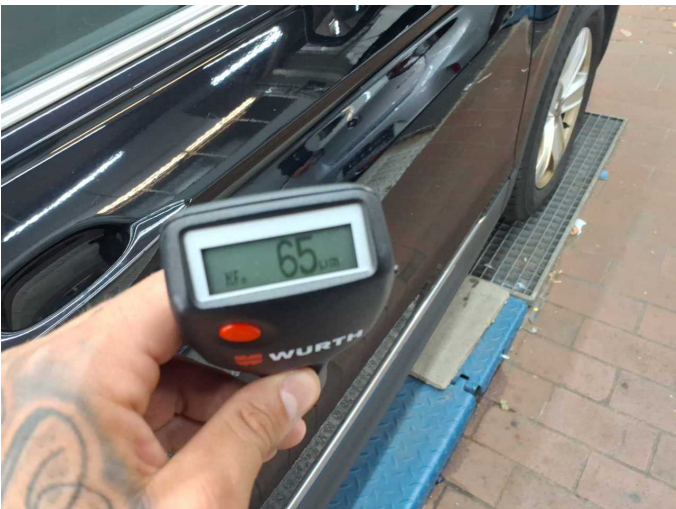
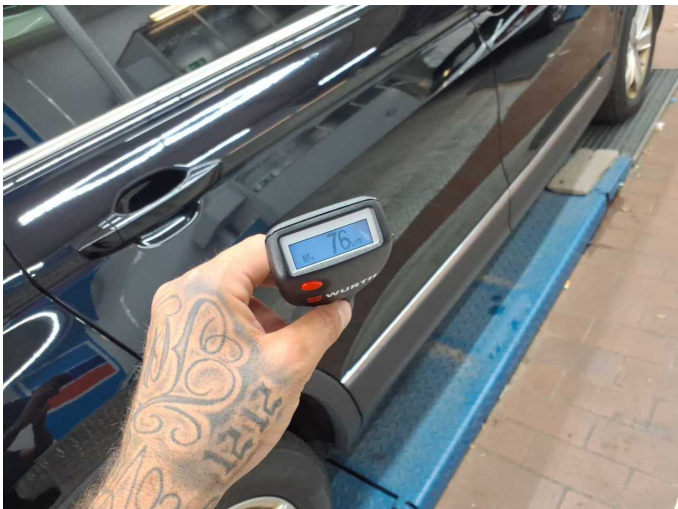
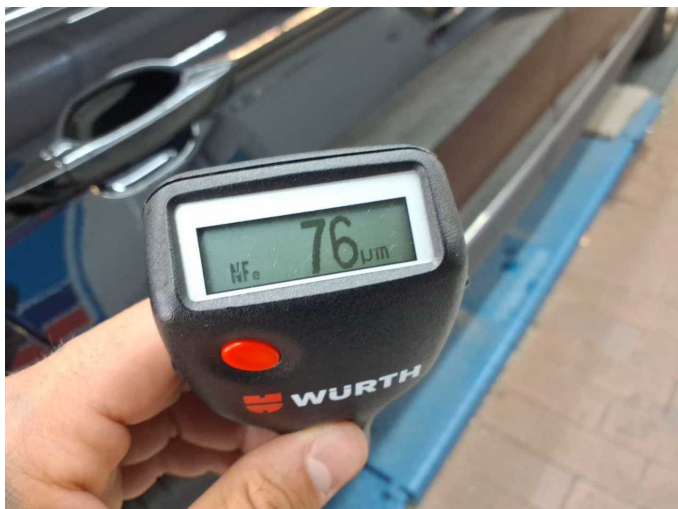
Previous damage 1: Side right

| No. | Previous damage | Extent of damage (Net) |
|---|---|---|
| 1 | Side right, Provided by user / customer, from 31 Jul 2024 | 1.001,45 € |

According to available information previous damages were repaired at the vehicle. Traces of repairs, which allow conclusions about the area of repair, were not recognizable during the inspection.

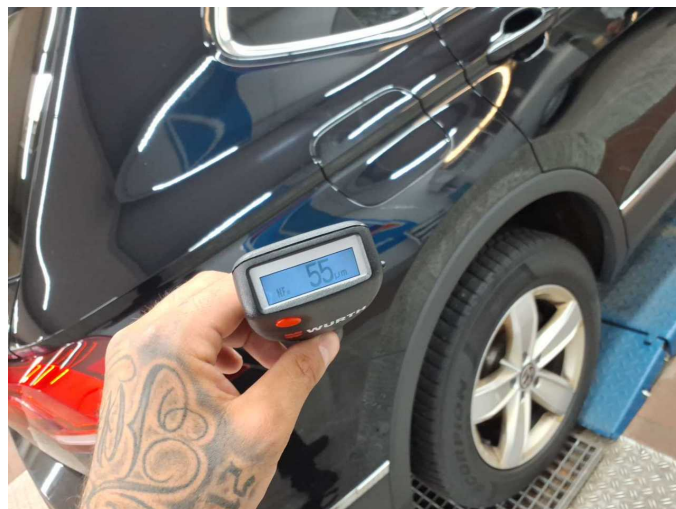
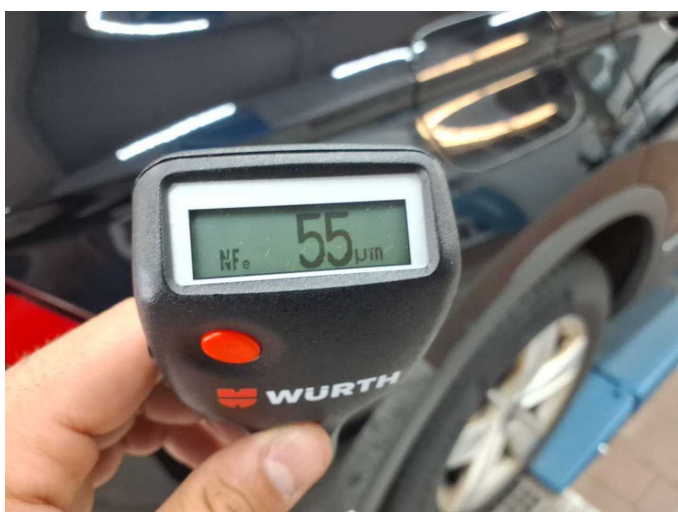
Previous damage 1: Side right
