## Expertise

Protocol number: 45559812  
Order No. / Reference: 26405980  
Inspection date: 21 May 2026

Manufacturer: Peugeot

Model: 308 SW BlueHDi 130 EAT8 Allure Pack

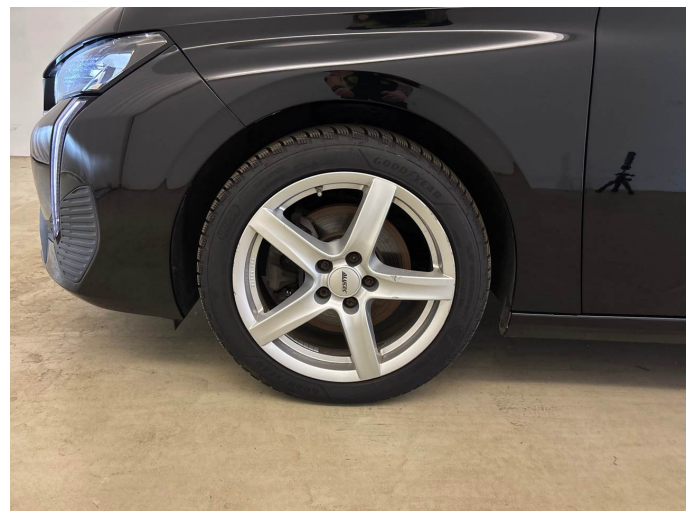
Figure 12: Mounted tyres

Mounted tyres				
#	Tyre size	Type of tyre	Manufacturer	Tread depth
1)	225/45 R17 91H	Winter tyres on Light alloy	Goodyear	5mm / 5mm
2)	225/45 R17 91H	Winter tyres on Light alloy	Goodyear	5mm / 5mm
Additional tyres				
#	Tyre size	Type of tyre	Manufacturer	Tread depth
1)	225/45 R17 91W	Summer tyres on Light alloy	Dunlop	4mm / 4mm
2)	225/45 R17 91W	Summer tyres on Light alloy	Dunlop	4mm / 4mm

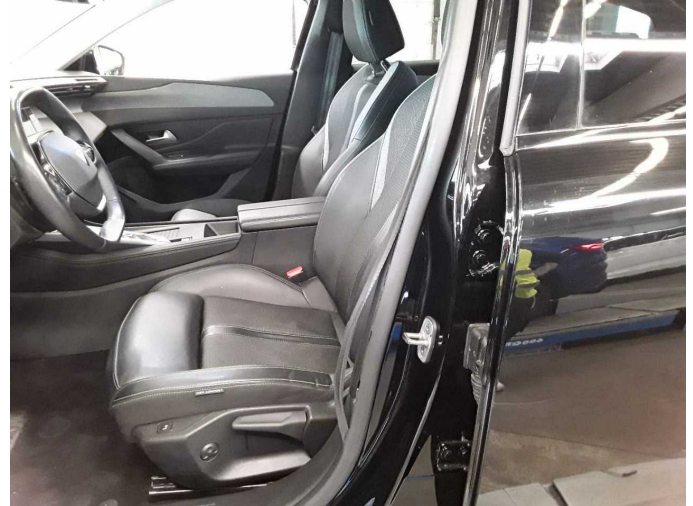
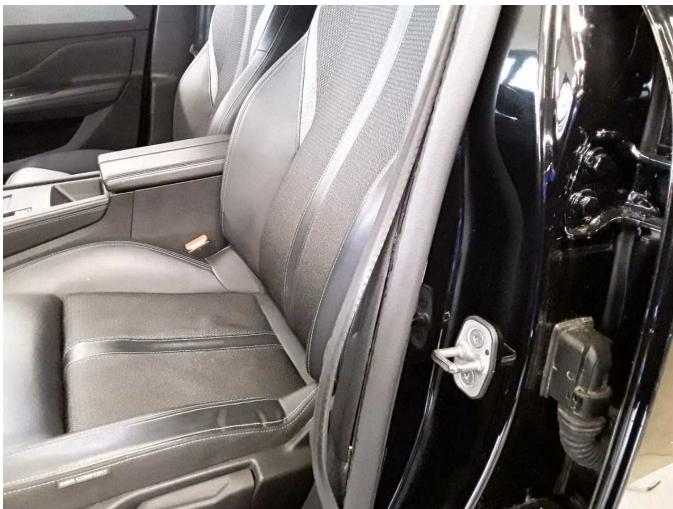
Damage 1: Cab: Door rubber seal - left side - Damaged - Replace

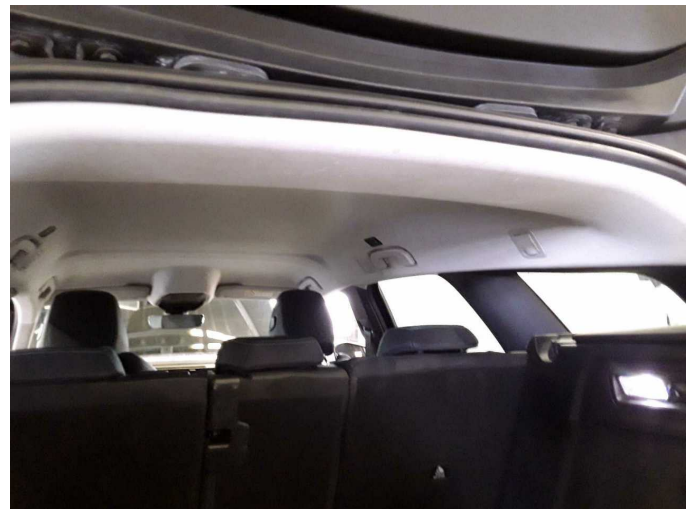
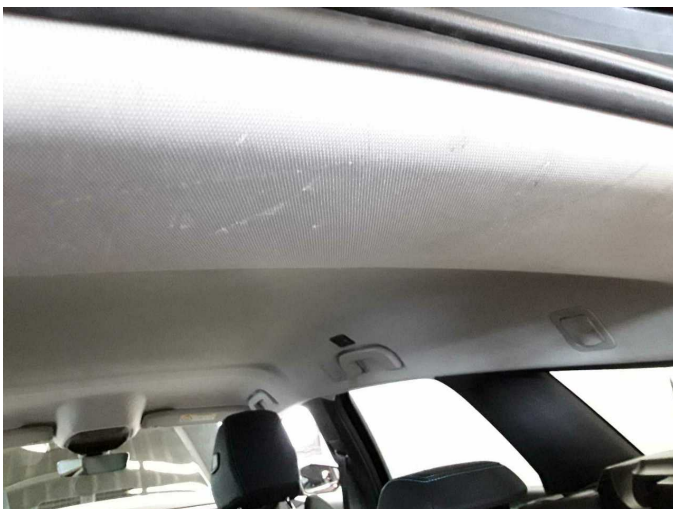
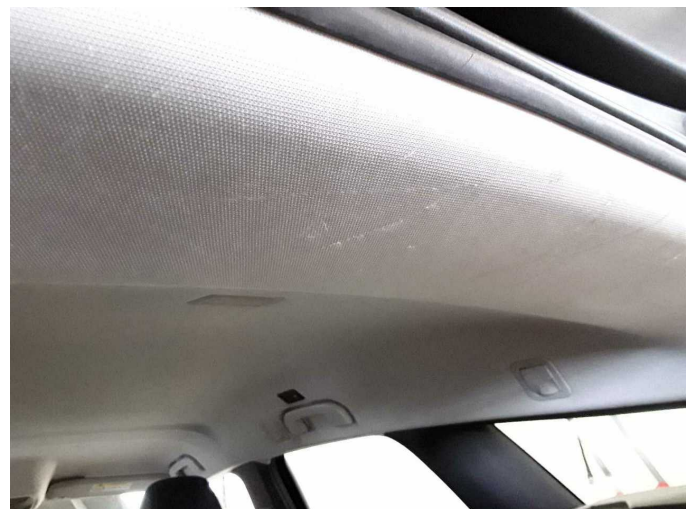
Damage 2: Trim / covers: Roof lining - Scratched - Loss in value

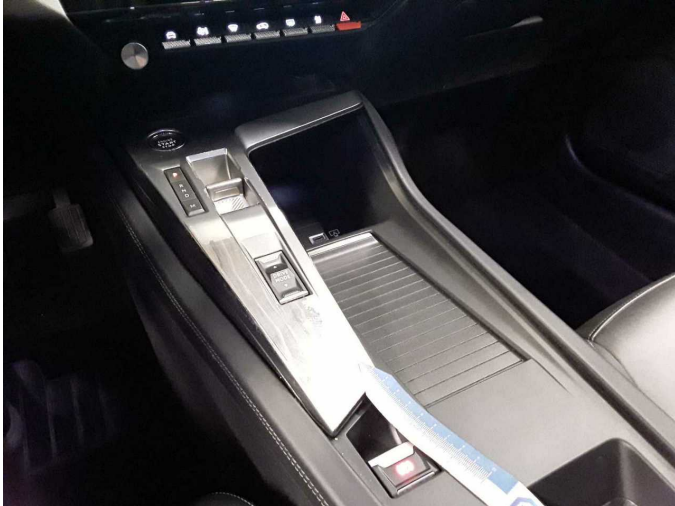
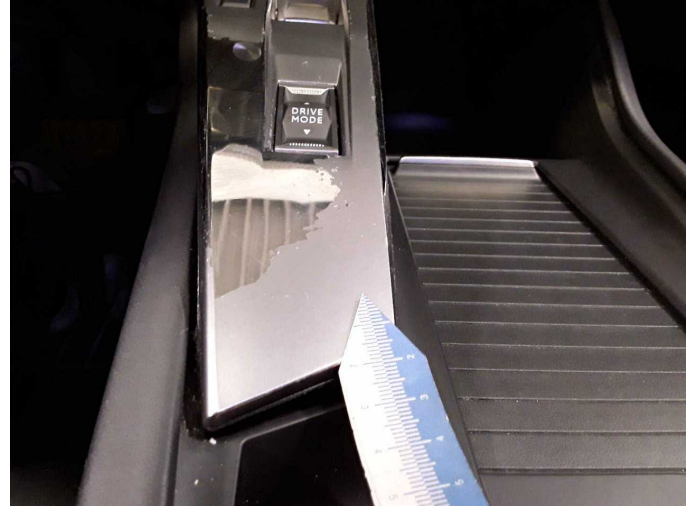
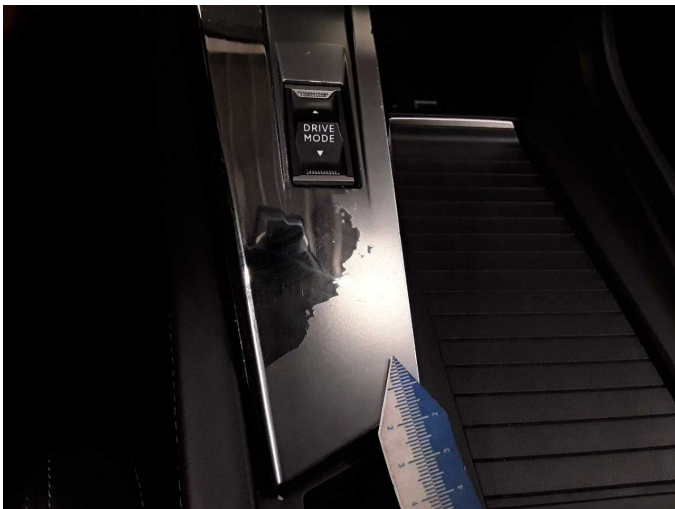
**Damage 3:** Instrument panel: Centre console - front - Scratched - Replace

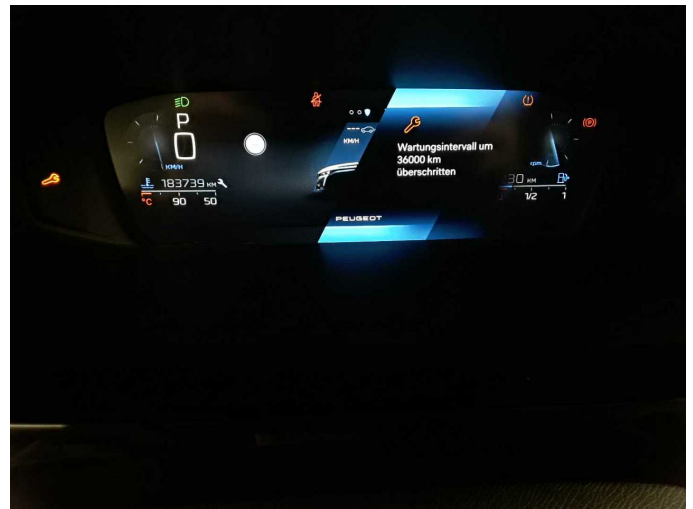
**Damage 4:** Misc.: Inspection / maintenance - Due - Perform

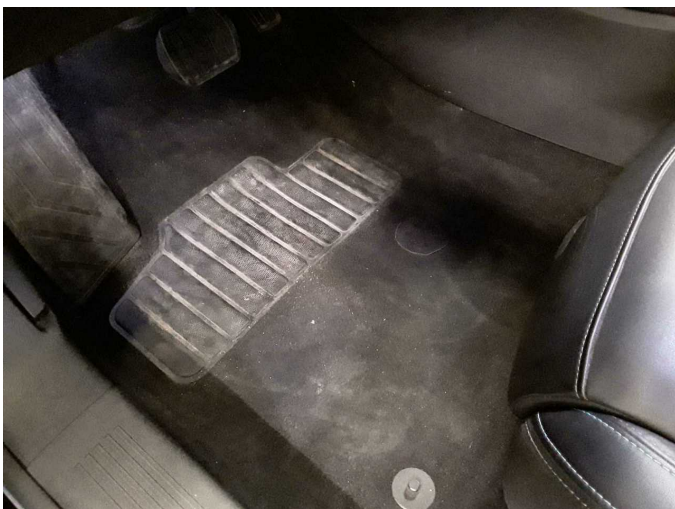
**Missing part 1:** Trim / covers: Floor mats - Missing - Replace

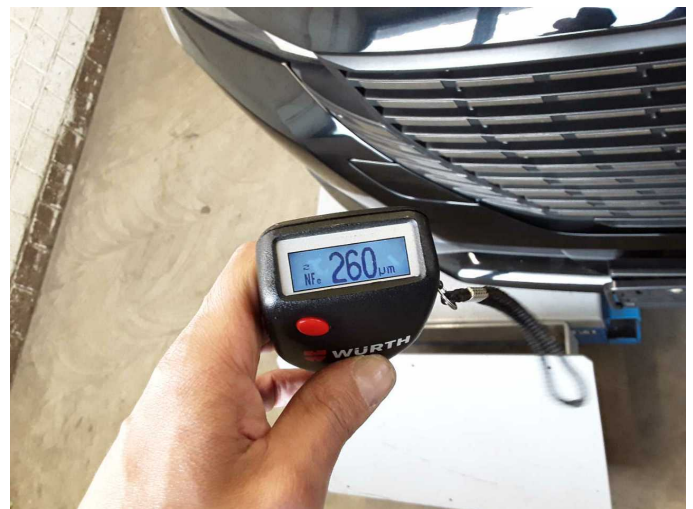
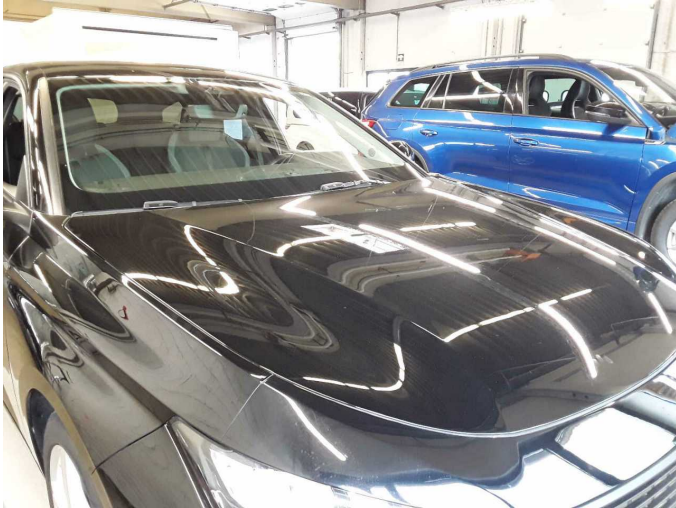
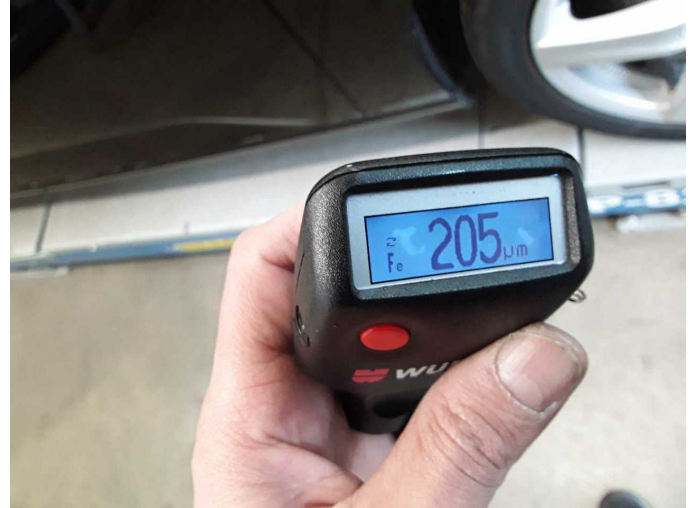
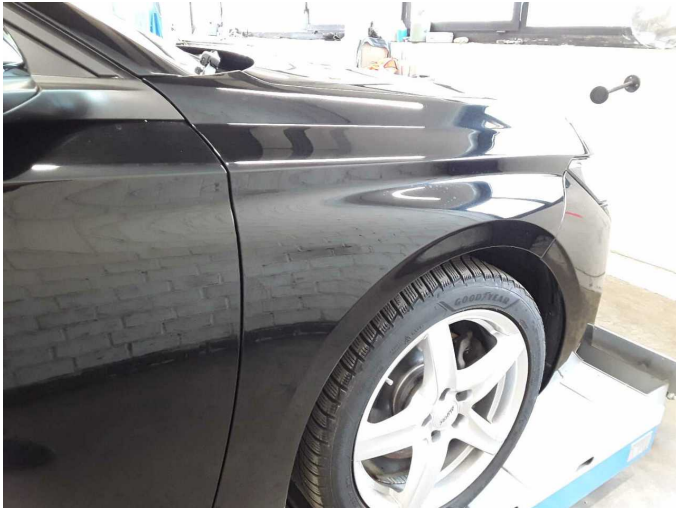
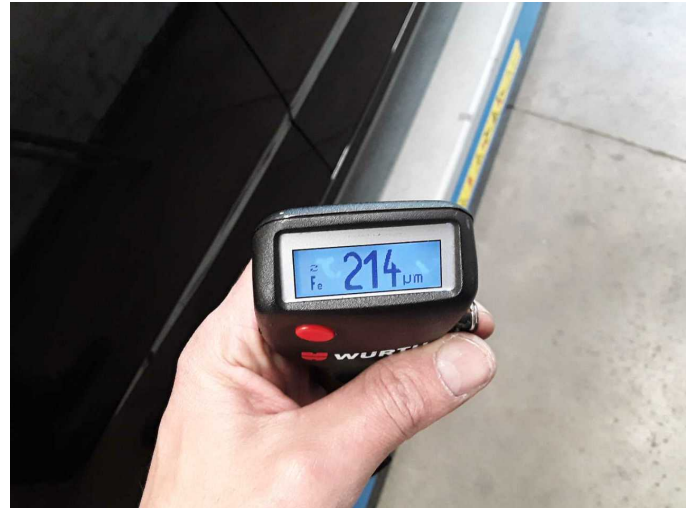
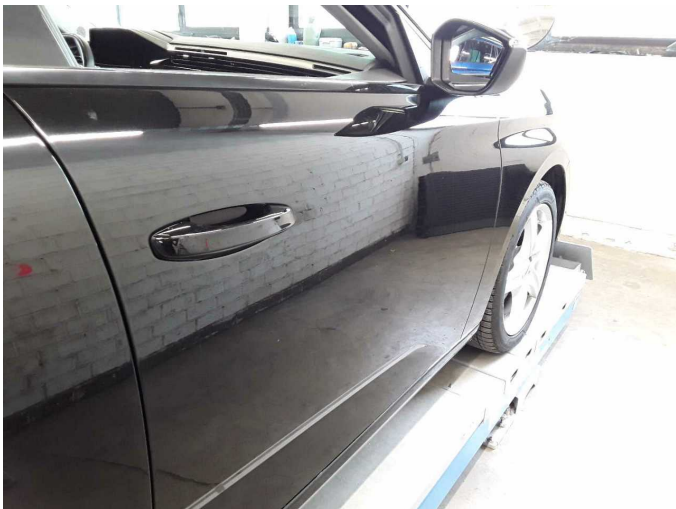
Roof	237 µm	Mudguard - left side	212 µm
Mudguard - right side	205 µm	Bonnet	260 µm
Side panel - rear left side	317 µm	Side panel - rear right side	507 µm
Door - rear left side	224 µm	Door - rear right side	218 µm
Door - front left side	208 µm	Door - front right side	214 µm

**Repainting 1:** Roof, Mudguard - left side, Mudguard - right side, Bonnet, Side panel - rear left side, Side panel - rear right side, Door - rear left side, Door - rear right side, Door - front left side, Door - front right side

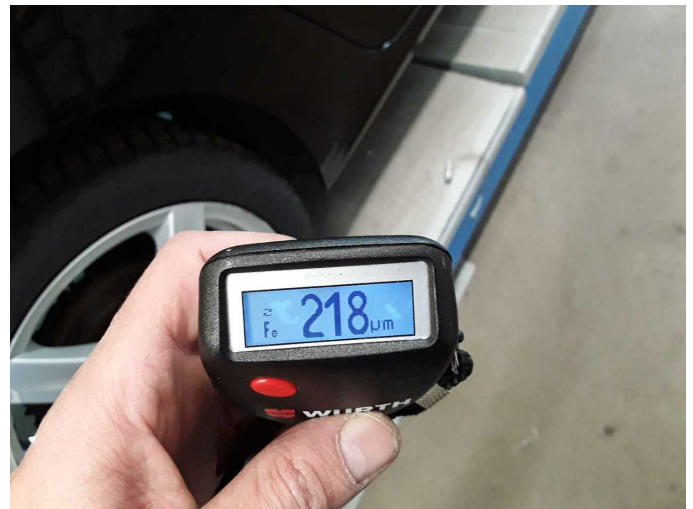
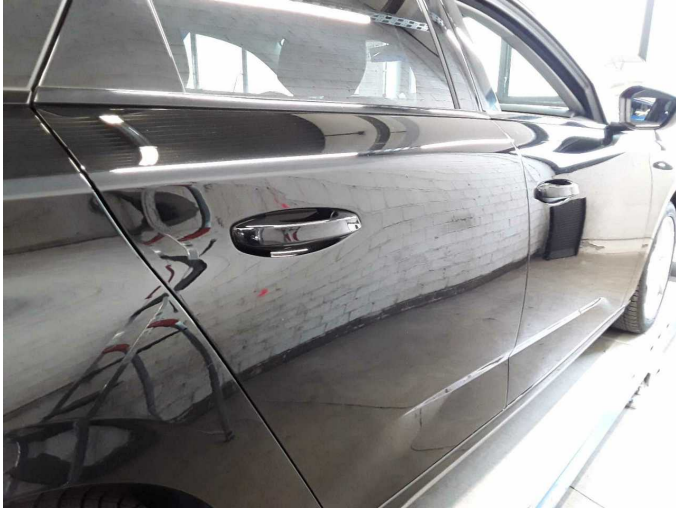
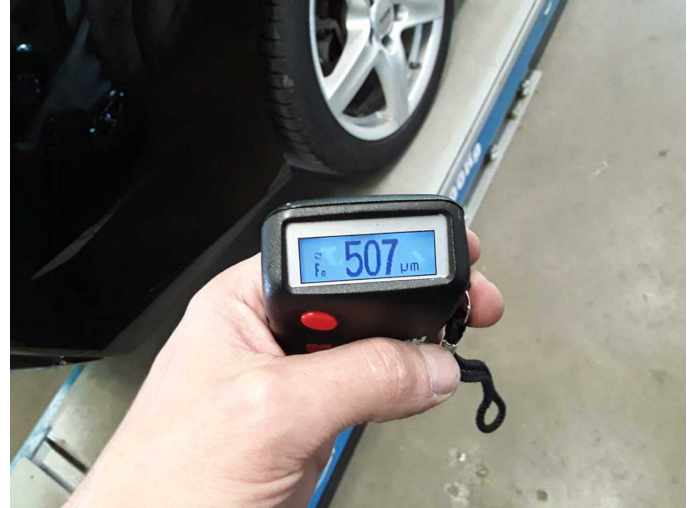
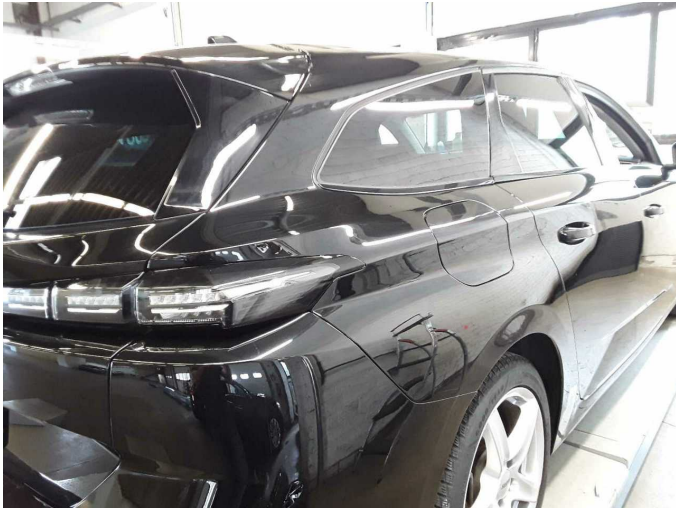
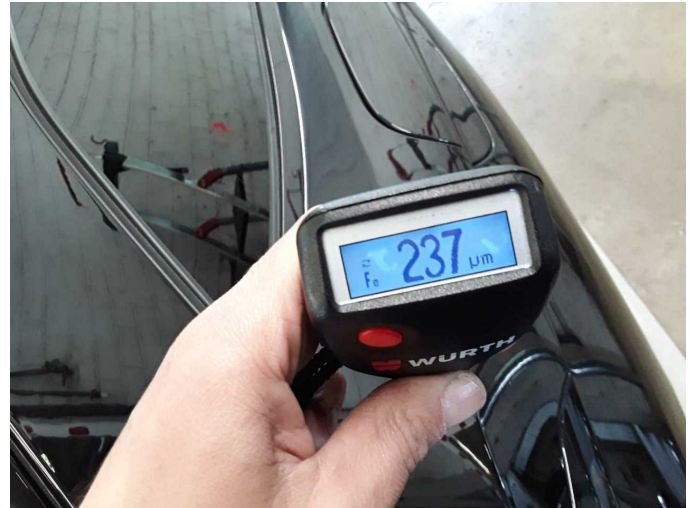
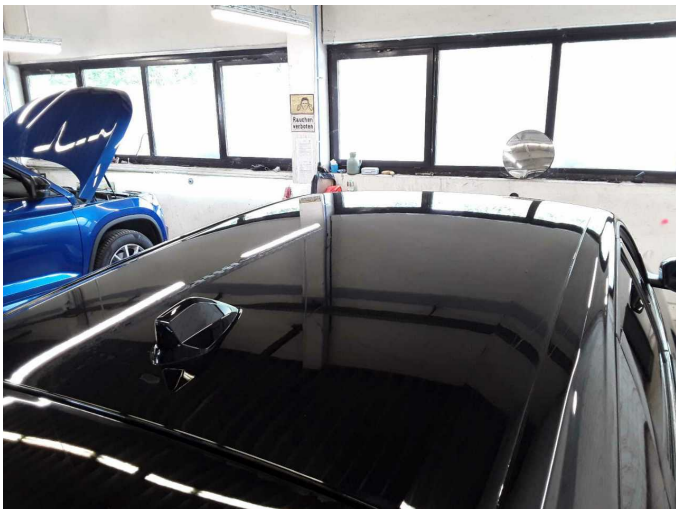
**Repainting 1:** Roof, Mudguard - left side, Mudguard - right side, Bonnet, Side panel - rear left side, Side panel - rear right side, Door - rear left side, Door - rear right side, Door - front left side, Door - front right side

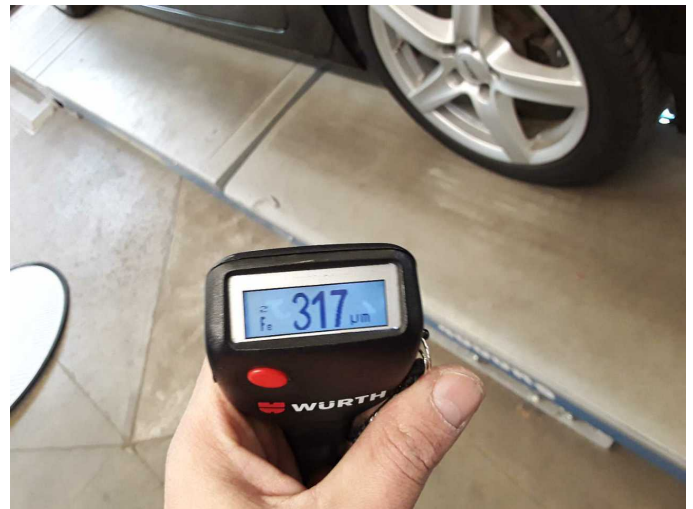
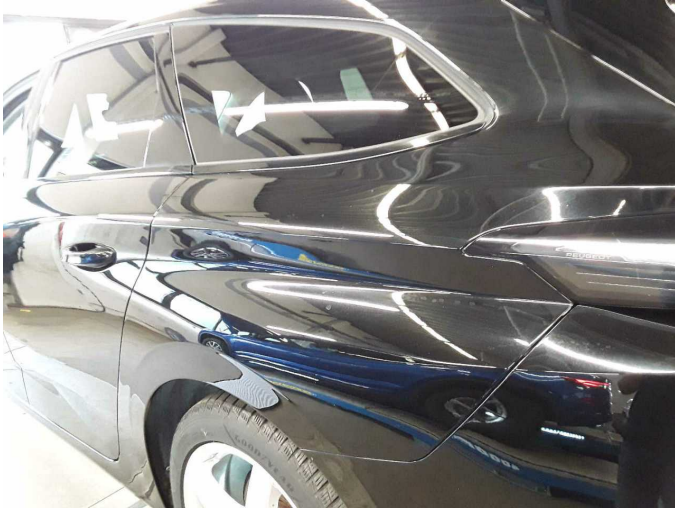
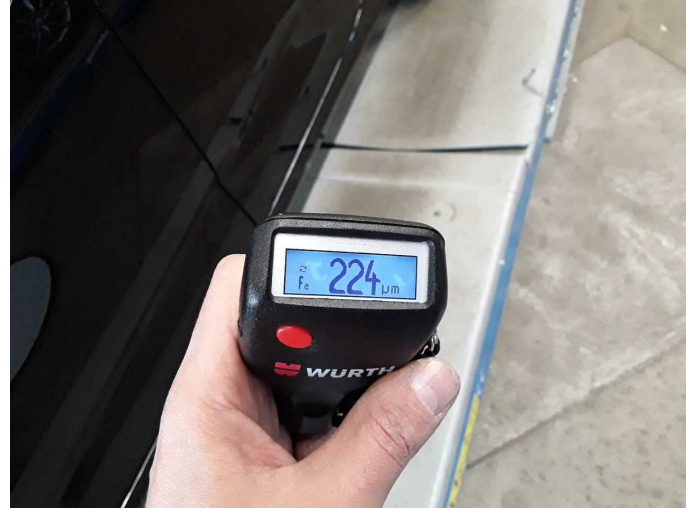
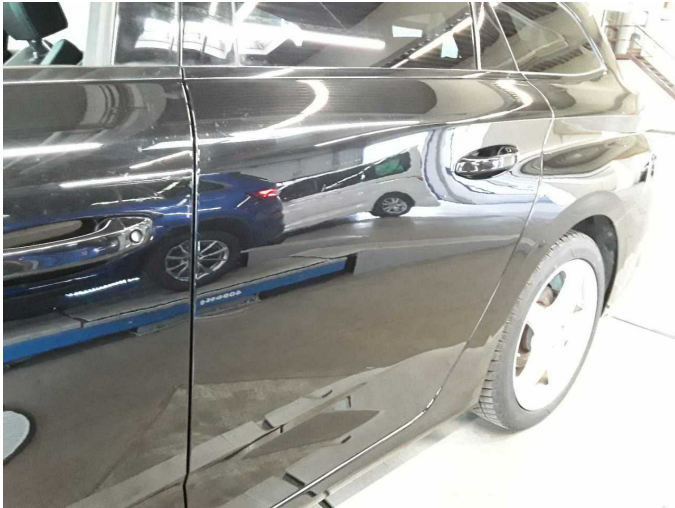
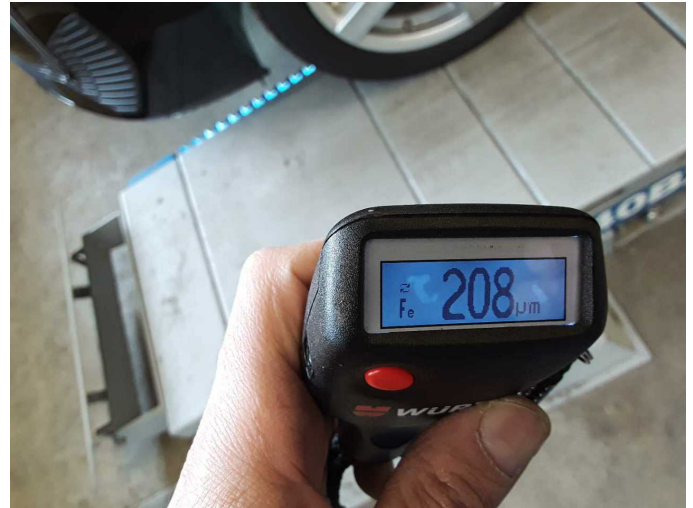
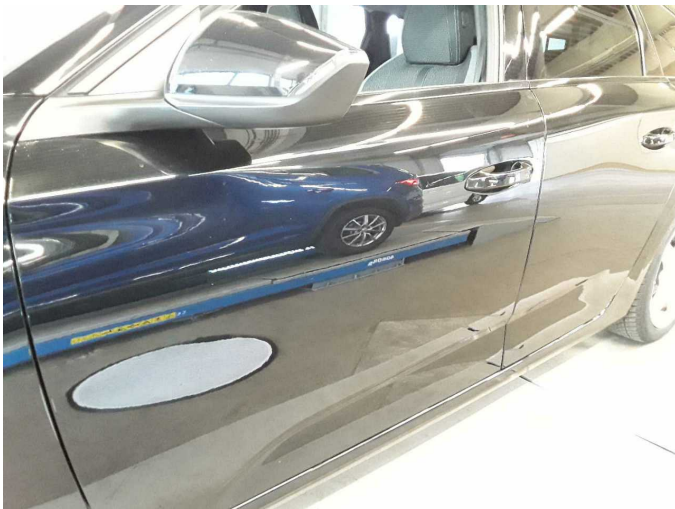
**Repainting 1:** Roof, Mudguard - left side, Mudguard - right side, Bonnet, Side panel - rear left side, Side panel - rear right side, Door - rear left side, Door - rear right side, Door - front left side, Door - front right side

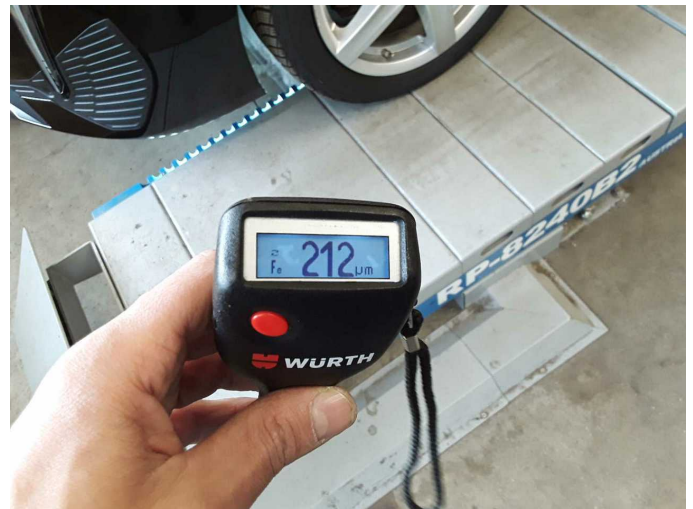
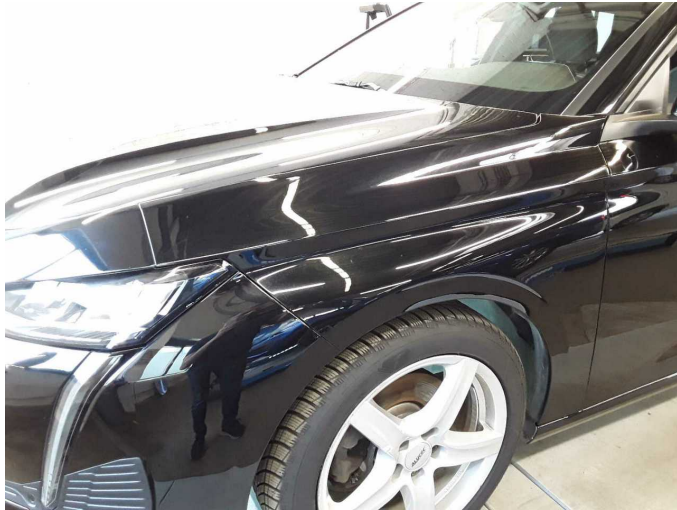
**Repainting 1:** Roof, Mudguard - left side, Mudguard - right side, Bonnet, Side panel - rear left side, Side panel - rear right side, Door - rear left side, Door - rear right side, Door - front left side, Door - front right side
