Expertise

Protocol number: 46670736  
Order No. / Reference: 26642369  
Inspection date: 23 Jul 2026

Manufacturer: Volvo  
VIN: YV1UZM1V2S1128630

Model: XC60 B5 B AWD Plus Black Edition

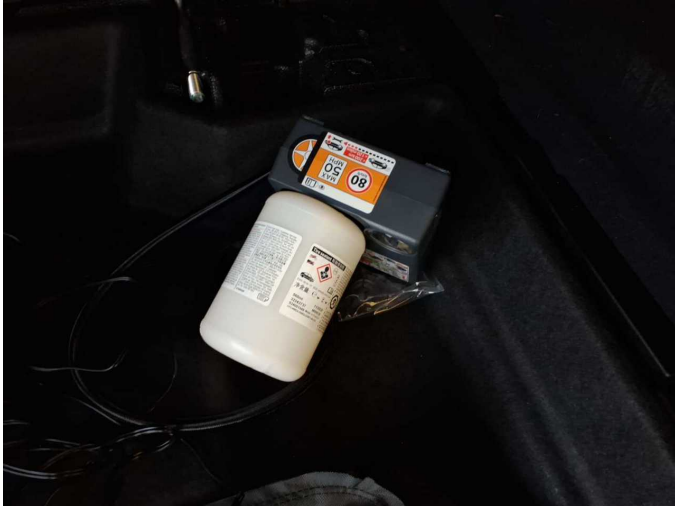
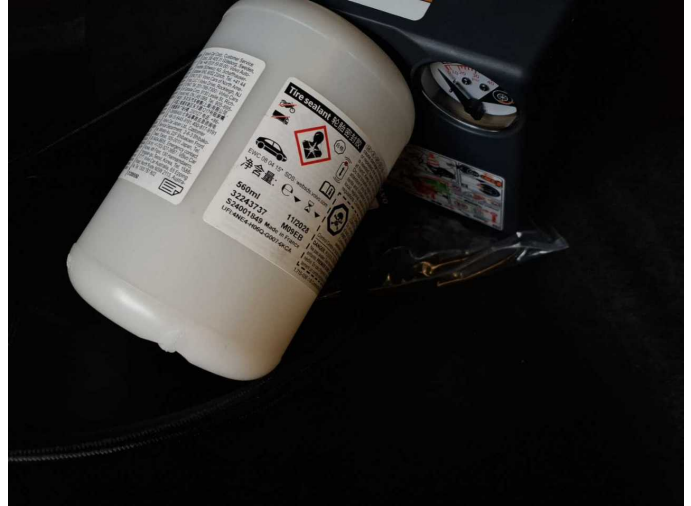
**Damage 2:** Equipment: Tirefit filler - Empty - Replace

| No. | Component group | Description |
|---|---|---|
| 2 | Equipment | Tirefit filler - Empty - Replace |

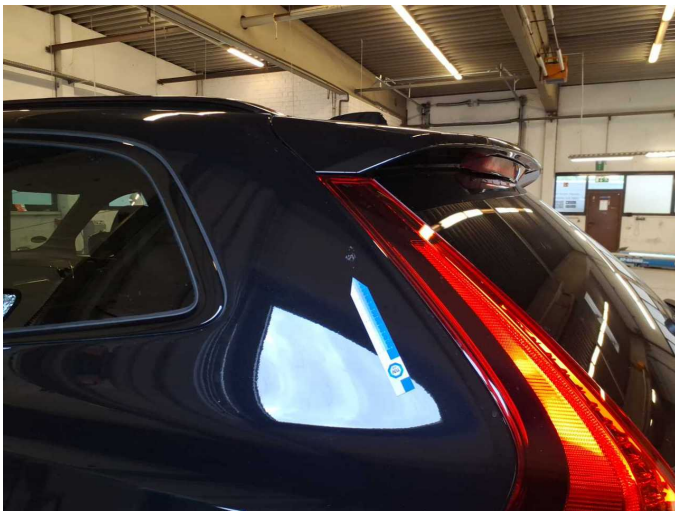
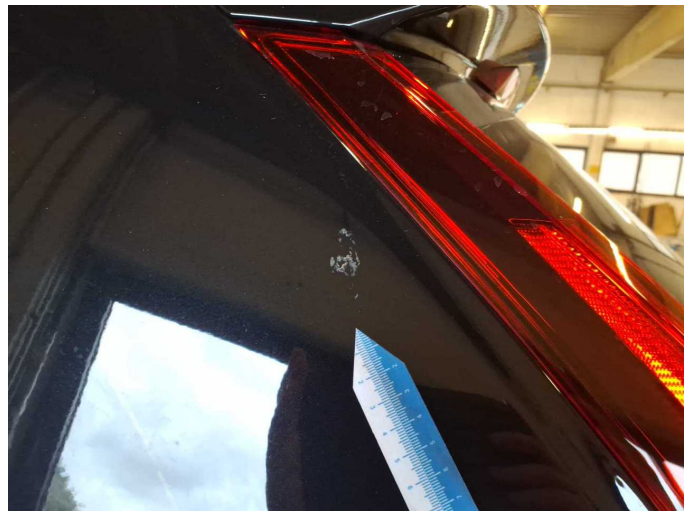
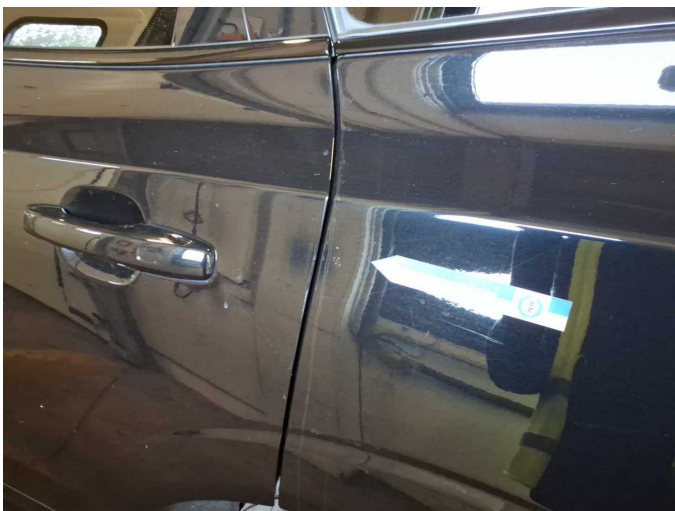
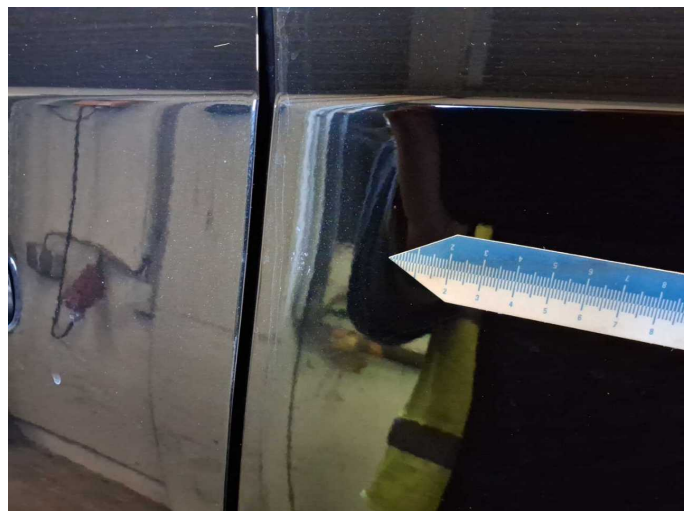
**Damage 3:** Side panel - rear left side: Side panel - Abrasion - Conditioning

| No. | Component group | Description |
|---|---|---|
| 3 | Side panel - rear left side | Side panel - Abrasion - Conditioning |

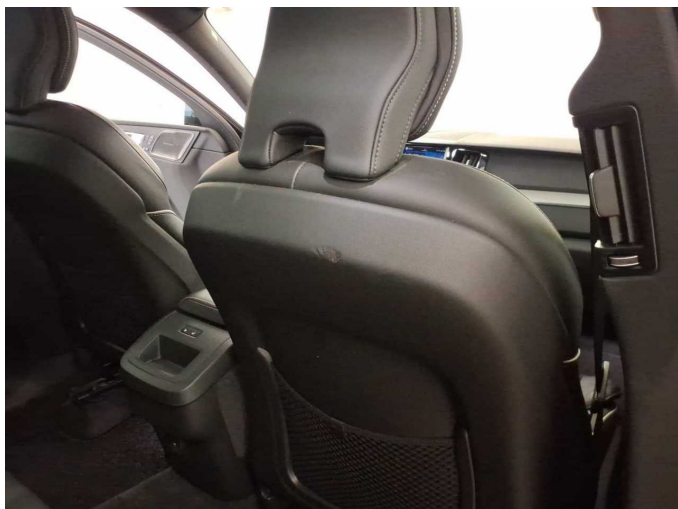
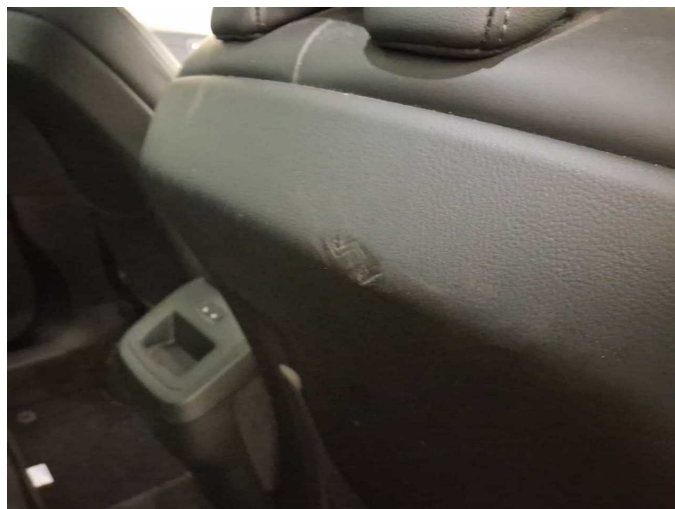
**Damage 4:** Seat - front: Backrest cover - right side (Schale hinten - Druckstelle durch Räder) - Scratch(es) - Smart repair

| No. | Component group | Description |
|---|---|---|
| 4 | Seat - front | Backrest cover - right side (Schale hinten - Druckstelle durch Räder) - Scratch(es) - Smart repair |

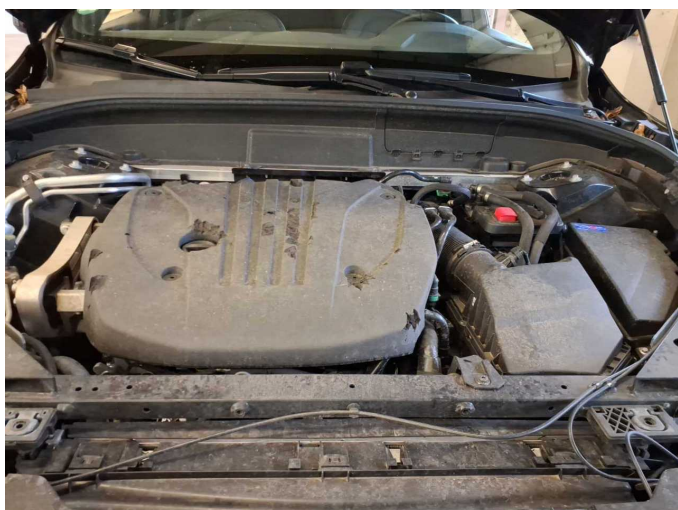
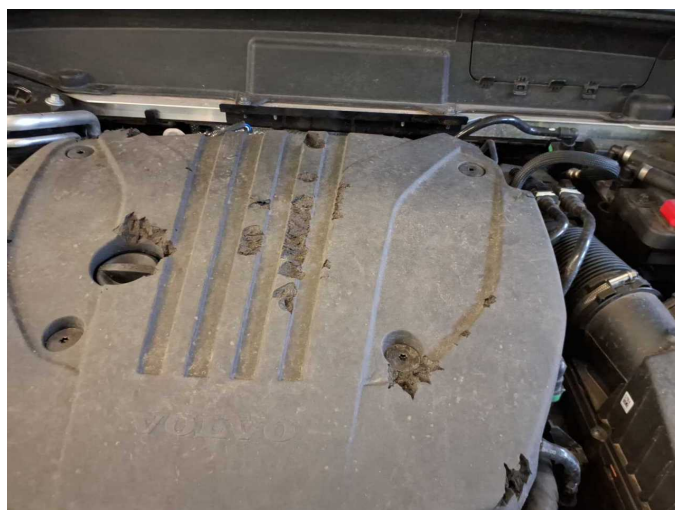
**Damage 5:** Engine: Engine cover - Damage caused by marten / rodent - Replace

| No. | Component group | Description |
|---|---|---|
| 5 | Engine | Engine cover - Damage caused by marten / rodent - Replace |

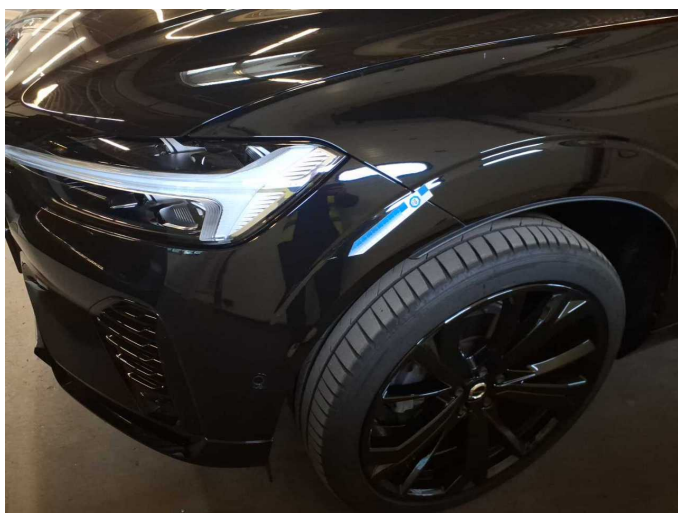
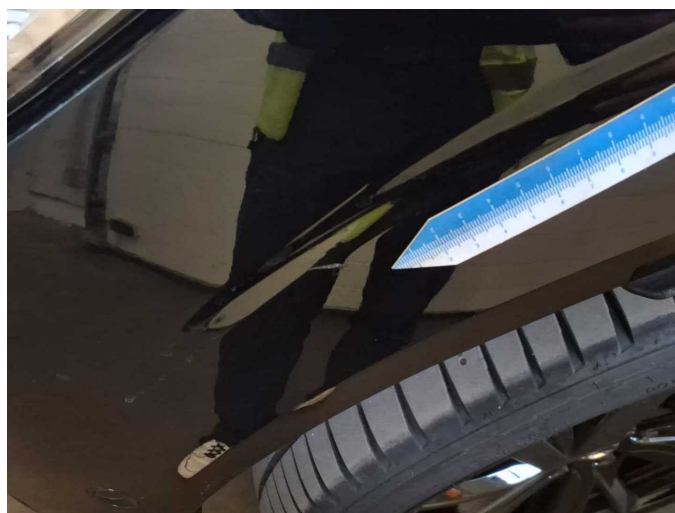
**Damage 6:** Front bumper: Front bumper - Scratch(es) - Smart repair

| No. | Component group | Description |
|---|---|---|
| 6 | Front bumper | Front bumper - Scratch(es) - Smart repair |

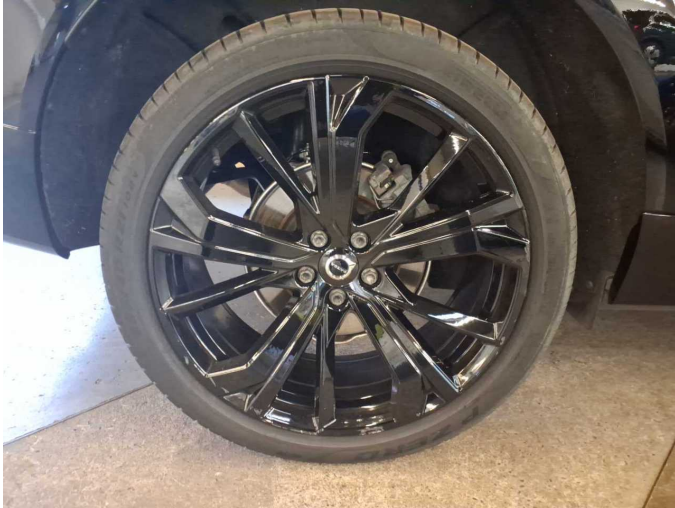
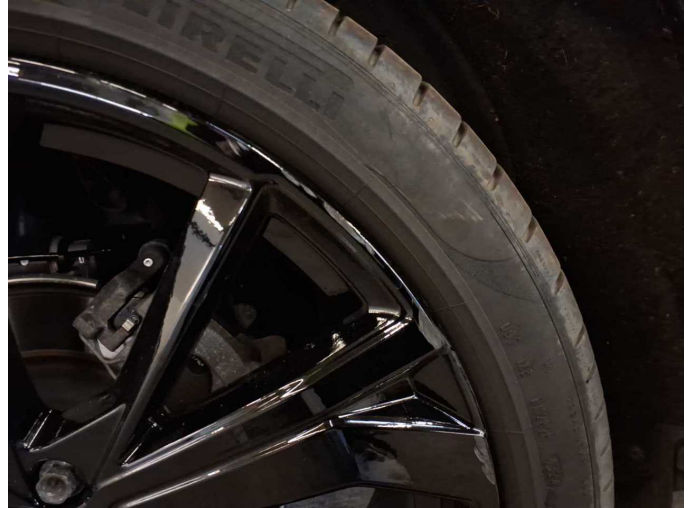
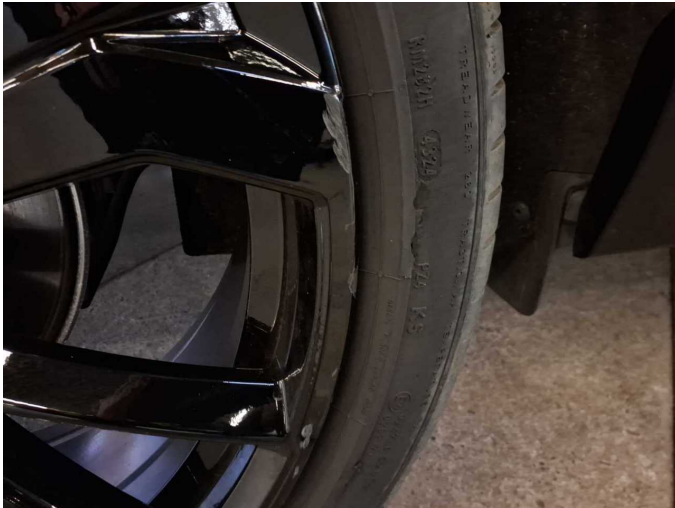
**Damage 7:** Wheel / tyres: Alloy rim - rear right side - Scratched - Loss in value

| No. | Component group | Description |
|---|---|---|
| 7 | Wheel / tyres | Alloy rim - rear right side - Scratched - Loss in value |

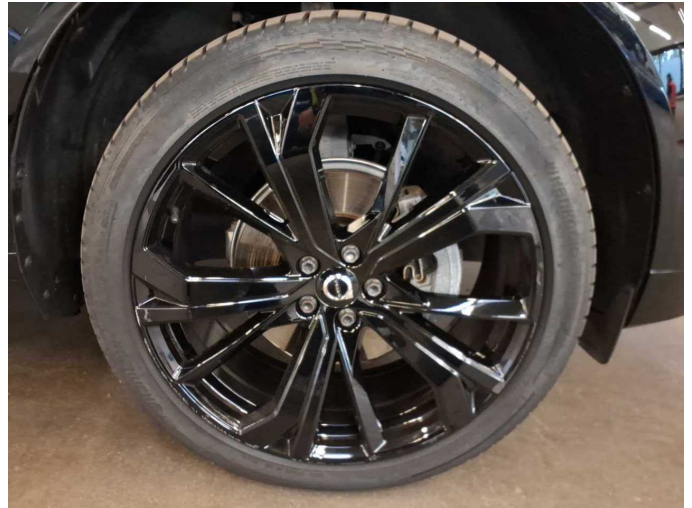
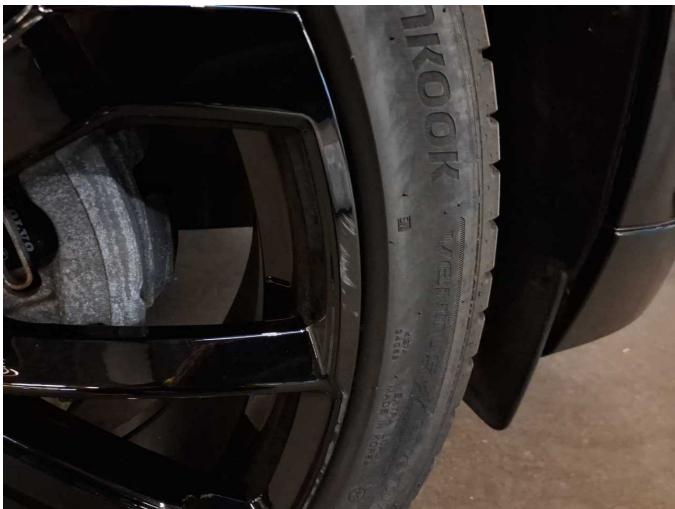
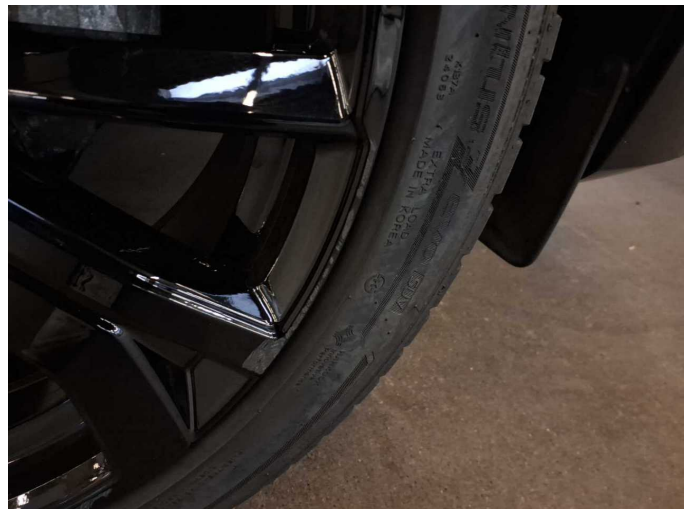
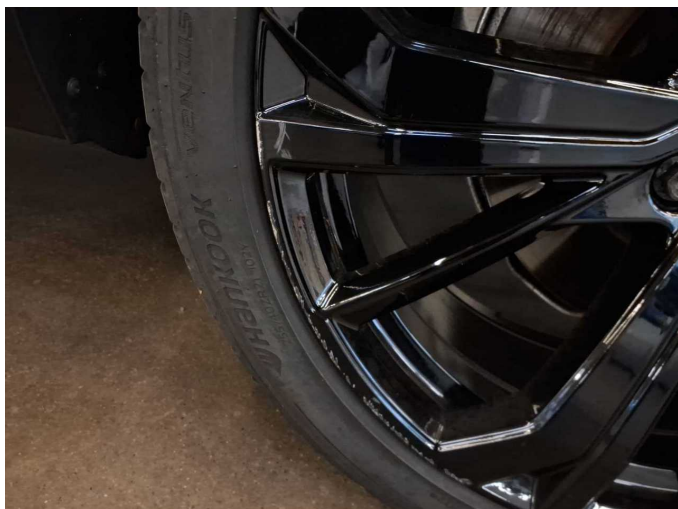
**Damage 8:** Wheel / tyres: Alloy rim - front right side - Scratched - Loss in value

| No. | Component group | Description |
|---|---|---|
| 8 | Wheel / tyres | Alloy rim - front right side - Scratched - Loss in value |

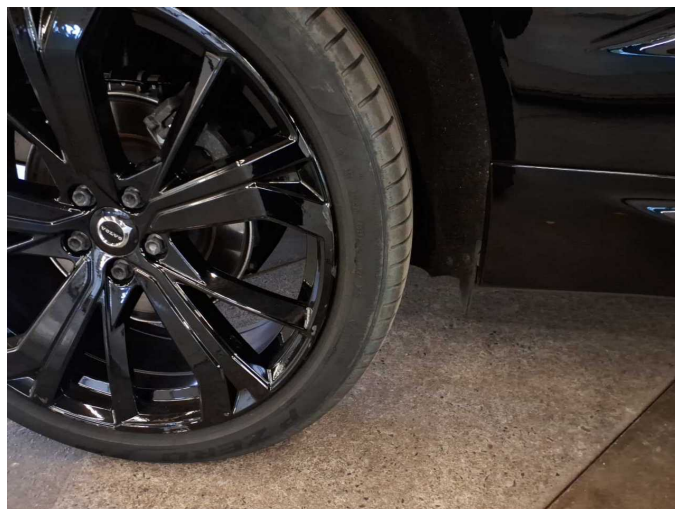
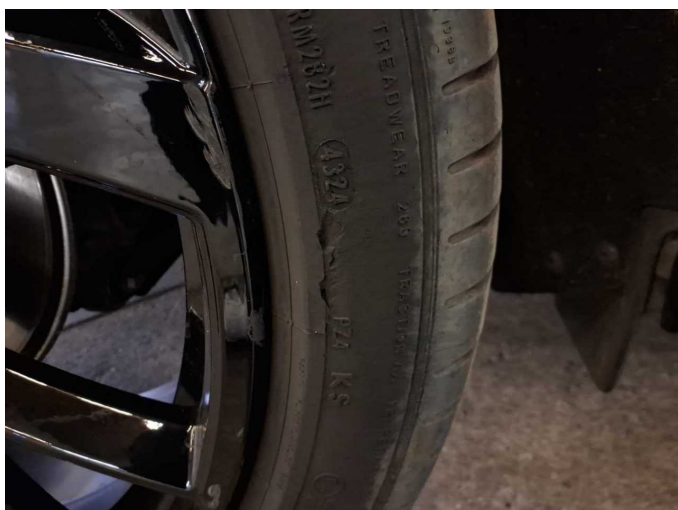
**Damage 9:** Wheel / tyres: Tyre - rear right side - Damaged - Replace

| No. | Component group | Description |
|---|---|---|
| 9 | Wheel / tyres | Tyre - rear right side - Damaged - Replace |

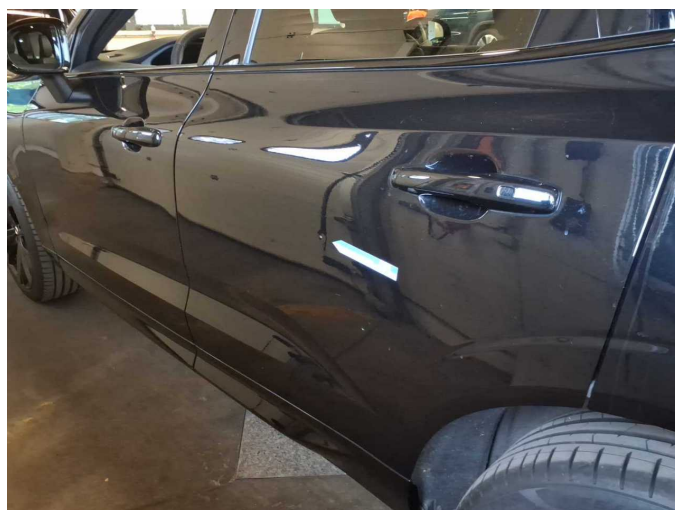
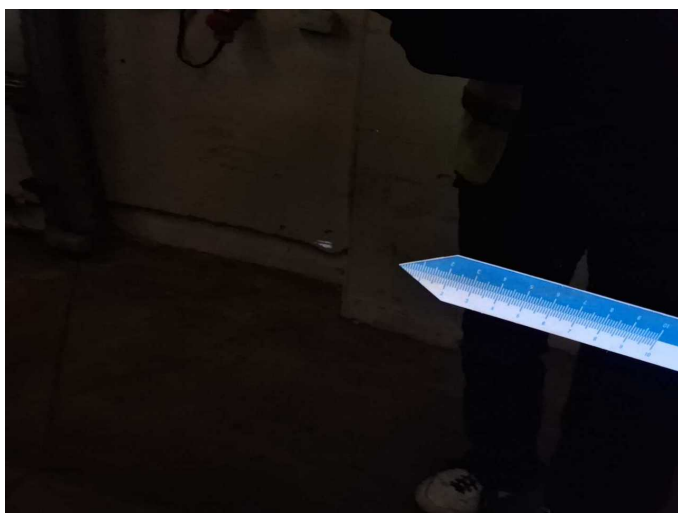
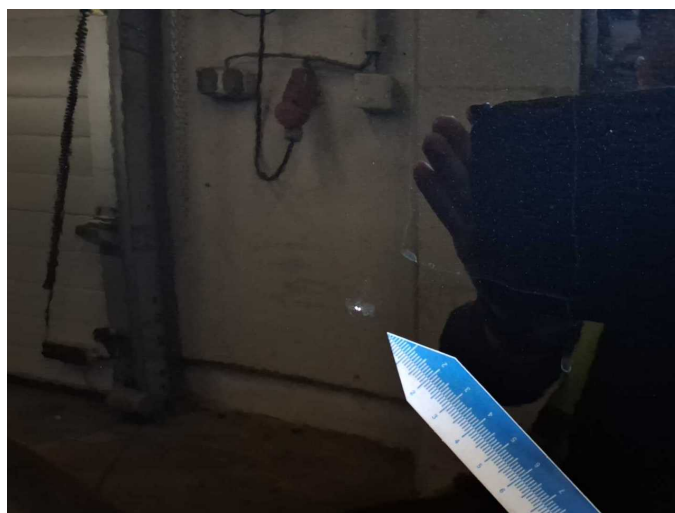
**Damage 10:** Door - rear left side: Door - Scratch(es) - Paint

| No. | Component group | Description |
|---|---|---|
| 10 | Door - rear left side | Door - Scratch(es) - Paint |

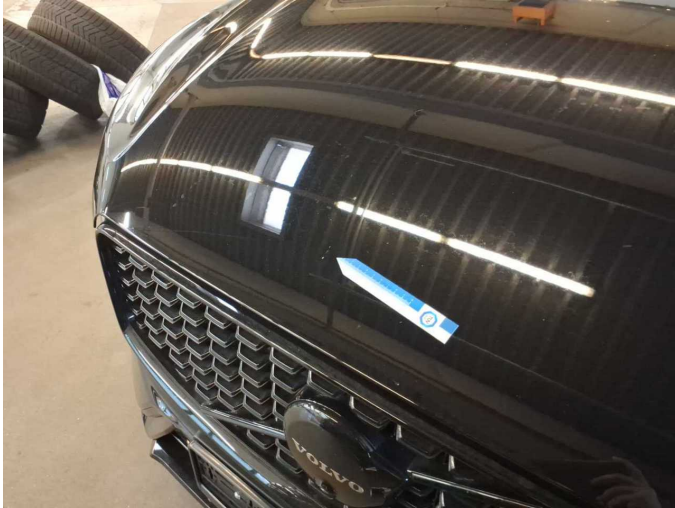
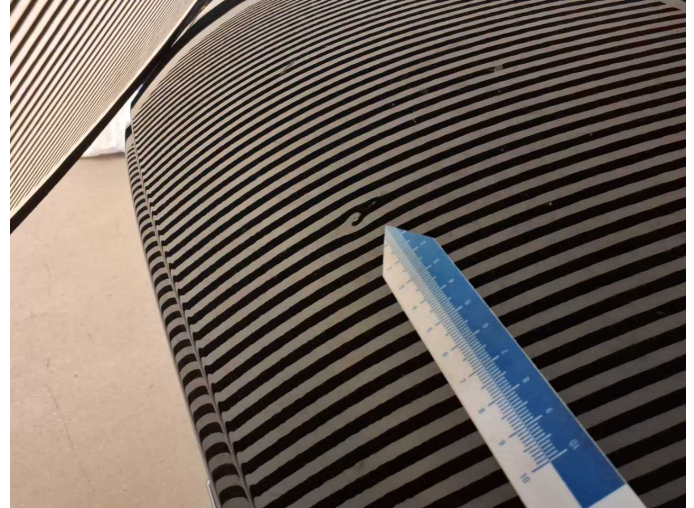
**Damage 11:** Bonnet: Bonnet - Dent / paintcoat damage - Repair and paint

| No. | Component group | Description |
|---|---|---|
| 11 | Bonnet | Bonnet - Dent / paintcoat damage - Repair and paint |
