Expertise

Protocol number: 46489916  
Order No. / Reference: 26581306  
Inspection date: 14 Jul 2026

| Manufacturer: Ford | Model: Focus Turnier 1.0 EcoBoost Start-Stopp-System Aut. ACTIVE X |
| VIN: WF0PXXGCHPMG56334 | |

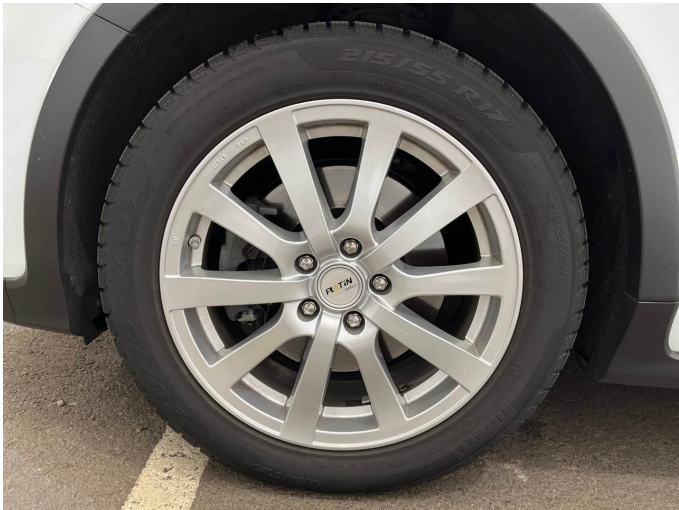
Figure 12: Mounted tyres

| # | Tyre size | Type of tyre | Manufacturer | Tread depth |
|---|---|---|---|---|
| 1) | 215/55 R17 98V | Winter tyres on Light alloy | Pirelli | 6mm / 6mm |
| 2) | 215/55 R17 98V | Winter tyres on Light alloy | Pirelli | 5mm / 5mm |

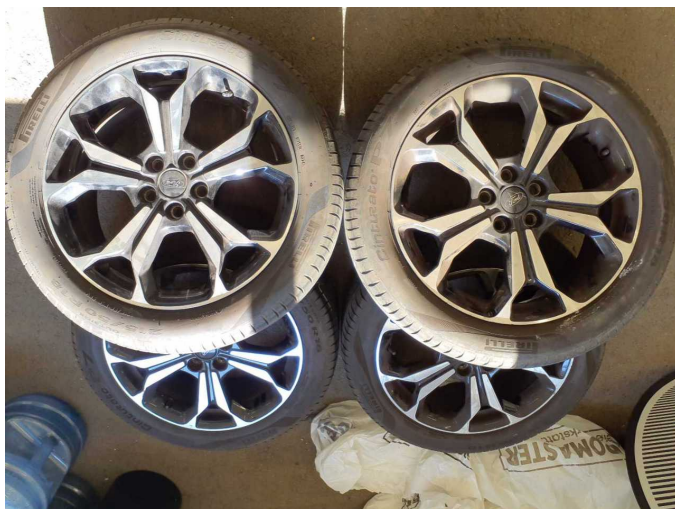
Figure 17: Additional tyres

| # | Tyre size | Type of tyre | Manufacturer | Tread depth |
|---|---|---|---|---|
| 1) | 215/50 R18 96V | Summer tyres on Light alloy | Pirelli | 5mm / 5mm |
| 2) | 215/50 R18 96V | Summer tyres on Light alloy | Pirelli | 6mm / 6mm |

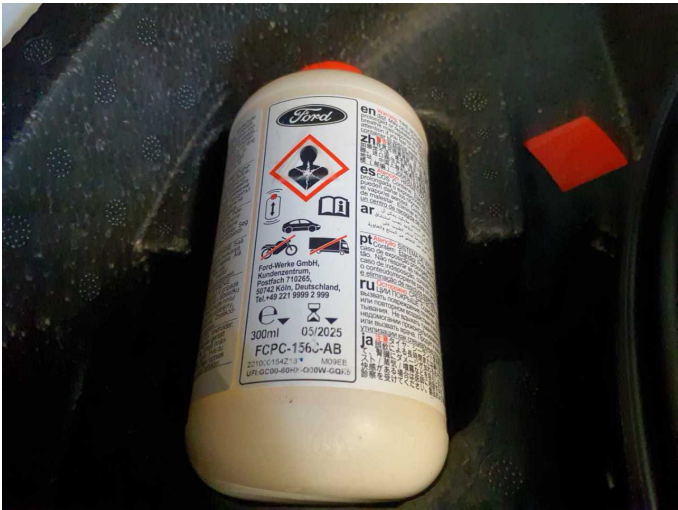
Damage 1: Equipment: Tirefit filler - Expired - Replace

| No. | Component group | Description |
|---|---|---|
| 1 | Equipment | Tirefit filler - Expired - Replace |

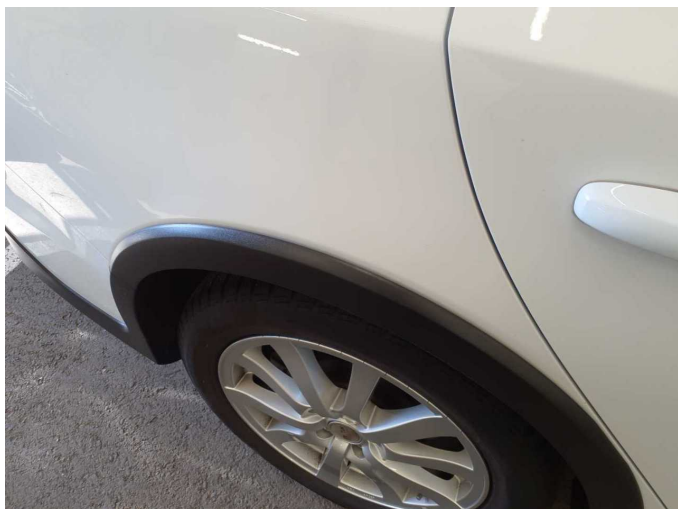
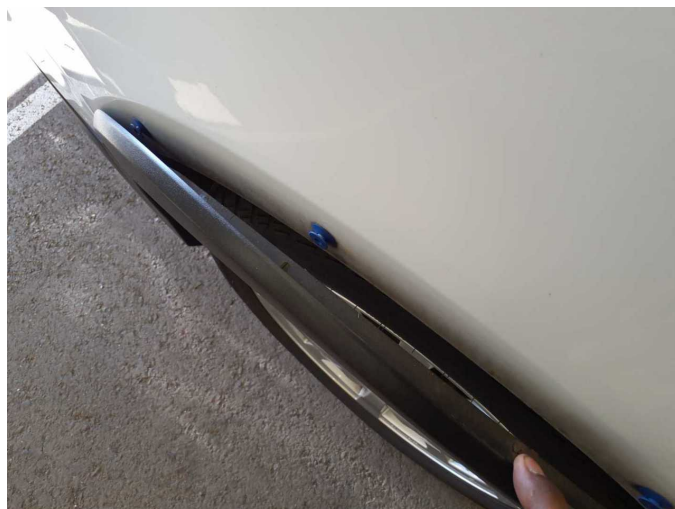
**Damage 2:** Side panel - rear right side: Wheel well extension - Malposition - Un- / install

| No. | Component group | Description |
|---|---|---|
| 2 | Side panel - rear right side | Wheel well extension - Malposition - Un- / install |

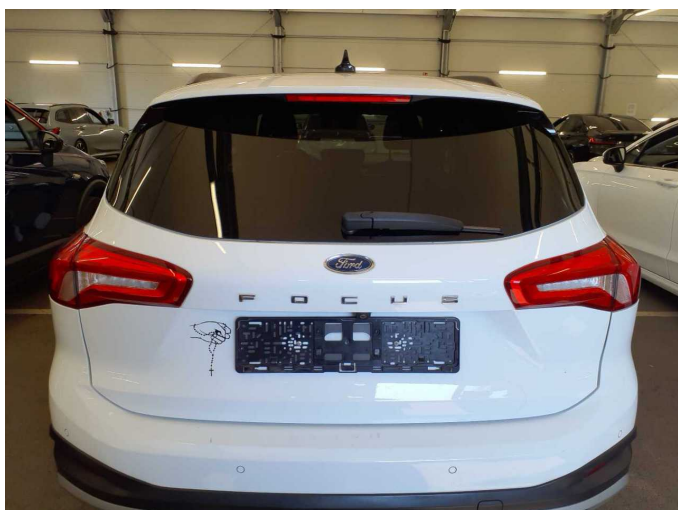
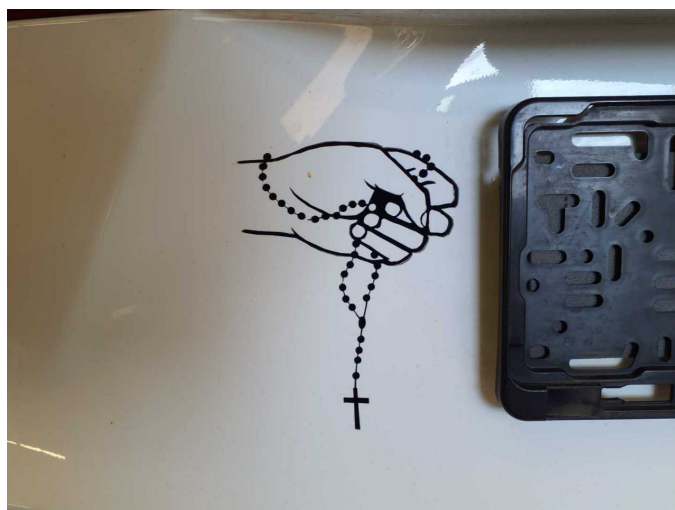
**Damage 3:** Boot lid / rear door: Boot lid - Glued / labelled - De-glue / neutralise

| No. | Component group | Description |
|---|---|---|
| 3 | Boot lid / rear door | Boot lid - Glued / labelled - De-glue / neutralise |

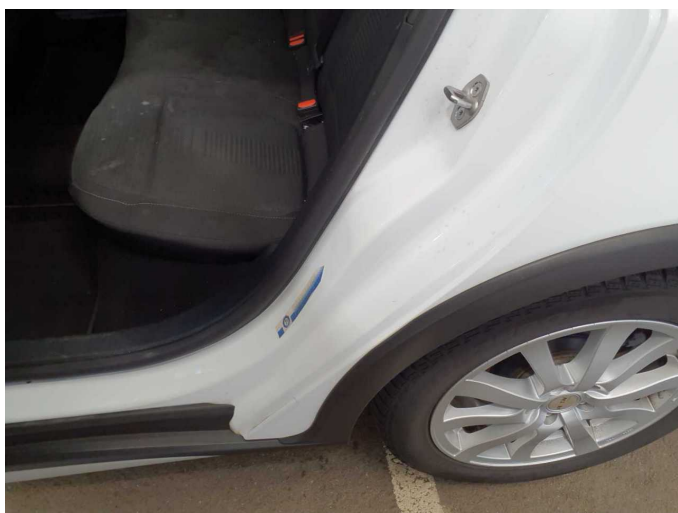
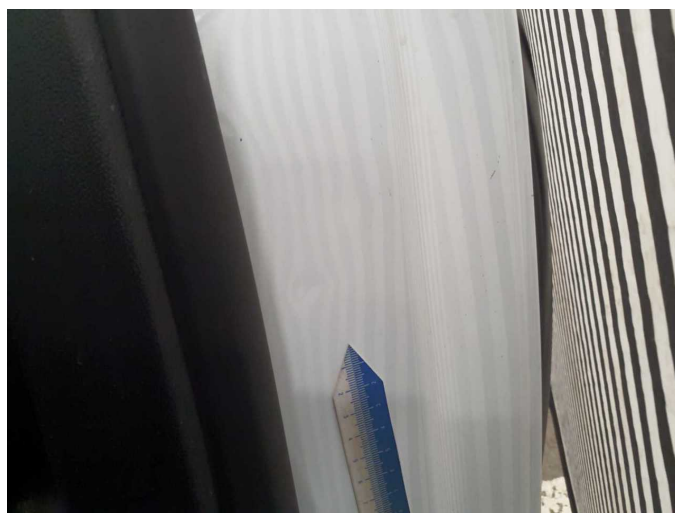
**Damage 4:** Side panel - rear left side: Sill - dent(s) - Smart repair

| No. | Component group | Description |
|---|---|---|
| 4 | Side panel - rear left side | Sill - dent(s) - Smart repair |

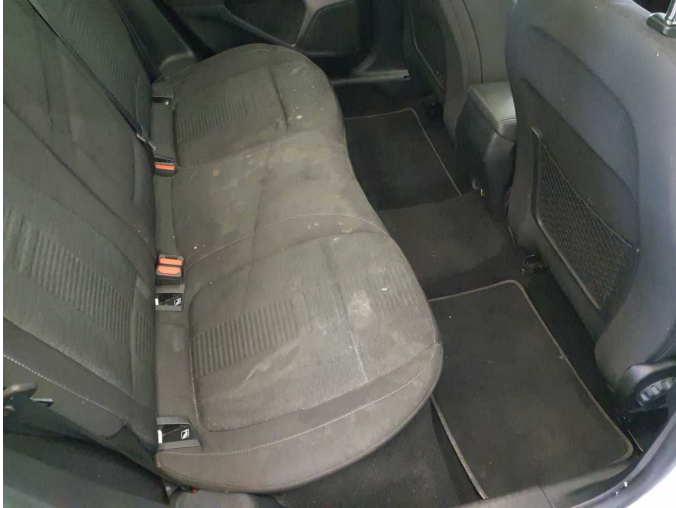
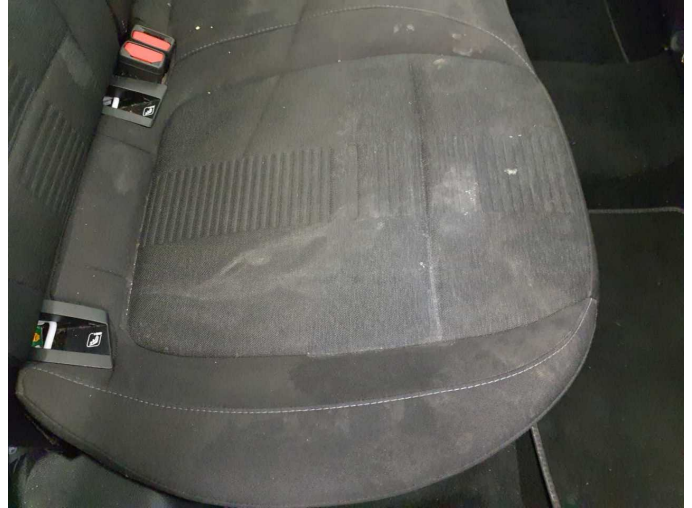
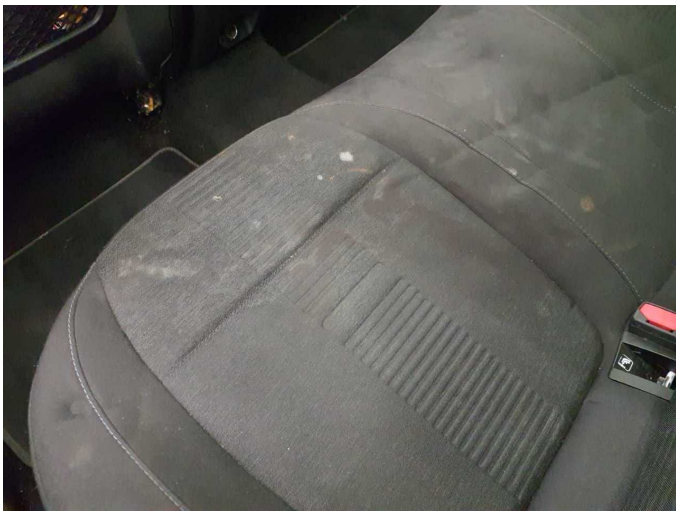
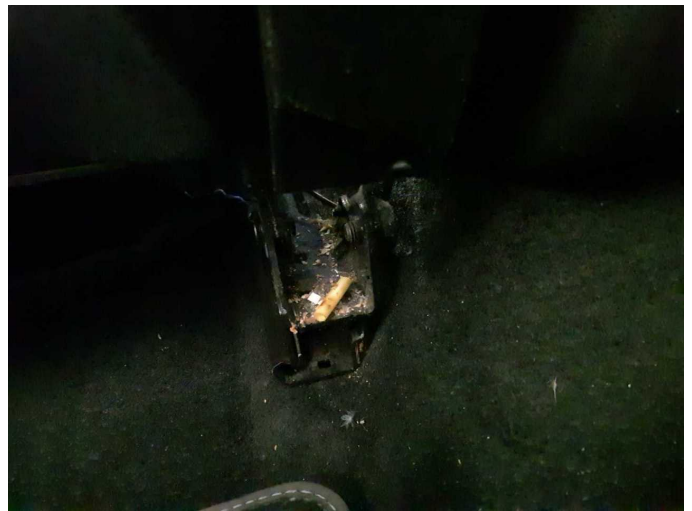
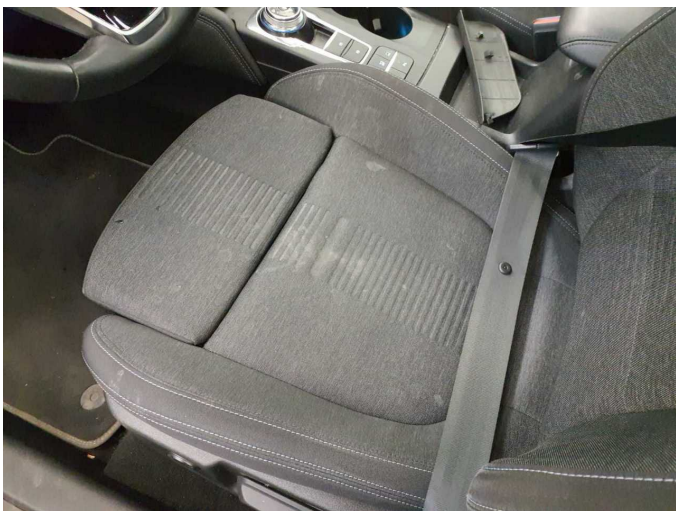
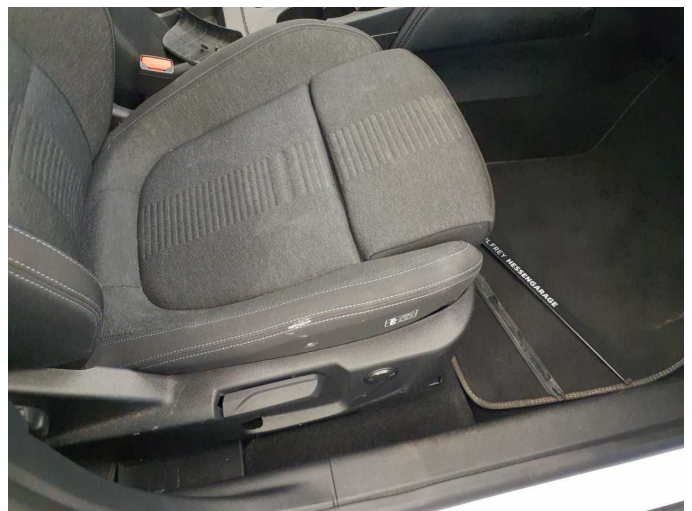
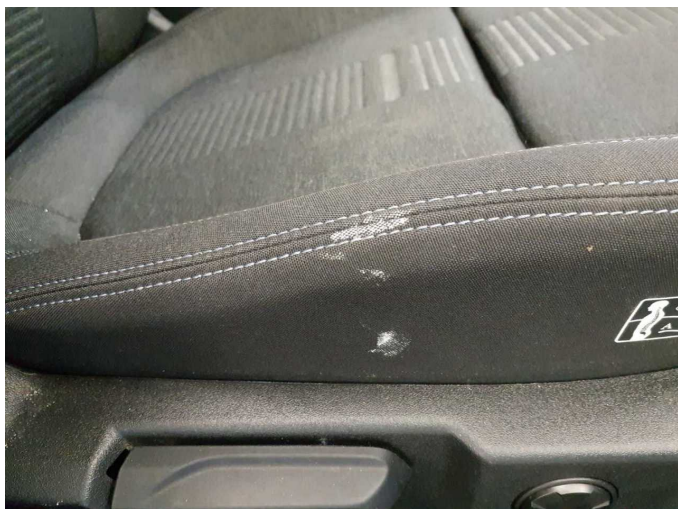
**Damage 5:** Interior: Interior - Soiled - Clean

| No. | Component group | Description |
|---|---|---|
| 5 | Interior | Interior - Soiled - Clean |

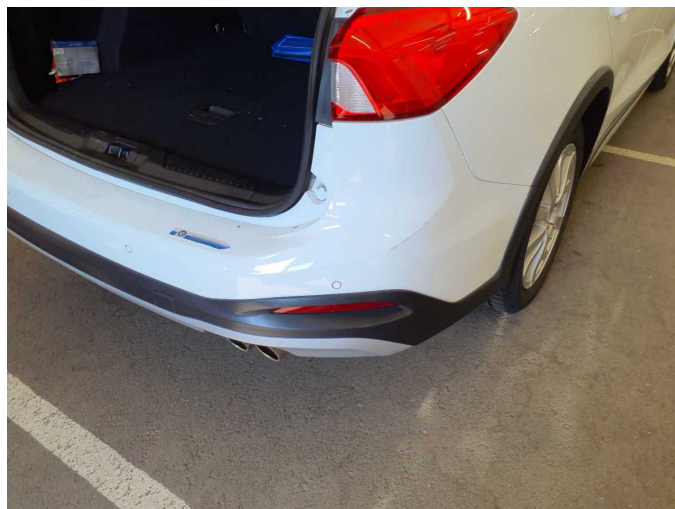
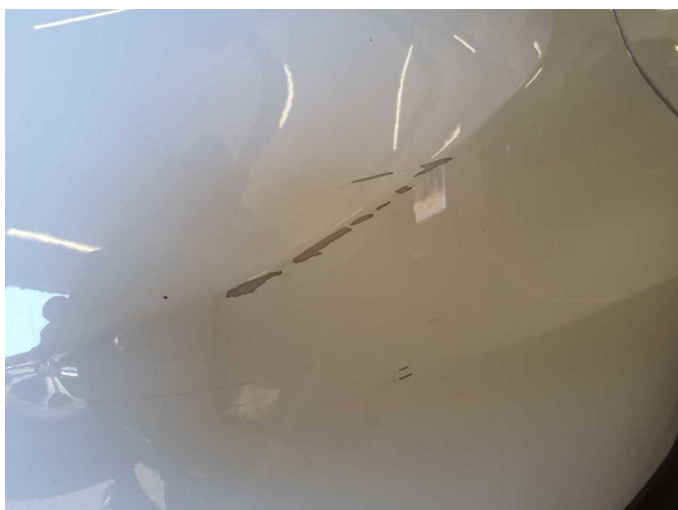
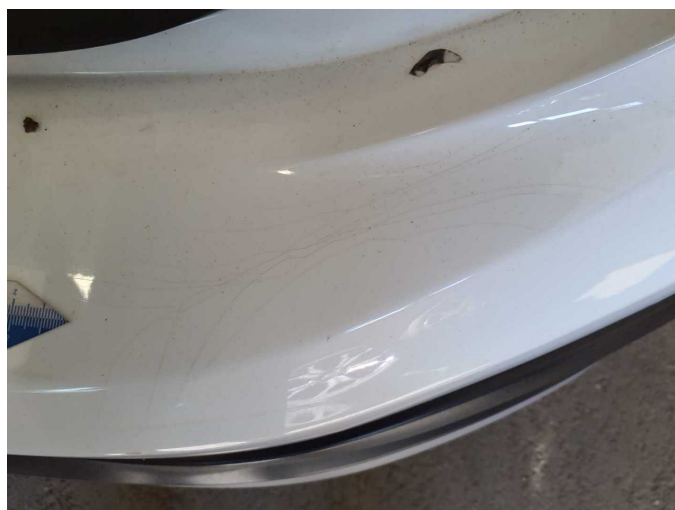
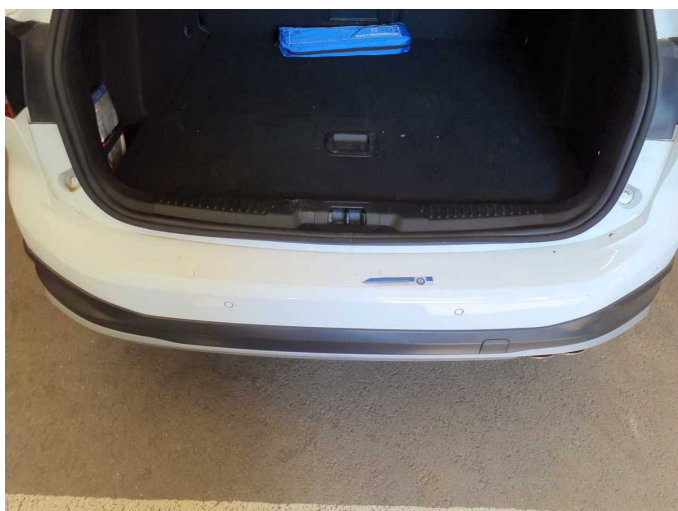
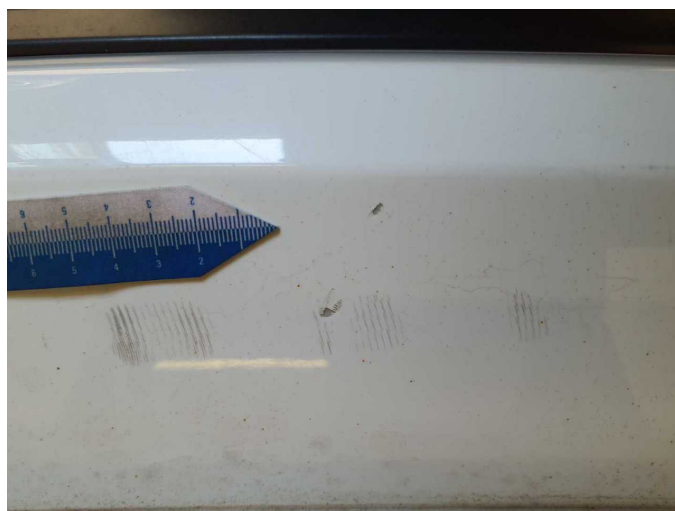
**Damage 6:** Rear bumper: Rear bumper - Scratch(es) - Paint

| No. | Component group | Description |
|---|---|---|
| 6 | Rear bumper | Rear bumper - Scratch(es) - Paint |

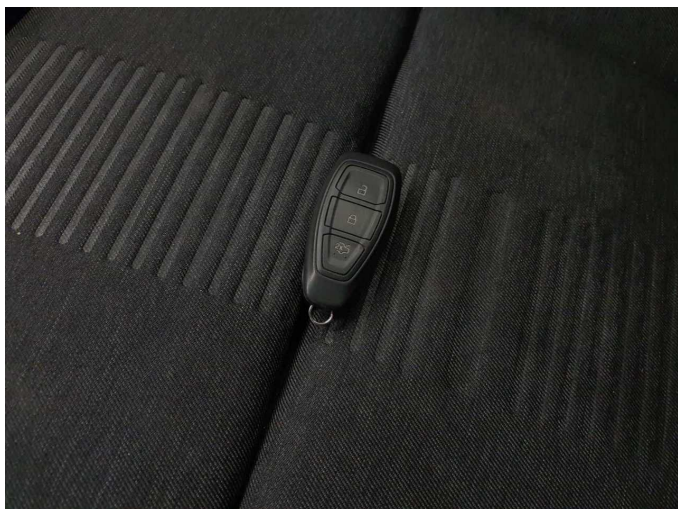
**Missing part 2:** Equipment: Vehicle key - Missing - Replace

Interior - Separation net  
Equipment - Vehicle key
