Expertise

Protocol number: 46427176  
Order No. / Reference: 26561800  
Inspection date: 9 Jul 2026

Manufacturer: Volkswagen

Model: Passat Variant 2.0 TDI SCR DSG Business

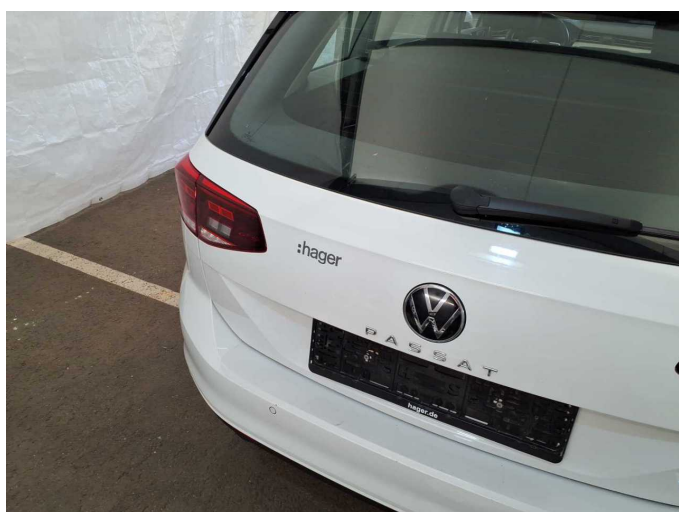
| No. | Component group | Description |
|---|---|---|
| 2 | Boot lid / rear door | Boot lid - Glued / labelled - De-glue / neutralise |

**Damage 2:** Boot lid / rear door: Boot lid - Glued / labelled - De-glue / neutralise

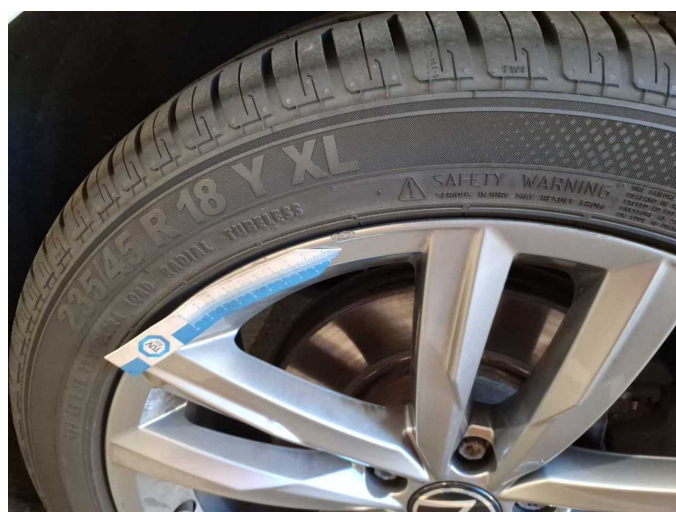
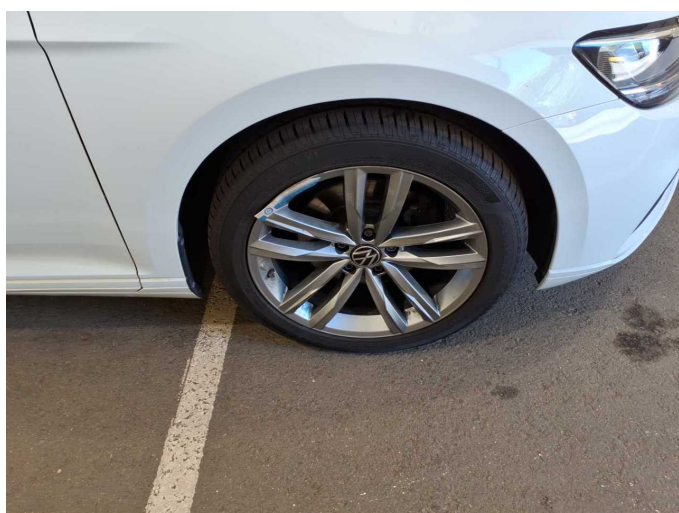
| No. | Component group | Description |
|---|---|---|
| 3 | Wheel / tyres | Alloy rim - front right side - Scratch(es) - Loss in value |

**Damage 3:** Wheel / tyres: Alloy rim - front right side - Scratch(es) - Loss in value

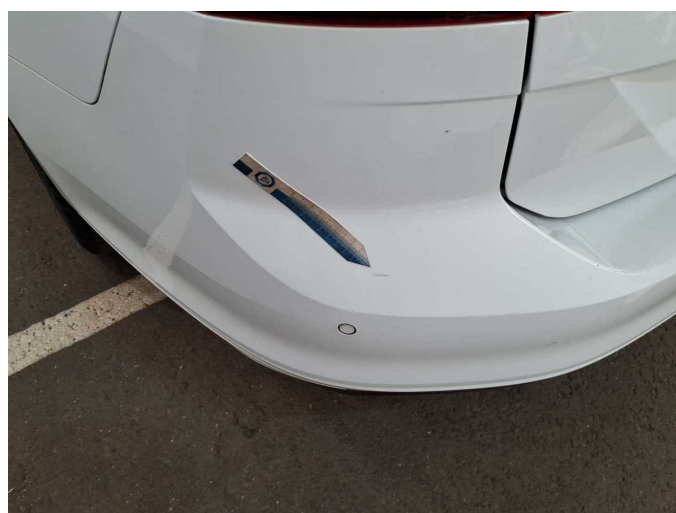
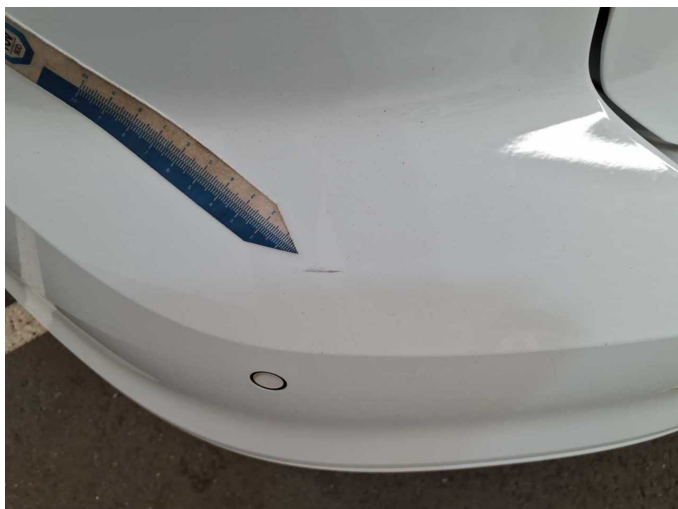
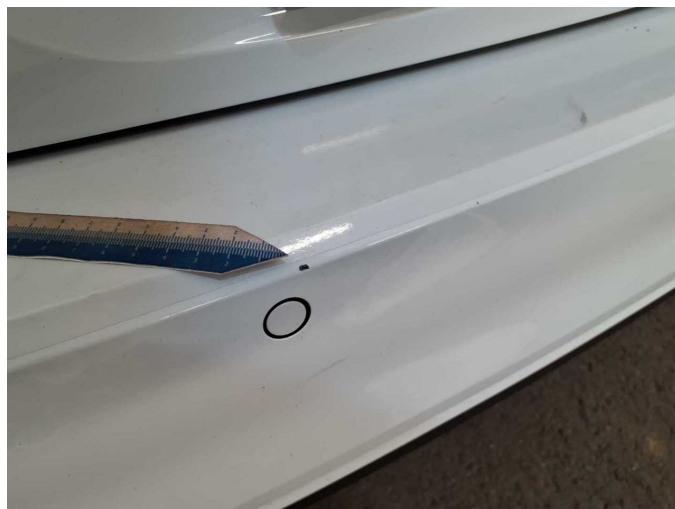
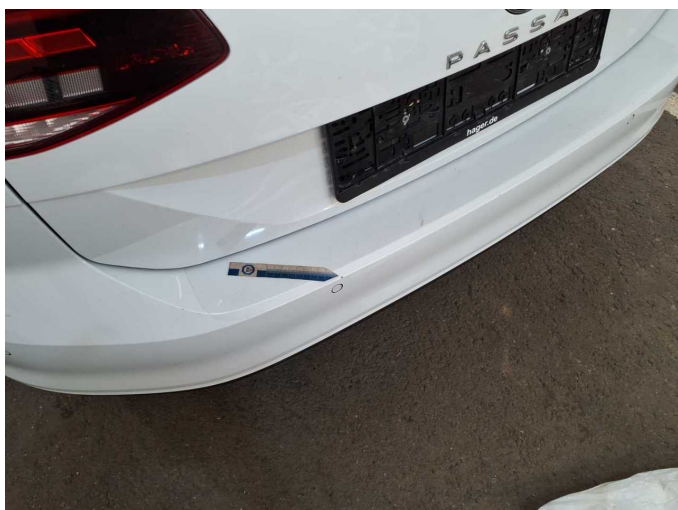
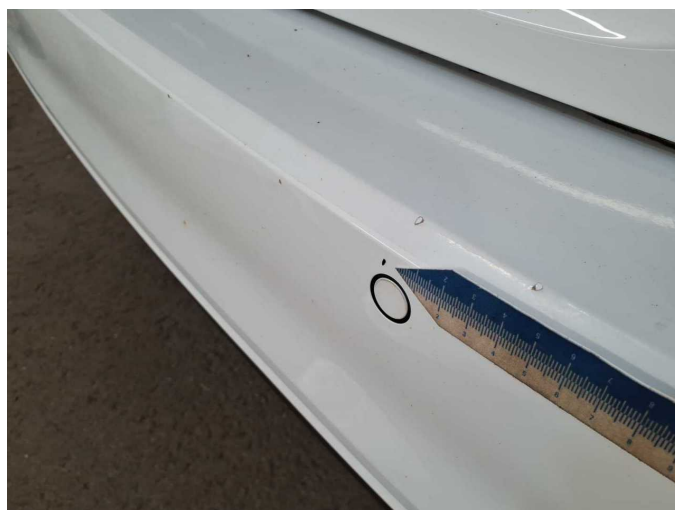
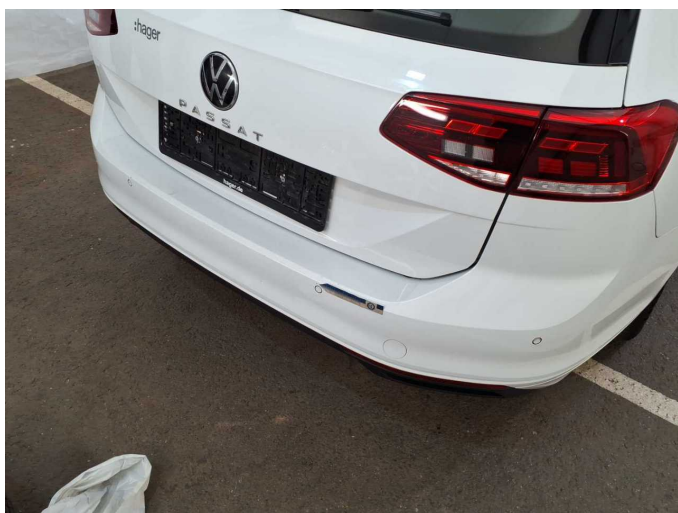
| No. | Component group | Description |
|---|---|---|
| 4 | Rear bumper | Rear bumper - Scratch(es) - Paint |

**Damage 4:** Rear bumper: Rear bumper - Scratch(es) - Paint

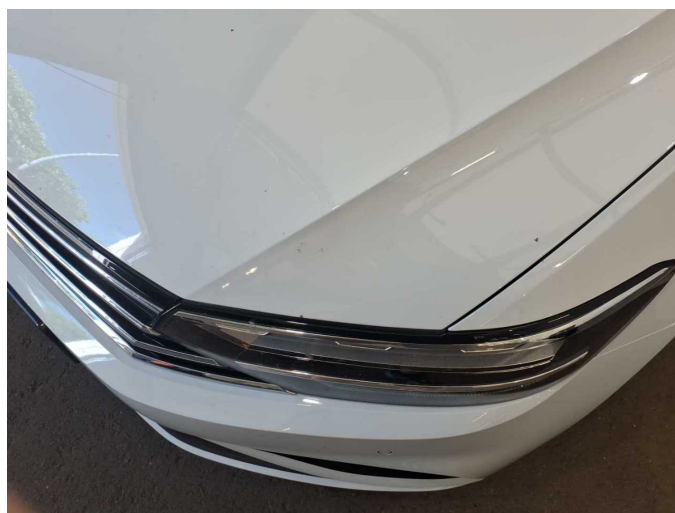
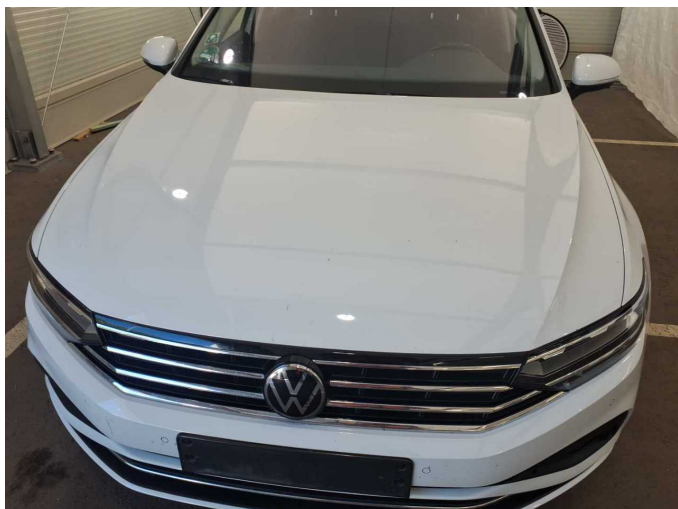
| No. | Component group | Description |
|---|---|---|
| 1 | Bonnet | Bonnet - Stone chips - No deduction |

**Wear and tear 1:** Bonnet: Bonnet - Stone chips - No deduction

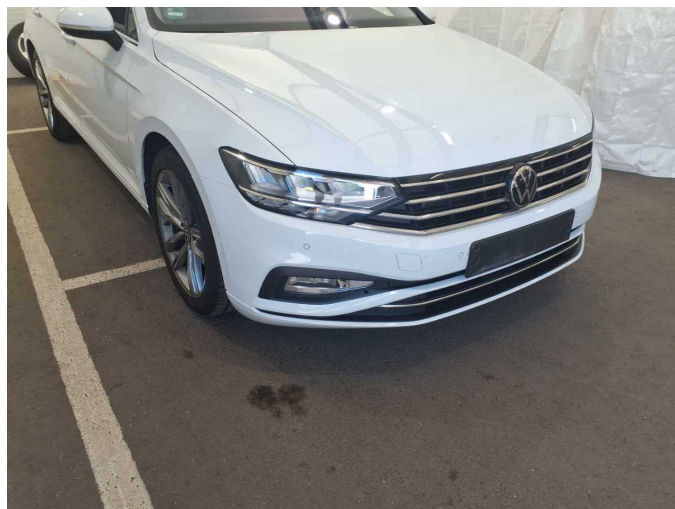
| No. | Component group | Description |
|---|---|---|
| 3 | Front bumper | Front bumper - Stone chips - No deduction |

**Wear and tear 3:** Front bumper: Front bumper - Stone chips - No deduction

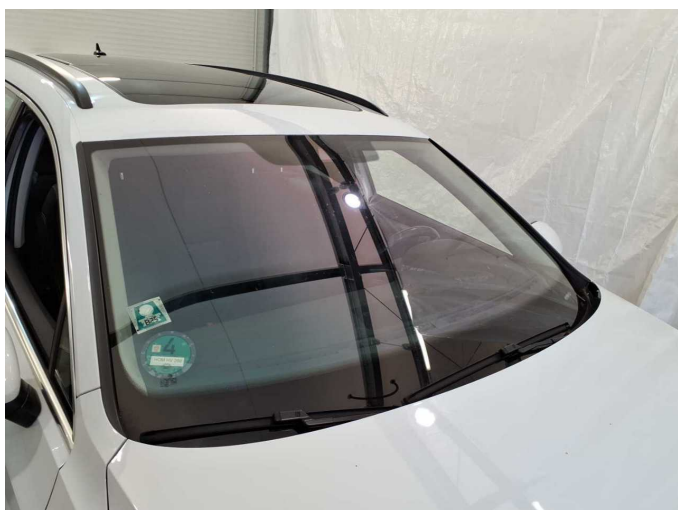
| No. | Component group | Description |
|---|---|---|
| 4 | Vehicle glazing | Windscreen - Stone chips - No deduction |

**Wear and tear 4:** Vehicle glazing: Windscreen - Stone chips - No deduction

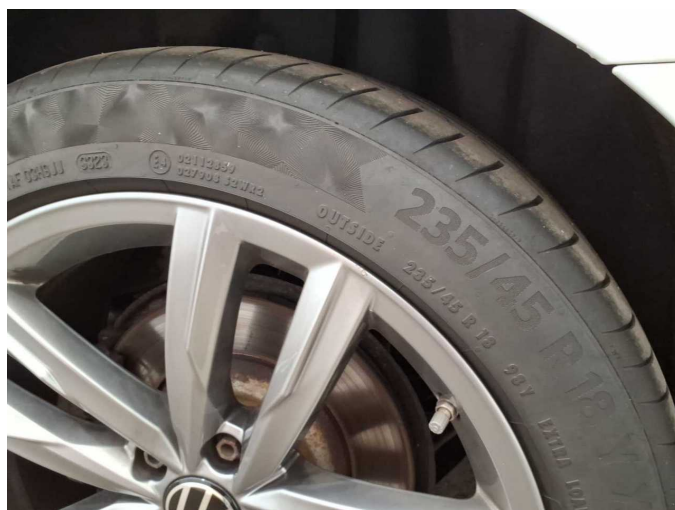
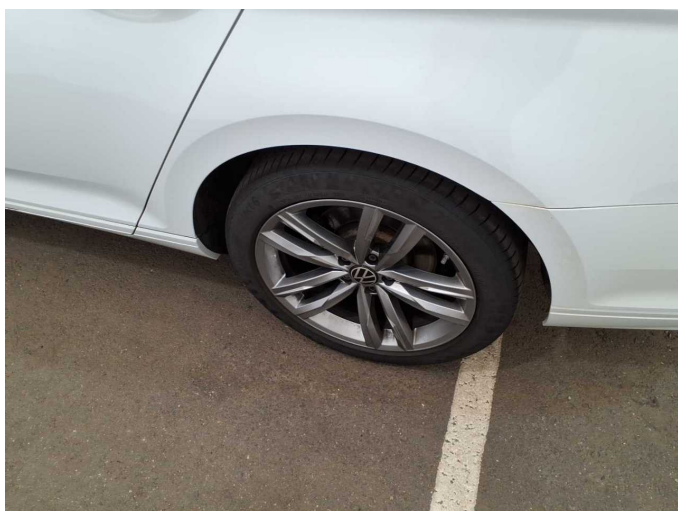
| No. | Component group | Description |
|---|---|---|
| 5 | Wheel / tyres | Alloy rim - rear left side - Stone chips - No deduction |

**Wear and tear 5:** Wheel / tyres: Alloy rim - rear left side - Stone chips - No deduction
