Expertise

Protocol number: 46339720  
Order No. / Reference: 26588385  
Inspection date: 2 Jul 2026

Manufacturer: Volkswagen

Model: Passat Variant 2.0 TDI SCR DSG Business

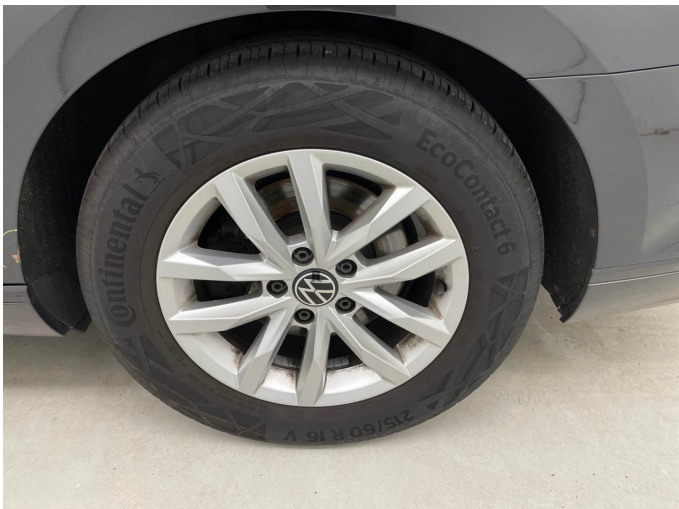
Figure 12: Mounted tyres

| Tyres | | | | |
|---|---|---|---|---|
| 1) | 215/60 R16 95V | Summer tyres on Light alloy | Continental | 6mm / 6mm |
| 2) | 215/60 R16 95V | Summer tyres on Light alloy | Continental | 7mm / 7mm |

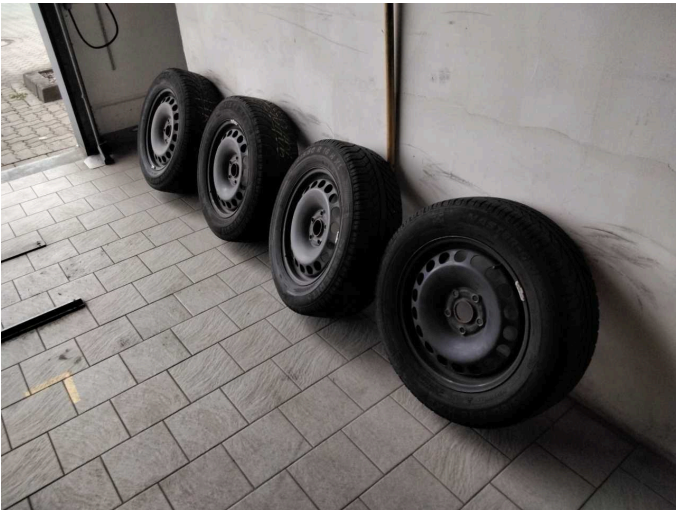
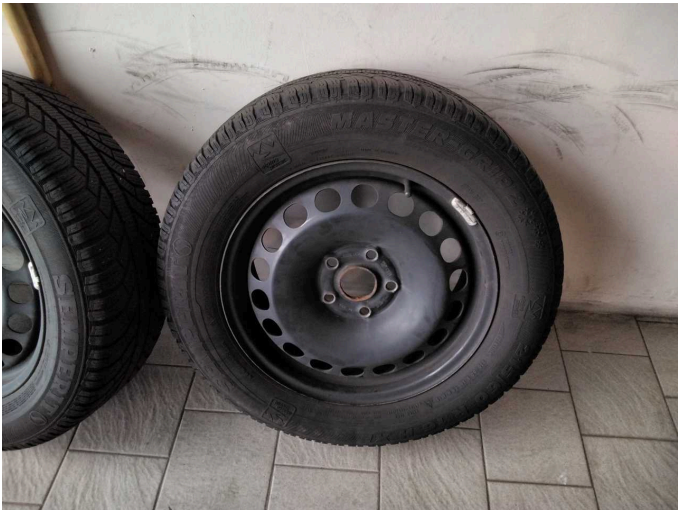
| Tyres | | | | |
|---|---|---|---|---|
| 1) | 215/60 R16 99H | Winter tyres on Steel | Semperit | 4mm / 4mm |
| 2) | 215/60 R16 99H | Winter tyres on Steel | Semperit | 5mm / 5mm |

Figure 17: Additional tyres

Figure 18: Additional tyres

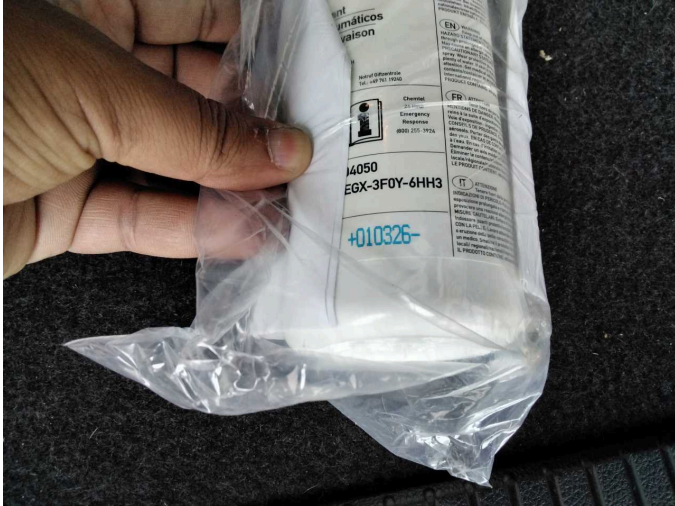
| No. | Component group | Description |
|---|---|---|
| 1 | Equipment | Tirefit filler - Expired - Replace |

**Damage 1:** Equipment: Tirefit filler - Expired - Replace

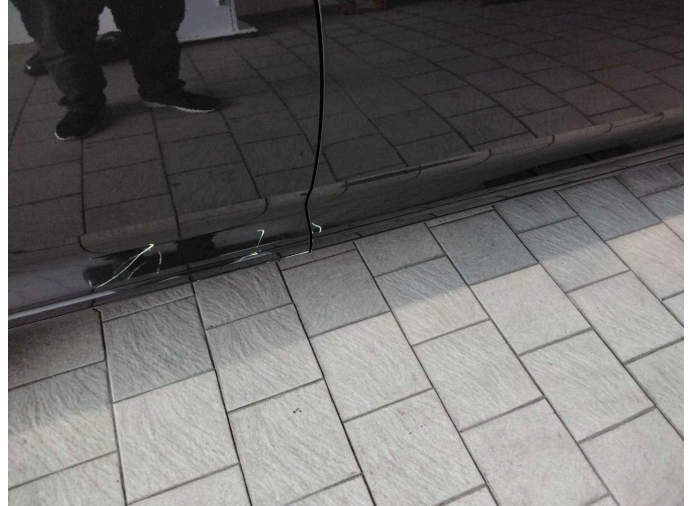
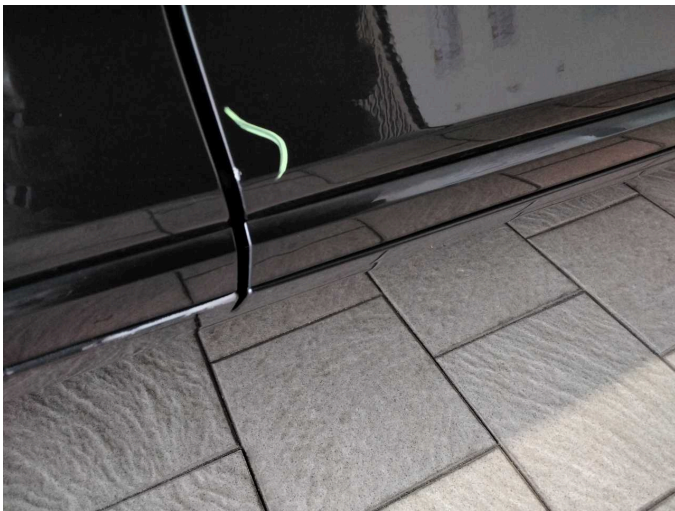
| No. | Component group | Description |
|---|---|---|
| 2 | Door - front right side | Door - Scratch(es) - Smart repair |

**Damage 2:** Door - front right side: Door - Scratch(es) - Smart repair

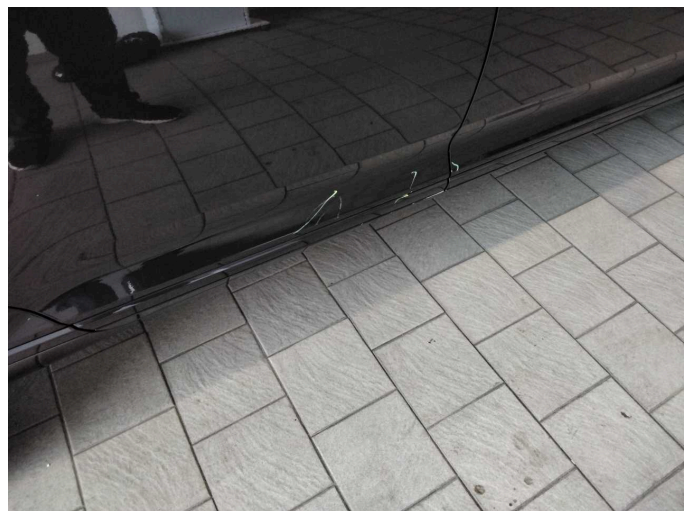
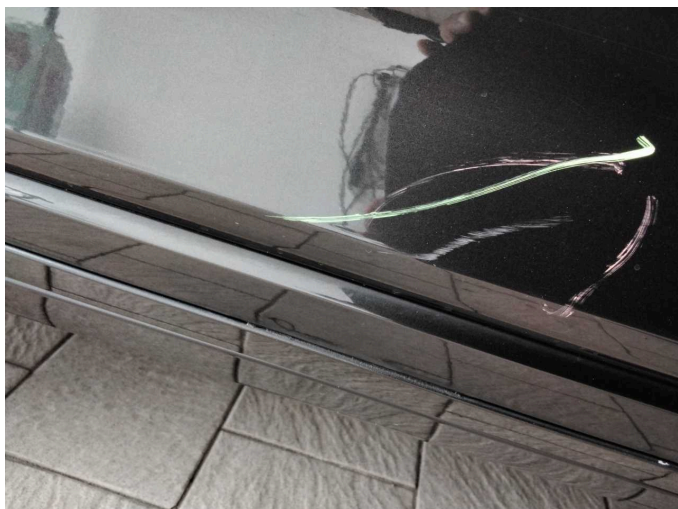
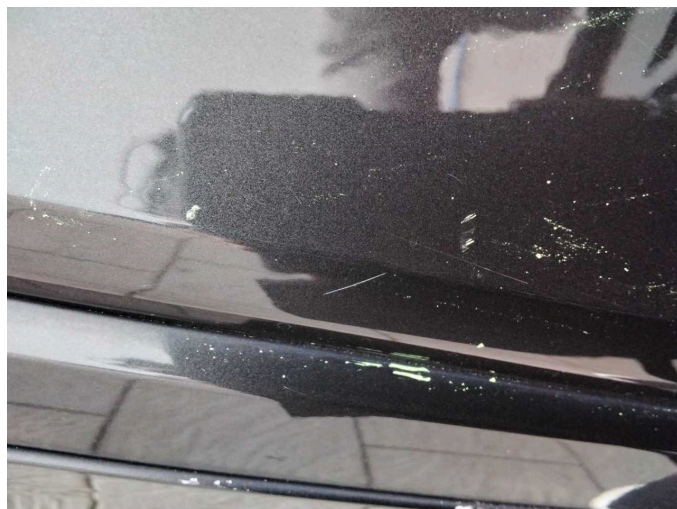
| No. | Component group | Description |
|---|---|---|
| 4 | Door - rear right side | Door - Scratch(es) - Smart repair |

**Damage 4:** Door - rear right side: Door - Scratch(es) - Smart repair

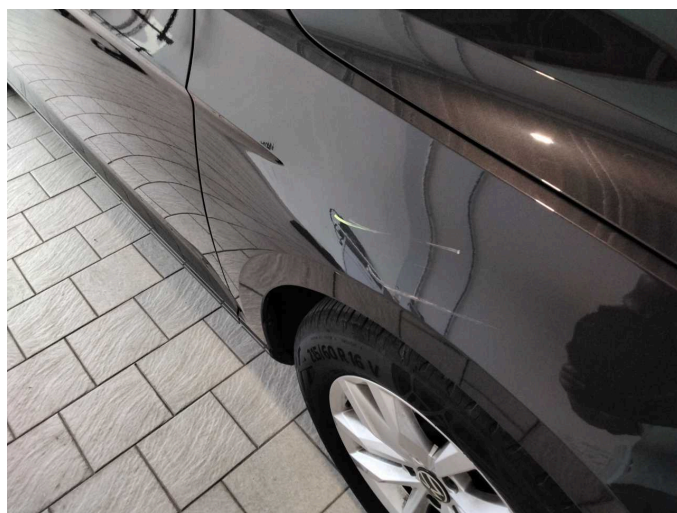
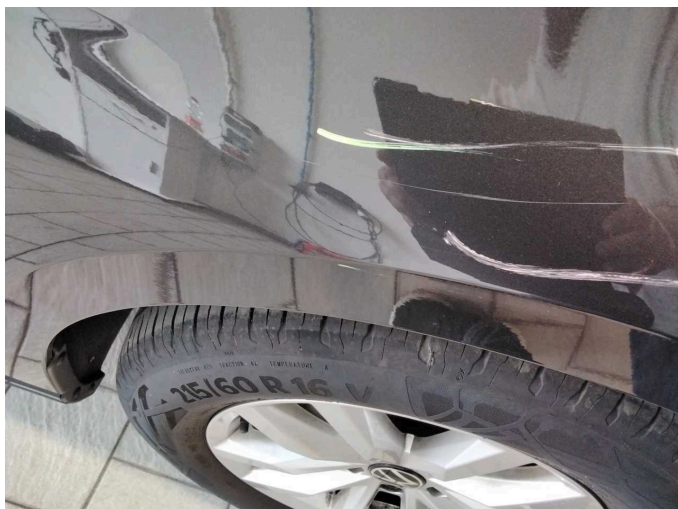
| No. | Component group | Description |
|---|---|---|
| 6 | Mudguard - right side | Mudguard - right side - Scratch(es) - Smart repair |

**Damage 6:** Mudguard - right side: Mudguard - right side - Scratch(es) - Smart repair

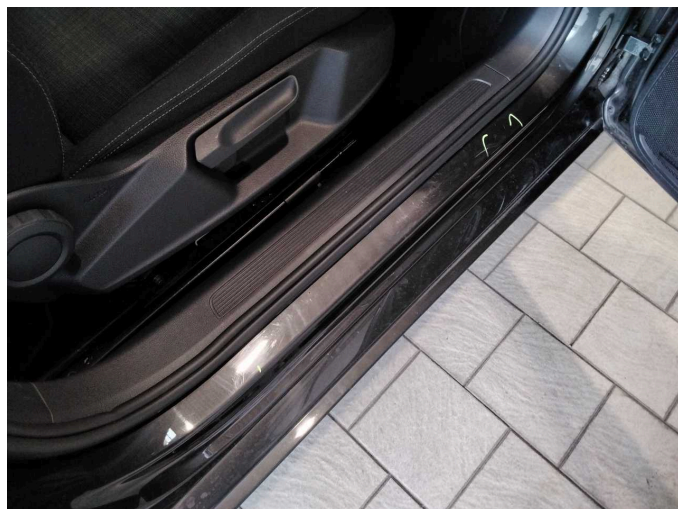
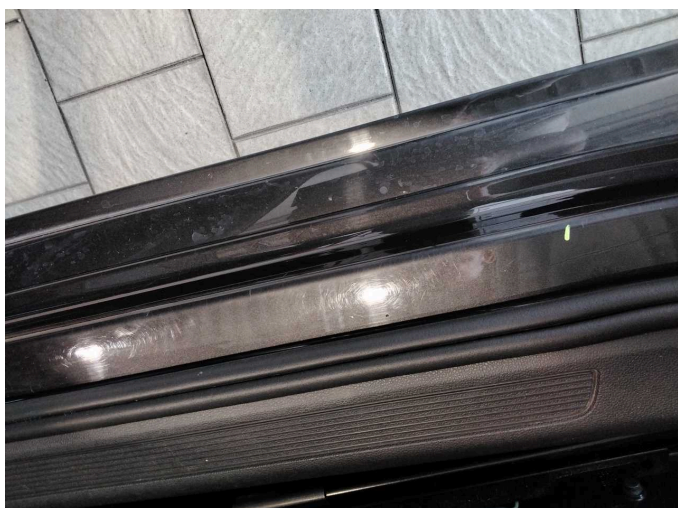
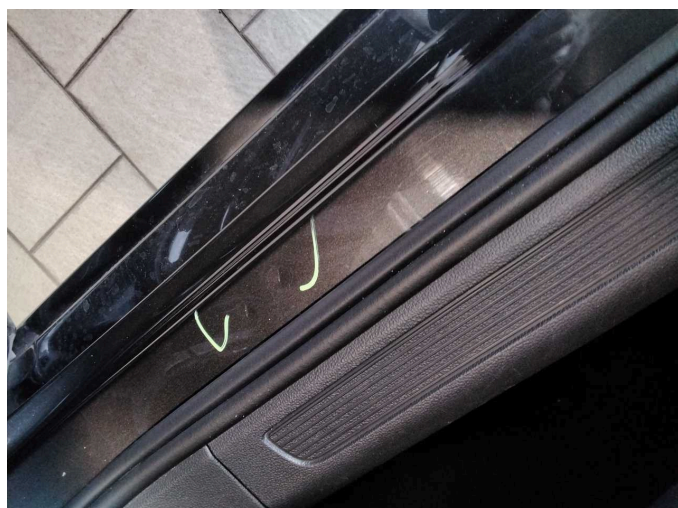
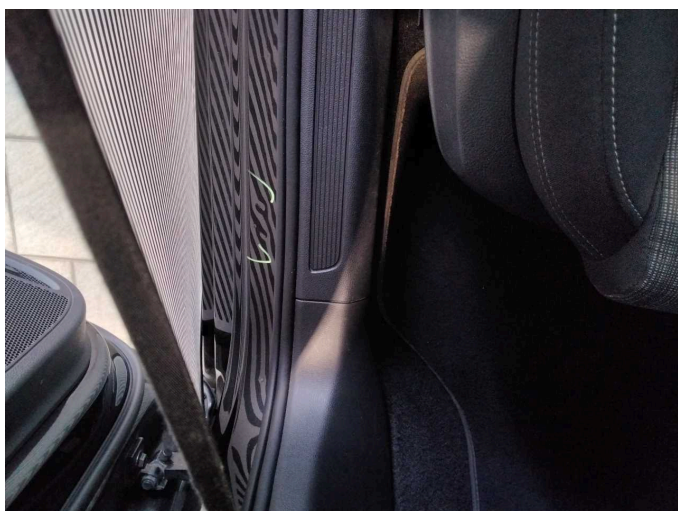
| No. | Component group | Description |
|---|---|---|
| 7 | Sill - right side | Sill - Dent / paintcoat damage - Smart repair |

**Damage 7:** Sill - right side: Sill - Dent / paintcoat damage - Smart repair

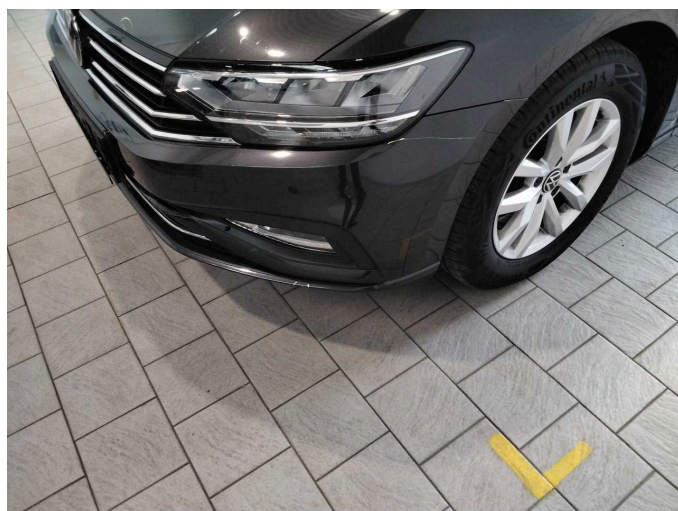
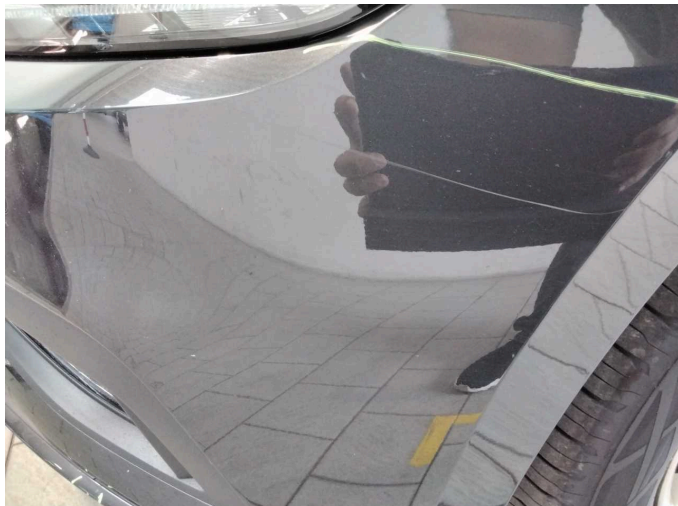
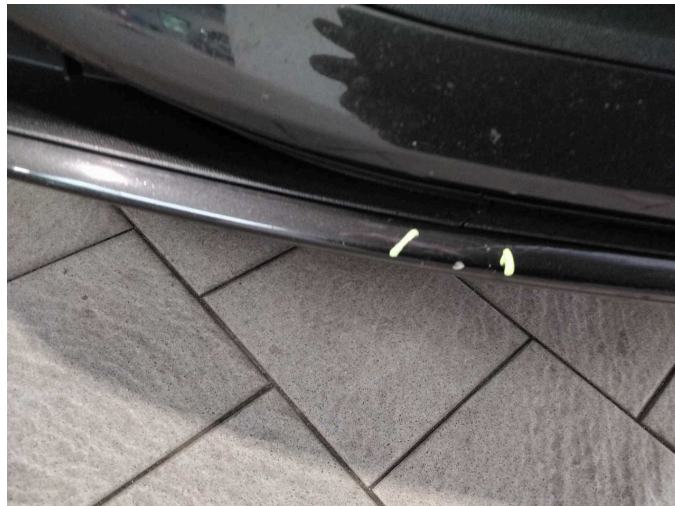
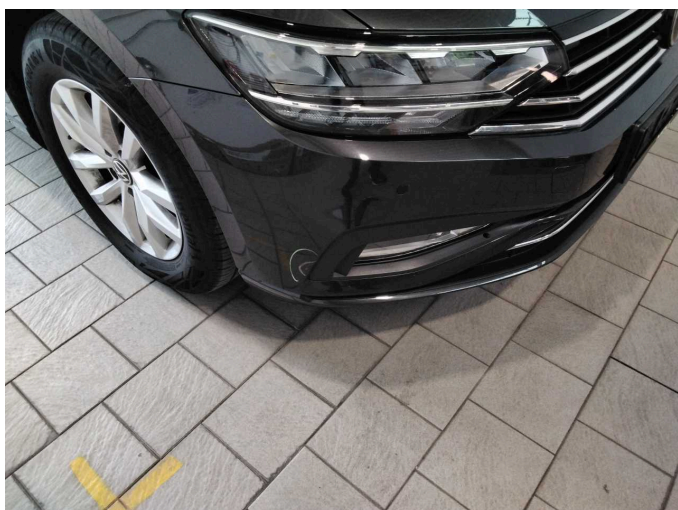
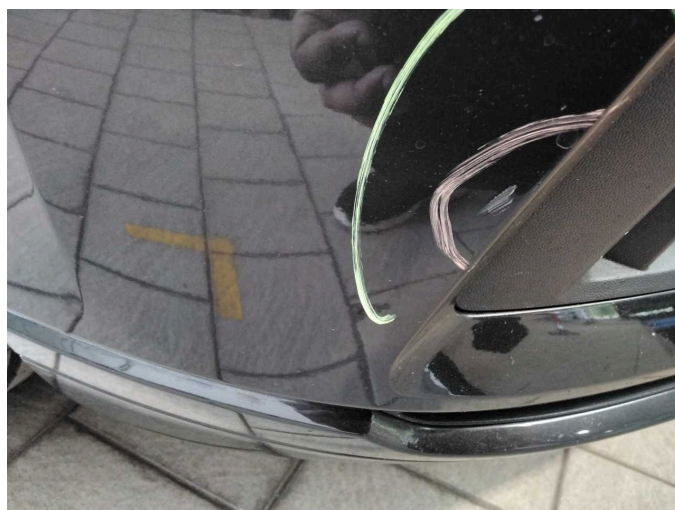
| No. | Component group | Description |
|---|---|---|
| 8 | Front bumper | Front bumper - Scratch(es) - Paint |

**Damage 8:** Front bumper: Front bumper - Scratch(es) - Paint

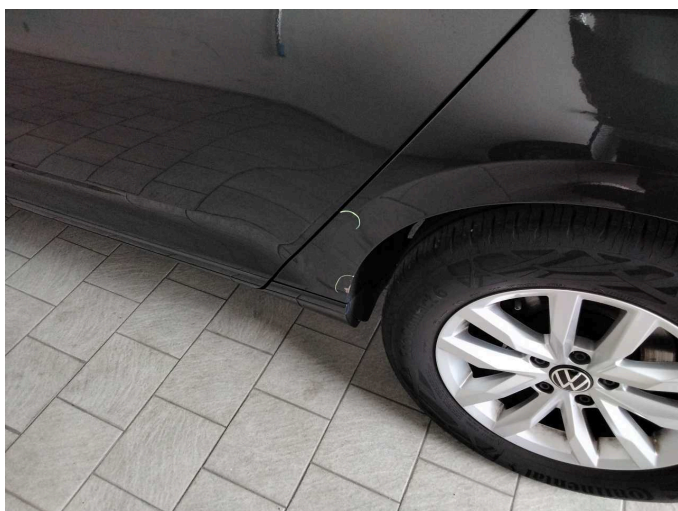
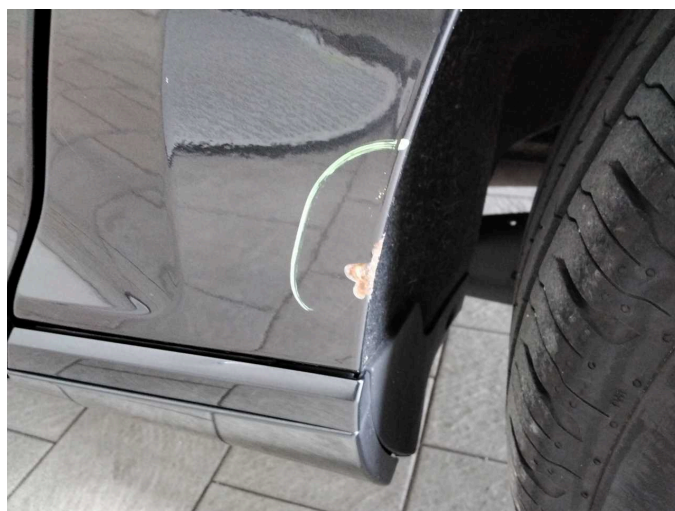
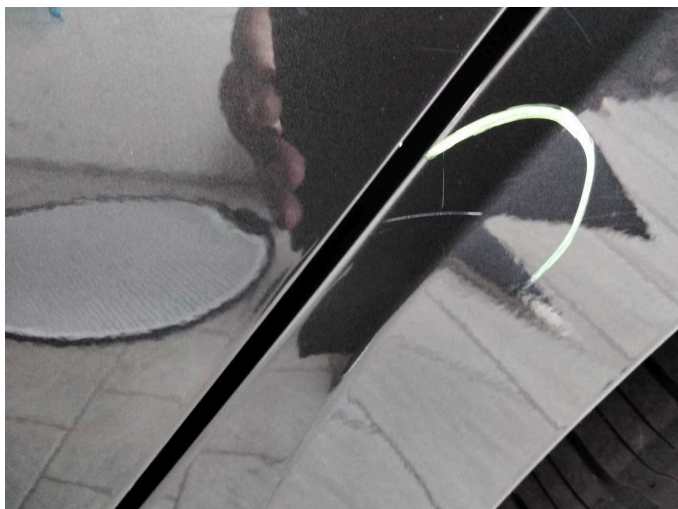
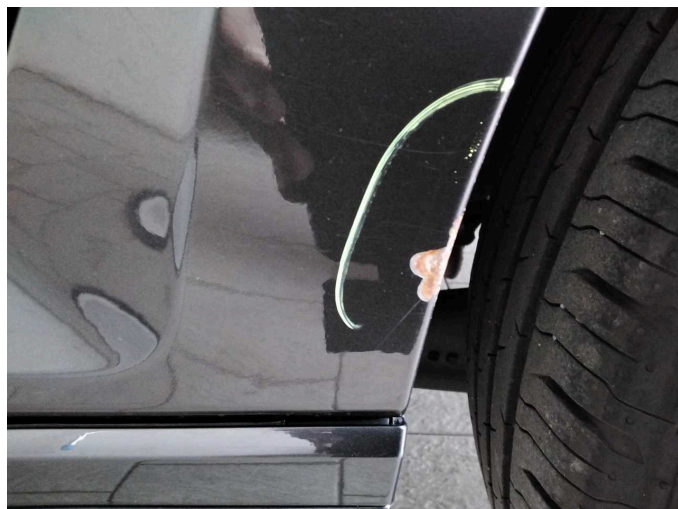
| No. | Component group | Description |
|---|---|---|
| 9 | Side panel - rear left side | Side panel - Paint defect - Paint |

**Damage 9:** Side panel - rear left side: Side panel - Paint defect - Paint

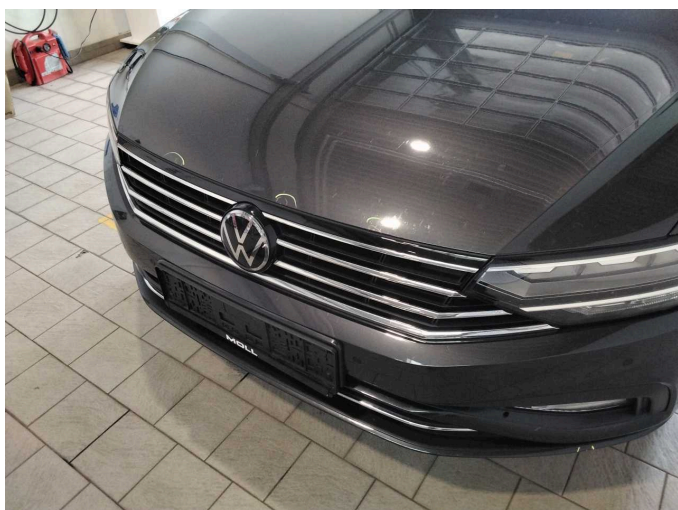
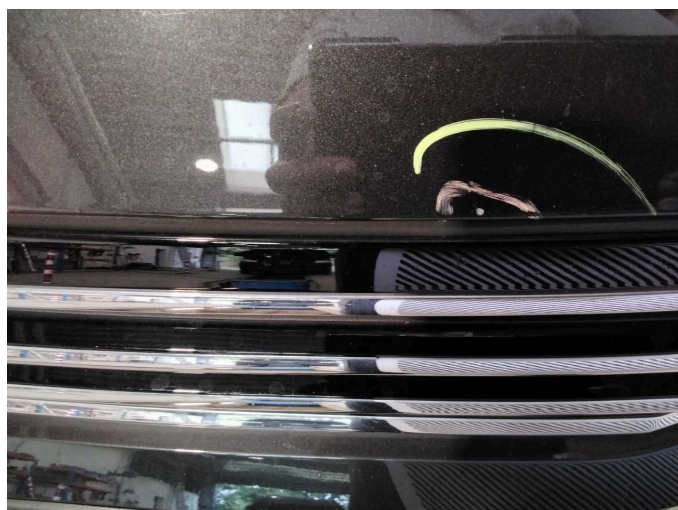
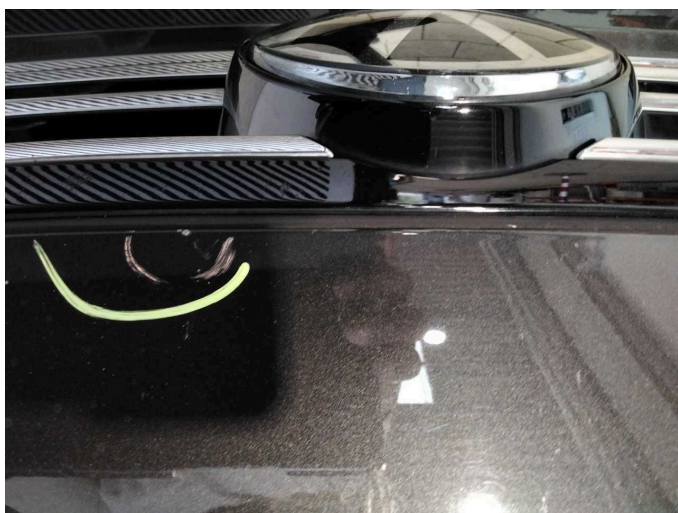
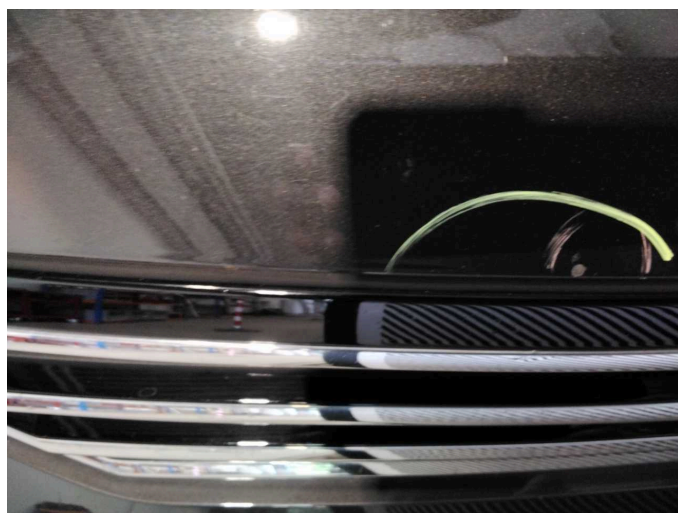
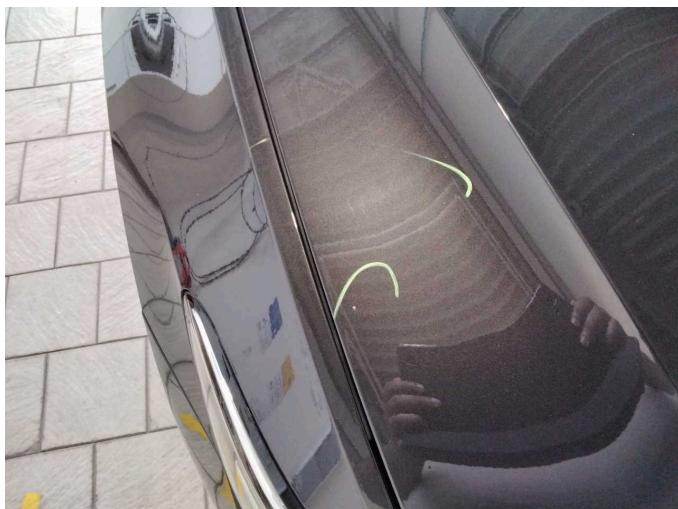
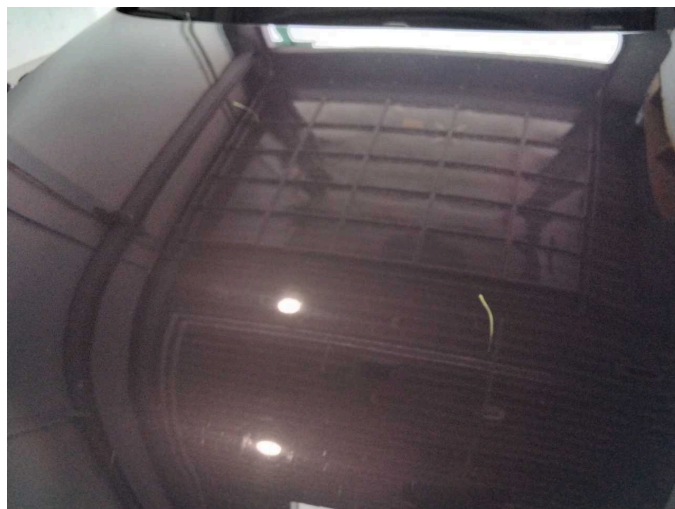
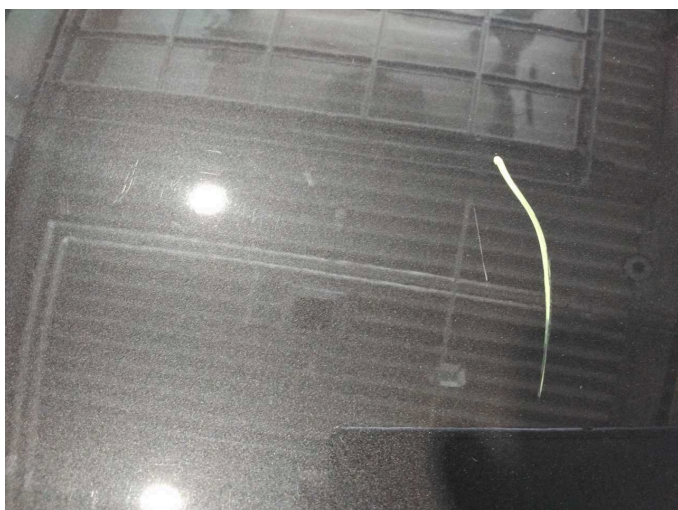
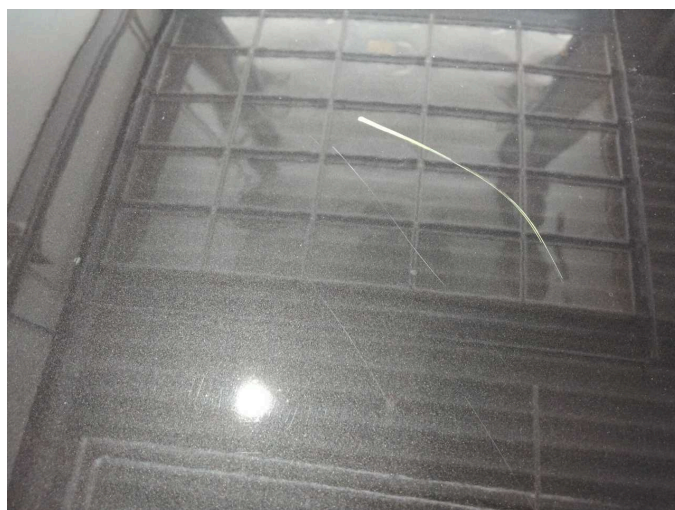
| No. | Component group | Description |
|---|---|---|
| 10 | Bonnet | Bonnet - Scratch(es) - Paint |

**Damage 10:** Bonnet: Bonnet - Scratch(es) - Paint

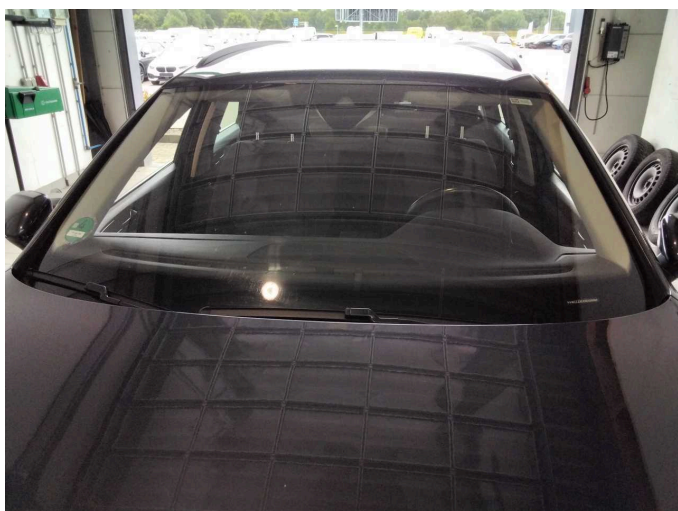
| No. | Component group | Description |
|---|---|---|
| 1 | Vehicle glazing | Windscreen - Stone chips - No deduction |

**Wear and tear 1:** Vehicle glazing: Windscreen - Stone chips - No deduction

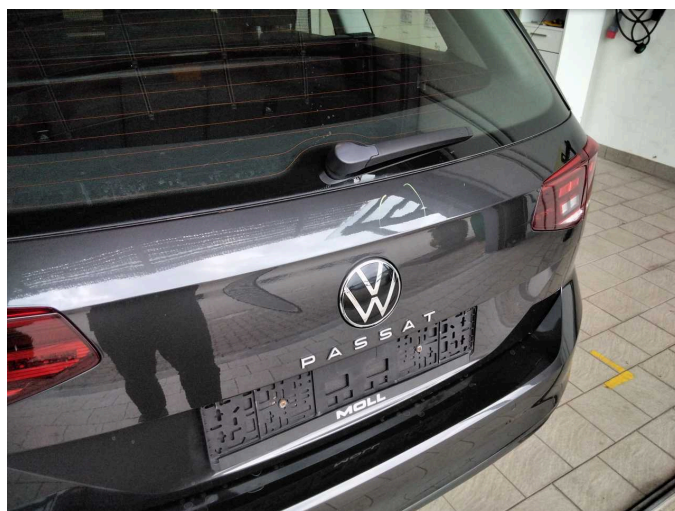
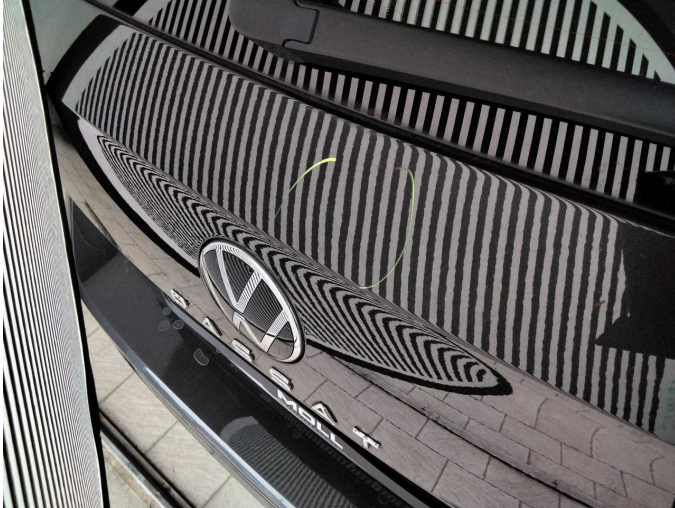
| No. | Component group | Description |
|---|---|---|
| 2 | Boot lid / rear door | Boot lid - dent(s) - No deduction |

**Wear and tear 2:** Boot lid / rear door: Boot lid - dent(s) - No deduction

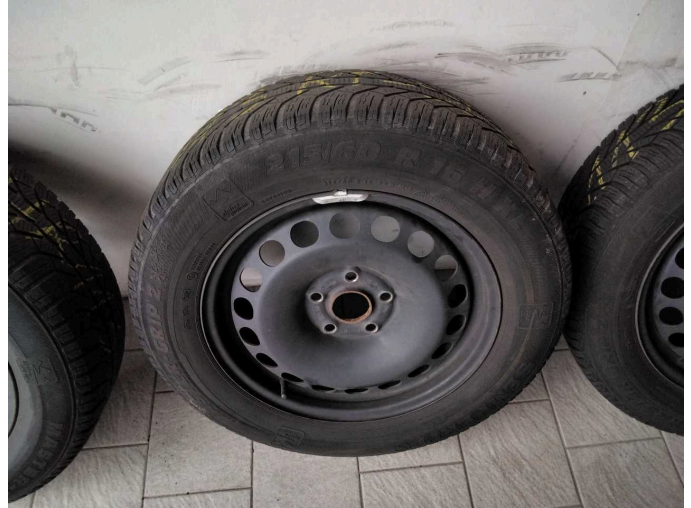
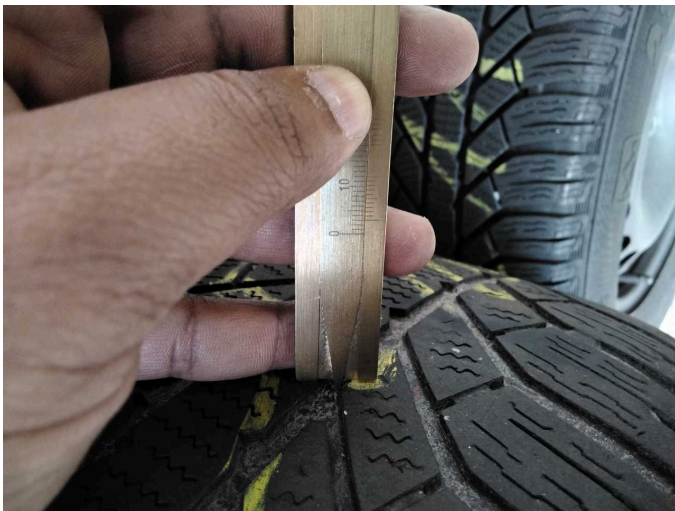
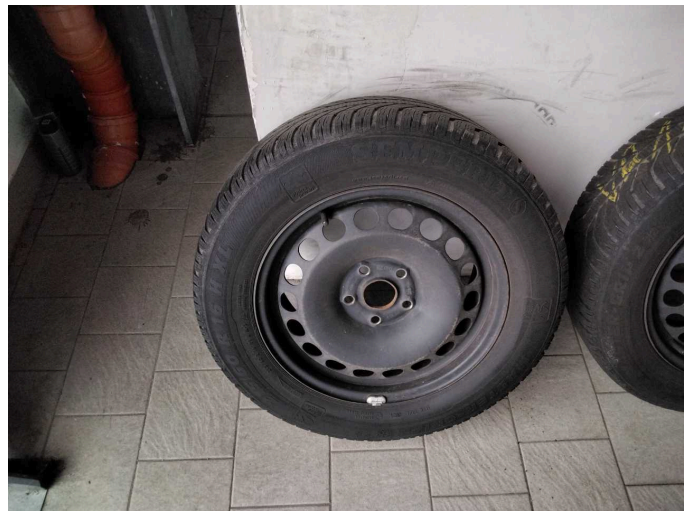
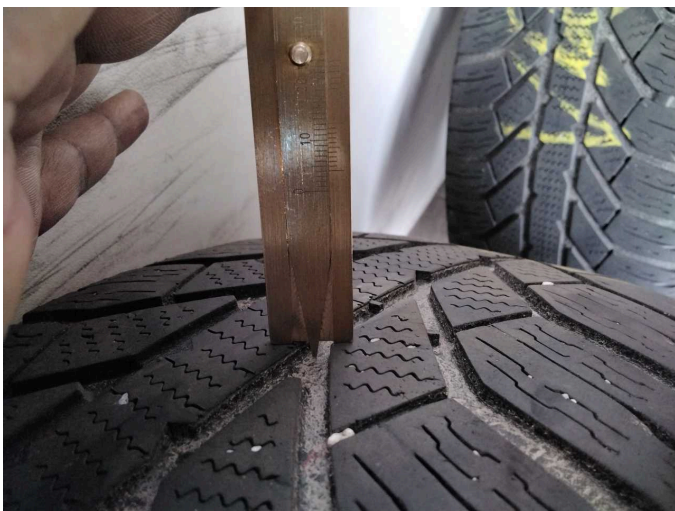
| No. | Component group | Description |
|---|---|---|
| 4 | 2nd wheel set | 2 tyres (4mm / Kein Teil der Ausstattung) - Does not meet the leasing specifications - No deduction |

**Wear and tear 4:** 2nd wheel set: 2 tyres (4mm / Kein Teil der Ausstattung) - Does not meet the leasing specifications - No deduction
