Expertise

Protocol number: 46465947  
Order No. / Reference: 26638452  
Inspection date: 10 Jul 2026

Manufacturer: Skoda  
VIN: TMBLJ7NU8P5067702

Model: Karoq 2.0 TDI SCR 4x4 DSG Tour

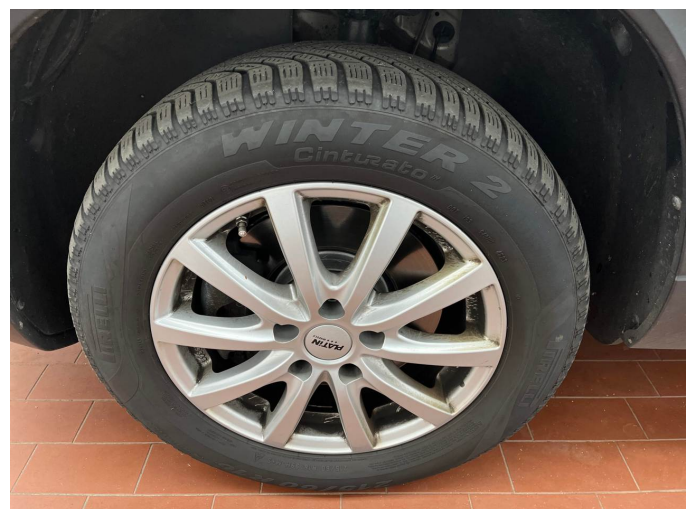
Figure 12: Mounted tyres

| # | Tyre size | Type of tyre | Manufacturer | Tread depth |
|---|---|---|---|---|
| 1) | 215/60 R16 99H | Winter tyres on Light alloy | Pirelli | 4mm / 4mm |
| 2) | 215/60 R16 99H | Winter tyres on Light alloy | Pirelli | 5mm / 5mm |

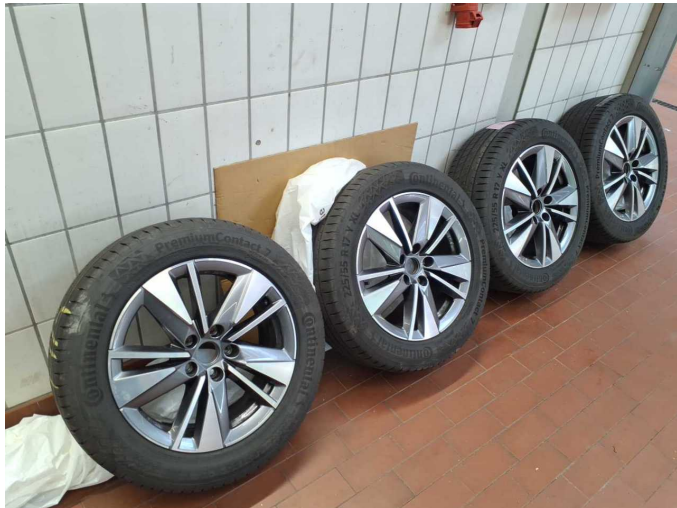
Figure 15: Additional tyres

| # | Tyre size | Type of tyre | Manufacturer | Tread depth |
|---|---|---|---|---|
| 1) | 225/55 R17 101Y | Summer tyres on Light alloy | Continental | 5mm / 5mm |
| 2) | 225/55 R17 101Y | Summer tyres on Light alloy | Continental | 5mm / 5mm |

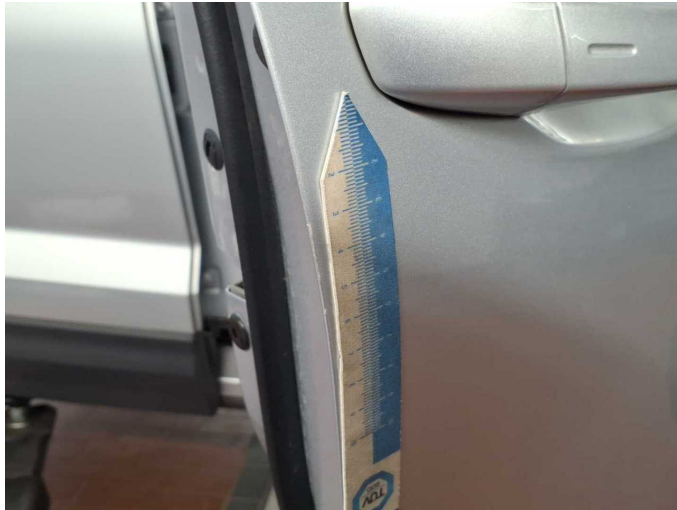
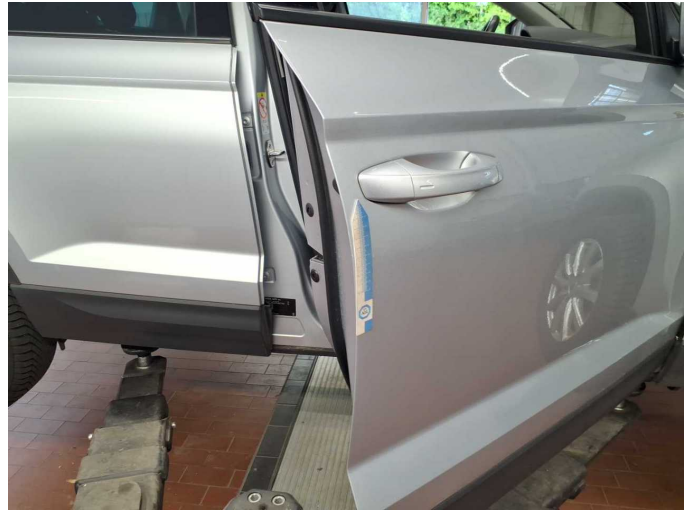
**Damage 1:** Door - front right side: Door edge - Scratch(es) - Smart repair

| No. | Component group | Description |
|---|---|---|
| 1 | Door - front right side | Door edge - Scratch(es) - Smart repair |

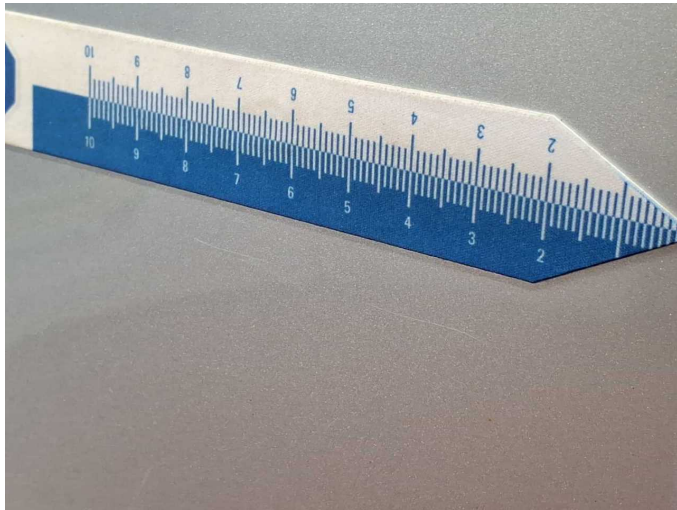
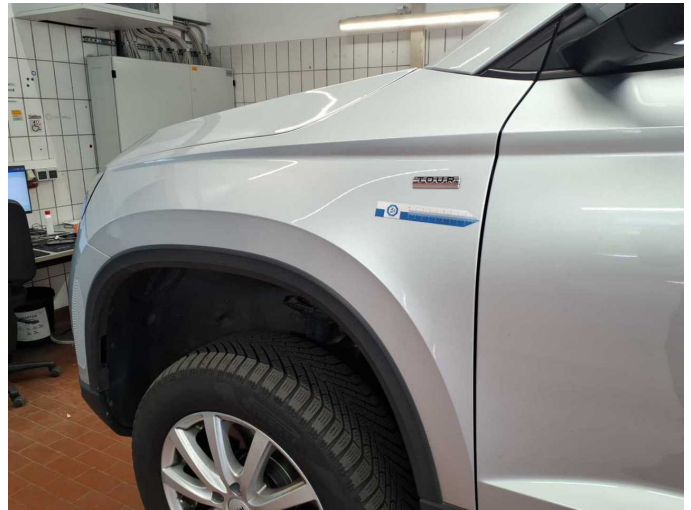
**Damage 2:** Mudguard - left side: Mudguard - left side - Scratch(es) - Smart repair

| No. | Component group | Description |
|---|---|---|
| 2 | Mudguard - left side | Mudguard - left side - Scratch(es) - Smart repair |

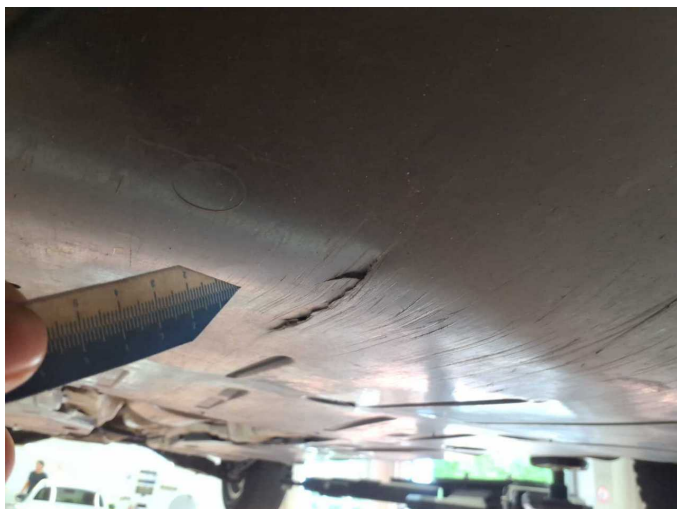
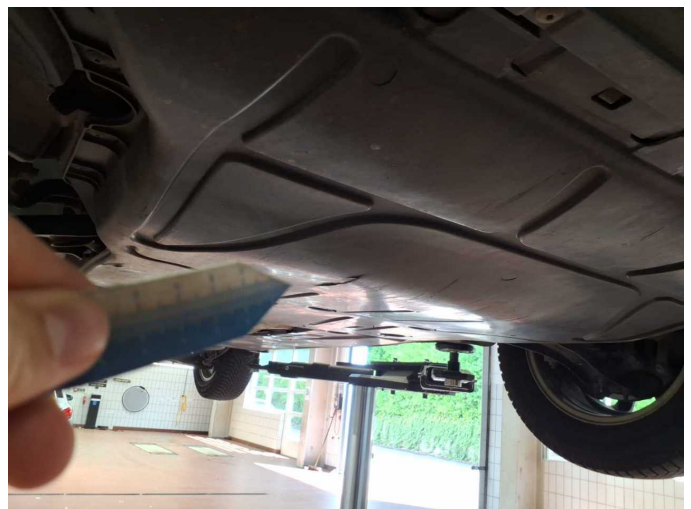
**Damage 4:** Body: Underbody panelling - Broken / torn - Replace

| No. | Component group | Description |
|---|---|---|
| 4 | Body | Underbody panelling - Broken / torn - Replace |

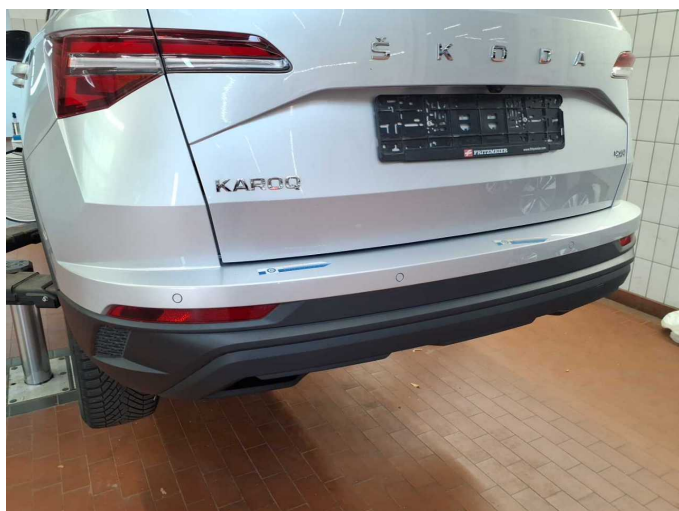
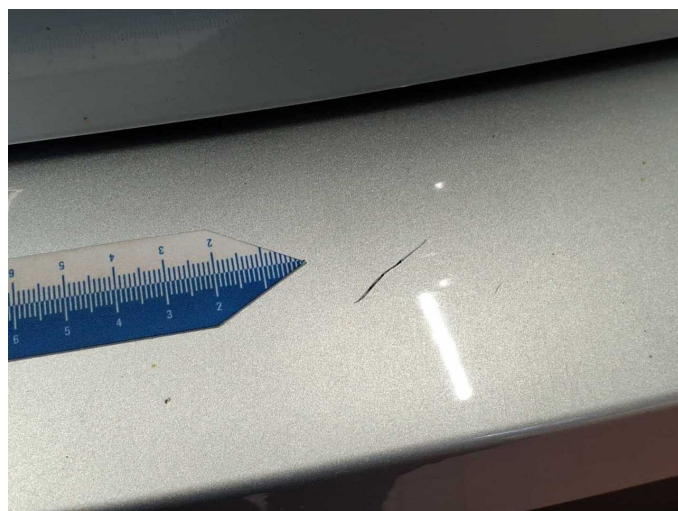
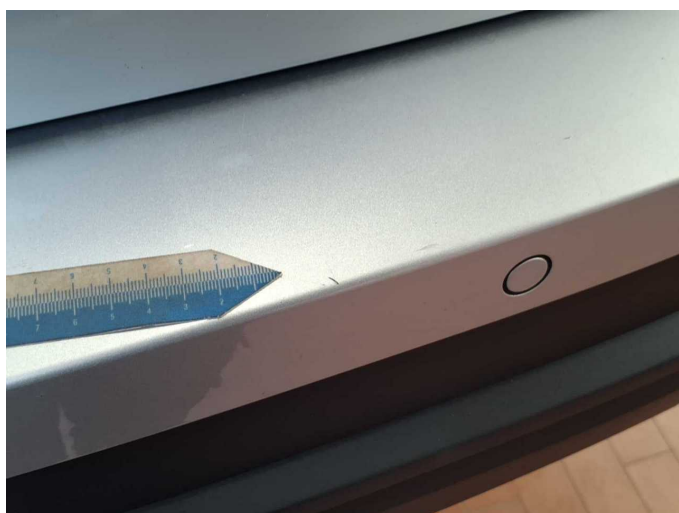
**Damage 5:** Rear bumper: Rear bumper - Scratch(es) - Paint

| No. | Component group | Description |
|---|---|---|
| 5 | Rear bumper | Rear bumper - Scratch(es) - Paint |

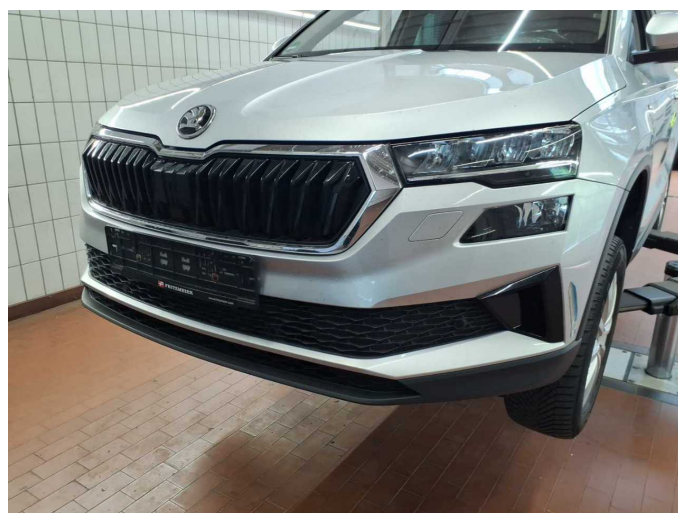
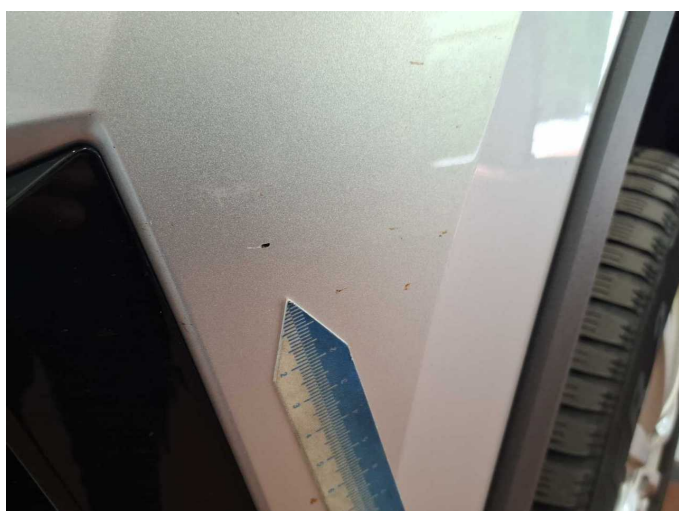
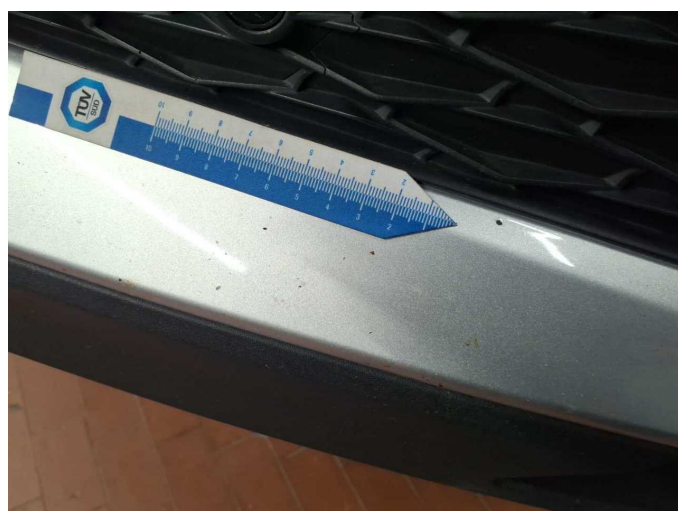
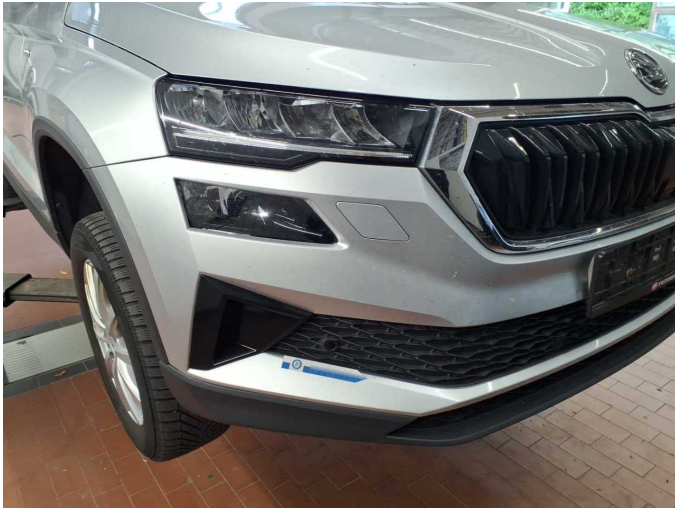
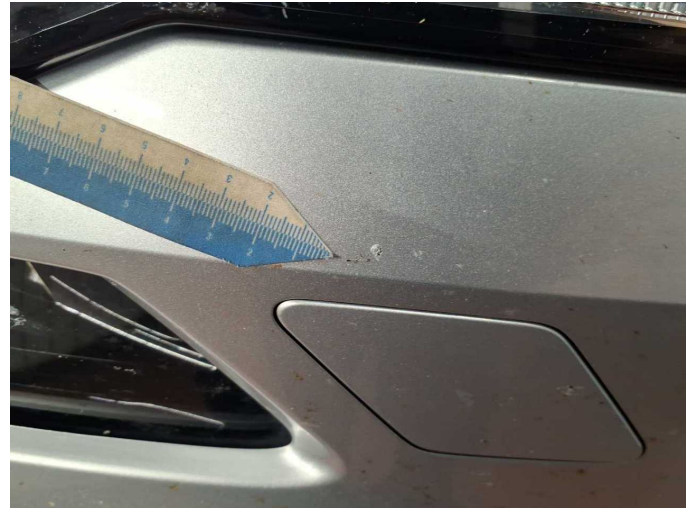
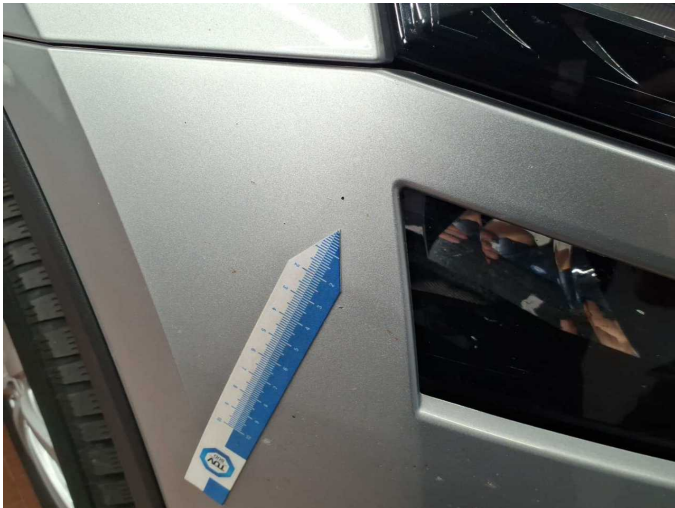
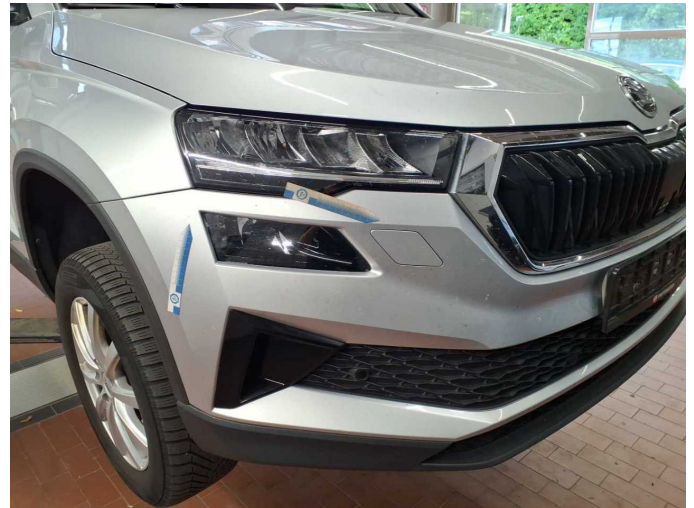
**Damage 6:** Front bumper: Front bumper - Stone chips - Paint

| No. | Component group | Description |
|---|---|---|
| 6 | Front bumper | Front bumper - Stone chips - Paint |

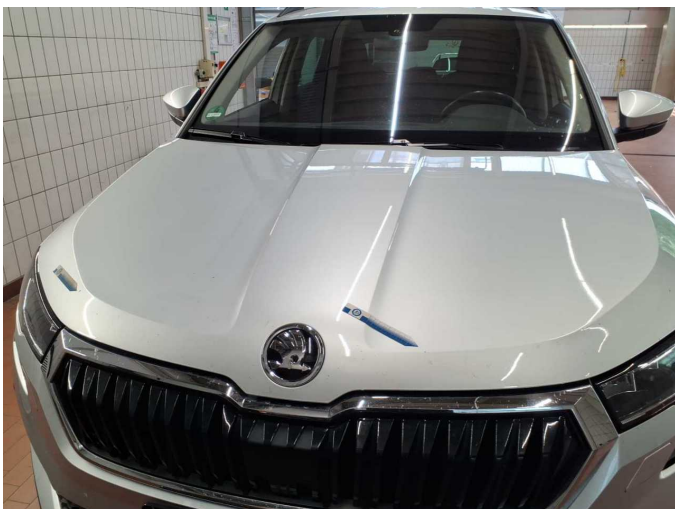
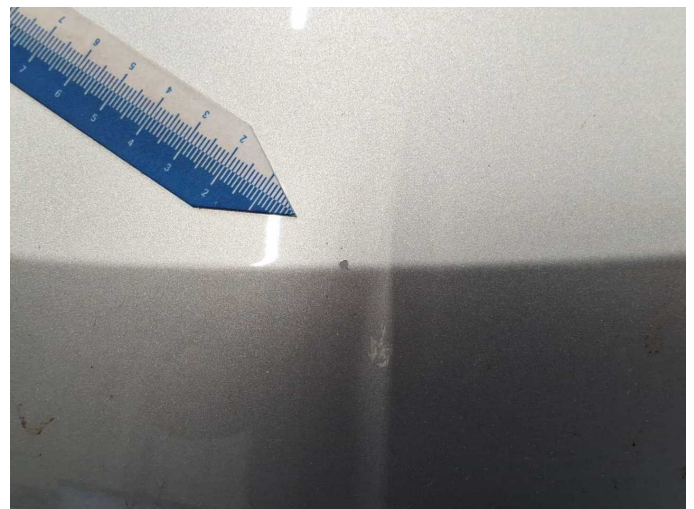
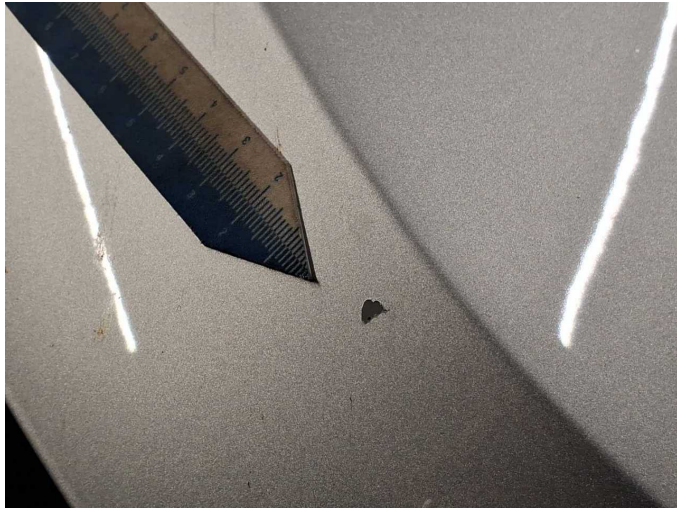
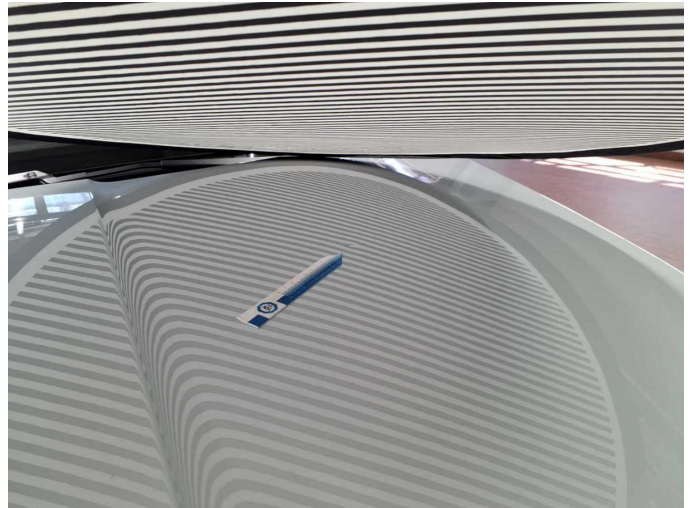
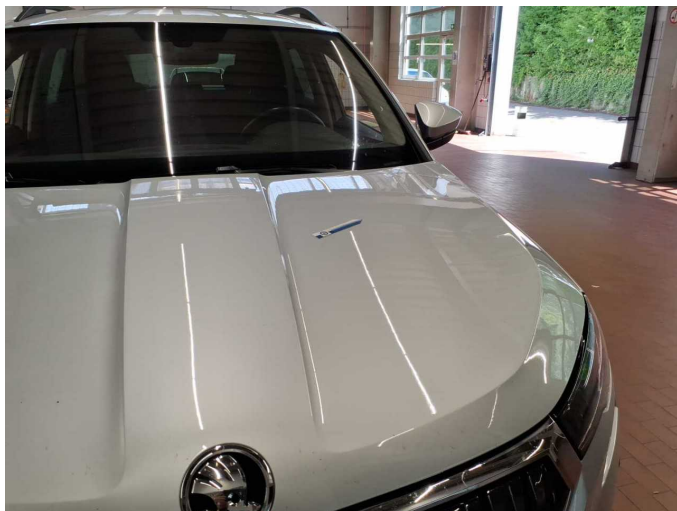
**Damage 7:** Bonnet: Bonnet - Dent / paintcoat damage - Repair and paint

| No. | Component group | Description |
|---|---|---|
| 7 | Bonnet | Bonnet - Dent / paintcoat damage - Repair and paint |

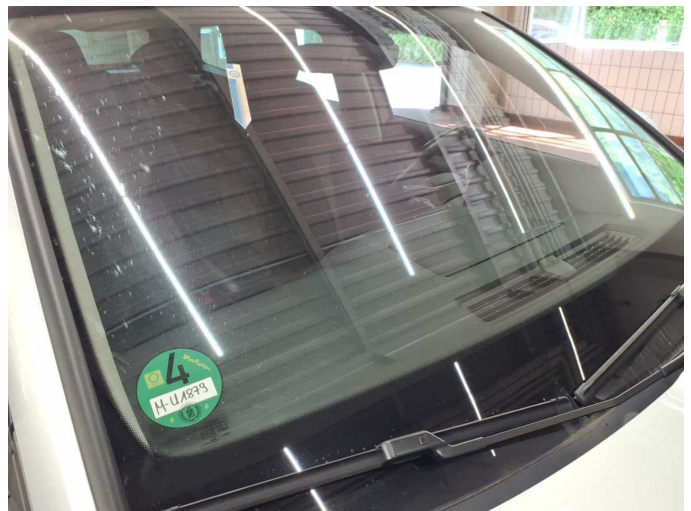
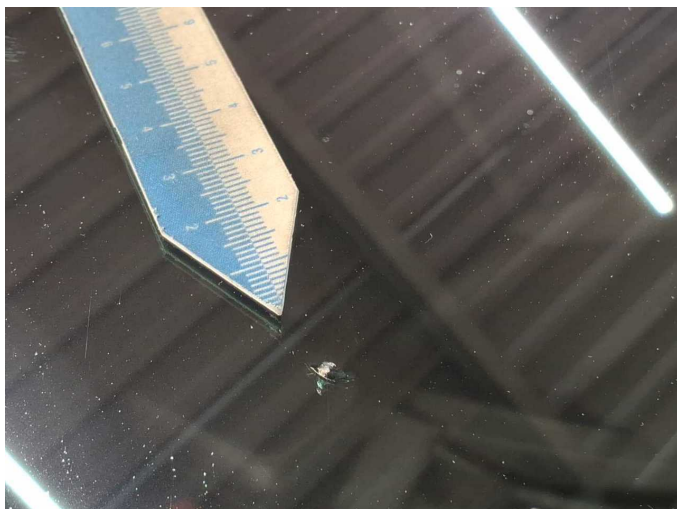
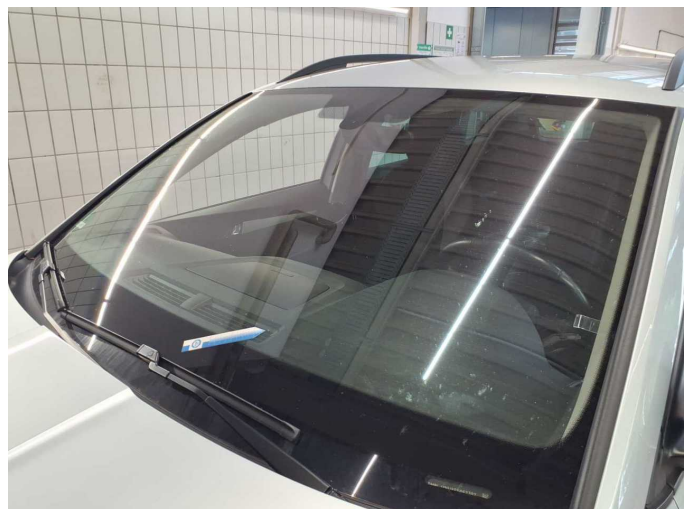
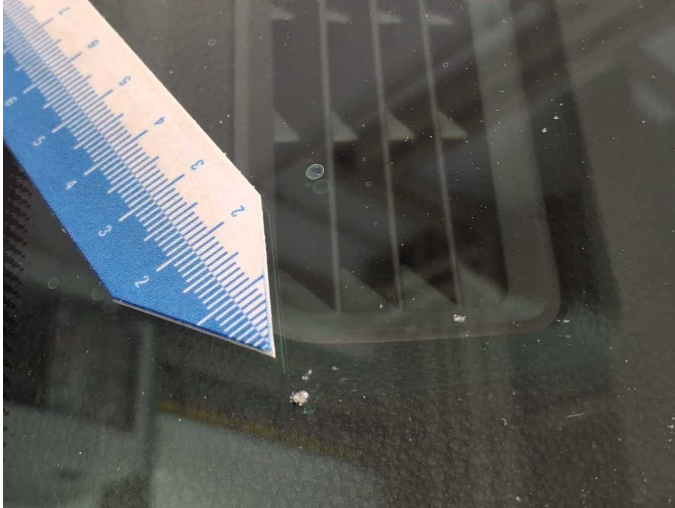
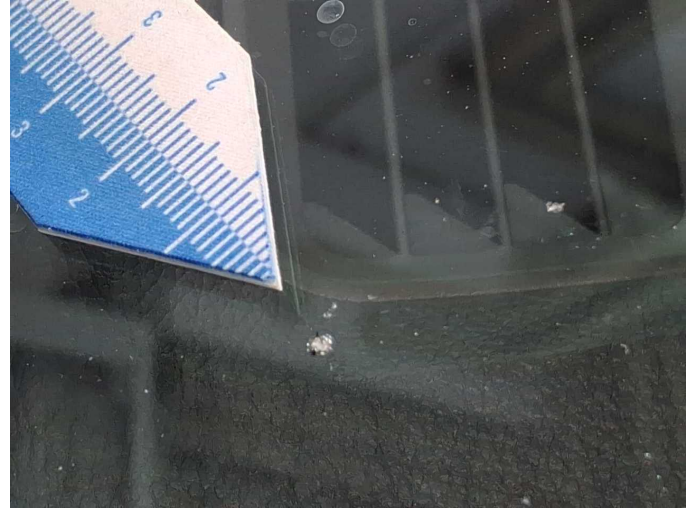
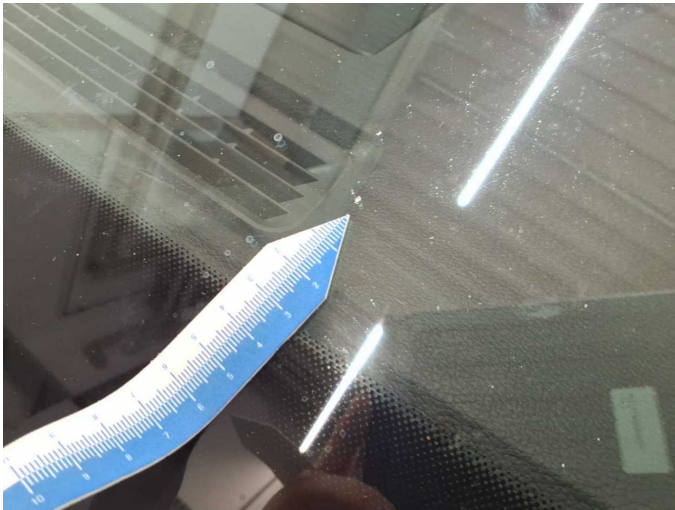
**Damage 8:** Vehicle glazing: Windscreen (Rissbildung) - Stone chips - Replace

| No. | Component group | Description |
|---|---|---|
| 8 | Vehicle glazing | Windscreen (Rissbildung) - Stone chips - Replace |

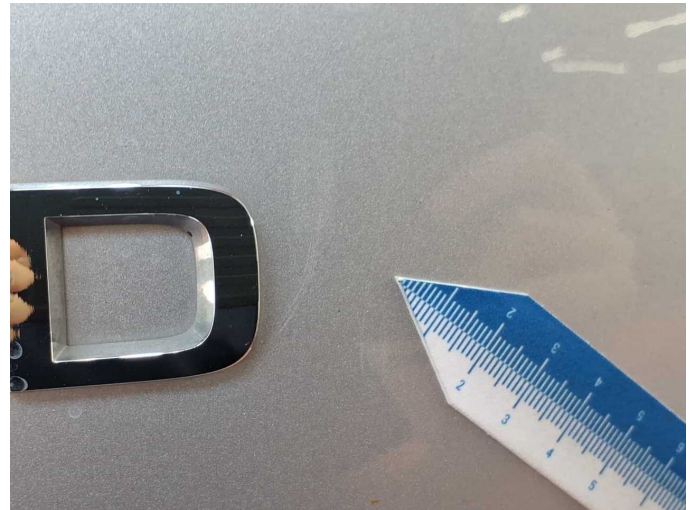
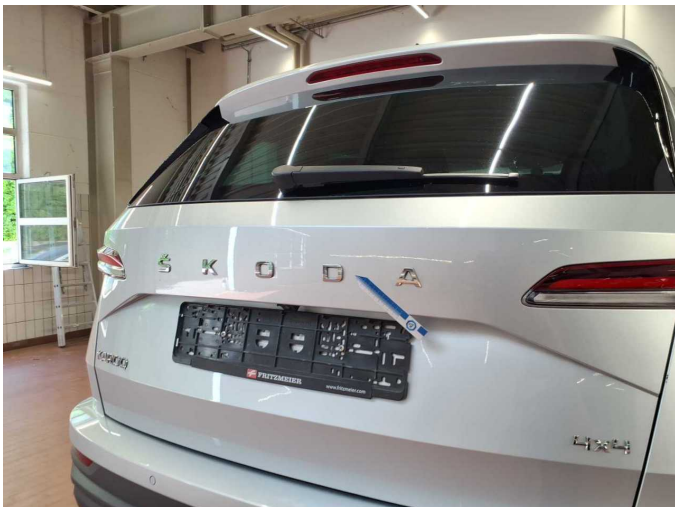
| No. | Component group | Description |
|---|---|---|
| 2 | Boot lid / rear door | Boot lid - Scratch(es) - No deduction |

**Wear and tear 2:** Boot lid / rear door: Boot lid - Scratch(es) - No deduction

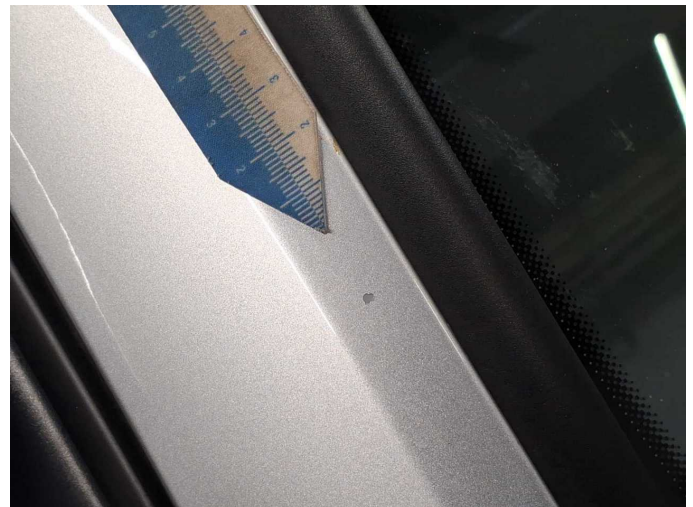
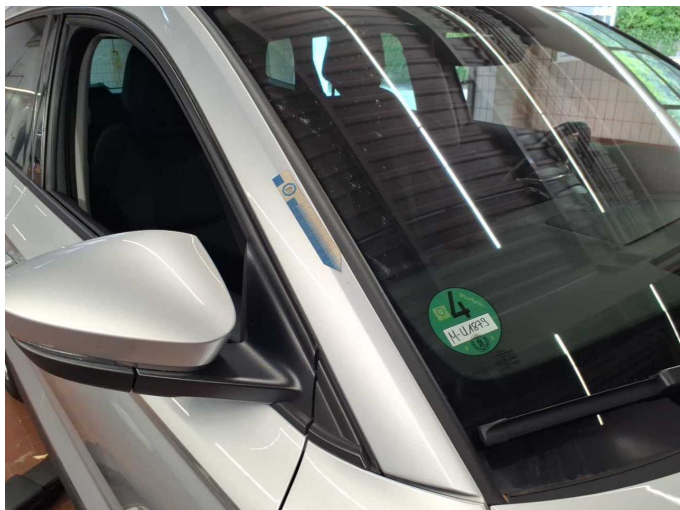
| No. | Component group | Description |
|---|---|---|
| 3 | Roof | Roof rail - right side - Stone chips - No deduction |

**Wear and tear 3:** Roof: Roof rail - right side - Stone chips - No deduction
