Expertise

Protocol number: 46494875  
Order No. / Reference: 26620279  
Inspection date: 14 Jul 2026

Manufacturer: Mercedes-Benz  
VIN: W1N4N1FB9PJ524844

Model: GLA 220 d 4Matic 8G-DCT AMG Line

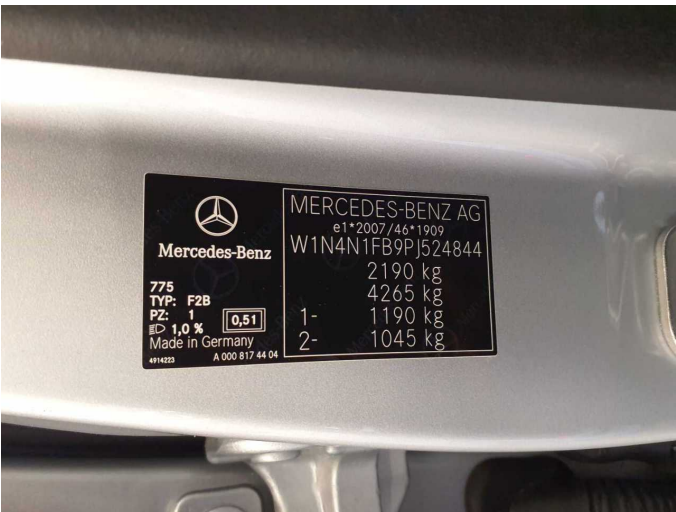
Figure 11: VIN

| VIN comparison | The vehicle identification number (VIN) was read from the vehicle and its conformity with the submitted documents was confirmed by the undersigned during the inspection. |

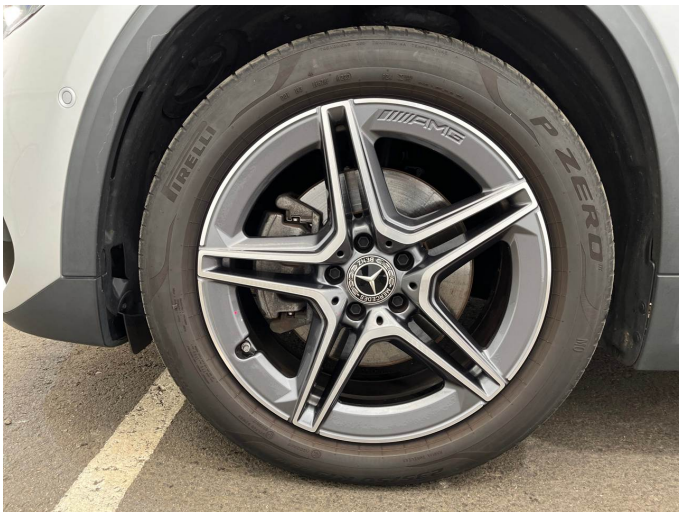
Figure 12: Mounted tyres

| Tyres | | | |
|---|---|---|---|
| 1) | 235/50 R19 99W | Summer tyres on Light alloy | 5mm / 5mm |
| 2) | 235/50 R19 99W | Summer tyres on Light alloy | 6mm / 6mm |

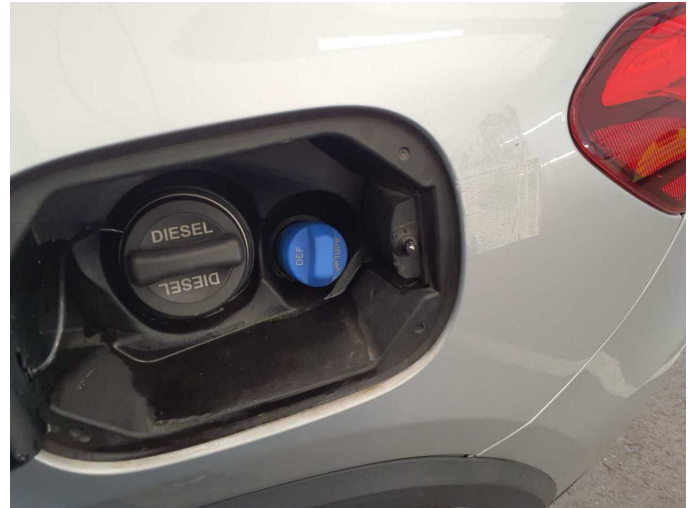
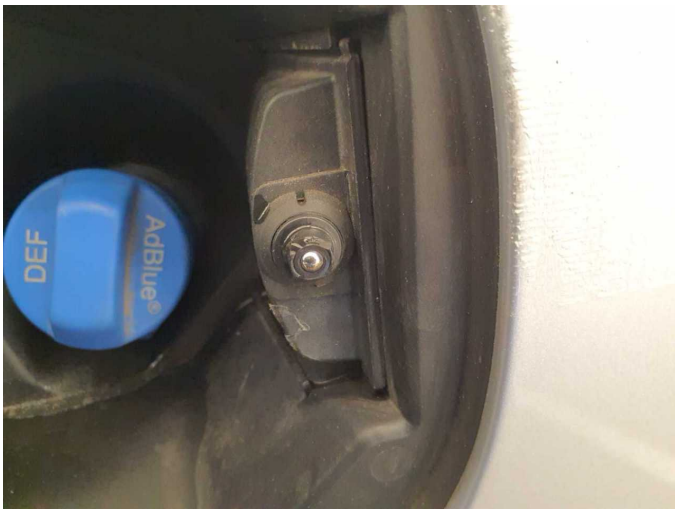
**Damage 2:** Fuel system: Tank flap (Betätigung) - Broken / torn - Replace

| No. | Component group | Description |
|---|---|---|
| 2 | Fuel system | Tank flap (Betätigung) - Broken / torn - Replace |

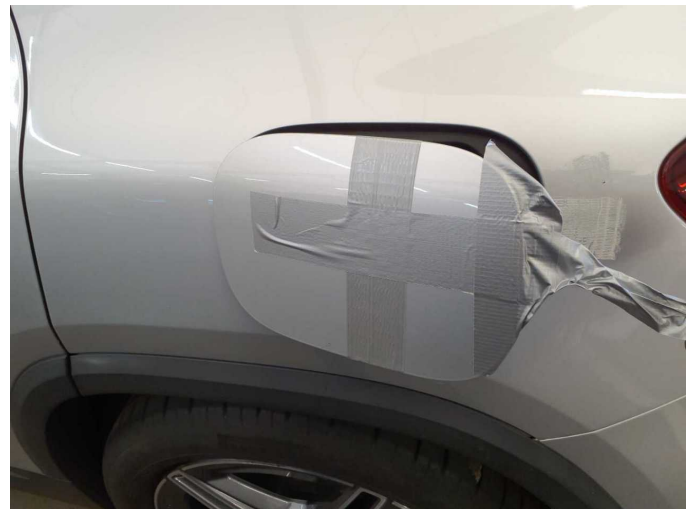
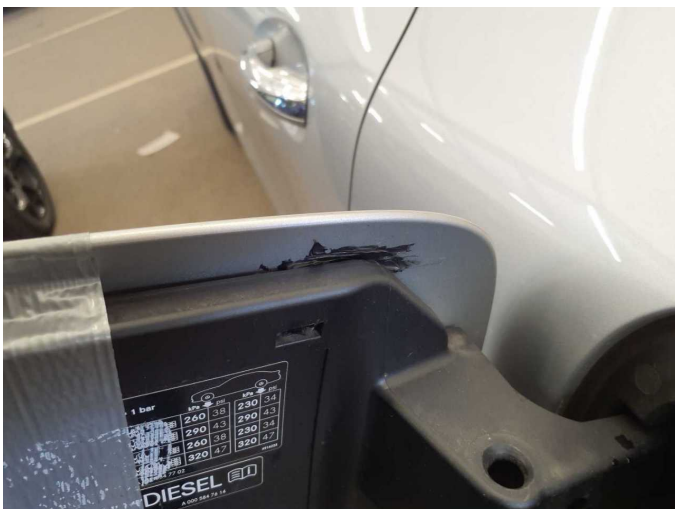
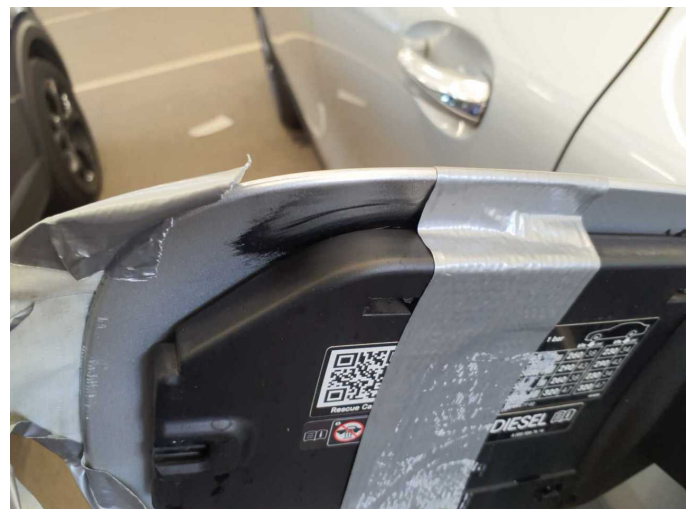
**Damage 3:** Fuel system: Tank flap - Broken / torn - Replace

| No. | Component group | Description |
|---|---|---|
| 3 | Fuel system | Tank flap - Broken / torn - Replace |

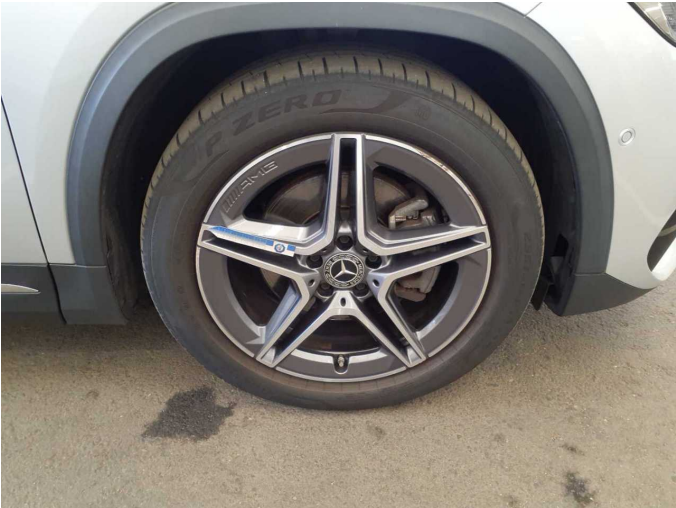
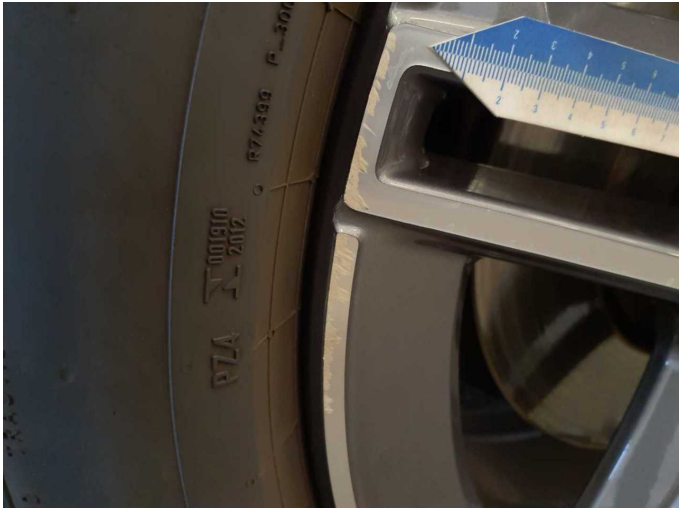
**Damage 4:** Wheel / tyres: Alloy rim - front right side - Scratched - Replace

| No. | Component group | Description |
|---|---|---|
| 4 | Wheel / tyres | Alloy rim - front right side - Scratched - Replace |

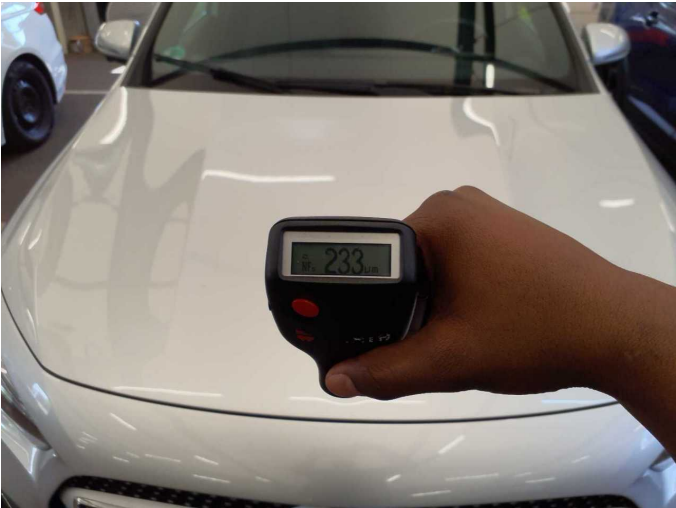
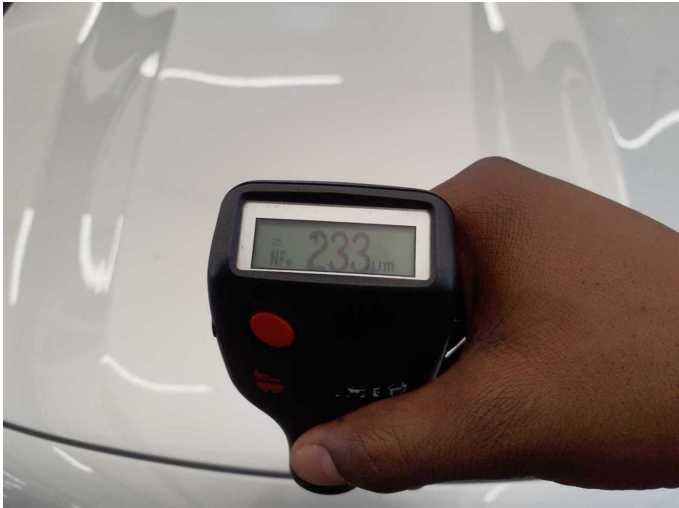
| No. | Repainting |
|---|---|
| 1 | Bonnet, Professionally carried out, Invoice of repair done Non-existent |

**Repainting 1:** Bonnet

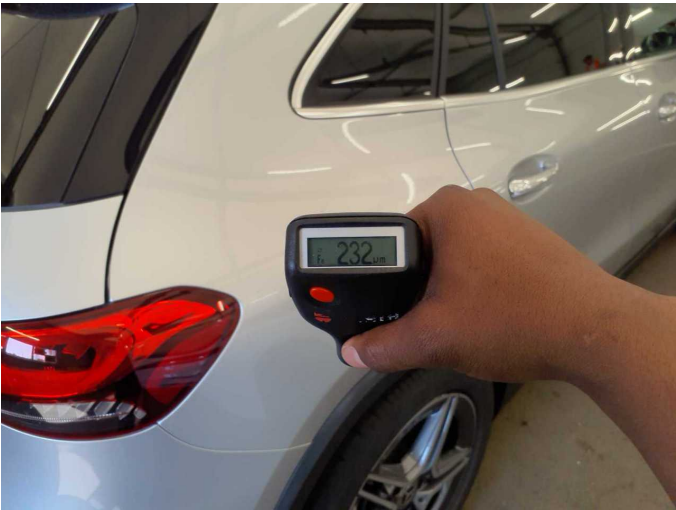
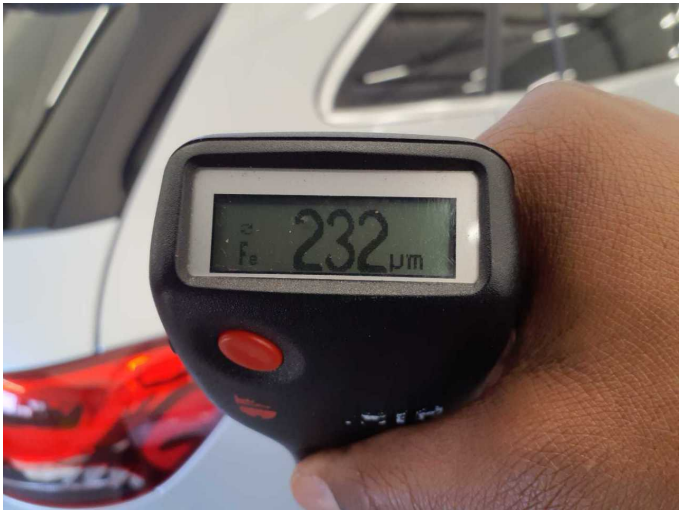
| No. | Repainting |
|---|---|
| 2 | Side panel - rear right side, Professionally carried out, Invoice of repair done Non-existent |

| Side panel - rear right side | 232 µm |

**Repainting 2:** Side panel - rear right side
