Expertise

Protocol number: 46838146  
Order No. / Reference: 26830504  
Inspection date: 31 Jul 2026

| Manufacturer: Opel | Model: Insignia Sports Tourer 2.0 Diesel Aut. Business |

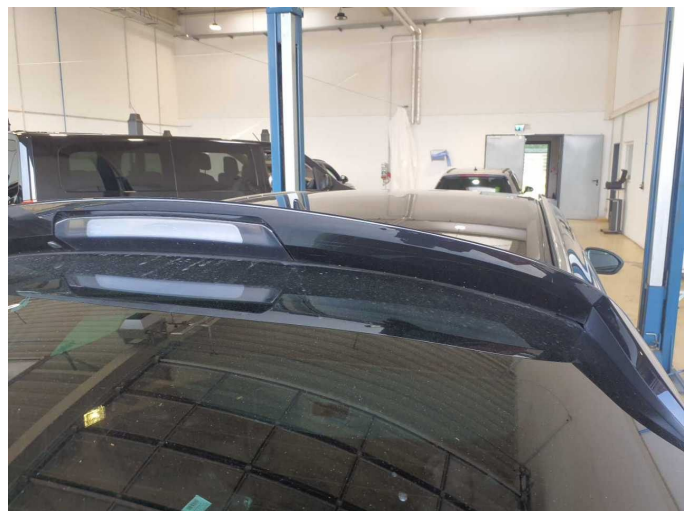
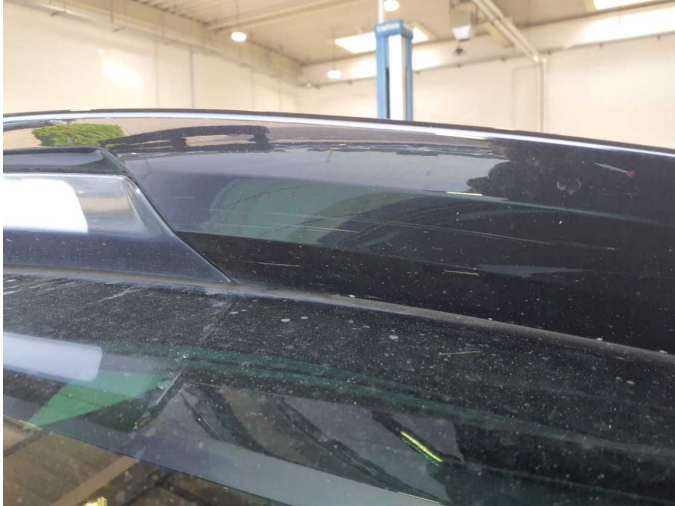
| No. | Component group | Description |
|---|---|---|
| 1 | Boot lid / rear door | Rear spoiler - Scratch(es) - Smart repair |

**Damage 1:** Boot lid / rear door: Rear spoiler - Scratch(es) - Smart repair

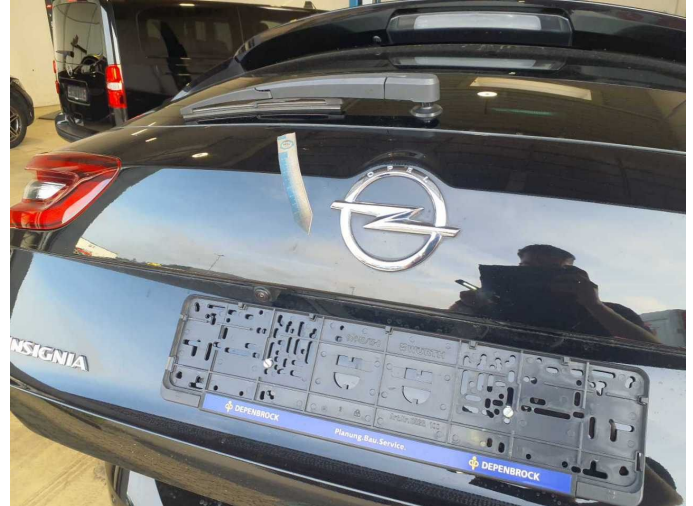
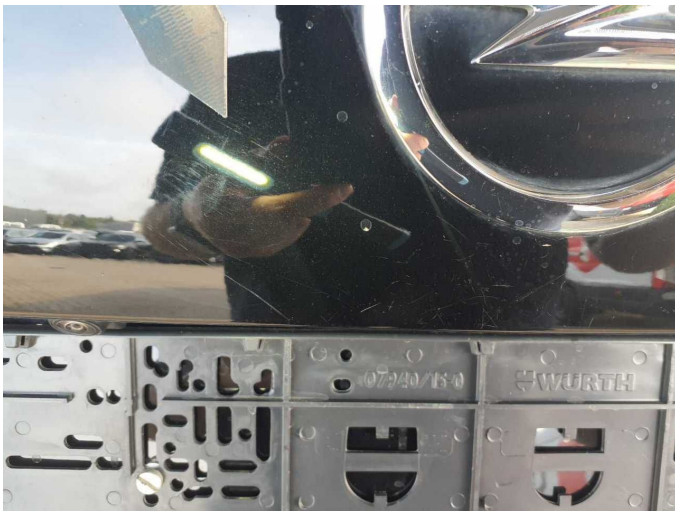
| No. | Component group | Description |
|---|---|---|
| 2 | Boot lid / rear door | Boot lid - Scratch(es) - Smart repair |

**Damage 2:** Boot lid / rear door: Boot lid - Scratch(es) - Smart repair

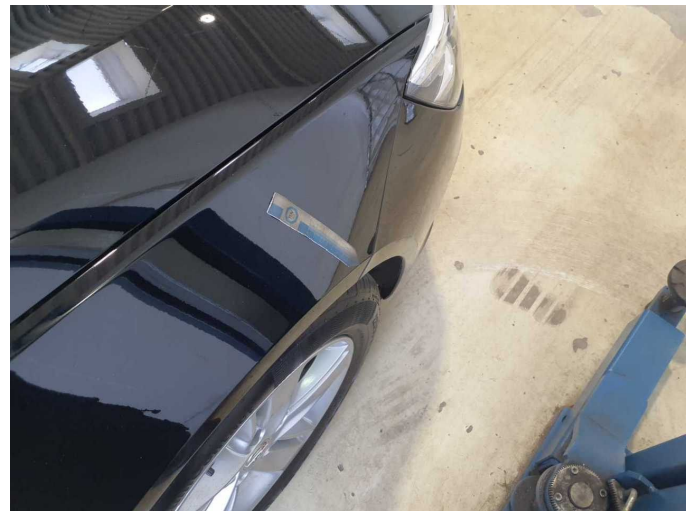
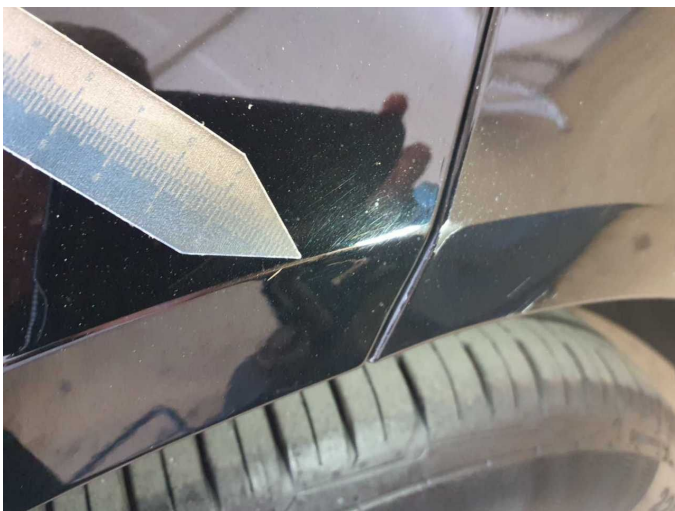
| No. | Component group | Description |
|---|---|---|
| 3 | Mudguard - right side | Mudguard - right side - Scratch(es) - Smart repair |

**Damage 3:** Mudguard - right side: Mudguard - right side - Scratch(es) - Smart repair

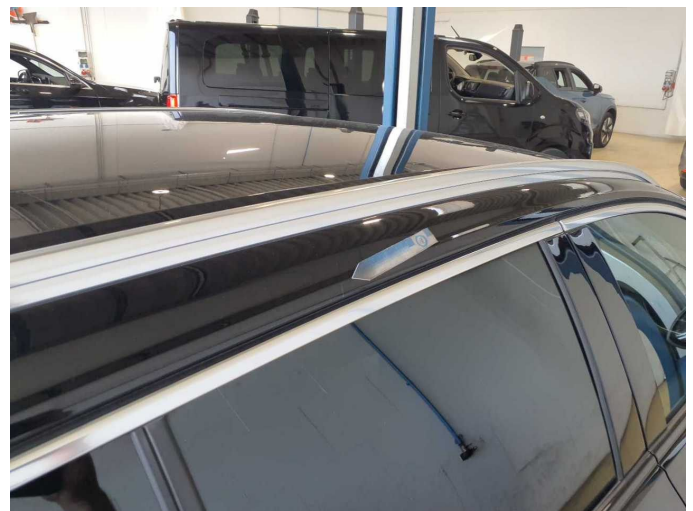
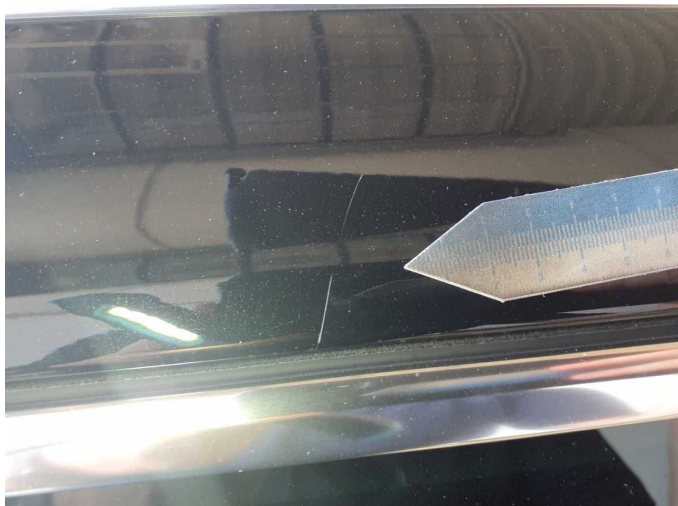
| No. | Component group | Description |
|---|---|---|
| 4 | Roof | Roof rail - right side - Scratch(es) - Smart repair |

**Damage 4:** Roof: Roof rail - right side - Scratch(es) - Smart repair

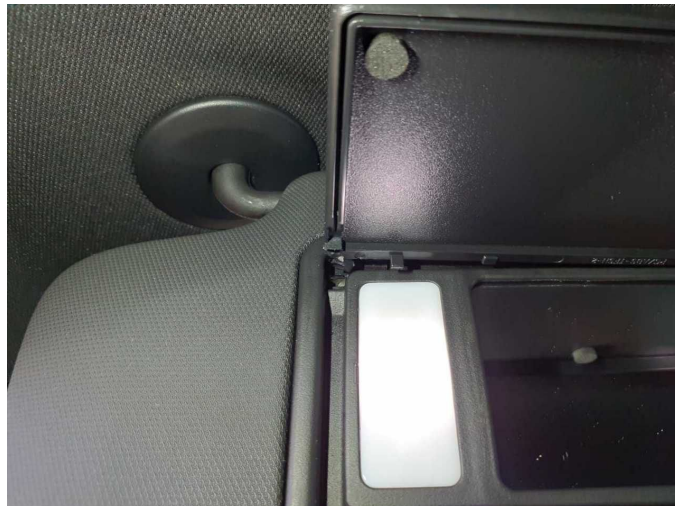
| No. | Component group | Description |
|---|---|---|
| 5 | Interior | Sun visor - left side - Broken / torn - Replace |

**Damage 5:** Interior: Sun visor - left side - Broken / torn - Replace

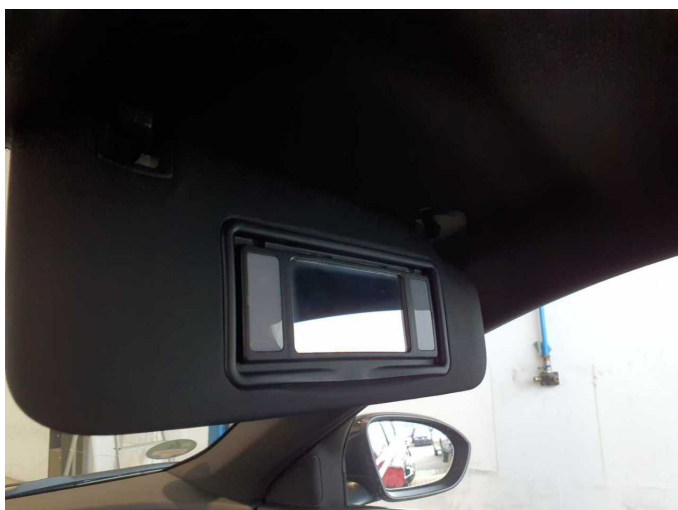
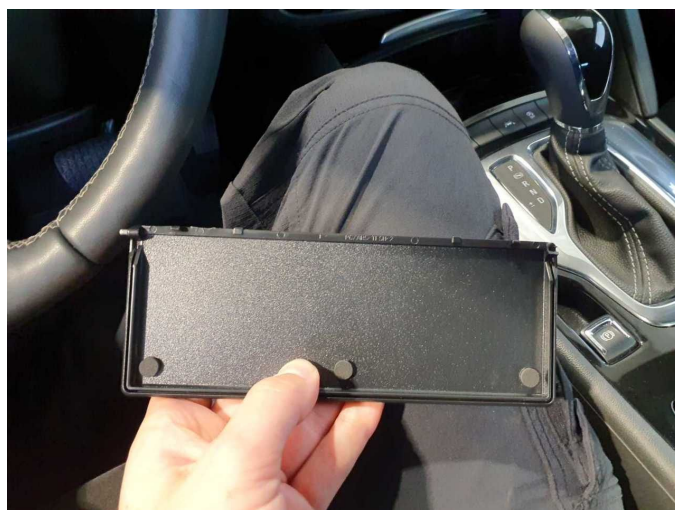
| No. | Component group | Description |
|---|---|---|
| 6 | Interior | Sun visor - right side - Broken / torn - Replace |

**Damage 6:** Interior: Sun visor - right side - Broken / torn - Replace

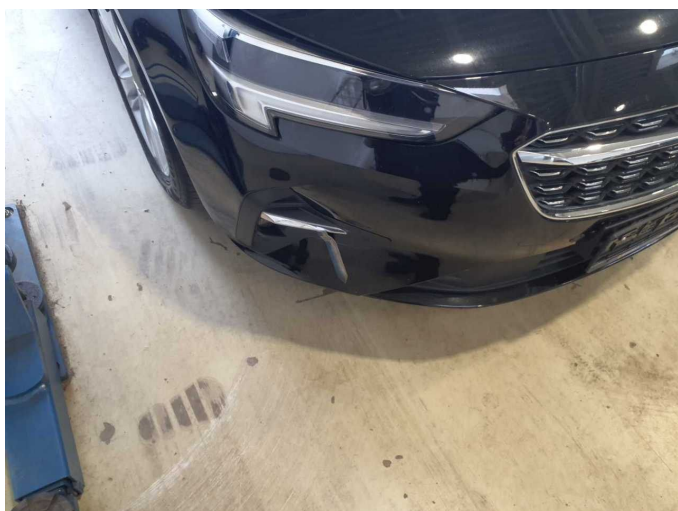
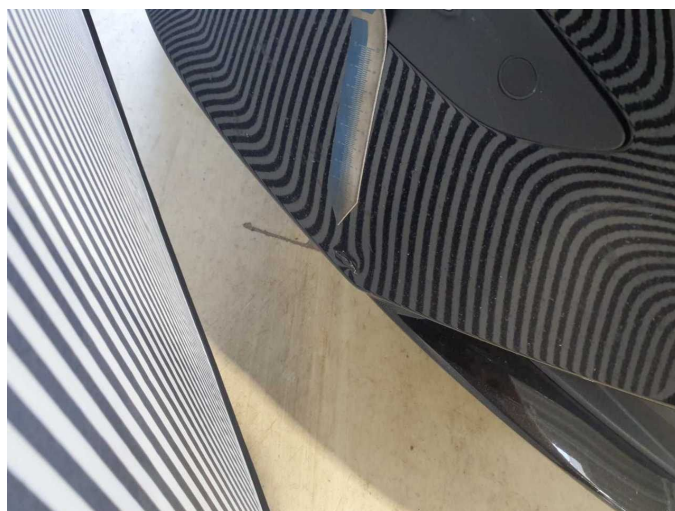
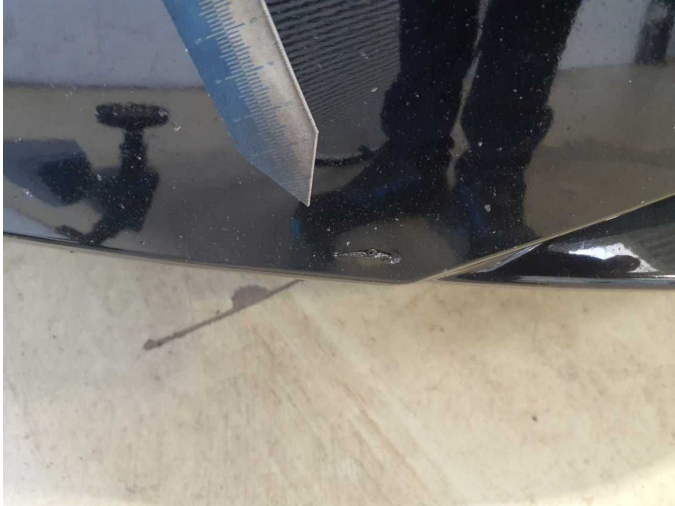
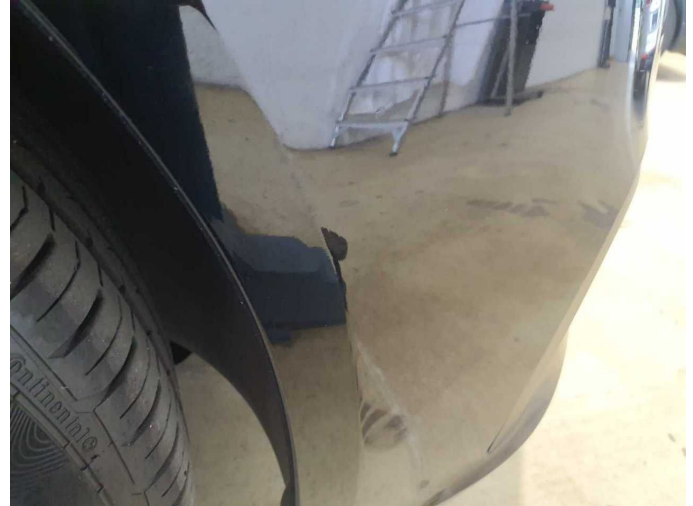
| No. | Component group | Description |
|---|---|---|
| 7 | Front bumper | Front bumper - Dent / paintcoat damage - Repair and paint |

**Damage 7:** Front bumper: Front bumper - Dent / paintcoat damage - Repair and paint

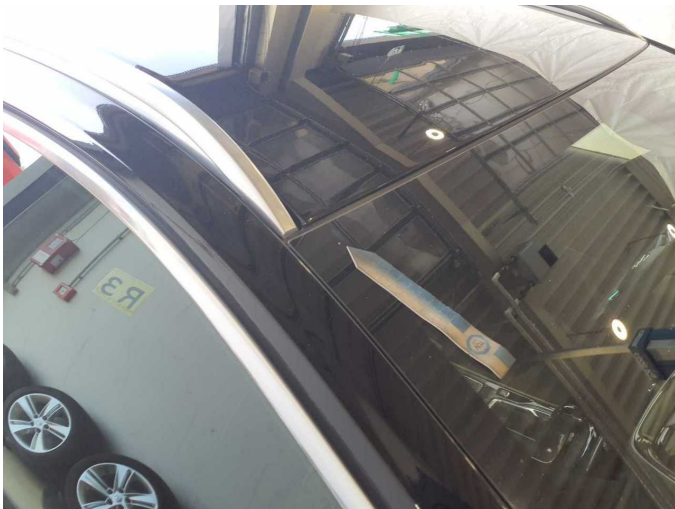
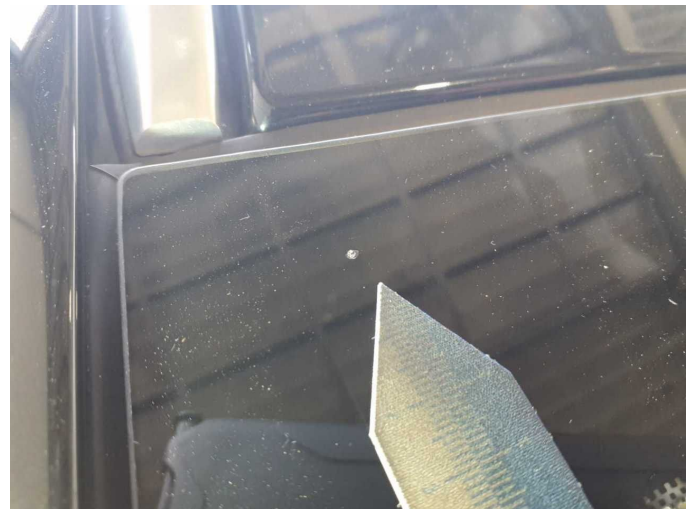
| No. | Component group | Description |
|---|---|---|
| 8 | Vehicle glazing | Windscreen - Stone chips - Replace |

**Damage 8:** Vehicle glazing: Windscreen - Stone chips - Replace
