Expertise

Protocol number: 45966229
Order No. / Reference: 26412914
Inspection date: 16 Jun 2026

Model: Focus Turnier 1.5 EcoBlue Start-Stopp-System Aut. TITANIUM

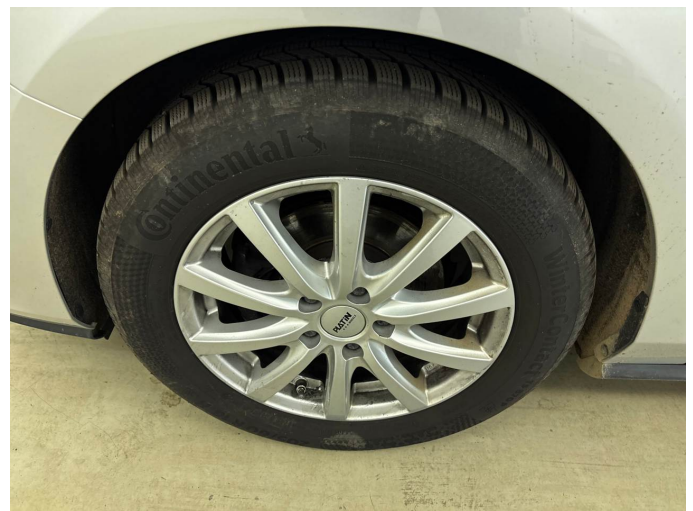
Figure 12: Mounted tyres

Mounted tyres				
#	Tyre size	Type of tyre	Manufacturer	Tread depth
1)	205/60 R16 92H	Winter tyres on Light alloy	Continental	5mm / 5mm
2)	205/60 R16 92H	Winter tyres on Light alloy	Continental	5mm / 5mm
Additional tyres				
#	Tyre size	Type of tyre	Manufacturer	Tread depth
1)	205/60 R16 92V	Summer tyres on Steel rim with wheel cover	Goodyear	6mm / 6mm
2)	205/60 R16 92V	Summer tyres on Steel rim with wheel cover	Goodyear	6mm / 6mm
Replacement				
Typ	Tyre size	Type of tyre	Manufacturer	Tread depth
	Tirefit	Expiration date 05/2027

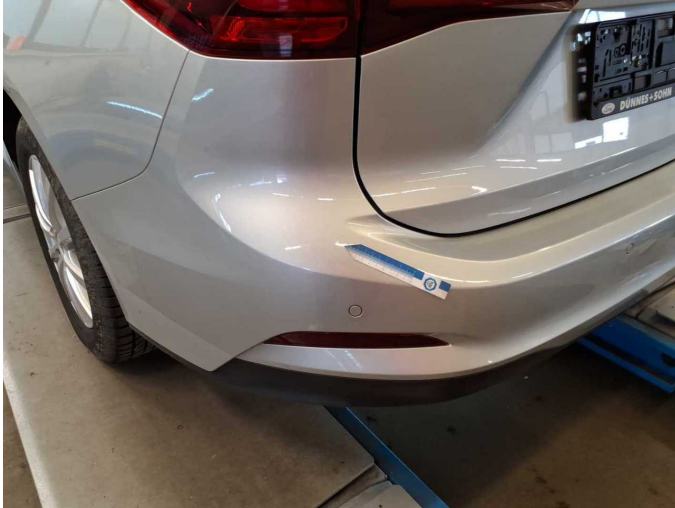
Damage 2: Rear bumper: Rear bumper - Scratch(es) - Paint

No.	Component group	Description
1	Interior	Interior - Odour - Ozone treatment
2	Rear bumper	Rear bumper - Scratch(es) - Paint

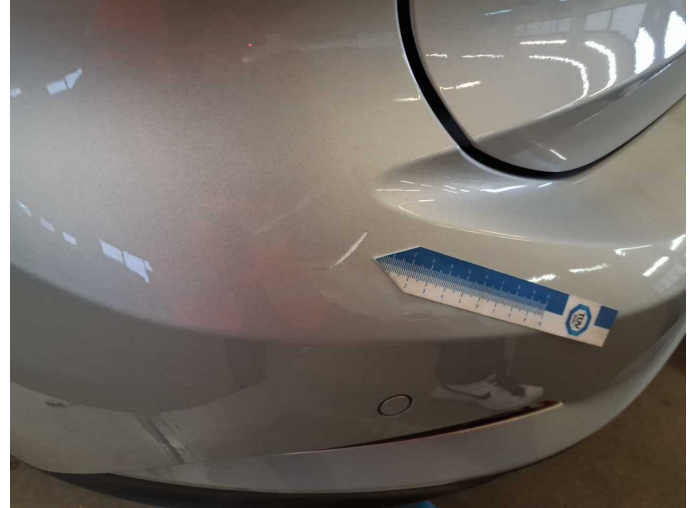
Damage 2: Rear bumper: Rear bumper - Scratch(es) - Paint

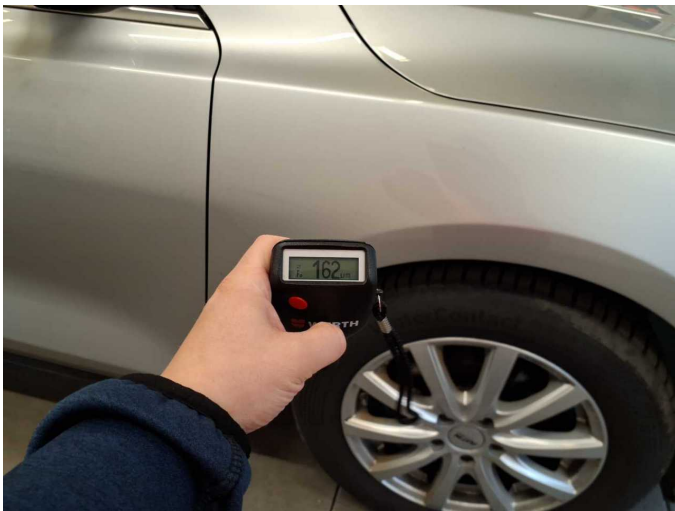
1	Mudguard - right side, Professionally carried out, Invoice of repair done Non-existent
---	--

Mudguard - right side	162 µm
-----------------------	--------

Repainting 1: Mudguard - right side
