## Expertise

Protocol number: 46098841  
Order No. / Reference: 26528009  
Inspection date: 18 Jun 2026

Model: Focus 1.5 EcoBlue Start-Stopp-System Aut. TITANIUM X

VIN: WF0NXXGCHNPD64230

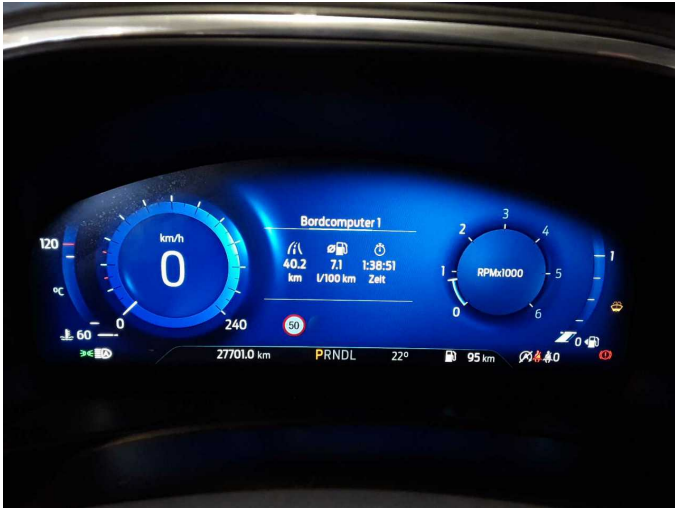
**Mileage (Read)** 27,701 km

Figure 7: Instrument cluster

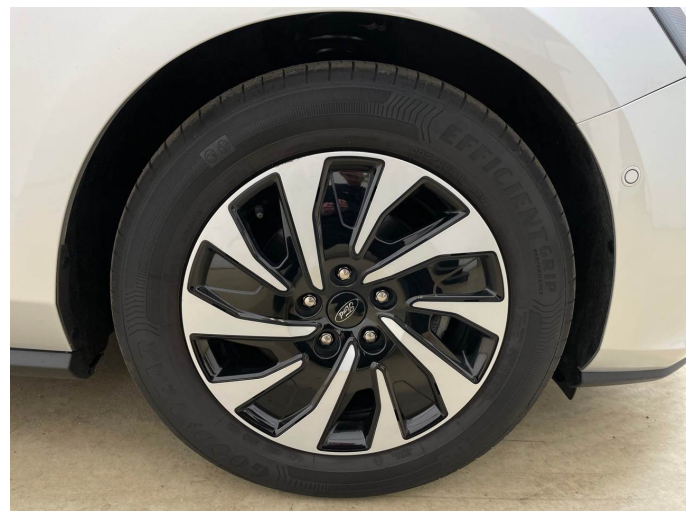
#	Tyre size	Type of tyre	Manufacturer	Tread depth
1)	205/60 R16 92V	Summer tyres on Steel rim with wheel cover	Goodyear	5mm / 5mm
2)	205/60 R16 92V	Summer tyres on Steel rim with wheel cover	Goodyear	5mm / 5mm

Figure 12: Mounted tyres

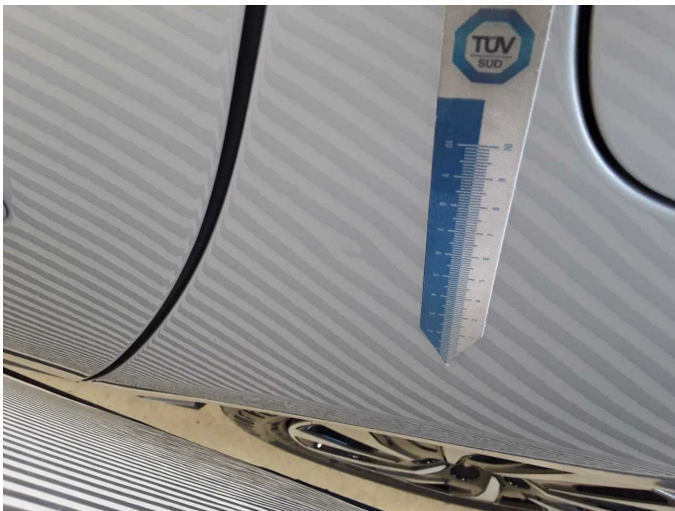
No.	Component group	Description
1	Side panel - rear left side	Side panel - dent(s) - Smooth repair work

Damage 1: Side panel - rear left side: Side panel - dent(s) - Smooth repair work

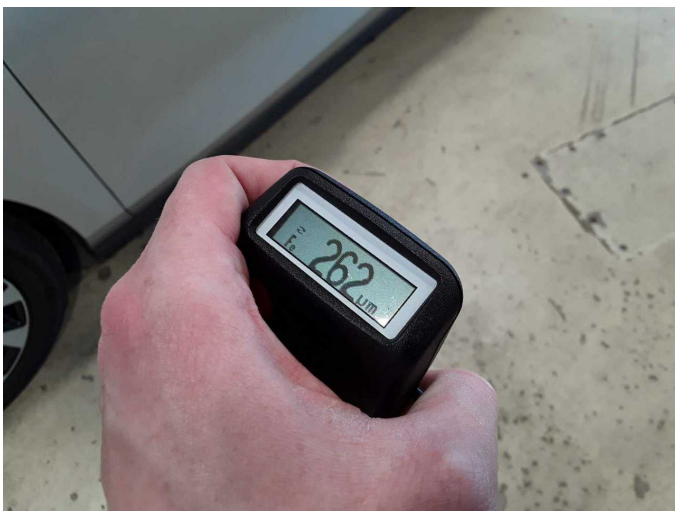
No.	Repainting
1	Door - front left side, Professionally carried out, Invoice of repair done Non-existent

Door - front left side	262 µm
------------------------	--------

Repainting 1: Door - front left side
