Expertise

Protocol number: 46606655  
Order No. / Reference: 26453225  
Inspection date: 20 Jul 2026

Model: Focus Turnier 1.5 EcoBlue Start-Stopp-System  
COOL&CONNECT

VIN: WF0PXXGCHPLS81213

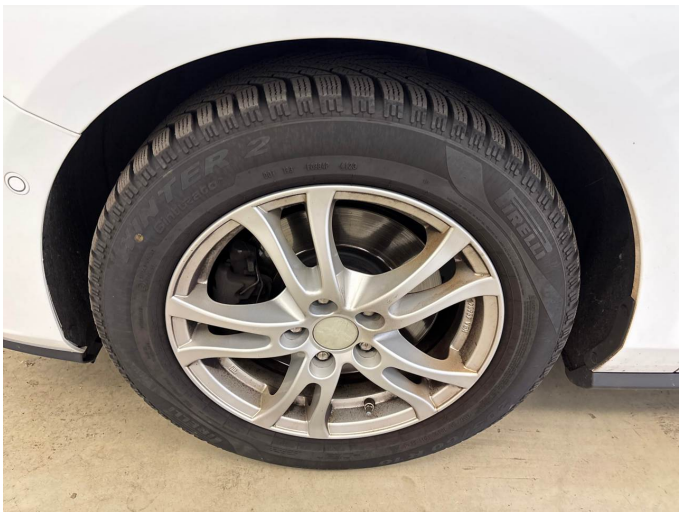
Figure 12: Mounted tyres

| Tyres | | | | |
|---|---|---|---|---|
| 1) | 205/60 R16 96H | Winter tyres on Light alloy | Pirelli | 5mm / 5mm |
| 2) | 205/60 R16 96H | Winter tyres on Light alloy | Pirelli | 6mm / 6mm |

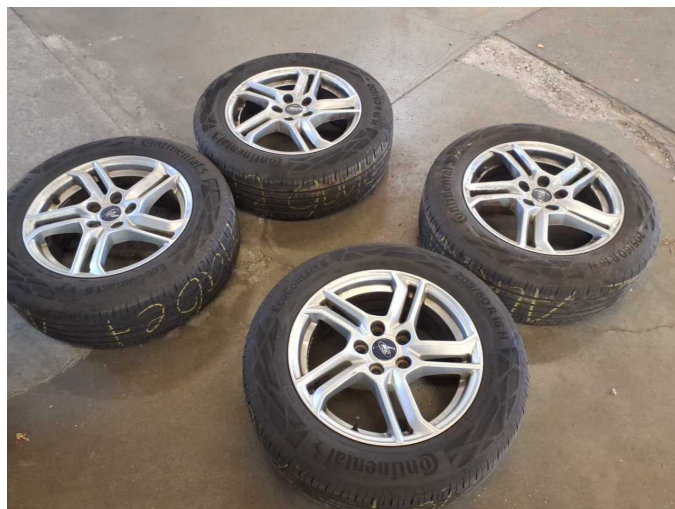
Figure 20: Additional tyres

| Tyres | | | | |
|---|---|---|---|---|
| 1) | 205/60 R16 92H | Summer tyres on Light alloy | Continental | 5mm / 5mm |
| 2) | 205/60 R16 92H | Summer tyres on Light alloy | Continental | 6mm / 6mm |

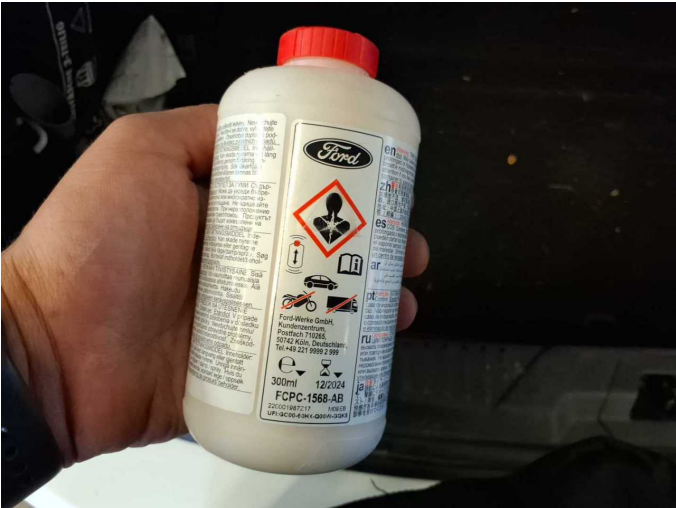
Damage 1: Equipment: Tirefit filler - Expired - Replace

| No. | Component group | Description |
|---|---|---|
| 1 | Equipment | Tirefit filler - Expired - Replace |

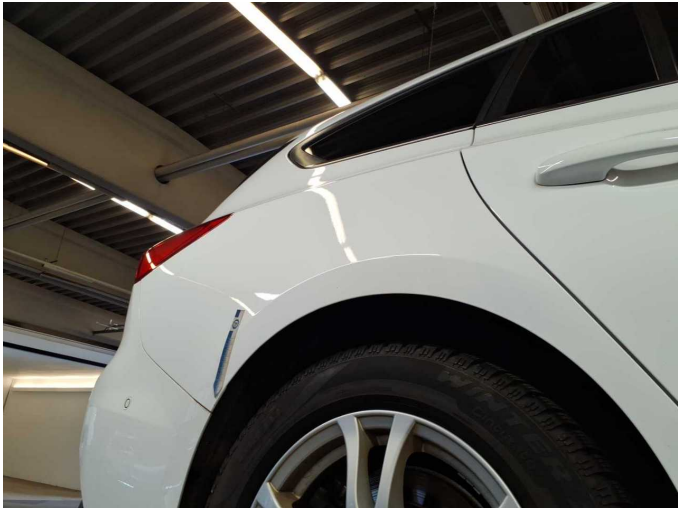
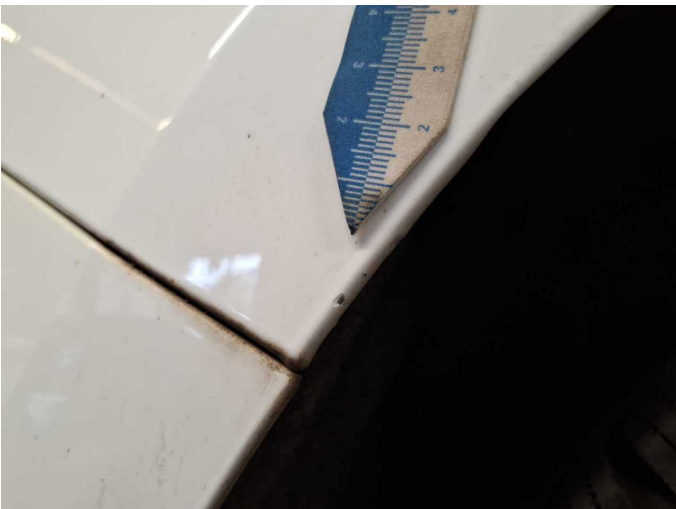
Damage 2: Side panel - rear right side: Side panel - Stone chips - Smart repair

| No. | Component group | Description |
|---|---|---|
| 2 | Side panel - rear right side | Side panel - Stone chips - Smart repair |

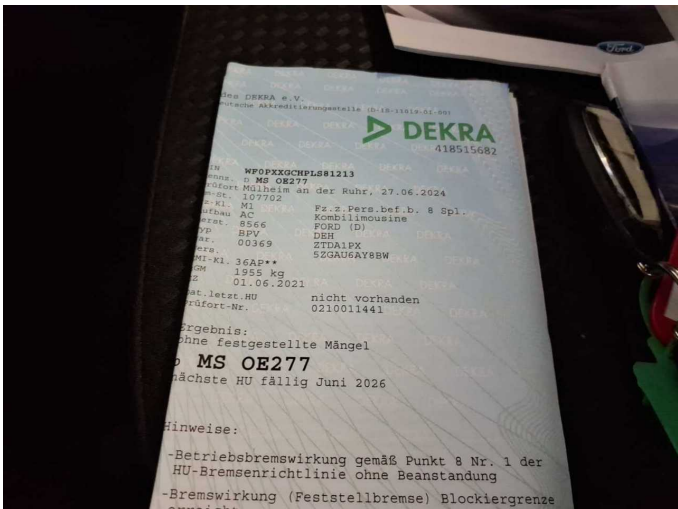
Damage 3: Misc.: Main inspection - Due - Replace

| No. | Component group | Description |
|---|---|---|
| 3 | Misc. | Main inspection - Due - Replace |

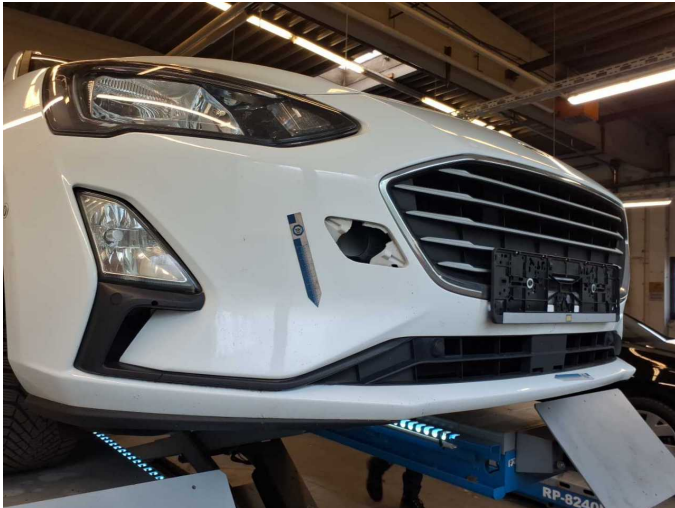
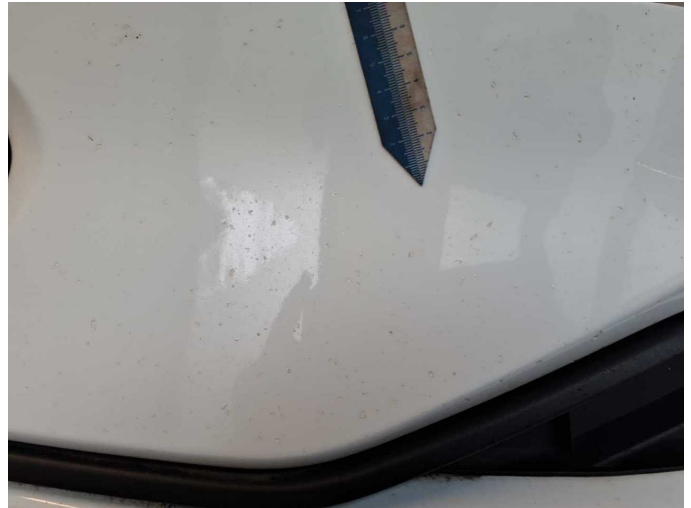
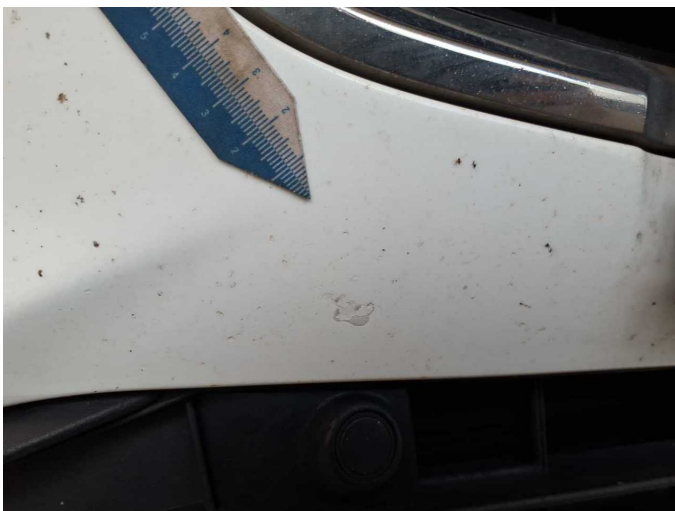
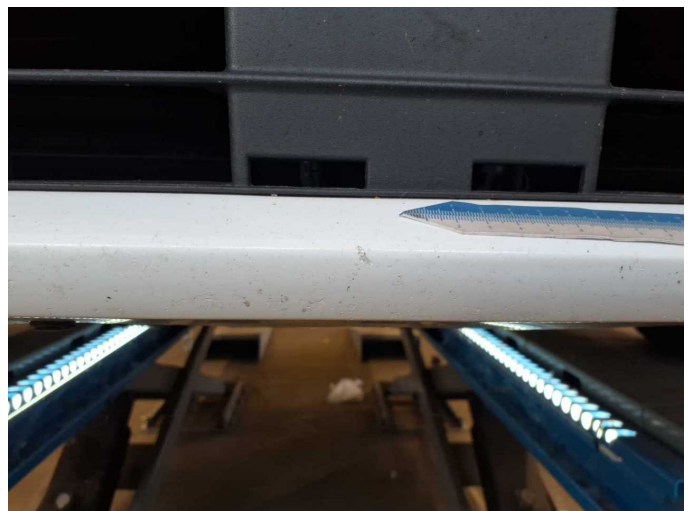
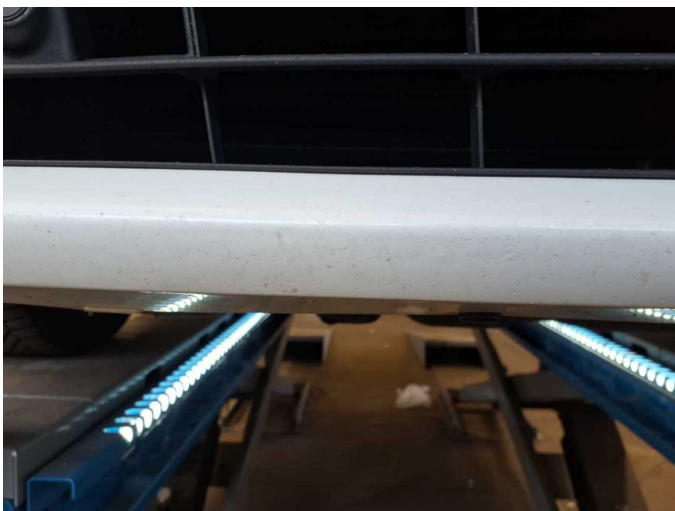
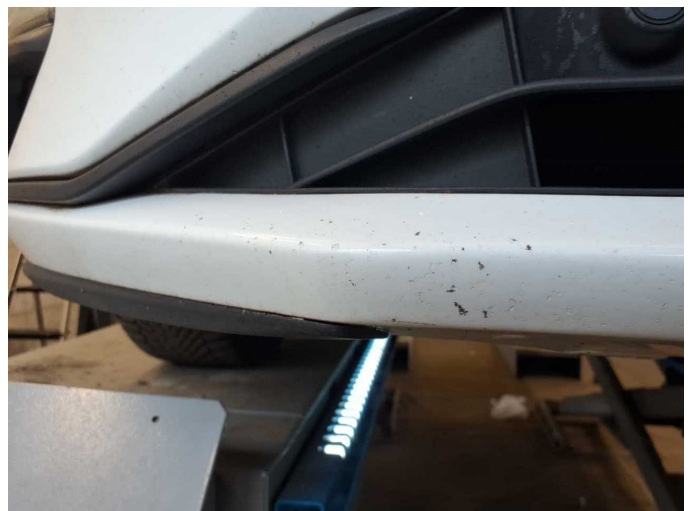
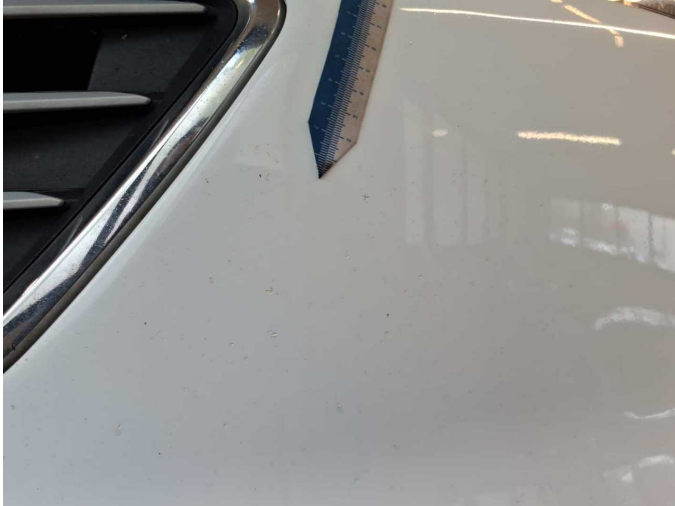
**Damage 4:** Front bumper: Front bumper - Stone chips - Paint

| No. | Component group | Description |
|---|---|---|
| 4 | Front bumper | Front bumper - Stone chips - Paint |

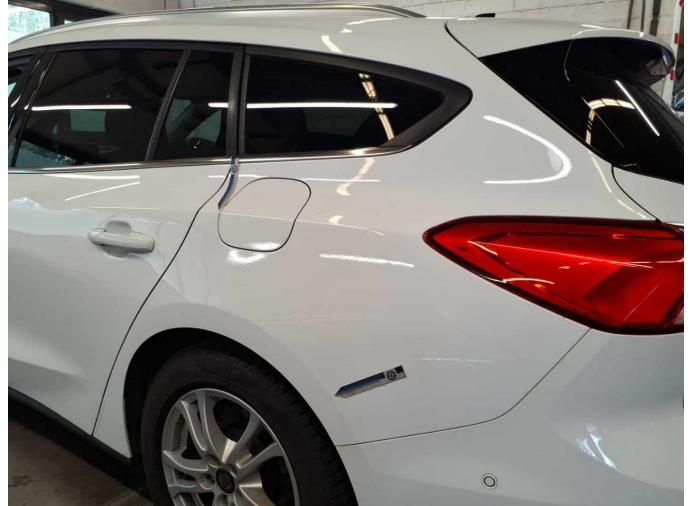
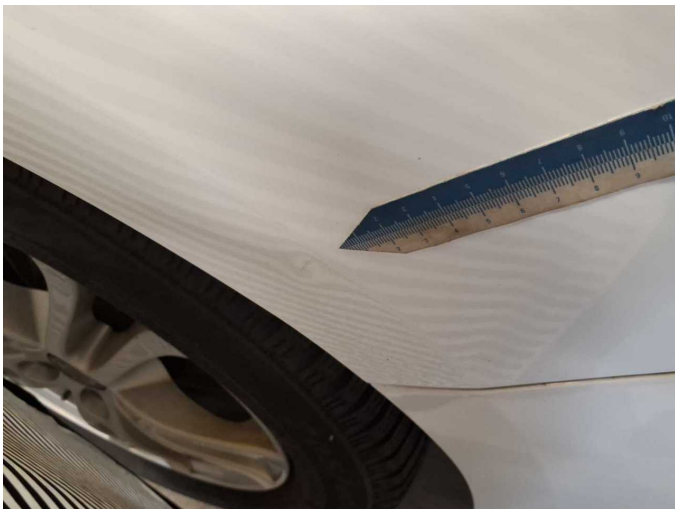
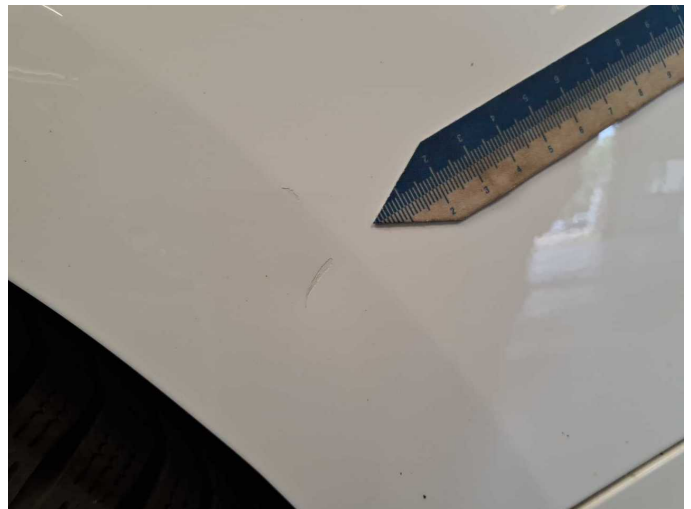
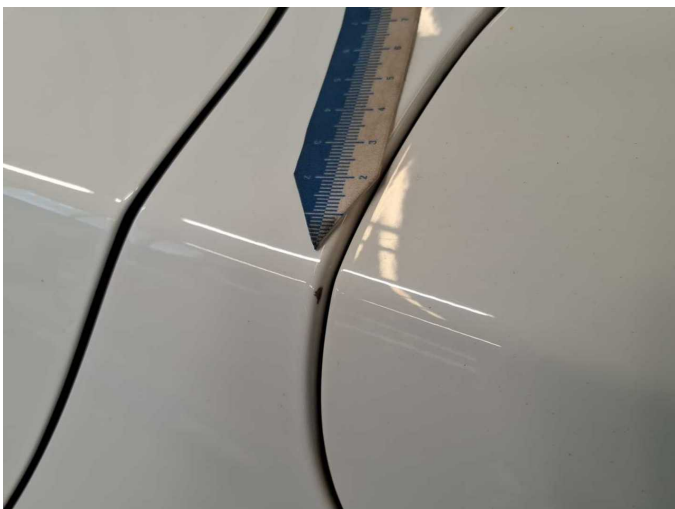
**Damage 5:** Side panel - rear left side: Side panel - Dent / paintcoat damage - Repair and paint

| No. | Component group | Description |
|---|---|---|
| 5 | Side panel - rear left side | Side panel - Dent / paintcoat damage - Repair and paint |

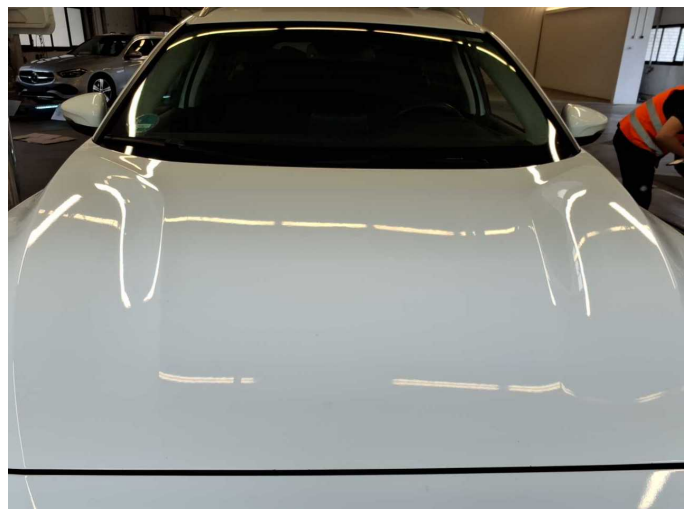
**Wear and tear 1:** Bonnet: Bonnet - Stone chips - No deduction

| No. | Component group | Description |
|---|---|---|
| 1 | Bonnet | Bonnet - Stone chips - No deduction |

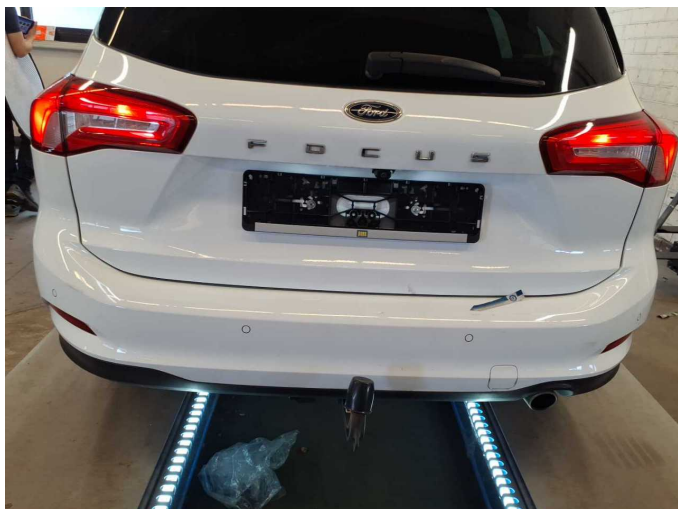
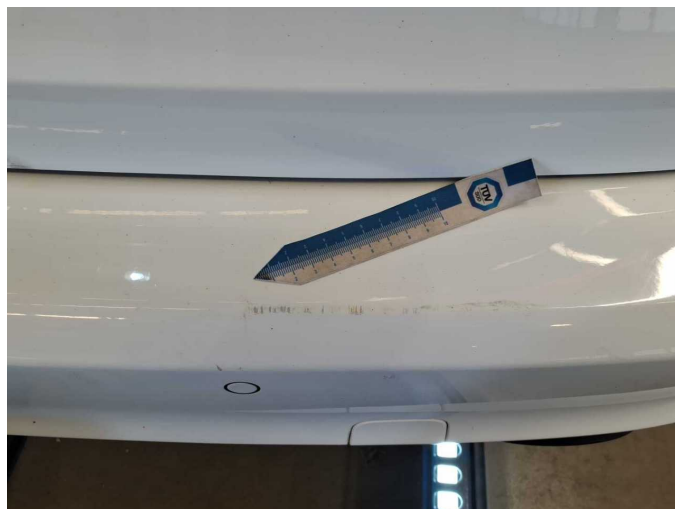
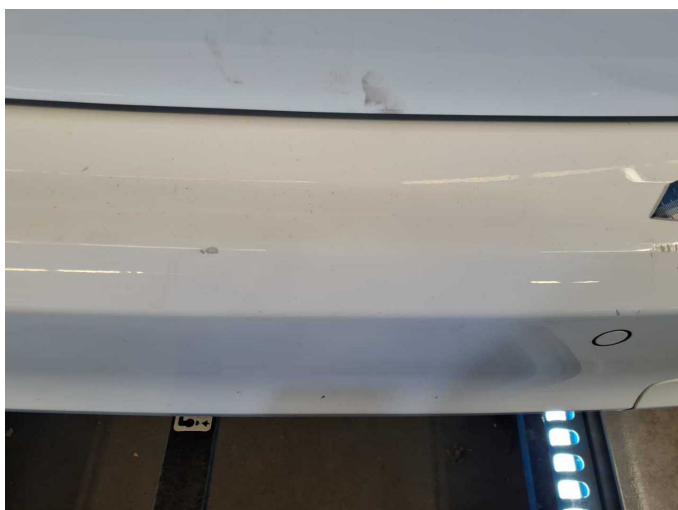
**Wear and tear 2:** Rear bumper: Rear bumper (Verladebereich) - Scratched - No deduction

| No. | Component group | Description |
|---|---|---|
| 2 | Rear bumper | Rear bumper (Verladebereich) - Scratched - No deduction |

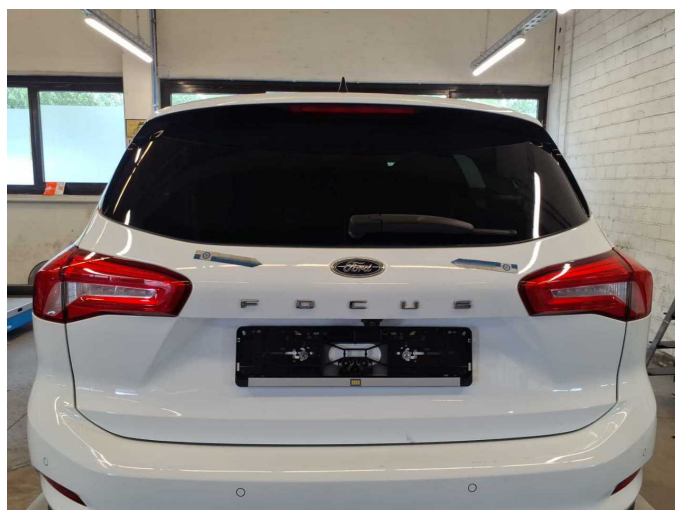
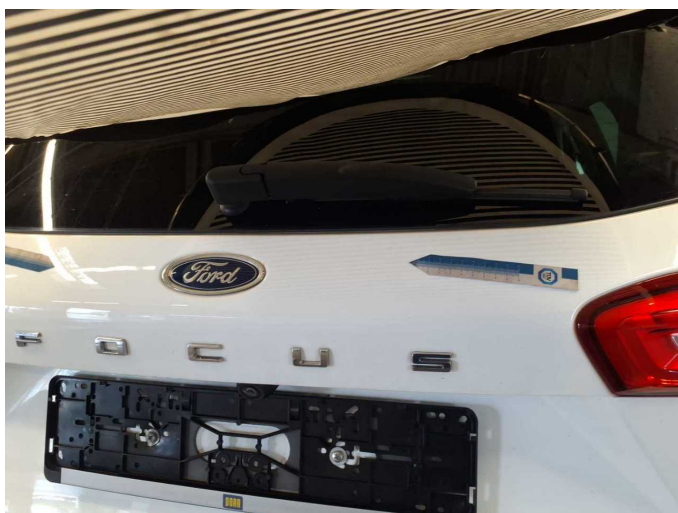
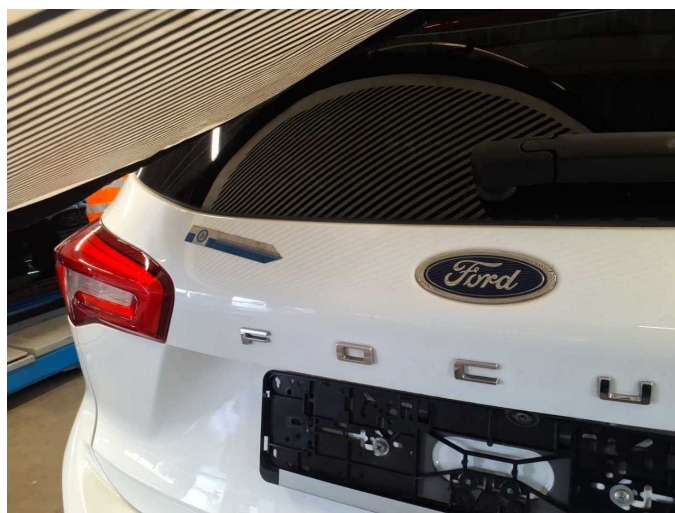
**Wear and tear 3:** Boot lid / rear door: Boot lid - dent(s) - No deduction

| No. | Component group | Description |
|---|---|---|
| 3 | Boot lid / rear door | Boot lid - dent(s) - No deduction |

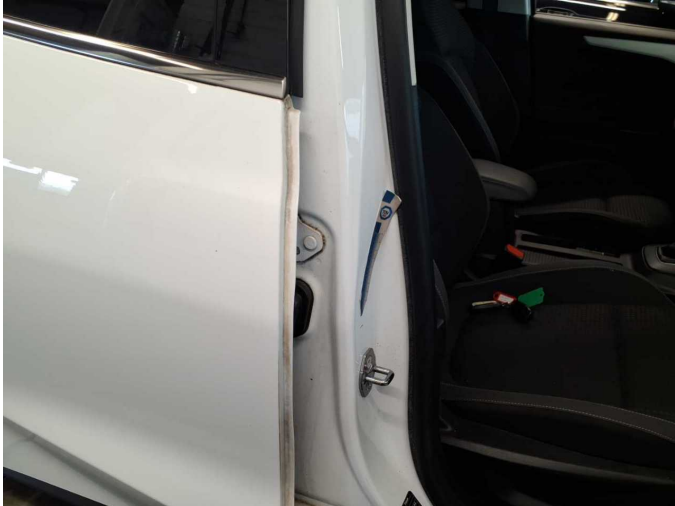
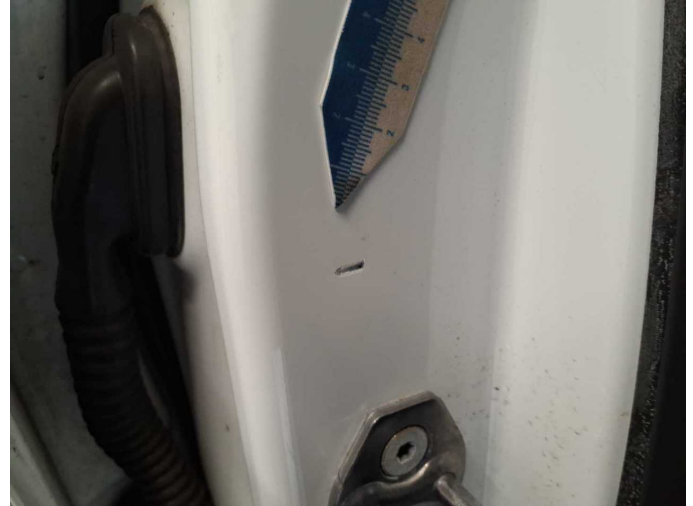
**Wear and tear 4:** Body: B-pillar - right side - Scratched - Smart repair

| No. | Component group | Description |
|---|---|---|
| 4 | Body | B-pillar - right side - Scratched - Smart repair |

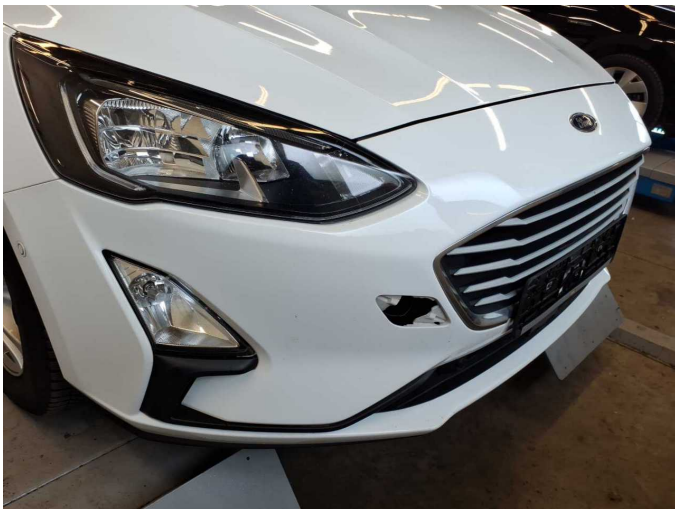
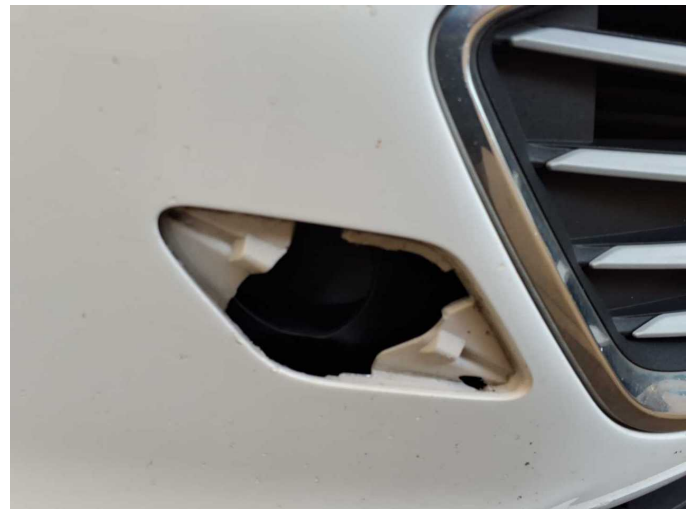
**Missing part 1:** Equipment: Towing eye - Missing - Replace

Equipment - Towing eye
