Protocol number: 46275816
Order No. / Reference: 26511559
Inspection date: 2 Jul 2026

Manufacturer: Opel

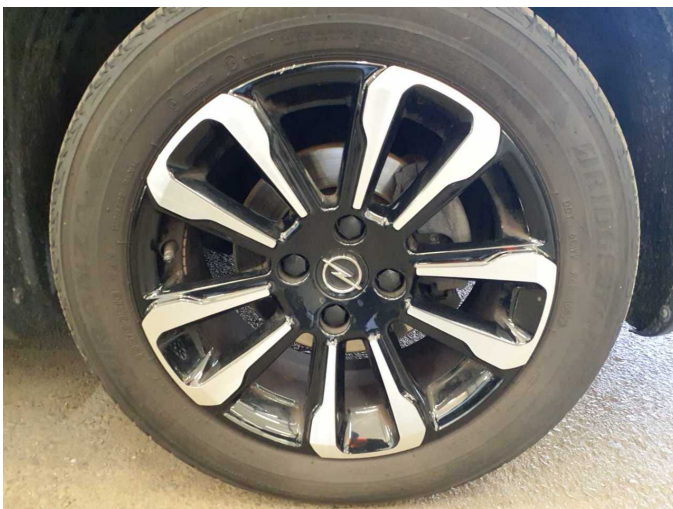
Damage 1: Wheel / tyres: Alloy rim - front right side - Scratch(es) - Loss in value

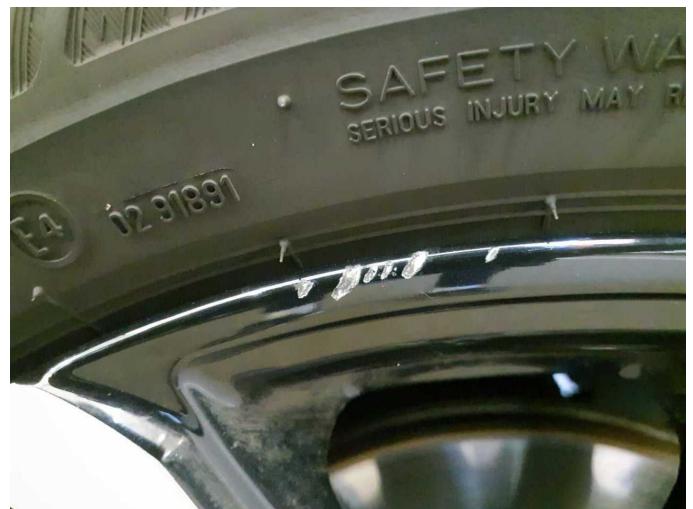
Damage 1: Wheel / tyres: Alloy rim - front right side - Scratch(es) - Loss in value

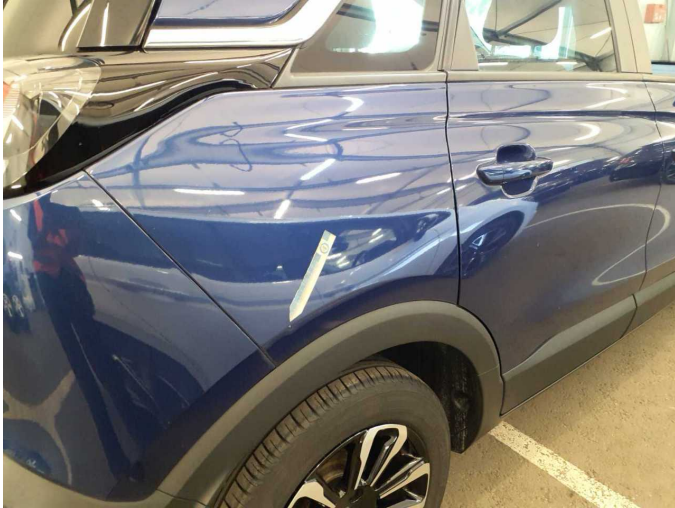
Damage 2: Side panel - rear right side: Side panel - dent(s) - Smart repair

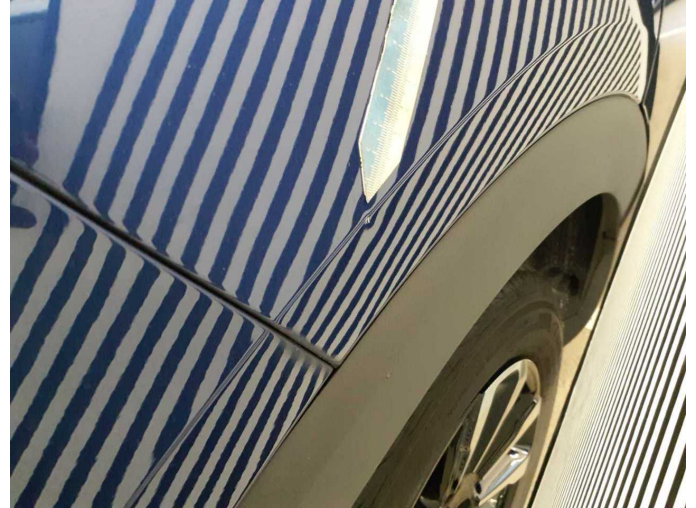
Damage 2: Side panel - rear right side: Side panel - dent(s) - Smart repair

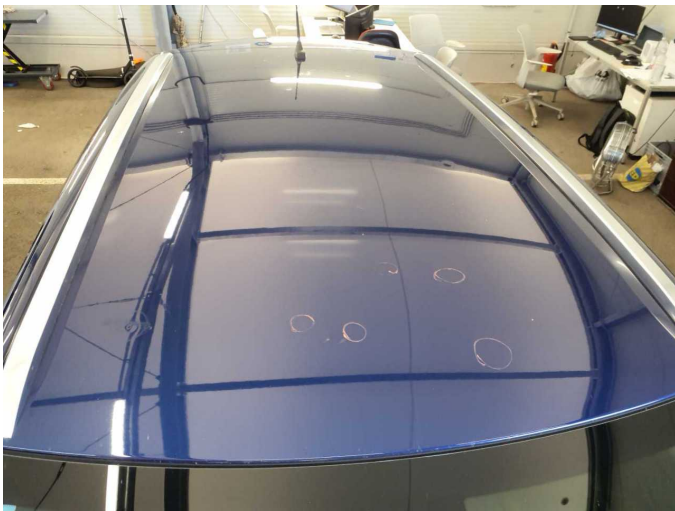
Damage 3: Body: Body - Damage by hail - Repair

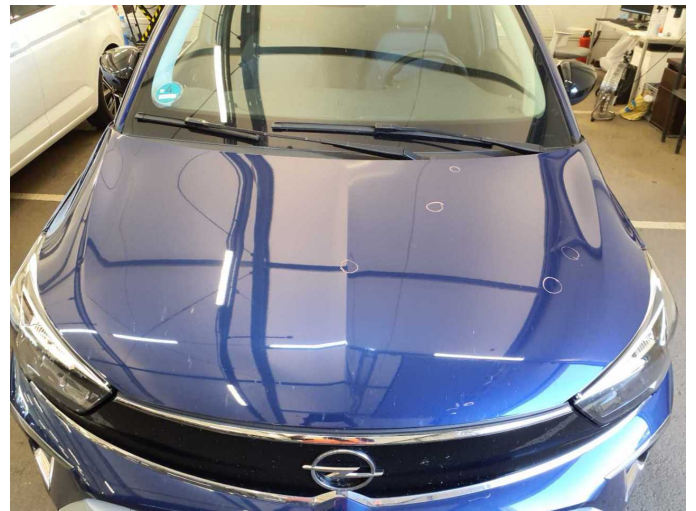
Damage 3: Body: Body - Damage by hail - Repair

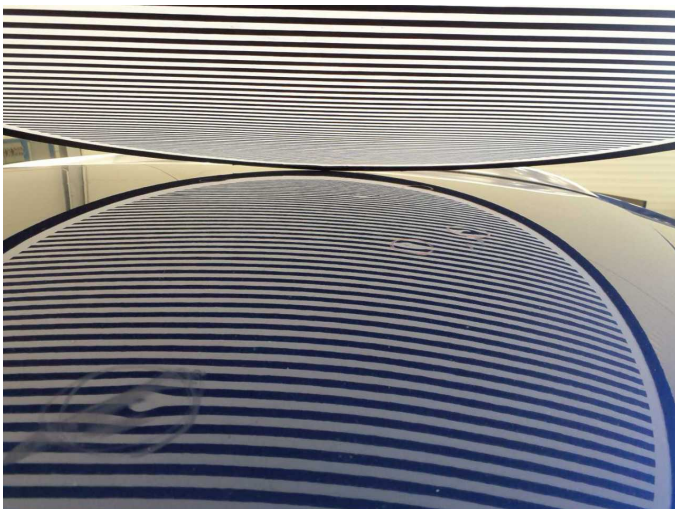
Damage 3: Body: Body - Damage by hail - Repair

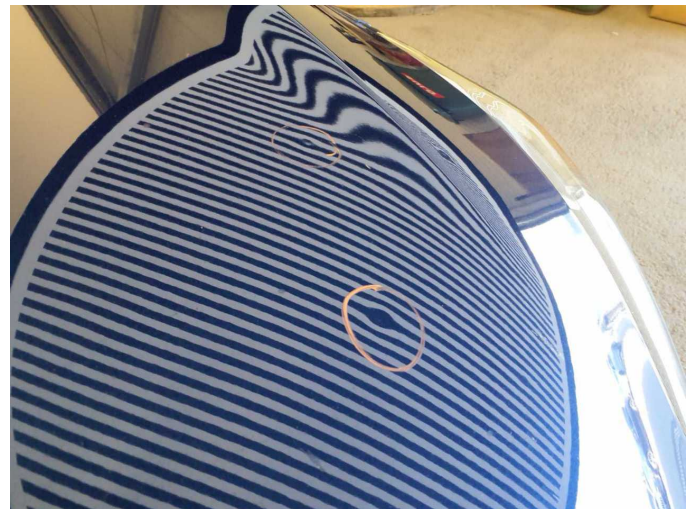
Damage 3: Body: Body - Damage by hail - Repair

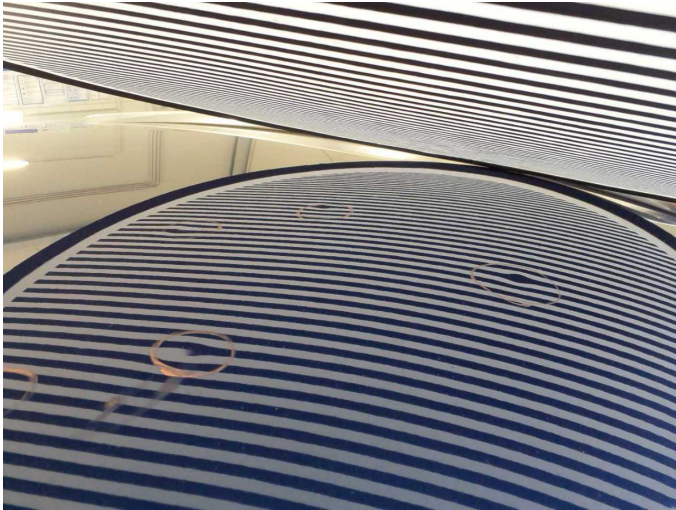
Damage 3: Body: Body - Damage by hail - Repair

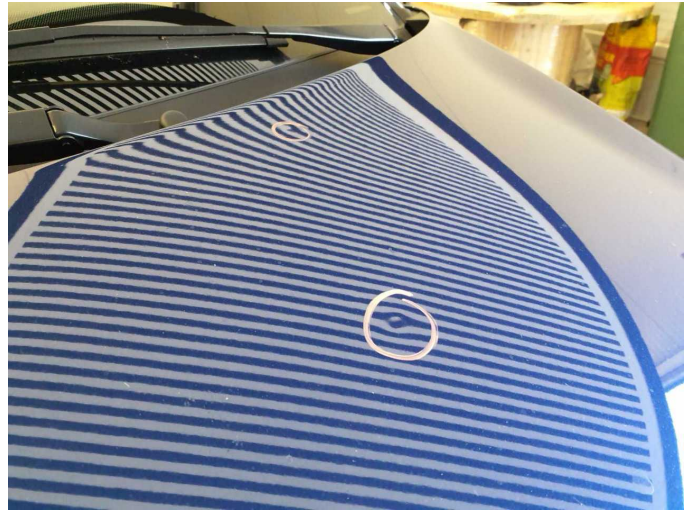
Damage 3: Body: Body - Damage by hail - Repair

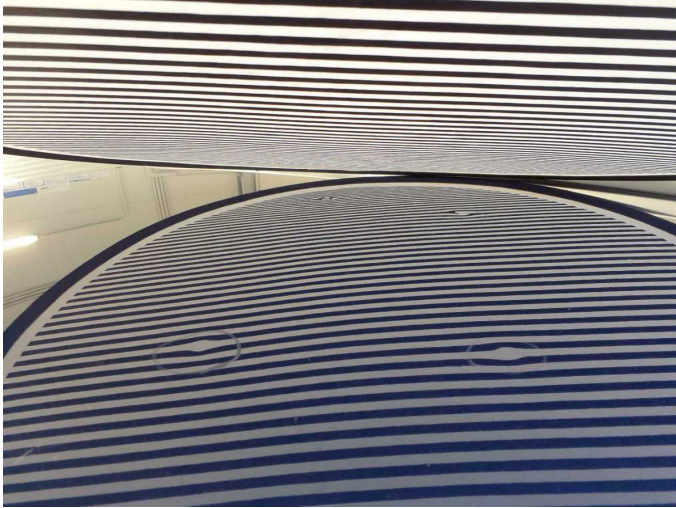
Damage 3: Body: Body - Damage by hail - Repair

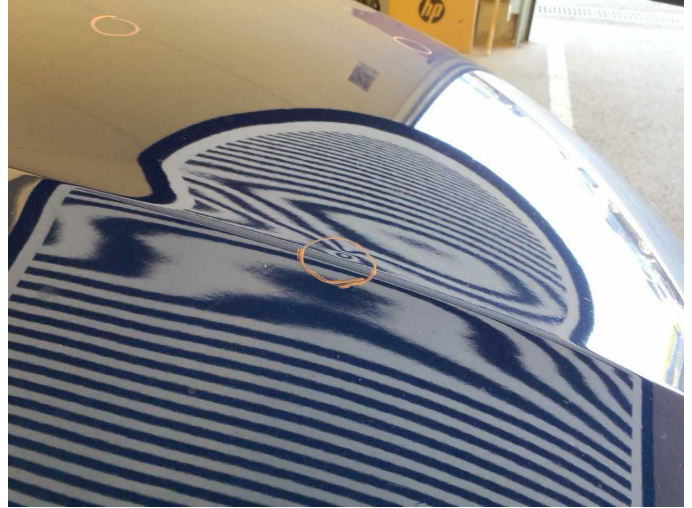
Damage 3: Body: Body - Damage by hail - Repair

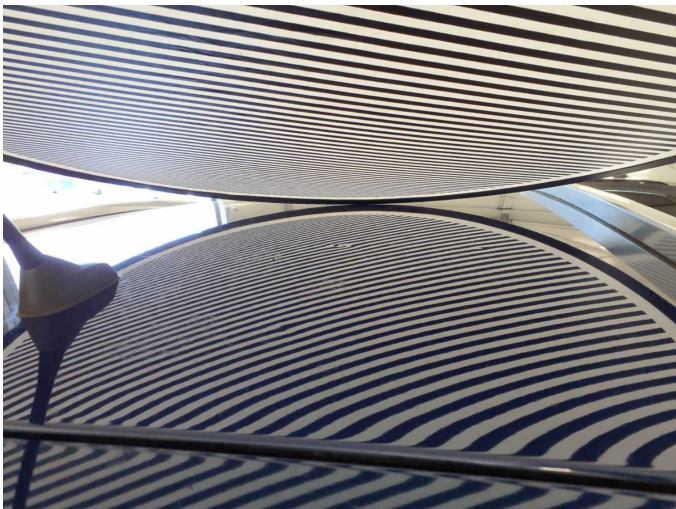
Damage 3: Body: Body - Damage by hail - Repair

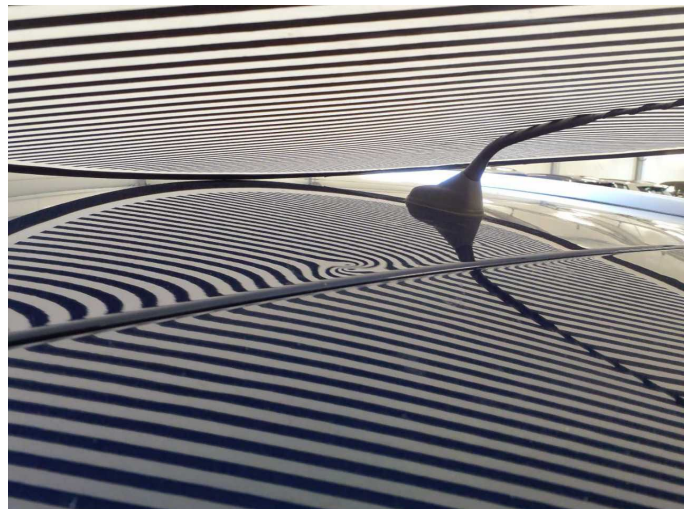
Damage 3: Body: Body - Damage by hail - Repair
