Expertise

Protocol number: 45840837
Order No. / Reference: 26306935
Inspection date: 9 Jun 2026

Model: Astra Sports Tourer 1.2 Turbo Automatik GS

VIN: VXKFRHNSXR1089959

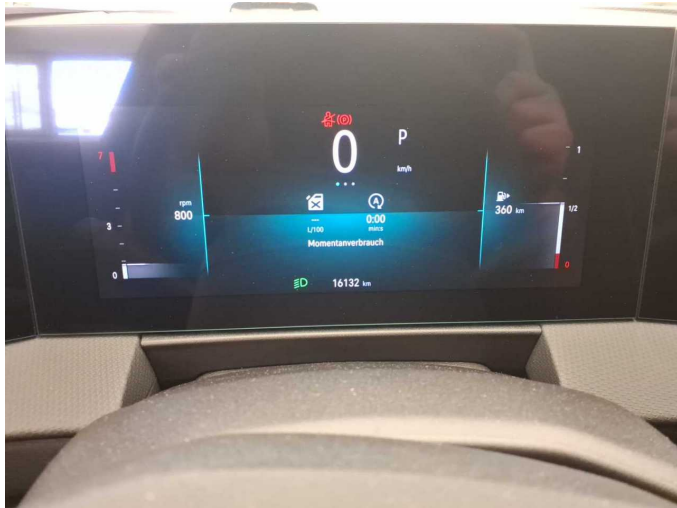
Figure 7: Instrument cluster

Mileage (Read) 16,132 km
