Expertise

Protocol number: 46233974  
Order No. / Reference: 26539545  
Inspection date: 29 Jun 2026

Manufacturer: Mercedes-Benz

Model: GLC 300 de 4Matic 9G-TRONIC

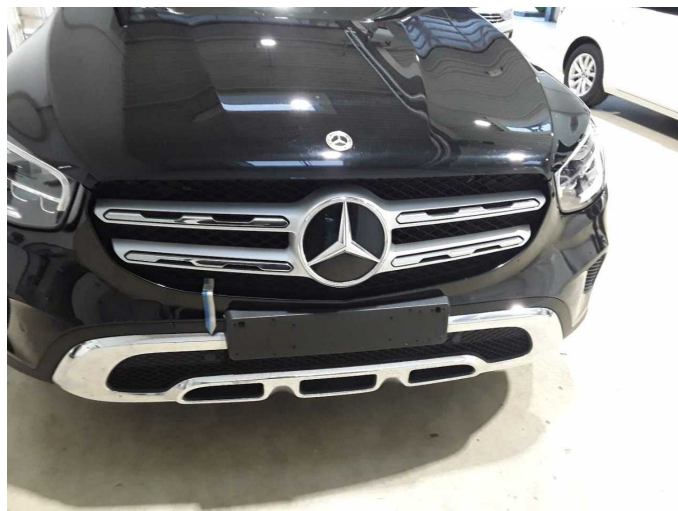
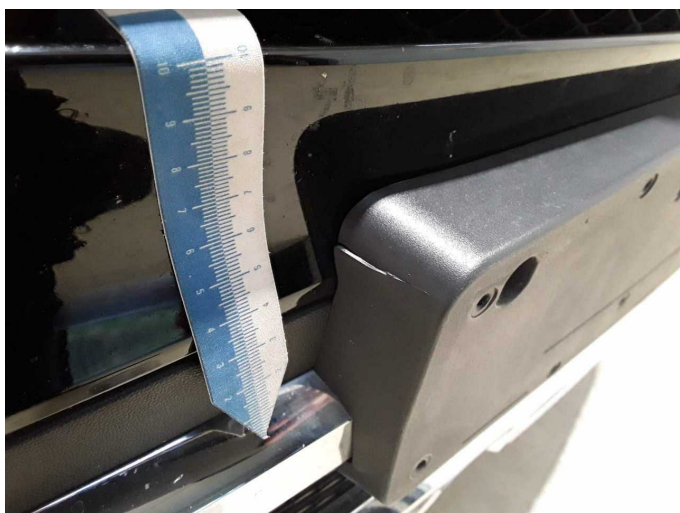
| No. | Component group | Description |
|---|---|---|
| 1 | Front bumper | Licence plate holder - Broken / torn - Replace |

**Damage 1:** Front bumper: Licence plate holder - Broken / torn - Replace

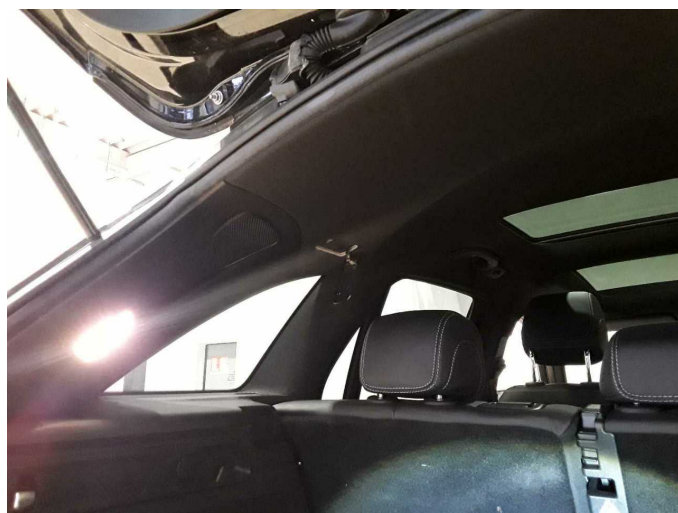
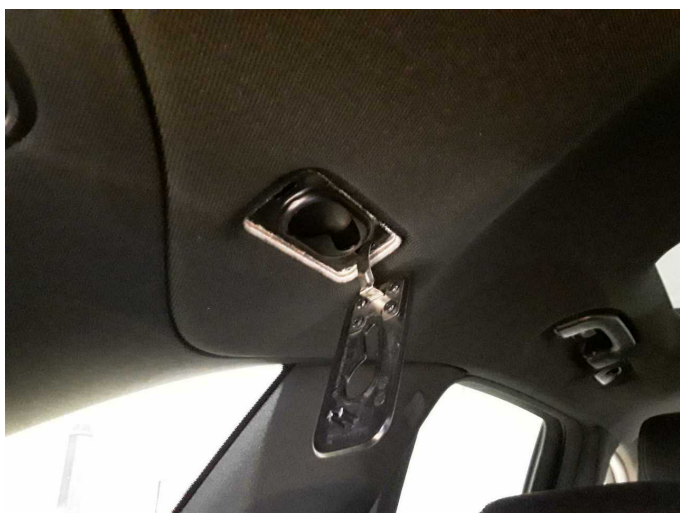
| No. | Component group | Description |
|---|---|---|
| 2 | Trim / covers | Roof lining (Abdeckung) - Differs from the original configuration - Replace |

**Damage 2:** Trim / covers: Roof lining (Abdeckung) - Differs from the original configuration - Replace

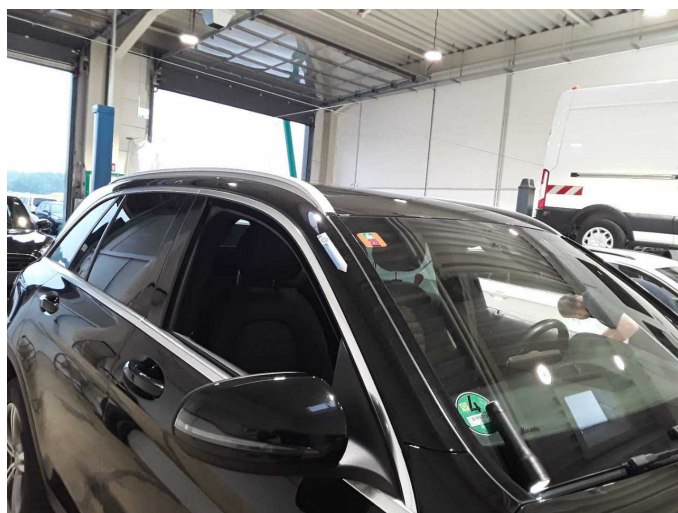
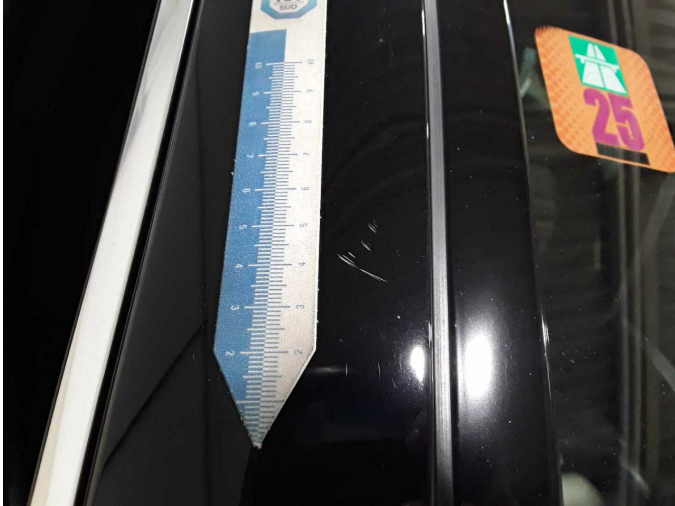
| No. | Component group | Description |
|---|---|---|
| 3 | Body | A-pillar - right side - Scratch(es) - Smart repair |

**Damage 3:** Body: A-pillar - right side - Scratch(es) - Smart repair

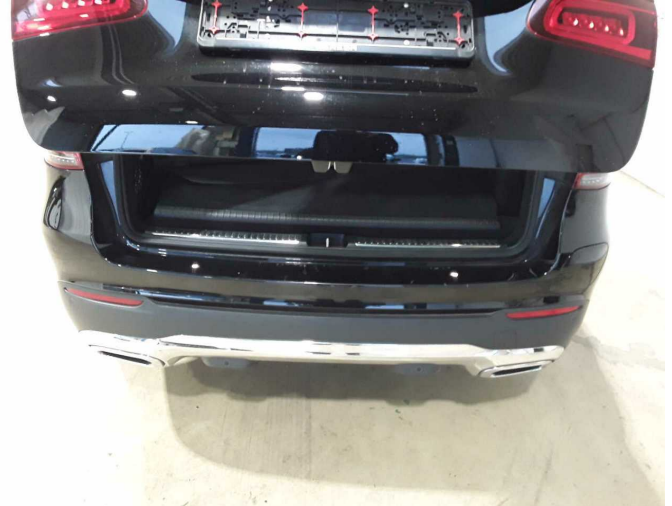
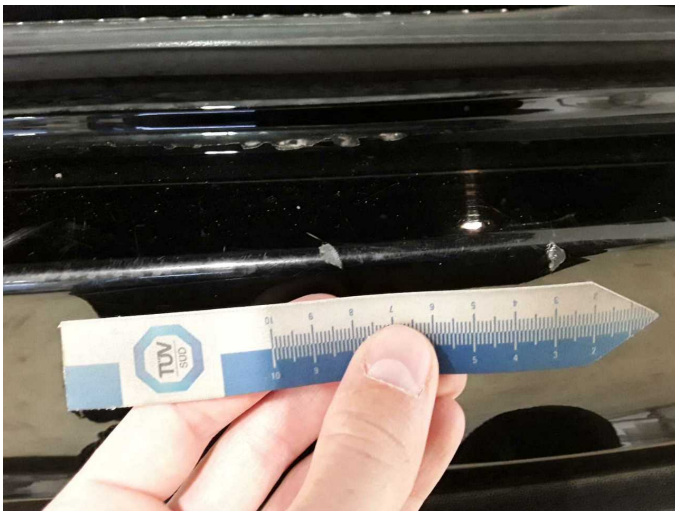
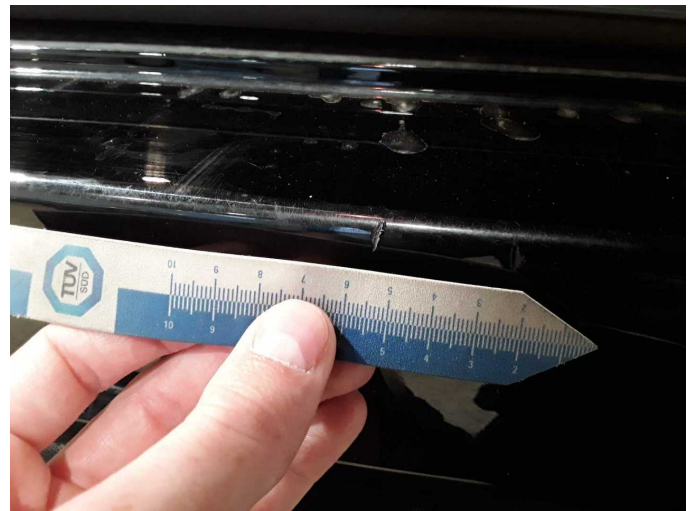
| No. | Component group | Description |
|---|---|---|
| 4 | Rear bumper | Rear bumper (Ladekante) - Scratch(es) - Smart repair |

**Damage 4:** Rear bumper: Rear bumper (LadeKante) - Scratch(es) - Smart repair

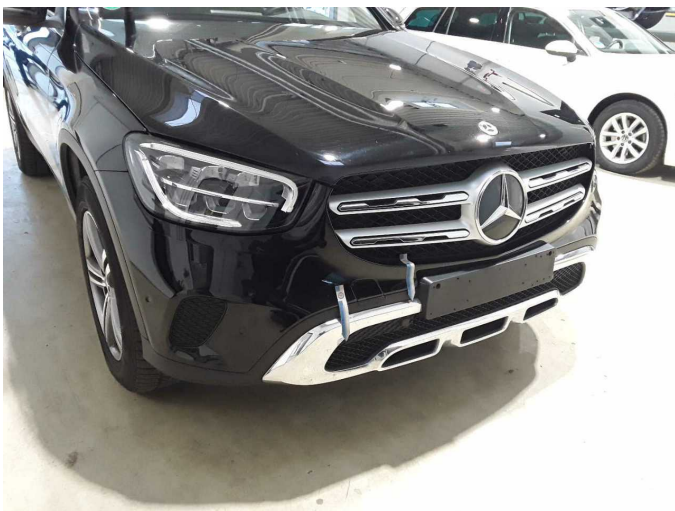
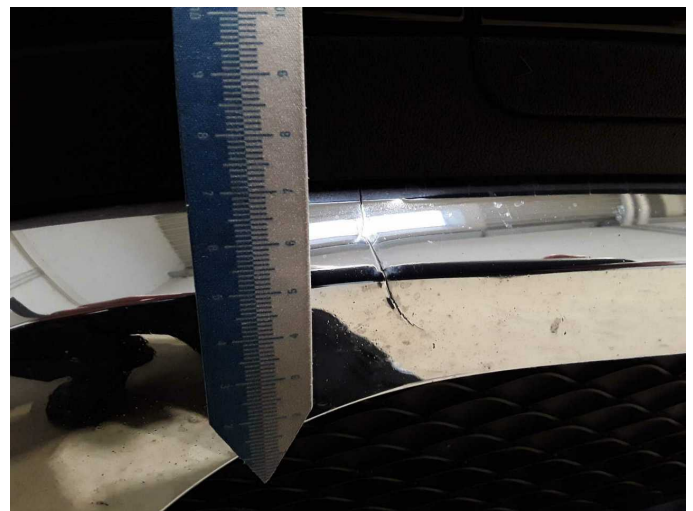
| No. | Component group | Description |
|---|---|---|
| 5 | Front bumper | Cover bumper - front - Broken / torn - Replace |

**Damage 5:** Front bumper: Cover bumper - front - Broken / torn - Replace

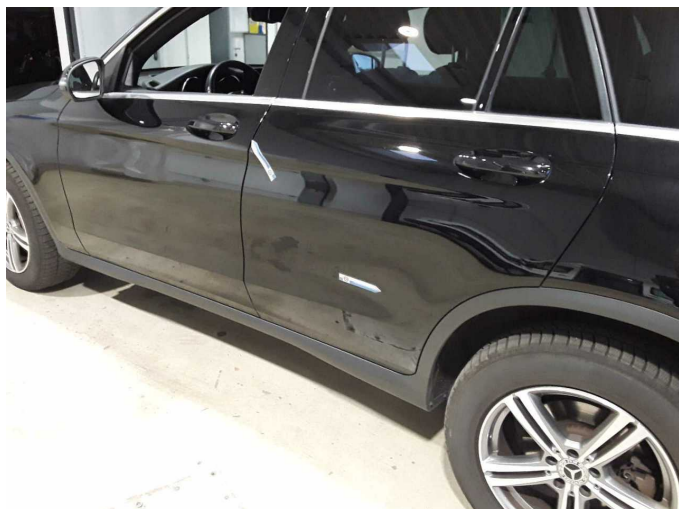
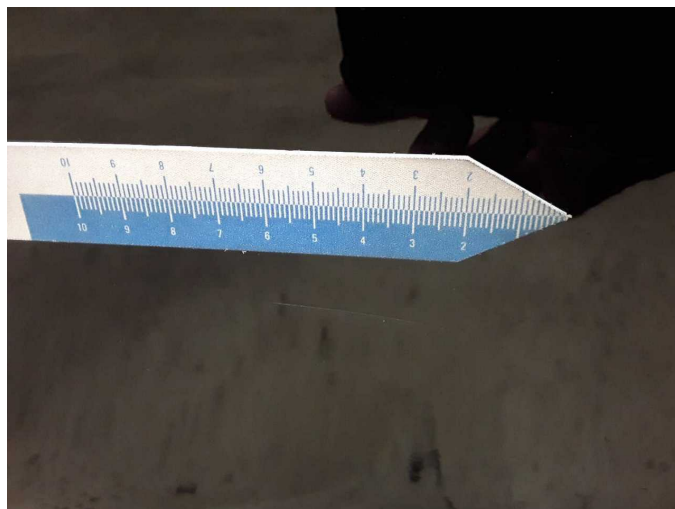
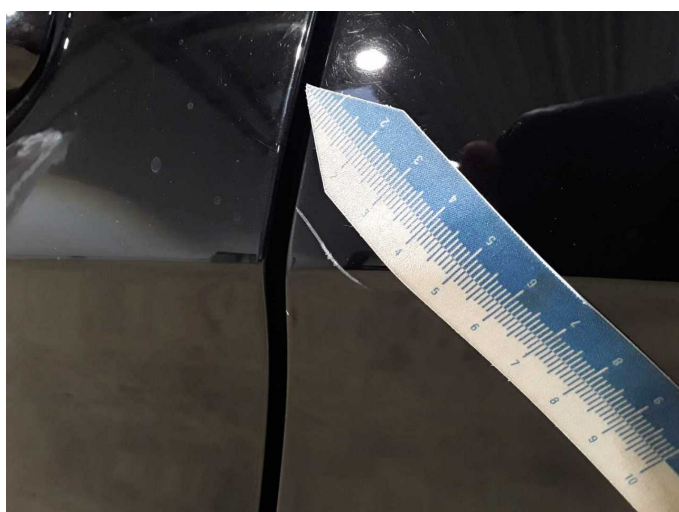
| No. | Component group | Description |
|---|---|---|
| 6 | Door - rear left side | Door - Scratch(es) - Paint |

**Damage 6:** Door - rear left side: Door - Scratch(es) - Paint

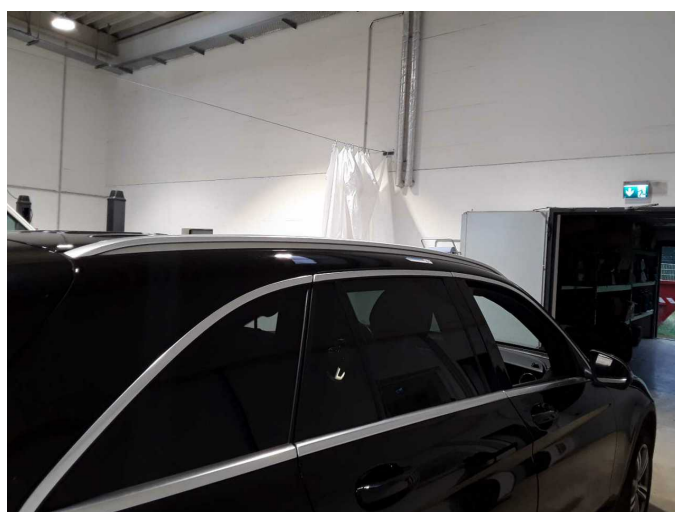
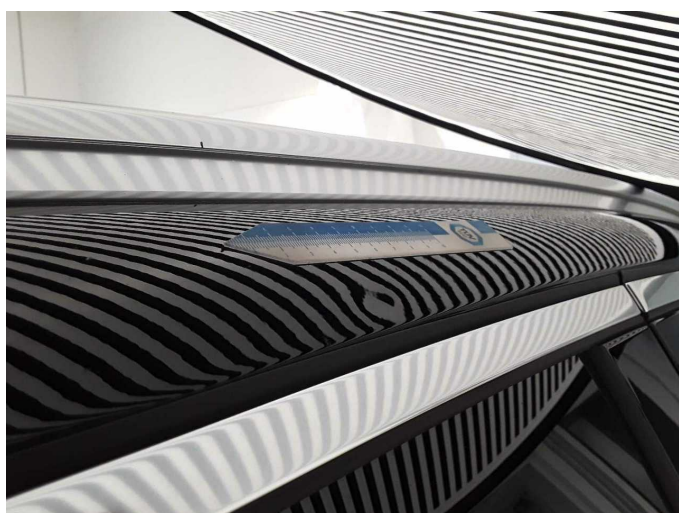
| No. | Component group | Description |
|---|---|---|
| 2 | Roof | Roof rail - right side - dent(s) - No deduction |

**Wear and tear 2:** Roof: Roof rail - right side - dent(s) - No deduction

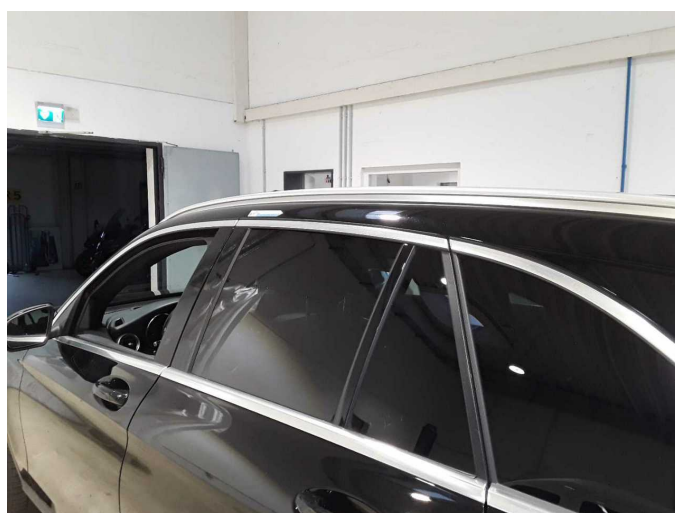
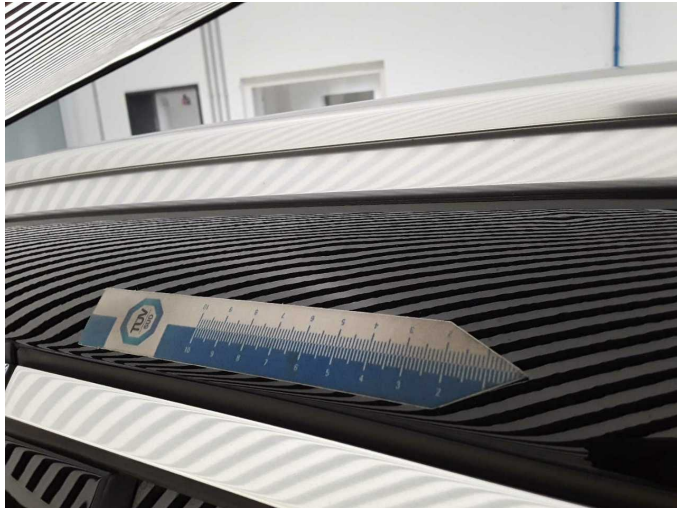
| No. | Component group | Description |
|---|---|---|
| 3 | Roof | Roof rail - left side - dent(s) - No deduction |

**Wear and tear 3:** Roof: Roof rail - left side - dent(s) - No deduction

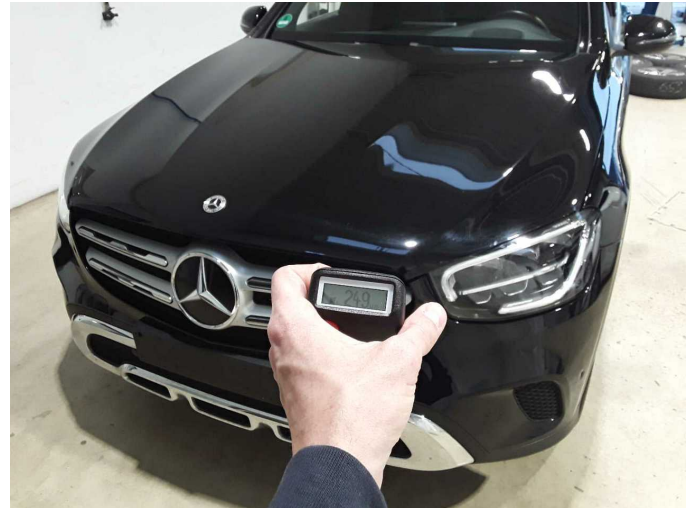
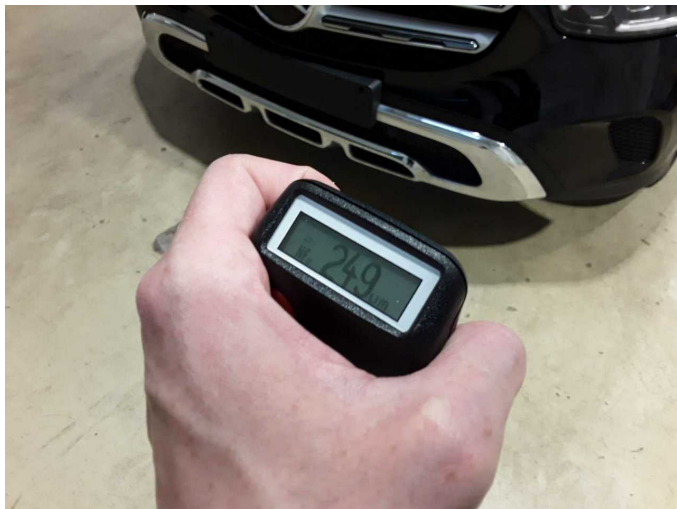
| No. | Repainting |
|---|---|
| 1 | Bonnet, Professionally carried out, Invoice of repair done Non-existent |

| Bonnet | 249 µm |

**Repainting 1:** Bonnet
