Protocol number: 45790419
Order No. / Reference: 26397253
Inspection date: 2 Jun 2026

Manufacturer: Opel

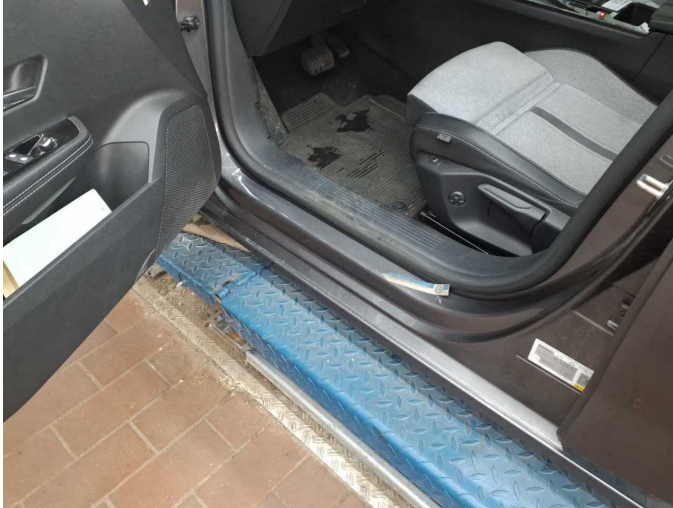
Damage 1: Sill - left side: Sill - Scratch(es) - Smart repair

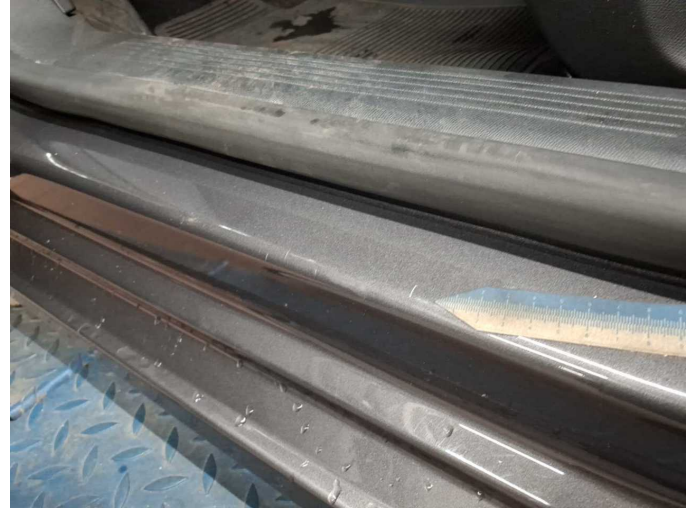
Damage 1: Sill - left side: Sill - Scratch(es) - Smart repair

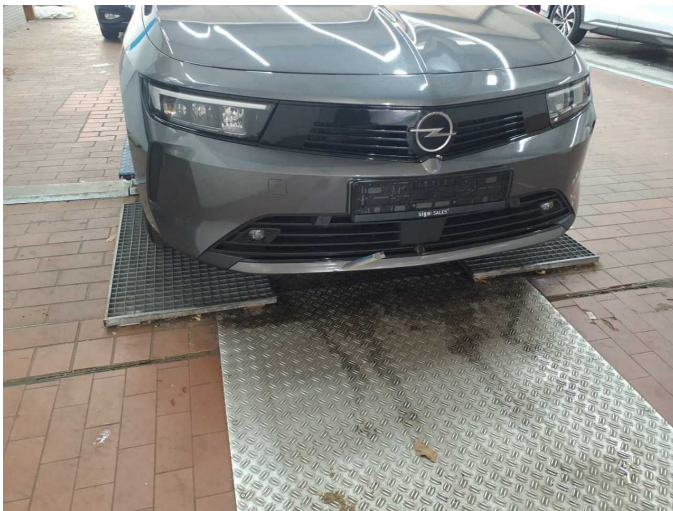
Damage 2: Front bumper: Front bumper - Scratch(es) - Paint

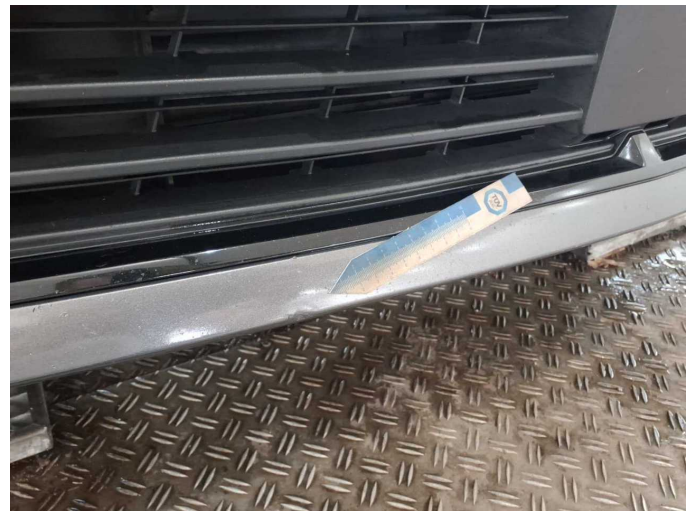
Damage 2: Front bumper: Front bumper - Scratch(es) - Paint

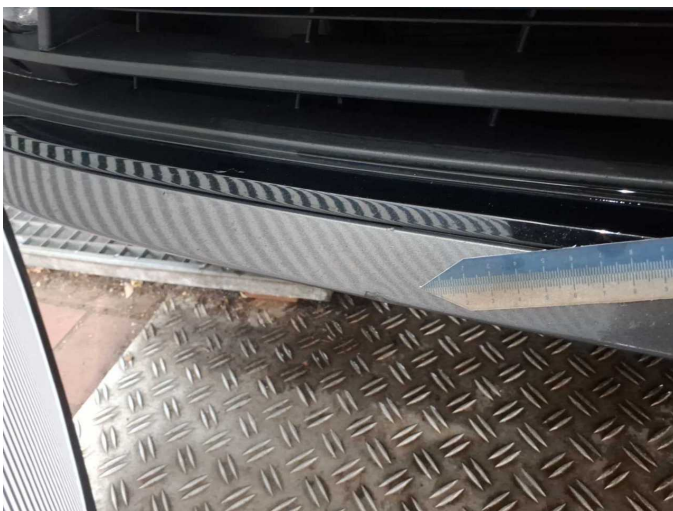
Damage 2: Front bumper: Front bumper - Scratch(es) - Paint

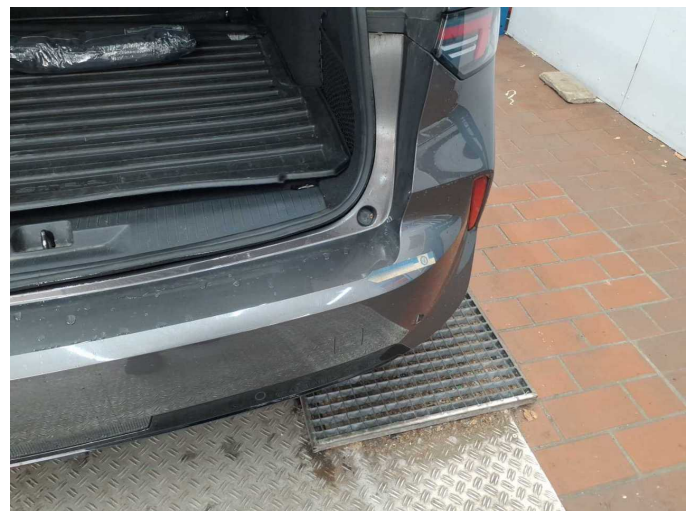
Damage 3: Rear bumper: Rear bumper - Scratch(es) - Paint

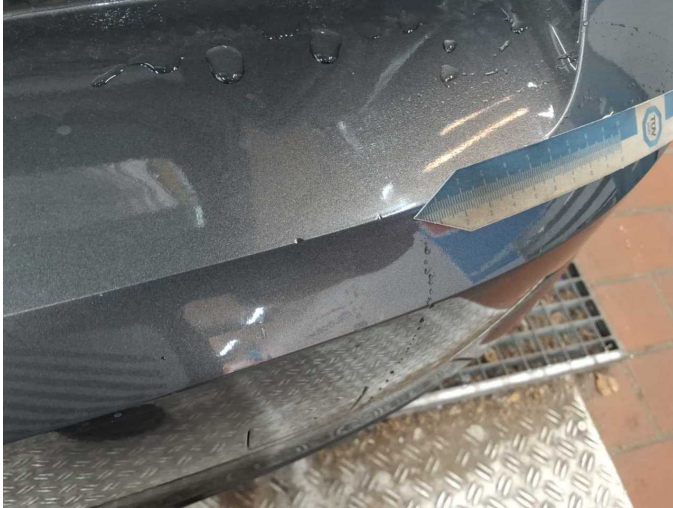
Damage 3: Rear bumper: Rear bumper - Scratch(es) - Paint

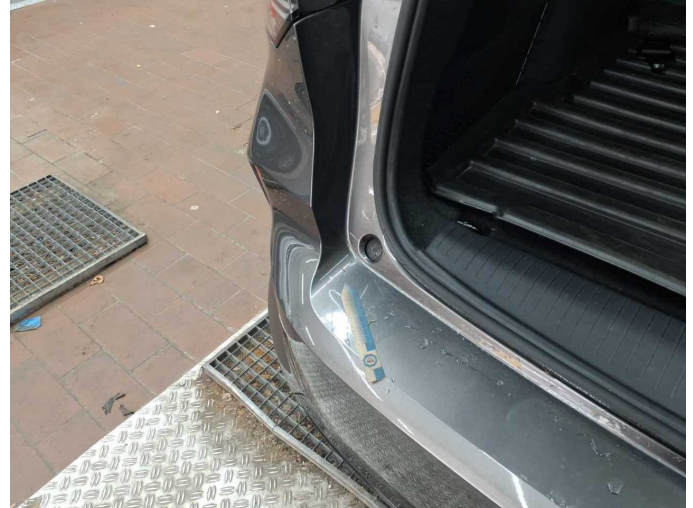
Damage 3: Rear bumper: Rear bumper - Scratch(es) - Paint

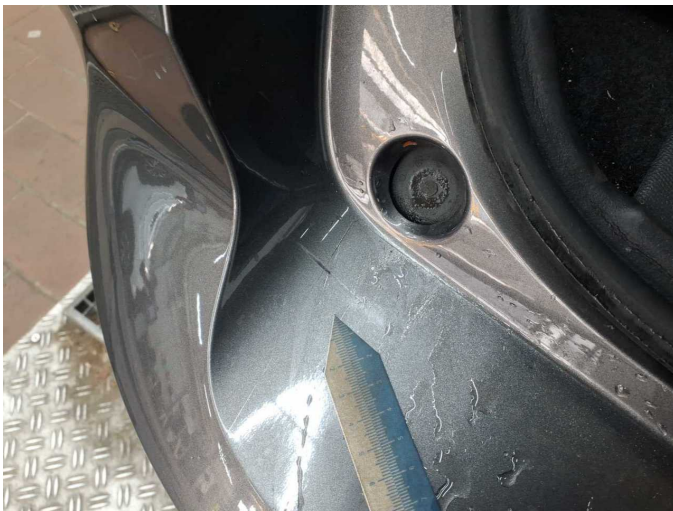
Damage 3: Rear bumper: Rear bumper - Scratch(es) - Paint

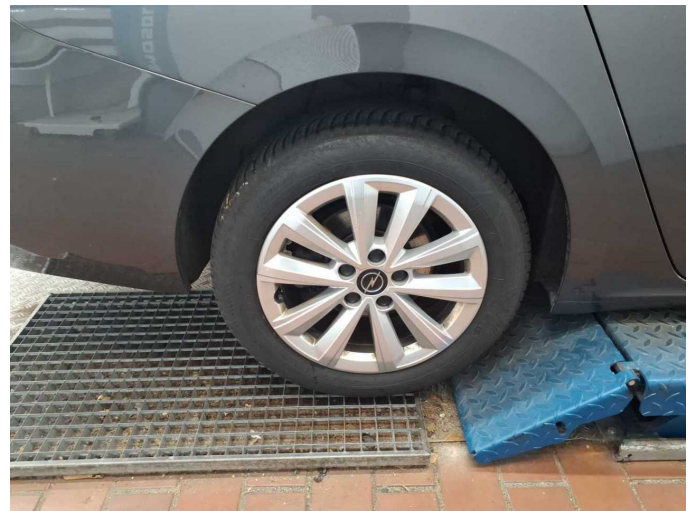
Wear and tear 6: Wheel / tyres: Alloy rim - rear right side - Scratch(es) - No deduction

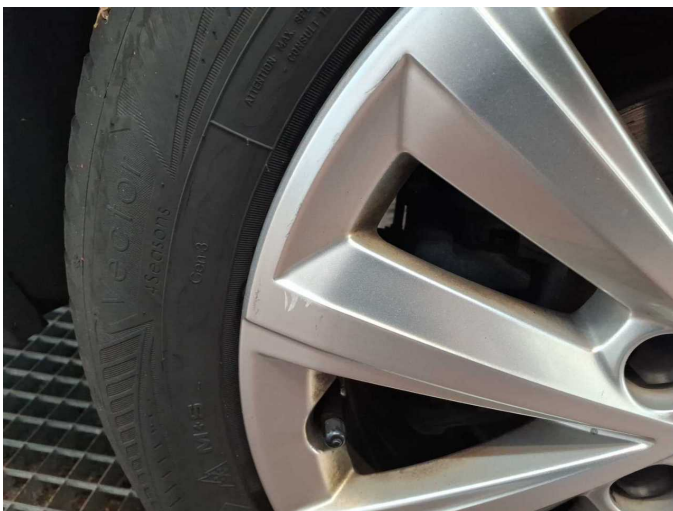
Wear and tear 6: Wheel / tyres: Alloy rim - rear right side - Scratch(es) - No deduction
