Expertise

Protocol number: 46407937  
Order No. / Reference: 26553279  
Inspection date: 7 Jul 2026

Model: 5008 BlueHDi 130 EAT8 GT

VIN: VF3MCYHZUNS200369

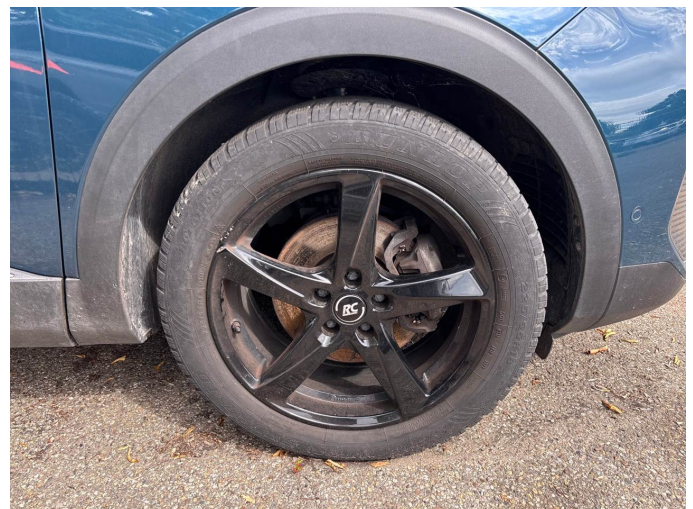
Figure 12: Mounted tyres

| # | Tyre size | Type of tyre | Manufacturer | Tread depth |
|---|---|---|---|---|
| 1) | 225/55 R18 102H | Winter tyres on Light alloy | Dunlop | 6mm / 6mm |
| 2) | 225/55 R18 102H | Winter tyres on Light alloy | Dunlop | 5mm / 5mm |

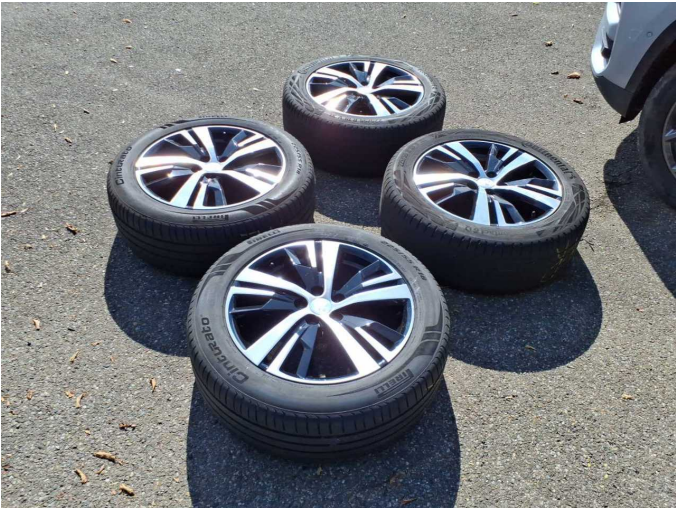
Figure 15: Additional tyres

| # | Tyre size | Type of tyre | Manufacturer | Tread depth |
|---|---|---|---|---|
| 1) | 225/55 R18 102Y | Summer tyres on Light alloy | Pirelli | 6mm / 6mm |
| 2) | 225/55 R18 102Y | Summer tyres on Light alloy | Pirelli | 6mm / 6mm |

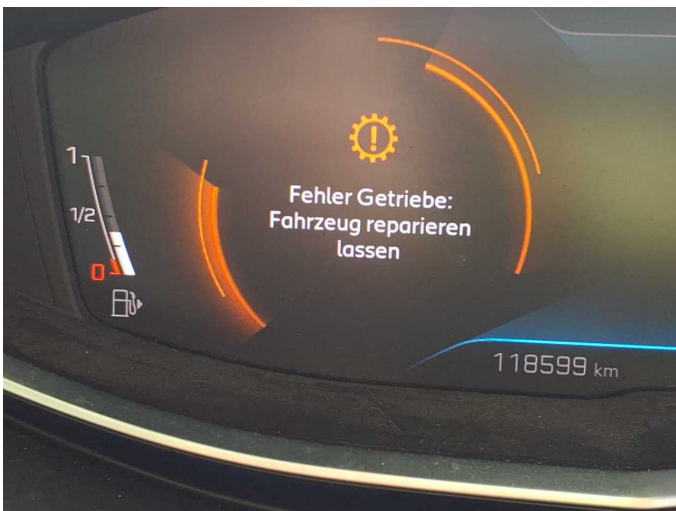
| No. | Component group | Description |
|---|---|---|
| 3 | Gearbox | Gearbox - Non-operational - Perform diagnosis |

**Damage 3:** Gearbox: Gearbox - Non-operational - Perform diagnosis

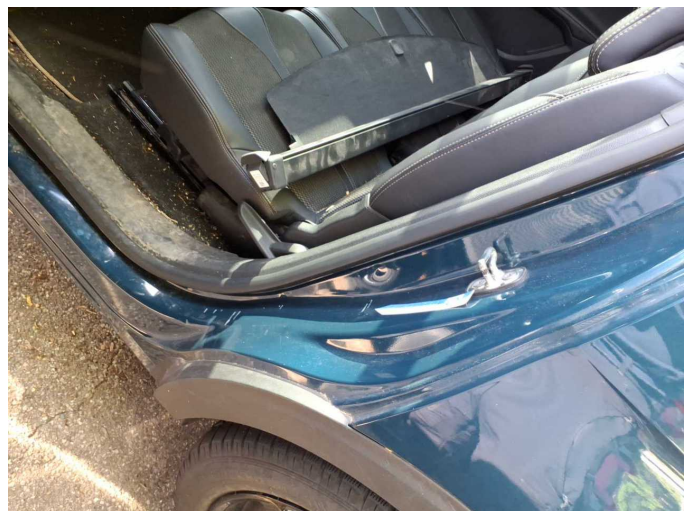
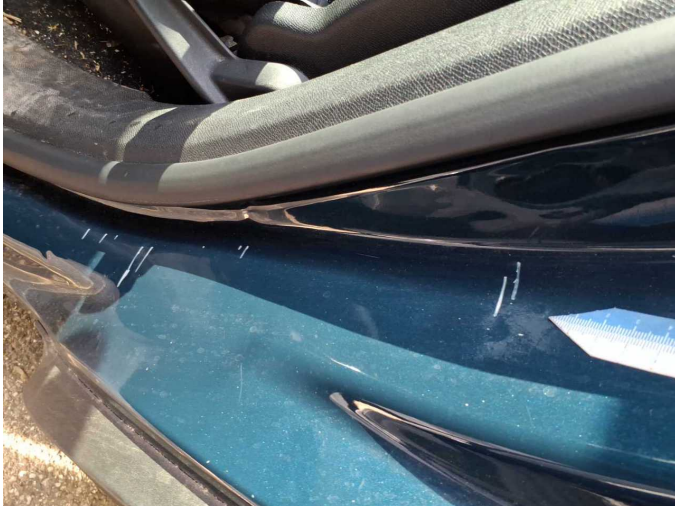
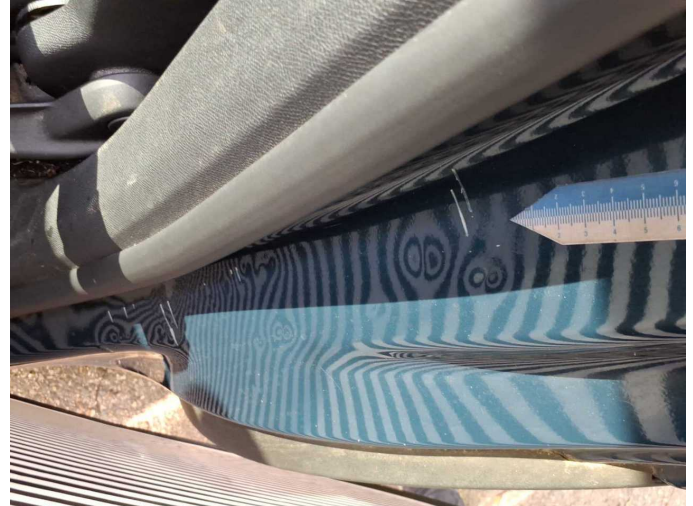
| No. | Component group | Description |
|---|---|---|
| 4 | Side panel - rear left side | Sill - Dent / paintcoat damage - Repair and paint |

**Damage 4:** Side panel - rear left side: Sill - Dent / paintcoat damage - Repair and paint

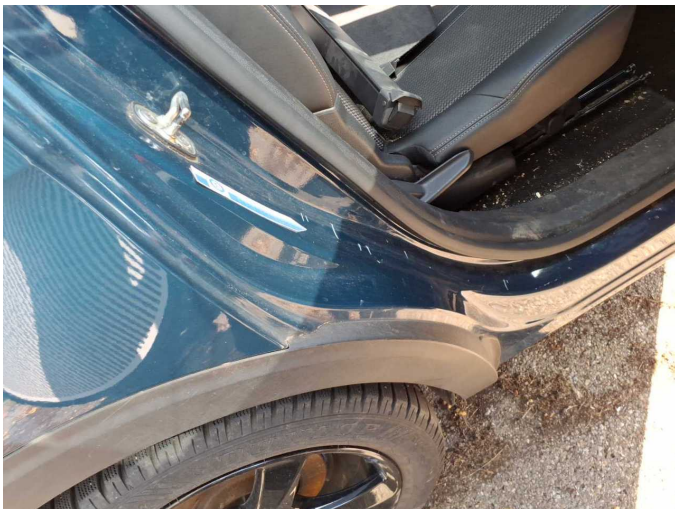
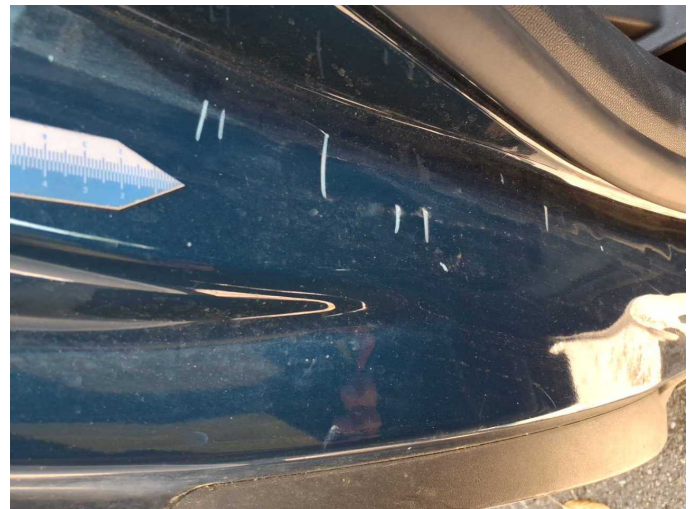
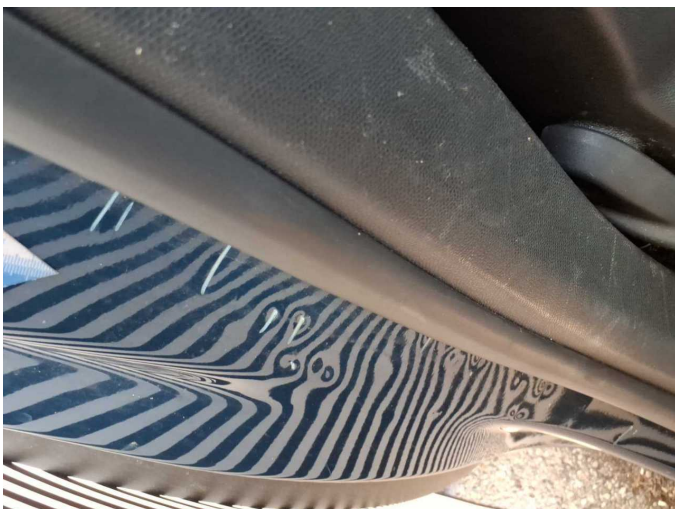
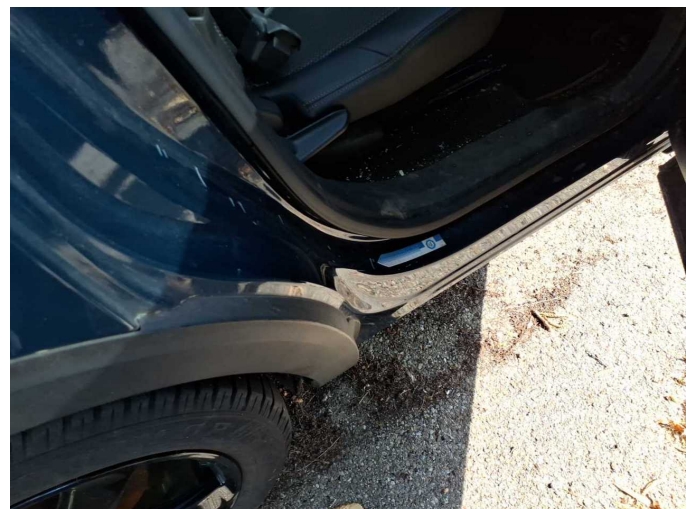
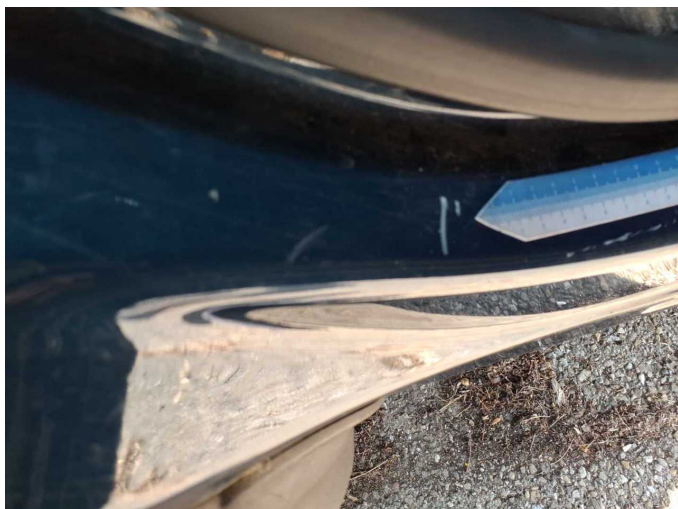
| No. | Component group | Description |
|---|---|---|
| 5 | Side panel - rear right side | Sill - Dent / paintcoat damage - Repair and paint |

**Damage 5:** Side panel - rear right side: Sill - Dent / paintcoat damage - Repair and paint

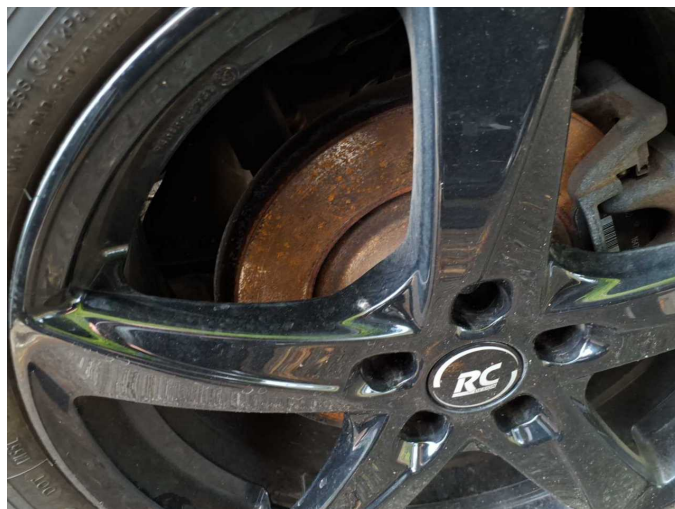
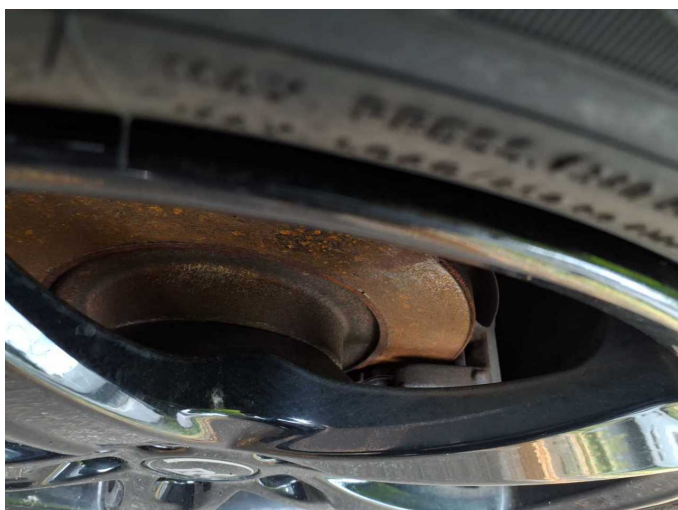
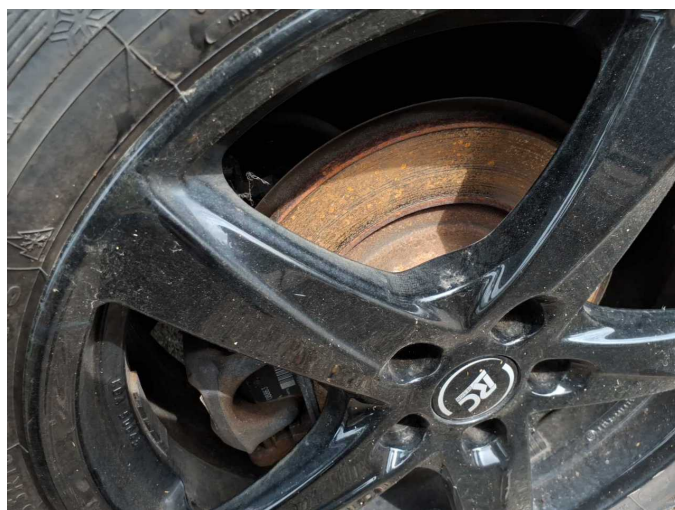
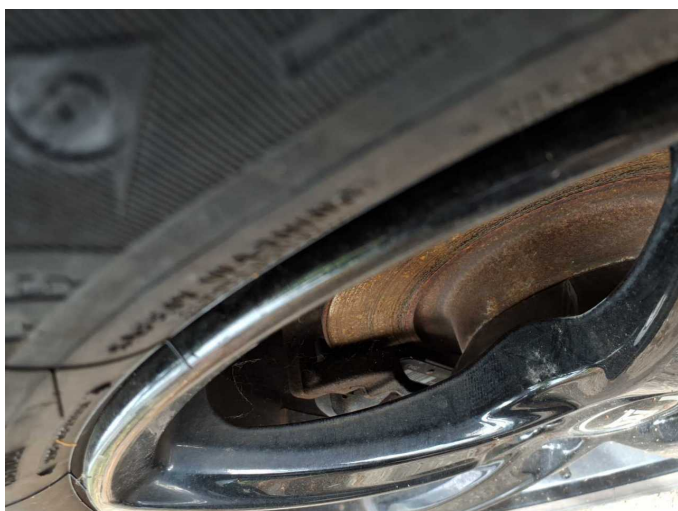
| No. | Component group | Description |
|---|---|---|
| 6 | Braking system | Brake discs and pads - rear - Corrosion - Replace |

**Damage 6:** Braking system: Brake discs and pads - rear - Corrosion - Replace

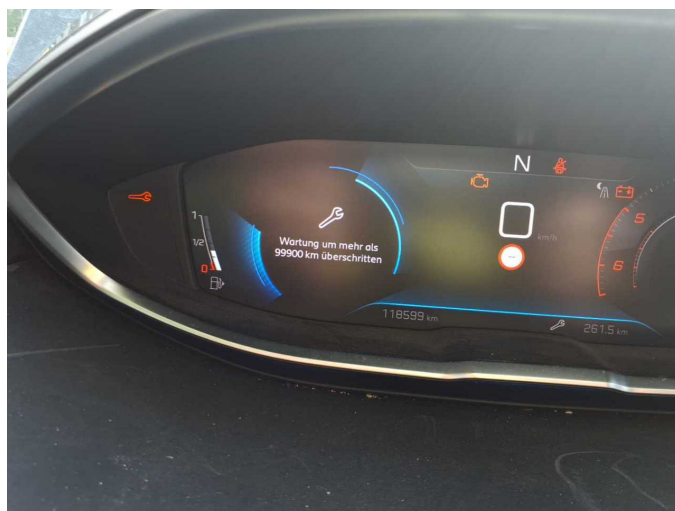
| No. | Component group | Description |
|---|---|---|
| 7 | Misc. | Inspection / maintenance - Expired - Replace |

**Damage 7:** Misc.: Inspection / maintenance - Expired - Replace

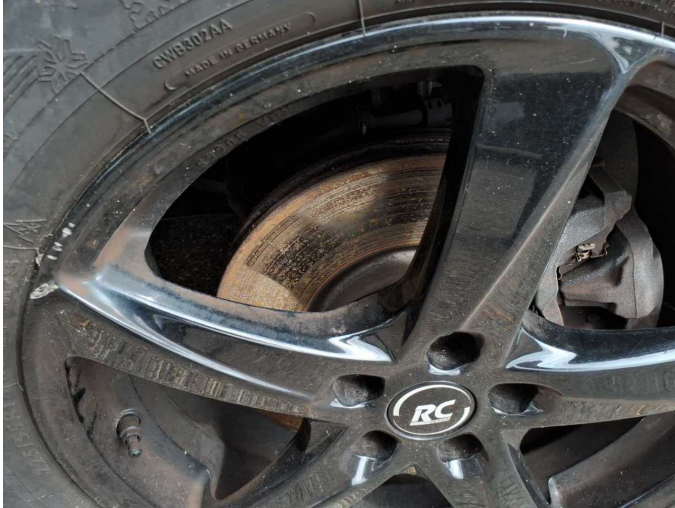
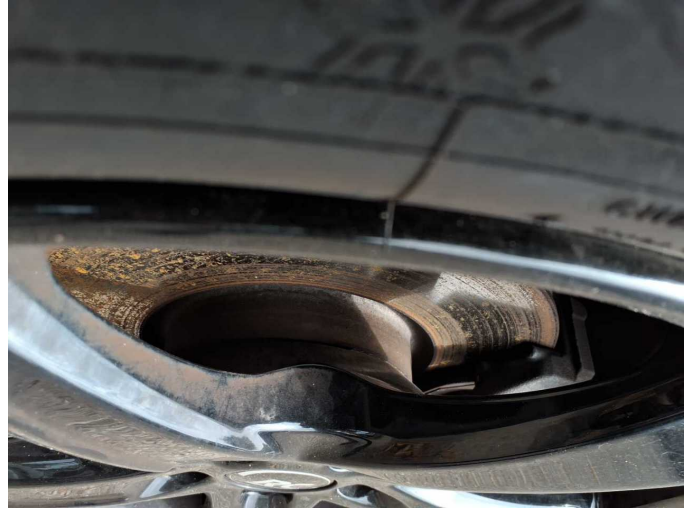
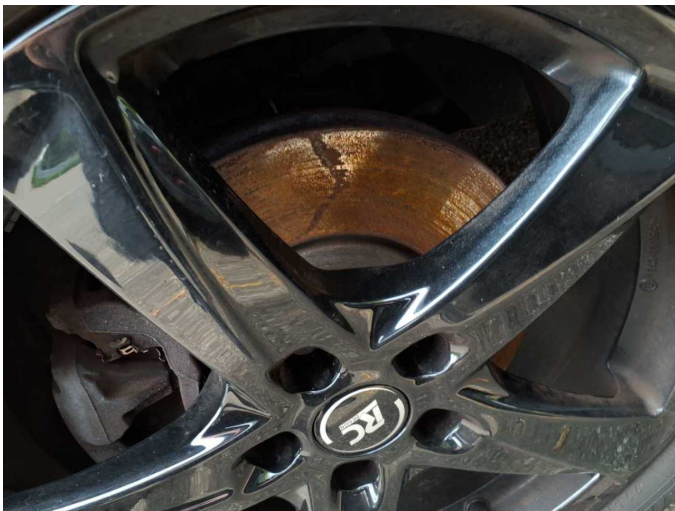
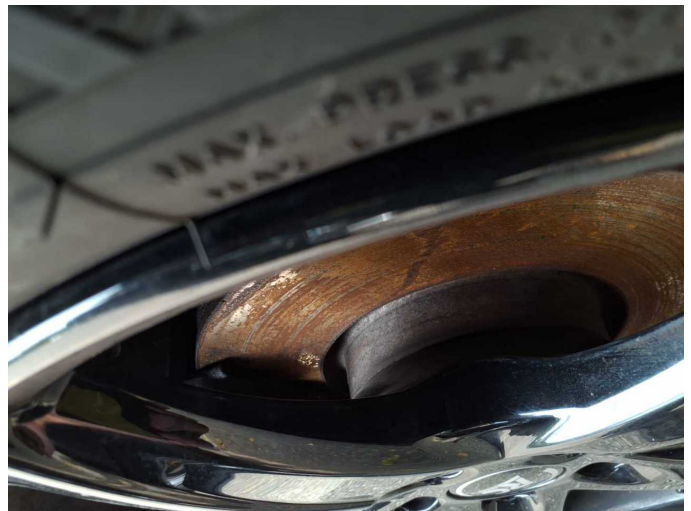
| No. | Component group | Description |
|---|---|---|
| 8 | Braking system | Brake discs and brake pads - front - Corrosion - Replace |

**Damage 8:** Braking system: Brake discs and brake pads - front - Corrosion - Replace

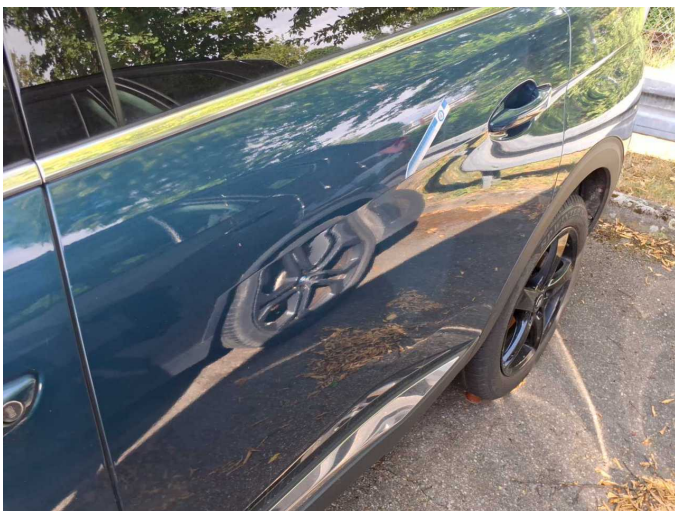
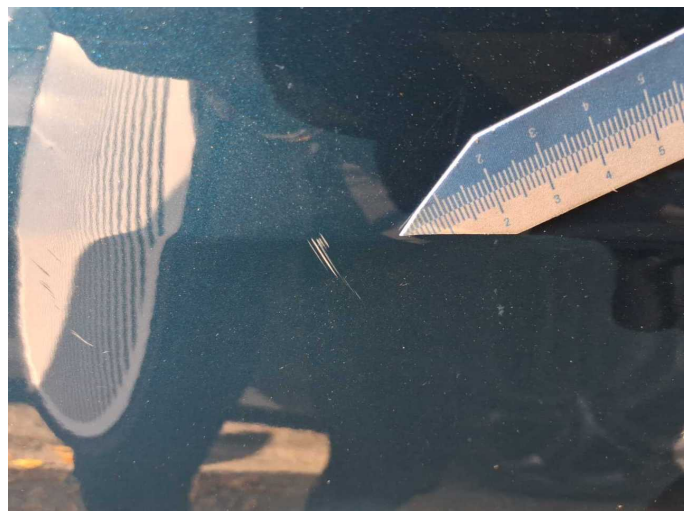
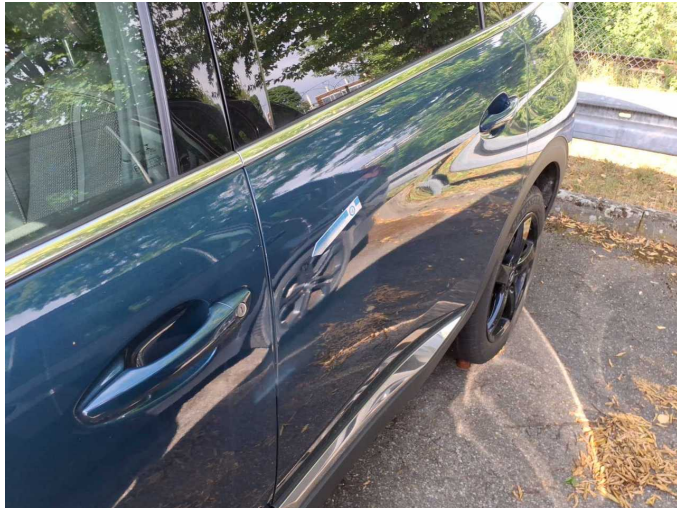
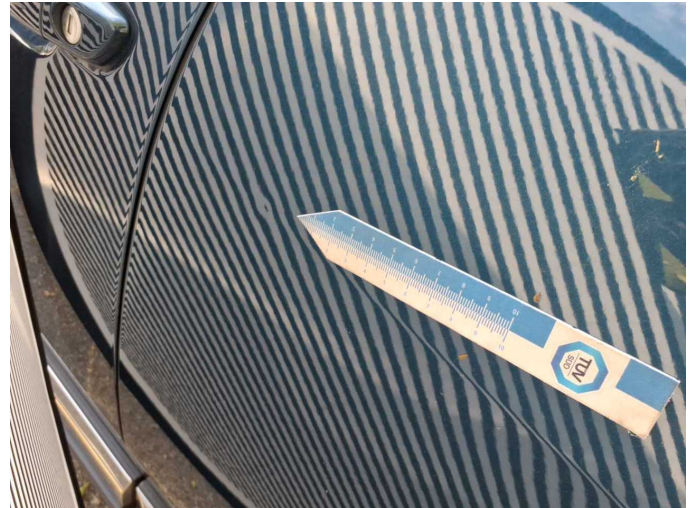
| No. | Component group | Description |
|---|---|---|
| 9 | Door - rear left side | Door - Dent / paintcoat damage - Paint |

**Damage 9:** Door - rear left side: Door - Dent / paintcoat damage - Paint

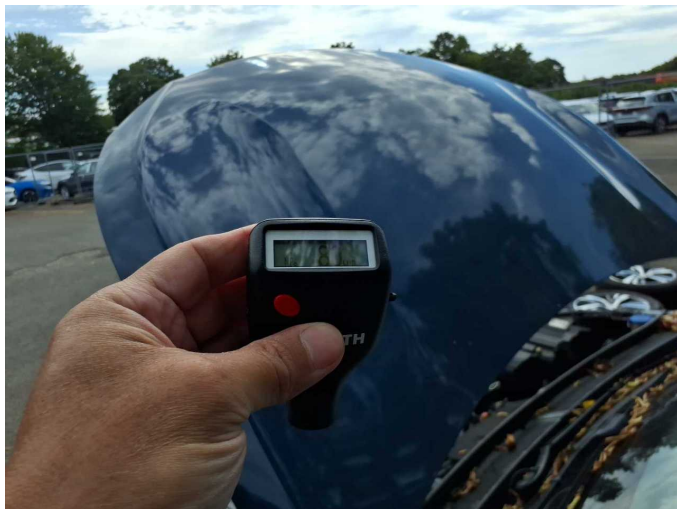
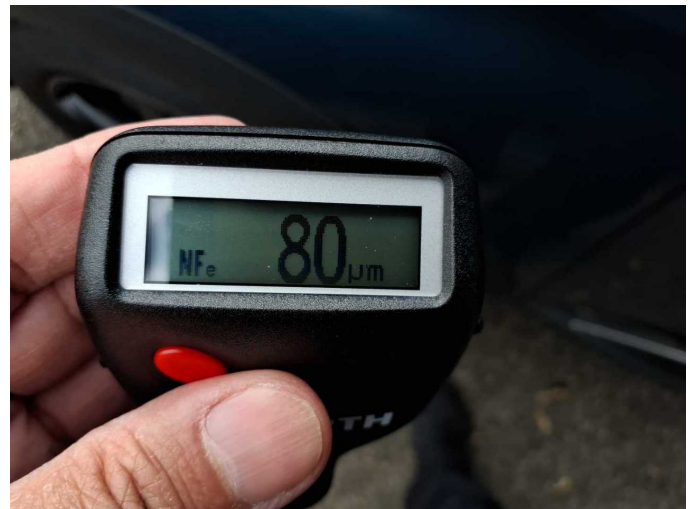
| No. | Repainting |
|---|---|
| 1 | Bonnet, Professionally carried out |

Bonnet 80 µm |

**Repainting 1:** Bonnet
