Expertise

Protocol number: 46364842  
Order No. / Reference: 26661501  
Inspection date: 3 Jul 2026

Manufacturer: Skoda  
VIN: TMBJW7NX3MY152962

Model: Octavia Combi 1.4 TSI iV DSG Style

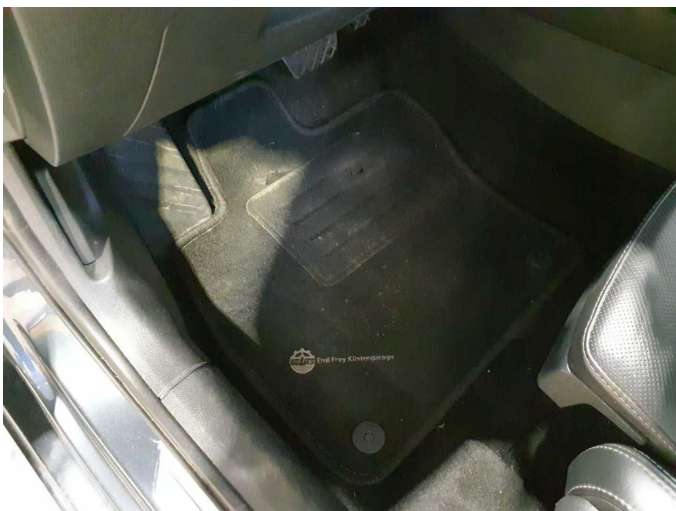
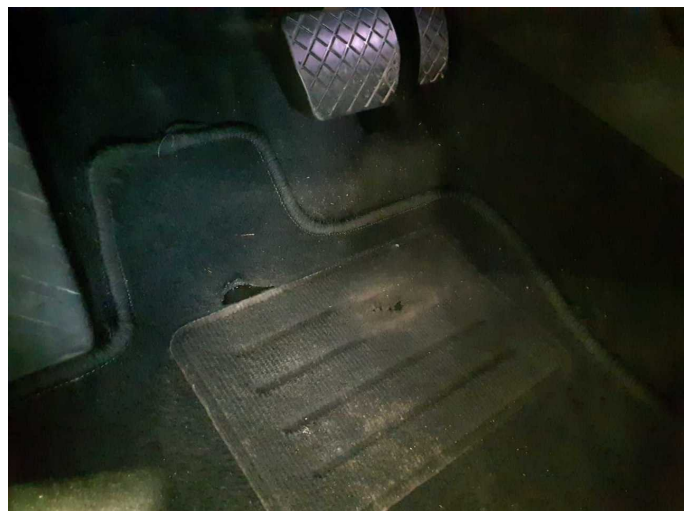
| No. | Component group | Description |
|---|---|---|
| 1 | Trim / covers | Floor mats - Broken / torn - Replace |

**Damage 1:** Trim / covers: Floor mats - Broken / torn - Replace

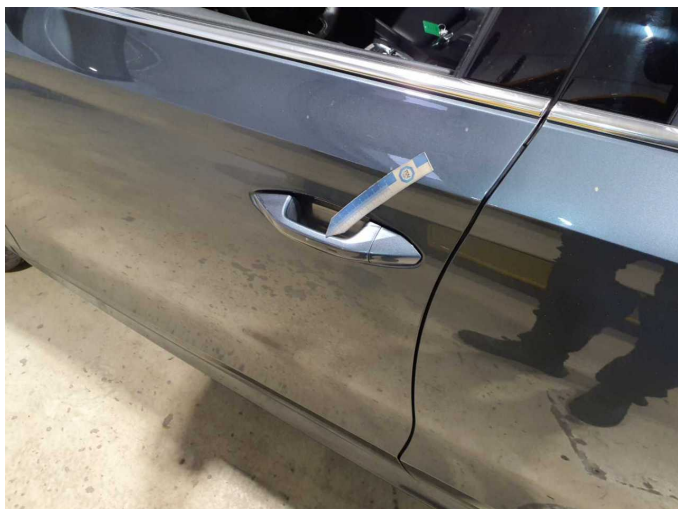
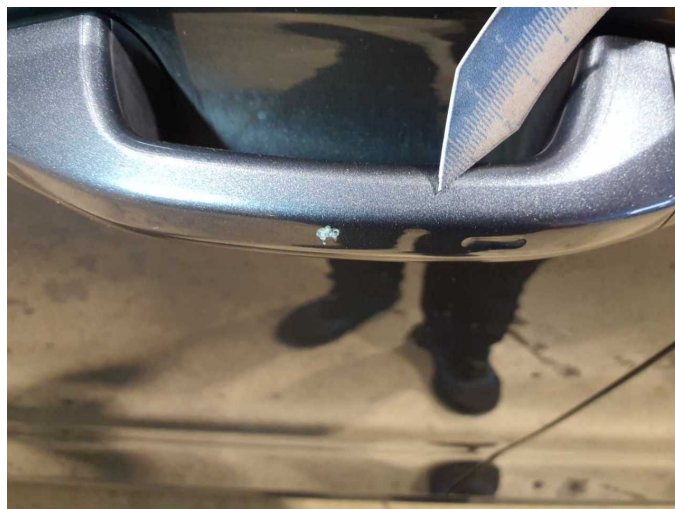
| No. | Component group | Description |
|---|---|---|
| 2 | Door - front left side | Door handle - outside - Scratch(es) - Smart repair |

**Damage 2:** Door - front left side: Door handle - outside - Scratch(es) - Smart repair

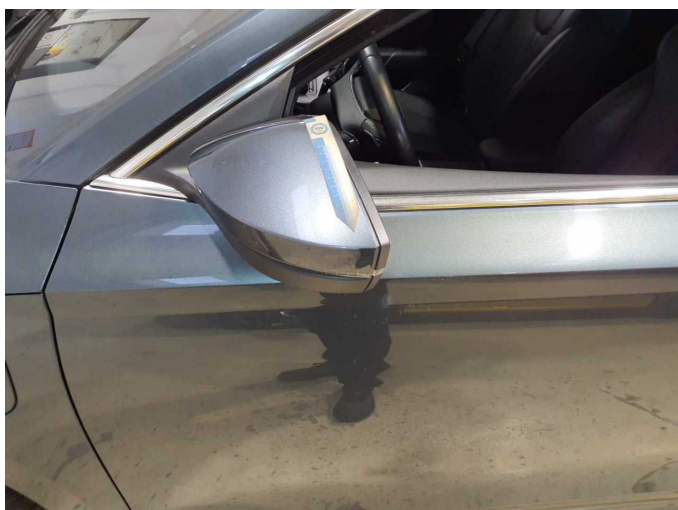
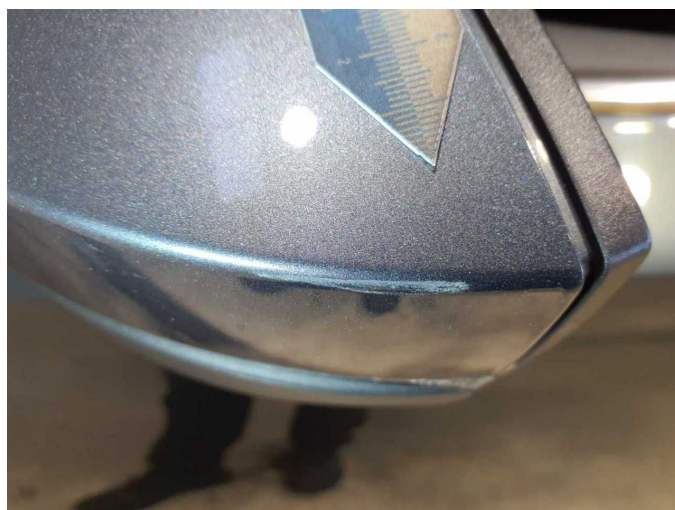
| No. | Component group | Description |
|---|---|---|
| 3 | Wing mirror - left side | Cap - Scratch(es) - Smart repair |

**Damage 3:** Wing mirror - left side: Cap - Scratch(es) - Smart repair

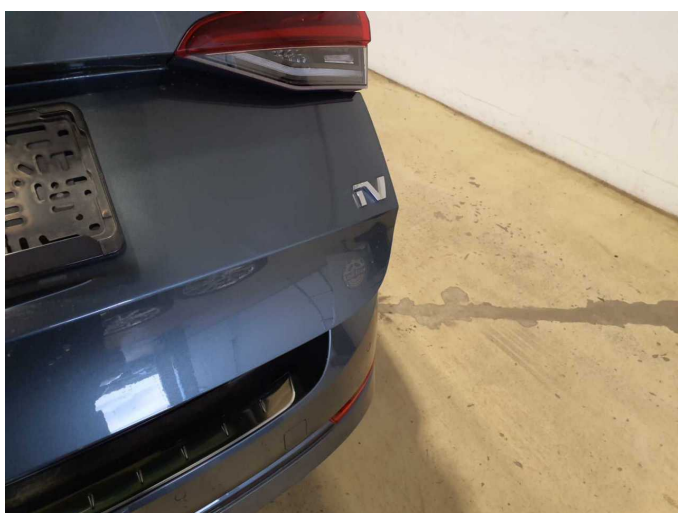
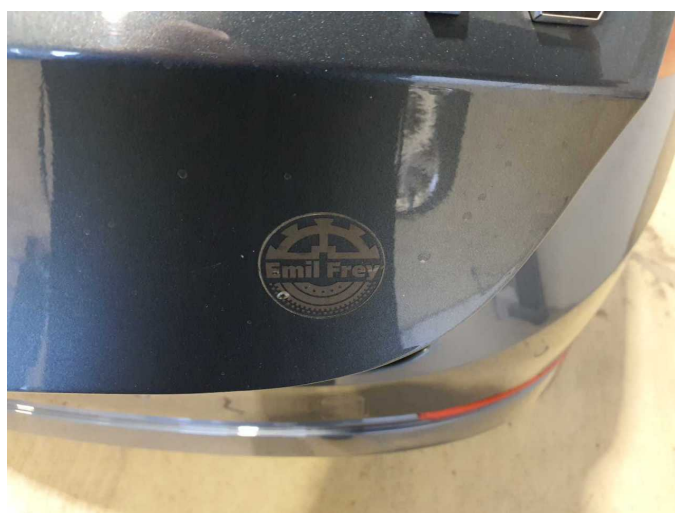
| No. | Component group | Description |
|---|---|---|
| 4 | Boot lid / rear door | Boot lid - Glued / labelled - De-glue / neutralise |

**Damage 4:** Boot lid / rear door: Boot lid - Glued / labelled - De-glue / neutralise

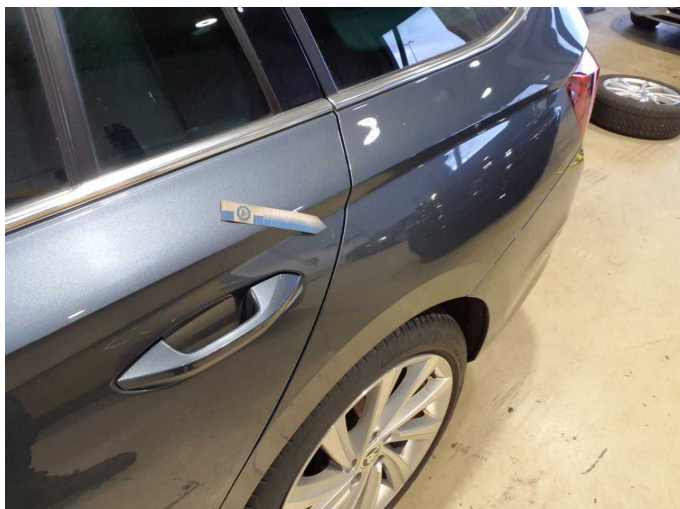
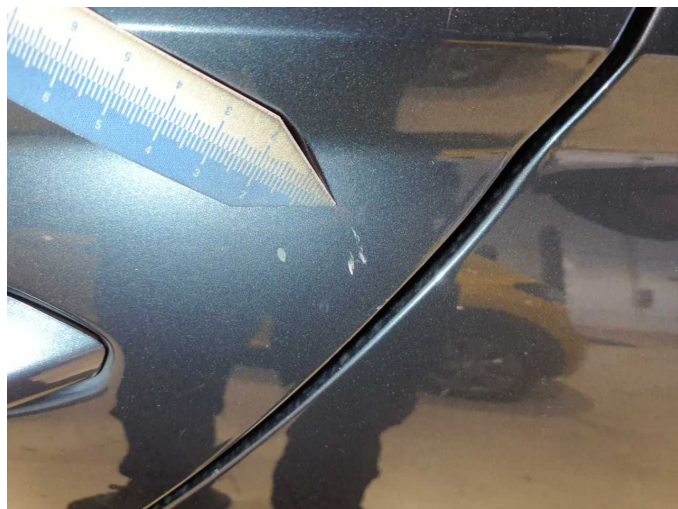
| No. | Component group | Description |
|---|---|---|
| 5 | Door - rear left side | Door - Scratch(es) - Smart repair |

**Damage 5:** Door - rear left side: Door - Scratch(es) - Smart repair

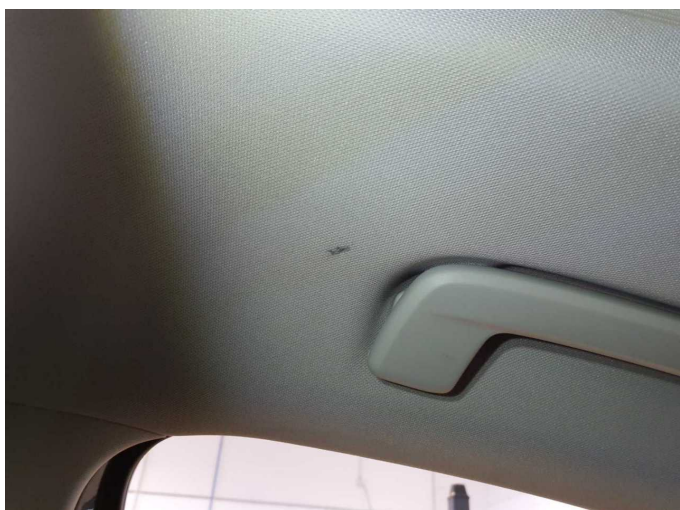
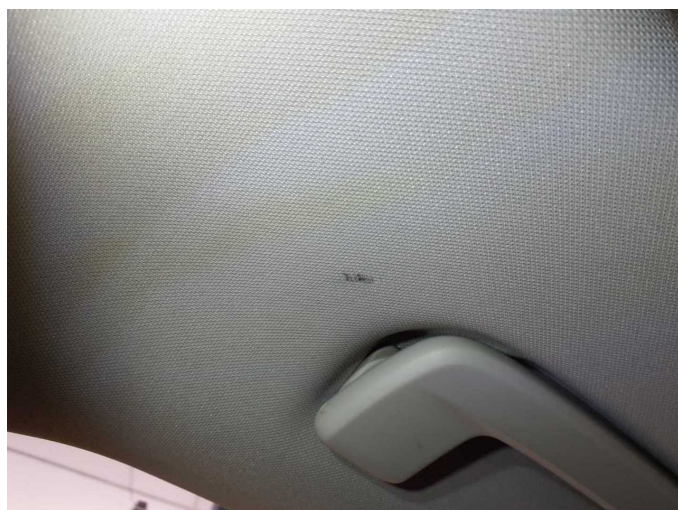
| No. | Component group | Description |
|---|---|---|
| 6 | Trim / covers | Roof lining - Burn hole (cigarettes) - Smart repair |

**Damage 6:** Trim / covers: Roof lining - Burn hole (cigarettes) - Smart repair

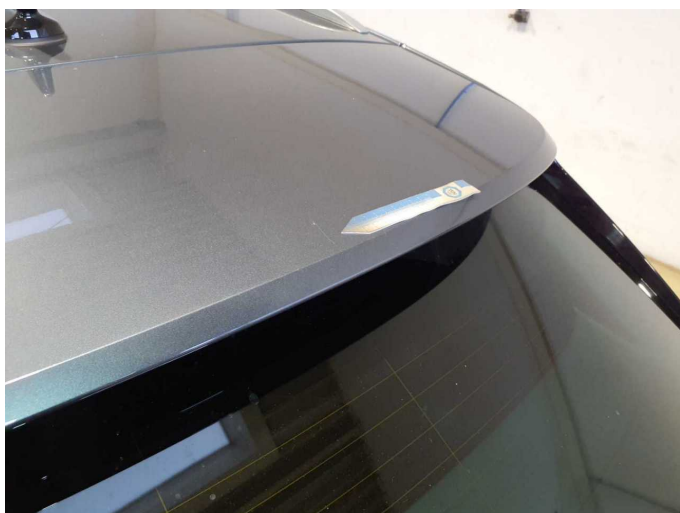
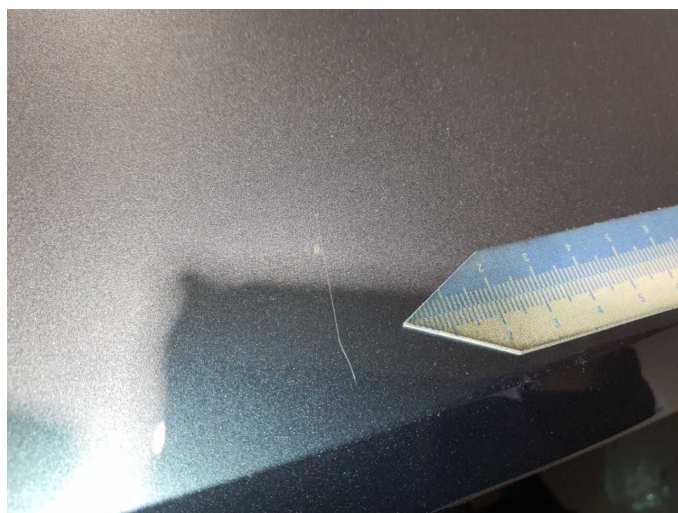
| No. | Component group | Description |
|---|---|---|
| 7 | Boot lid / rear door | Rear spoiler - Scratch(es) - Smart repair |

**Damage 7:** Boot lid / rear door: Rear spoiler - Scratch(es) - Smart repair

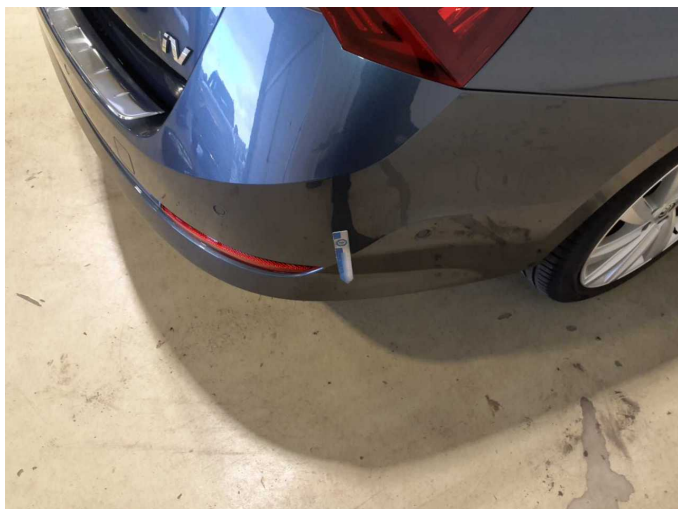
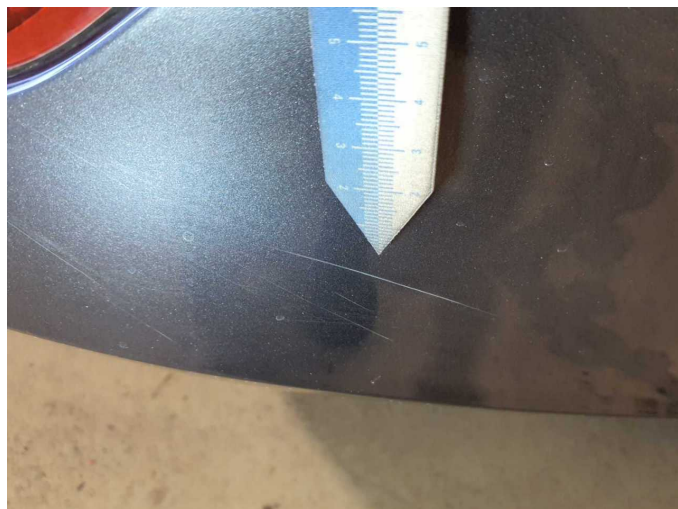
| No. | Component group | Description |
|---|---|---|
| 8 | Rear bumper | Rear bumper - Scratch(es) - Smart repair |

**Damage 8:** Rear bumper: Rear bumper - Scratch(es) - Smart repair

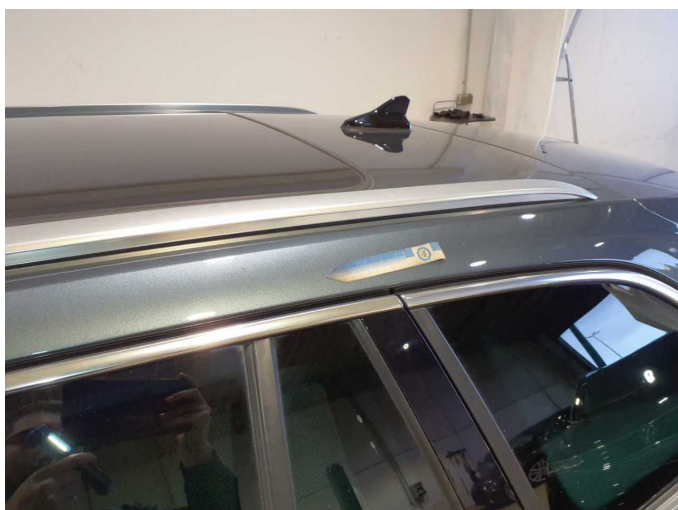
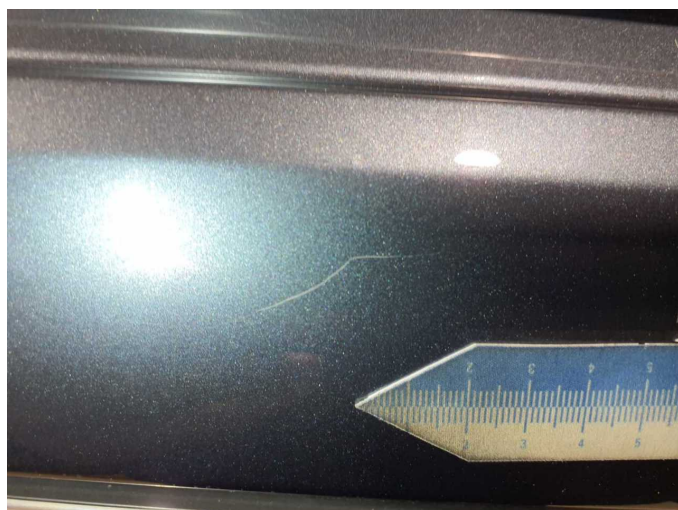
| No. | Component group | Description |
|---|---|---|
| 9 | Roof | Roof rail - left side - Scratch(es) - Smart repair |

**Damage 9:** Roof: Roof rail - left side - Scratch(es) - Smart repair

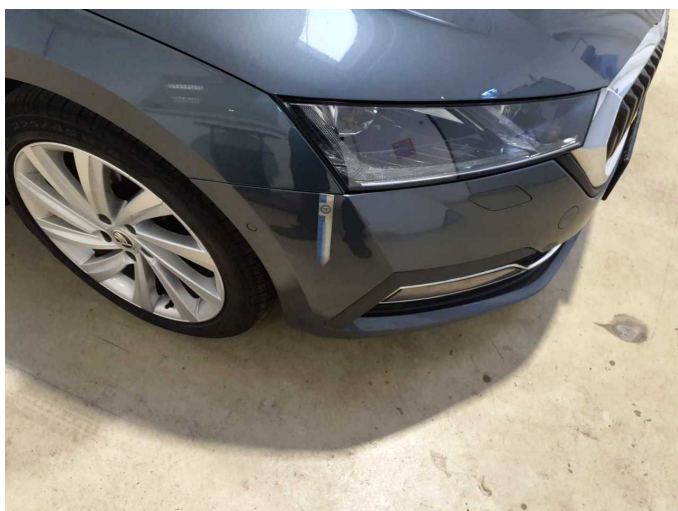
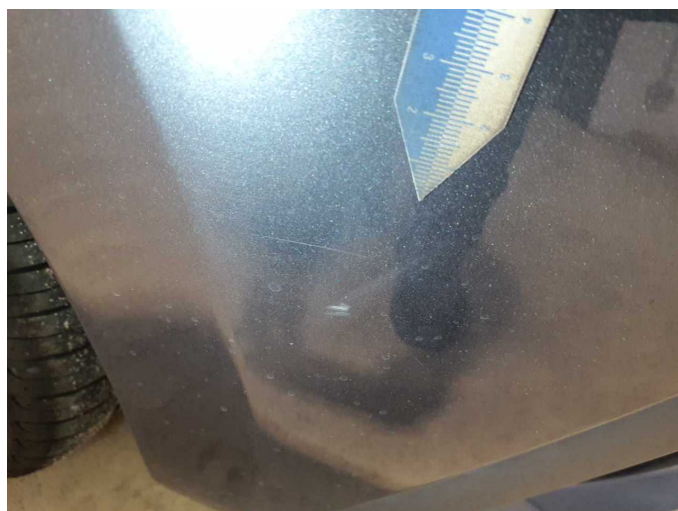
| No. | Component group | Description |
|---|---|---|
| 10 | Front bumper | Front bumper - Scratch(es) - Smart repair |

**Damage 10:** Front bumper: Front bumper - Scratch(es) - Smart repair

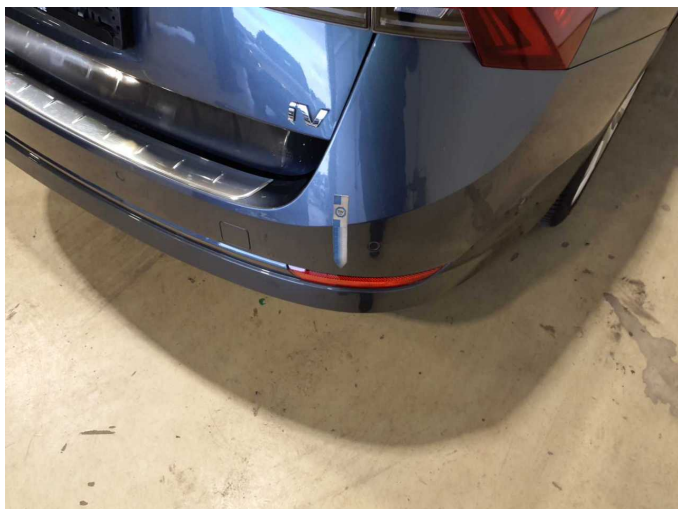
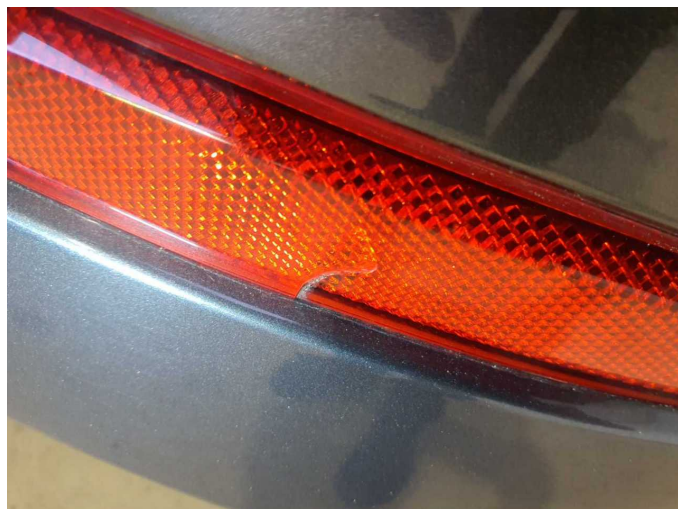
| No. | Component group | Description |
|---|---|---|
| 11 | Boot lid / rear door | Reflectors - Broken / torn - Replace |

**Damage 11:** Boot lid / rear door: Reflectors - Broken / torn - Replace

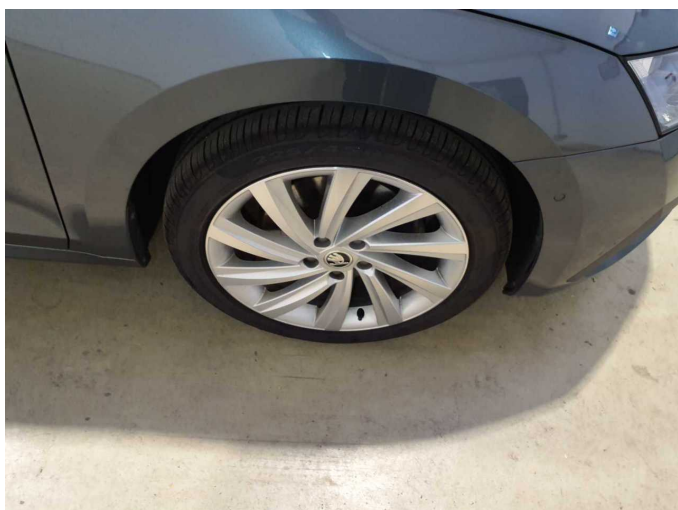
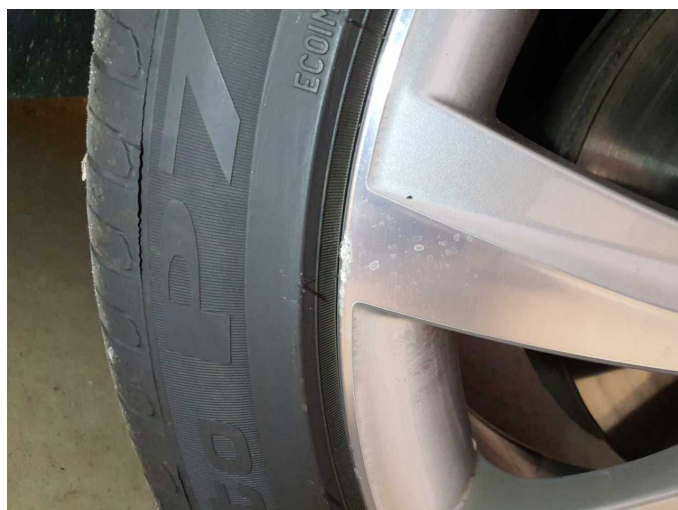
| No. | Component group | Description |
|---|---|---|
| 12 | Wheel / tyres | Alloy rim - front right side - Scratch(es) - Loss in value |

**Damage 12:** Wheel / tyres: Alloy rim - front right side - Scratch(es) - Loss in value

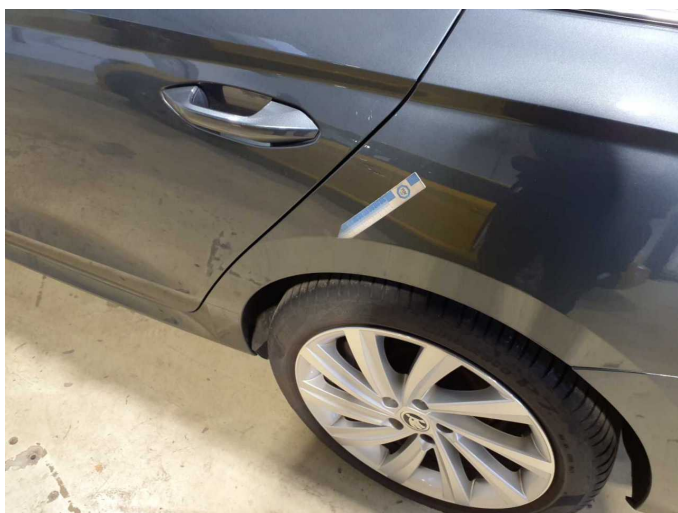
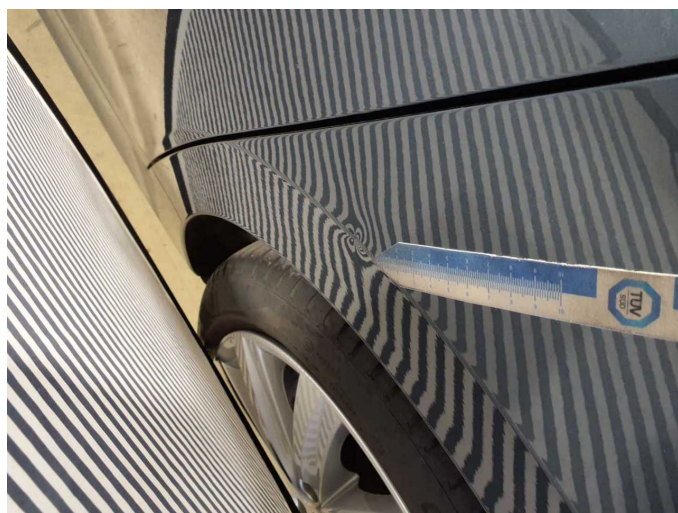
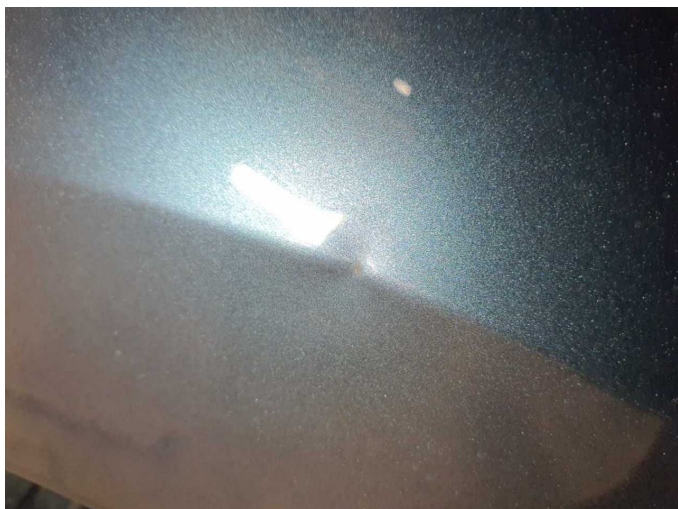
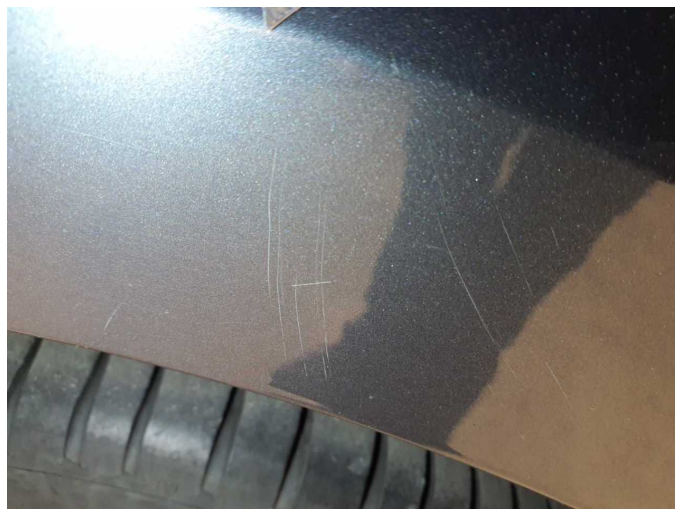
| No. | Component group | Description |
|---|---|---|
| 13 | Side panel - rear left side | Side panel - Dent / paintcoat damage - Repair and paint |

**Damage 13:** Side panel - rear left side: Side panel - Dent / paintcoat damage - Repair and paint

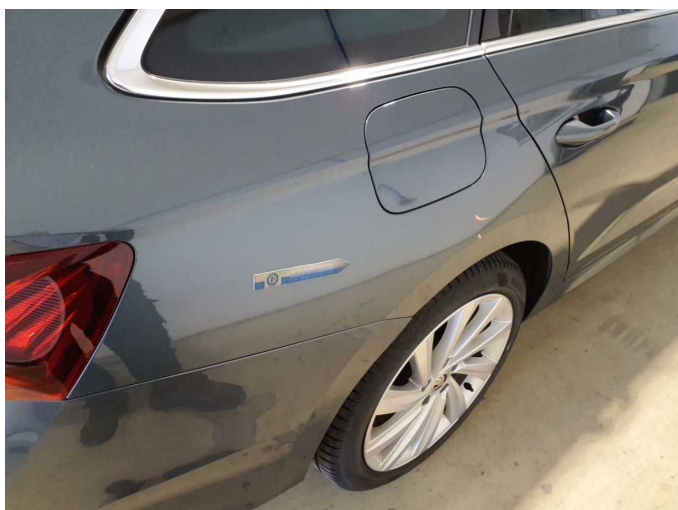
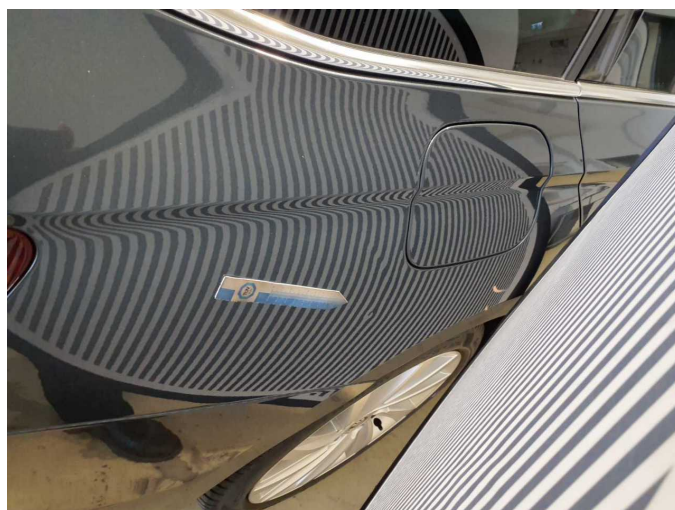
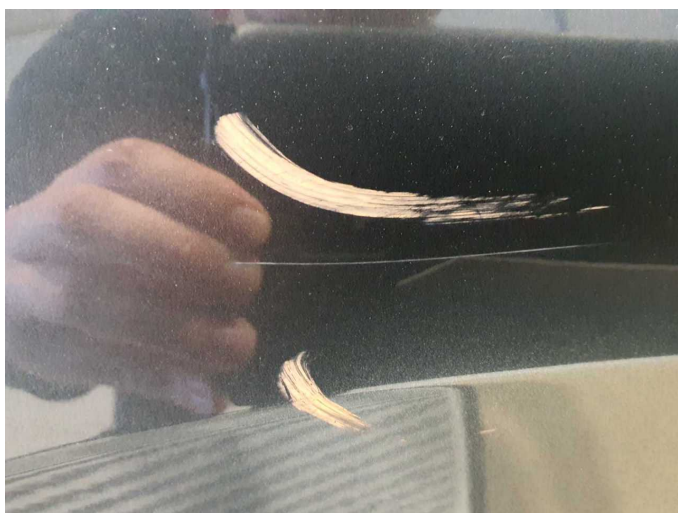
| No. | Component group | Description |
|---|---|---|
| 14 | Side panel - rear right side | Side panel - Dent / paintcoat damage - Repair and paint |

**Damage 14:** Side panel - rear right side: Side panel - Dent / paintcoat damage - Repair and paint

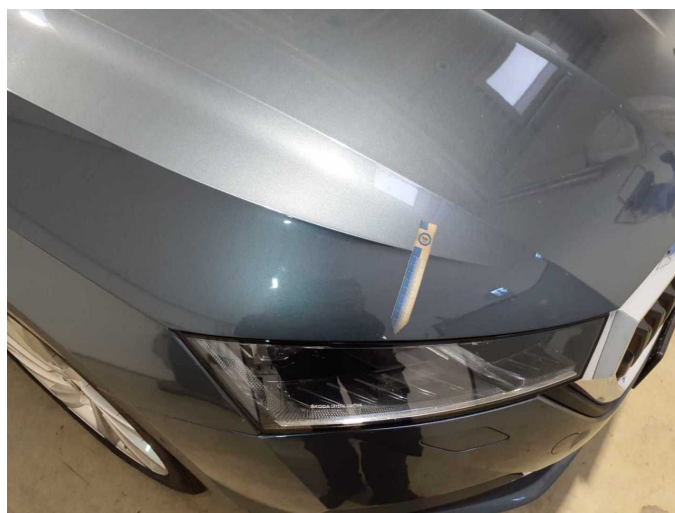
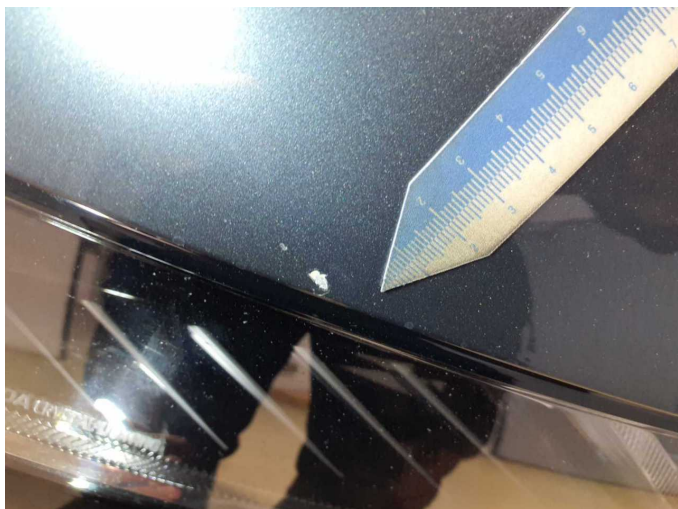
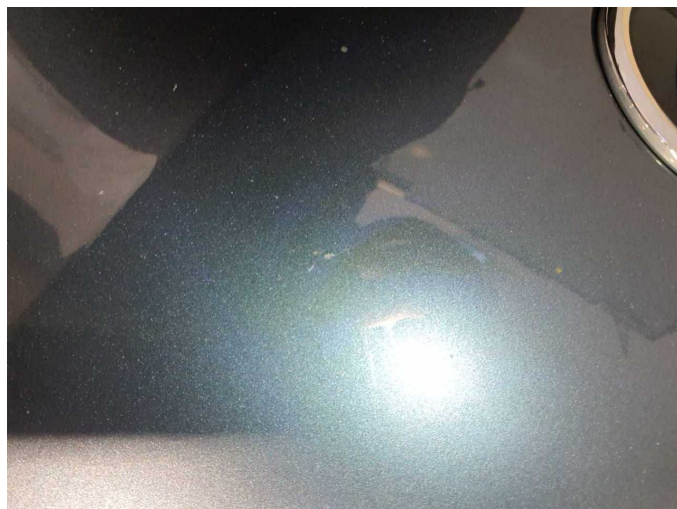
| No. | Component group | Description |
|---|---|---|
| 15 | Bonnet | Bonnet - Scratch(es) - Paint |

**Damage 15:** Bonnet: Bonnet - Scratch(es) - Paint

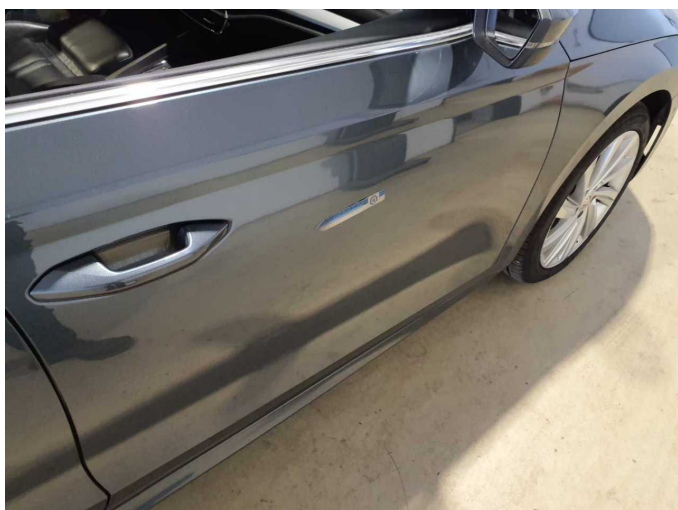
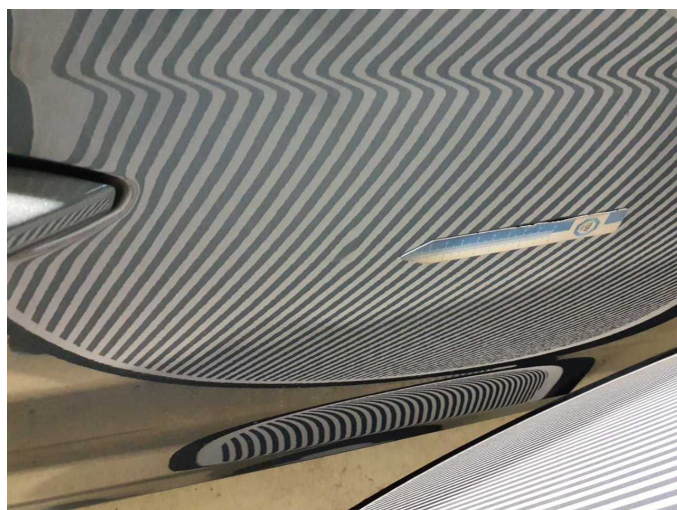
| No. | Component group | Description |
|---|---|---|
| 5 | Door - front right side | Door - Dent / paintcoat damage - No deduction |

**Wear and tear 5:** Door - front right side: Door - Dent / paintcoat damage - No deduction

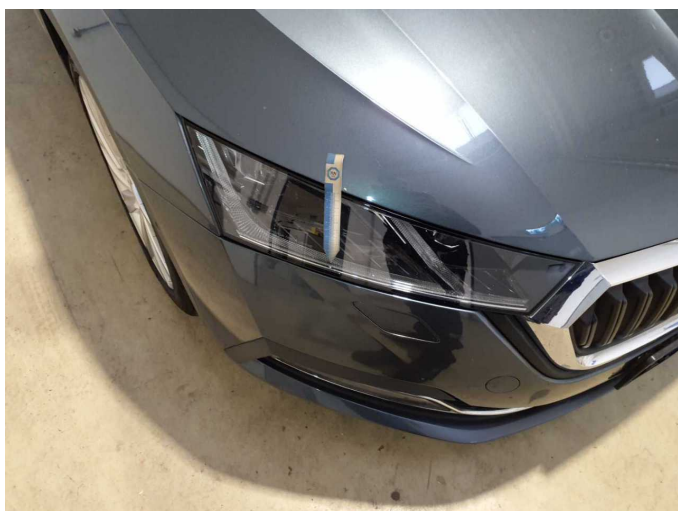
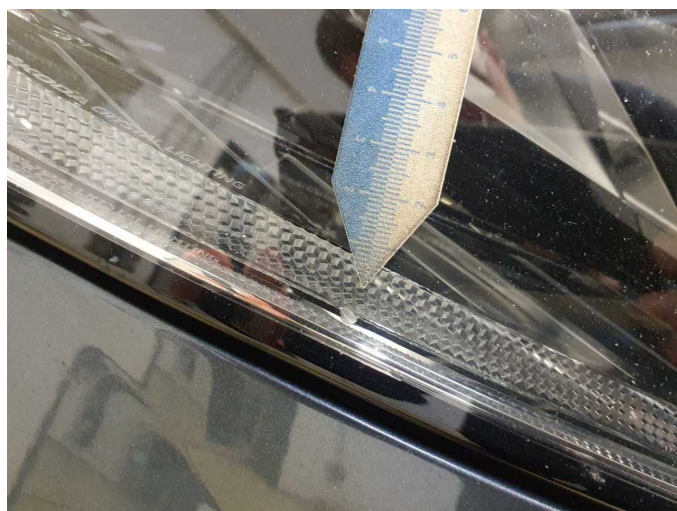
| No. | Component group | Description |
|---|---|---|
| 6 | Headlight | Headlight - right side - Scratch(es) - No deduction |

**Wear and tear 6:** Headlight: Headlight - right side - Scratch(es) - No deduction

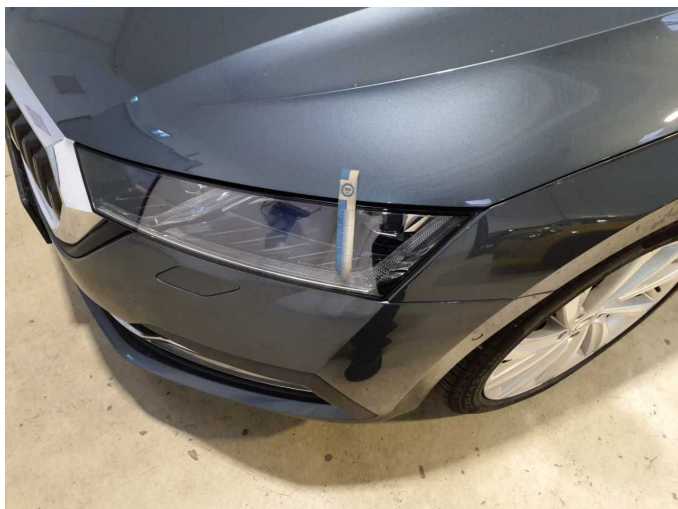
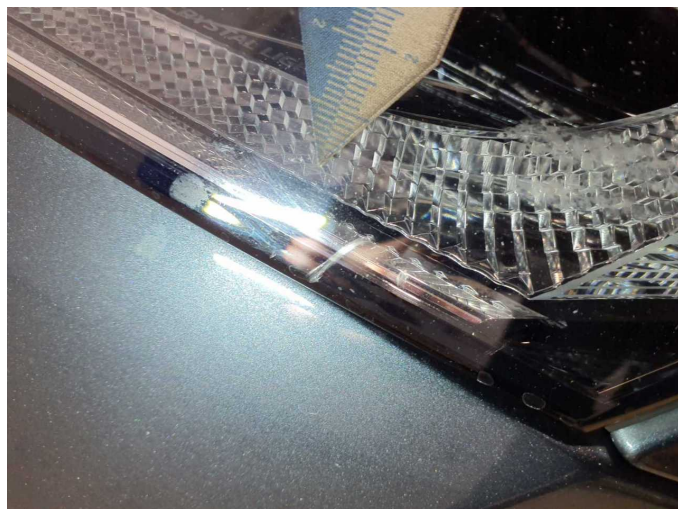
| No. | Component group | Description |
|---|---|---|
| 7 | Headlight | Headlight - left side (außerhalb Blendbereich) - Scratch(es) - No deduction |

**Wear and tear 7:** Headlight: Headlight - left side (außerhalb Blendbereich) - Scratch(es) - No deduction
