Expertise

Protocol number: 46053799  
Order No. / Reference: 26512689  
Inspection date: 19 Jun 2026

Manufacturer: Audi  
VIN: WAUZZZF31N1104496

Model: Q3 40 TDI Sportback quattro S tronic

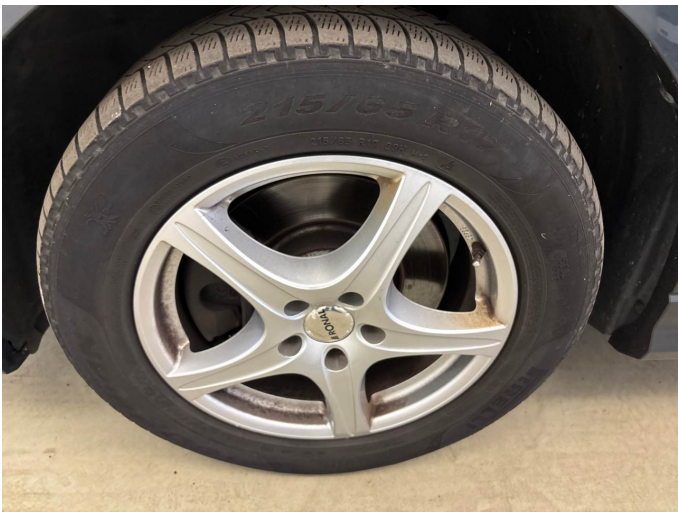
Figure 12: Mounted tyres

| Tyres | | | | |
|---|---|---|---|---|
| 1) | 215/65 R17 99H | Winter tyres on Light alloy | Pirelli | 2mm / 2mm |
| 2) | 215/65 R17 99H | Winter tyres on Light alloy | Pirelli | 3mm / 3mm |

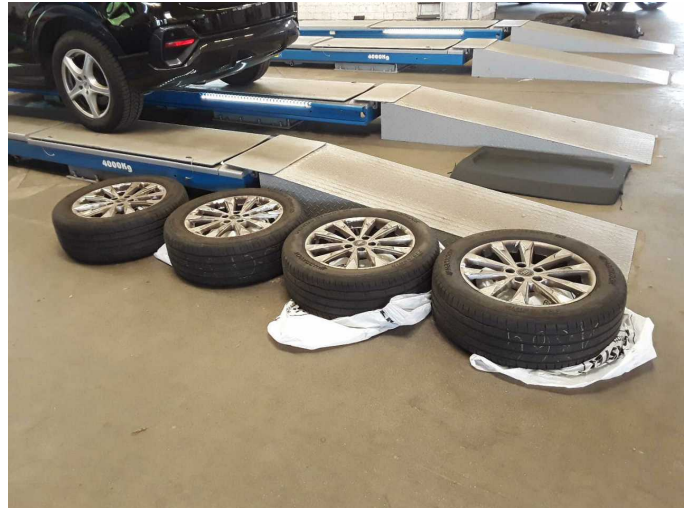
Figure 14: Additional tyres

| Tyres | | | | |
|---|---|---|---|---|
| 1) | 235/55 R18 100V | Summer tyres on Light alloy | Hankook | 4mm / 4mm |
| 2) | 235/55 R18 100V | Summer tyres on Light alloy | Hankook | 4mm / 4mm |

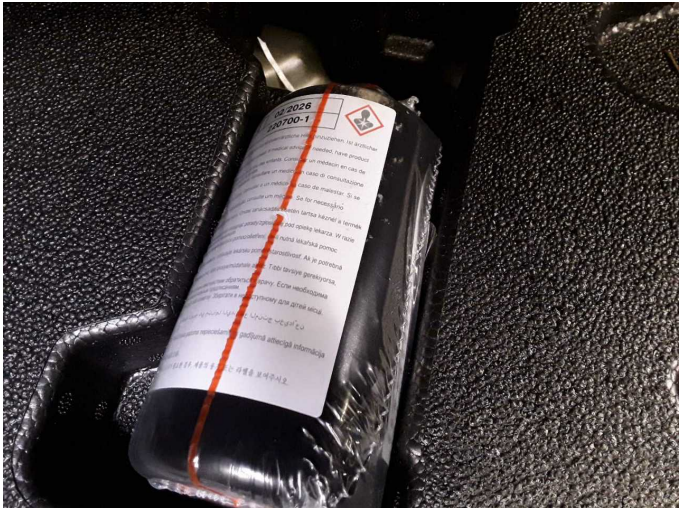
| No. | Component group | Description |
|---|---|---|
| 1 | Equipment | Tirefit filler - Expired - Replace |

Damage 1: Equipment: Tirefit filler - Expired - Replace

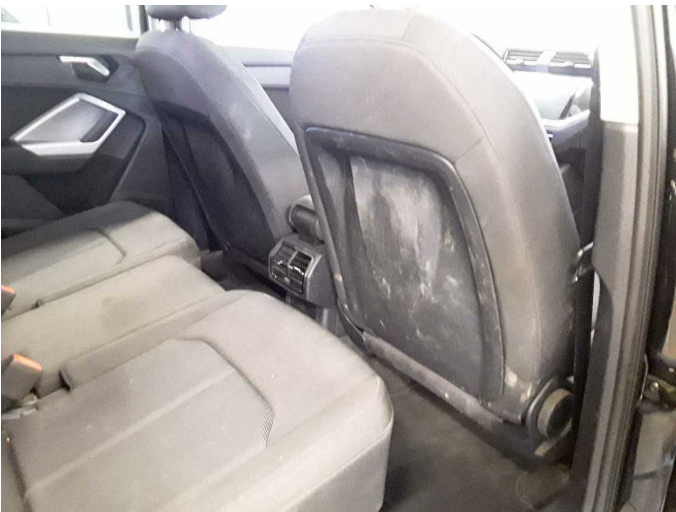
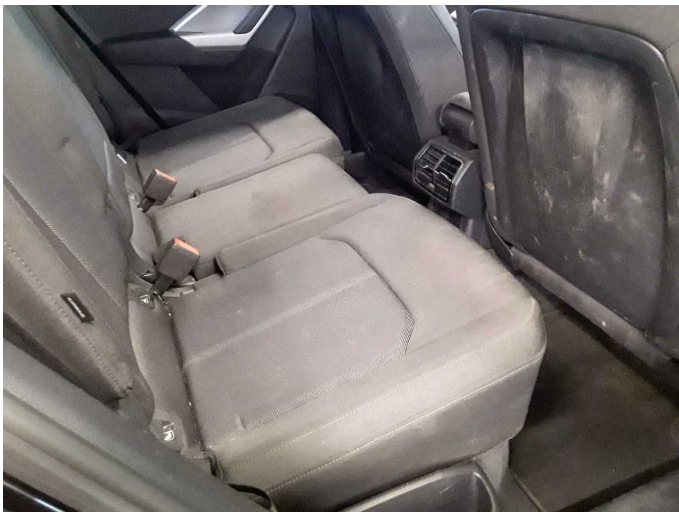
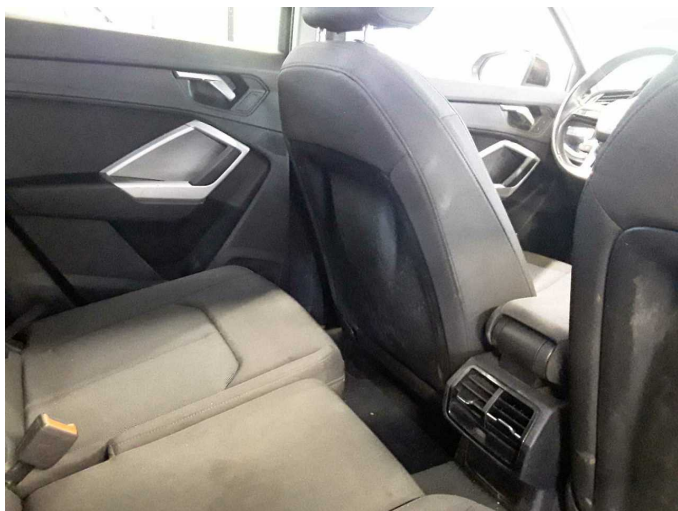
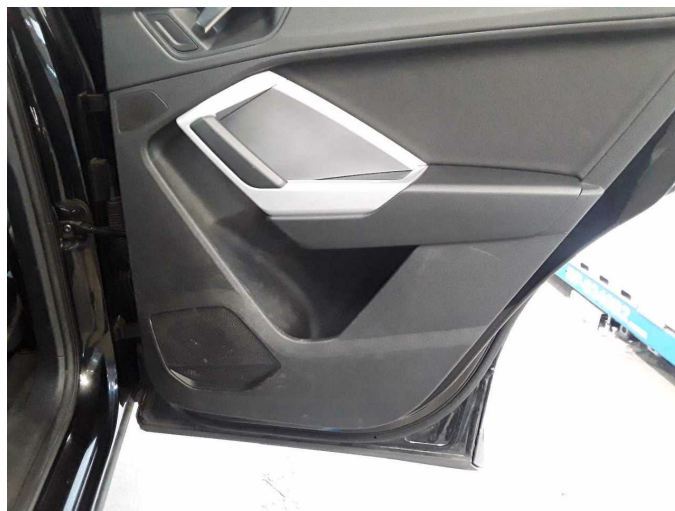
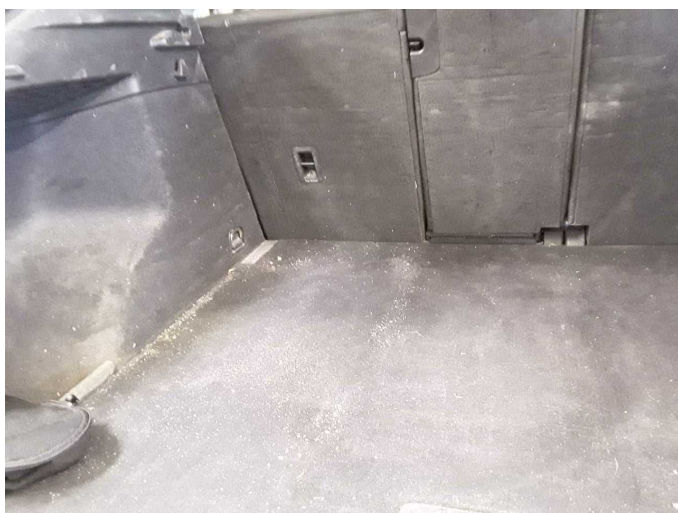
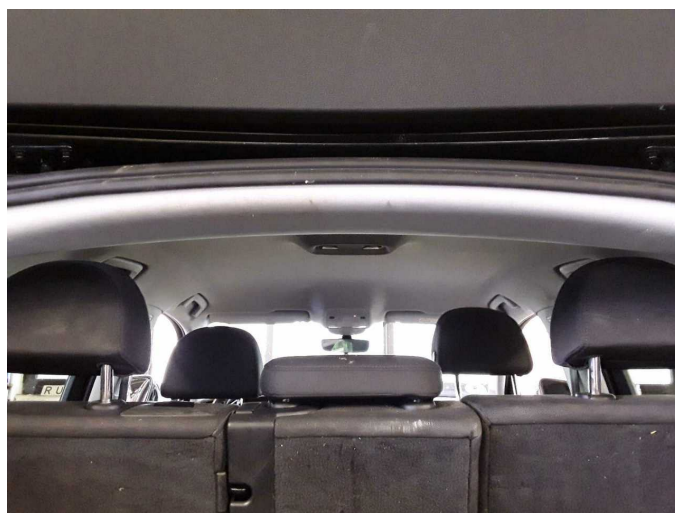
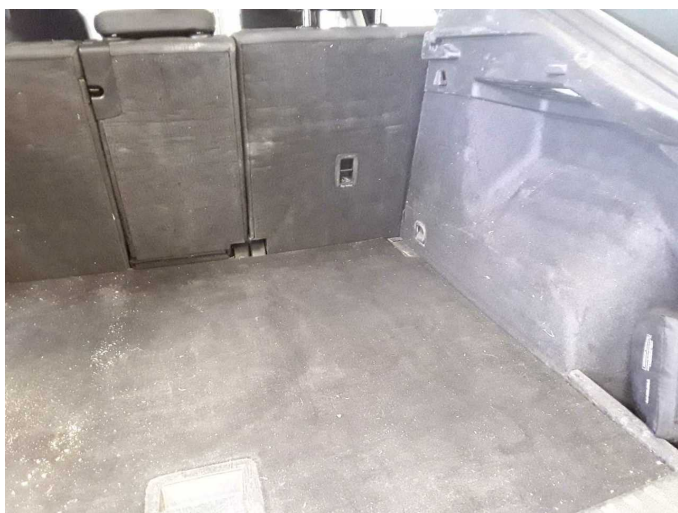
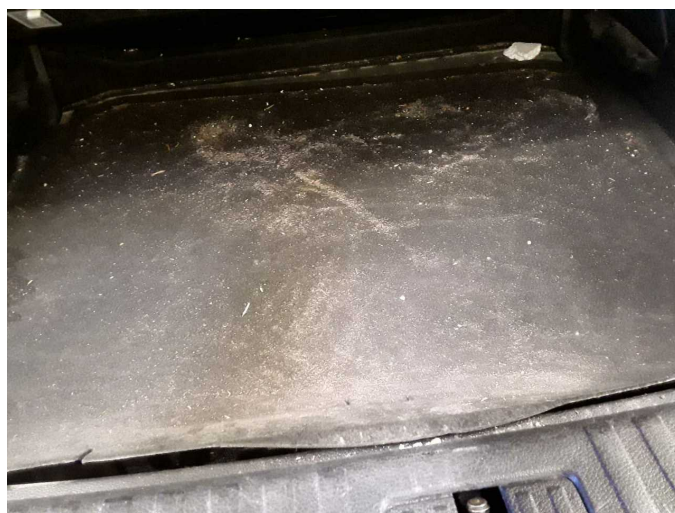
| No. | Component group | Description |
|---|---|---|
| 2 | Interior | Interior - Soiled - Conditioning |

Damage 2: Interior: Interior - Soiled - Conditioning

**Damage 2:** Interior: Interior - Soiled - Conditioning

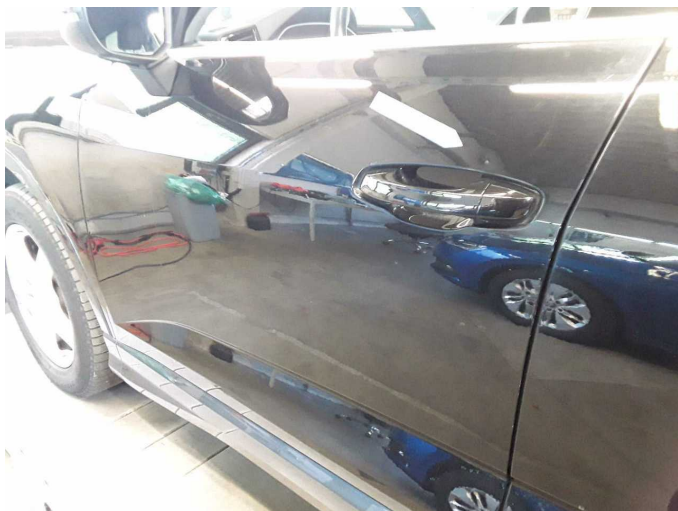
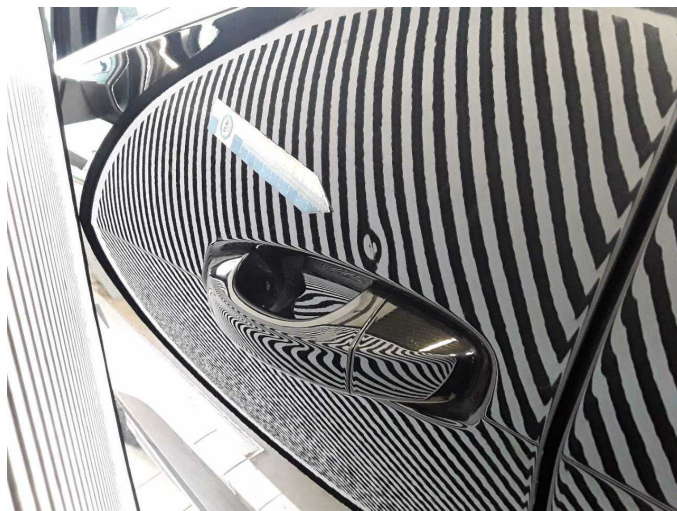
| No. | Component group | Description |
|---|---|---|
| 3 | Door - front left side | Door - Dent / paintcoat damage - Smart repair |

**Damage 3:** Door - front left side: Door - Dent / paintcoat damage - Smart repair

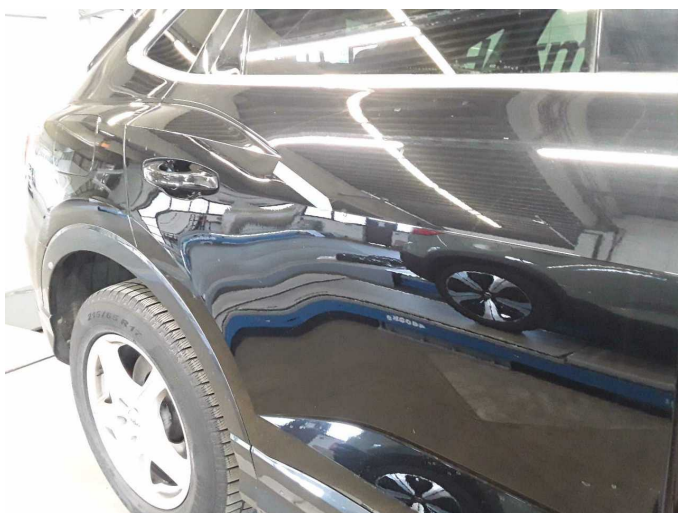
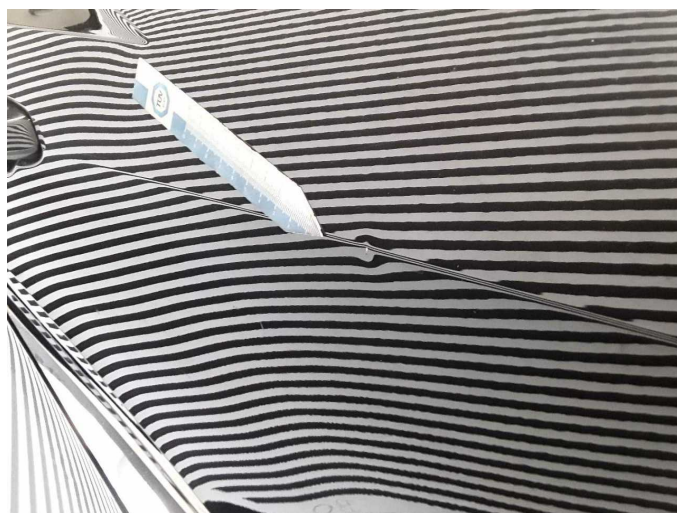
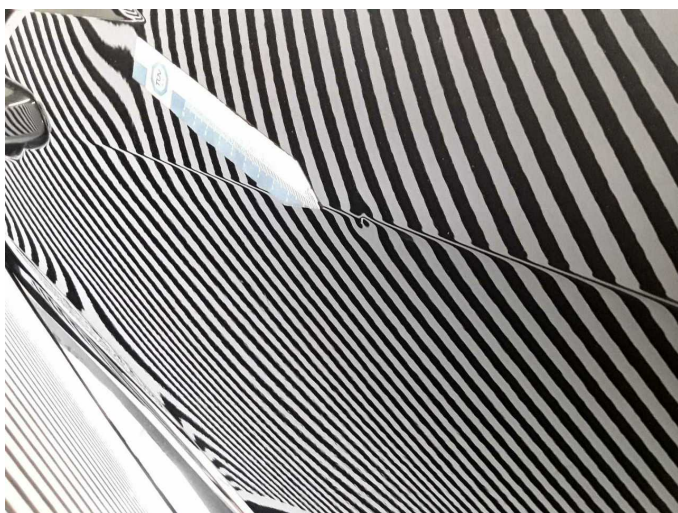
| No. | Component group | Description |
|---|---|---|
| 4 | Door - rear right side | Door - Dent / paintcoat damage - Smart repair |

**Damage 4:** Door - rear right side: Door - Dent / paintcoat damage - Smart repair

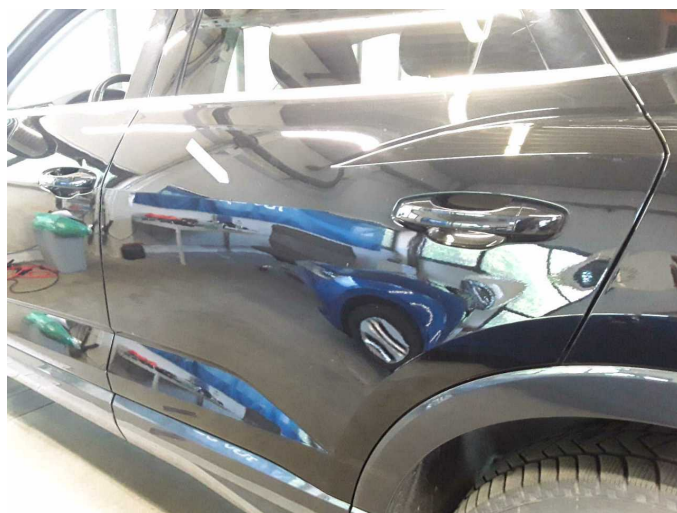
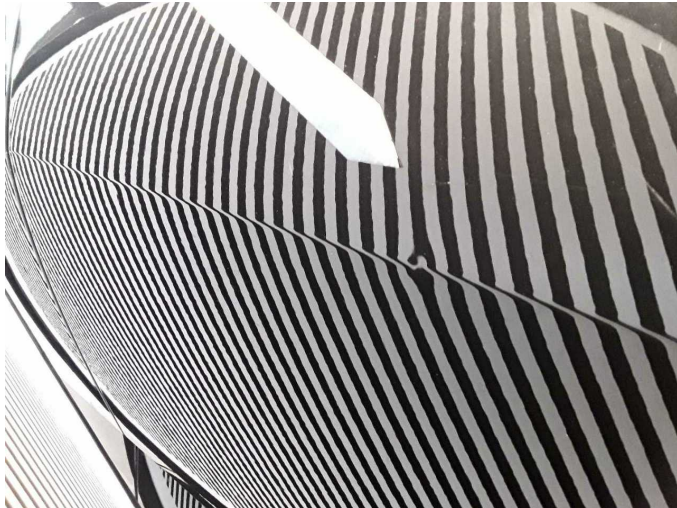
| No. | Component group | Description |
|---|---|---|
| 5 | Door - rear left side | Door - Dent / paintcoat damage - Smart repair |

**Damage 5:** Door - rear left side: Door - Dent / paintcoat damage - Smart repair

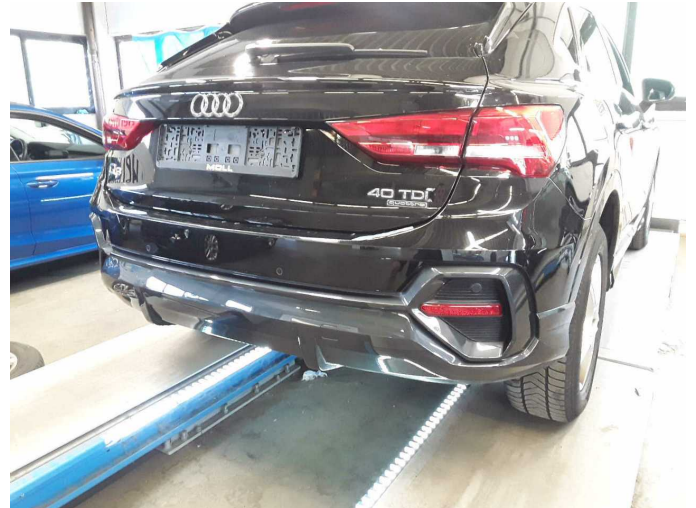
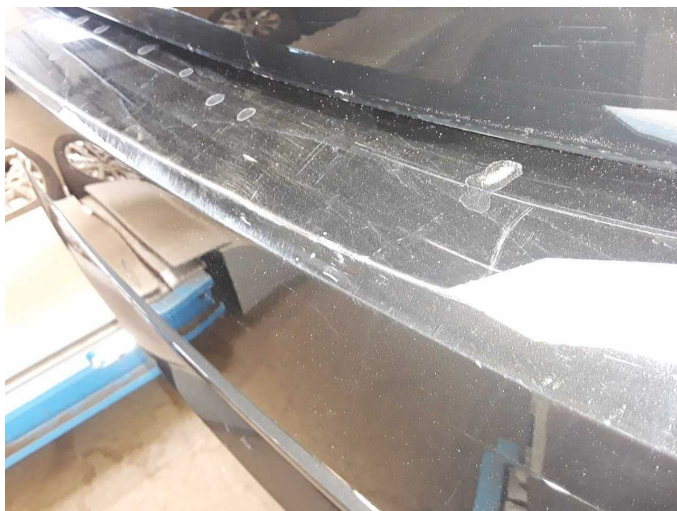
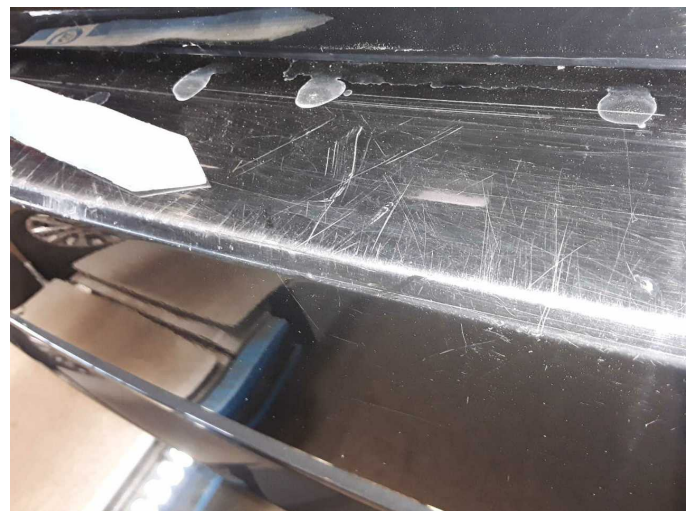
| No. | Component group | Description |
|---|---|---|
| 6 | Rear bumper | Rear bumper - Scratch(es) - Paint |

**Damage 6:** Rear bumper: Rear bumper - Scratch(es) - Paint

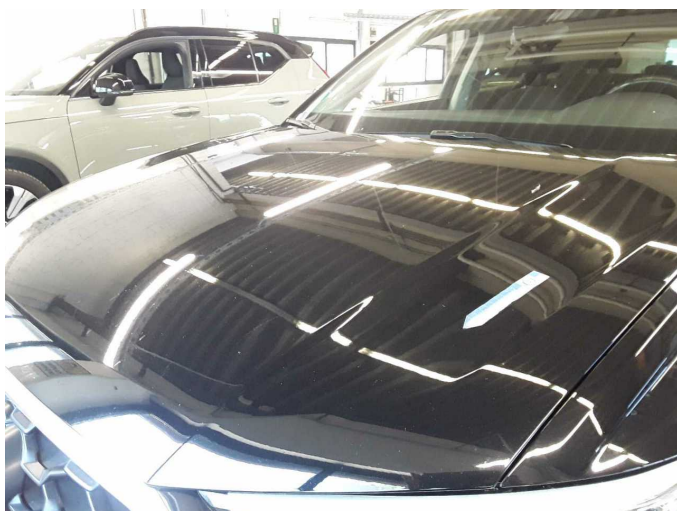
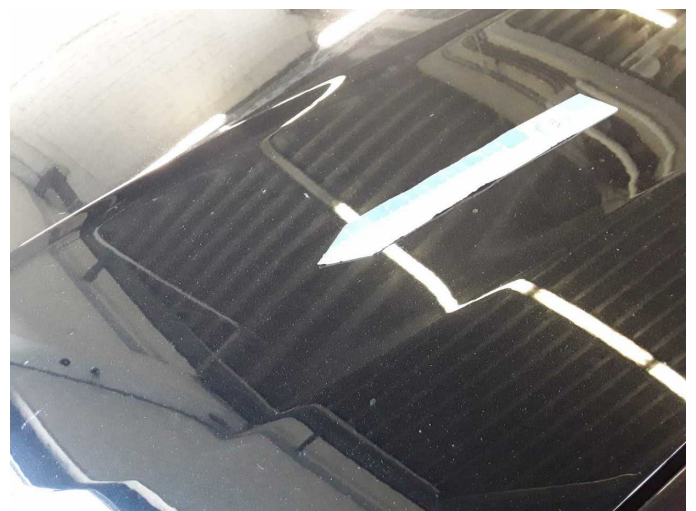
| No. | Component group | Description |
|---|---|---|
| 2 | Bonnet | Bonnet - Stone chips - No deduction |

**Wear and tear 2:** Bonnet: Bonnet - Stone chips - No deduction

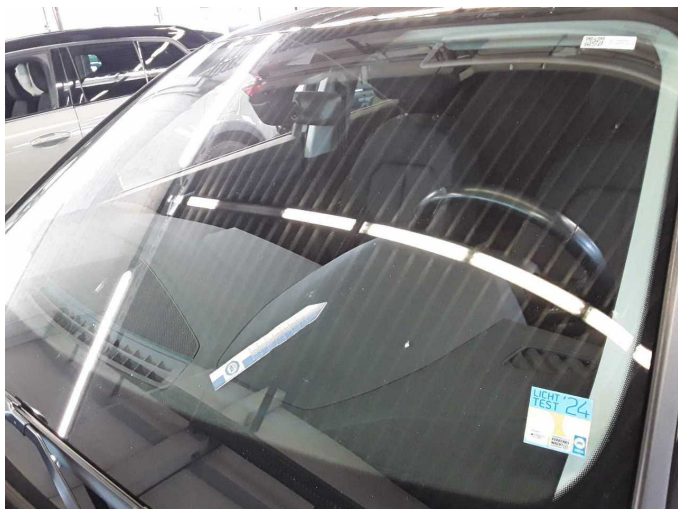
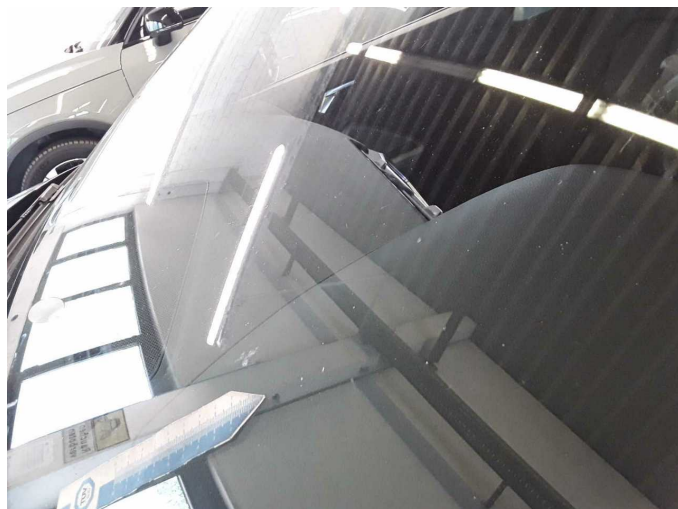
| No. | Component group | Description |
|---|---|---|
| 3 | Vehicle glazing | Windscreen - Stone chips - No deduction |

**Wear and tear 3:** Vehicle glazing: Windscreen - Stone chips - No deduction

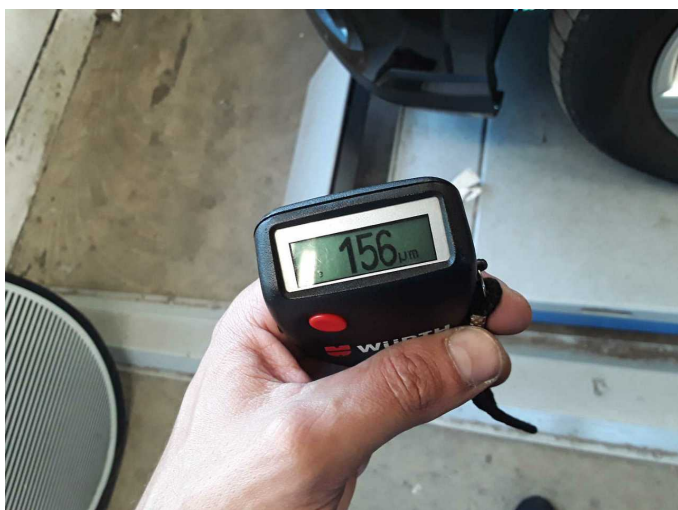
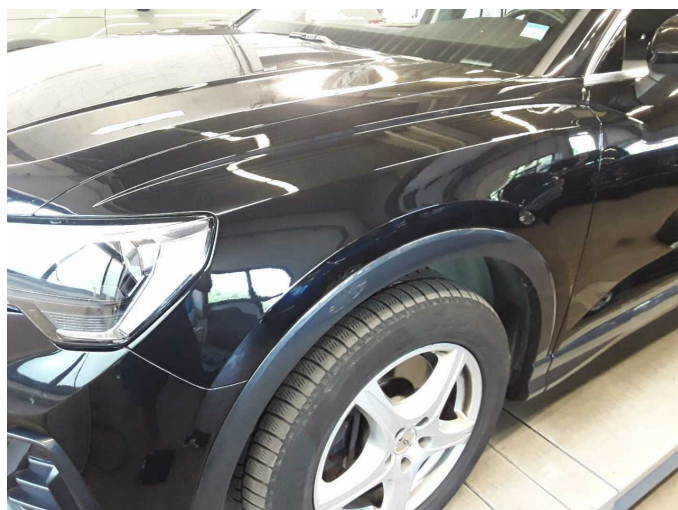
| No. | Repainting |
|---|---|
| 1 | Mudguard - left side, Professionally carried out, Invoice of repair done Non-existent |

| Mudguard - left side | 156 µm |

**Repainting 1:** Mudguard - left side
