Expertise

Protocol number: 46383471  
Order No. / Reference: 26689543  
Inspection date: 8 Jul 2026

| Manufacturer: Opel | Model: Astra Sports Tourer 1.5 D Automatik Business Elegance |
| VIN: VXKFCYHZTP1099782 | |

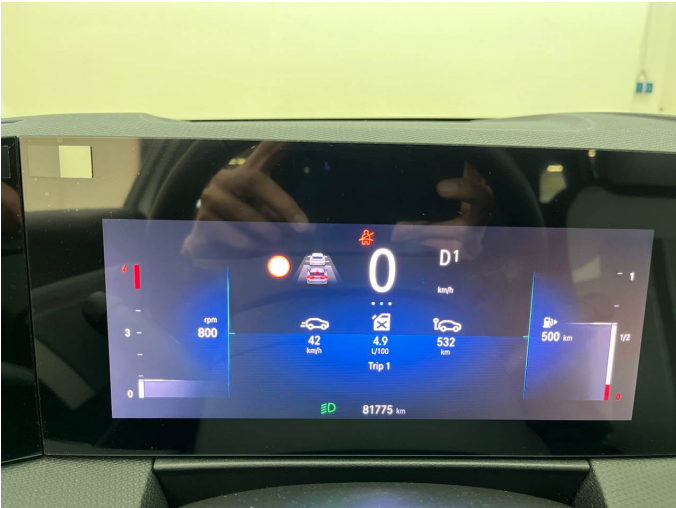
Figure 7: Instrument cluster

| Vehicle details | |
|---|---|
| Mileage (Read) | 81,775 km |

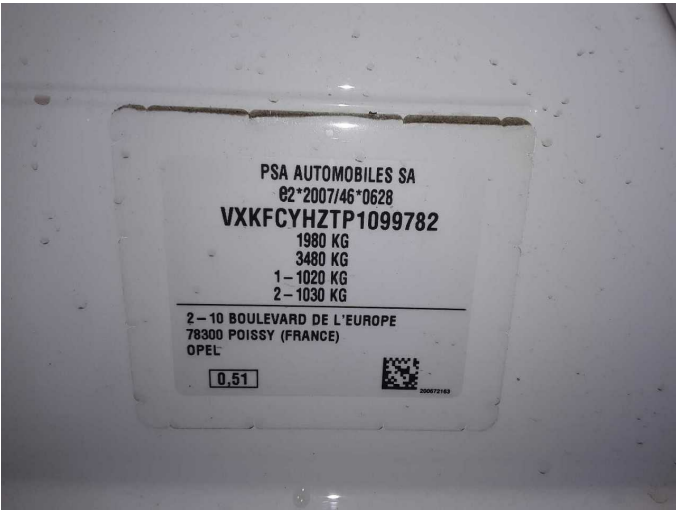
Figure 11: VIN

| VIN comparison | The vehicle identification number (VIN) was read from the vehicle and its conformity with the submitted documents was confirmed by the undersigned during the inspection. |

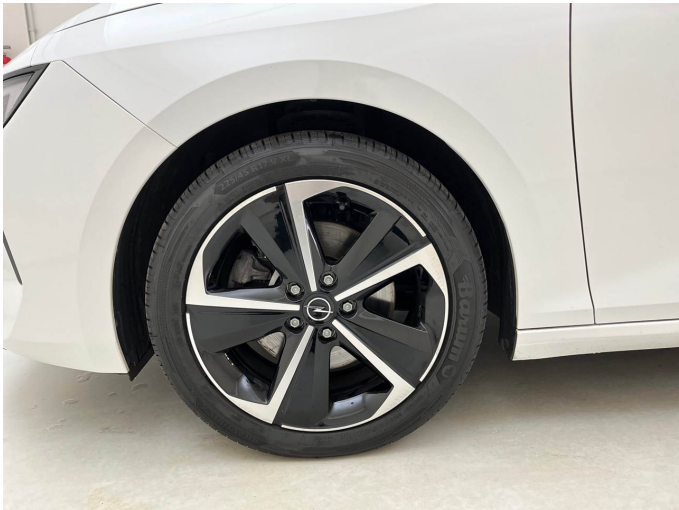
Figure 12: Mounted tyres

| # | Tyre size | Type of tyre | Manufacturer | Tread depth |
|---|---|---|---|---|
| 1) | 225/45 R17 94V | Summer tyres on Light alloy | Barum | 7mm / 7mm |
| 2) | 225/45 R17 94V | Summer tyres on Light alloy | Barum | 7mm / 7mm |

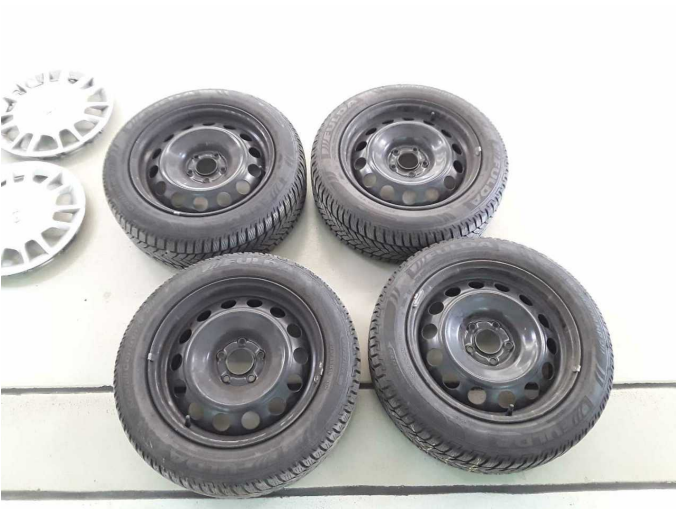
Figure 23: Additional tyres

| # | Tyre size | Type of tyre | Manufacturer | Tread depth |
|---|---|---|---|---|
| 1) | 205/55 R16 91H | Winter tyres on Steel rim with wheel cover | Fulda | 6mm / 6mm |
| 2) | 205/55 R16 91H | Winter tyres on Steel rim with wheel cover | Fulda | 7mm / 7mm |

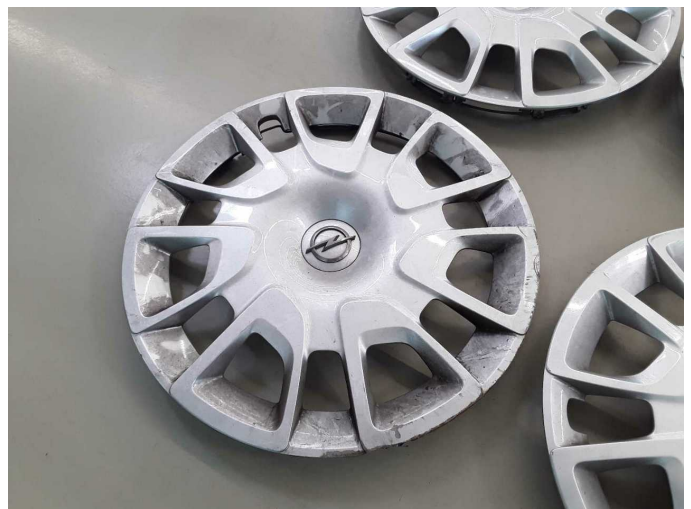
Damage 1: 2nd wheel set: 1 wheel cover - Broken / torn - Replace

| No. | Component group | Description |
|---|---|---|
| 1 | 2nd wheel set | 1 wheel cover - Broken / torn - Replace |

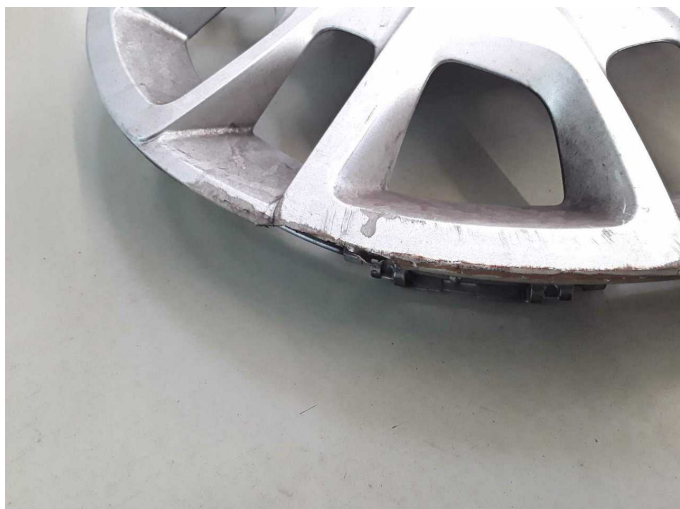
**Damage 1:** 2nd wheel set: 1 wheel cover - Broken / torn - Replace

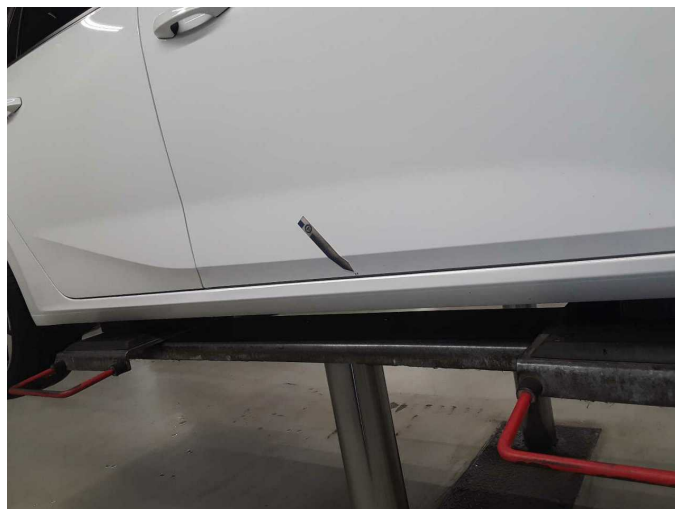
**Damage 2:** Door - front right side: Door - Scratch(es) - Smart repair

| No. | Component group | Description |
|---|---|---|
| 2 | Door - front right side | Door - Scratch(es) - Smart repair |

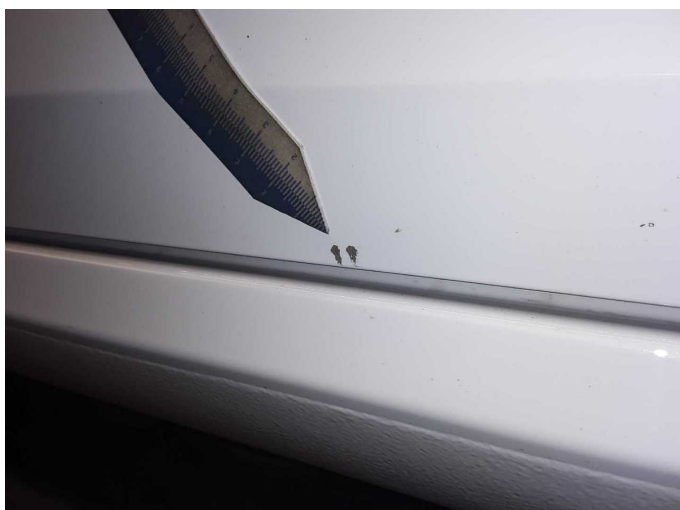
**Damage 2:** Door - front right side: Door - Scratch(es) - Smart repair

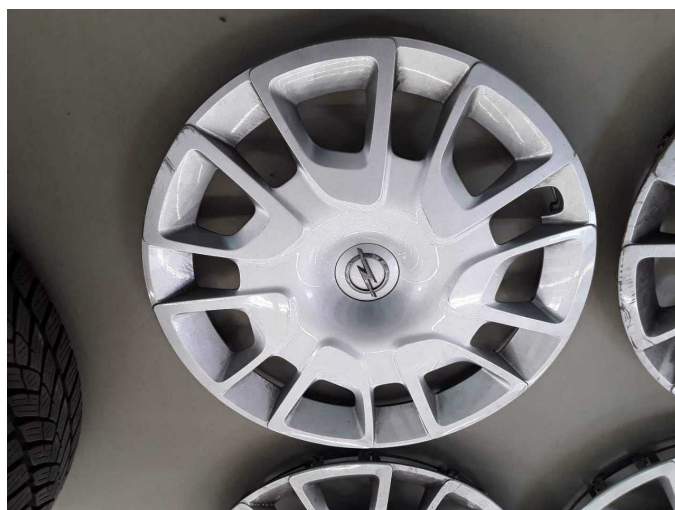
| No. | Component group | Description |
|---|---|---|
| 1 | 2nd wheel set | 1 wheel cover - Scratch(es) - No deduction |

**Wear and tear 1:** 2nd wheel set: 1 wheel cover - Scratch(es) - No deduction

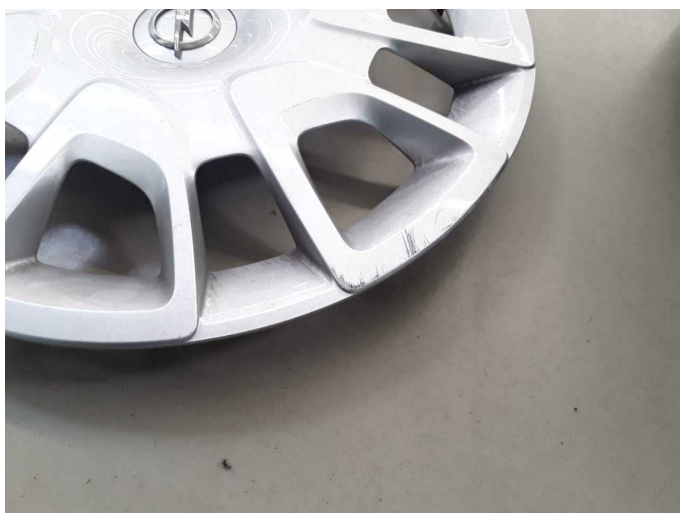
**Wear and tear 1:** 2nd wheel set: 1 wheel cover - Scratch(es) - No deduction
