Expertise

Protocol number: 46702807  
Order No. / Reference: 26646396  
Inspection date: 23 Jul 2026

| Manufacturer: Opel | Model: Grandland 1.5 D Automatik Business Elegance |

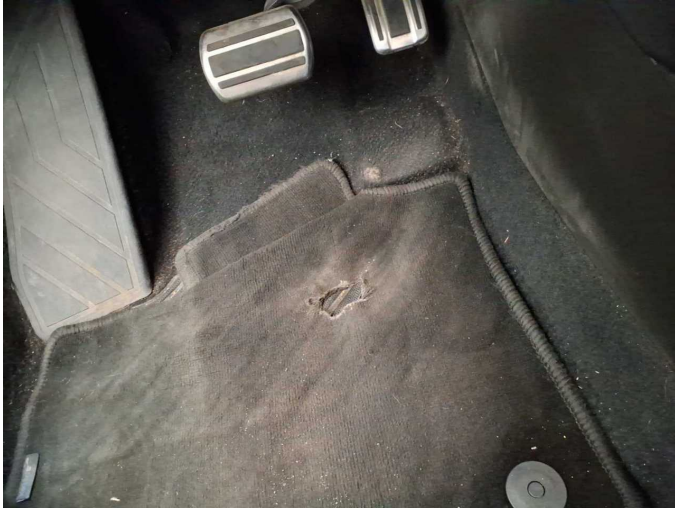
| No. | Component group | Description |
|---|---|---|
| 1 | Trim / covers | Floor mats (Vorne links) - Damaged - Replace |

**Damage 1:** Trim / covers: Floor mats (Vorne links) - Damaged - Replace

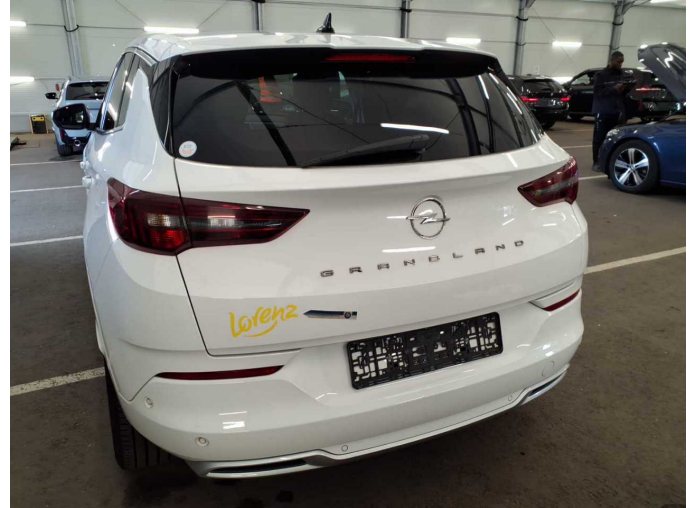
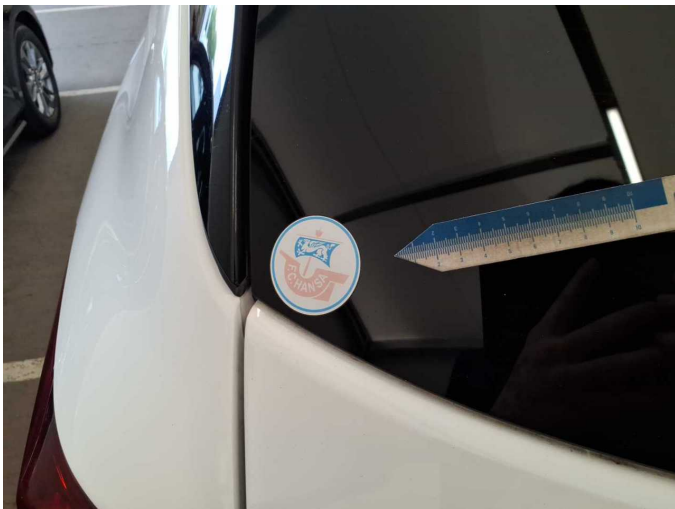
| No. | Component group | Description |
|---|---|---|
| 2 | Boot lid / rear door | Boot lid - Glued / labelled - De-glue / neutralise |

**Damage 2:** Boot lid / rear door: Boot lid - Glued / labelled - De-glue / neutralise

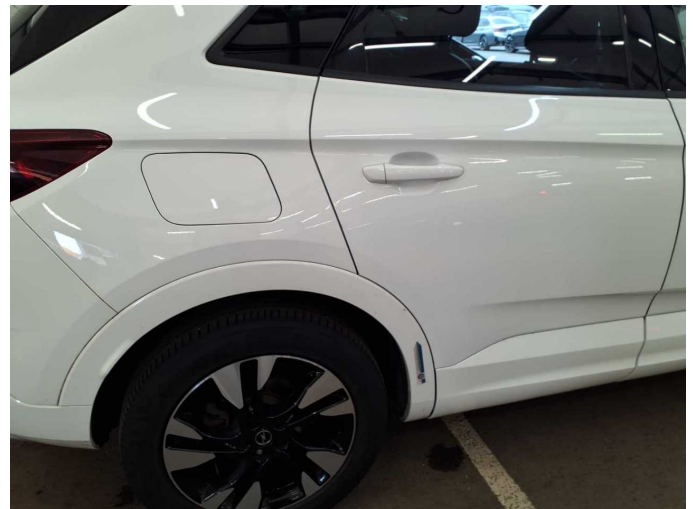
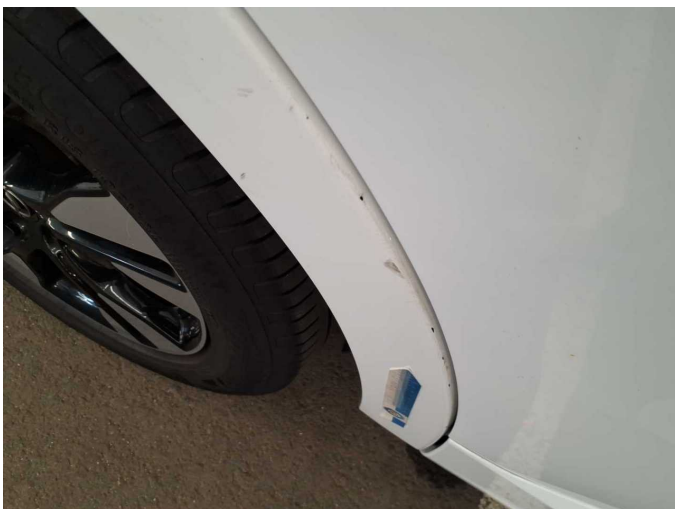
| No. | Component group | Description |
|---|---|---|
| 3 | Side panel - rear right side | Wheel well extension - Scratch(es) - Smart repair |

**Damage 3:** Side panel - rear right side: Wheel well extension - Scratch(es) - Smart repair

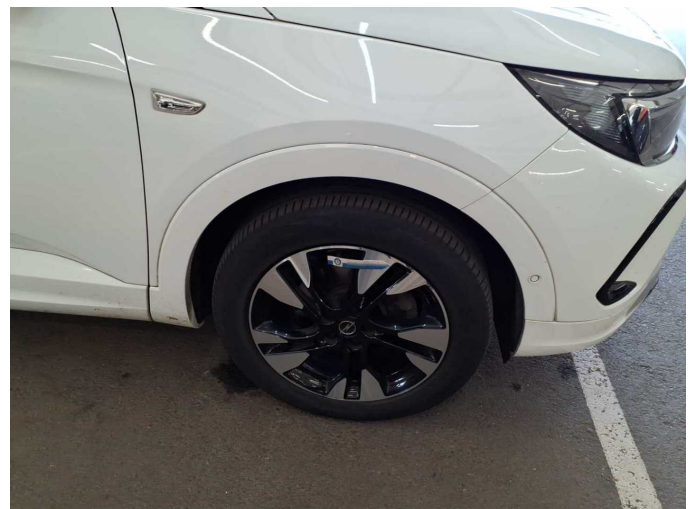
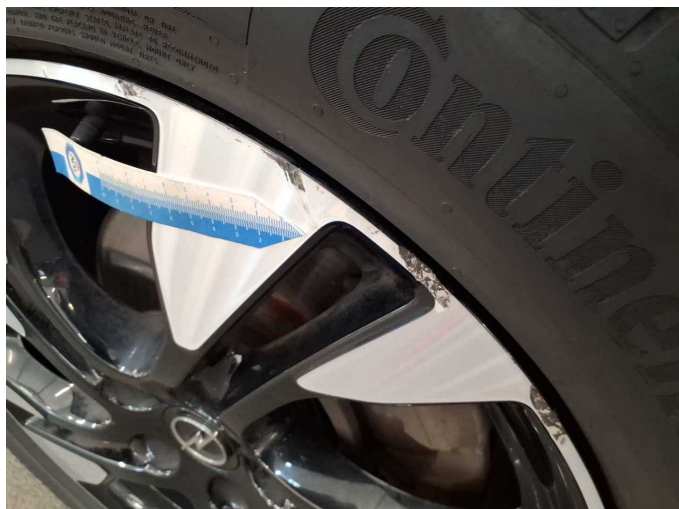
| No. | Component group | Description |
|---|---|---|
| 4 | Wheel / tyres | Alloy rim - front right side - Scratch(es) - Loss in value |

**Damage 4:** Wheel / tyres: Alloy rim - front right side - Scratch(es) - Loss in value

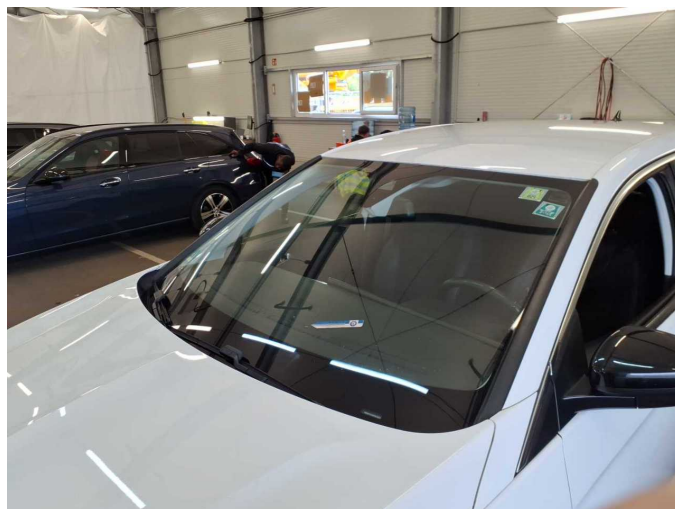
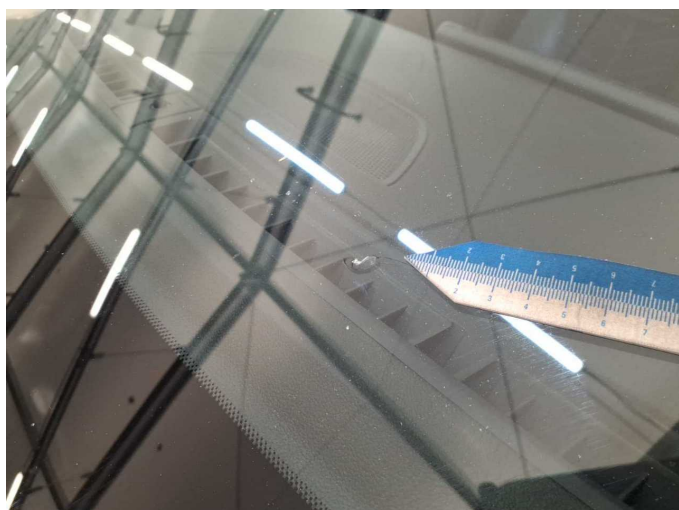
| No. | Component group | Description |
|---|---|---|
| 5 | Vehicle glazing | Windscreen (Im Randbereich mit Rissbildung) - Stone chips - Replace |

**Damage 5:** Vehicle glazing: Windscreen (Im Randbereich mit Rissbildung) - Stone chips - Replace

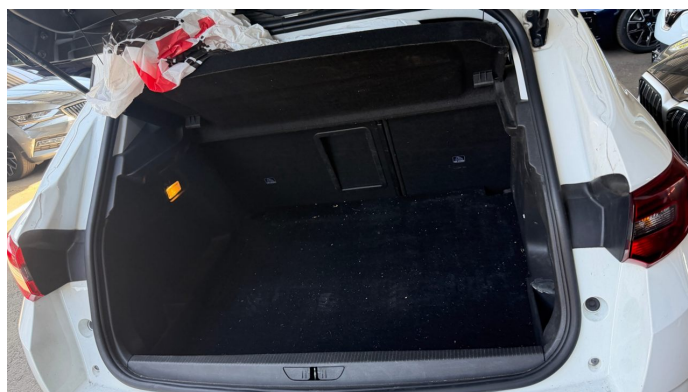
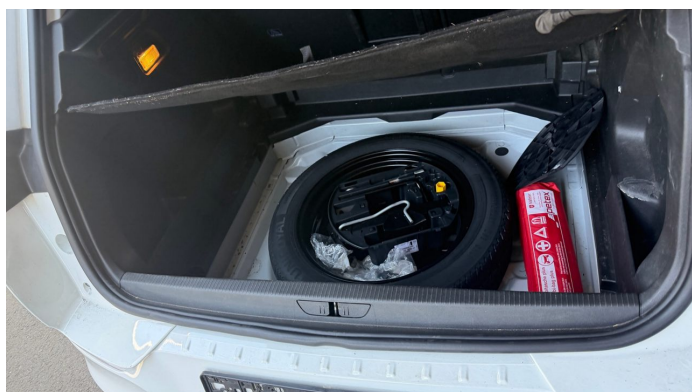
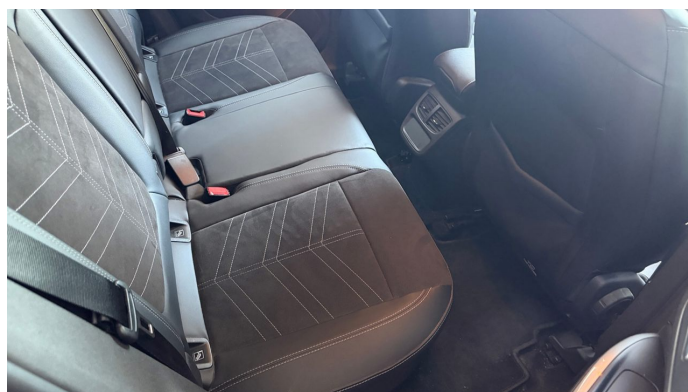
Interior - Separation net (Sicherheitsnetz)

**Missing part 1:** Interior: Separation net (Sicherheitsnetz) - Missing - Replace
