Expertise

Protocol number: 45974345
Order No. / Reference: 26407717
Inspection date: 12 Jun 2026

Model: Karoq 2.0 TDI SCR DSG Style

VIN: TMBJF7NU6P5070333

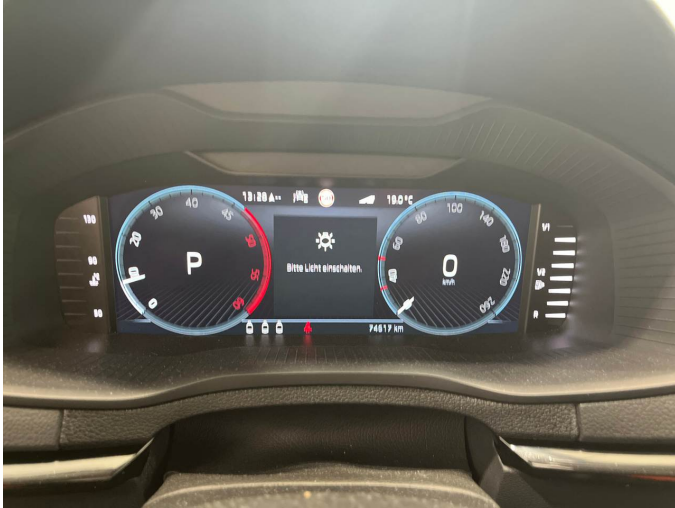
Mileage (Read) 74,617 km

Figure 7: Instrument cluster

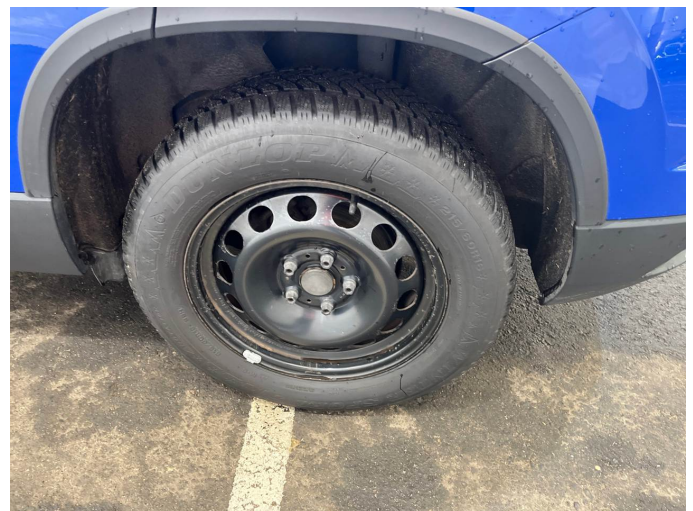
#	Tyre size	Type of tyre	Manufacturer	Tread depth
1)	215/60 R16 95H	Winter tyres on Steel	Dunlop	6mm / 6mm
2)	215/60 R16 95H	Winter tyres on Steel	Dunlop	6mm / 6mm

Figure 12: Mounted tyres

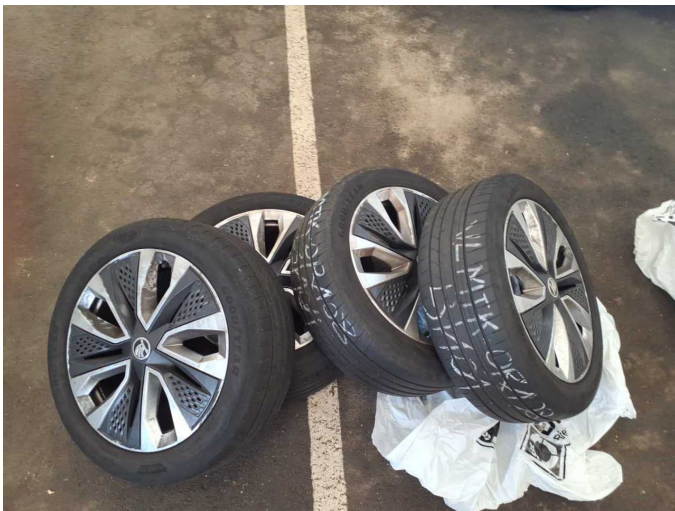
#	Tyre size	Type of tyre	Manufacturer	Tread depth
1)	215/50 R18 96W	Summer tyres on Light alloy	Goodyear	6mm / 6mm
2)	215/50 R18 96W	Summer tyres on Light alloy	Goodyear	6mm / 6mm

Figure 15: Additional tyres

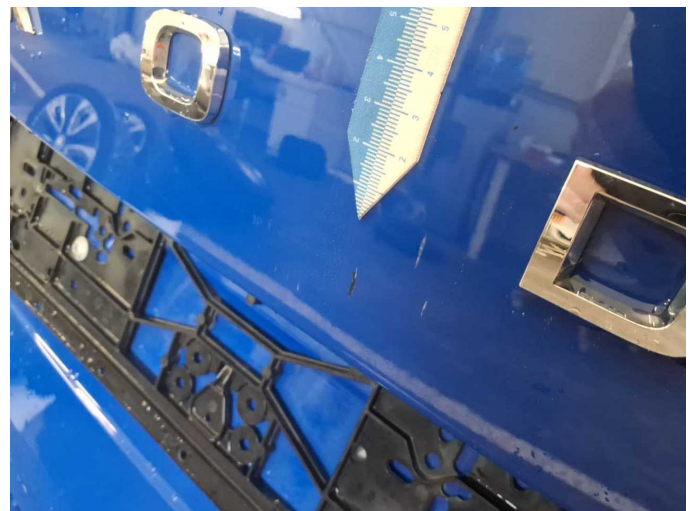
Damage 1: Boot lid / rear door: Boot lid - Scratched - Paint

No.	Component group	Description
1	Boot lid / rear door	Boot lid - Scratched - Paint
2	Rear bumper	Rear bumper - Paint defect - Repair and paint

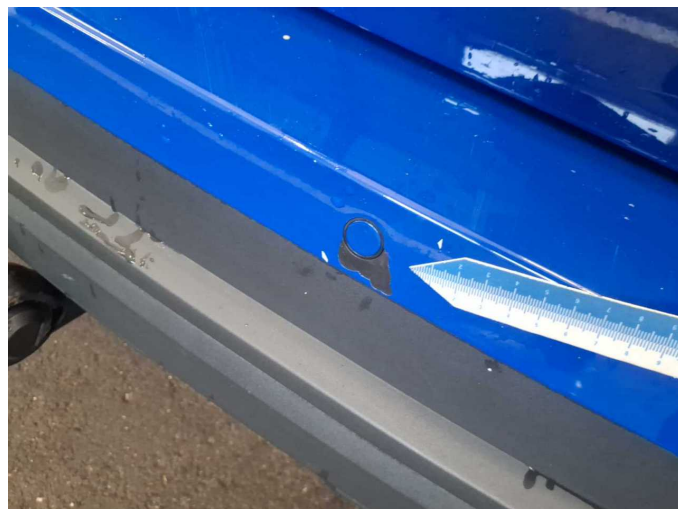
Damage 2: Rear bumper: Rear bumper - Paint defect - Repair and paint
