Expertise

Protocol number: 46611327  
Order No. / Reference: 26663030  
Inspection date: 15 Jul 2026

Manufacturer: Volkswagen

Model: Tiguan Allspace 2.0 TDI SCR DSG Comfortline

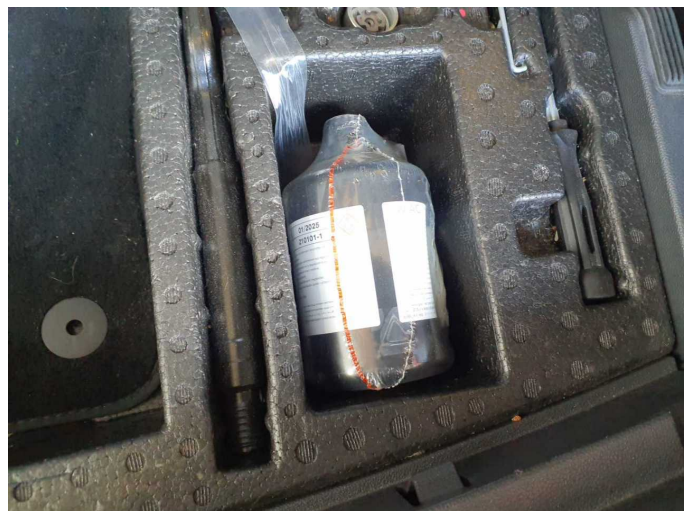
Damage 1: Equipment: Tirefit filler - Expired - Replace

| No. | Component group | Description |
|---|---|---|
| 1 | Equipment | Tirefit filler - Expired - Replace |

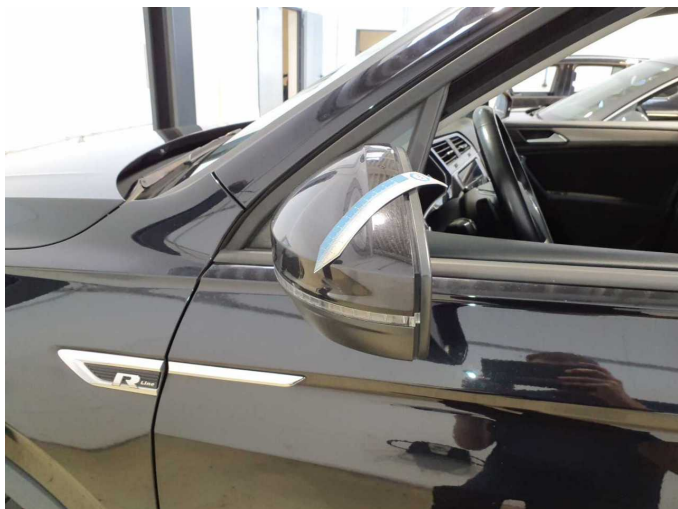
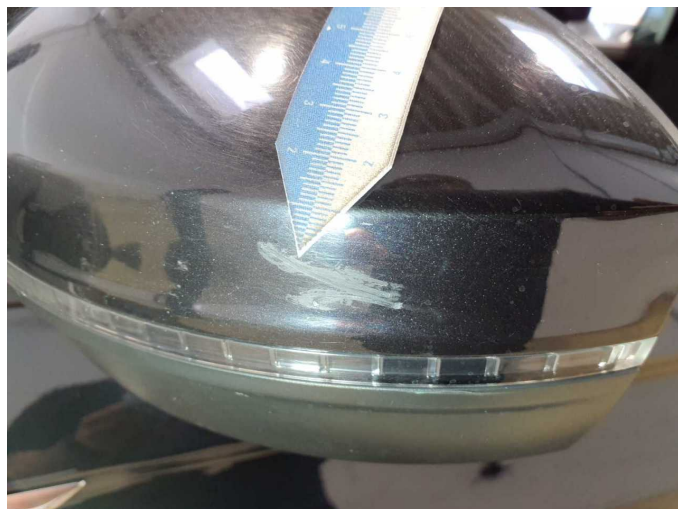
**Damage 2:** Wing mirror - left side: Cap - Scratch(es) - Smart repair

| No. | Component group | Description |
|---|---|---|
| 2 | Wing mirror - left side | Cap - Scratch(es) - Smart repair |

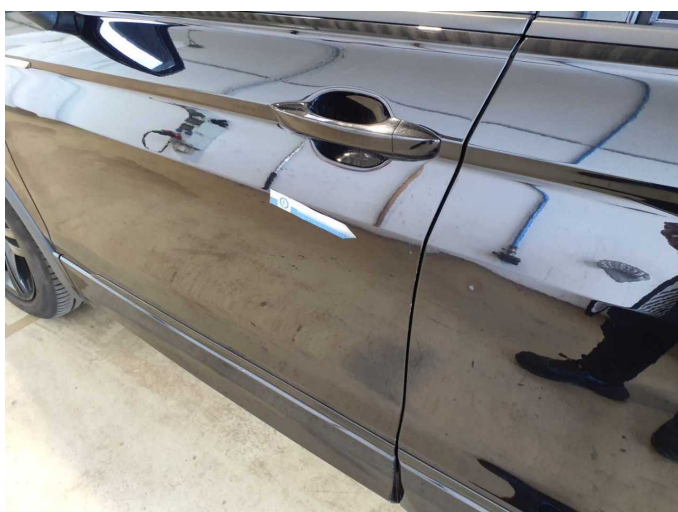
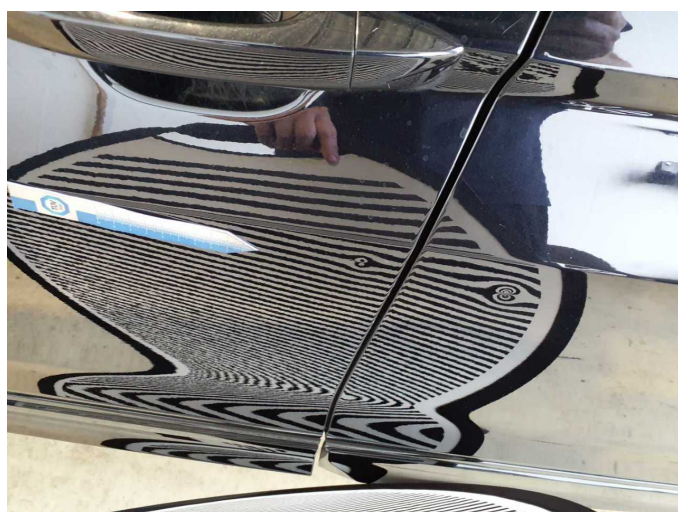
**Damage 3:** Door - front left side: Door - dent(s) - Smooth repair work

| No. | Component group | Description |
|---|---|---|
| 3 | Door - front left side | Door - dent(s) - Smooth repair work |

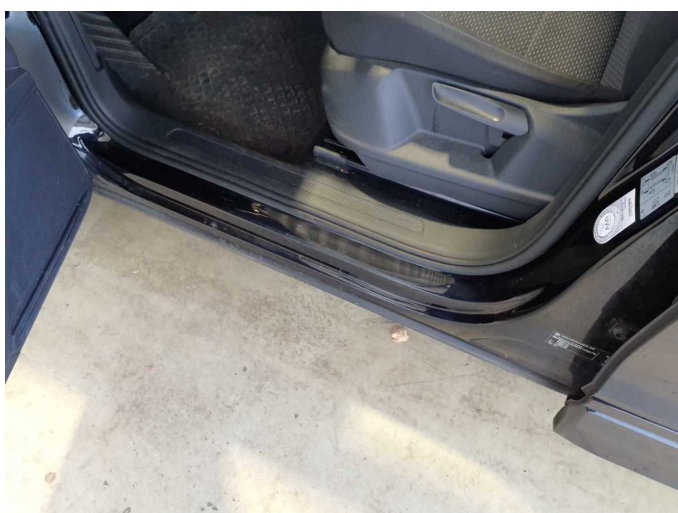
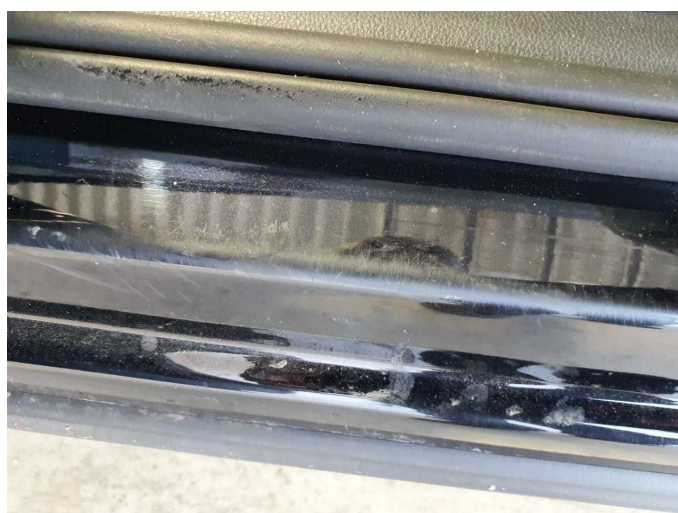
**Damage 4:** Sill - left side: Sill - Scratch(es) - Smart repair

| No. | Component group | Description |
|---|---|---|
| 4 | Sill - left side | Sill - Scratch(es) - Smart repair |

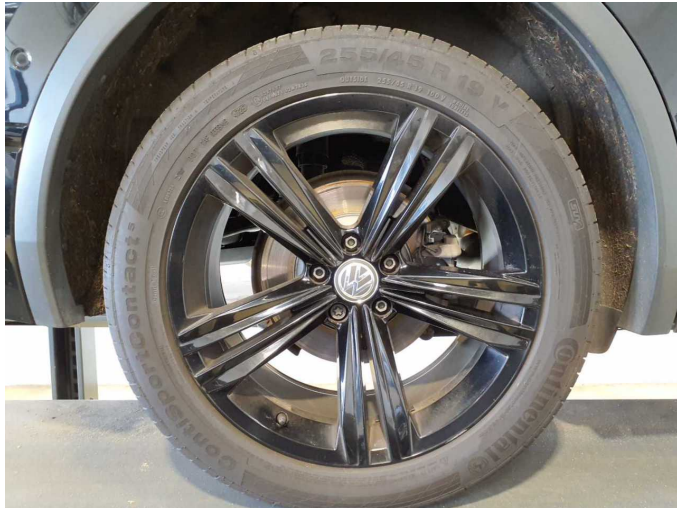
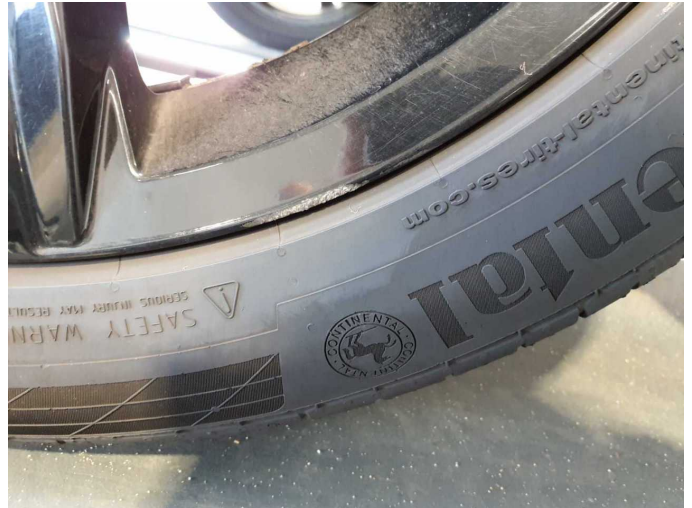
**Damage 5:** Wheel / tyres: Alloy rim - rear right side - Scratch(es) - Loss in value

| No. | Component group | Description |
|---|---|---|
| 5 | Wheel / tyres | Alloy rim - rear right side - Scratch(es) - Loss in value |

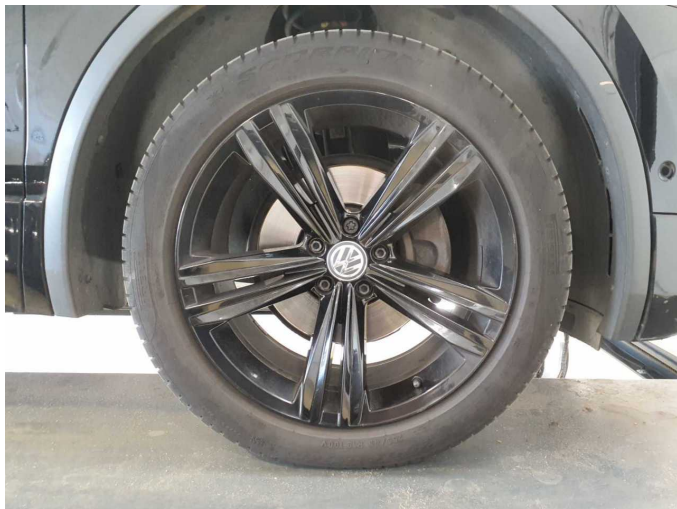
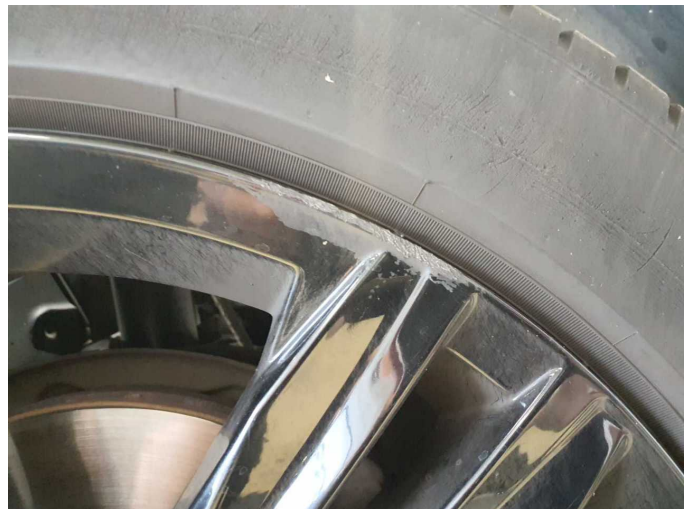
**Damage 6:** Wheel / tyres: Alloy rim - front right side - Scratch(es) - Loss in value

| No. | Component group | Description |
|---|---|---|
| 6 | Wheel / tyres | Alloy rim - front right side - Scratch(es) - Loss in value |

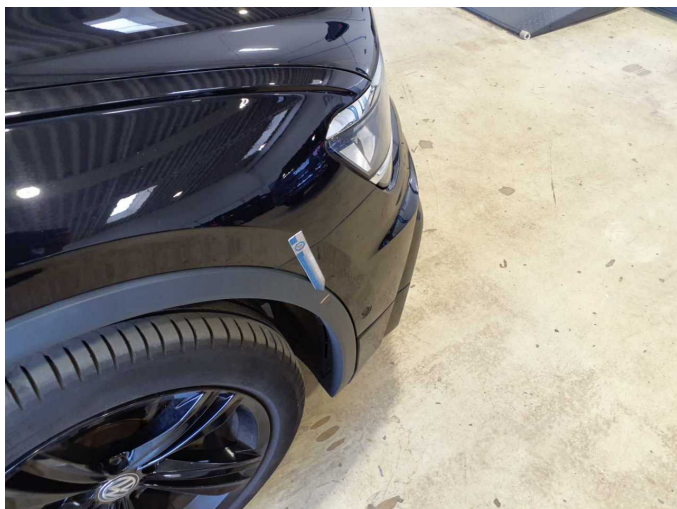
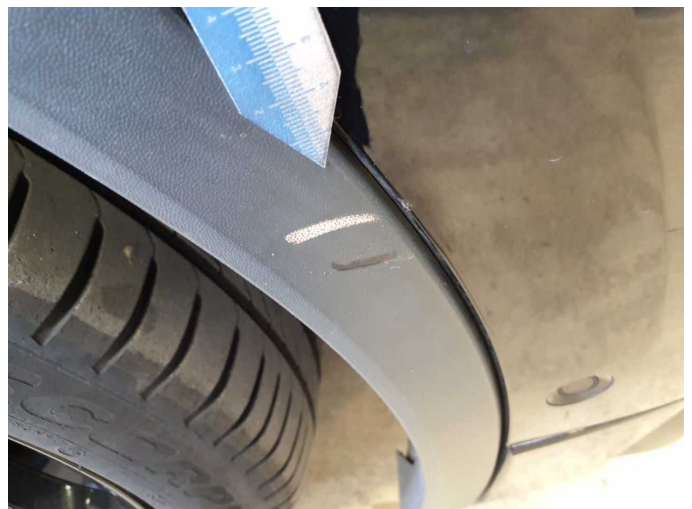
**Damage 7:** Mudguard - right side: Wheel well extension - Scratch(es) - Replace

| No. | Component group | Description |
|---|---|---|
| 7 | Mudguard - right side | Wheel well extension - Scratch(es) - Replace |

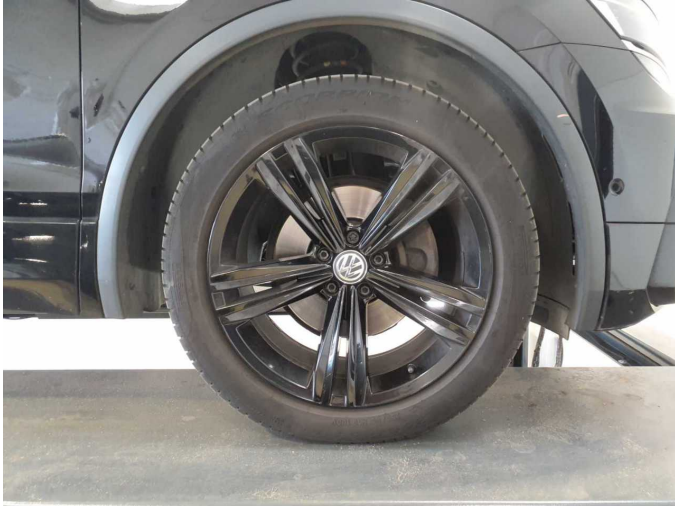
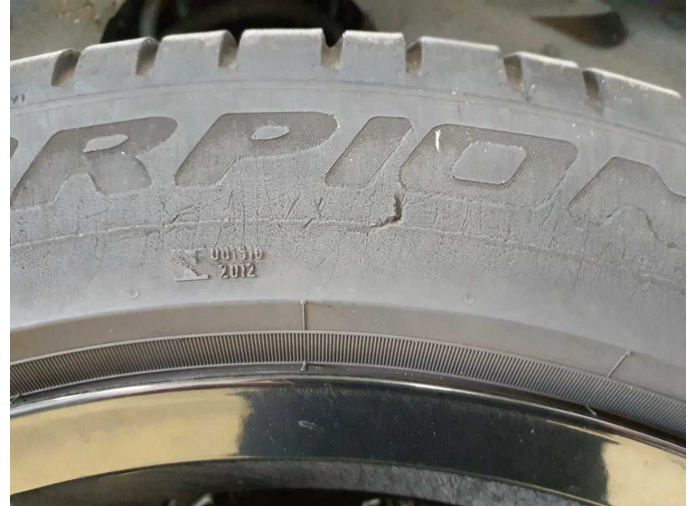
**Damage 8:** Wheel / tyres: Tyre - front right side - Broken / torn - Replace

| No. | Component group | Description |
|---|---|---|
| 8 | Wheel / tyres | Tyre - front right side - Broken / torn - Replace |

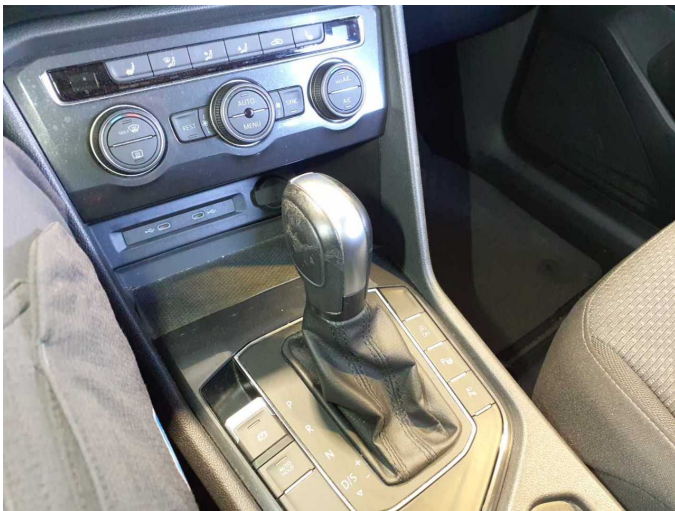
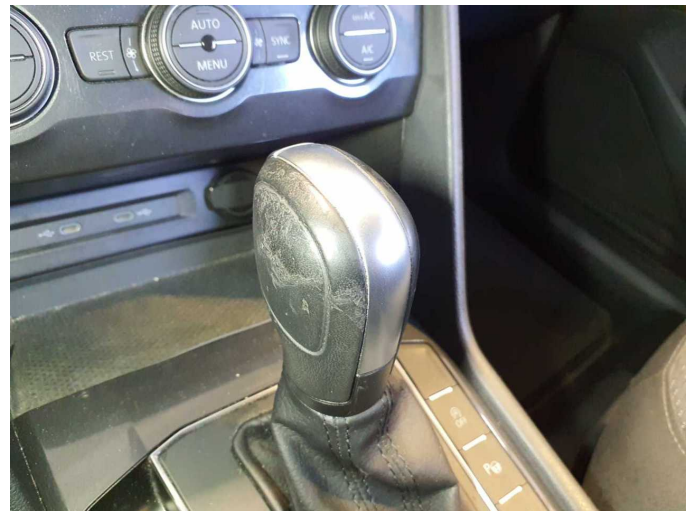
**Damage 9:** Gearbox: Selector lever - Scratch(es) - Replace

| No. | Component group | Description |
|---|---|---|
| 9 | Gearbox | Selector lever - Scratch(es) - Replace |

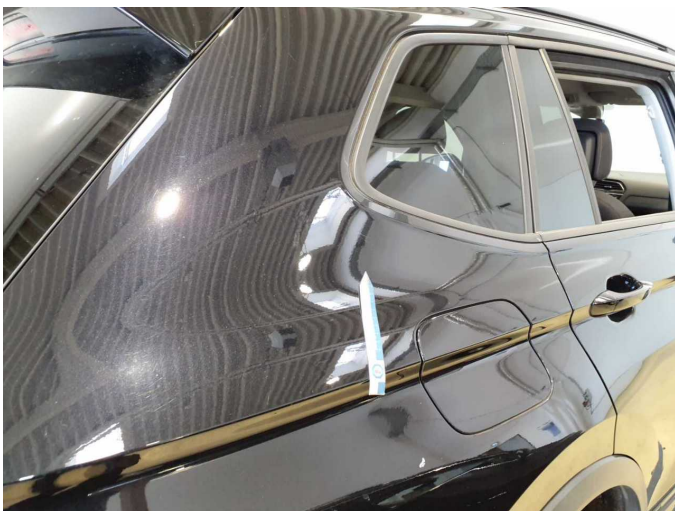
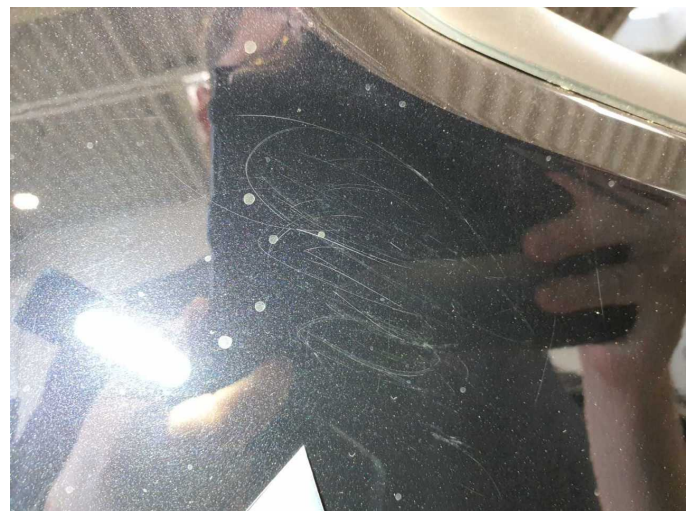
**Damage 10:** Side panel - rear right side: Side panel - Scratch(es) - Paint

| No. | Component group | Description |
|---|---|---|
| 10 | Side panel - rear right side | Side panel - Scratch(es) - Paint |

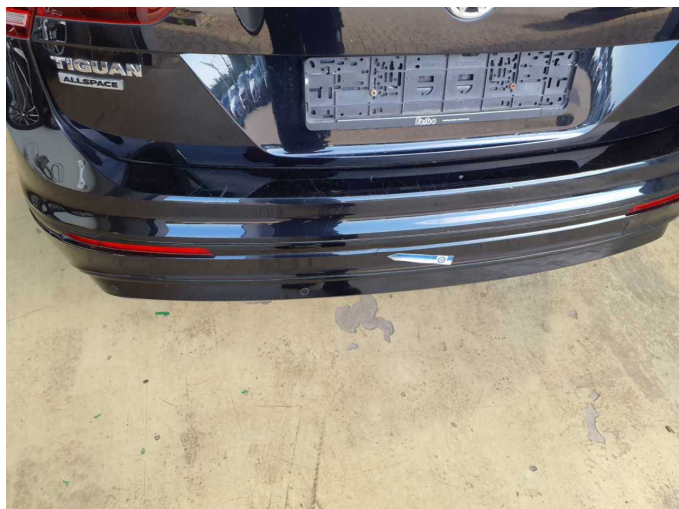
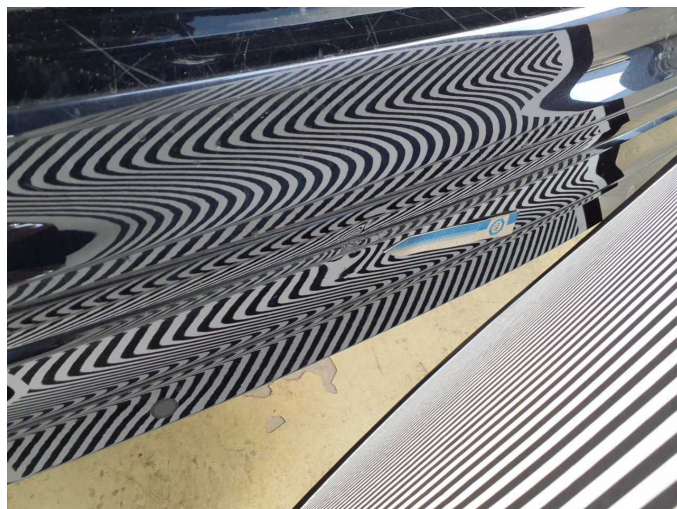
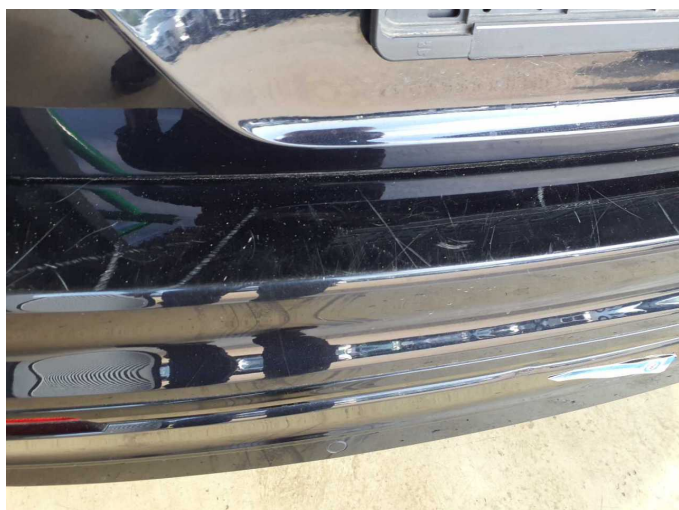
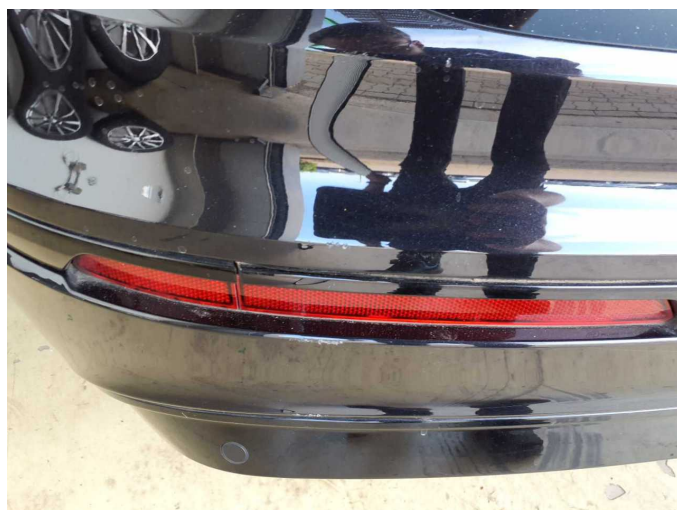
**Damage 11:** Rear bumper: Rear bumper - Dent / paintcoat damage - Repair and paint

| No. | Component group | Description |
|---|---|---|
| 11 | Rear bumper | Rear bumper - Dent / paintcoat damage - Repair and paint |

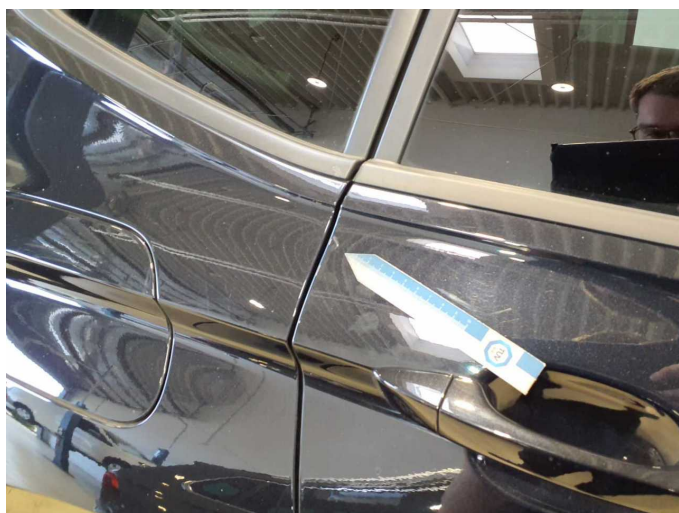
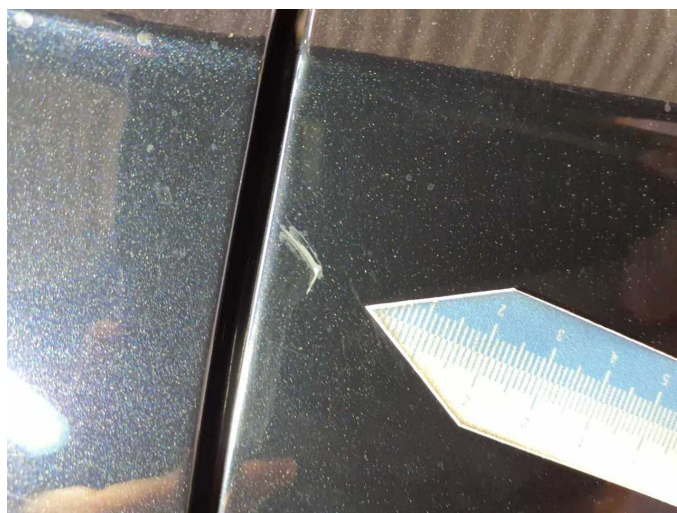
**Damage 12:** Door - rear right side: Door - Scratch(es) - Paint

| No. | Component group | Description |
|---|---|---|
| 12 | Door - rear right side | Door - Scratch(es) - Paint |

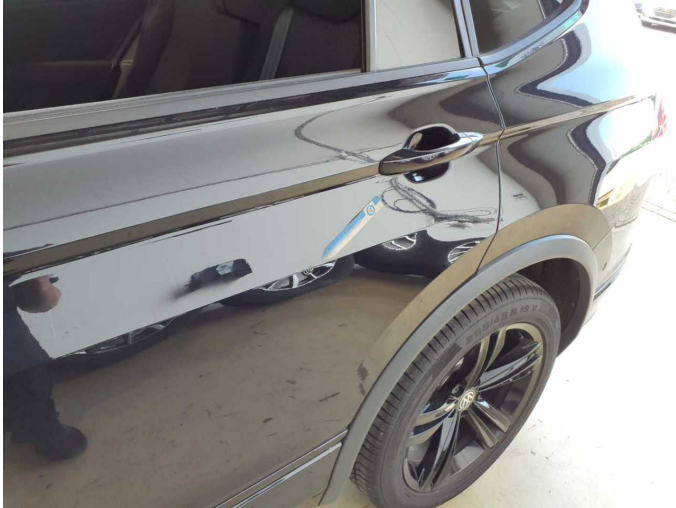
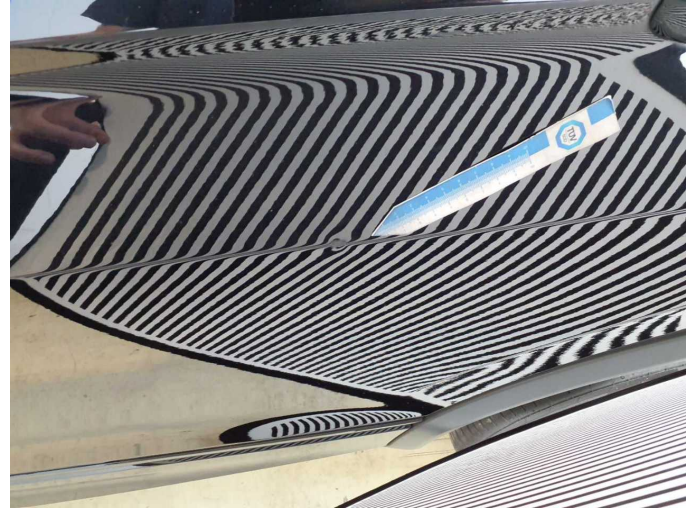
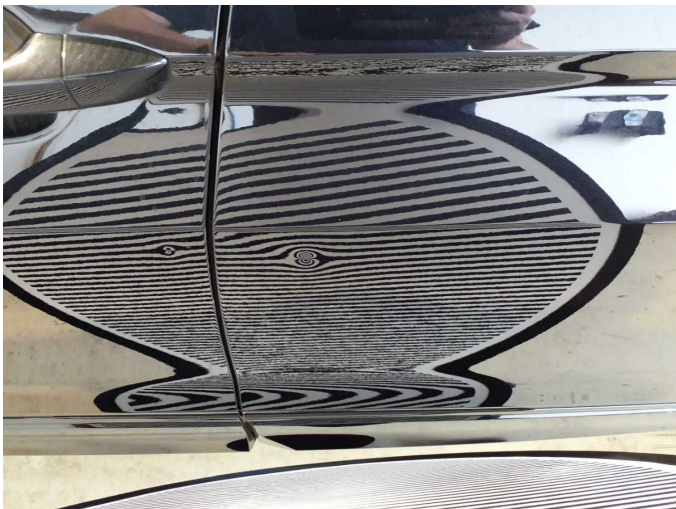
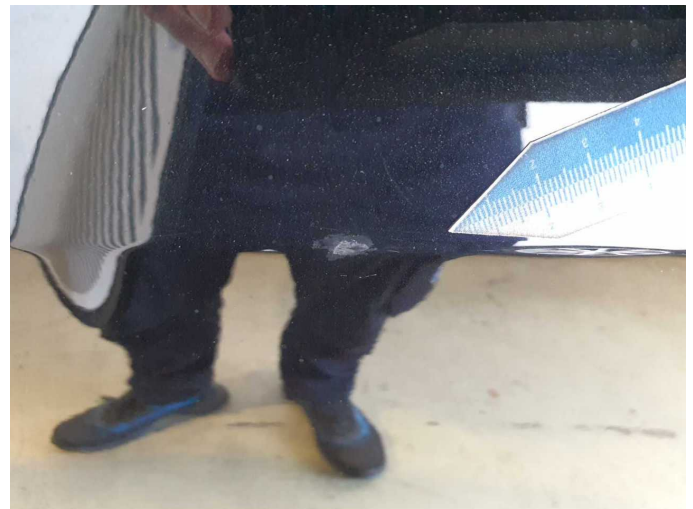
**Damage 13:** Door - rear left side: Door - Dent / paintcoat damage - Paint

| No. | Component group | Description |
|---|---|---|
| 13 | Door - rear left side | Door - Dent / paintcoat damage - Paint |

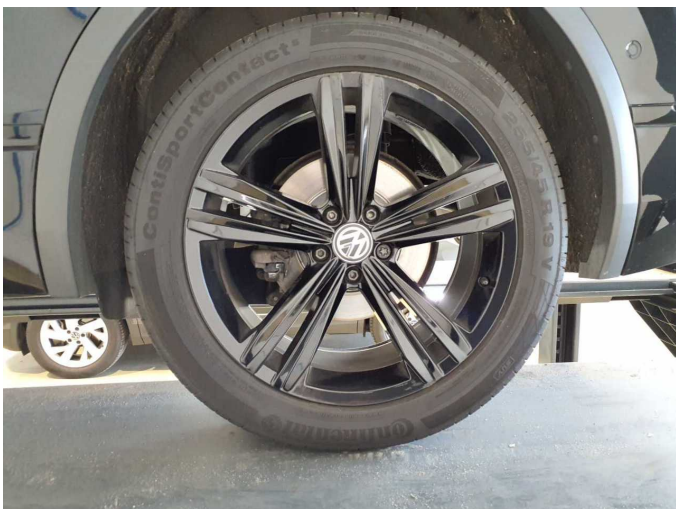
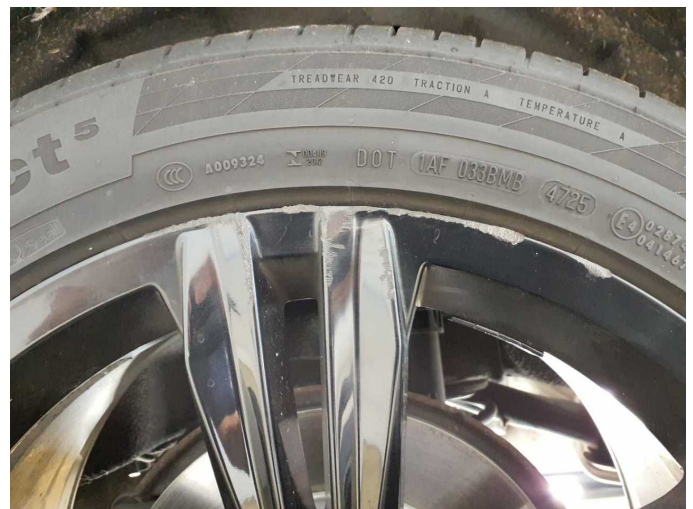
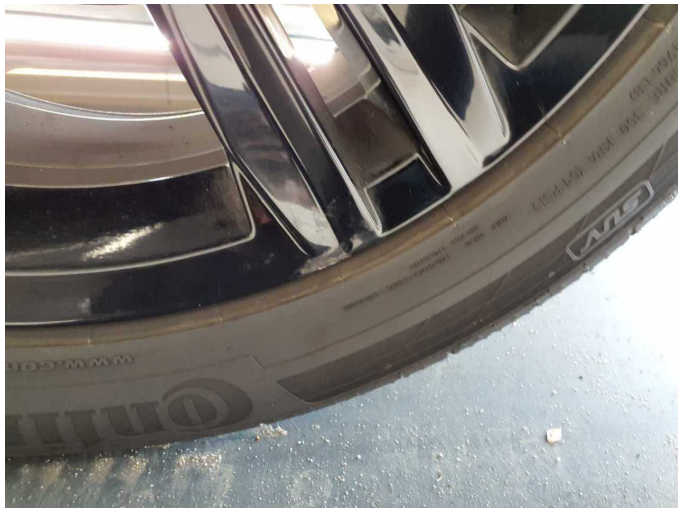
**Damage 14:** Wheel / tyres: Alloy rim - rear left side (Materialabtrag) - Scratched - Replace

| No. | Component group | Description |
|---|---|---|
| 14 | Wheel / tyres | Alloy rim - rear left side (Materialabtrag) - Scratched - Replace |

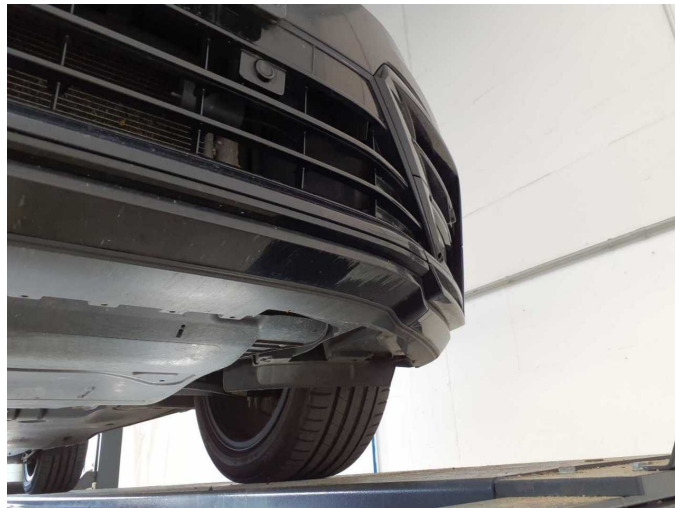
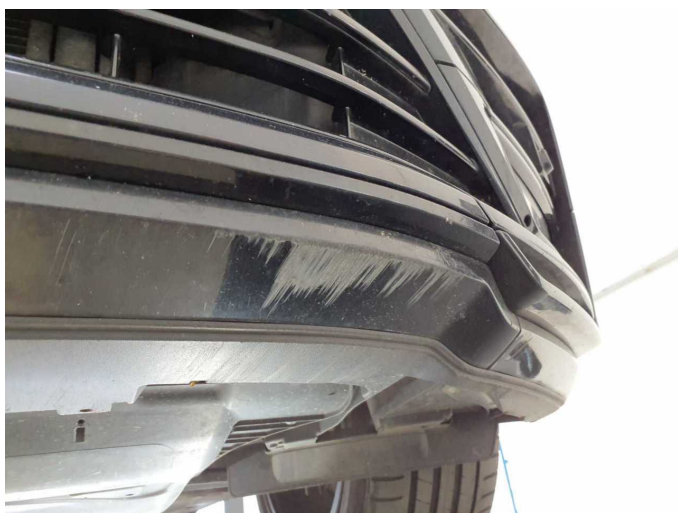
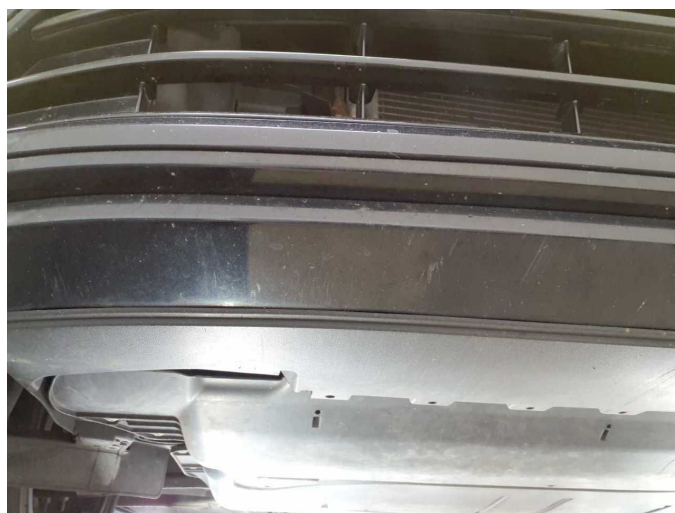
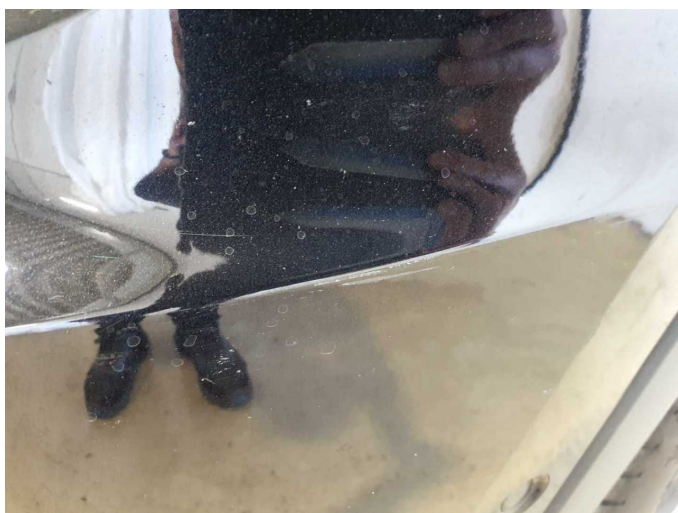
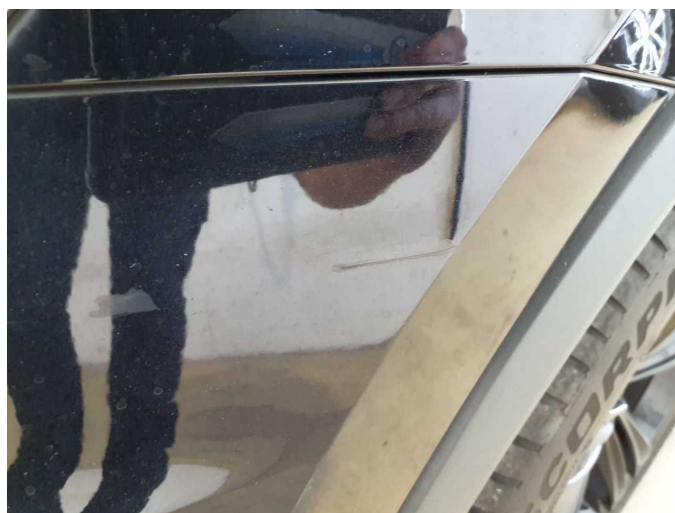
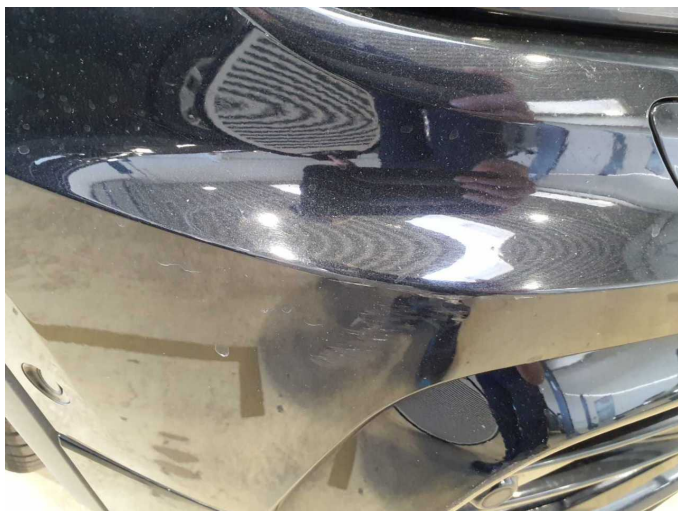
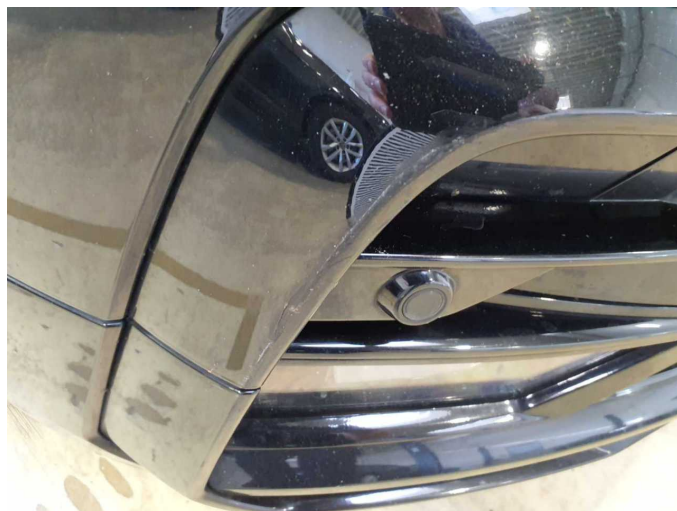
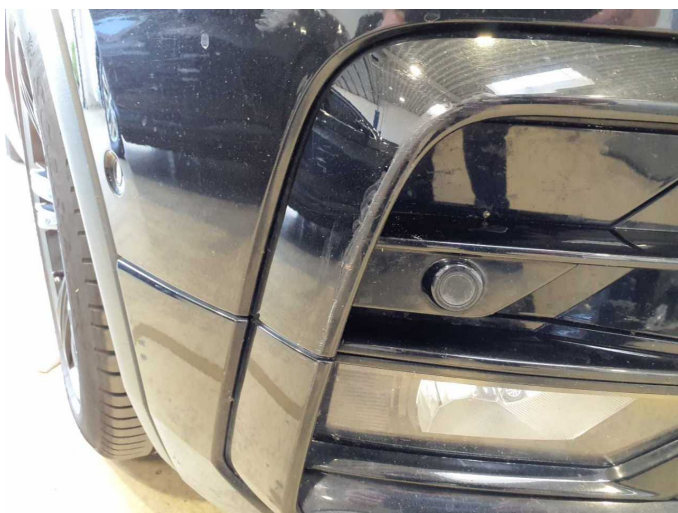
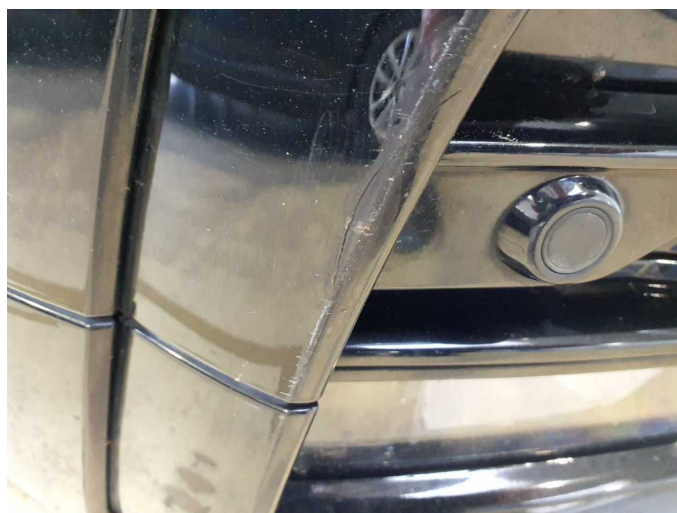
**Damage 15:** Front bumper: Front bumper (Inklusive anbauteile) - Scratch(es) - Paint

| No. | Component group | Description |
|---|---|---|
| 15 | Front bumper | Front bumper (Inklusive anbauteile) - Scratch(es) - Paint |

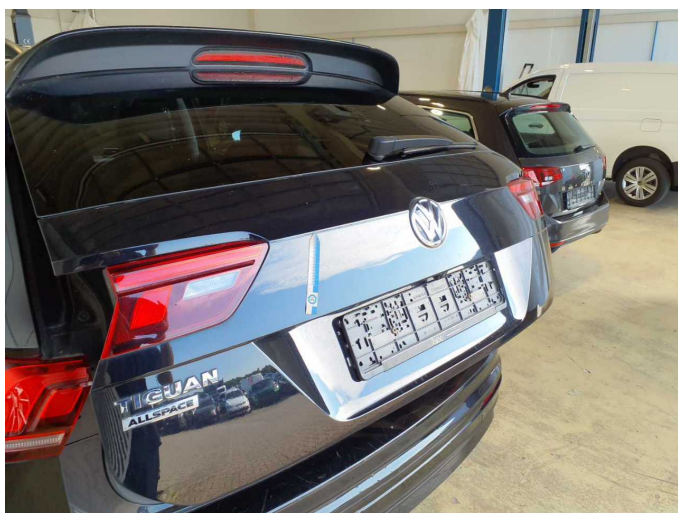
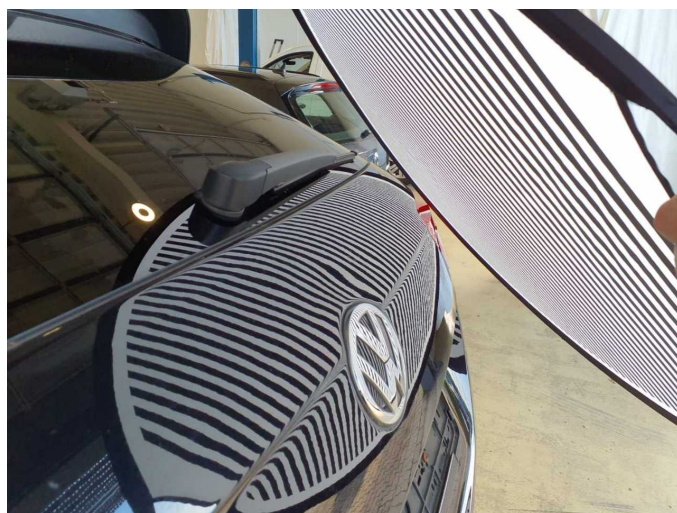
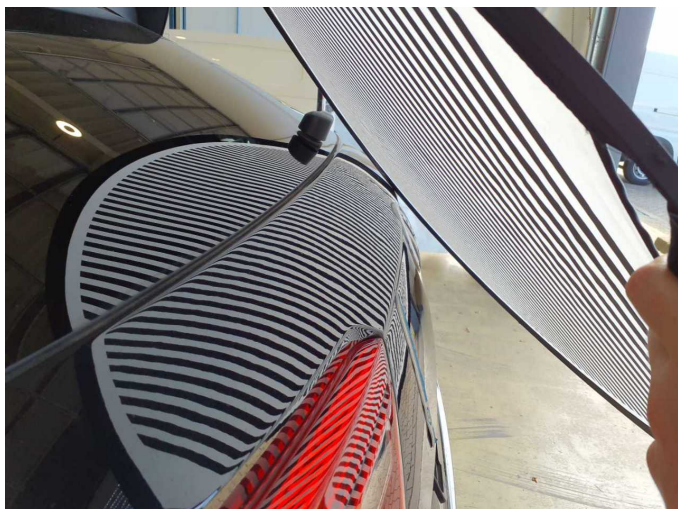
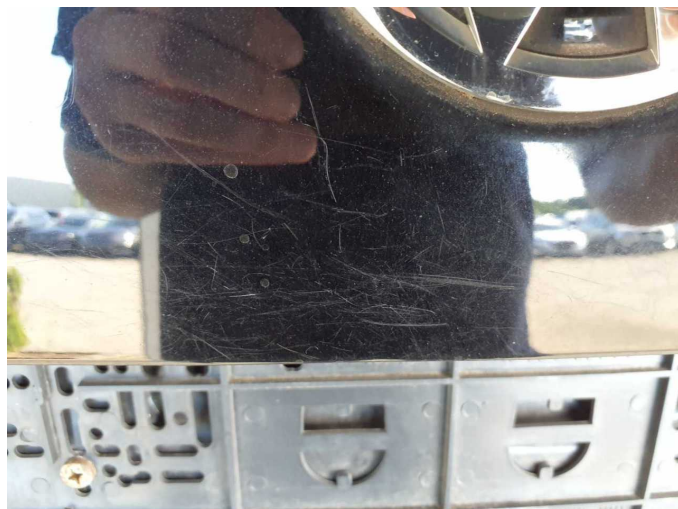
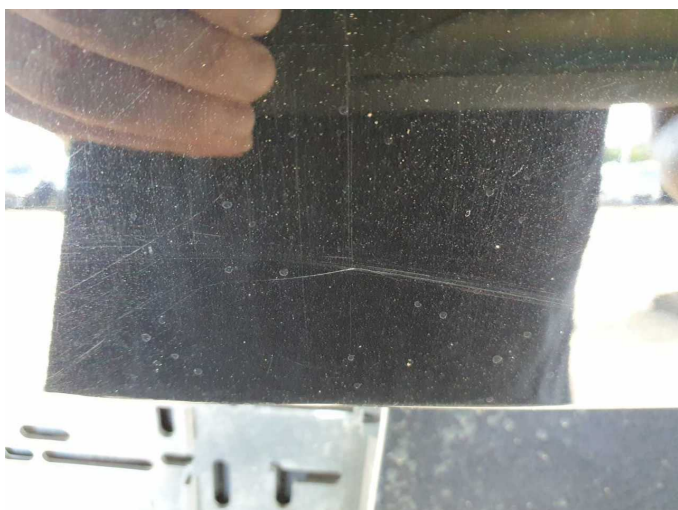
**Damage 16:** Boot lid / rear door: Boot lid - Dent / paintcoat damage - Repair and paint

| No. | Component group | Description |
|---|---|---|
| 16 | Boot lid / rear door | Boot lid - Dent / paintcoat damage - Repair and paint |

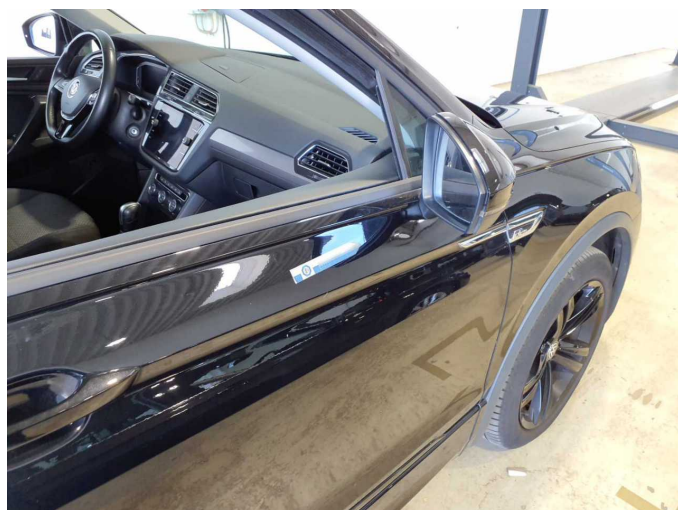
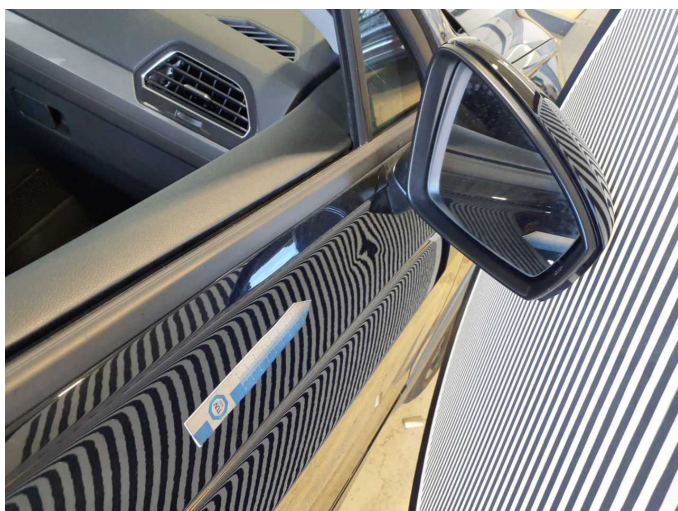
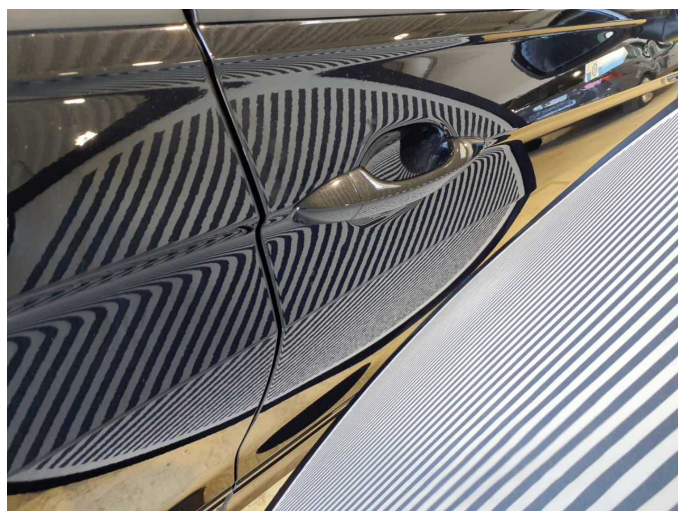
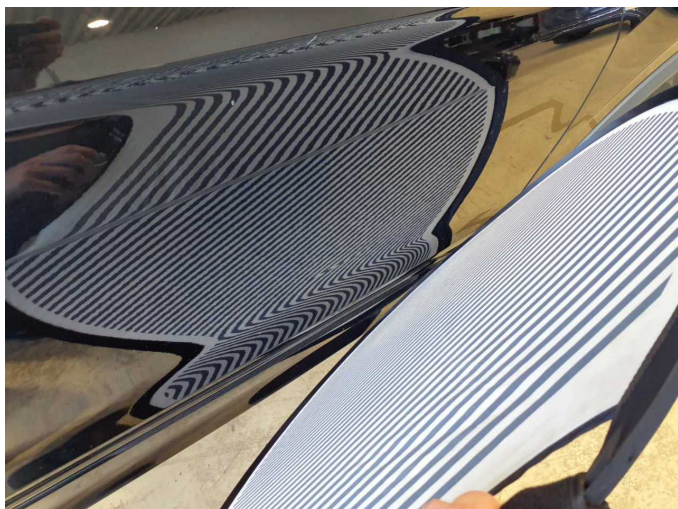
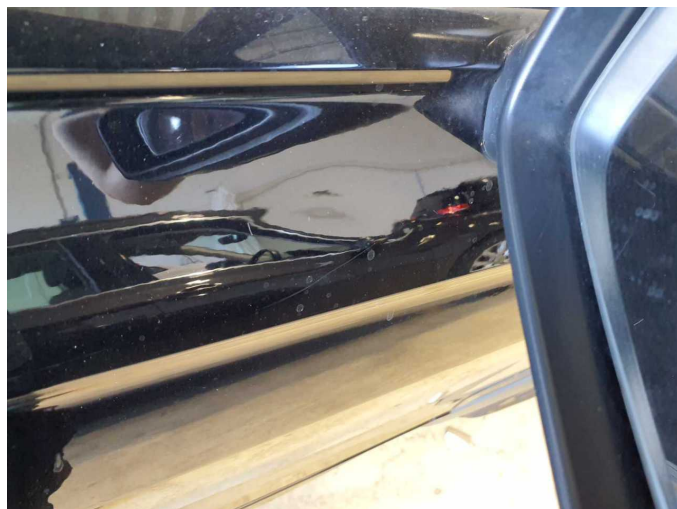
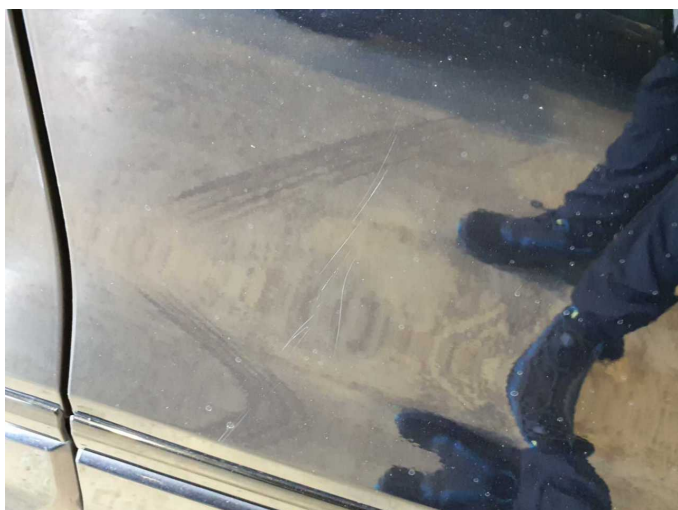
**Damage 17:** Door - front right side: Door - Dent / paintcoat damage - Repair and paint

| No. | Component group | Description |
|---|---|---|
| 17 | Door - front right side | Door - Dent / paintcoat damage - Repair and paint |

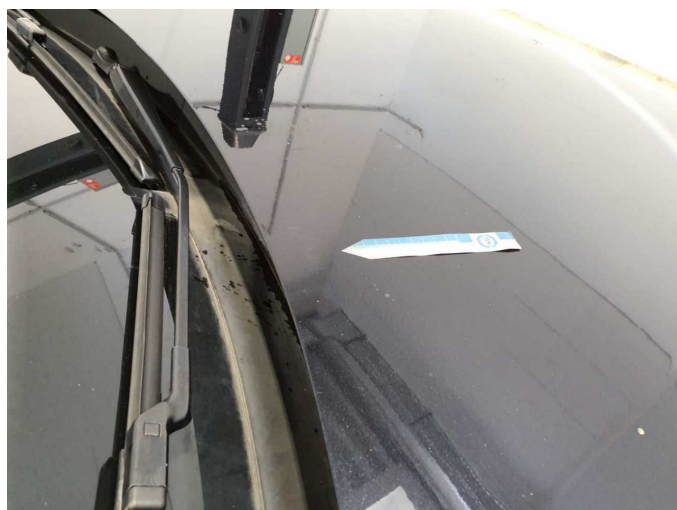
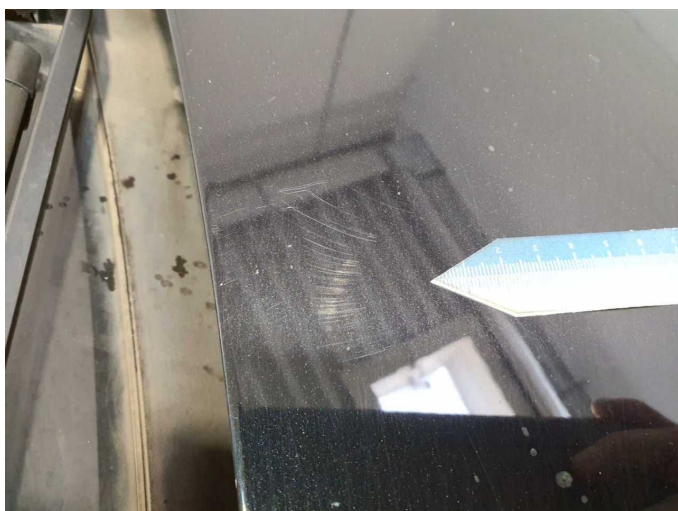
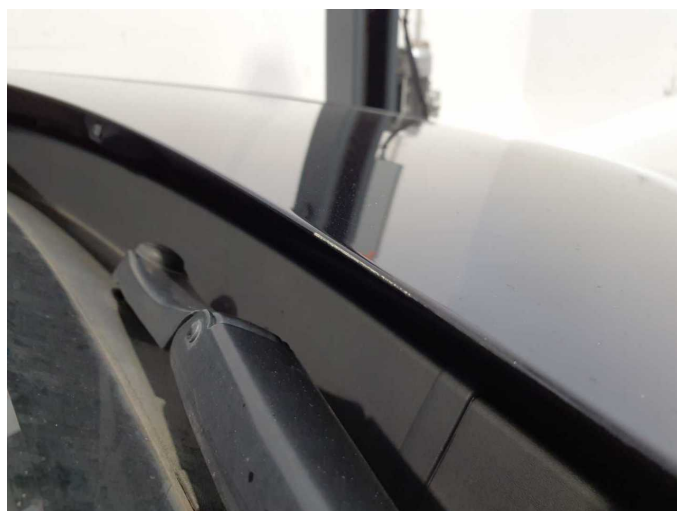
**Damage 18:** Bonnet: Bonnet - Scratch(es) - Paint

| No. | Component group | Description |
|---|---|---|
| 18 | Bonnet | Bonnet - Scratch(es) - Paint |

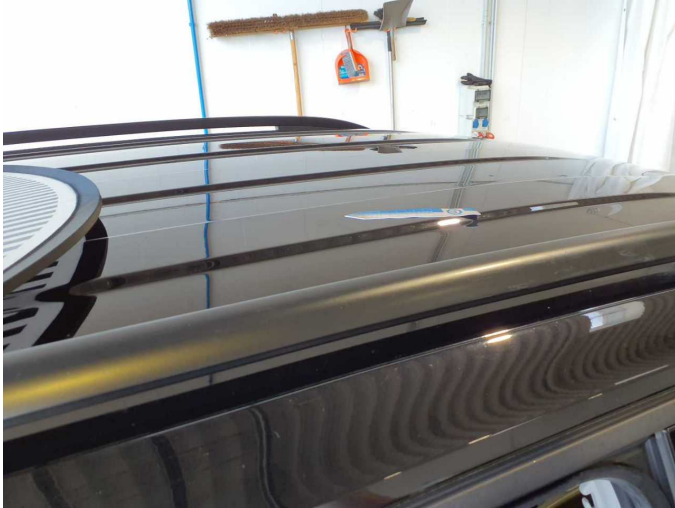
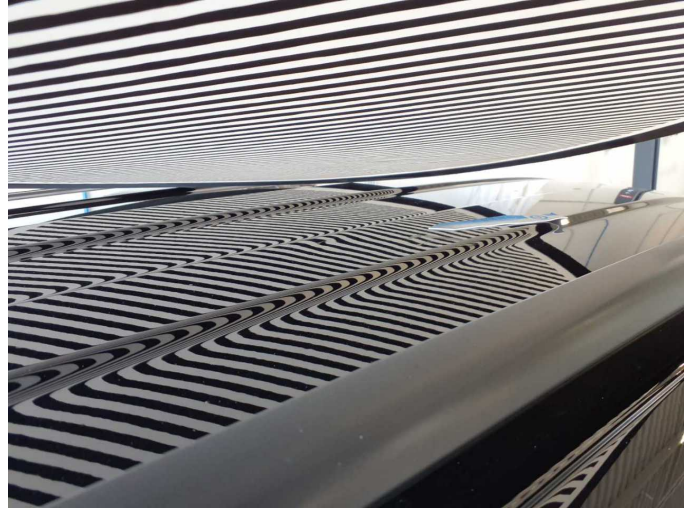
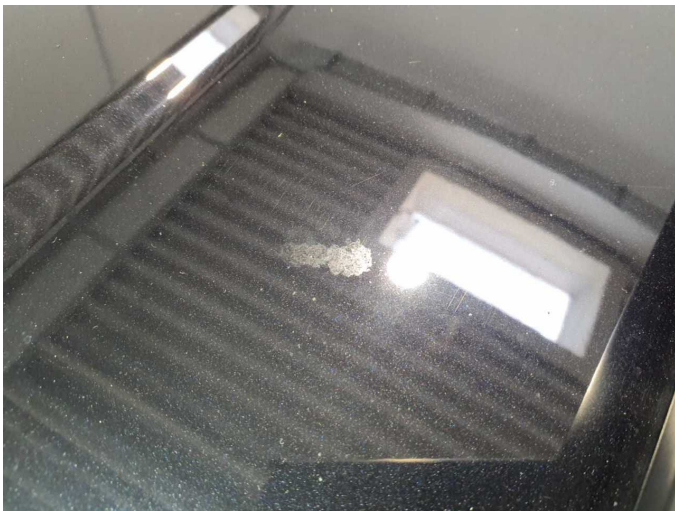
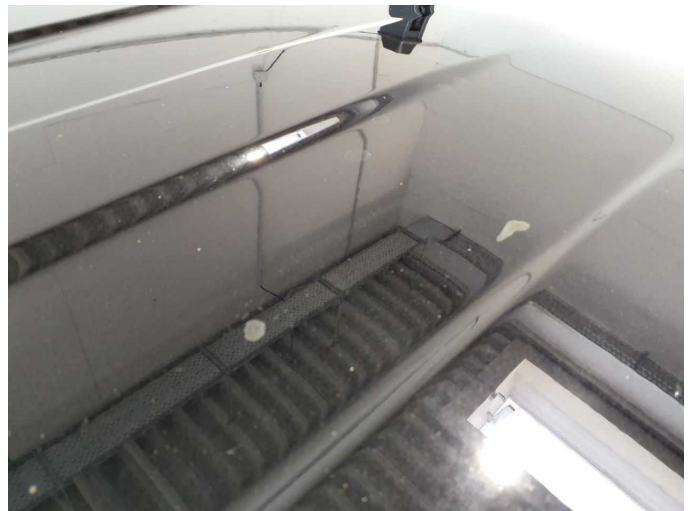
**Damage 19:** Roof: Roof (Anätzung) - Paint defect - Paint

| No. | Component group | Description |
|---|---|---|
| 19 | Roof | Roof (Anätzung) - Paint defect - Paint |

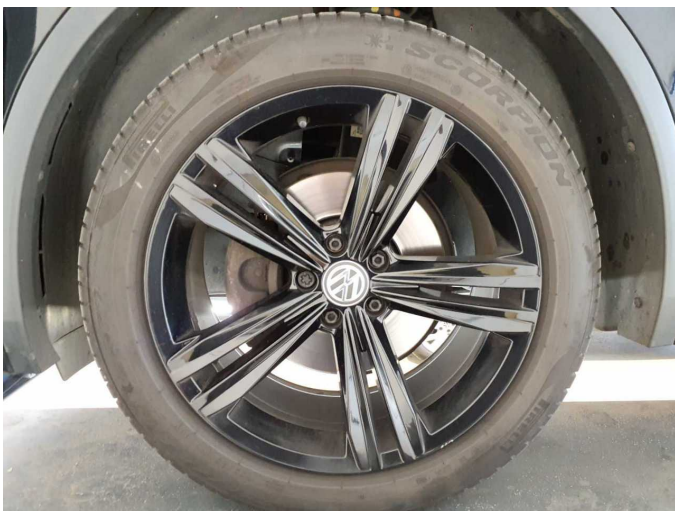
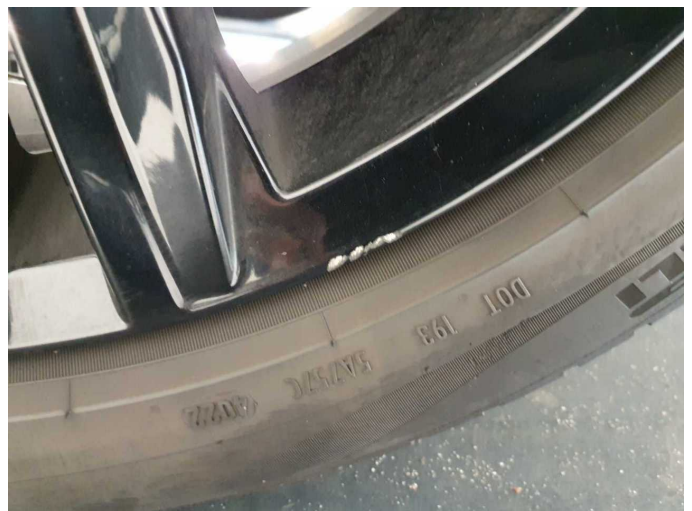
**Wear and tear 2:** Wheel / tyres: Alloy rim - front left side - Scratch(es) - No deduction

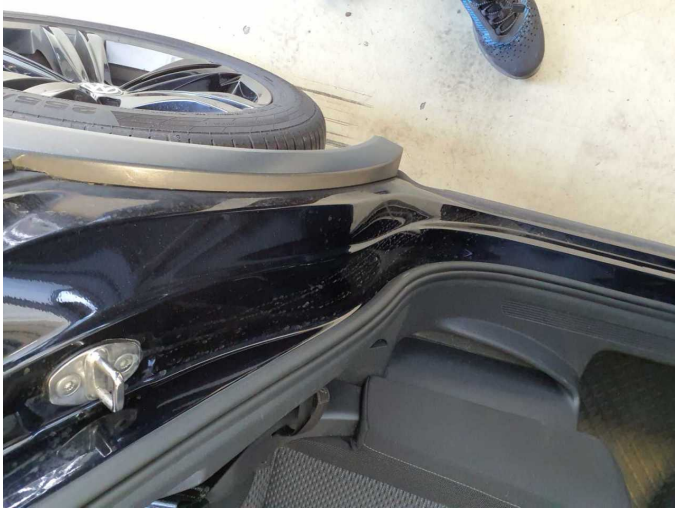
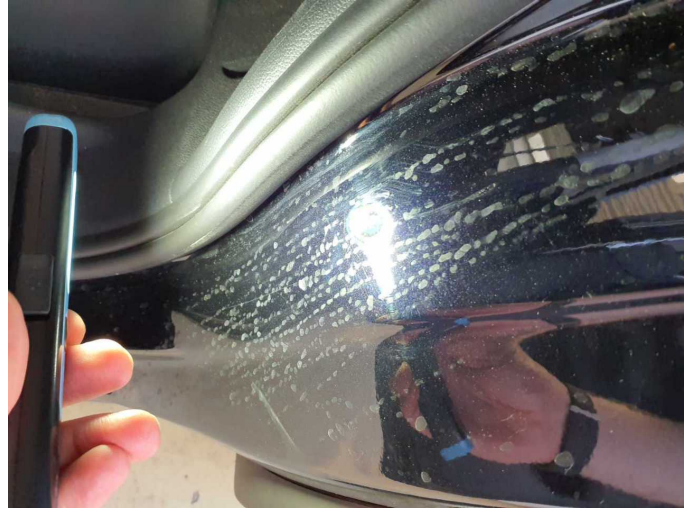
**Wear and tear 3:** Side panel - rear left side: Sill - dent(s) - No deduction
