Expertise

Protocol number: 46611327  
Order No. / Reference: 26663030  
Inspection date: 15 Jul 2026

Manufacturer: Volkswagen

Model: Tiguan Allspace 2.0 TDI SCR DSG Comfortline

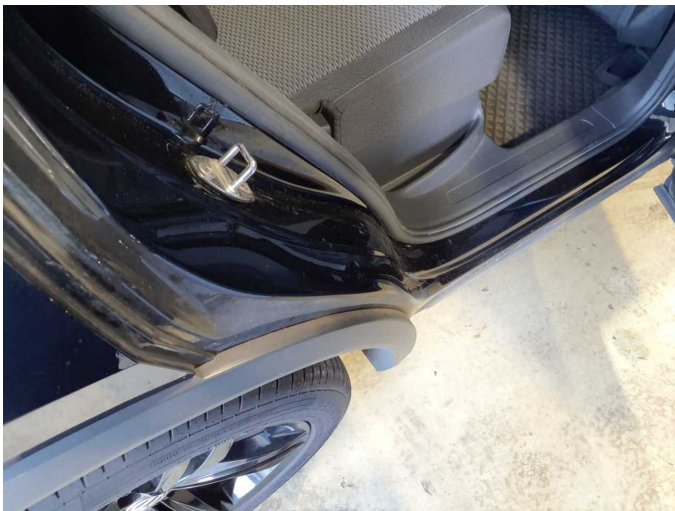
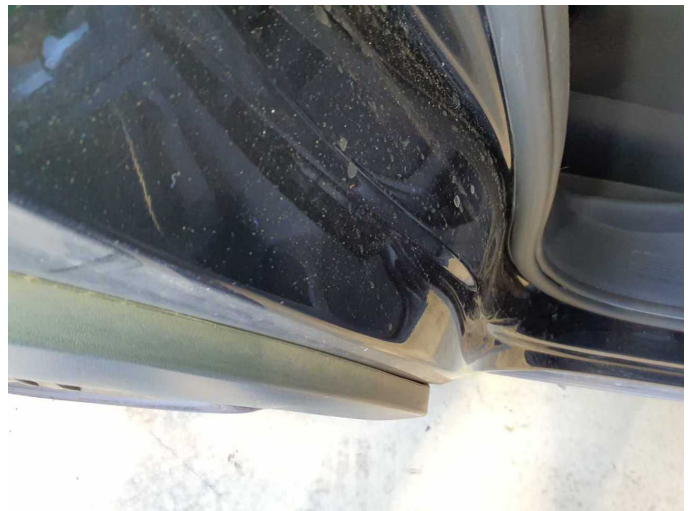
**Wear and tear 4:** Side panel - rear right side: Sill - dent(s) - No deduction

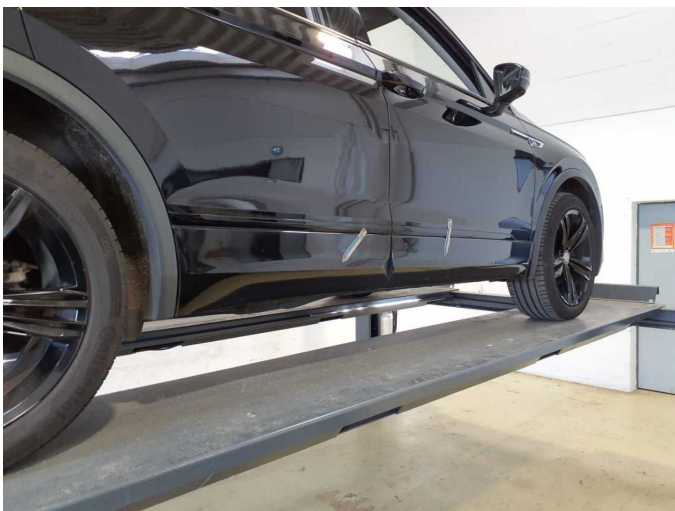
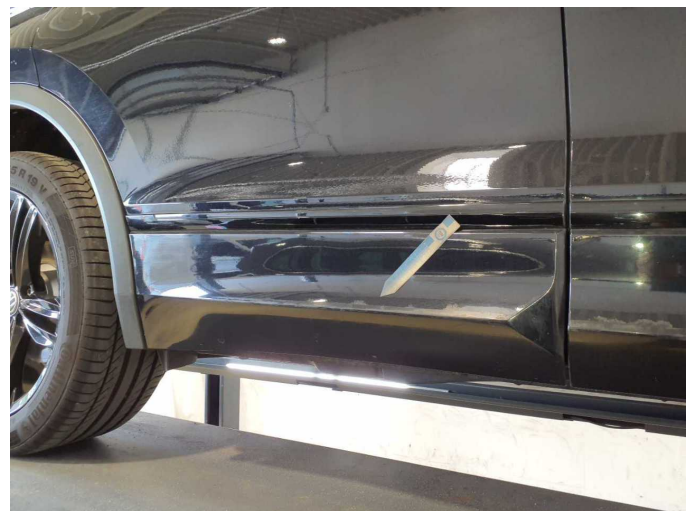
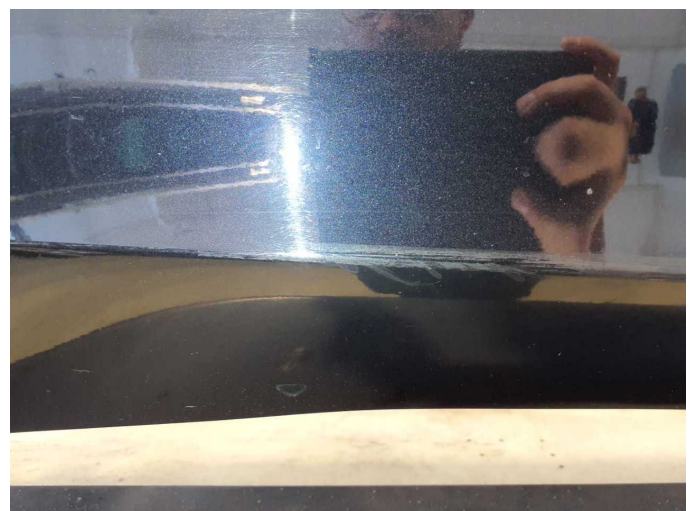
**Accident 1:** Side right

**Accident 1: Side right**
