Expertise

Protocol number: 45790528
Order No. / Reference: 26445867
Inspection date: 29 May 2026

Model: Q5 40 TDI quattro S tronic S line

VIN: WAUZZZFY3N2005233

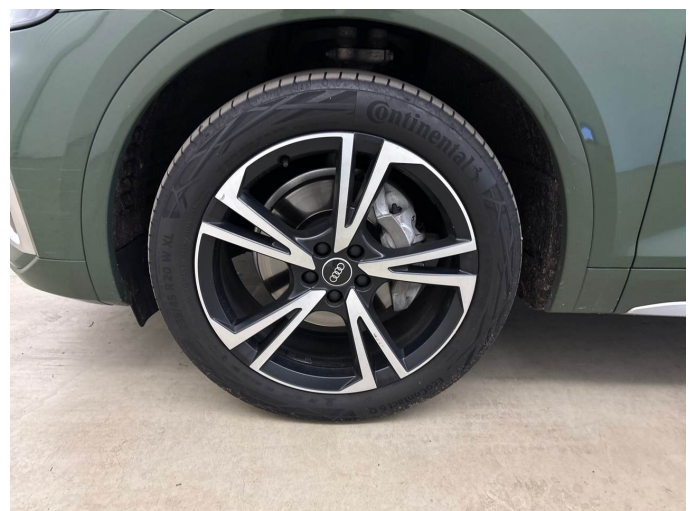
Figure 12: Mounted tyres

| # | Tyre size | Type of tyre | Manufacturer | Tread depth |
|---|---|---|---|---|
| 1) | 255/45 R20 105W | Summer tyres on Light alloy | Continental | 4mm / 4mm |
| 2) | 255/45 R20 105W | Summer tyres on Light alloy | Continental | 5mm / 5mm |

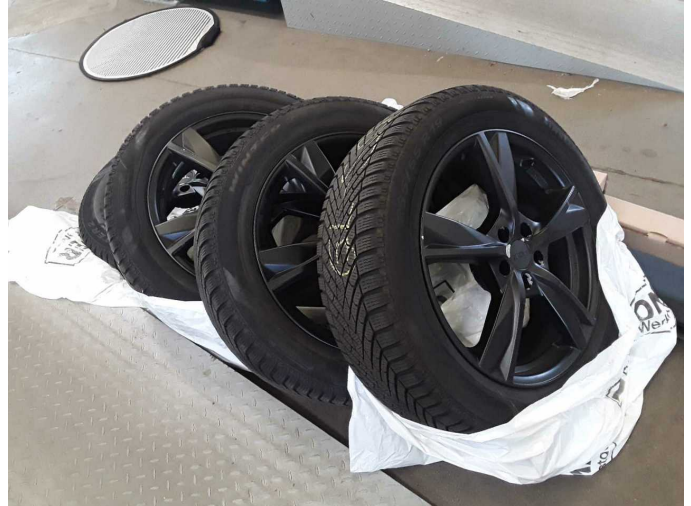
Figure 14: Additional tyres

| # | Tyre size | Type of tyre | Manufacturer | Tread depth |
|---|---|---|---|---|
| 1) | 235/55 R19 105H | Winter tyres on Light alloy | Pirelli | 5mm / 5mm |
| 2) | 235/55 R19 105H | Winter tyres on Light alloy | Pirelli | 6mm / 6mm |

Der beiliegende Winterradsatz ist kein Bestandteil der Ausstattung.

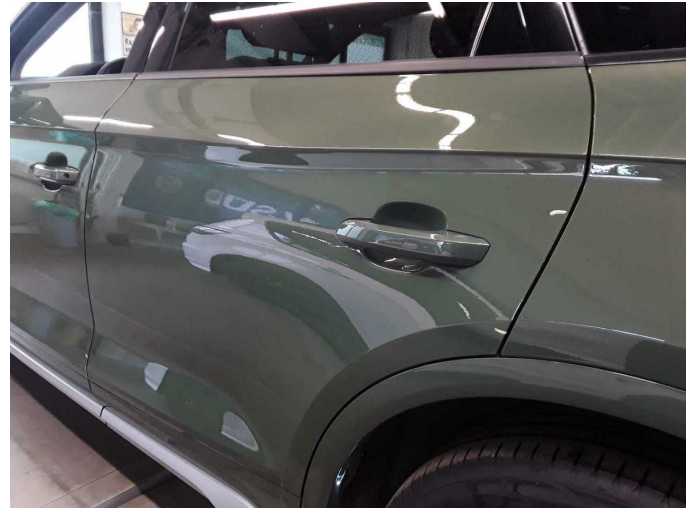
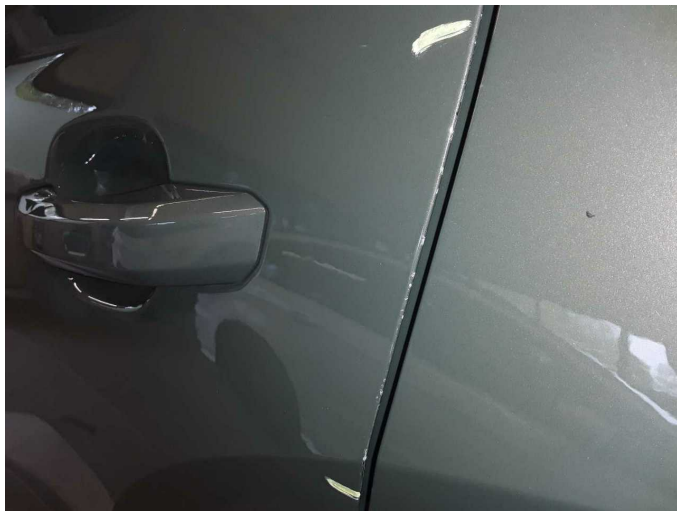
Damage 1: Door - rear left side: Door - Scratch(es) - Smart repair

| No. | Component group | Description |
|---|---|--|
| 1 | Door - rear left side | Door - Scratch(es) - Smart repair |

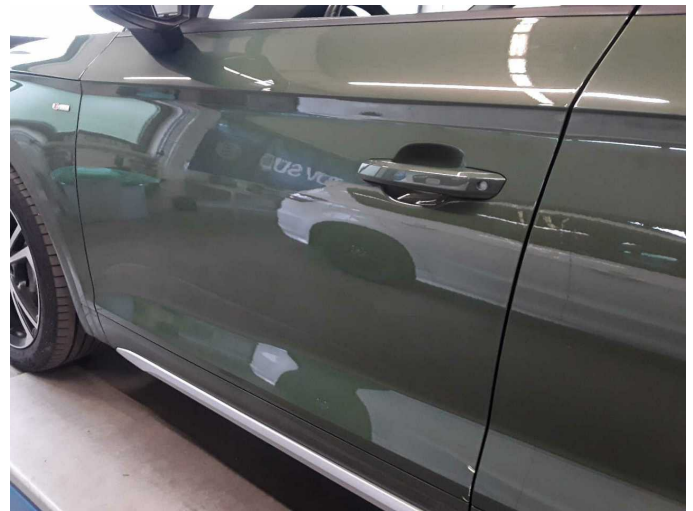
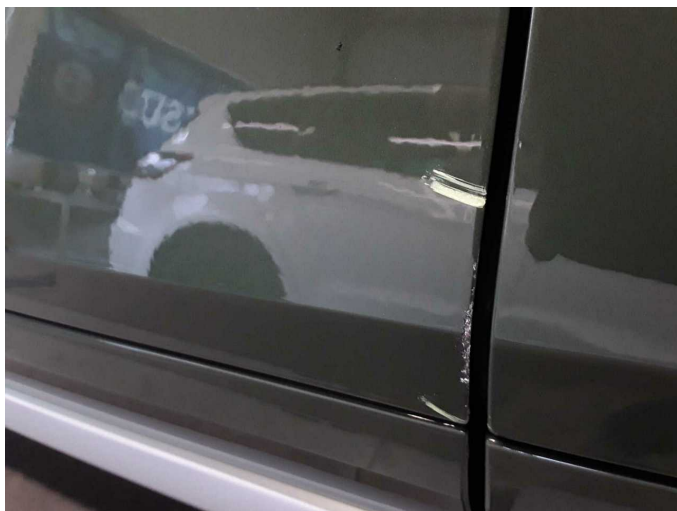
Damage 2: Door - front left side: Door - Scratch(es) - Smart repair

| No. | Component group | Description |
|---|---|--|
| 2 | Door - front left side | Door - Scratch(es) - Smart repair |

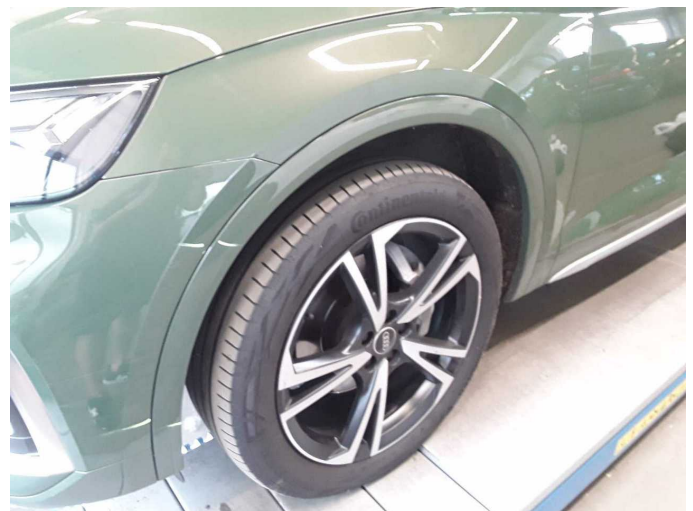
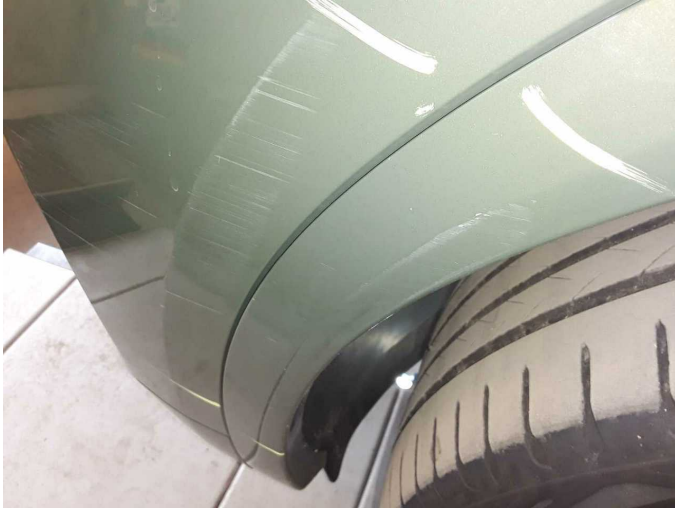
Damage 4: Mudguard - left side: Wheel arch - Scratch(es) - Smart repair

| No. | Component group | Description |
|---|---|--|
| 4 | Mudguard - left side | Wheel arch - Scratch(es) - Smart repair |

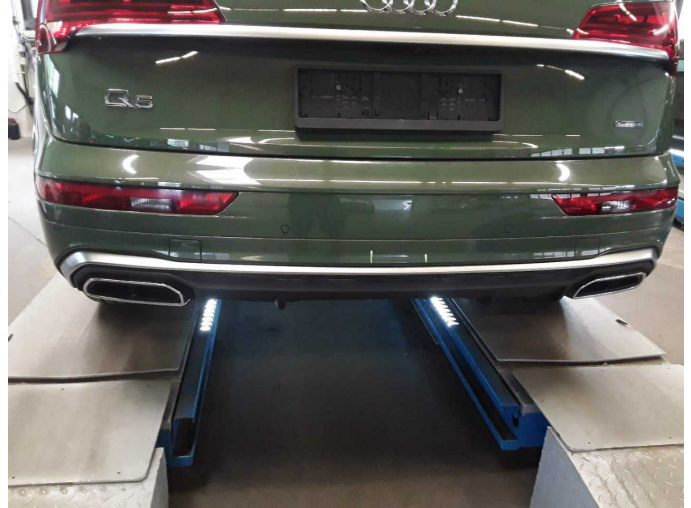
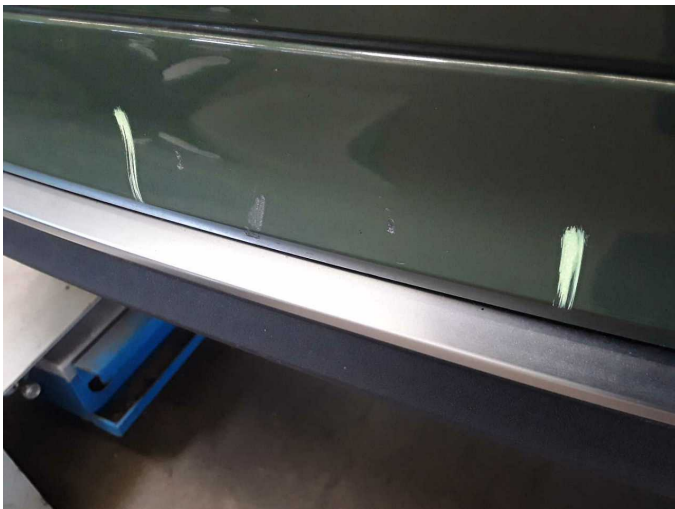
Damage 5: Rear bumper: Rear bumper - Scratch(es) - Smart repair

| No. | Component group | Description |
|---|---|--|
| 5 | Rear bumper | Rear bumper - Scratch(es) - Smart repair |

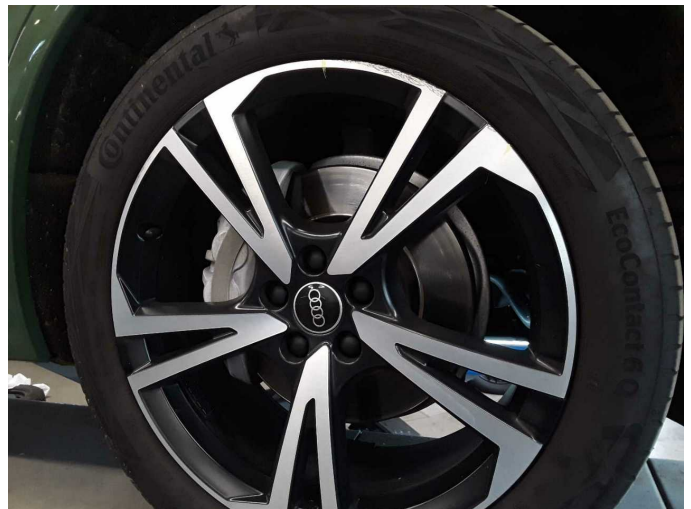
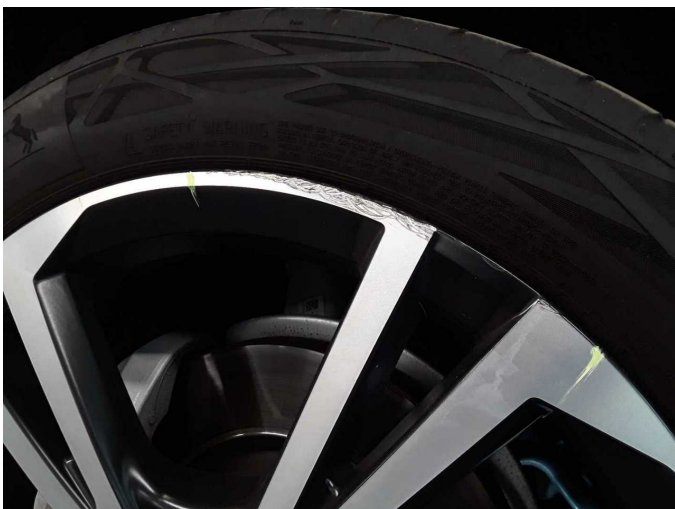
Damage 6: Wheel / tyres: Alloy rim - front right side - Scratched - Loss in value

| No. | Component group | Description |
|---|---|--|
| 6 | Wheel / tyres | Alloy rim - front right side - Scratched - Loss in value |

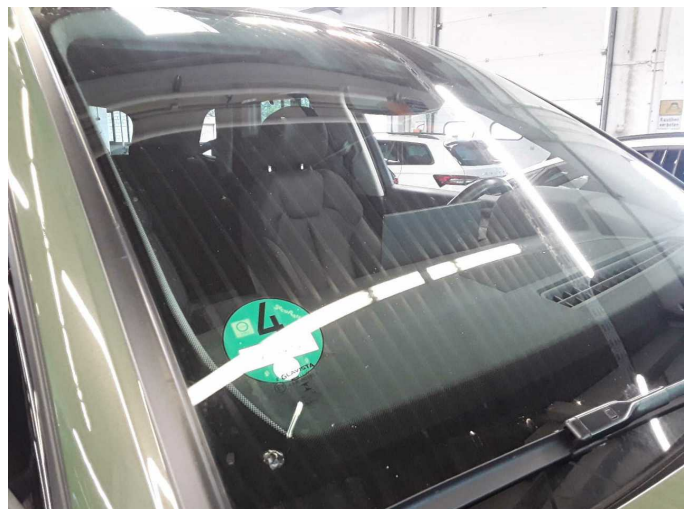
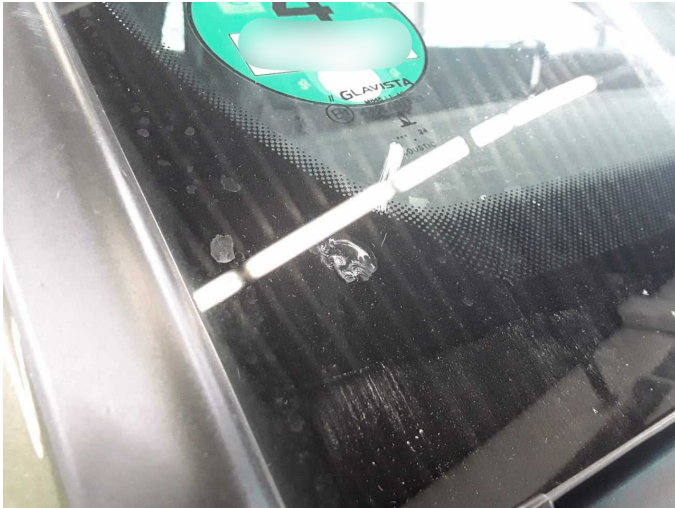
Damage 7: Vehicle glazing: Windscreen (Rissbildung) - Stone chips - Replace

| No. | Component group | Description |
|---|---|--|
| 7 | Vehicle glazing | Windscreen (Rissbildung) - Stone chips - Replace |

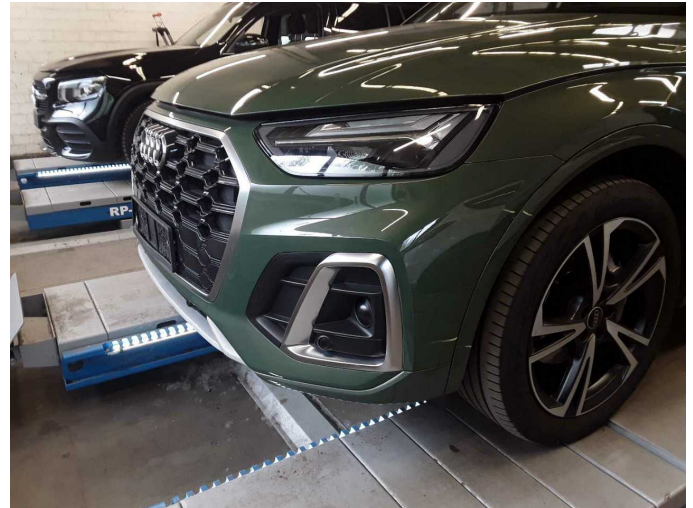
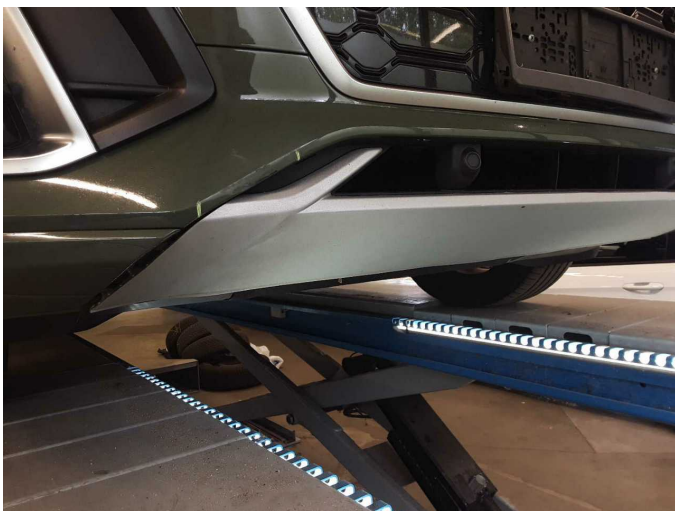
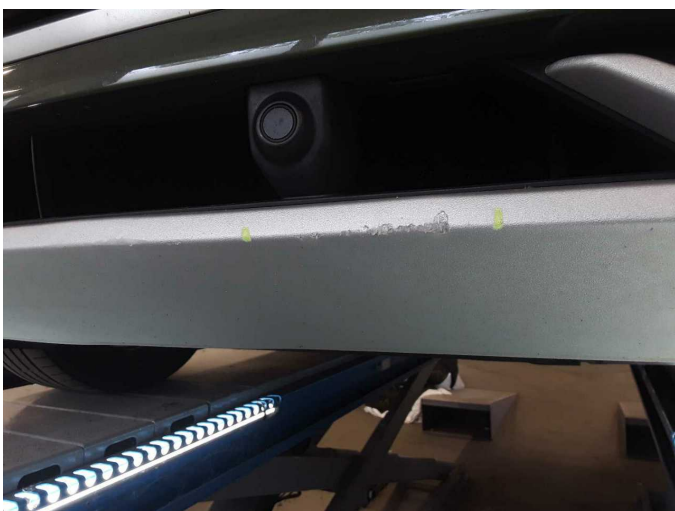
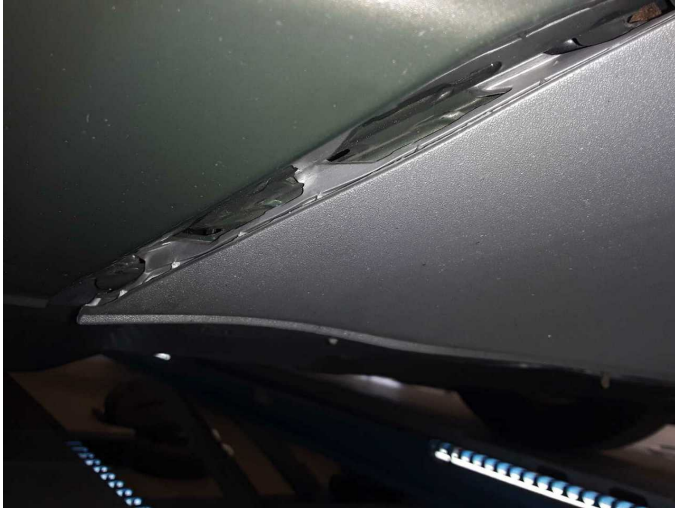
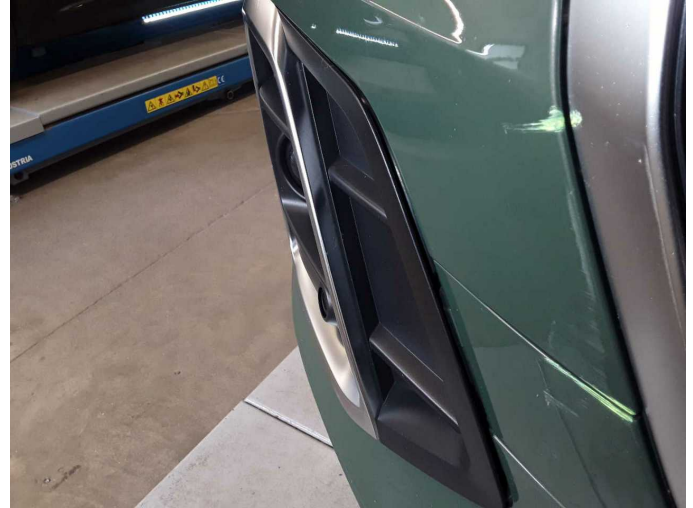
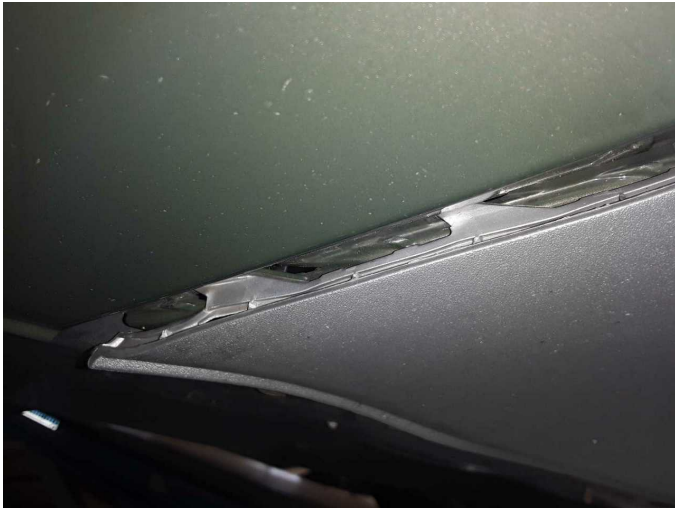
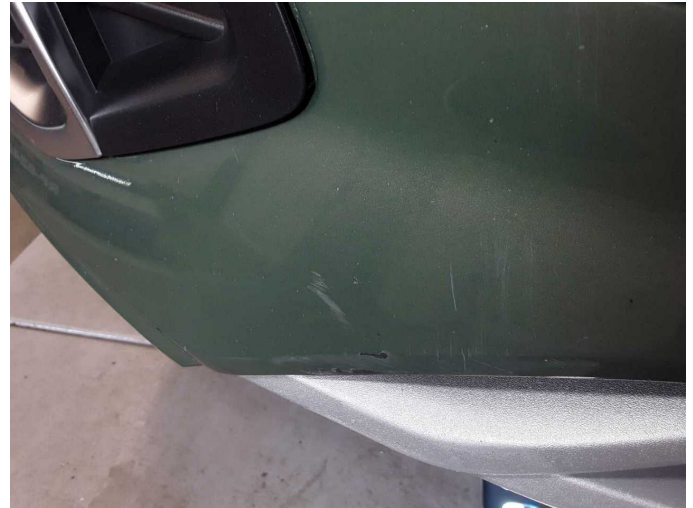
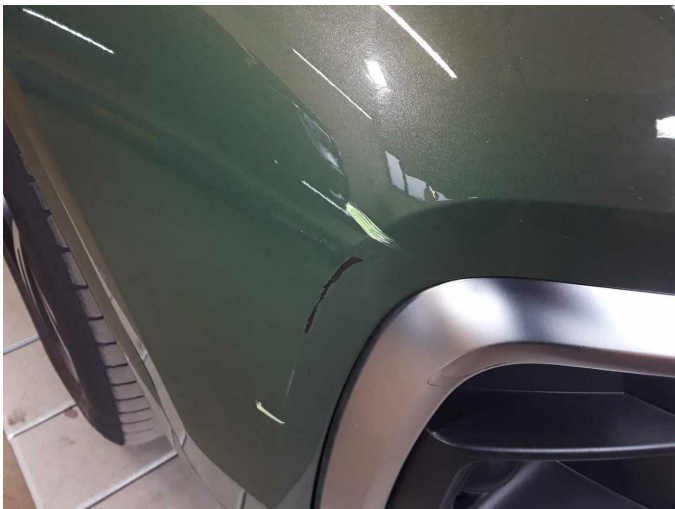
Damage 8: Front bumper: Front bumper (+ Zierleiste vorne erneuern) - Scratched - Paint

| No. | Component group | Description |
|---|---|--|
| 8 | Front bumper | Front bumper (+ Zierleiste vorne erneuern) - Scratched - Paint |

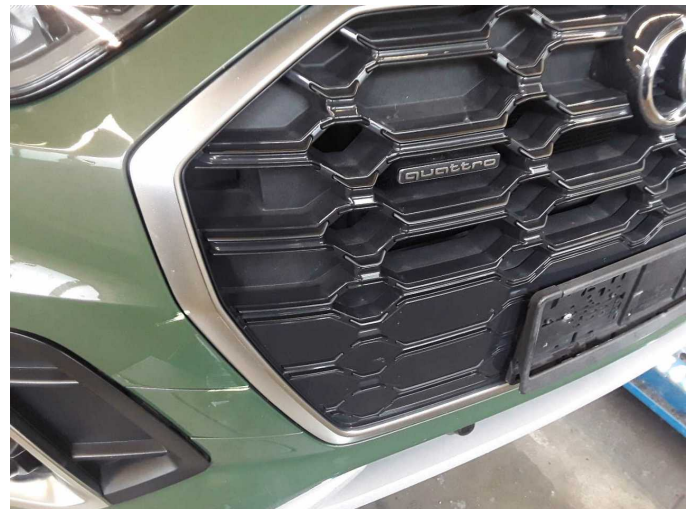
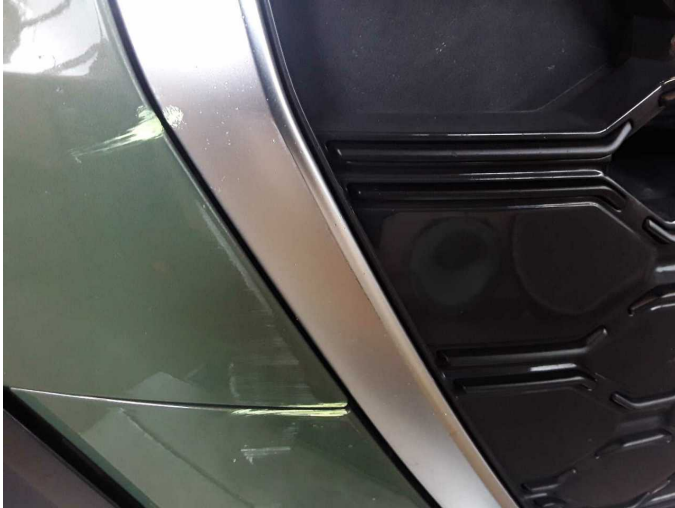
Wear and tear 1: Front bumper: Cover bumper - front - Scratch(es) - No deduction

| No. | Component group | Description |
|---|---|---|
| 1 | Front bumper | Cover bumper - front - Scratch(es) - No deduction |

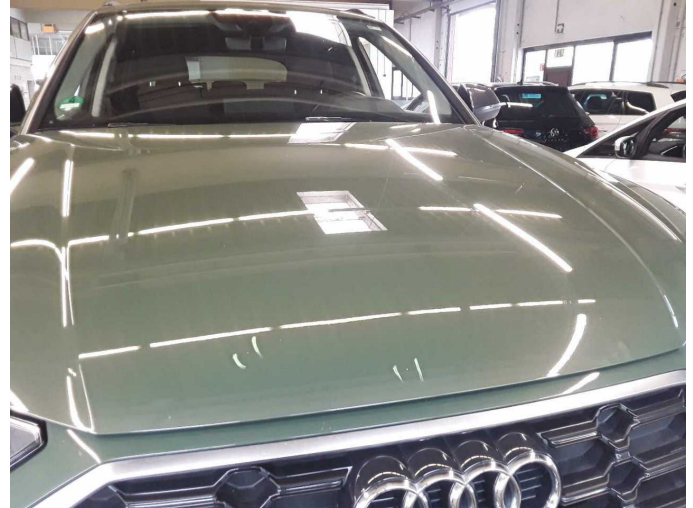
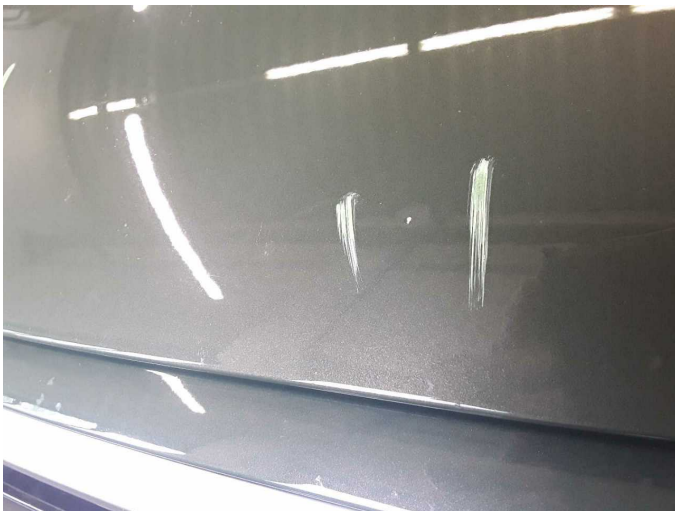
Wear and tear 2: Bonnet: Bonnet - Stone chips - No deduction

| No. | Component group | Description |
|---|---|---|
| 2 | Bonnet | Bonnet - Stone chips - No deduction |

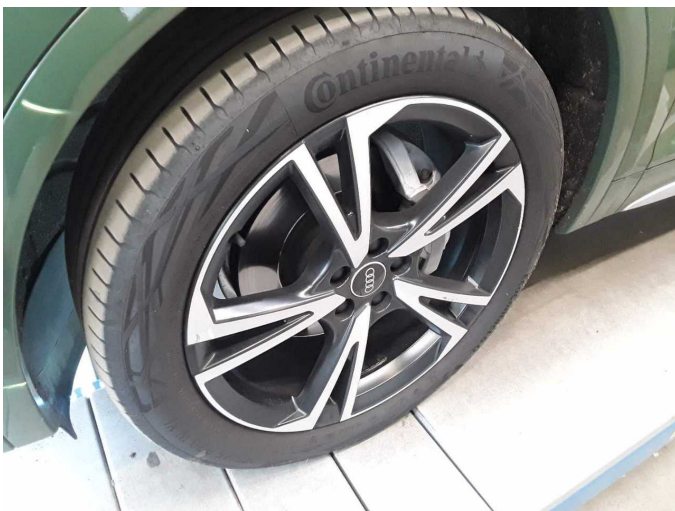
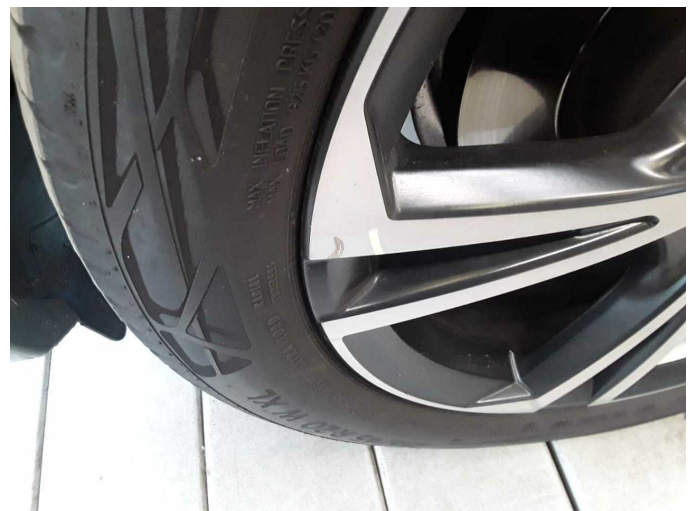
Wear and tear 4: Wheel / tyres: Alloy rim - front left side - Scratch(es) - No deduction

| No. | Component group | Description |
|---|---|---|
| 4 | Wheel / tyres | Alloy rim - front left side - Scratch(es) - No deduction |

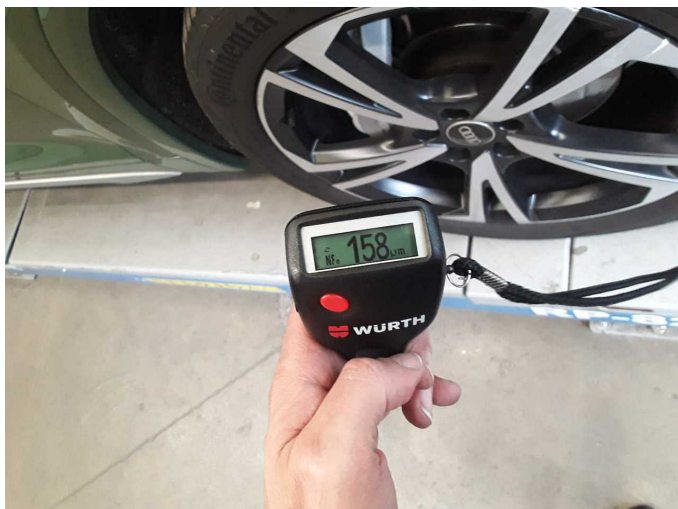
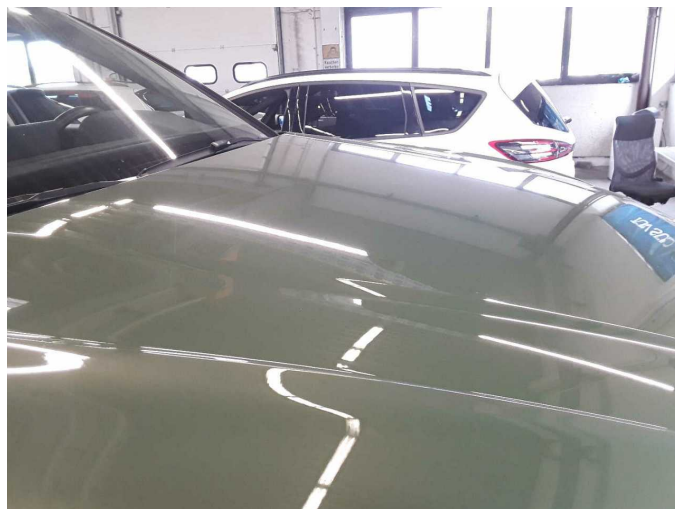
| No. | Repainting |
|---|---|
| 1 | Bonnet, Professionally carried out, Invoice of repair done Non-existent |

| Bonnet | 158 µm |

Repainting 1: Bonnet
