Expertise

Protocol number: 46260519  
Order No. / Reference: 26528307  
Inspection date: 18 Jun 2026

| Manufacturer: Ford | Model: Focus 1.5 EcoBlue Start-Stopp-System Aut. TITANIUM X |
| VIN: WF0NXXGCHNPD64392 | |

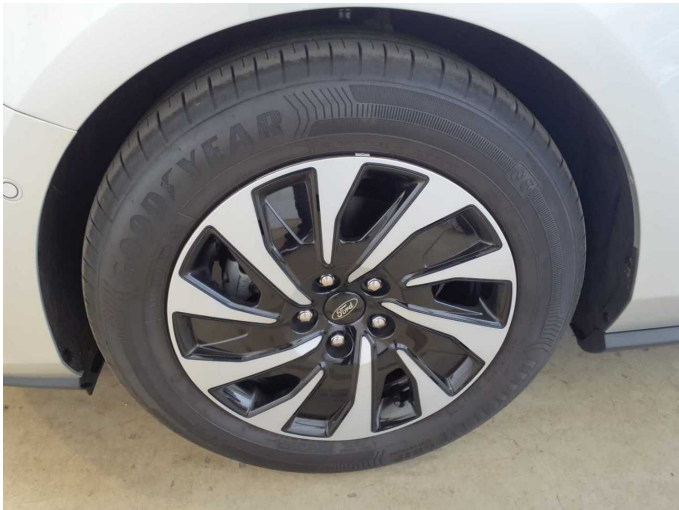
| Tyres | | | | |
|---|---|---|---|---|
| 1) | 205/60 R16 92V | Summer tyres on Steel rim with wheel cover | Goodyear | 6mm / 6mm |
| 2) | 205/60 R16 92V | Summer tyres on Steel rim with wheel cover | Goodyear | 6mm / 6mm |

Figure 12: Mounted tyres

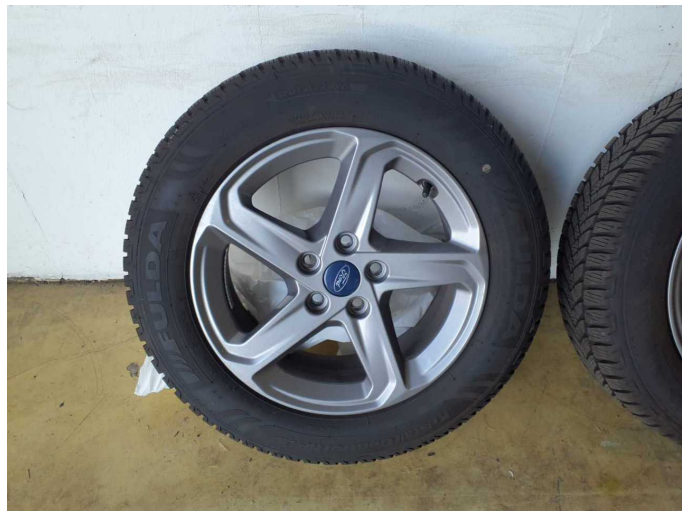
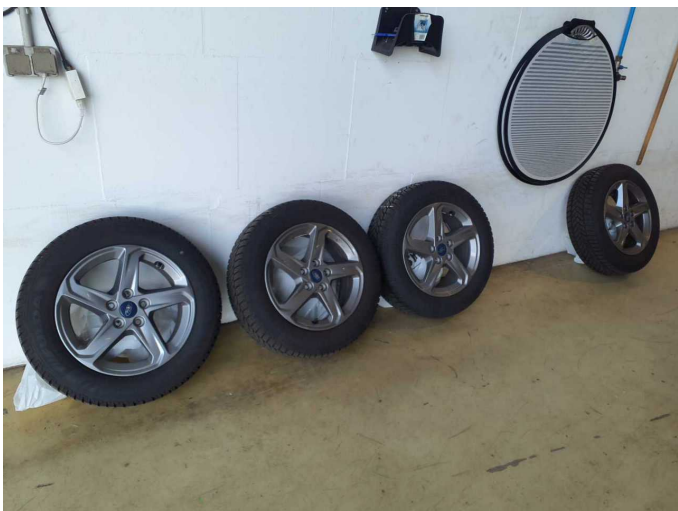
| Tyres | | | | |
|---|---|---|---|---|
| 1) | 205/60 R16 92H | Winter tyres on Light alloy | Fulda | 8mm / 8mm |
| 2) | 205/60 R16 92H | Winter tyres on Light alloy | Fulda | 8mm / 8mm |

Figure 16: Additional tyres

Figure 17: Additional tyres

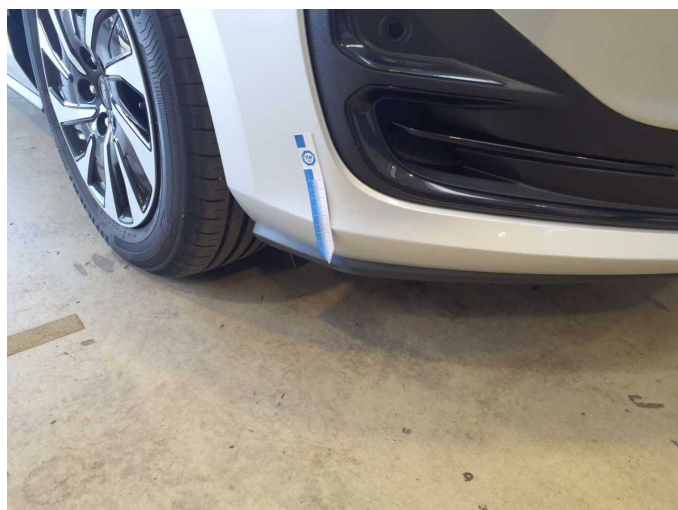
| No. | Component group | Description |
|---|---|---|
| 2 | Front bumper | Spoiler (Rechts) - Scratched - Replace |

Damage 2: Front bumper: Spoiler (Rechts) - Scratched - Replace

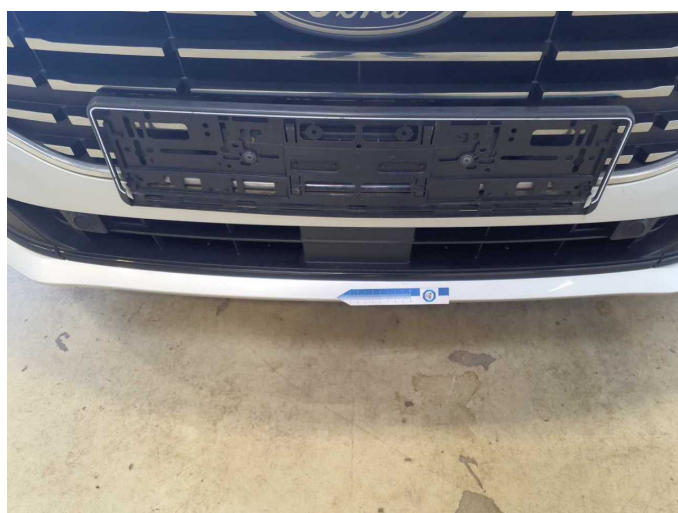
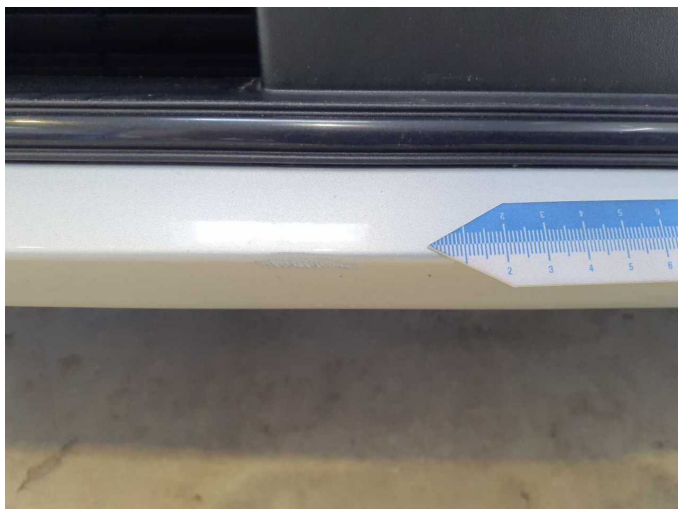
| No. | Component group | Description |
|---|---|---|
| 3 | Front bumper | Front bumper - Scratched - Smart repair |

Damage 3: Front bumper: Front bumper - Scratched - Smart repair

**Damage 3:** Front bumper: Front bumper - Scratched - Smart repair

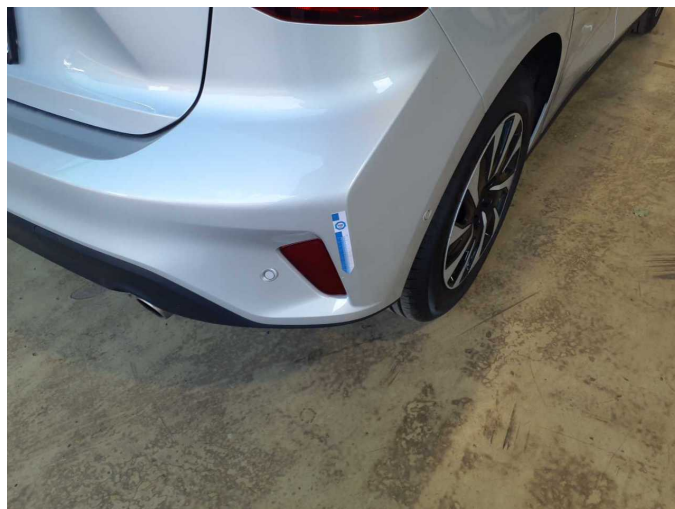
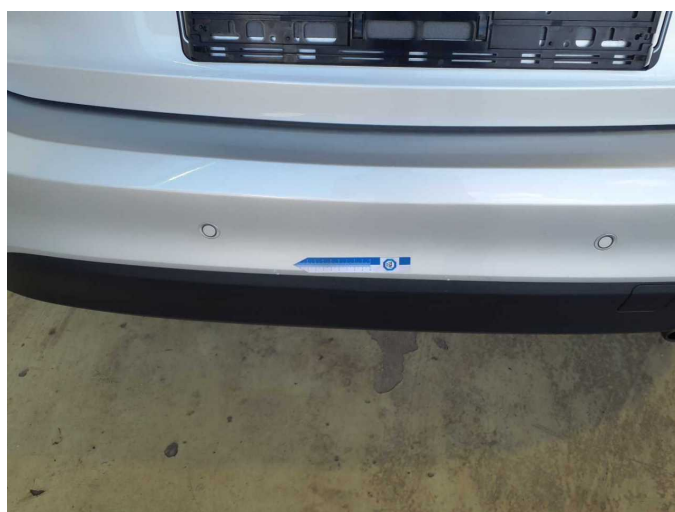
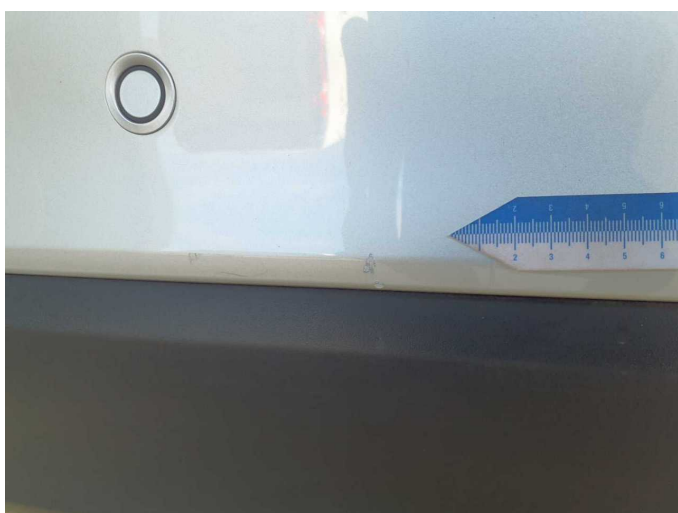
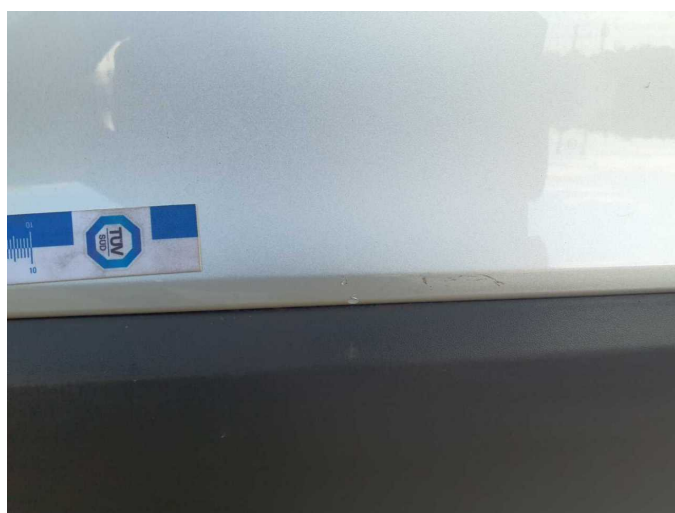
| No. | Component group | Description |
|---|---|---|
| 4 | Rear bumper | Rear bumper - Scratched - Paint |

**Damage 4:** Rear bumper: Rear bumper - Scratched - Paint

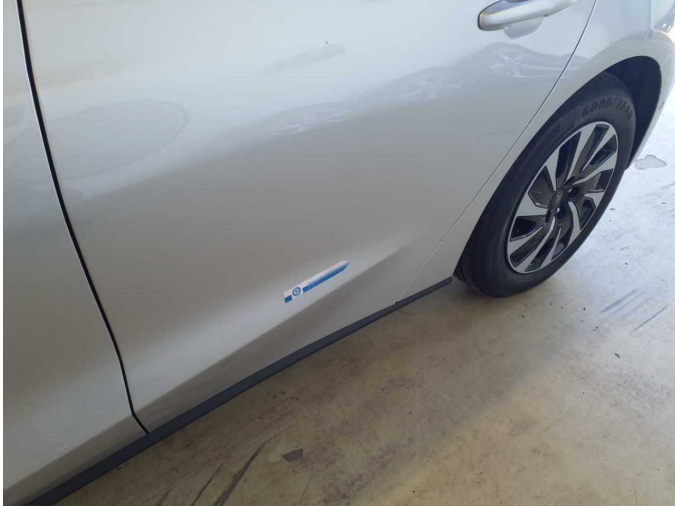
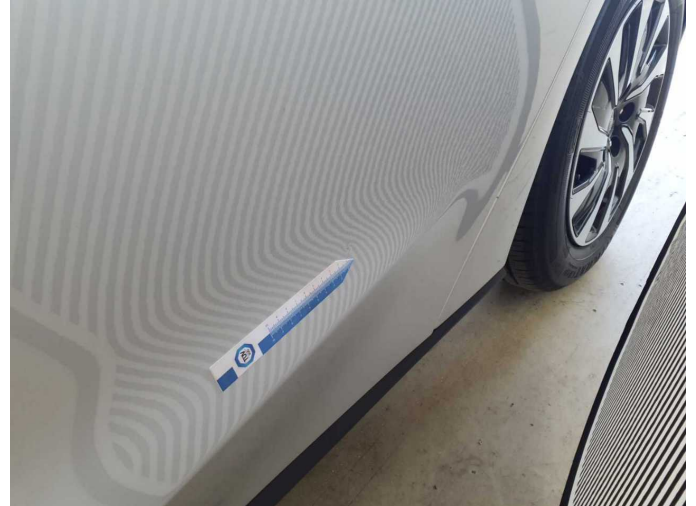
| No. | Component group | Description |
|---|---|---|
| 5 | Door - rear left side | Door - Dent / paintcoat damage - Repair and paint |

**Damage 5:** Door - rear left side: Door - Dent / paintcoat damage - Repair and paint

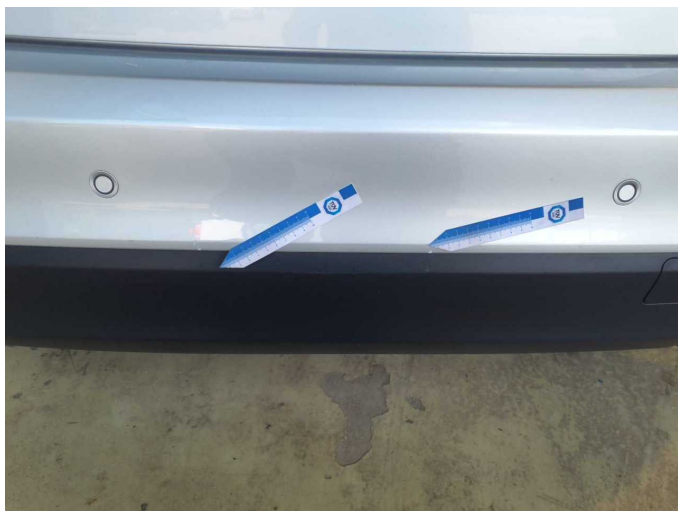
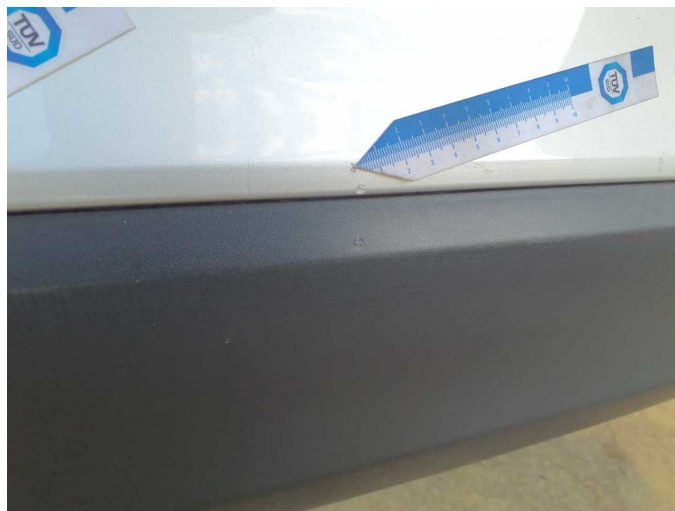
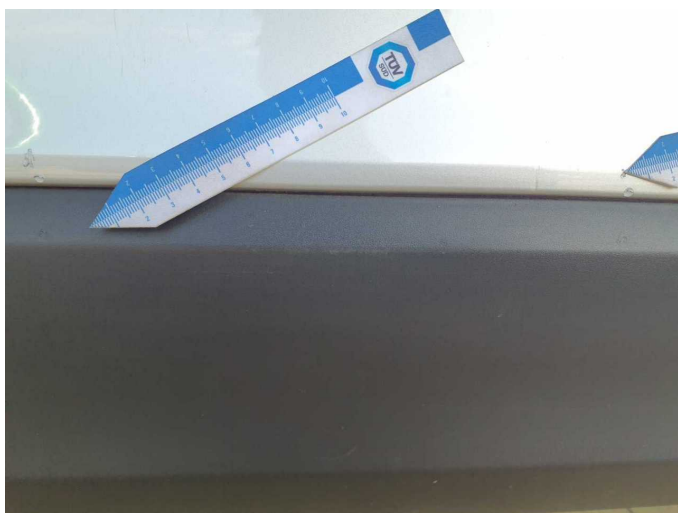
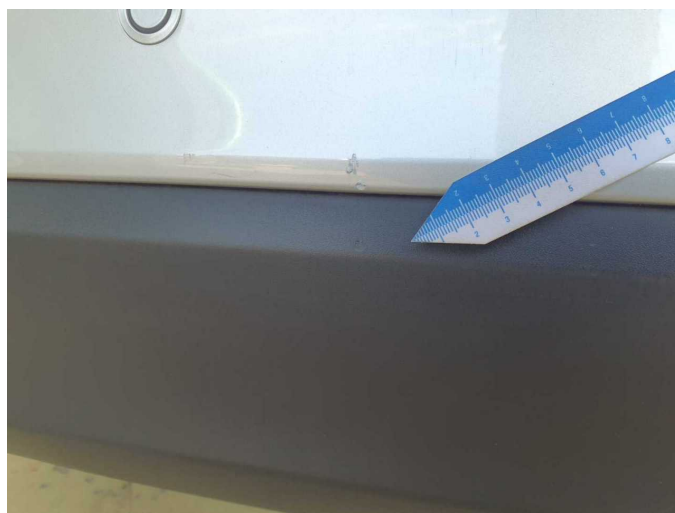
| No. | Component group | Description |
|---|---|---|
| 1 | Rear bumper | Spoiler - Scratch(es) - No deduction |

**Wear and tear 1:** Rear bumper: Spoiler - Scratch(es) - No deduction
