Expertise

Protocol number: 46464675  
Order No. / Reference: 26490269  
Inspection date: 13 Jul 2026

Manufacturer: Mercedes-Benz  
VIN: W1NKM0FBXPF035392

Model: GLC 220 d 4Matic 9G-TRONIC Avantgarde Advanced

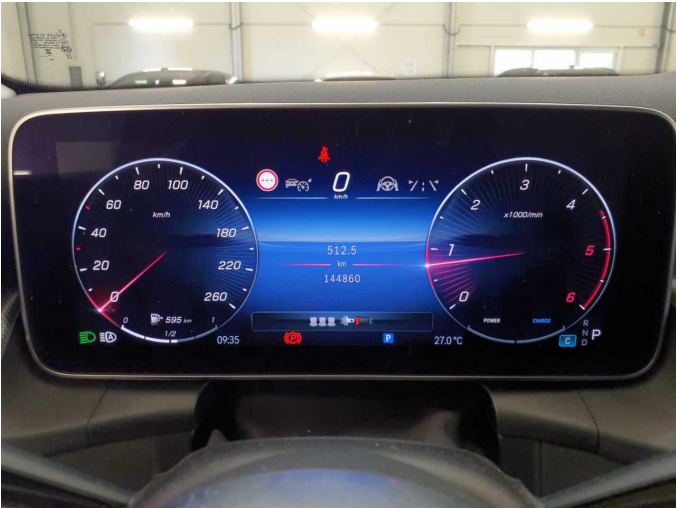
| Vehicle details | |
|---|---|
| Mileage (Read) | 144,860 km |

Figure 7: Instrument cluster

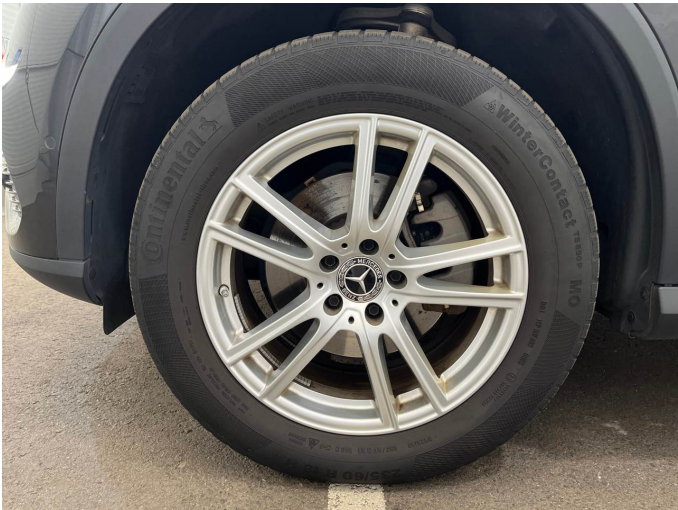
| # | Tyre size | Type of tyre | Manufacturer | Tread depth |
|---|---|---|---|---|
| 1) | 235/60 R18 103H | Winter tyres on Light alloy | Continental | 6mm / 6mm |
| 2) | 235/60 R18 103H | Winter tyres on Light alloy | Continental | 7mm / 7mm |

Figure 12: Mounted tyres

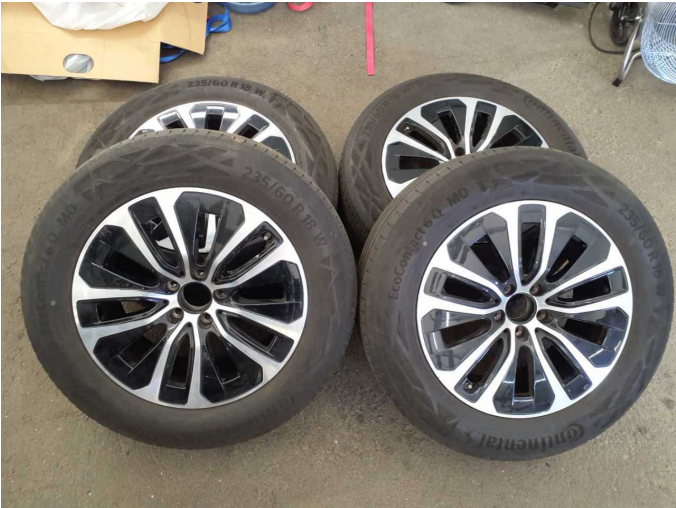
| # | Tyre size | Type of tyre | Manufacturer | Tread depth |
|---|---|---|---|---|
| 1) | 235/60 R18 103W | Summer tyres on Light alloy | Continental | 4mm / 4mm |
| 2) | 235/60 R18 103W | Summer tyres on Light alloy | Continental | 5mm / 5mm |

Figure 15: Additional tyres

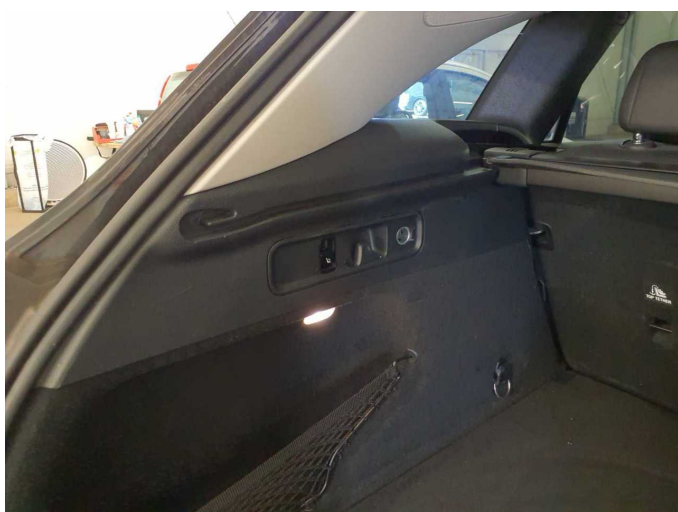
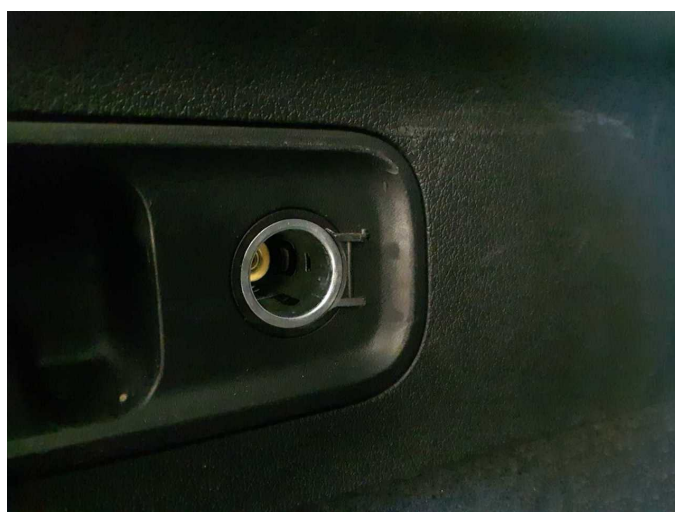
| No. | Component group | Description |
|---|---|---|
| 1 | Interior | Cigarette lighter (Abdeckung) - Broken / torn - Replace |

**Damage 1:** Interior: Cigarette lighter (Abdeckung) - Broken / torn - Replace

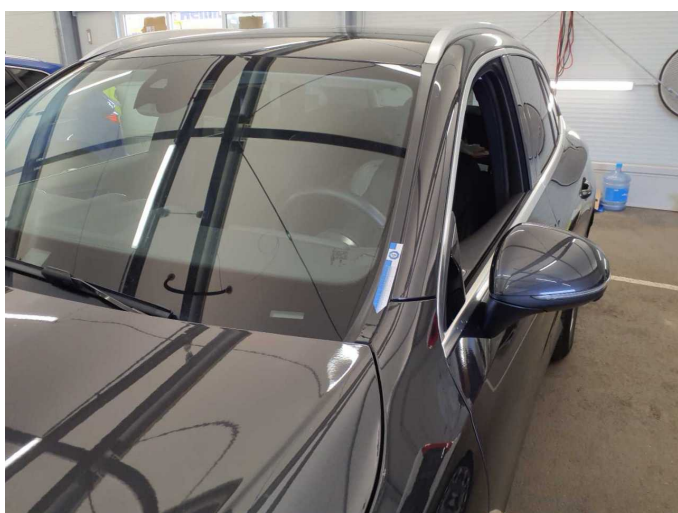
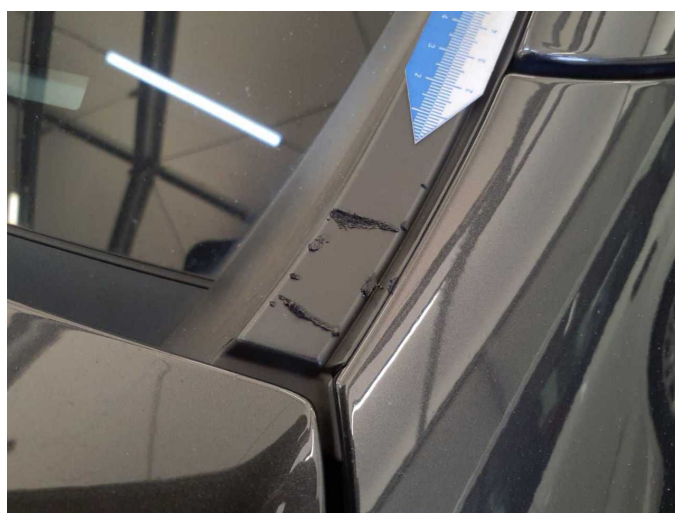
| No. | Component group | Description |
|---|---|---|
| 2 | Vehicle glazing | Windscreen seal (Blende) - Scratch(es) - Replace |

**Damage 2:** Vehicle glazing: Windscreen seal (Blende) - Scratch(es) - Replace

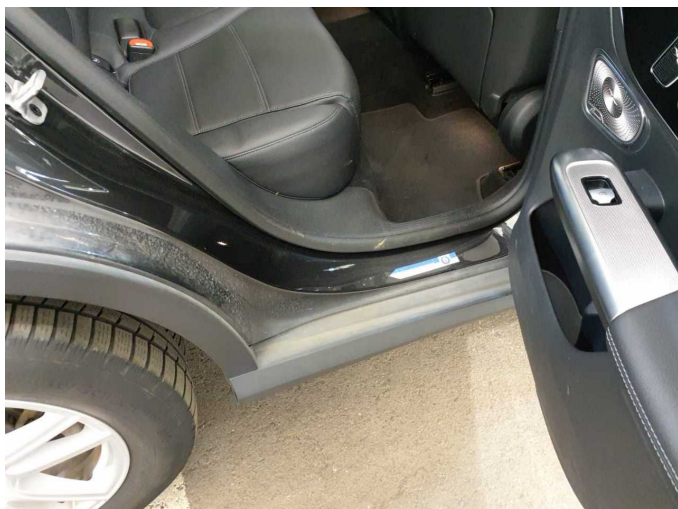
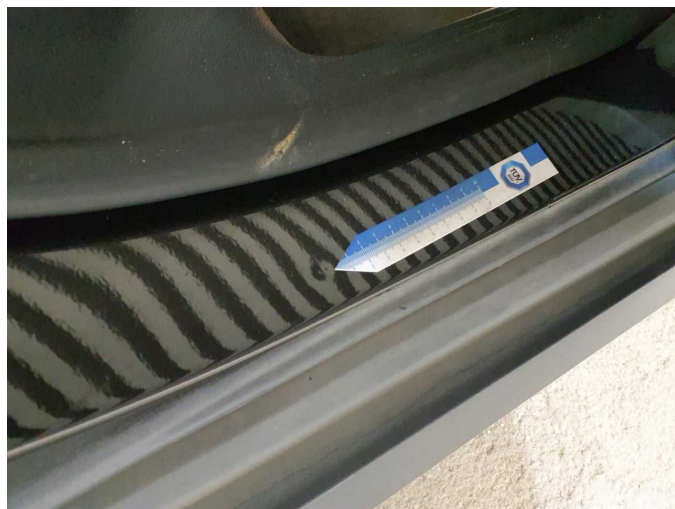
| No. | Component group | Description |
|---|---|---|
| 3 | Side panel - rear right side | Sill - dent(s) - Smart repair |

**Damage 3:** Side panel - rear right side: Sill - dent(s) - Smart repair

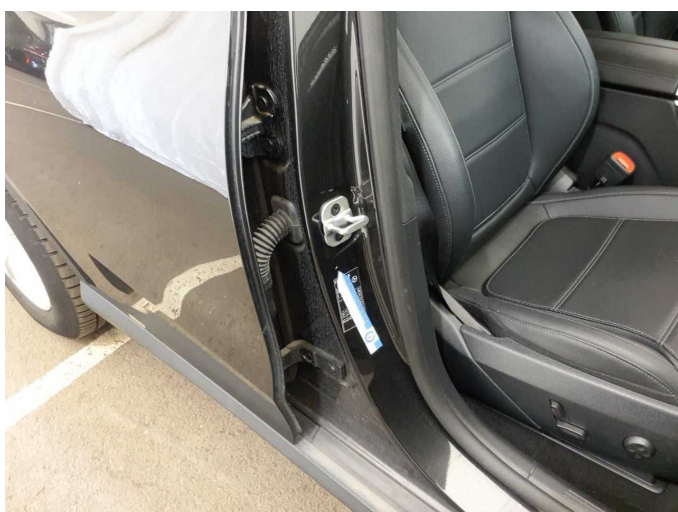
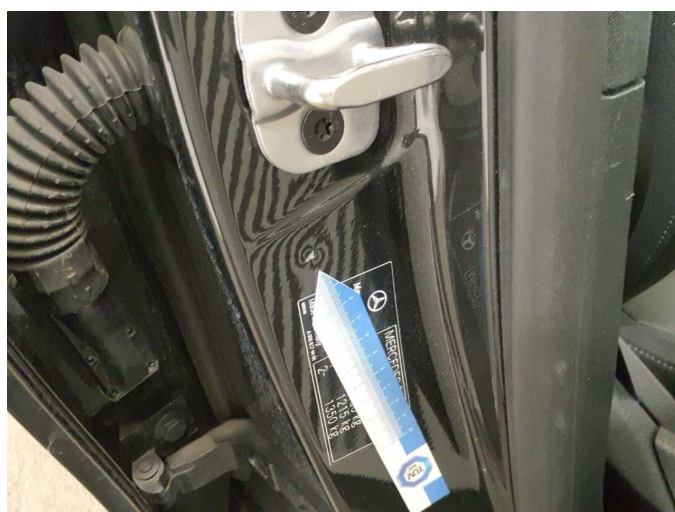
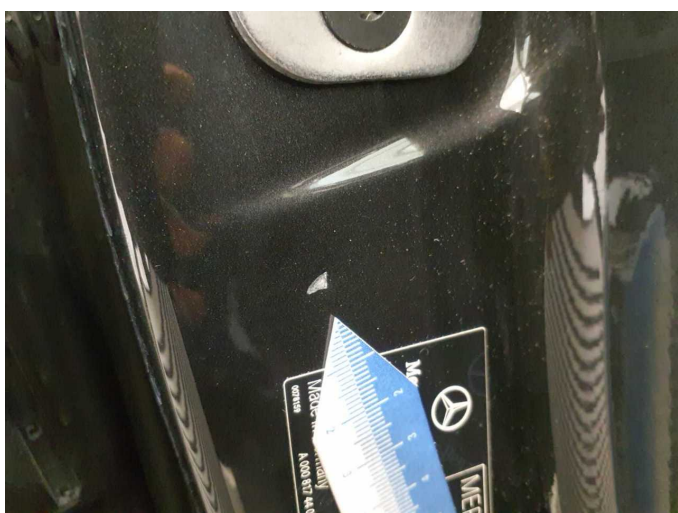
| No. | Component group | Description |
|---|---|---|
| 4 | Sill - right side | Sill - Dent / paintcoat damage - Smart repair |

**Damage 4:** Sill - right side: Sill - Dent / paintcoat damage - Smart repair

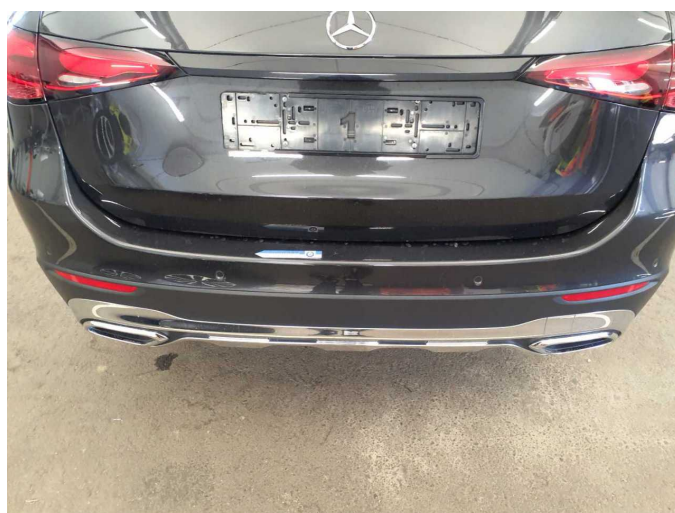
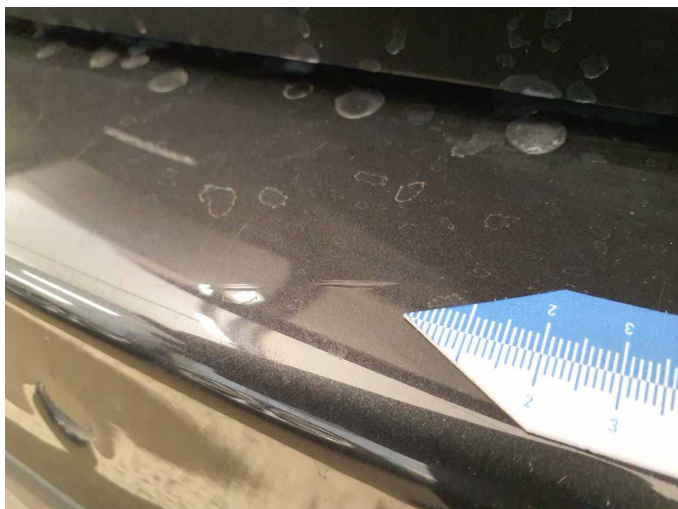
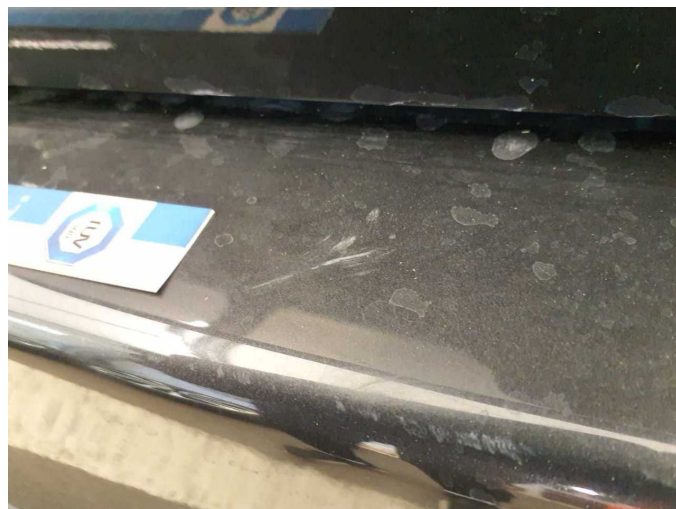
| No. | Component group | Description |
|---|---|---|
| 5 | Rear bumper | Rear bumper - Scratch(es) - Smart repair |

**Damage 5:** Rear bumper: Rear bumper - Scratch(es) - Smart repair

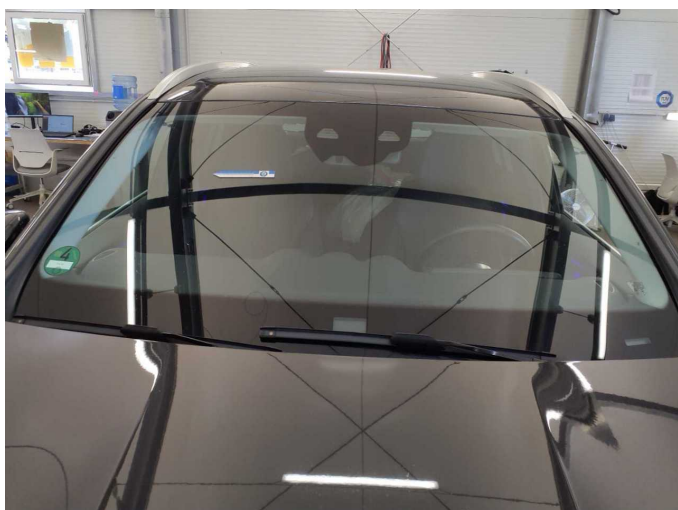
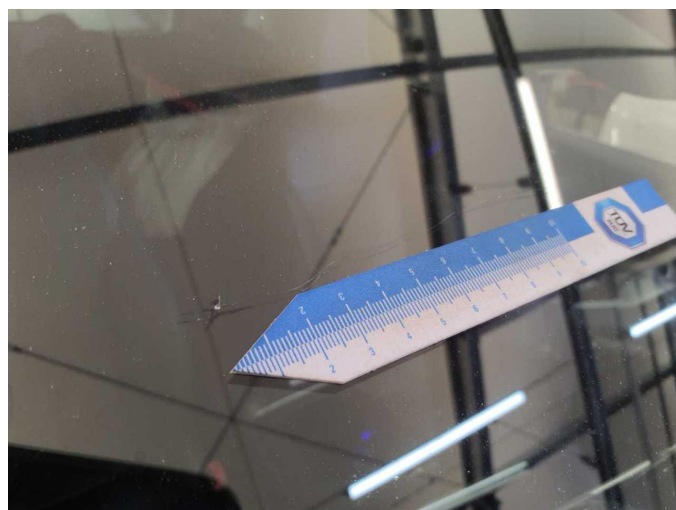
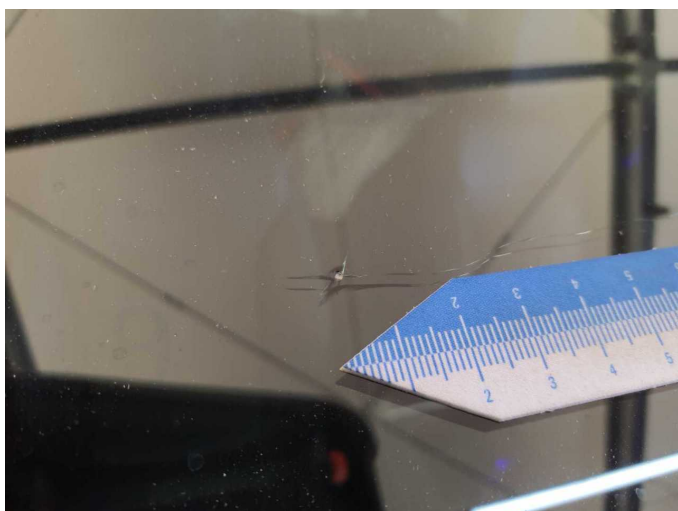
| No. | Component group | Description |
|---|---|---|
| 6 | Vehicle glazing | Windscreen with lane departure assistant - Broken / torn - repair according to calculation |

**Damage 6:** Vehicle glazing: Windscreen with lane departure assistant - Broken / torn - repair according to calculation
