Expertise

Protocol number: 46417495  
Order No. / Reference: 26484703  
Inspection date: 30 Jun 2026

Model: Transit Connect 230 L2 S&S Autm. Trend

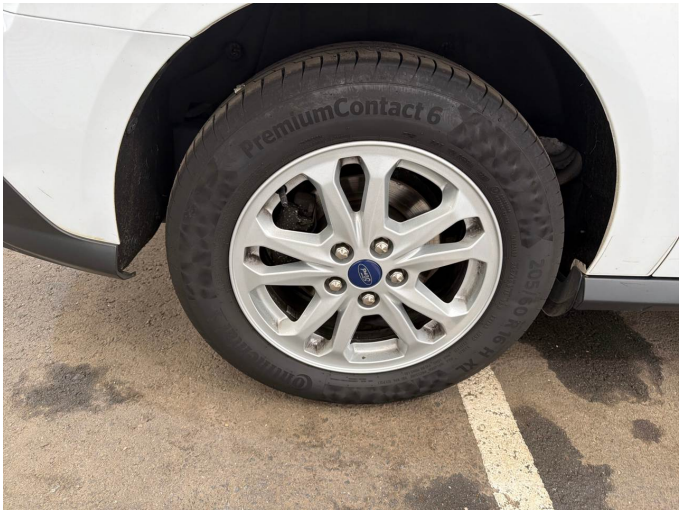
Figure 12: Mounted tyres

| # | Tyre size | Type of tyre | Manufacturer | Tread depth |
|---|---|---|---|---|
| 1) | 205/60 R16 96H | Summer tyres on Light alloy | Continental | 5mm / 5mm |
| 2) | 205/60 R16 96H | Summer tyres on Light alloy | Continental | 5mm / 5mm |

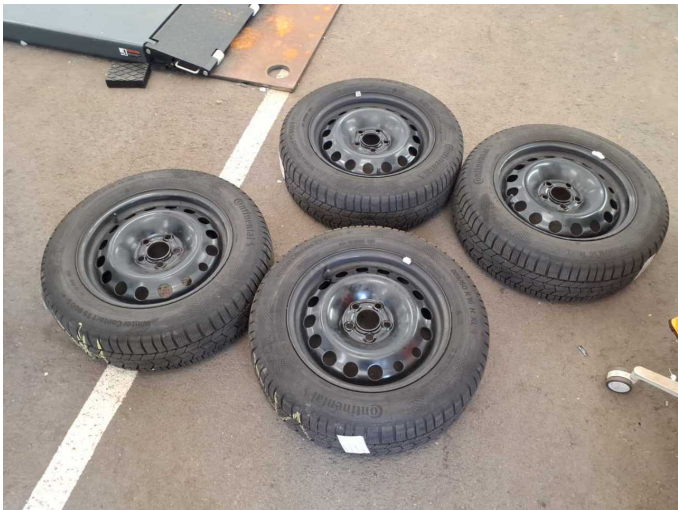
Figure 19: Additional tyres

| # | Tyre size | Type of tyre | Manufacturer | Tread depth |
|---|---|---|---|---|
| 1) | 205/60 R16 96H | Winter tyres on Steel | Continental | 5mm / 5mm |
| 2) | 205/60 R16 96H | Winter tyres on Steel | Continental | 6mm / 6mm |

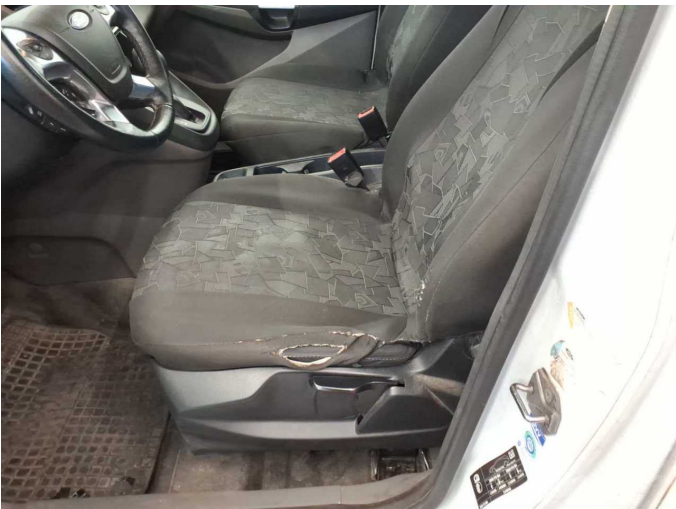
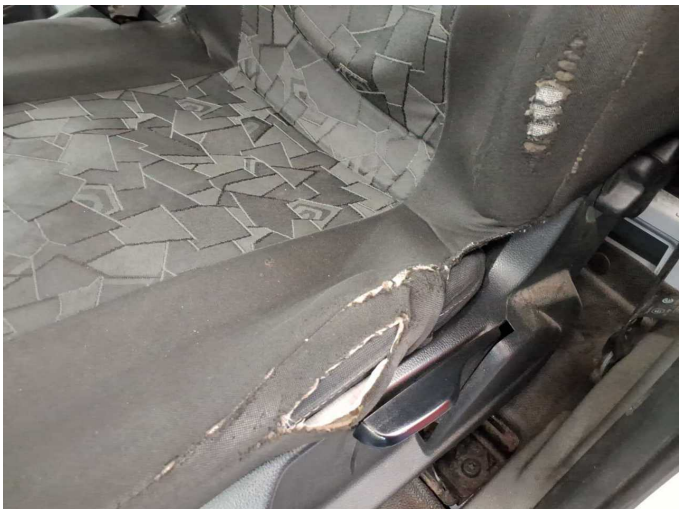
| No. | Component group | Description |
|---|---|---|
| 1 | Seat - front | Protective Cover - left side - Damaged - Replace |

Damage 1: Seat - front: Protective Cover - left side - Damaged - Replace

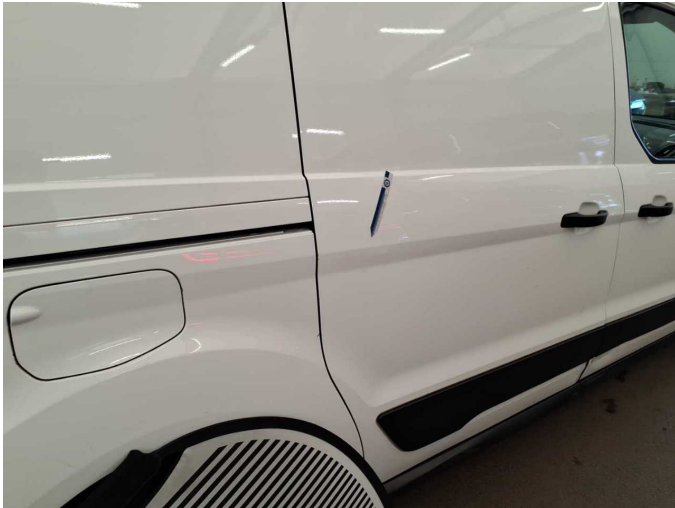
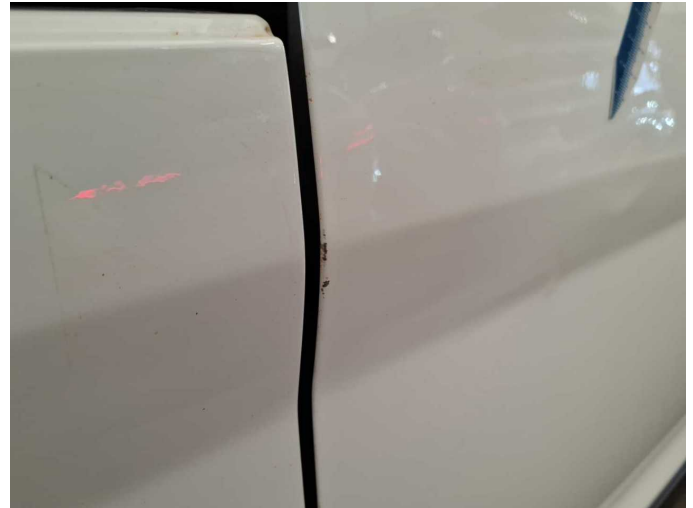
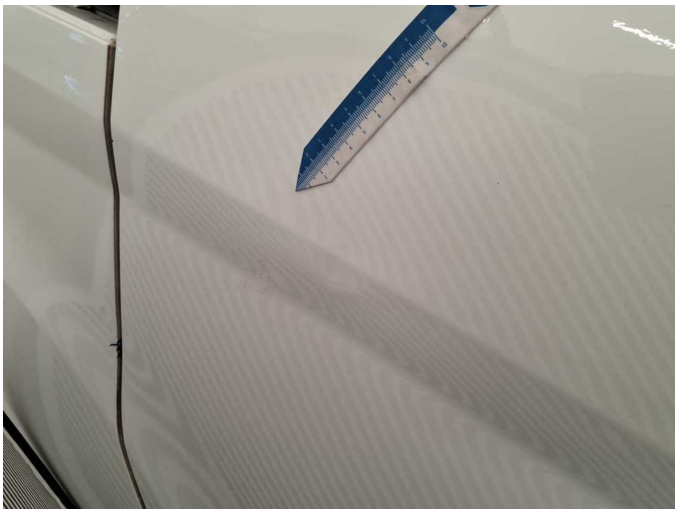
| No. | Component group | Description |
|---|---|---|
| 2 | Sliding door, right | Sliding door - Dent / paintcoat damage - Repair and paint |

**Damage 2:** Sliding door, right: Sliding door - Dent / paintcoat damage - Repair and paint

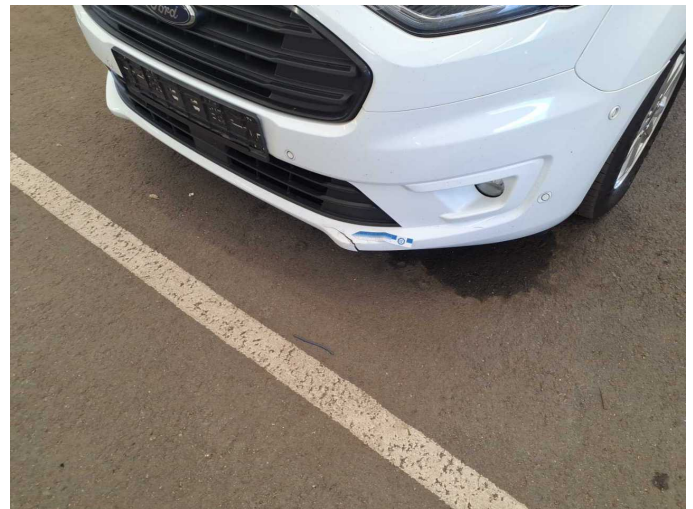
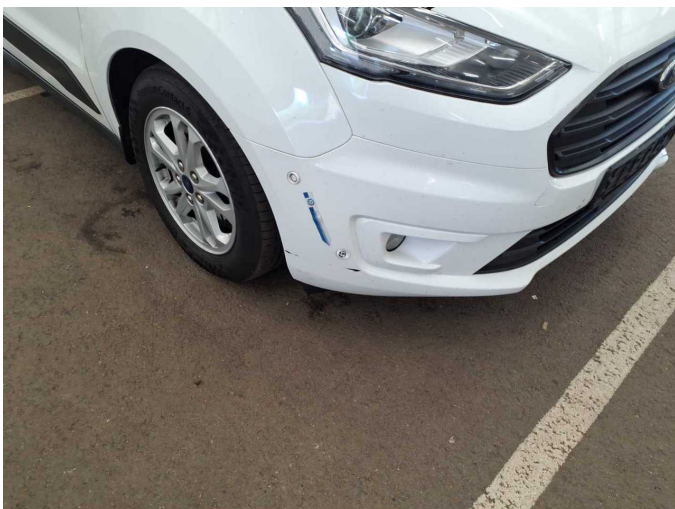
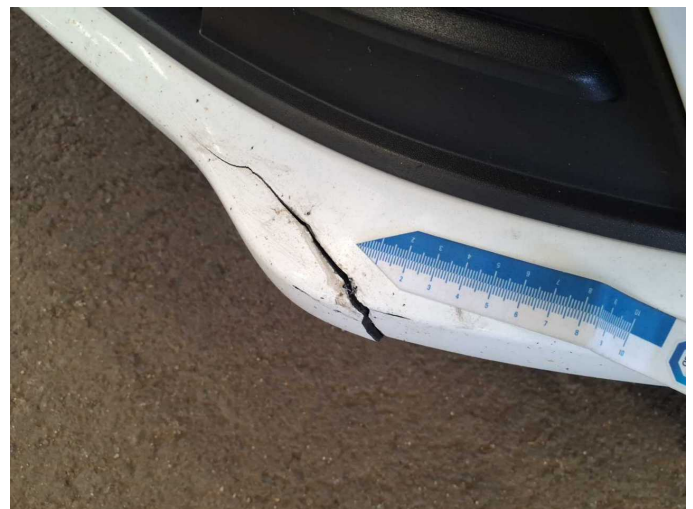
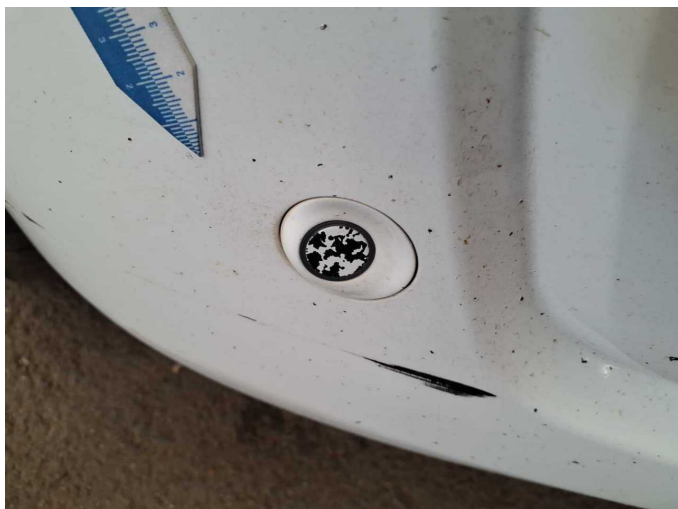
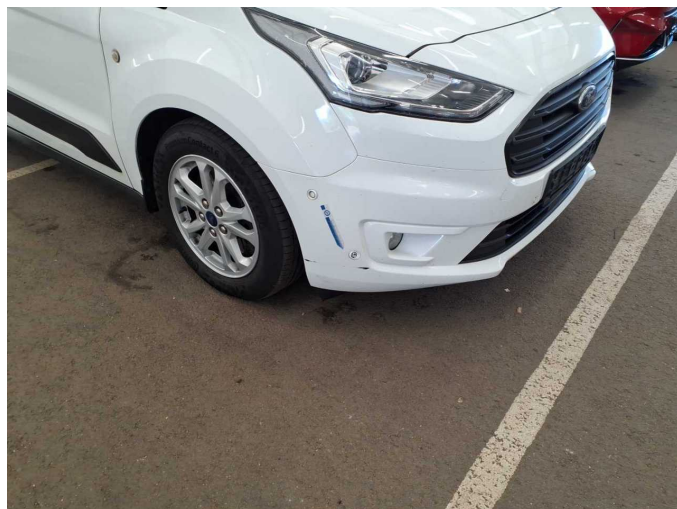
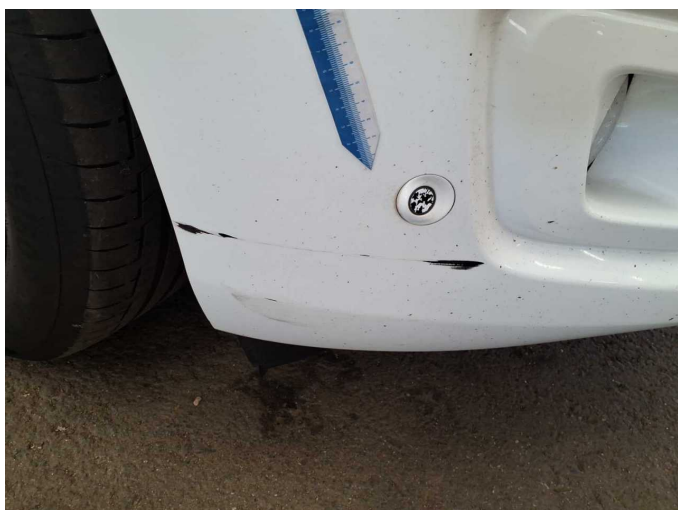
| No. | Component group | Description |
|---|---|---|
| 3 | Front bumper | Front bumper (inkl. Parksensor) - Broken / torn - Replace |

**Damage 3:** Front bumper: Front bumper (inkl. Parksensor) - Broken / torn - Replace

**Damage 3:** Front bumper: Front bumper (inkl. Parksensor) - Broken / torn  
- Replace

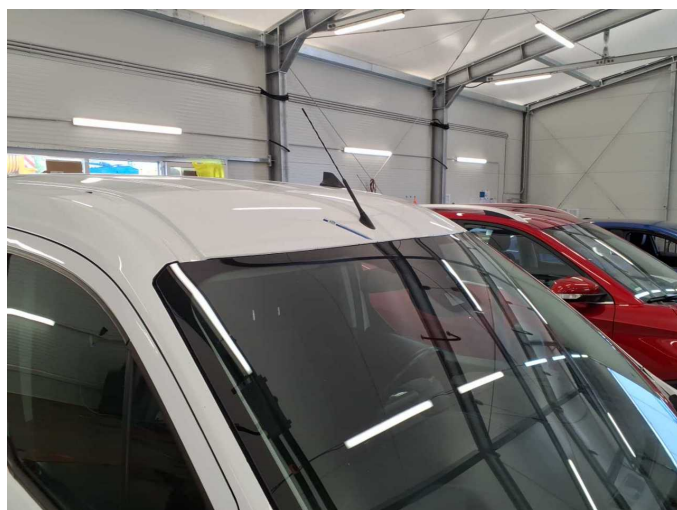
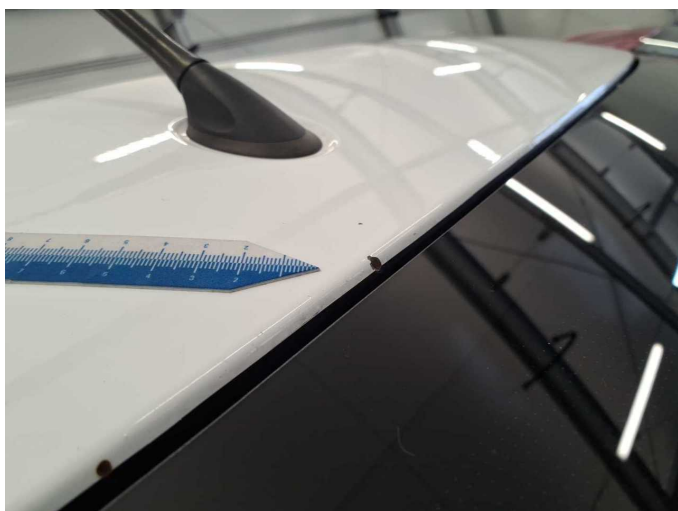
| No. | Component group | Description |
|---|---|---|
| 4 | Roof | Roof (Dachkante) - Corrosion - Repair and paint |

**Damage 4:** Roof: Roof (Dachkante) - Corrosion - Repair and paint

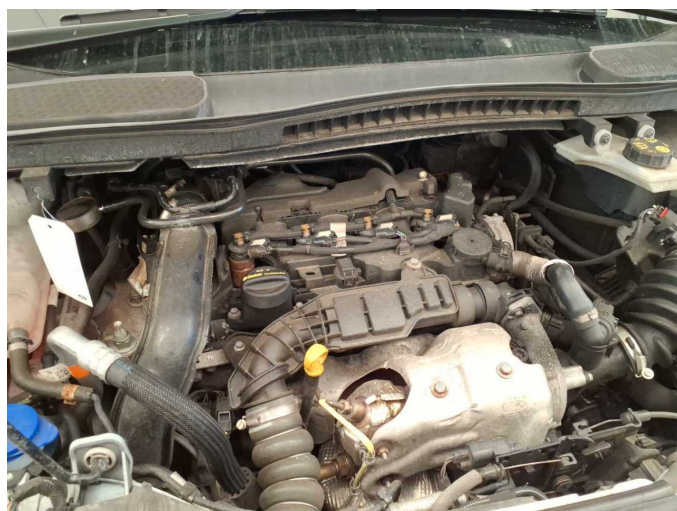
Engine - Engine cover

**Missing part 1:** Engine: Engine cover - Missing - Replace

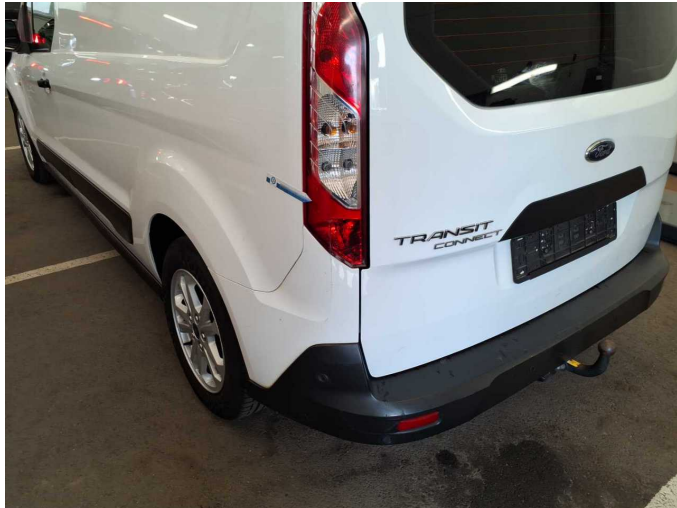
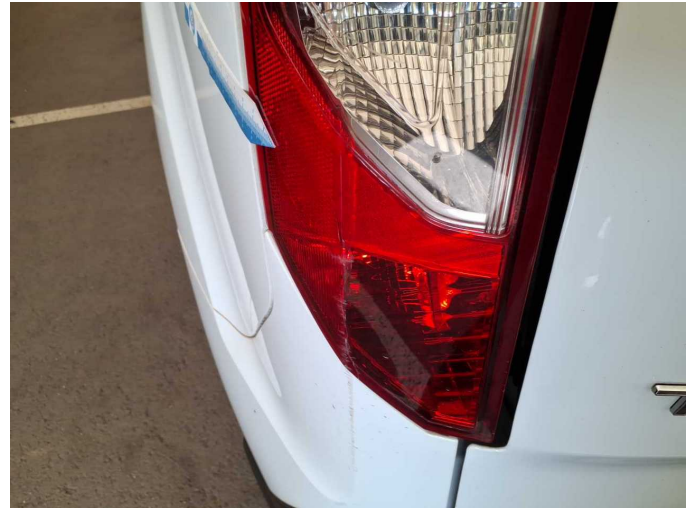
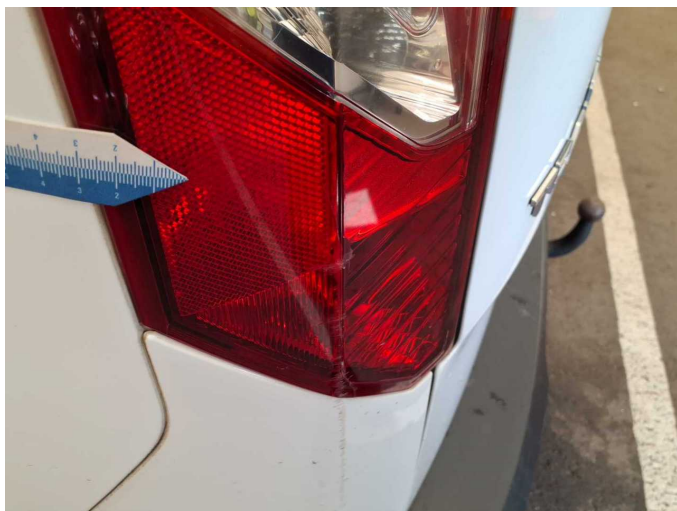
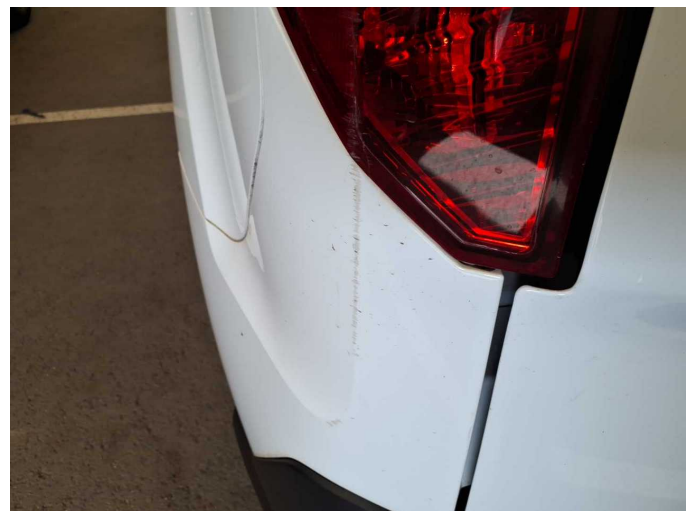
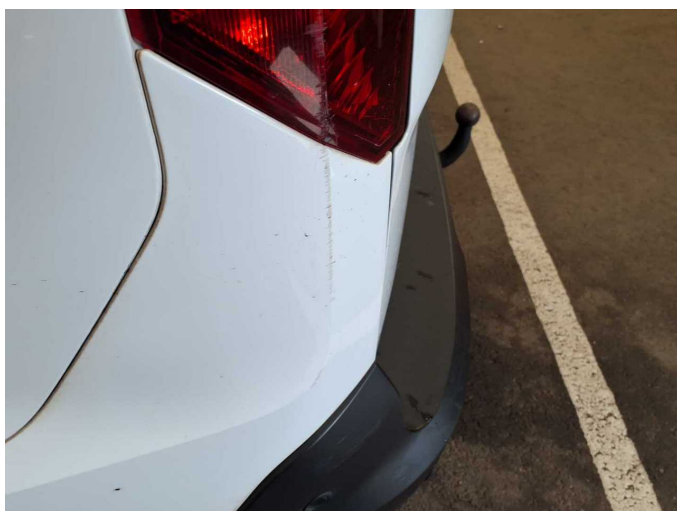
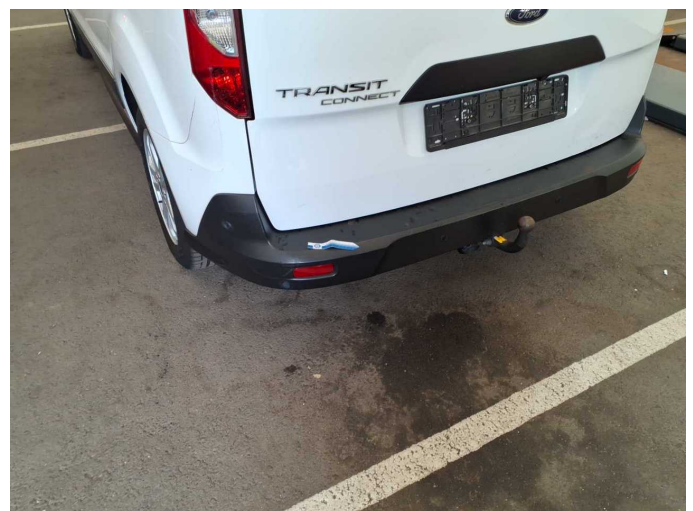
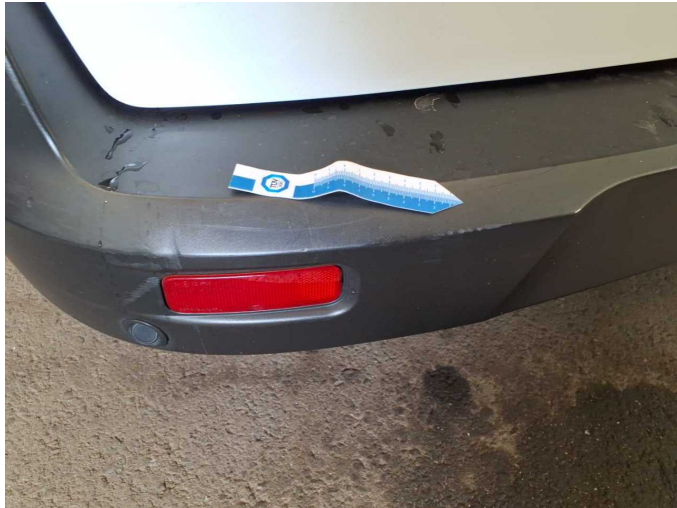
- 1 Rear, Side - left
- 2 Side right

**Accident 1: Rear, Side - left**

**Accident 1:** Rear, Side - left

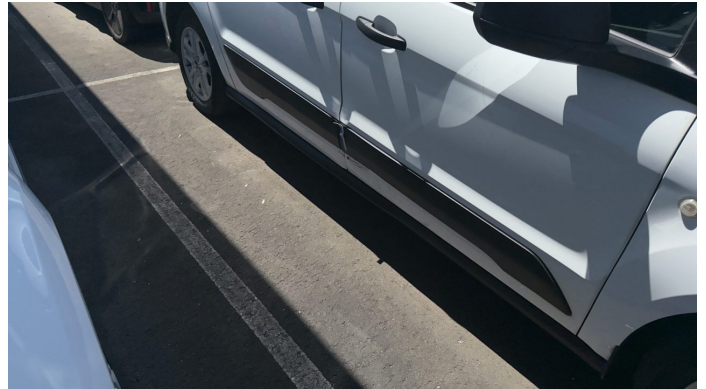
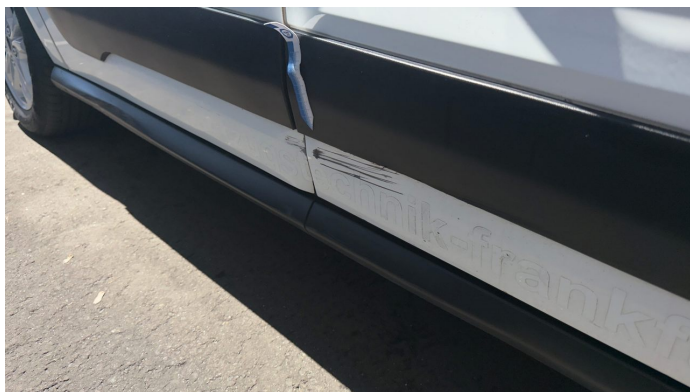
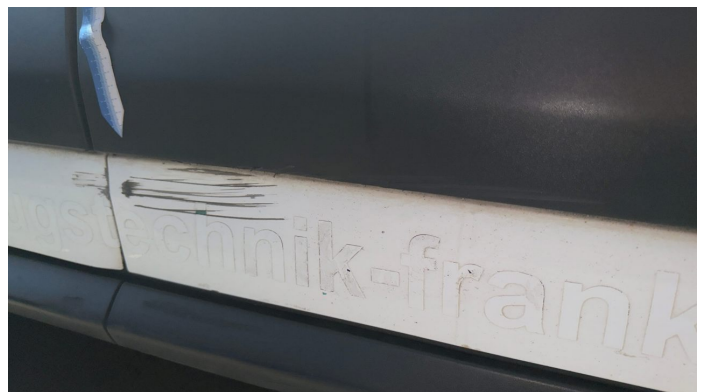
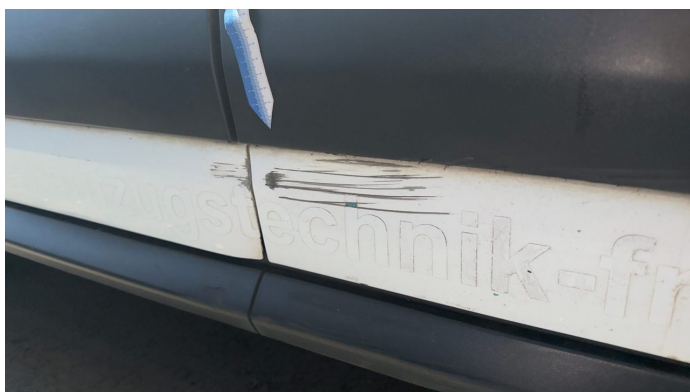
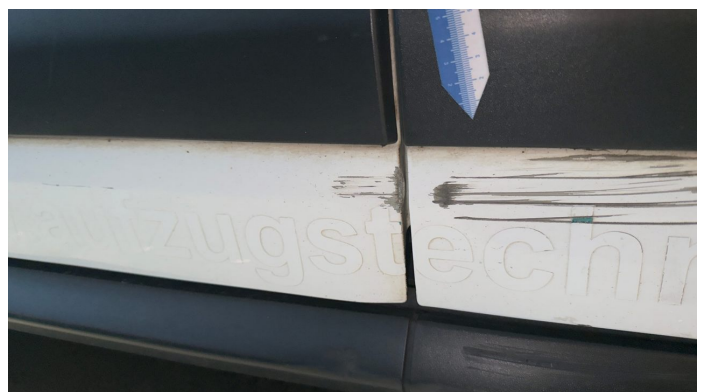
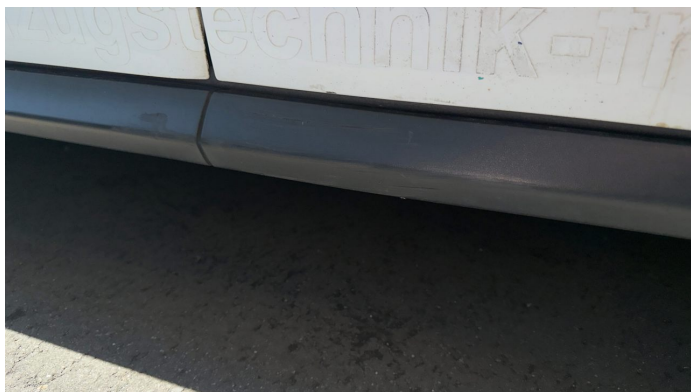
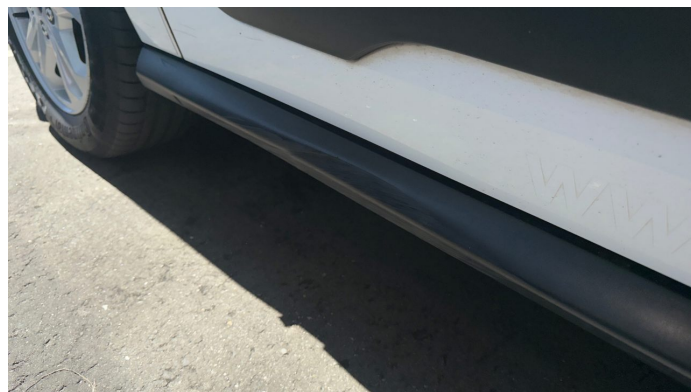
**Accident 2:** Side right
