Expertise

Protocol number: 46330726  
Order No. / Reference: 26581911  
Inspection date: 6 Jul 2026

Manufacturer: Ford

Model: Focus Turnier 1.5 EcoBlue Start-Stopp-System Aut. ST-LINE X

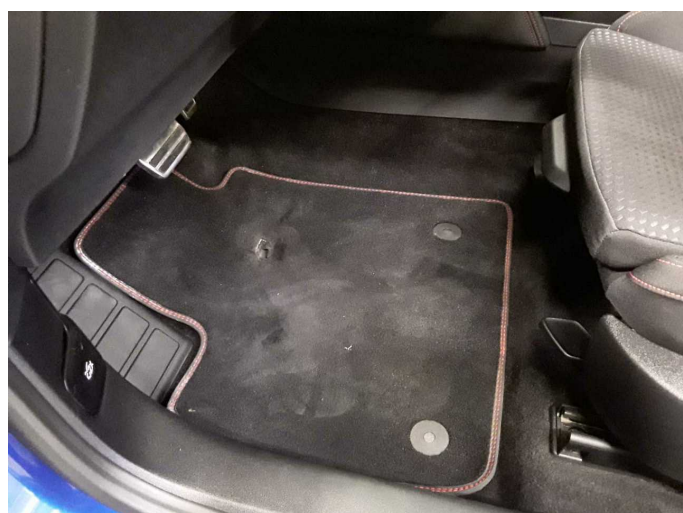
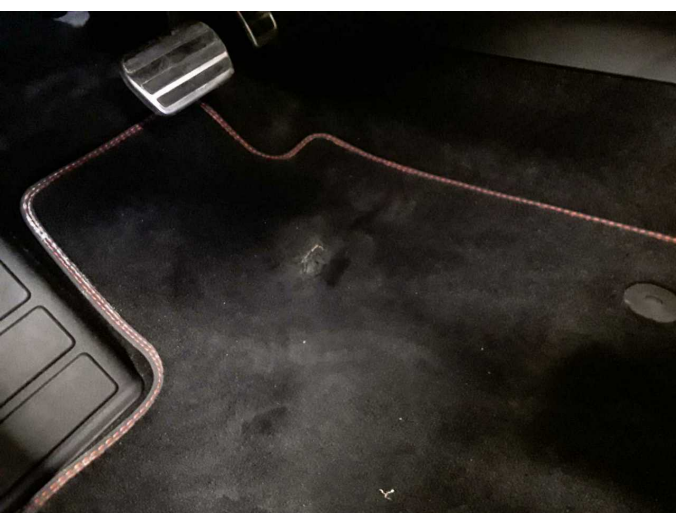
Damage 1: Trim / covers: Floor mats - Damaged - Replace

| No. | Component group | Description |
|---|---|---|
| 1 | Trim / covers | Floor mats - Damaged - Replace |

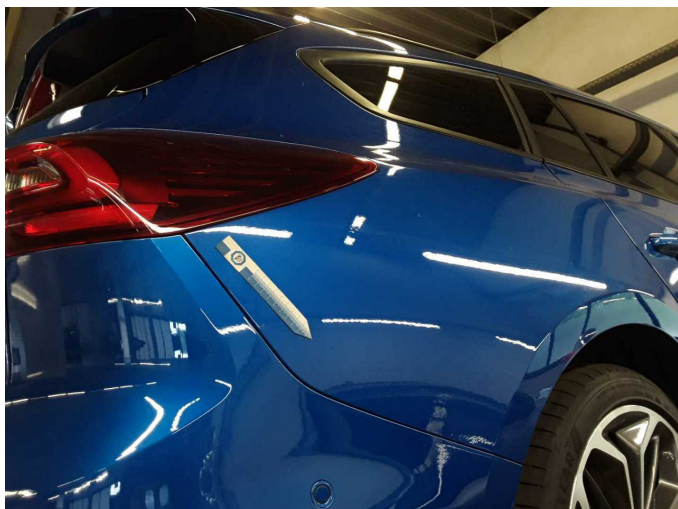
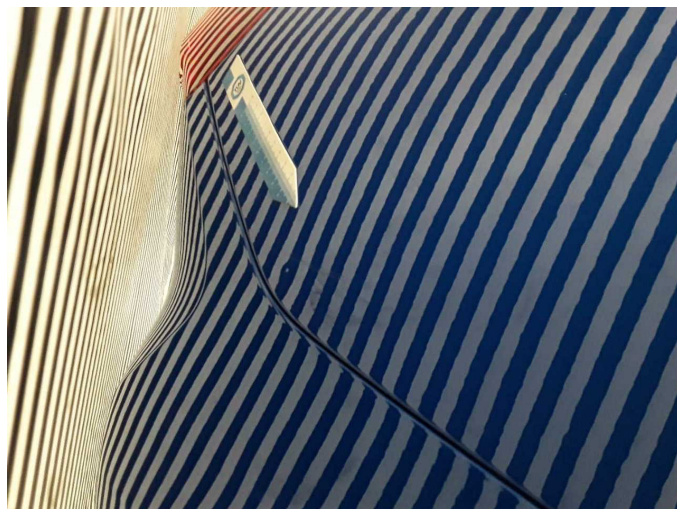
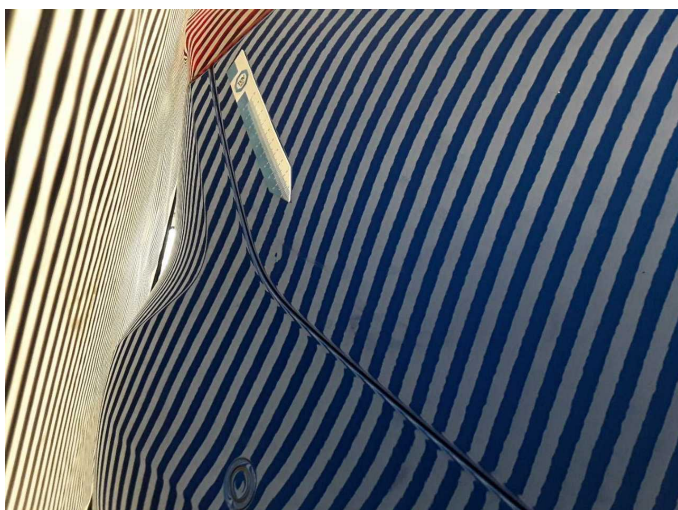
**Damage 2:** Side panel - rear right side: Side panel - dent(s) - Smooth repair work

| No. | Component group | Description |
|---|---|---|
| 2 | Side panel - rear right side | Side panel - dent(s) - Smooth repair work |

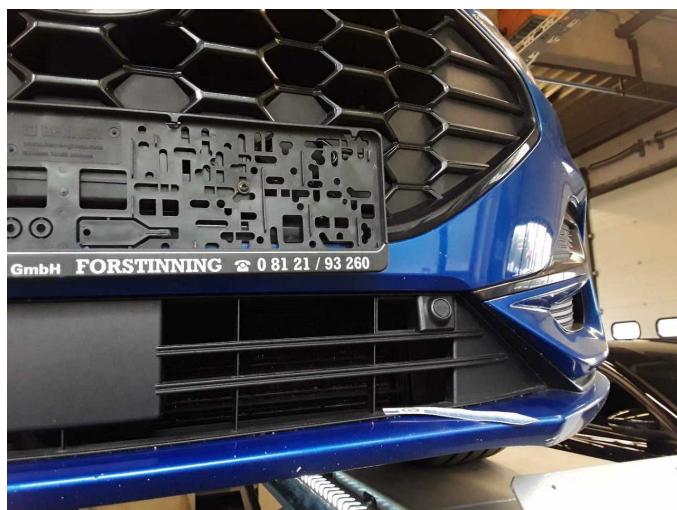
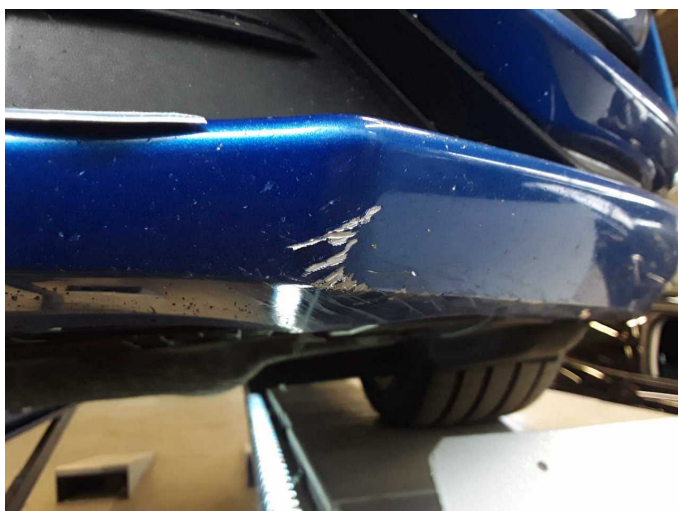
**Damage 3:** Front bumper: Front bumper - Scratched - Smart repair

| No. | Component group | Description |
|---|---|---|
| 3 | Front bumper | Front bumper - Scratched - Smart repair |

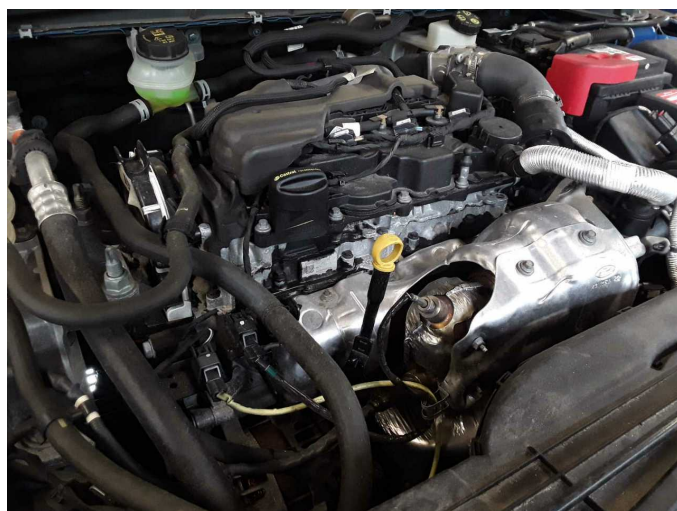
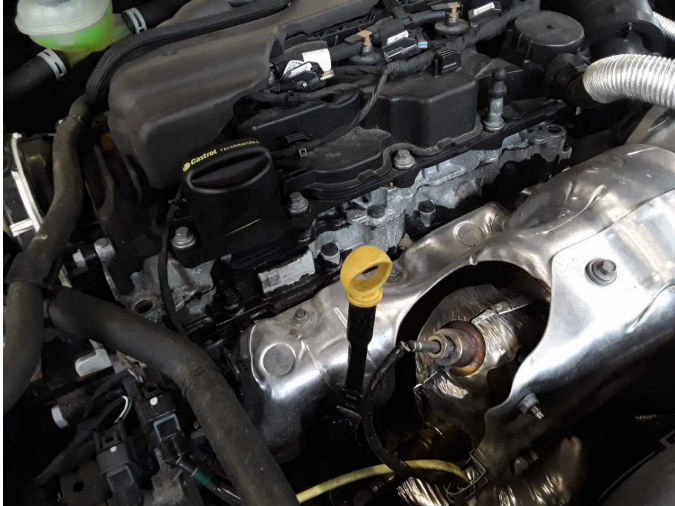
**Damage 4:** Engine: Engine - Leaking - Perform diagnosis

| No. | Component group | Description |
|---|---|---|
| 4 | Engine | Engine - Leaking - Perform diagnosis |

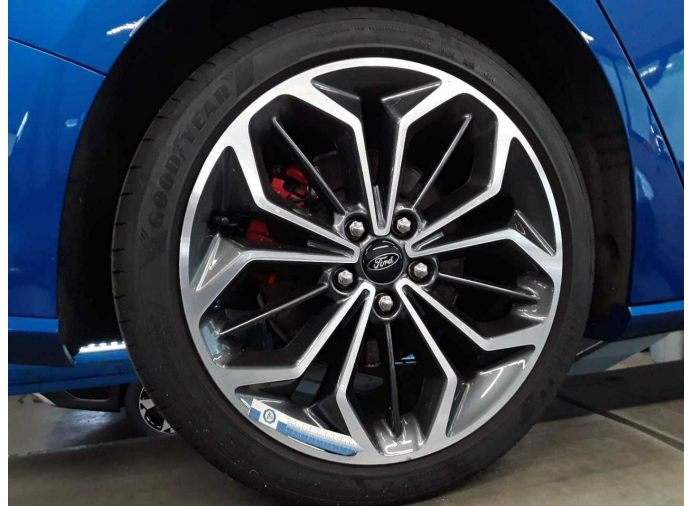
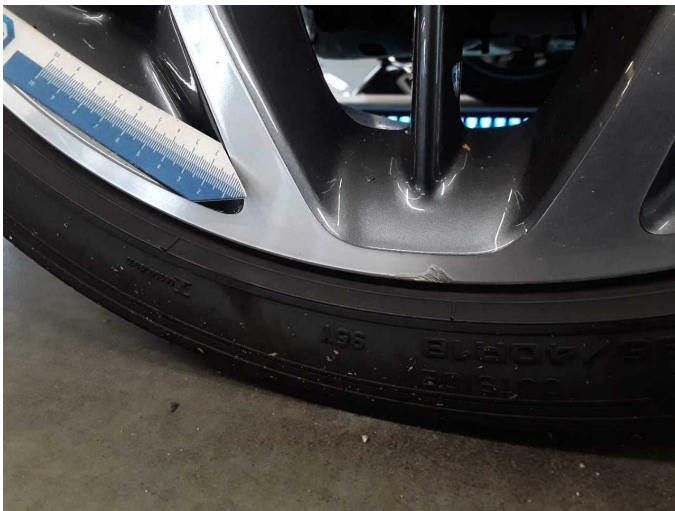
**Damage 6:** Wheel / tyres: Alloy rim - rear right side - Scratch(es) - Loss in value

| No. | Component group | Description |
|---|---|---|
| 6 | Wheel / tyres | Alloy rim - rear right side - Scratch(es) - Loss in value |

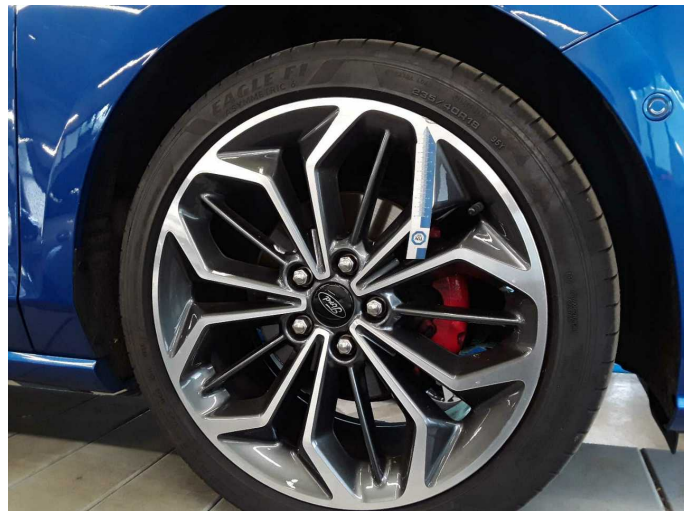
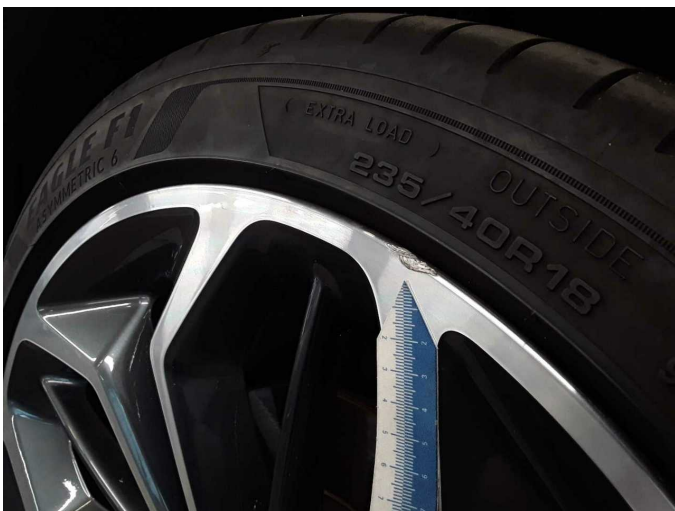
**Damage 7:** Wheel / tyres: Alloy rim - front right side - Scratch(es) - Loss in value

| No. | Component group | Description |
|---|---|---|
| 7 | Wheel / tyres | Alloy rim - front right side - Scratch(es) - Loss in value |

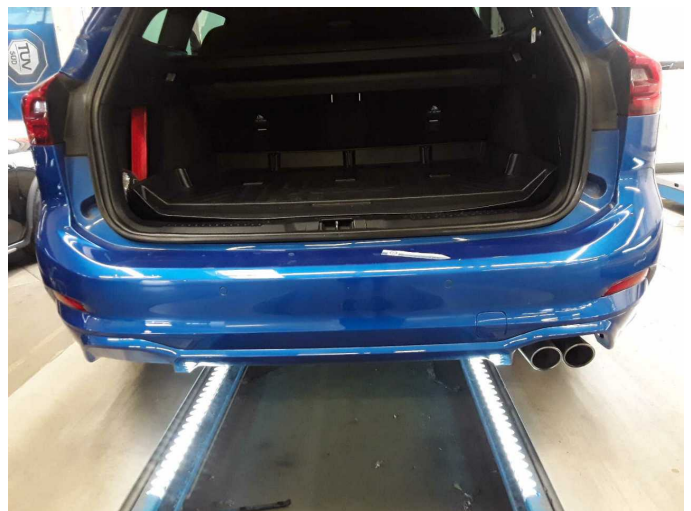
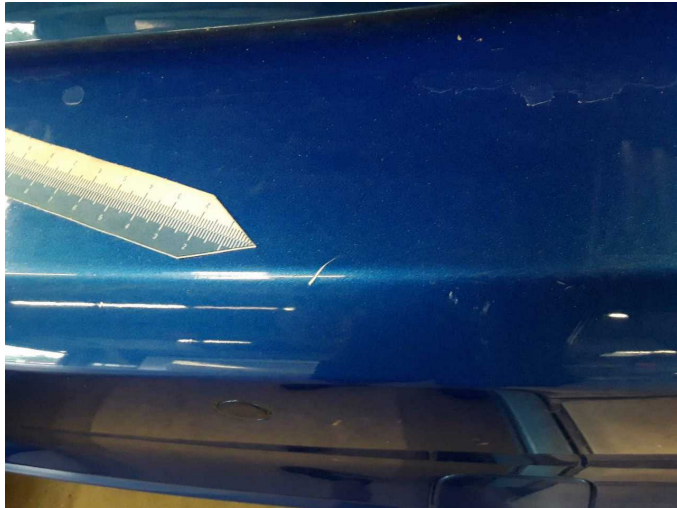
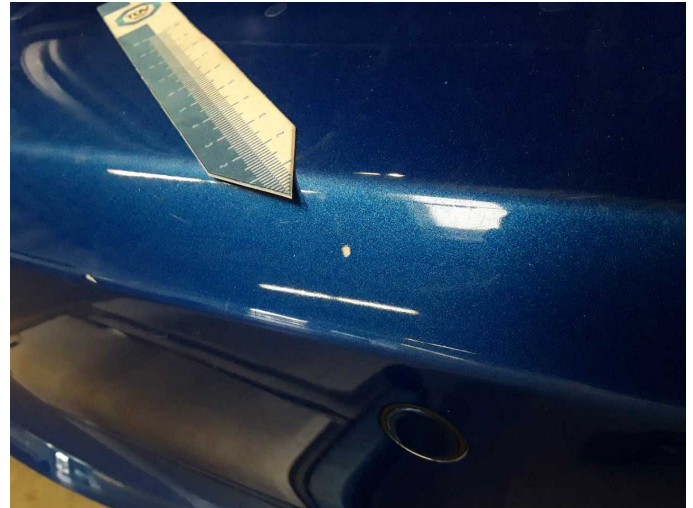
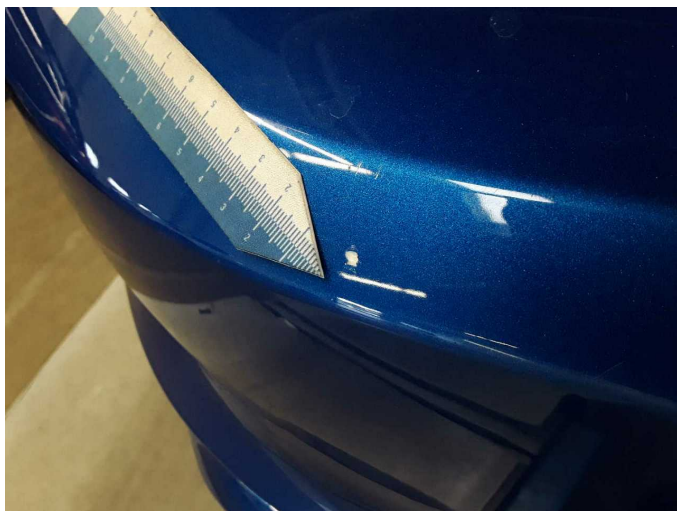
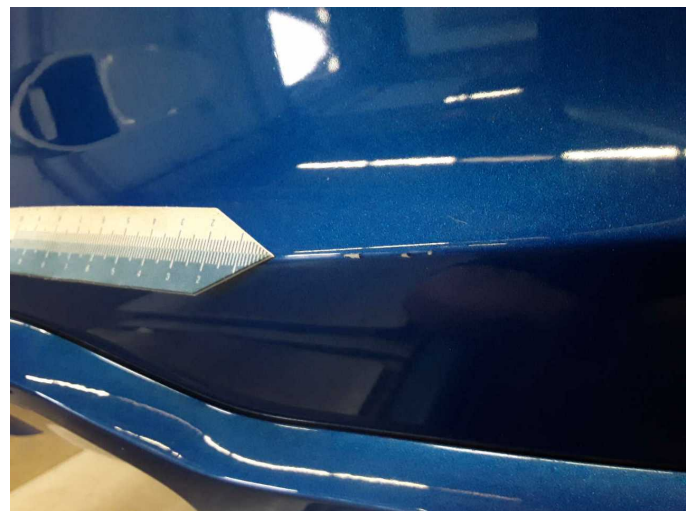
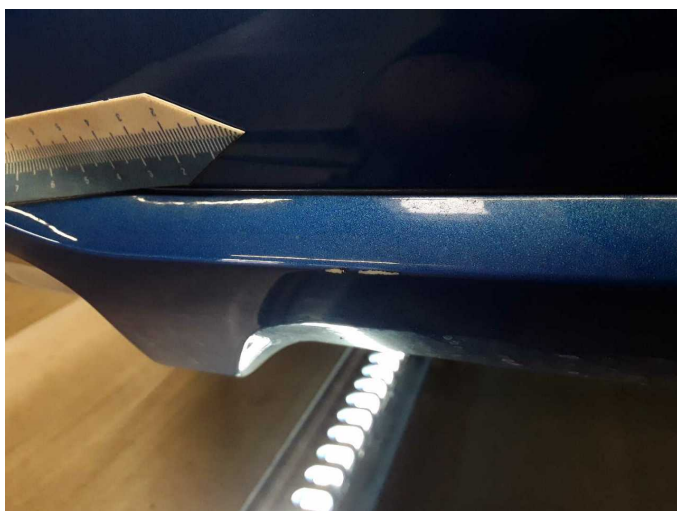
**Damage 8:** Rear bumper: Rear bumper - Scratch(es) - Paint

| No. | Component group | Description |
|---|---|---|
| 8 | Rear bumper | Rear bumper - Scratch(es) - Paint |

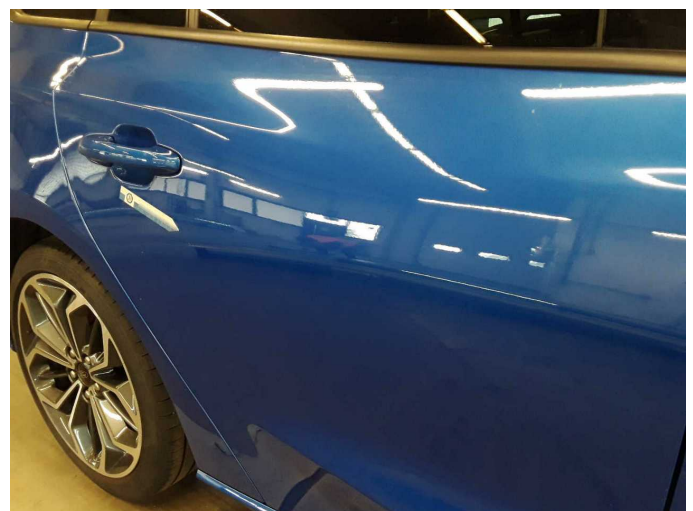
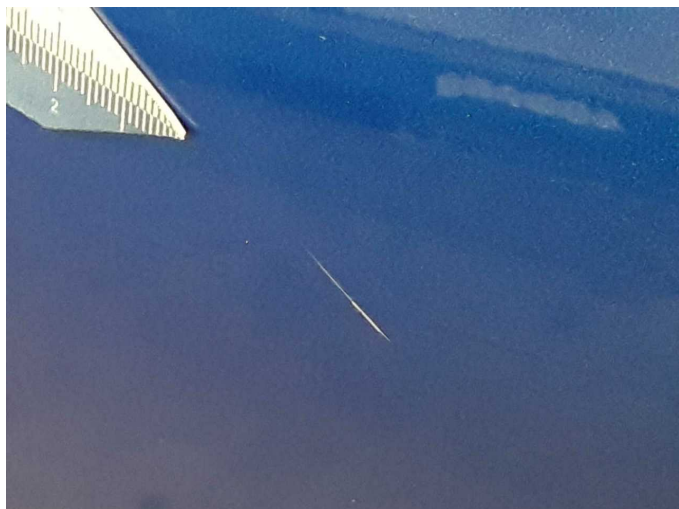
**Damage 9:** Door - rear right side: Door - Scratch(es) - Paint

| No. | Component group | Description |
|---|---|---|
| 9 | Door - rear right side | Door - Scratch(es) - Paint |

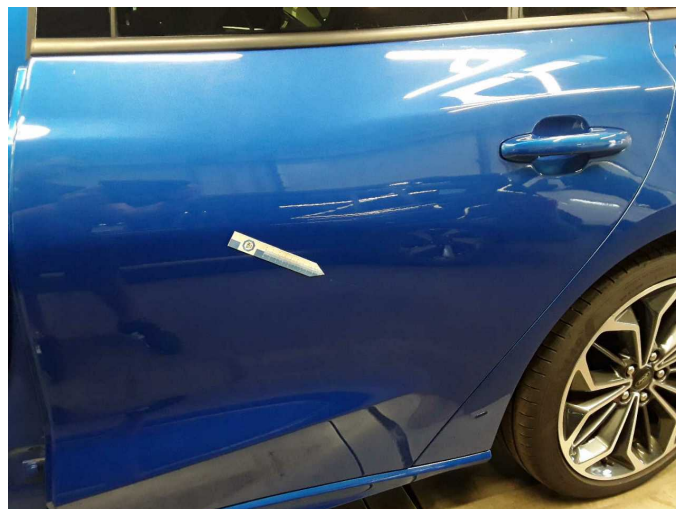
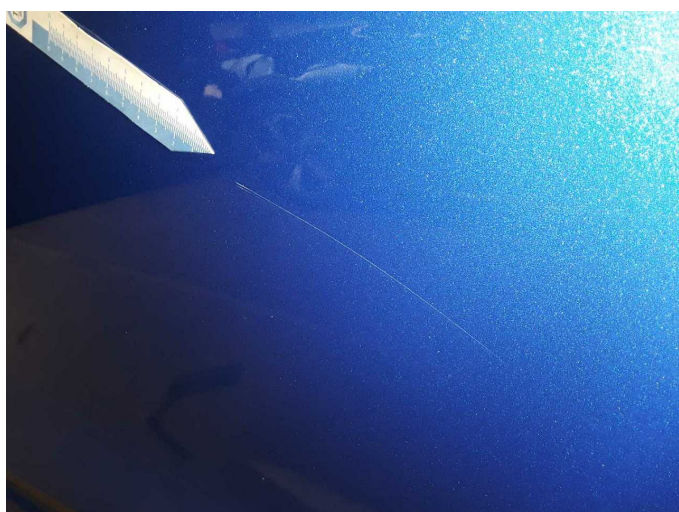
**Damage 10:** Door - rear left side: Door - Scratch(es) - Paint

| No. | Component group | Description |
|---|---|---|
| 10 | Door - rear left side | Door - Scratch(es) - Paint |

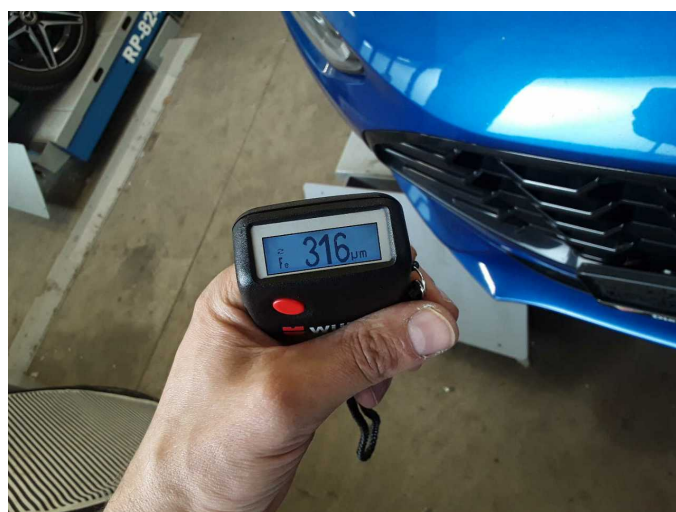
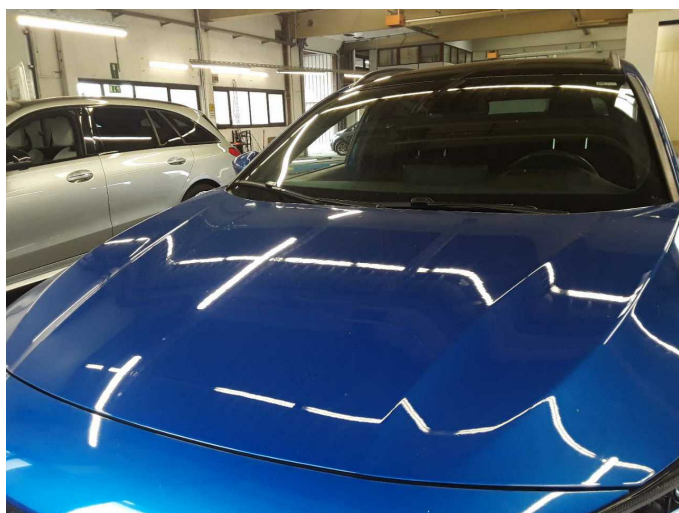
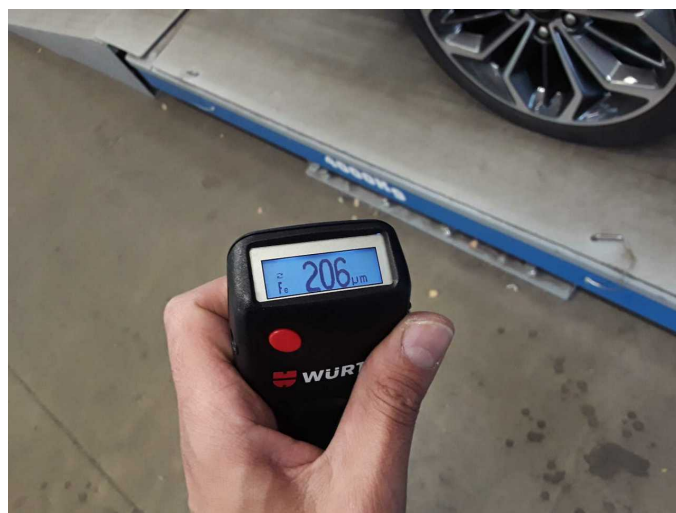
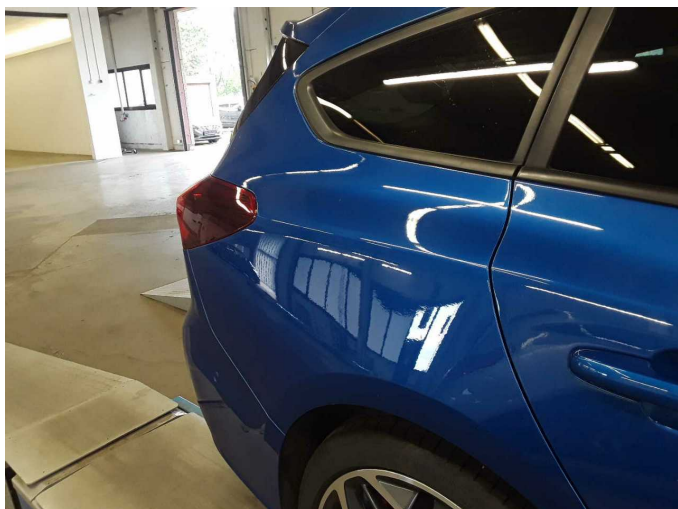
| No. | Repainting |
|---|---|
| 1 | Bonnet, Side panel - rear right side, Professionally carried out, Invoice of repair done Non-existent |

**Repainting 1:** Bonnet, Side panel - rear right side
