Expertise

Protocol number: 46577015  
Order No. / Reference: 26751160  
Inspection date: 15 Jul 2026

Manufacturer: Opel

Model: Grandland 1.5 D Automatik Elegance

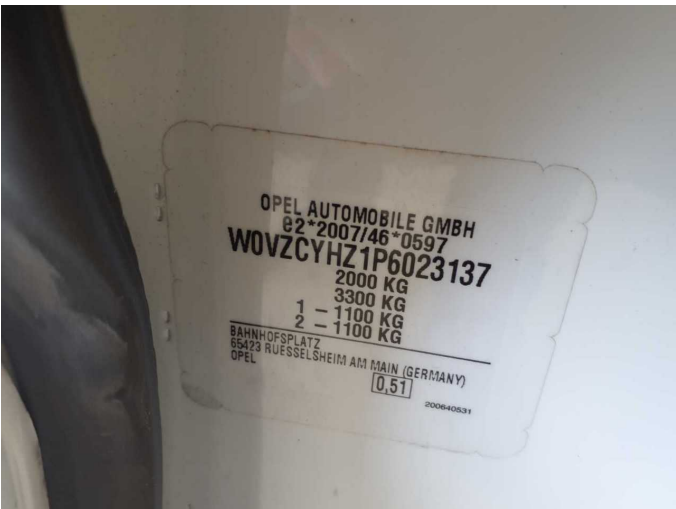
| VIN comparison | The vehicle identification number (VIN) was read from the vehicle and its conformity with the submitted documents was confirmed by the undersigned during the inspection. |

Figure 11: VIN

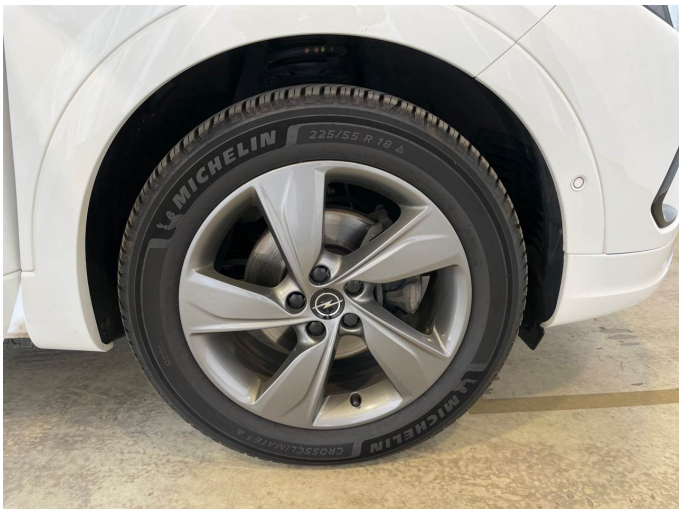
| Tyres | | | | |
|---|---|---|---|---|
| 1) | 225/55 R18 98V | All-season tyres on Light alloy | Michelin | 6mm / 6mm |
| 2) | 225/55 R18 98V | All-season tyres on Light alloy | Michelin | 6mm / 6mm |

Figure 12: Mounted tyres

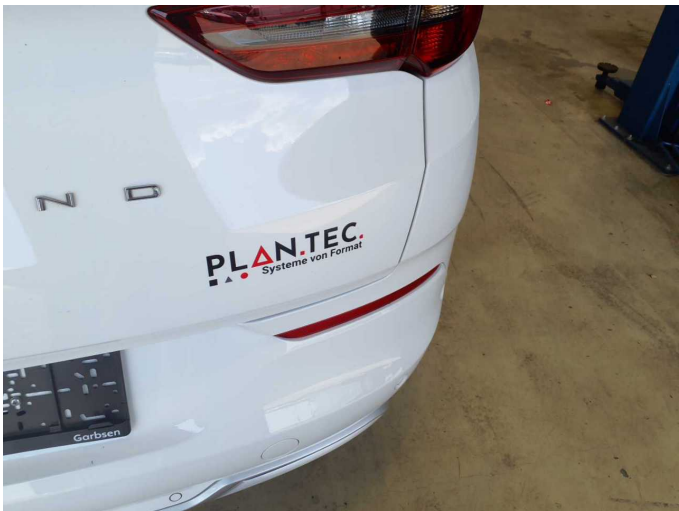
Damage 1: Boot lid / rear door: Boot lid - Glued / labelled - De-glue / neutralise

| No. | Component group | Description |
|---|---|---|
| 1 | Boot lid / rear door | Boot lid - Glued / labelled - De-glue / neutralise |

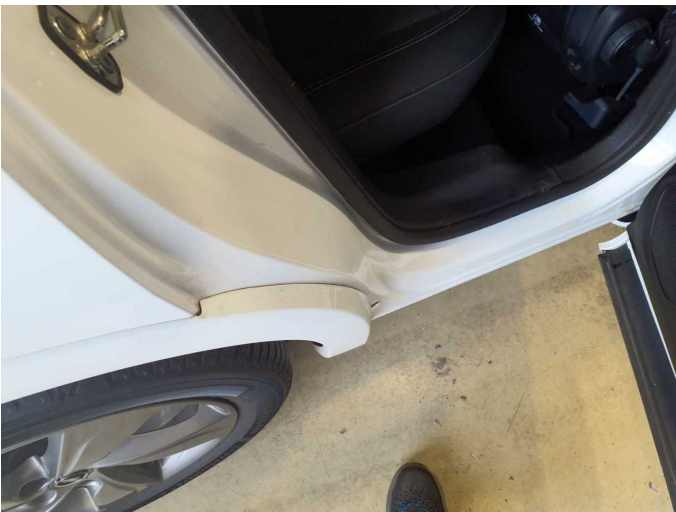
Damage 2: Side panel - rear right side: Sill - dent(s) - Smooth repair work

| No. | Component group | Description |
|---|---|---|
| 2 | Side panel - rear right side | Sill - dent(s) - Smooth repair work |

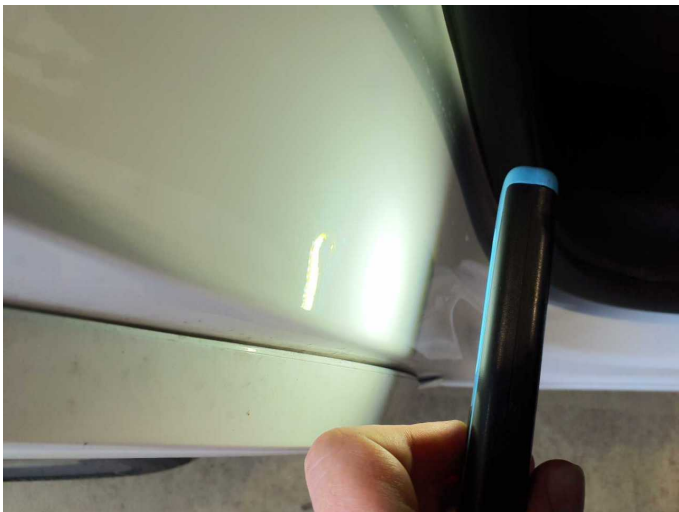
Damage 2: Side panel - rear right side: Sill - dent(s) - Smooth repair work

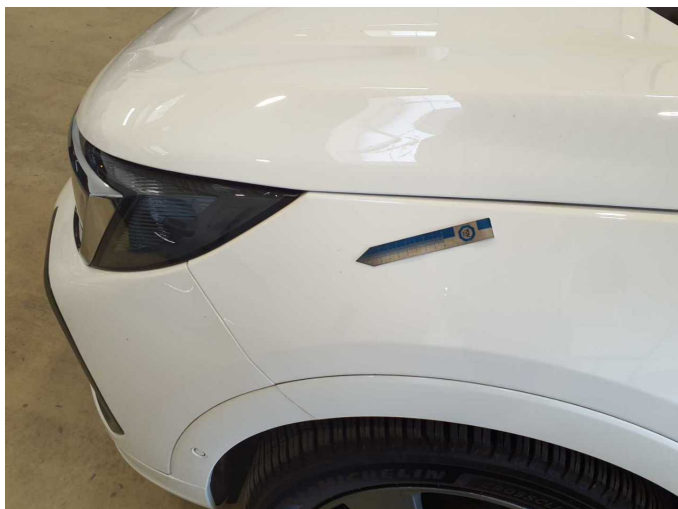
**Damage 3:** Mudguard - left side: Mudguard - left side - Stone chips - Loss in value

| No. | Component group | Description |
|---|---|---|
| 3 | Mudguard - left side | Mudguard - left side - Stone chips - Loss in value |

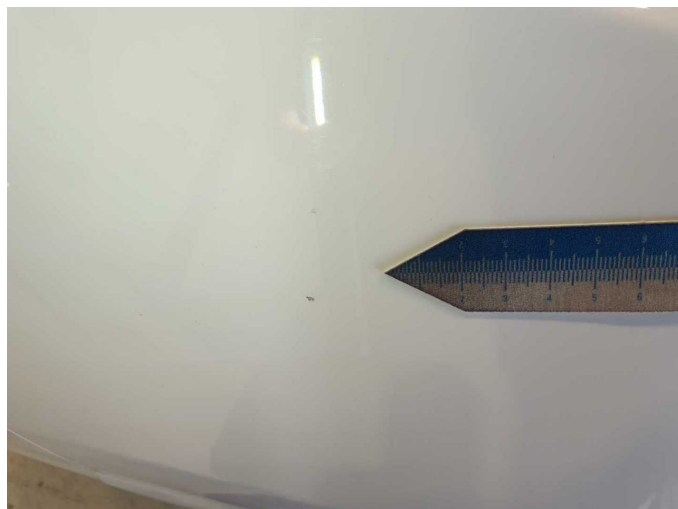
**Damage 3:** Mudguard - left side: Mudguard - left side - Stone chips - Loss in value

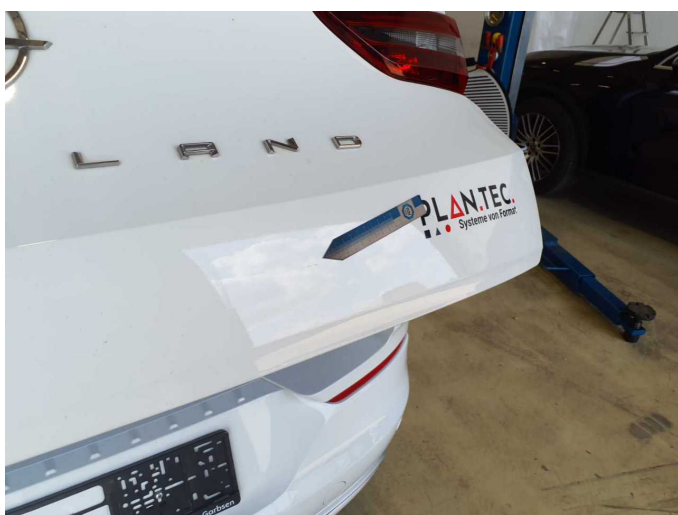
**Damage 4:** Boot lid / rear door: Boot lid - Scratch(es) - Smart repair

| No. | Component group | Description |
|---|---|---|
| 4 | Boot lid / rear door | Boot lid - Scratch(es) - Smart repair |

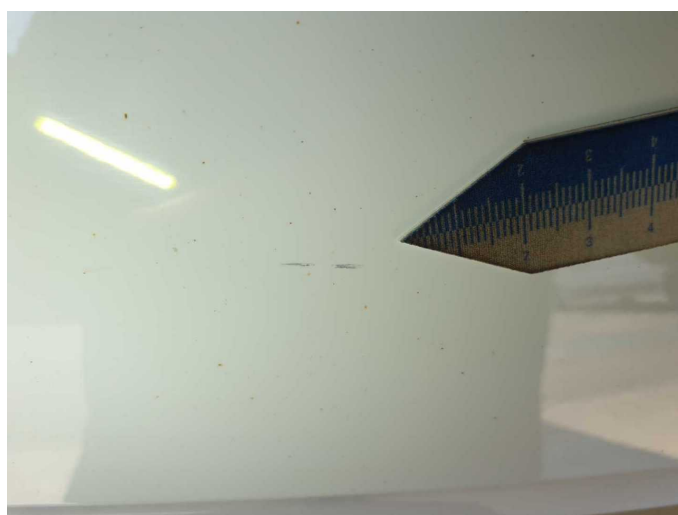
**Damage 4:** Boot lid / rear door: Boot lid - Scratch(es) - Smart repair

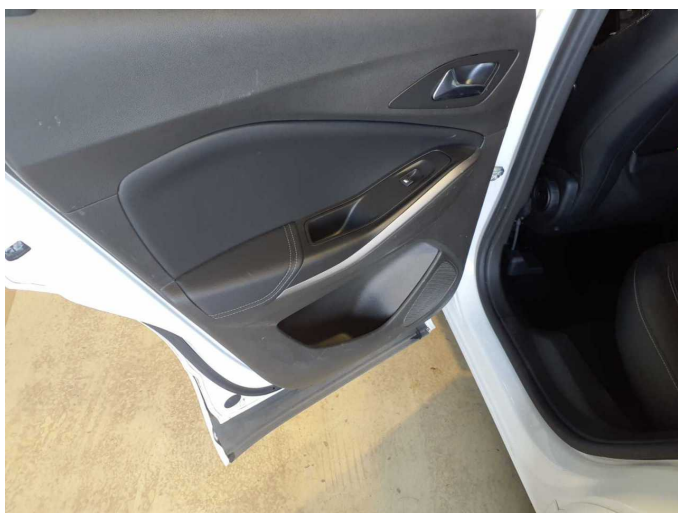
**Damage 6:** Trim / covers: Door trim - rear left side - Scratch(es) - Loss in value

| No. | Component group | Description |
|---|---|---|
| 6 | Trim / covers | Door trim - rear left side - Scratch(es) - Loss in value |

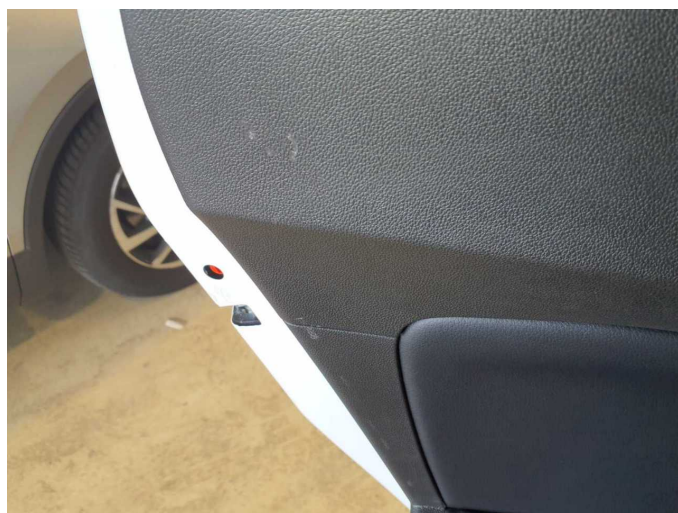
**Damage 6:** Trim / covers: Door trim - rear left side - Scratch(es) - Loss in value

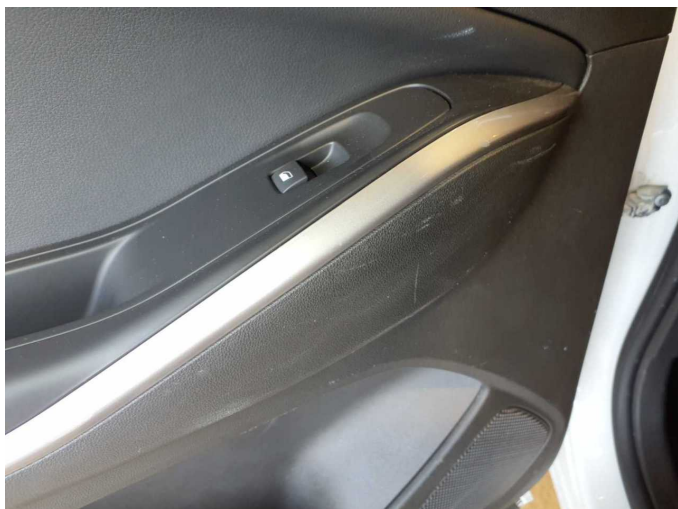
**Damage 6:** Trim / covers: Door trim - rear left side - Scratch(es) - Loss in value

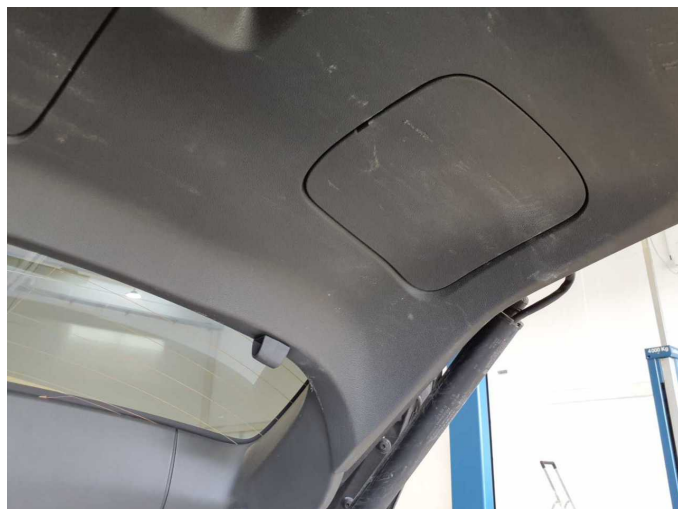
**Damage 7:** Trim / covers: Boot lid - interior trim - Scratch(es) - Loss in value

| No. | Component group | Description |
|---|---|---|
| 7 | Trim / covers | Boot lid - interior trim - Scratch(es) - Loss in value |

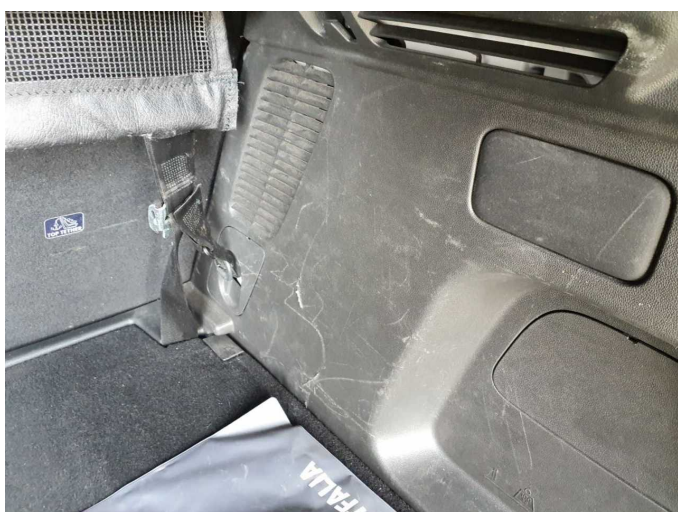
**Damage 8:** Trim / covers: Boot lining - Scratch(es) - Loss in value

| No. | Component group | Description |
|---|---|---|
| 8 | Trim / covers | Boot lining - Scratch(es) - Loss in value |

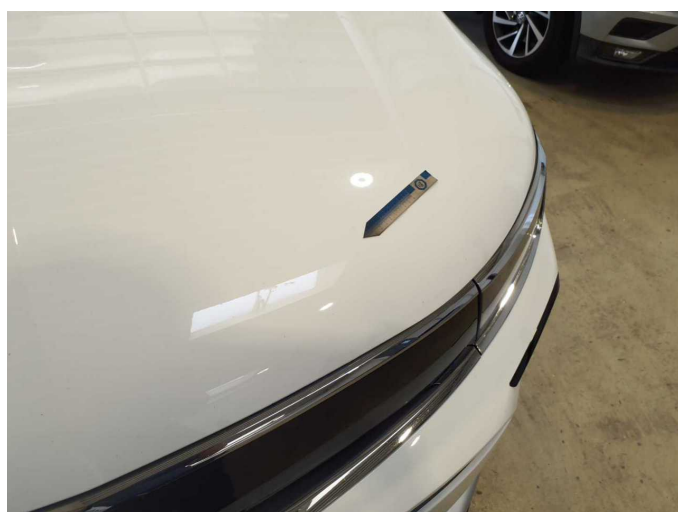
**Damage 9:** Bonnet: Bonnet - Dent / paintcoat damage - Loss in value

| No. | Component group | Description |
|---|---|---|
| 9 | Bonnet | Bonnet - Dent / paintcoat damage - Loss in value |

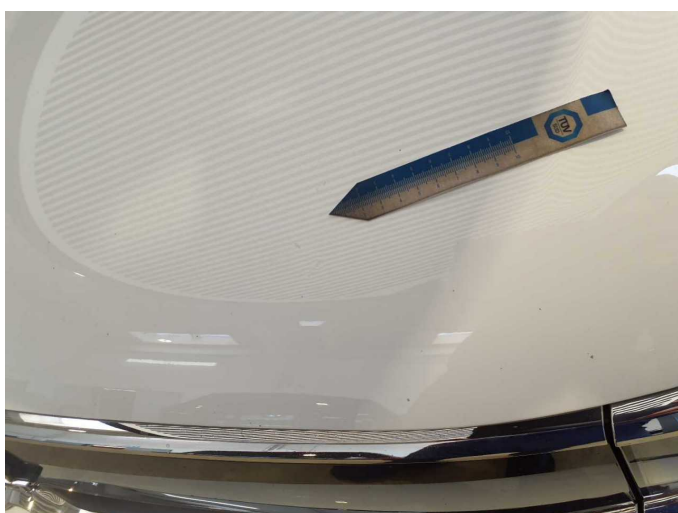
**Damage 9:** Bonnet: Bonnet - Dent / paintcoat damage - Loss in value

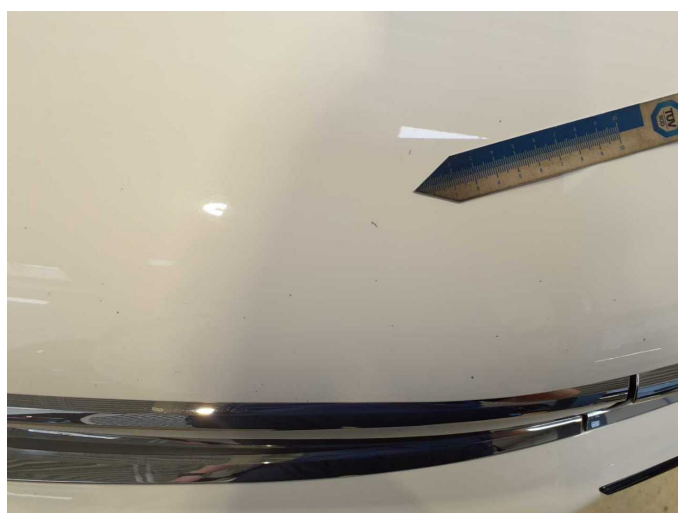
**Damage 9:** Bonnet: Bonnet - Dent / paintcoat damage - Loss in value

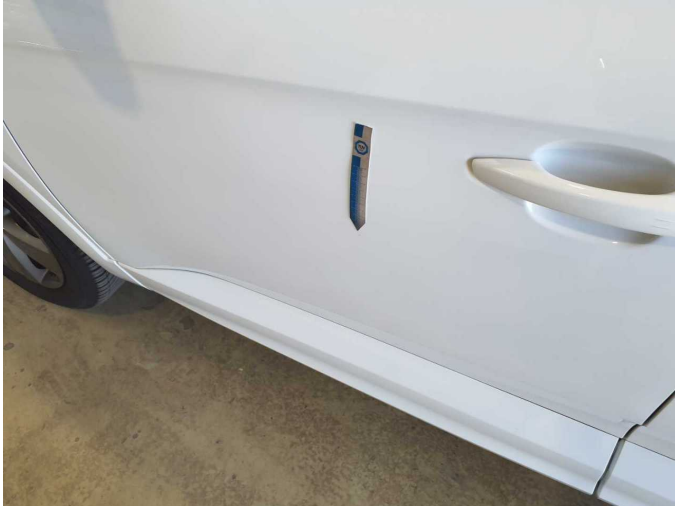
**Damage 10:** Door - front left side: Door - Scratch(es) - Loss in value

| No. | Component group | Description |
|---|---|---|
| 10 | Door - front left side | Door - Scratch(es) - Loss in value |

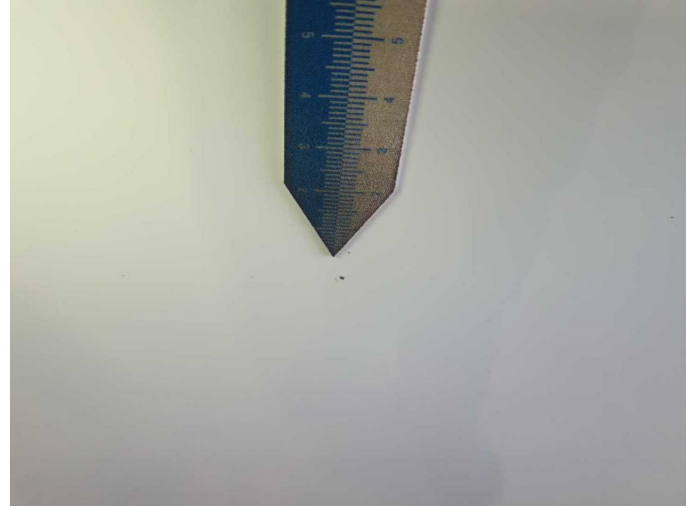
**Damage 10:** Door - front left side: Door - Scratch(es) - Loss in value

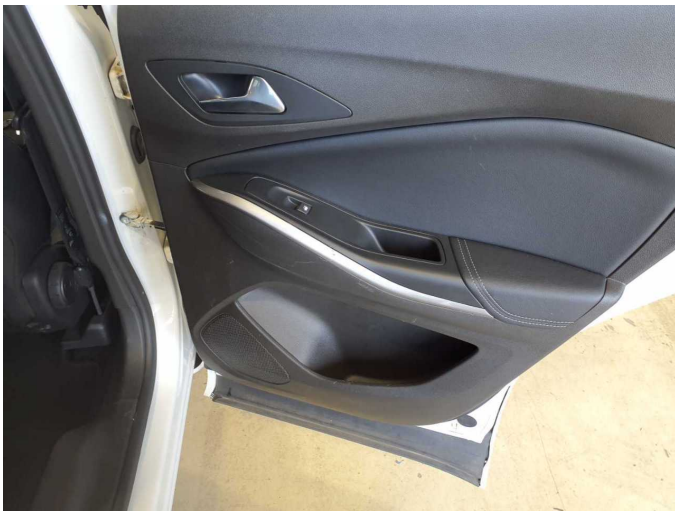
**Damage 11:** Trim / covers: Door trim - rear right side - Scratch(es) - Loss in value

| No. | Component group | Description |
|---|---|---|
| 11 | Trim / covers | Door trim - rear right side - Scratch(es) - Loss in value |

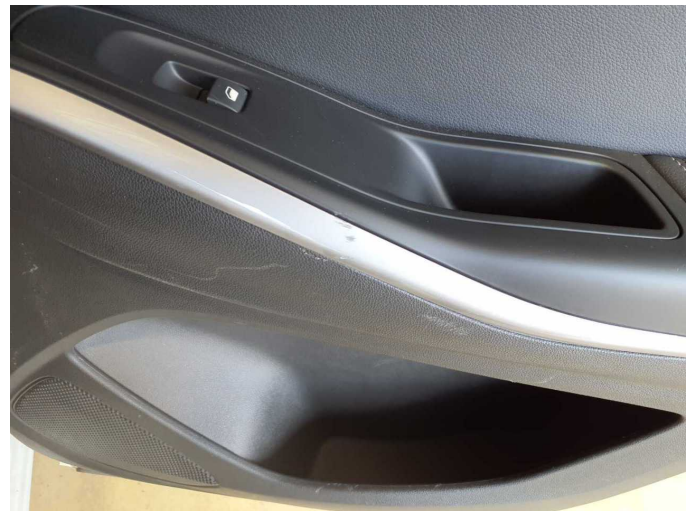
**Damage 11:** Trim / covers: Door trim - rear right side - Scratch(es) - Loss in value
