Expertise

Protocol number: 46409357  
Order No. / Reference: 26644585  
Inspection date: 2 Jul 2026

Manufacturer: Volkswagen

Model: ID.4 GTX 220 KW

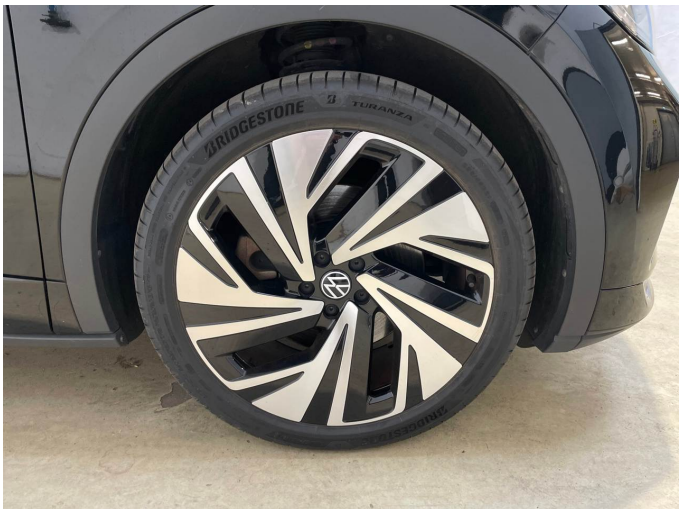
Figure 12: Mounted tyres

| # | Tyre size | Type of tyre | Manufacturer | Tread depth |
|---|---|---|---|---|
| 1) | 235/45 R21 101T | Summer tires (with run-flat tires) on Light alloy | Bridgestone | 6mm / 6mm |
| 2) | 255/40 R21 102T | Summer tires (with run-flat tires) on Light alloy | Bridgestone | 3mm / 3mm |

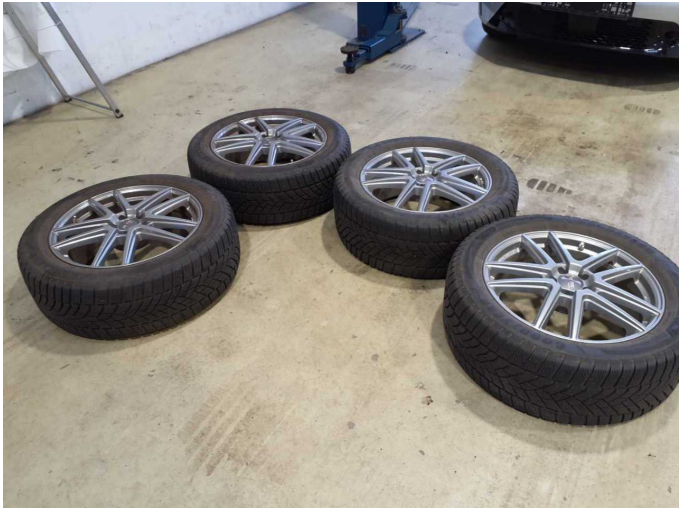
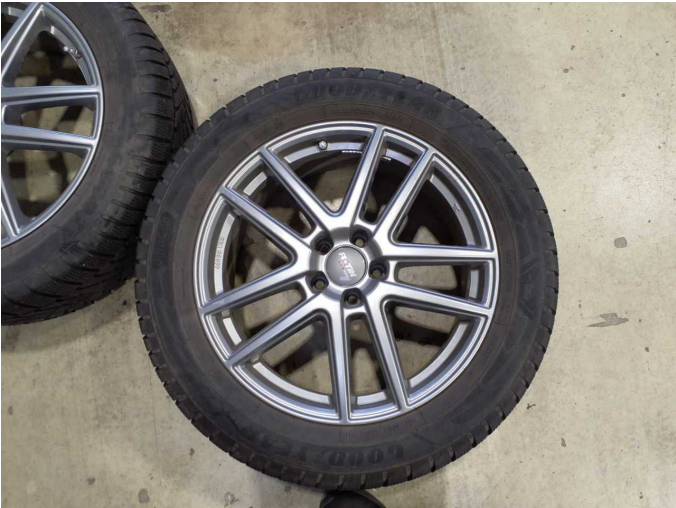
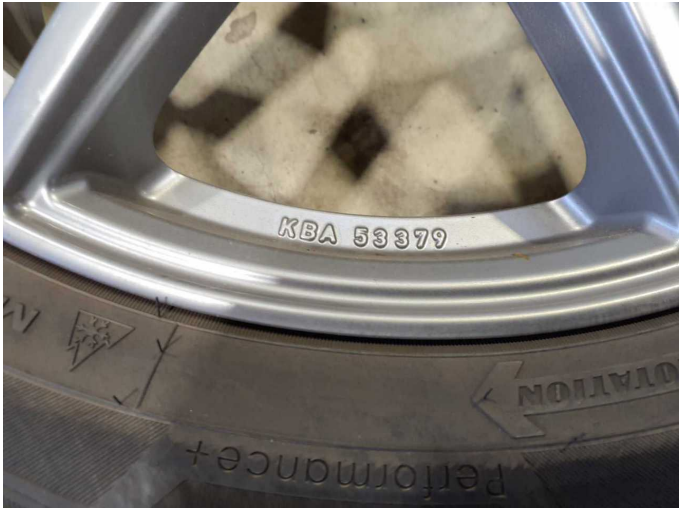
| # | Tyre size | Type of tyre | Manufacturer | Tread depth |
|---|---|---|---|---|
| 1) | 235/55 R19 105T | Winter tires (with run-flat tires) on Light alloy | Goodyear | 7mm / 7mm |
| 2) | 255/50 R19 107T | Winter tires (with run-flat tires) on Light alloy | Goodyear | 7mm / 7mm |

Figure 14: Additional tyres

Figure 15: Additional tyres

Figure 16: Additional tyres

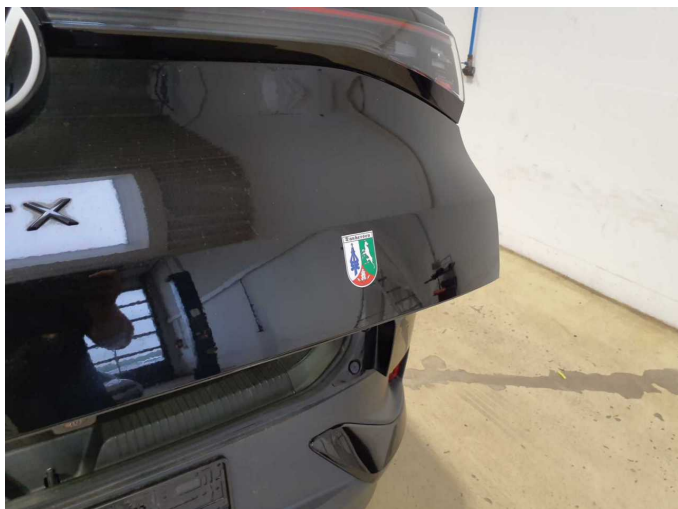
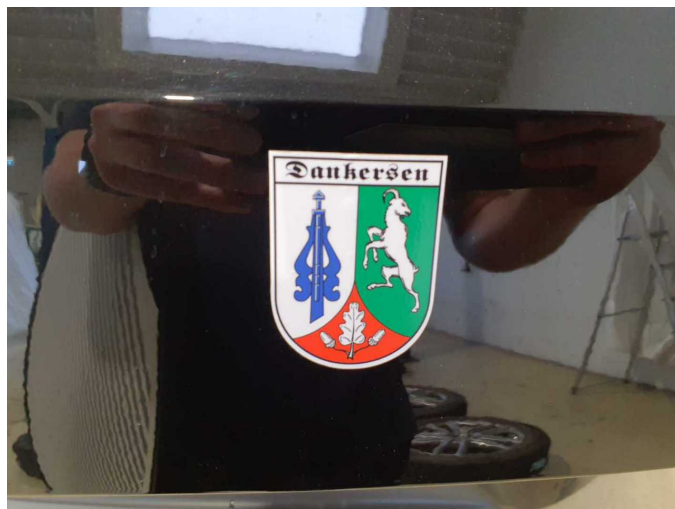
| No. | Component group | Description |
|---|---|---|
| 2 | Boot lid / rear door | Boot lid - Glued / labelled - De-glue / neutralise |

**Damage 2:** Boot lid / rear door: Boot lid - Glued / labelled - De-glue / neutralise

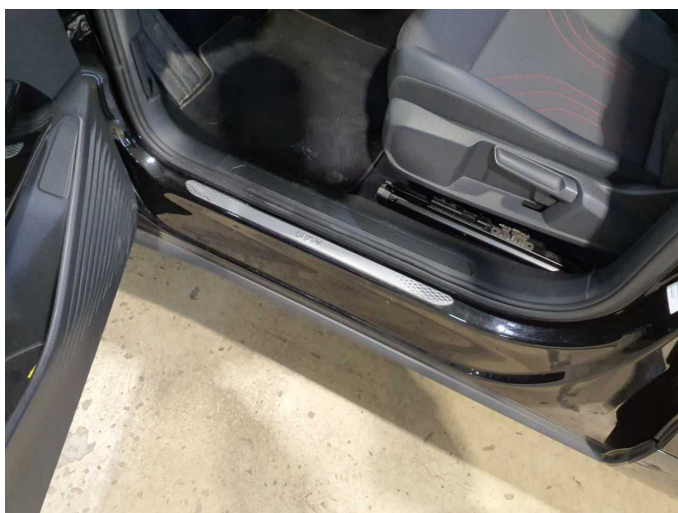
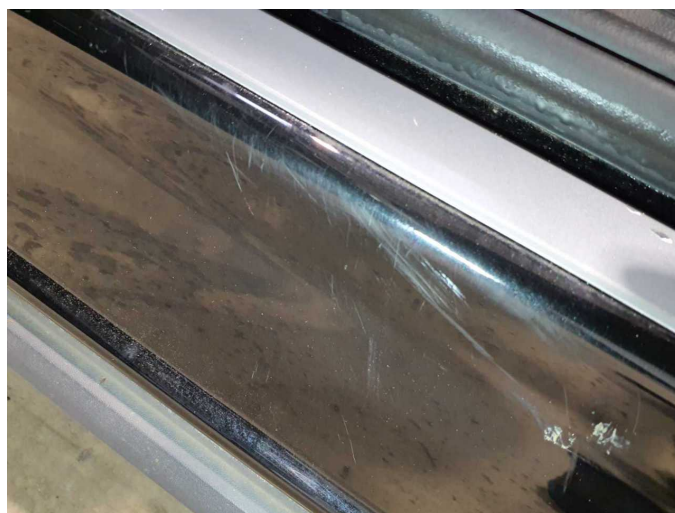
| No. | Component group | Description |
|---|---|---|
| 3 | Sill - left side | Sill - Scratch(es) - Smart repair |

**Damage 3:** Sill - left side: Sill - Scratch(es) - Smart repair

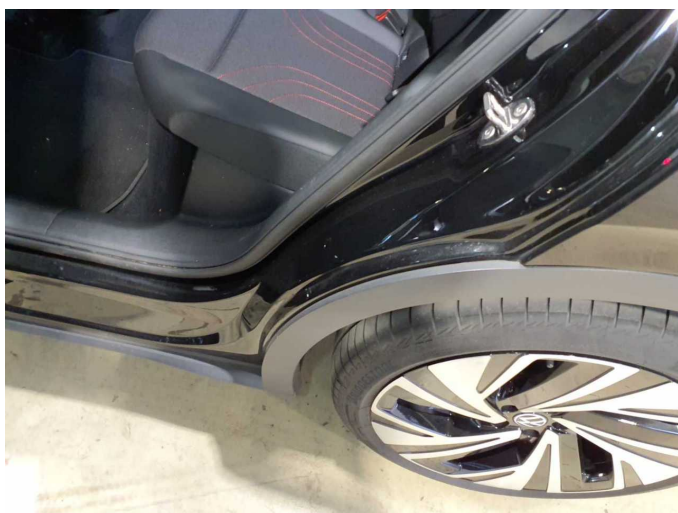
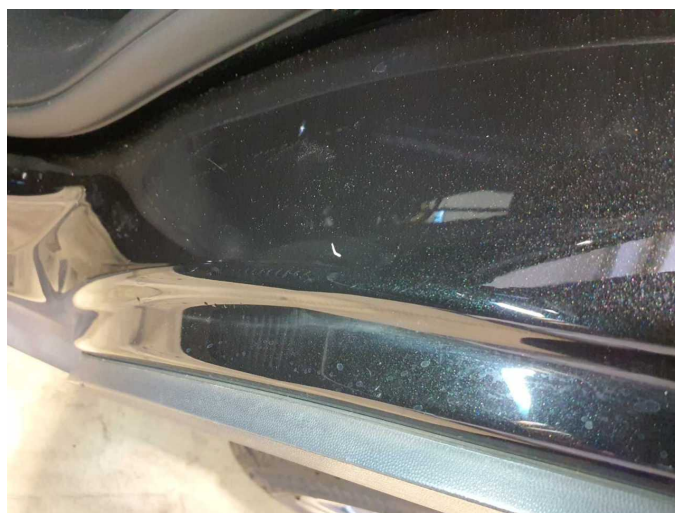
| No. | Component group | Description |
|---|---|---|
| 4 | Side panel - rear left side | Sill - Scratch(es) - Smart repair |

**Damage 4:** Side panel - rear left side: Sill - Scratch(es) - Smart repair

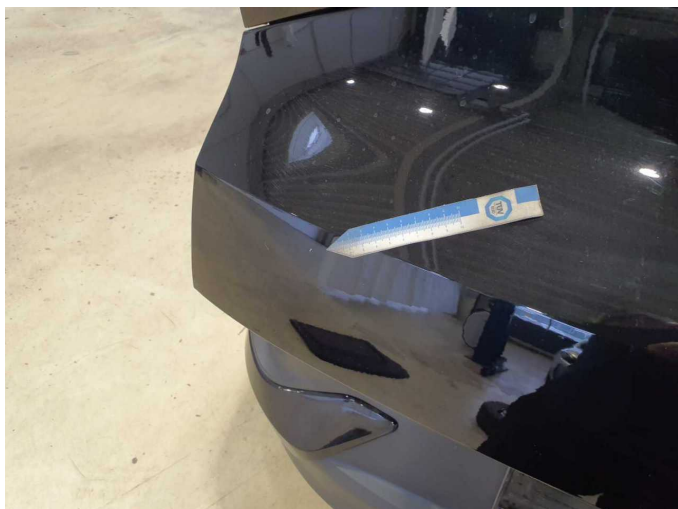
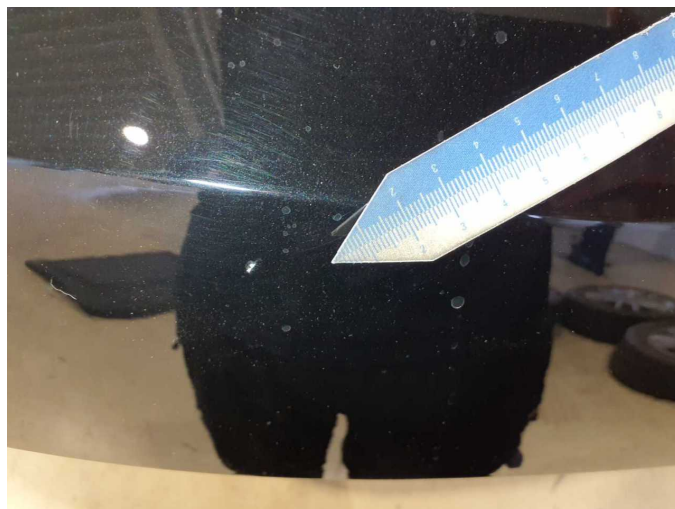
| No. | Component group | Description |
|---|---|---|
| 5 | Boot lid / rear door | Boot lid - Scratch(es) - Smart repair |

**Damage 5:** Boot lid / rear door: Boot lid - Scratch(es) - Smart repair

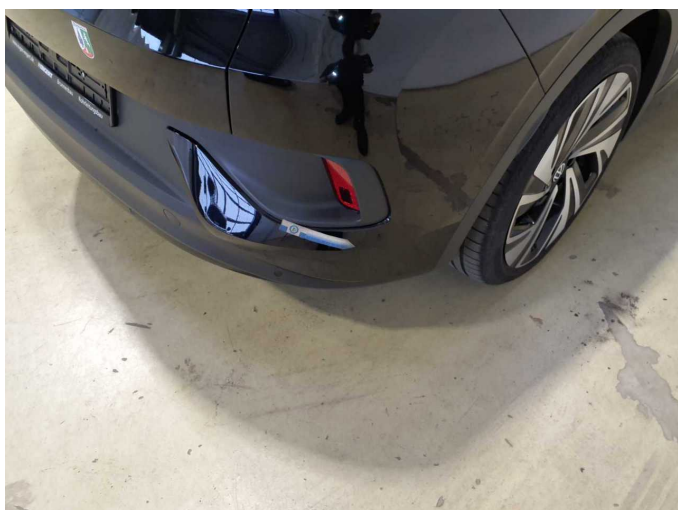
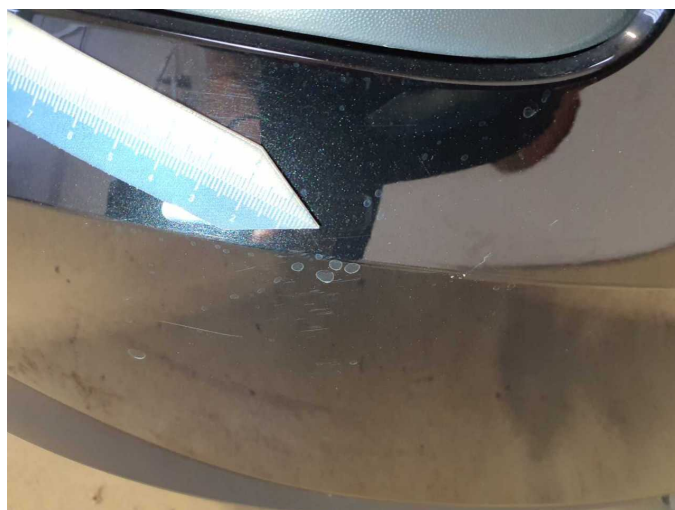
| No. | Component group | Description |
|---|---|---|
| 6 | Rear bumper | Bumper - rear right side - Scratch(es) - Smart repair |

**Damage 6:** Rear bumper: Bumper - rear right side - Scratch(es) - Smart repair

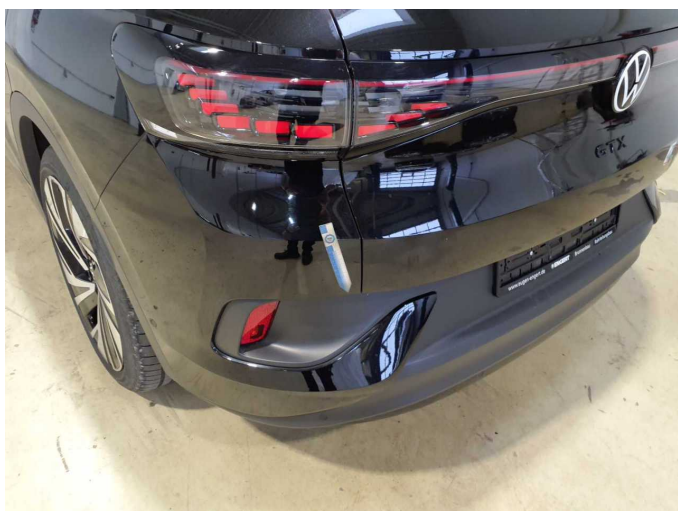
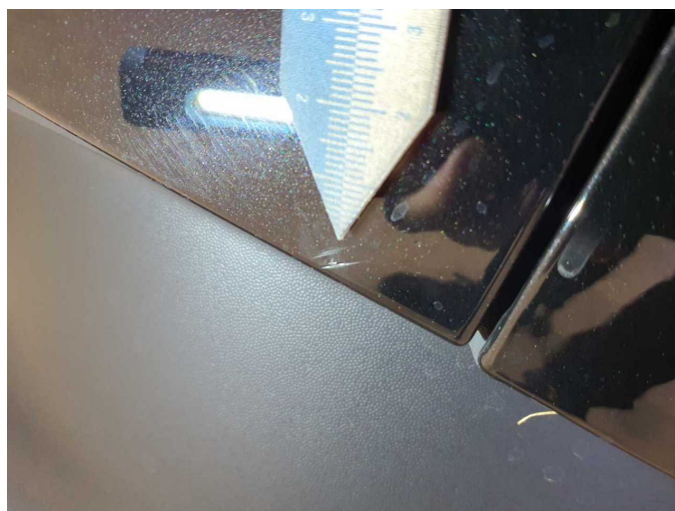
| No. | Component group | Description |
|---|---|---|
| 7 | Rear bumper | Bumper - rear left side - Scratch(es) - Smart repair |

**Damage 7:** Rear bumper: Bumper - rear left side - Scratch(es) - Smart repair

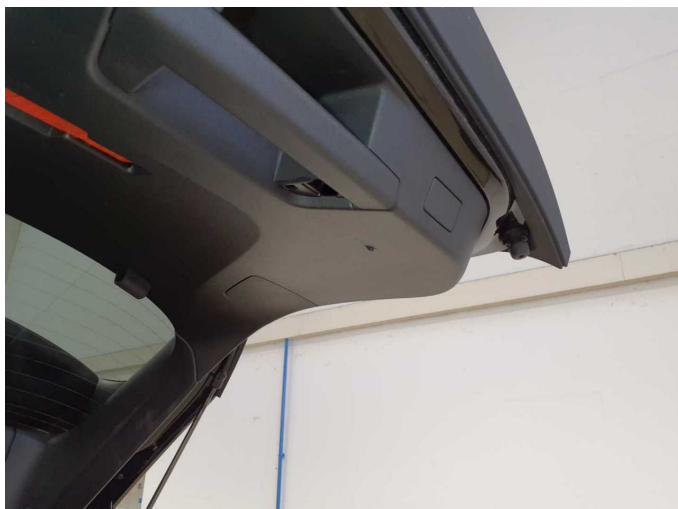
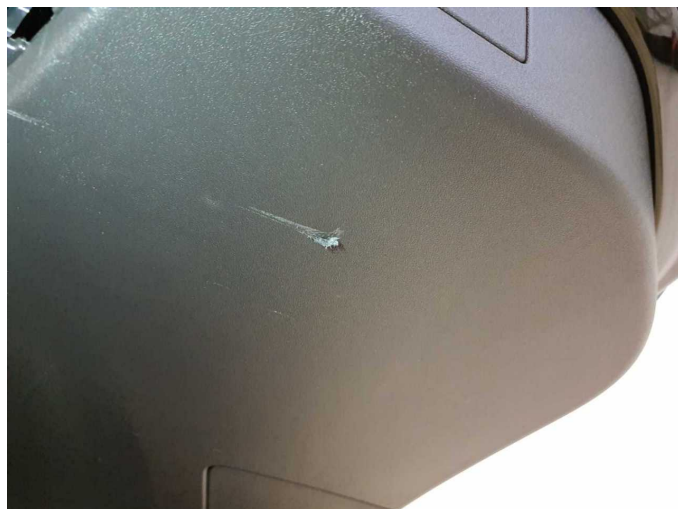
| No. | Component group | Description |
|---|---|---|
| 8 | Trim / covers | Boot lid - interior trim - Scratch(es) - Replace |

**Damage 8:** Trim / covers: Boot lid - interior trim - Scratch(es) - Replace

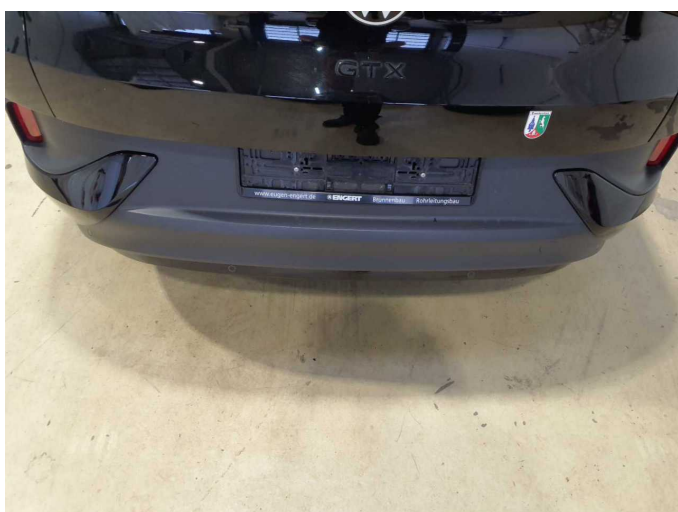
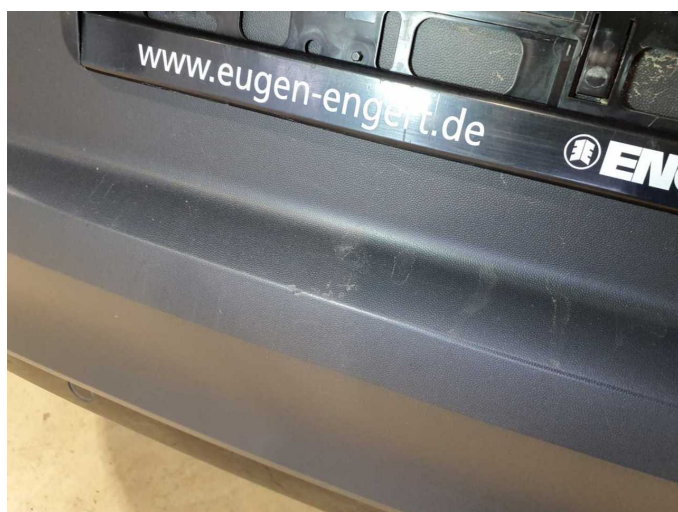
| No. | Component group | Description |
|---|---|---|
| 9 | Rear bumper | Rear bumper - Scratch(es) - Loss in value |

**Damage 9:** Rear bumper: Rear bumper - Scratch(es) - Loss in value

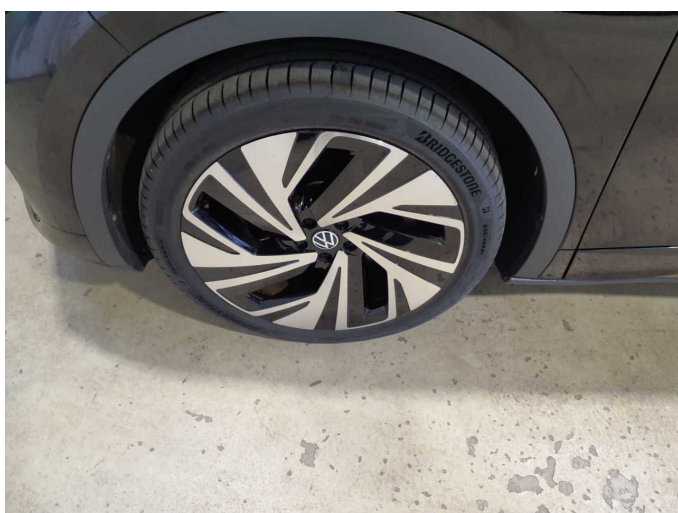
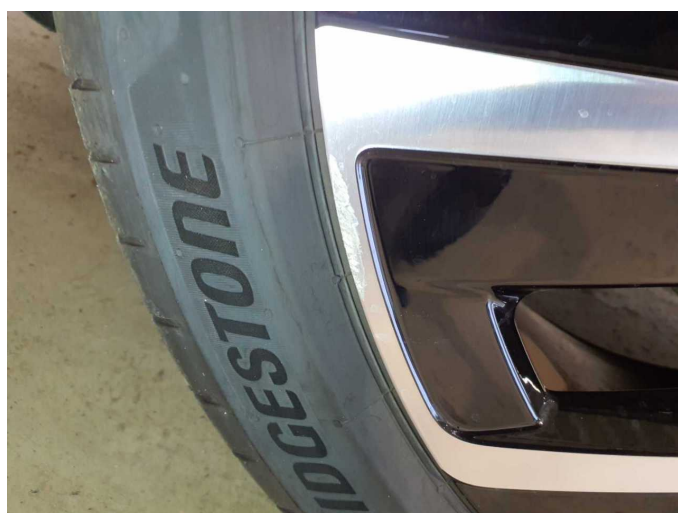
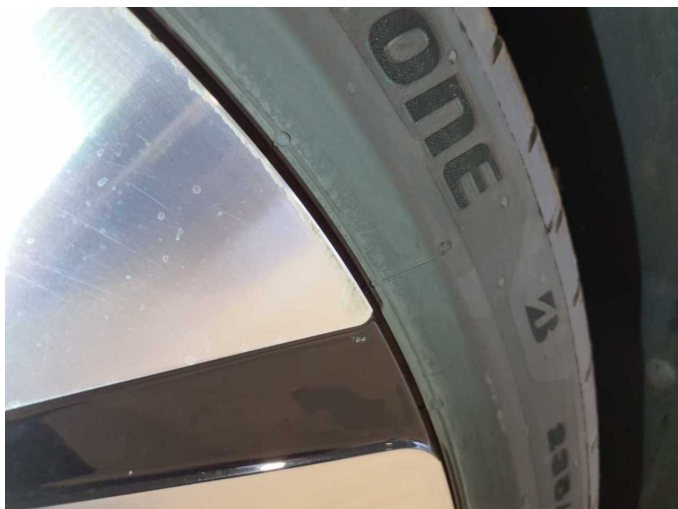
| No. | Component group | Description |
|---|---|---|
| 10 | Wheel / tyres | Alloy rim - front left side - Scratch(es) - Loss in value |

**Damage 10:** Wheel / tyres: Alloy rim - front left side - Scratch(es) - Loss in value

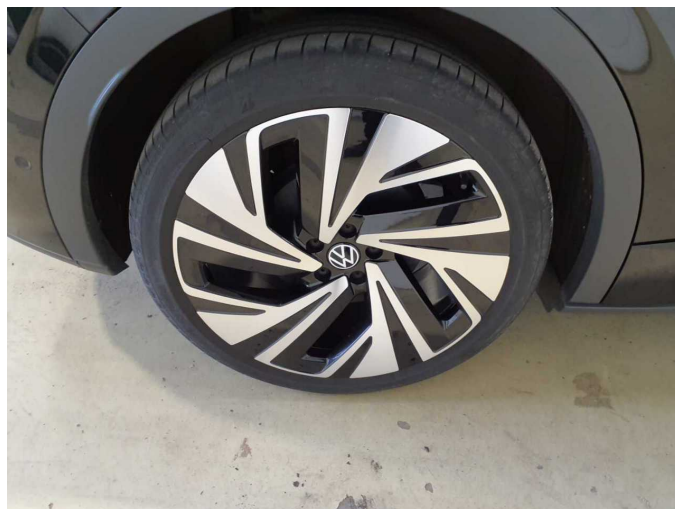
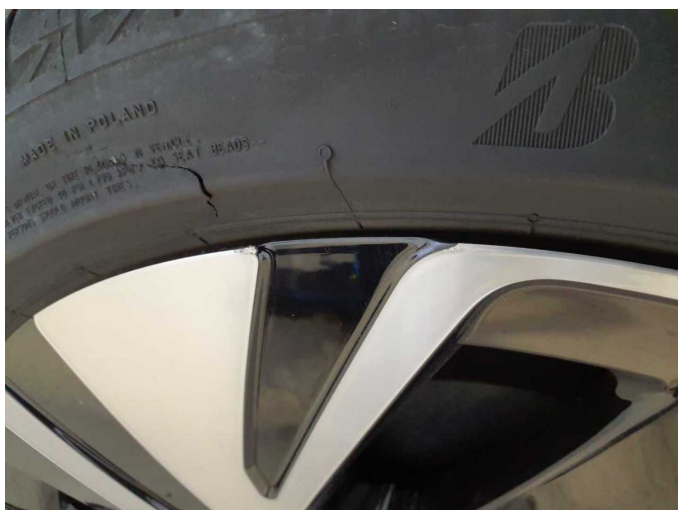
| No. | Component group | Description |
|---|---|---|
| 11 | Wheel / tyres | Alloy rim - rear right side - Scratch(es) - Loss in value |

**Damage 11:** Wheel / tyres: Alloy rim - rear right side - Scratch(es) - Loss in value

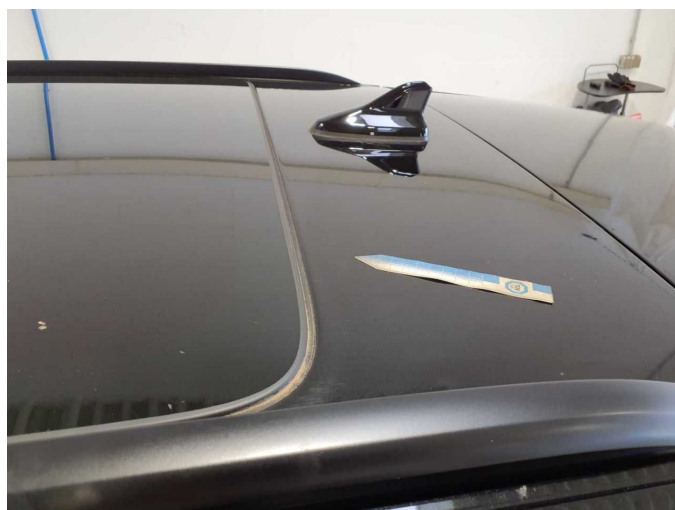
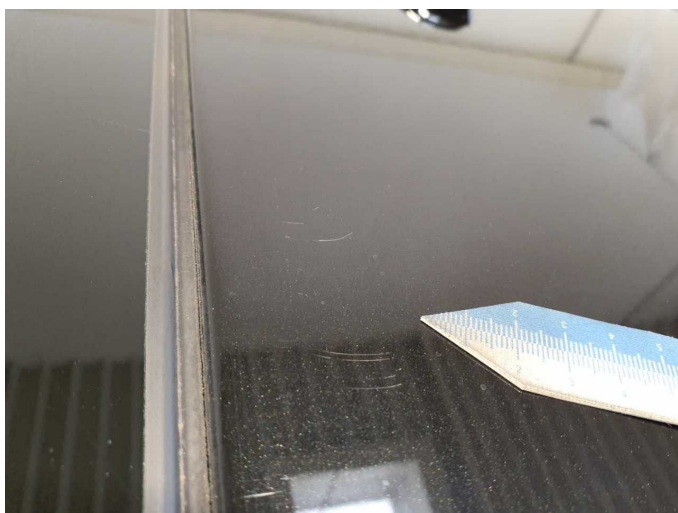
| No. | Component group | Description |
|---|---|---|
| 12 | Roof | Roof - Scratch(es) - Loss in value |

**Damage 12:** Roof: Roof - Scratch(es) - Loss in value

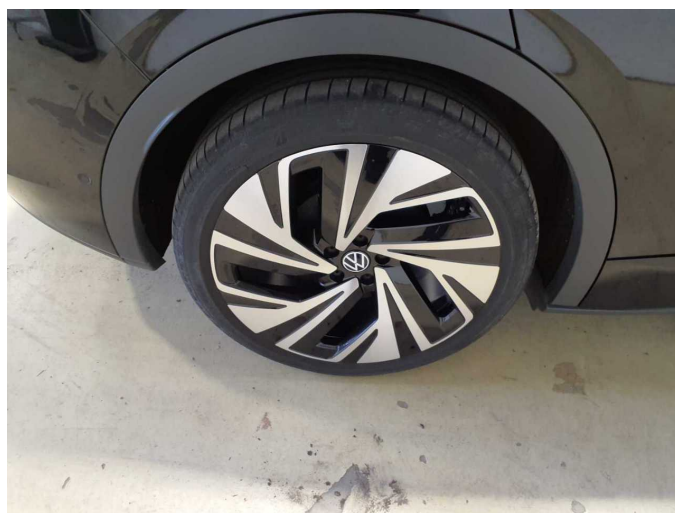
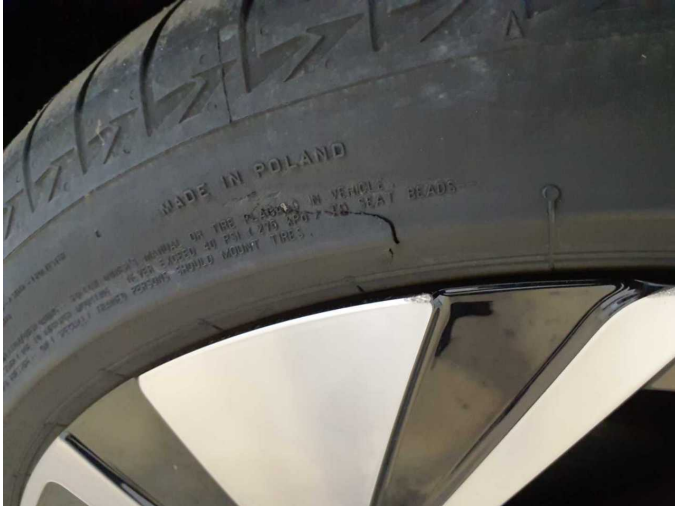
| No. | Component group | Description |
|---|---|---|
| 13 | Wheel / tyres | Tyre - rear right side - Broken / torn - Replace |

**Damage 13:** Wheel / tyres: Tyre - rear right side - Broken / torn - Replace

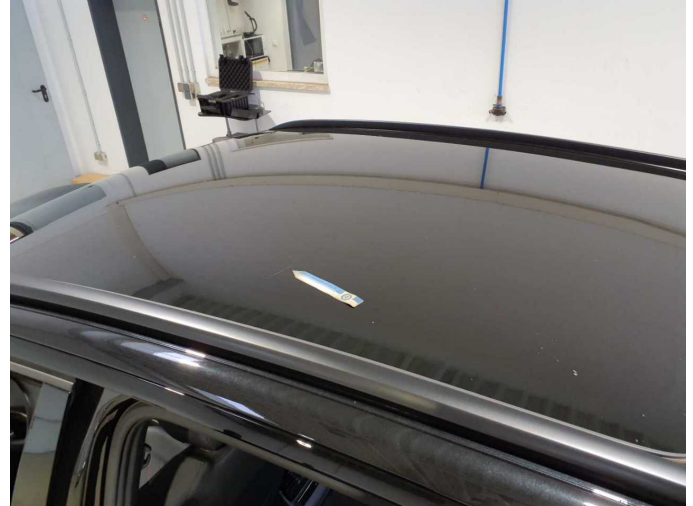
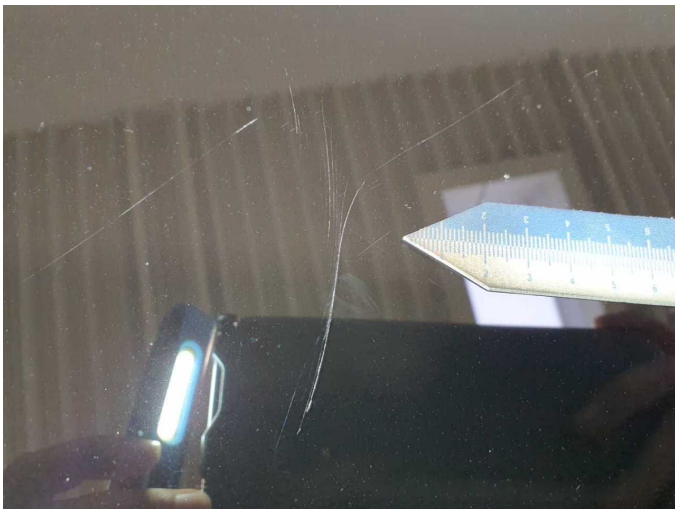
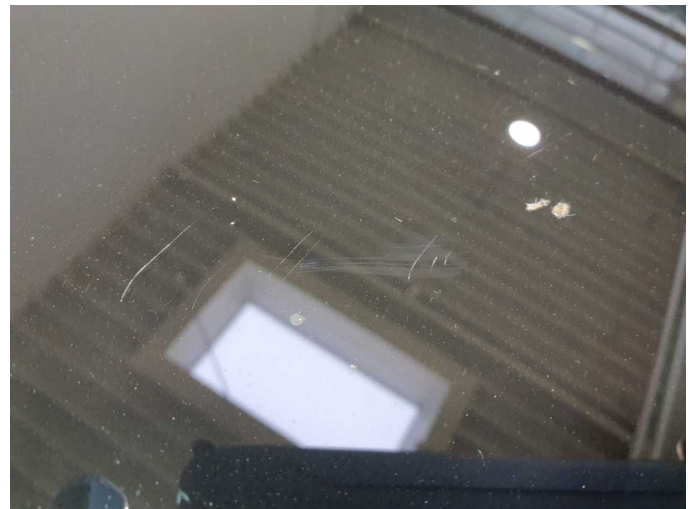
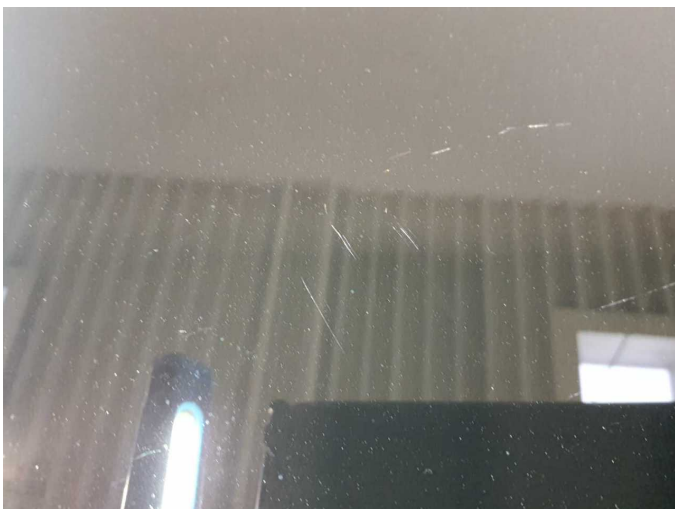
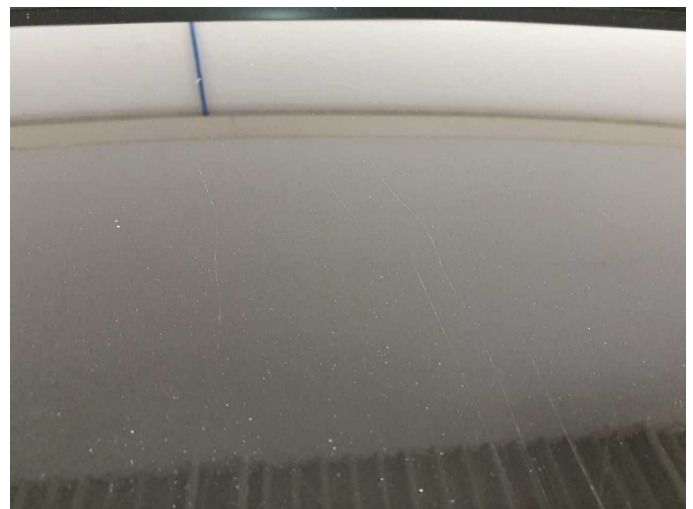
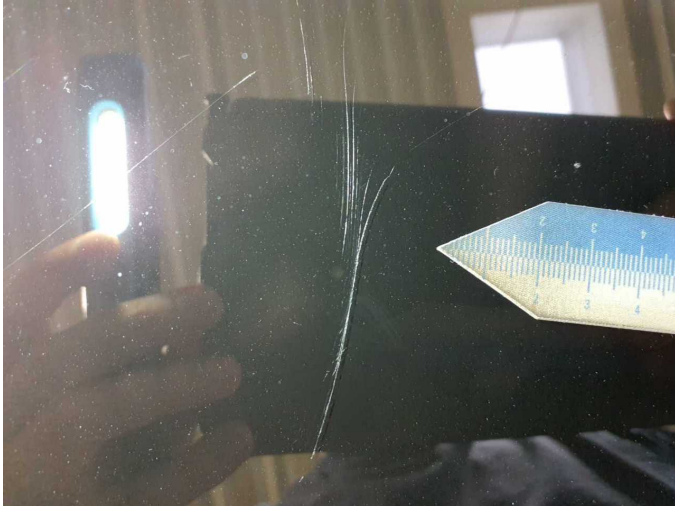
| No. | Component group | Description |
|---|---|---|
| 14 | Roof | Sun roof / glass - Scratch(es) - Replace |

**Damage 14:** Roof: Sun roof / glass - Scratch(es) - Replace
