Expertise

Protocol number: 46415257  
Order No. / Reference: 26609237  
Inspection date: 9 Jul 2026

Manufacturer: Ford

Model: Focus Turnier 1.5 EcoBlue Start-Stopp-System Aut. TITANIUM

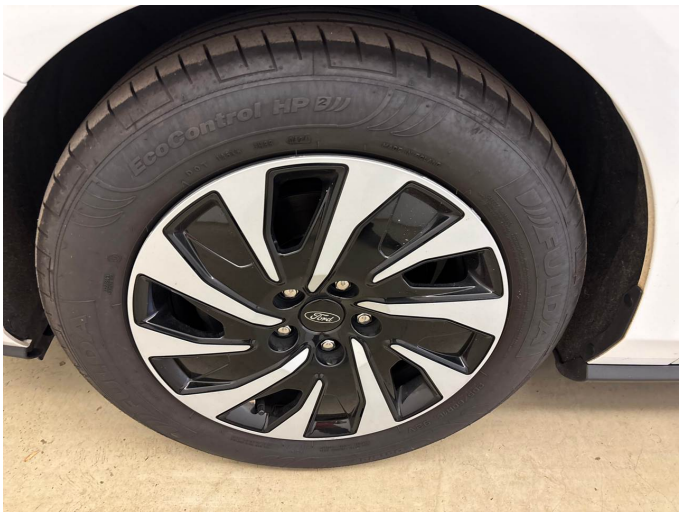
Figure 12: Mounted tyres

| # | Tyre size | Type of tyre | Manufacturer | Tread depth |
|---|---|---|---|---|
| 1) | 205/60 R16 92V | Summer tyres on Steel rim with wheel cover | Fulda | 4mm / 4mm |
| 2) | 205/60 R16 92V | Summer tyres on Steel rim with wheel cover | Fulda | 4mm / 4mm |

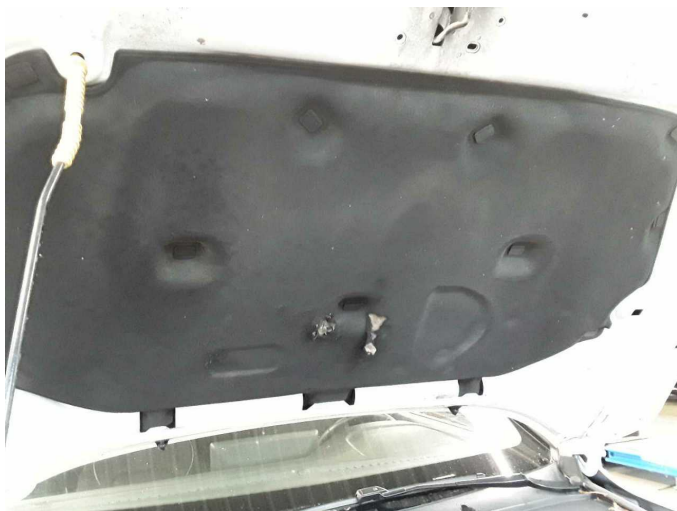
| No. | Component group | Description |
|---|---|---|
| 2 | Bonnet | Insulation lining - Damaged - Replace |

Damage 2: Bonnet: Insulation lining - Damaged - Replace

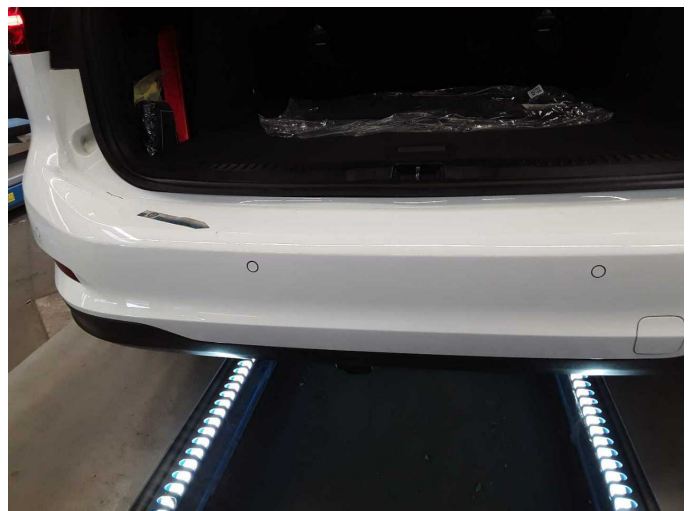
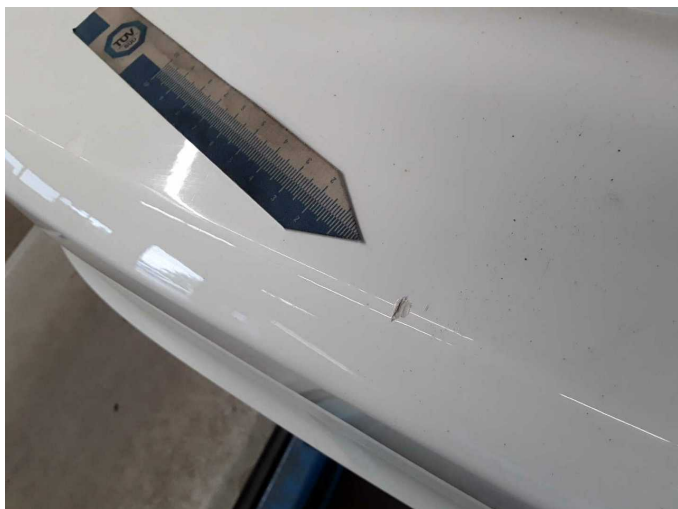
| No. | Component group | Description |
|---|---|---|
| 3 | Rear bumper | Rear bumper - Scratch(es) - Smart repair |

Damage 3: Rear bumper: Rear bumper - Scratch(es) - Smart repair

**Damage 3:** Rear bumper: Rear bumper - Scratch(es) - Smart repair

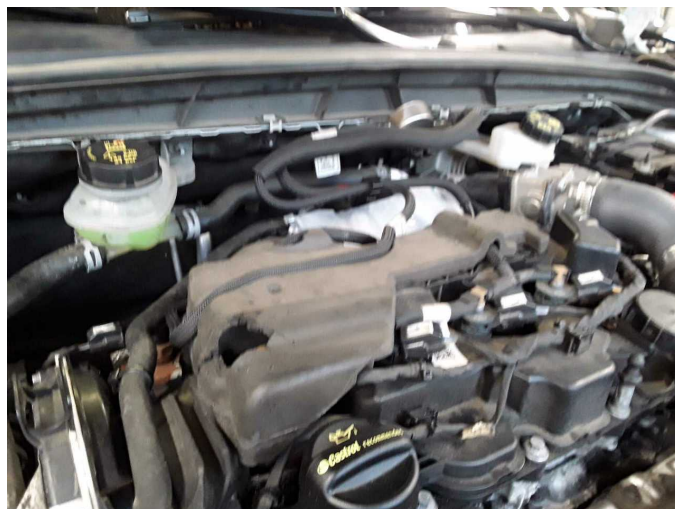
| No. | Component group | Description |
|---|---|---|
| 4 | Engine | Engine cover - Damaged - Replace |

**Damage 4:** Engine: Engine cover - Damaged - Replace

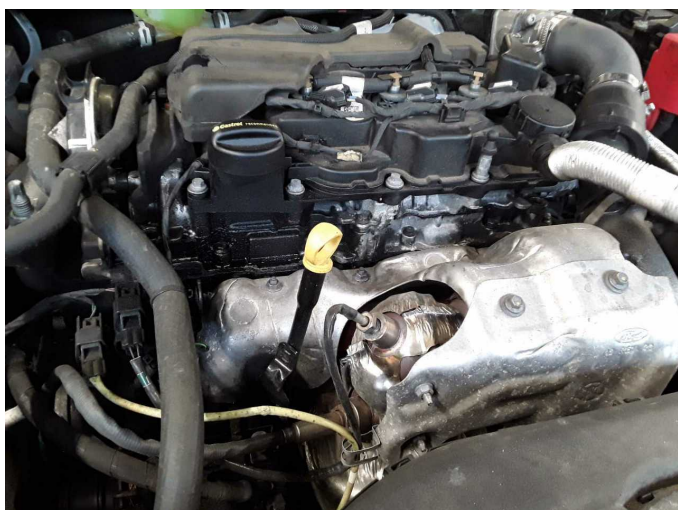
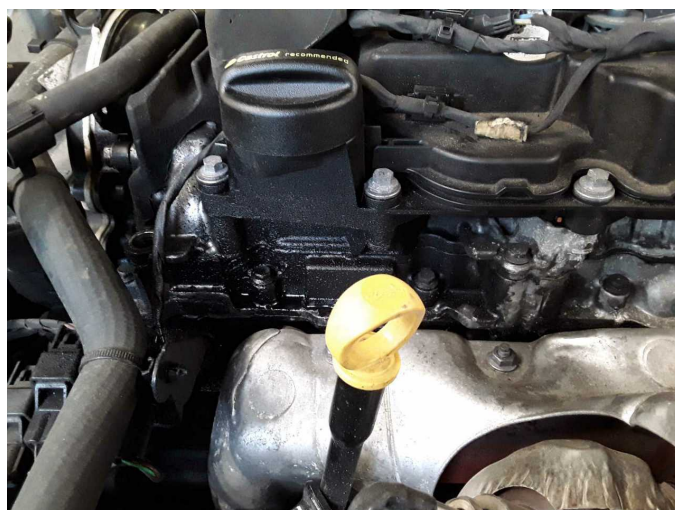
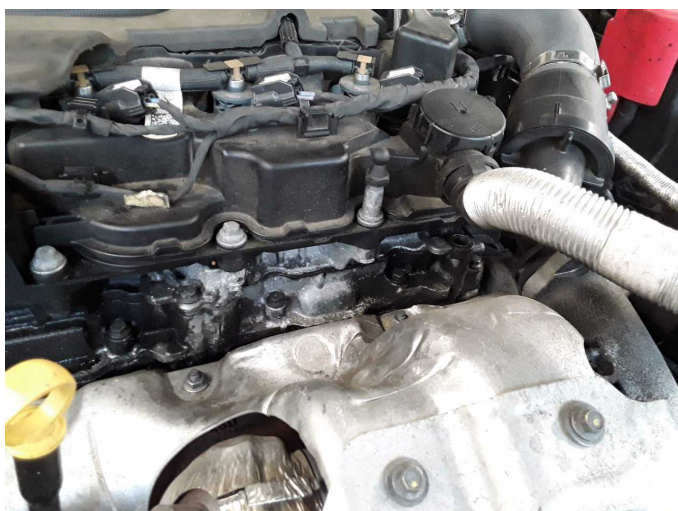
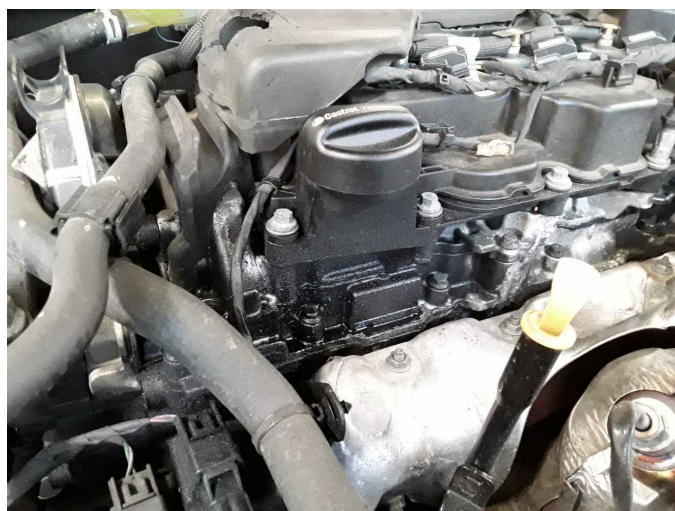
| No. | Component group | Description |
|---|---|---|
| 5 | Engine | Engine - Leaking - Diagnosed and repair if necessary |

**Damage 5:** Engine: Engine - Leaking - Diagnosed and repair if necessary

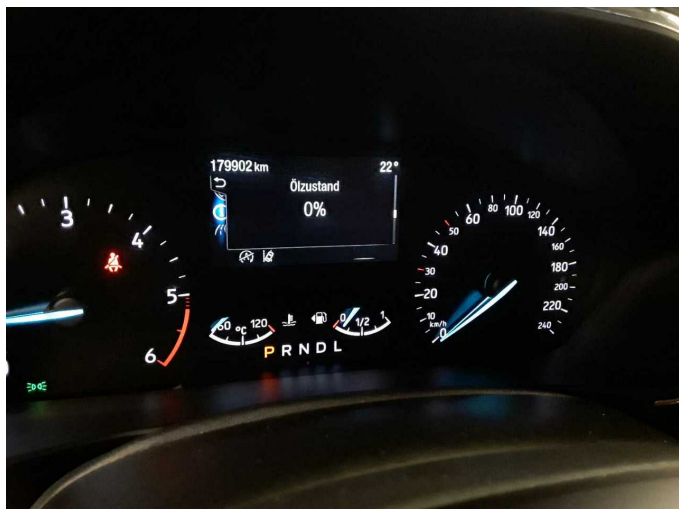
| No. | Component group | Description |
|---|---|---|
| 6 | Misc. | Inspection / maintenance - Due - Perform |

**Damage 6:** Misc.: Inspection / maintenance - Due - Perform
