Expertise

Protocol number: 46680656  
Order No. / Reference: 26788107  
Inspection date: 23 Jul 2026

Manufacturer: Volkswagen

Model: Tiguan Allspace 2.0 TDI SCR DSG Life

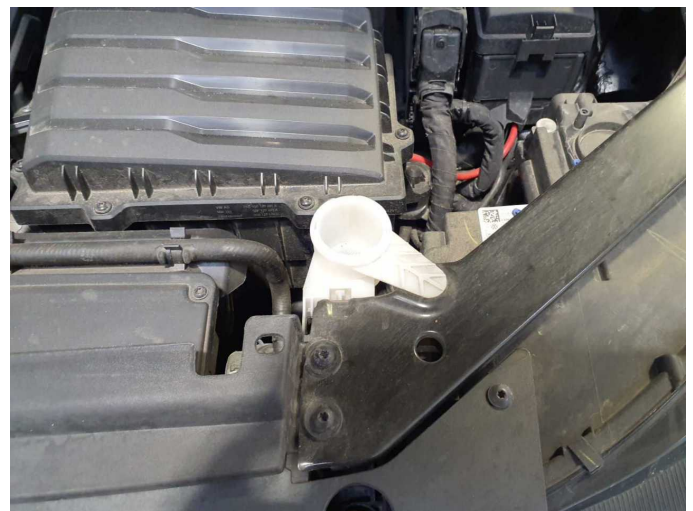
| No. | Component group | Description |
|---|---|---|
| 1 | Screen cleaning | Cover washing container - Missing - Replace |

**Damage 1:** Screen cleaning: Cover washing container - Missing - Replace

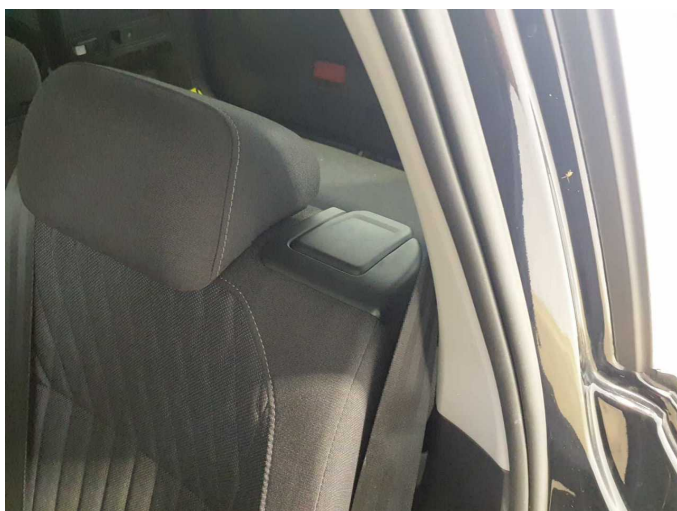
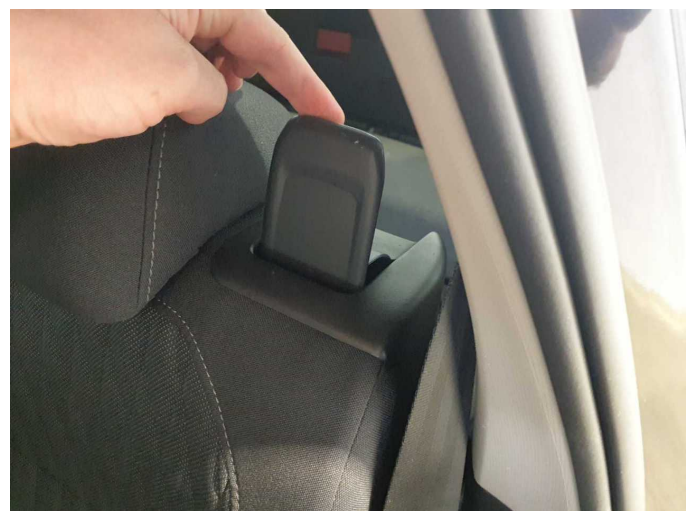
| No. | Component group | Description |
|---|---|---|
| 2 | Seat - rear | Lever seat adjustment - Broken / torn - Replace |

**Damage 2:** Seat - rear: Lever seat adjustment - Broken / torn - Replace

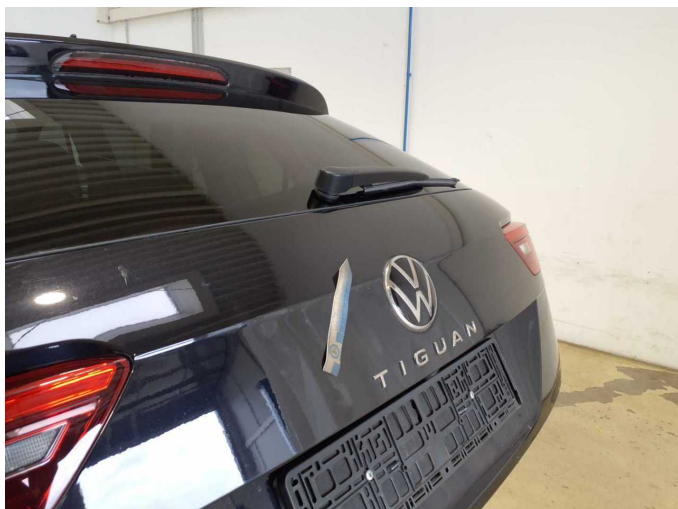
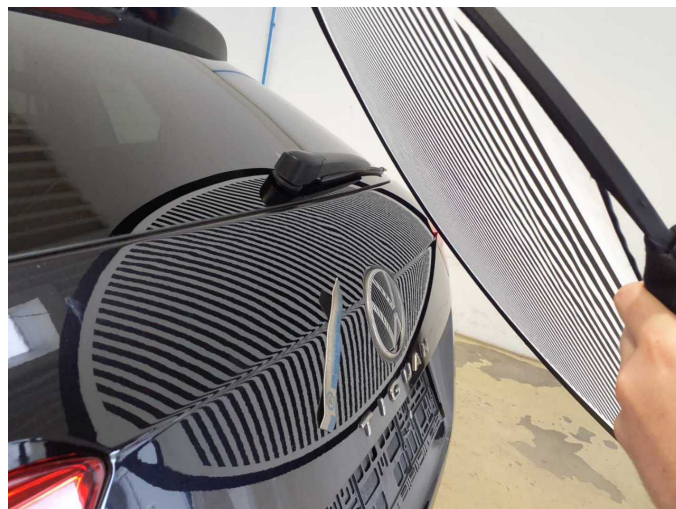
| No. | Component group | Description |
|---|---|---|
| 3 | Boot lid / rear door | Boot lid - dent(s) - Smooth repair work |

**Damage 3:** Boot lid / rear door: Boot lid - dent(s) - Smooth repair work

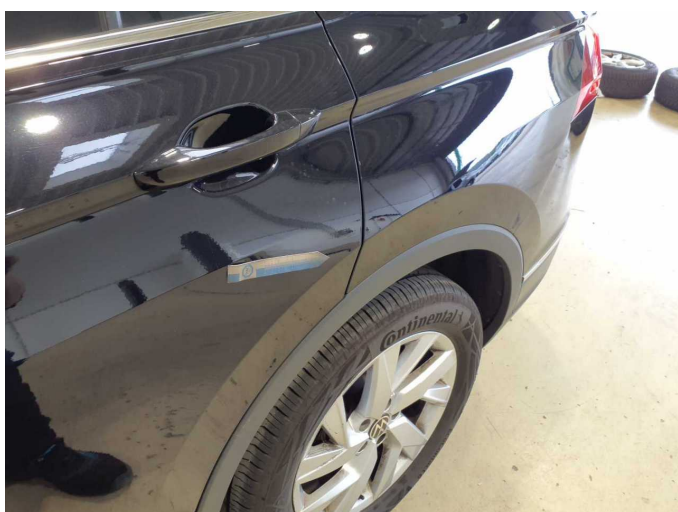
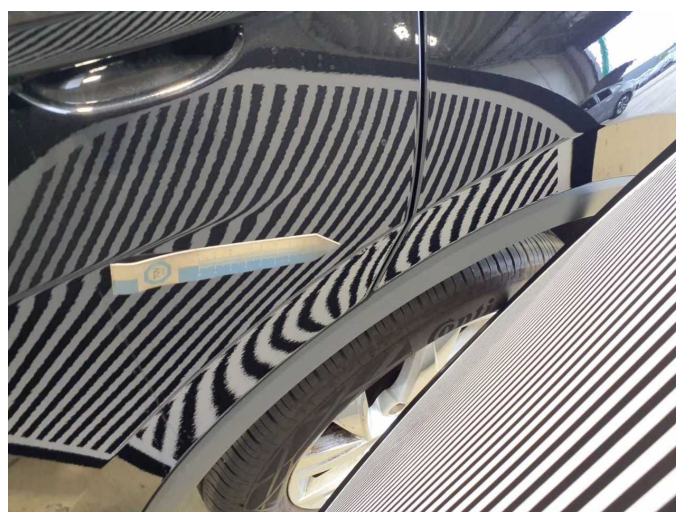
| No. | Component group | Description |
|---|---|---|
| 4 | Door - rear left side | Door - dent(s) - Smart repair |

**Damage 4:** Door - rear left side: Door - dent(s) - Smart repair

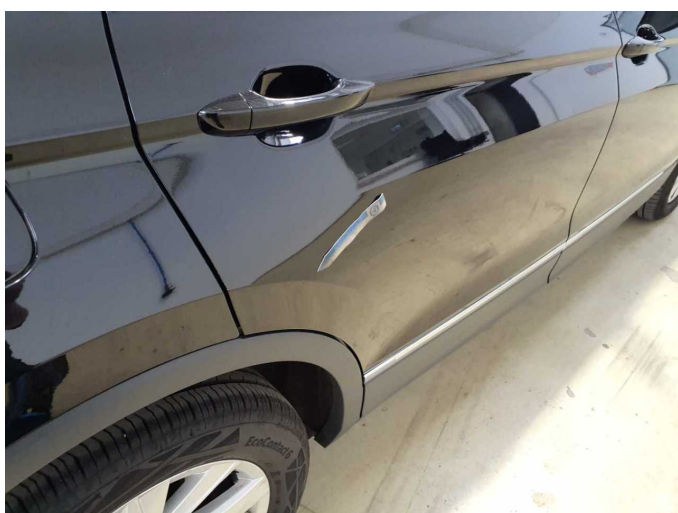
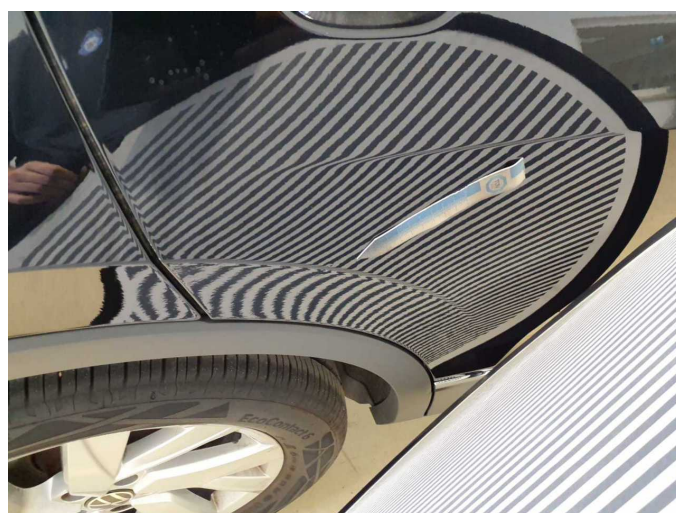
| No. | Component group | Description |
|---|---|---|
| 5 | Door - rear right side | Door - dent(s) - Smart repair |

**Damage 5:** Door - rear right side: Door - dent(s) - Smart repair

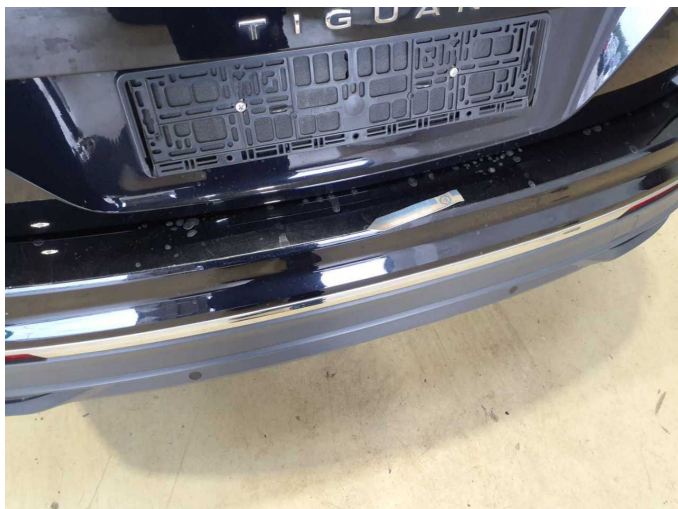
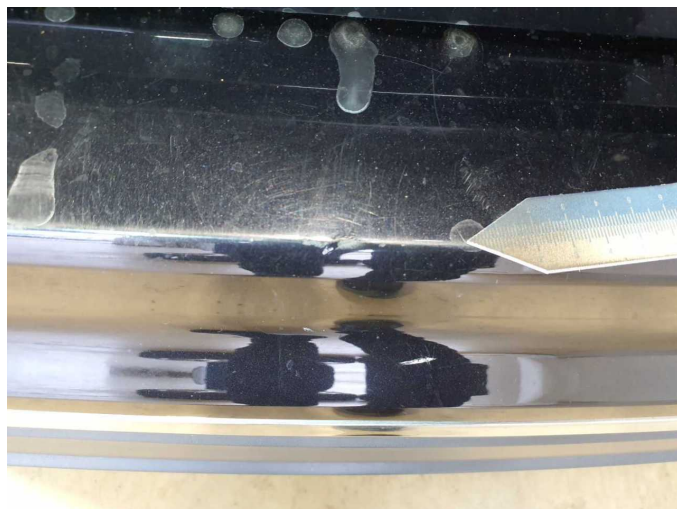
| No. | Component group | Description |
|---|---|---|
| 6 | Rear bumper | Rear bumper - Scratch(es) - Smart repair |

**Damage 6:** Rear bumper: Rear bumper - Scratch(es) - Smart repair

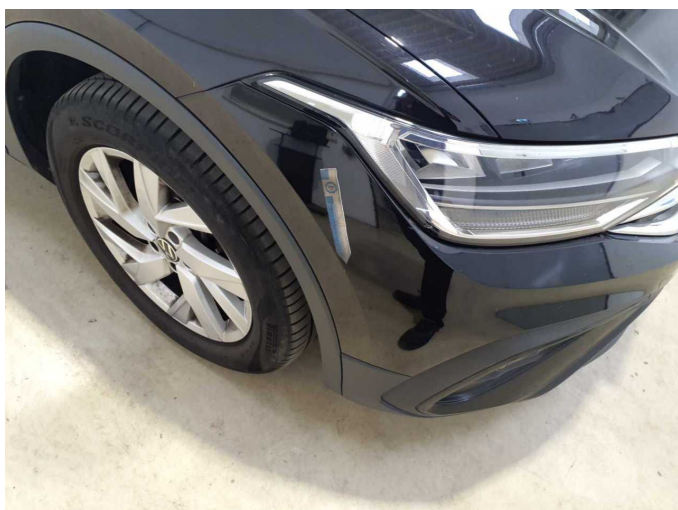
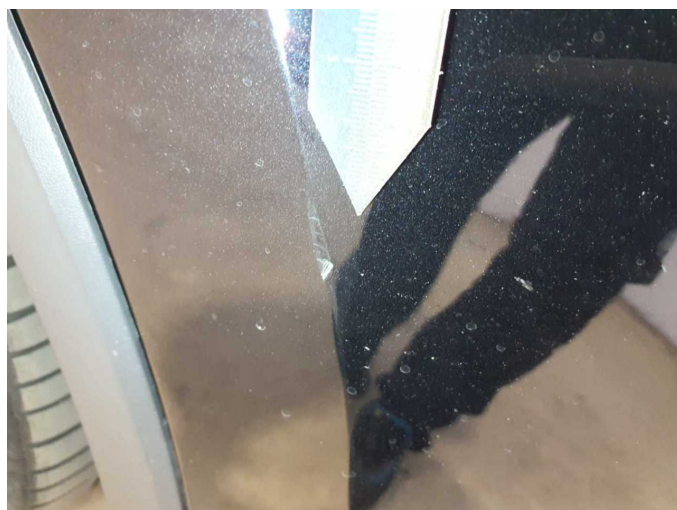
| No. | Component group | Description |
|---|---|---|
| 7 | Front bumper | Front bumper - Scratch(es) - Smart repair |

**Damage 7:** Front bumper: Front bumper - Scratch(es) - Smart repair

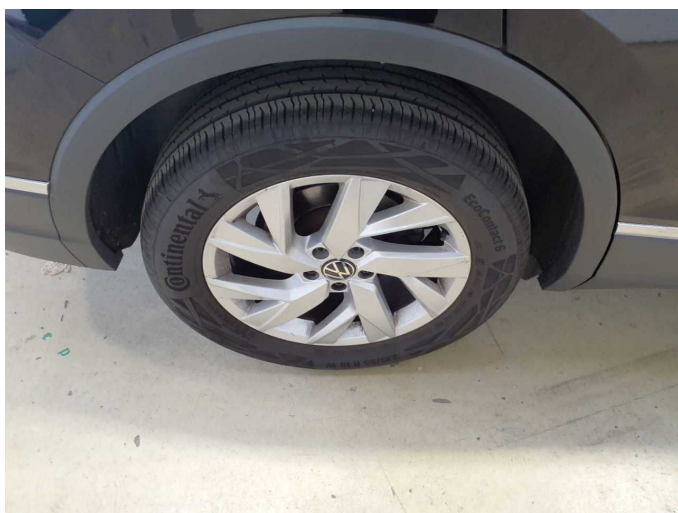
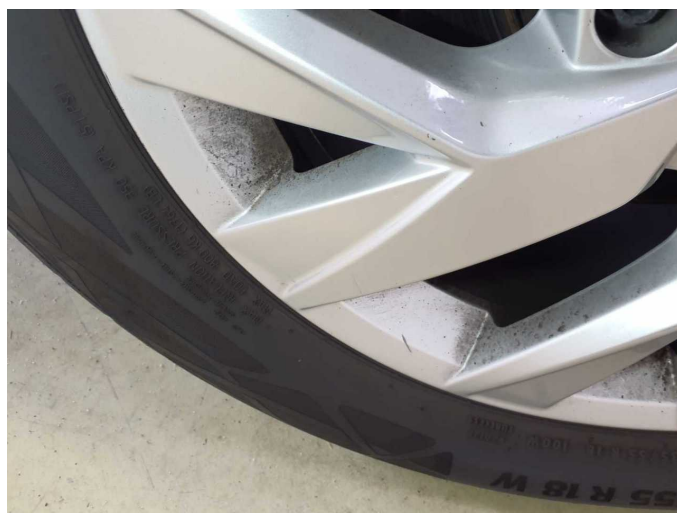
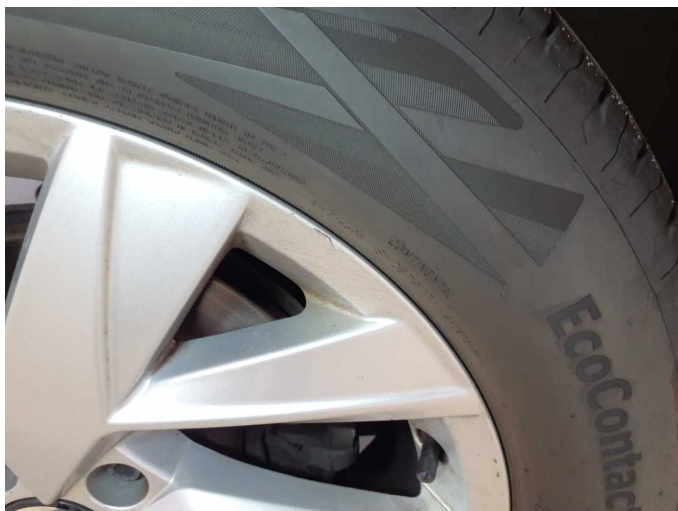
| No. | Component group | Description |
|---|---|---|
| 8 | Wheel / tyres | Alloy rim - rear right side - Scratch(es) - Loss in value |

**Damage 8:** Wheel / tyres: Alloy rim - rear right side - Scratch(es) - Loss in value

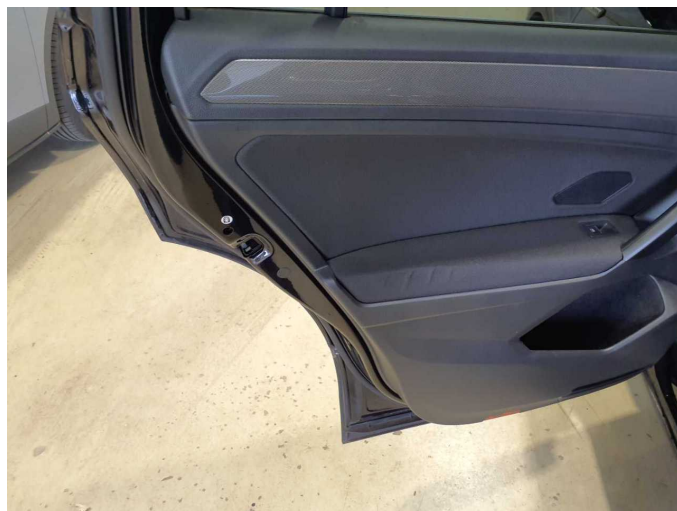
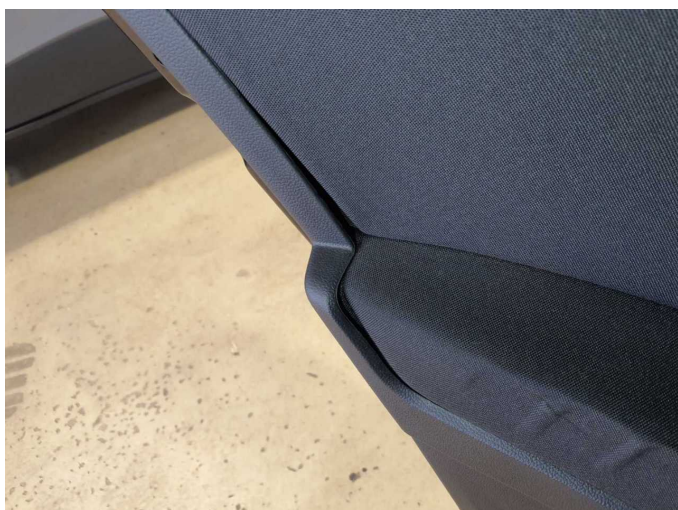
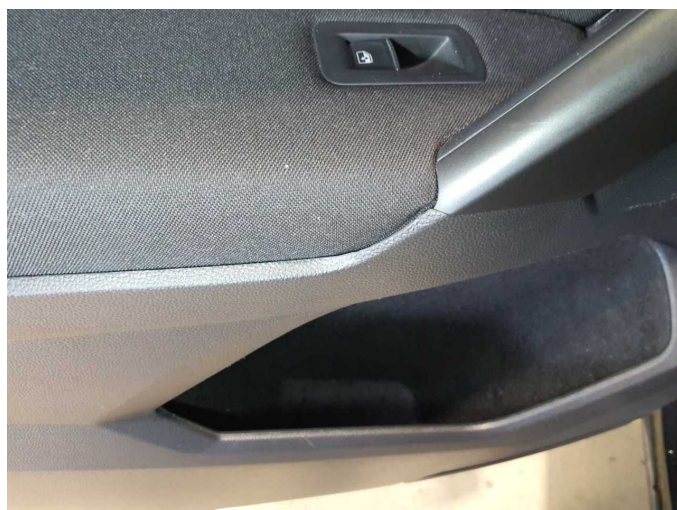
| No. | Component group | Description |
|---|---|---|
| 9 | Trim / covers | Door trim - rear left side - Broken / torn - Replace |

**Damage 9:** Trim / covers: Door trim - rear left side - Broken / torn - Replace

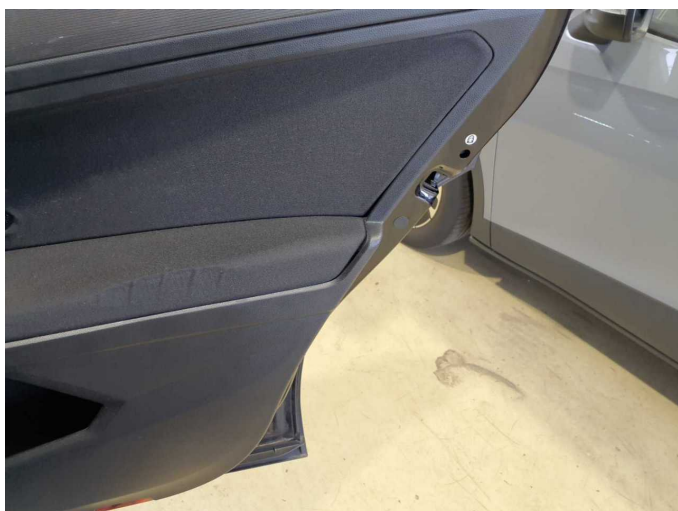
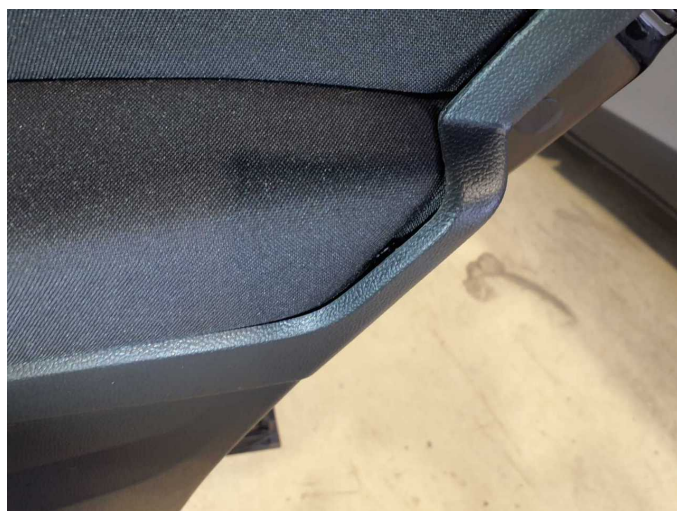
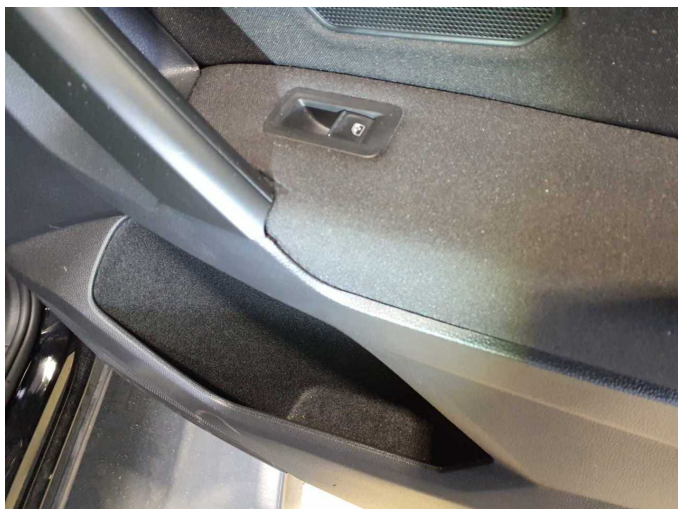
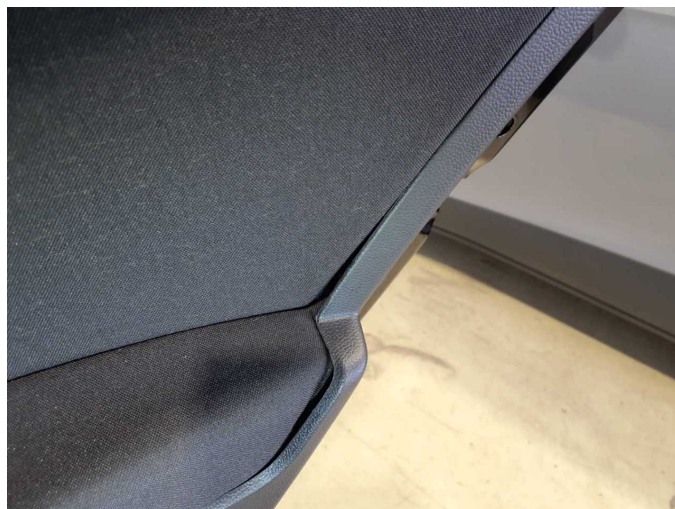
| No. | Component group | Description |
|---|---|---|
| 10 | Trim / covers | Door trim - rear right side - Broken / torn - Replace |

**Damage 10:** Trim / covers: Door trim - rear right side - Broken / torn - Replace

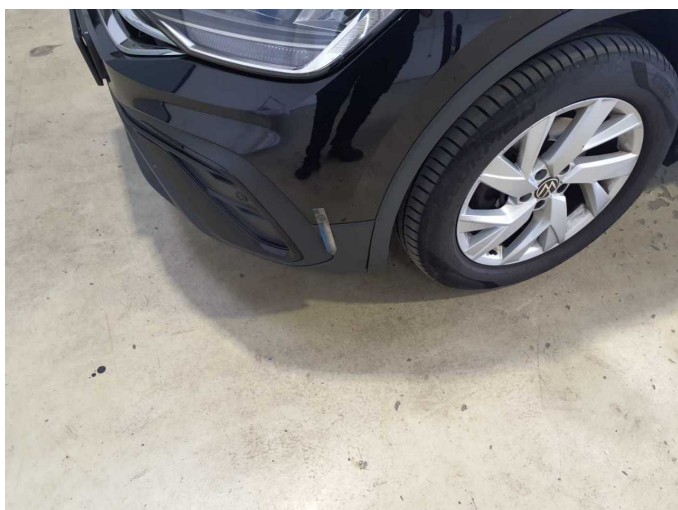
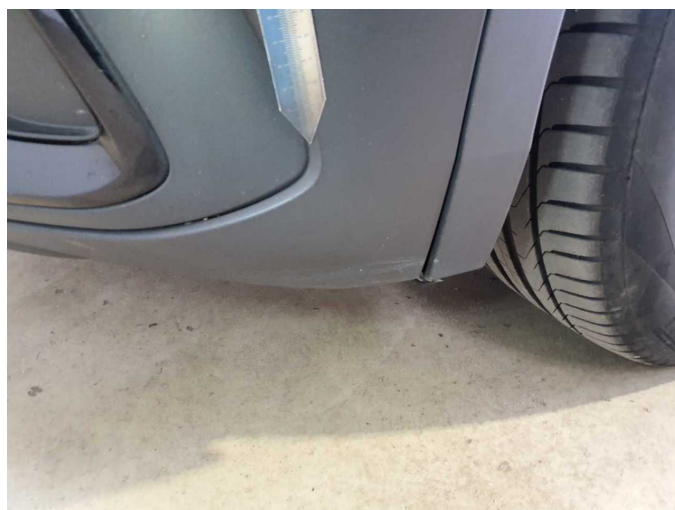
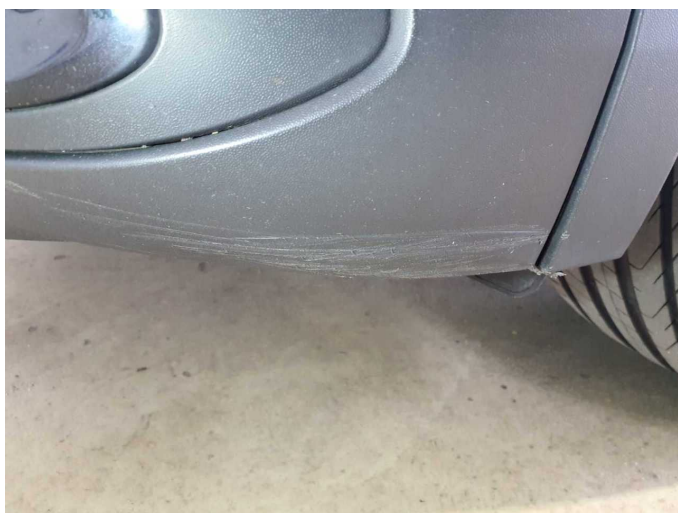
| No. | Component group | Description |
|---|---|---|
| 11 | Front bumper | Spoiler - Scratch(es) - Replace |

**Damage 11:** Front bumper: Spoiler - Scratch(es) - Replace

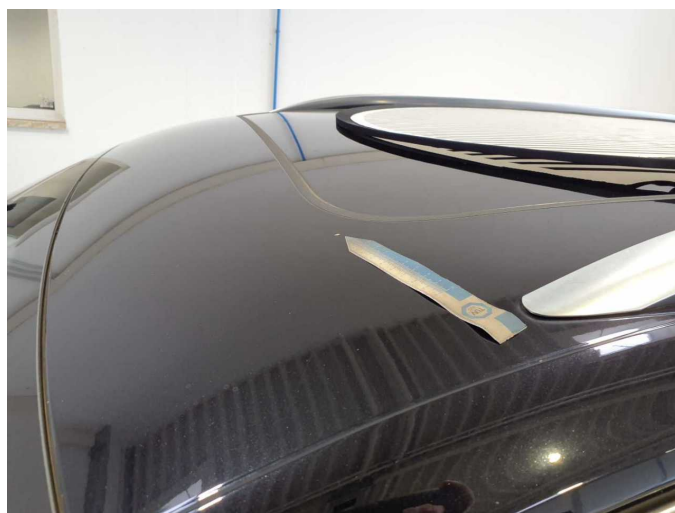
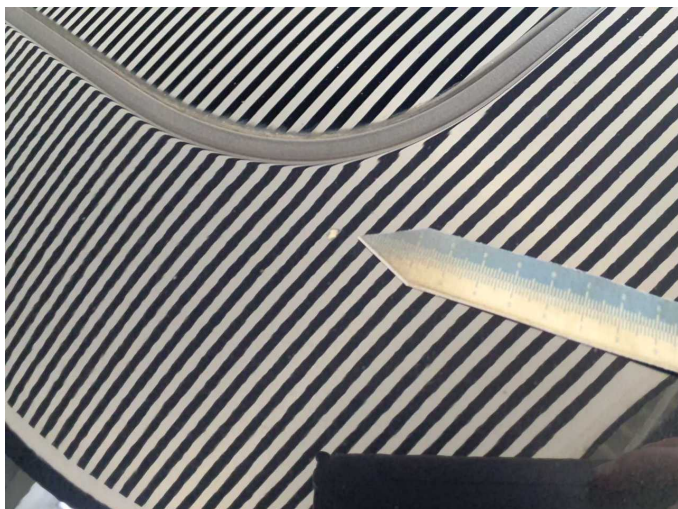
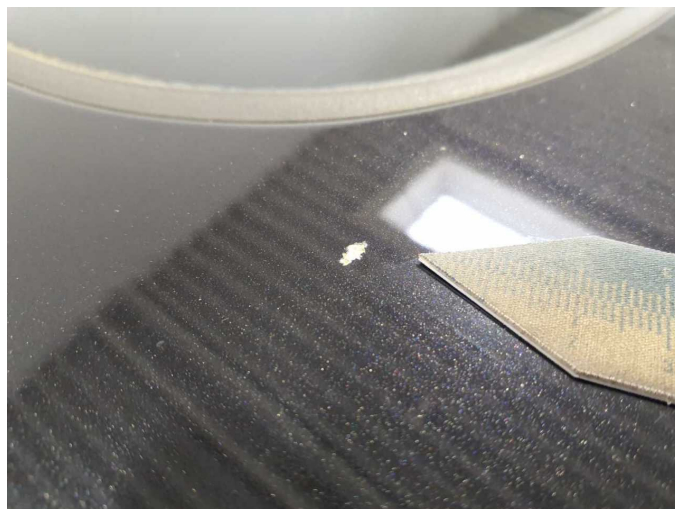
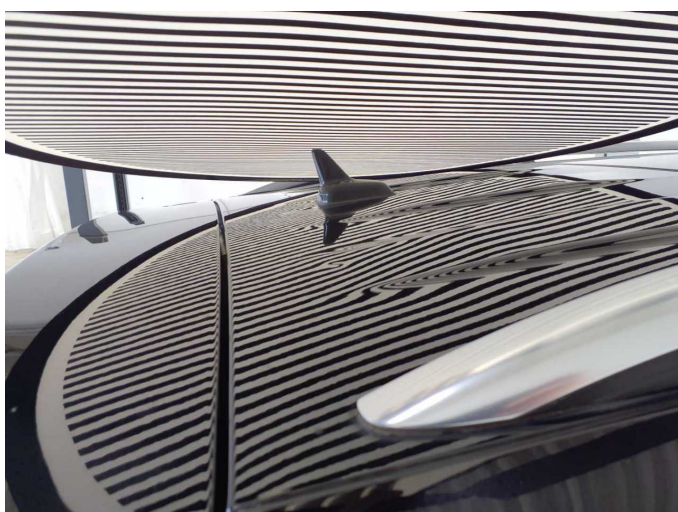
| No. | Component group | Description |
|---|---|---|
| 12 | Roof | Roof - Corrosion - Paint |

**Damage 12:** Roof: Roof - Corrosion - Paint

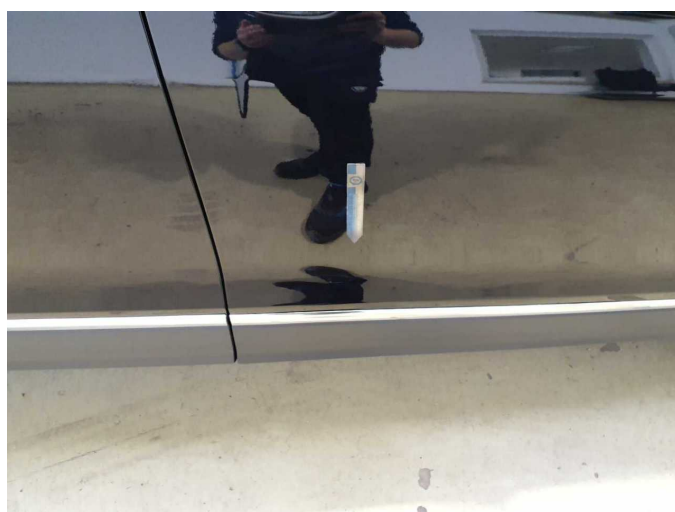
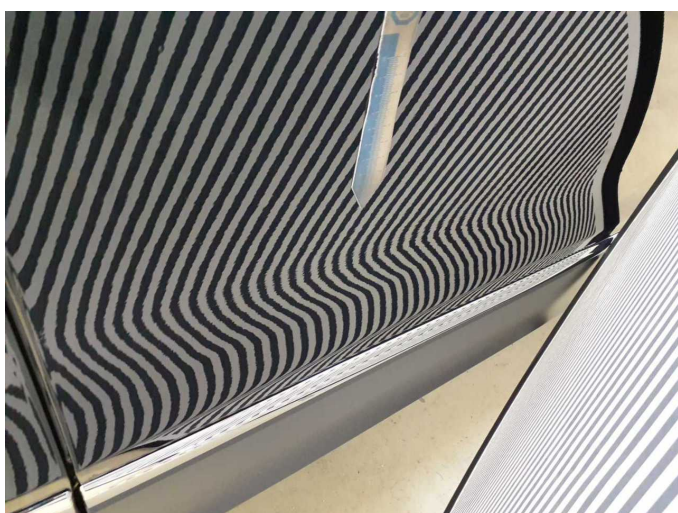
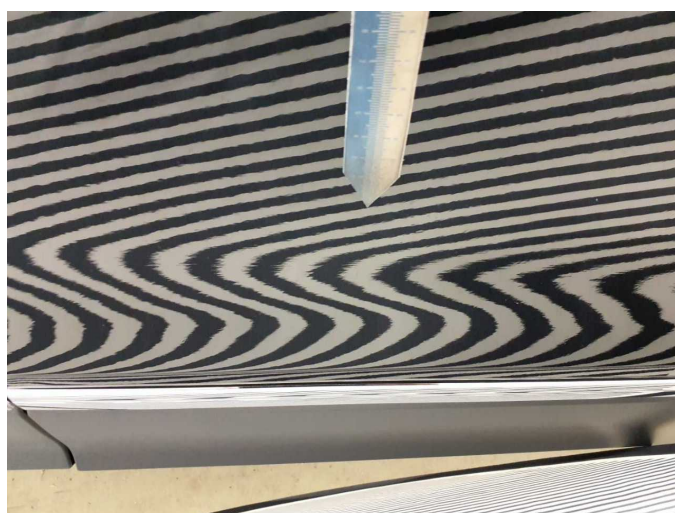
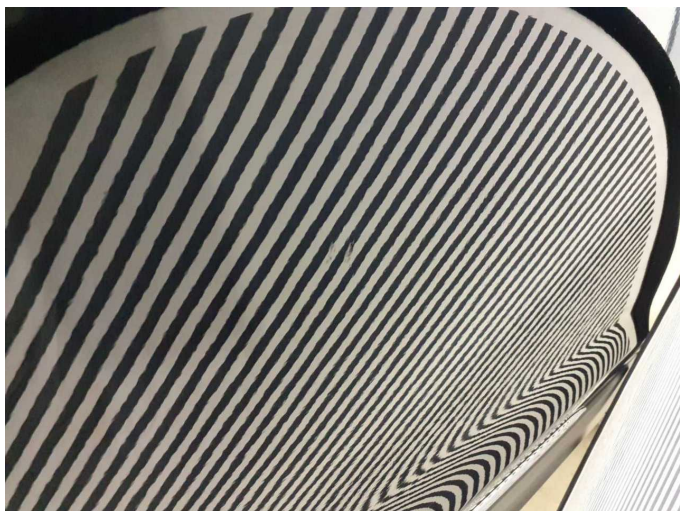
| No. | Component group | Description |
|---|---|---|
| 13 | Door - front right side | Door (Kratzer im spachtel) - Unprofessionally repaired - Paint |

| Door - front right side | 293 µm | | |

**Damage 13:** Door - front right side: Door (Kratzer im spachtel) - Unprofessionally repaired - Paint

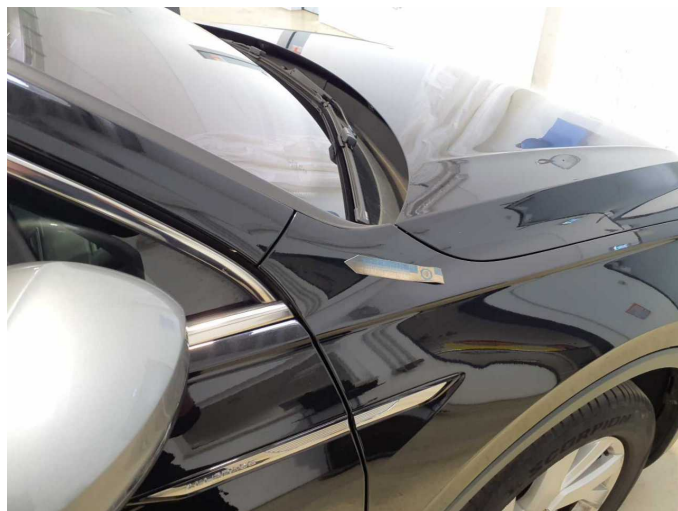
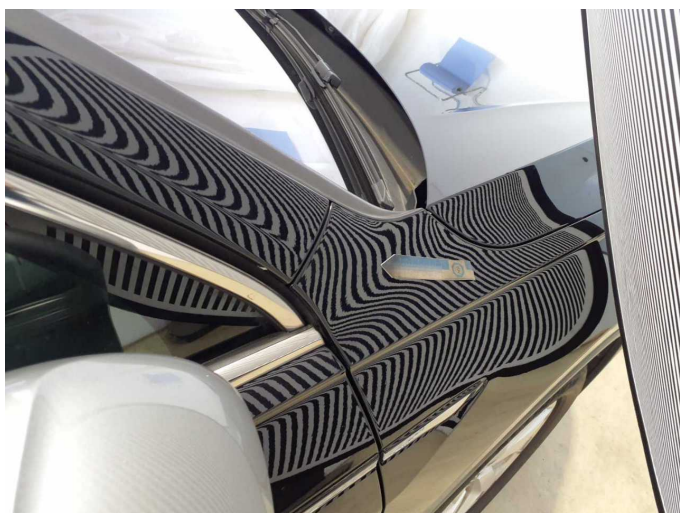
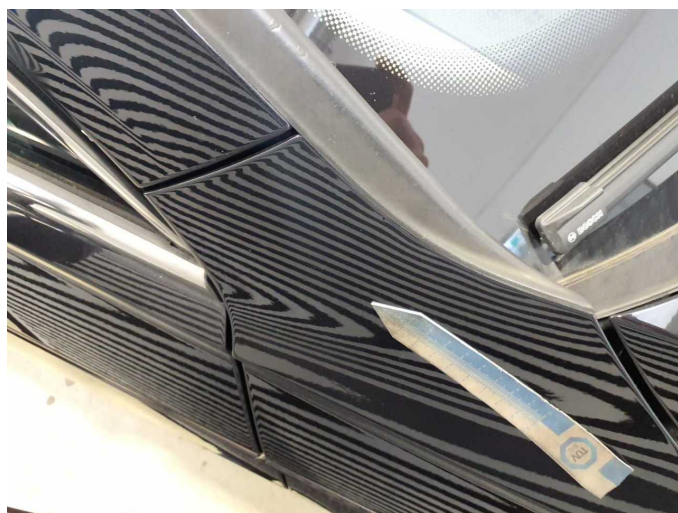
| No. | Component group | Description |
|---|---|---|
| 14 | Mudguard - right side | Mudguard - right side (Wellig und einschüsse) - Unprofessionally repaired - Paint |

| Mudguard - right side | 173 µm | Door - rear right side | 197 µm |

**Damage 14:** Mudguard - right side: Mudguard - right side (Wellig und einschüsse) - Unprofessionally repaired - Paint

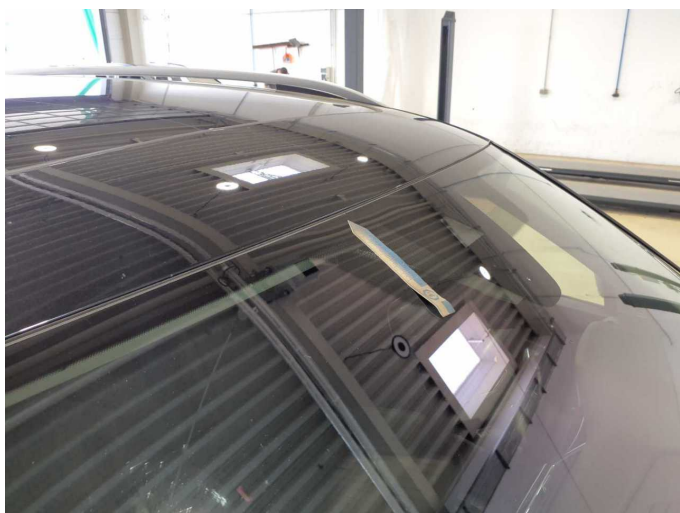
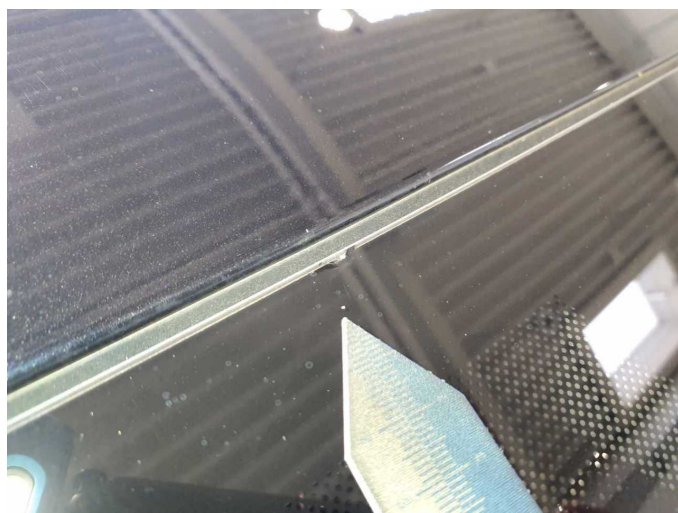
| No. | Component group | Description |
|---|---|---|
| 15 | Vehicle glazing | Windscreen - Stone chips - Replace |

**Damage 15:** Vehicle glazing: Windscreen - Stone chips - Replace

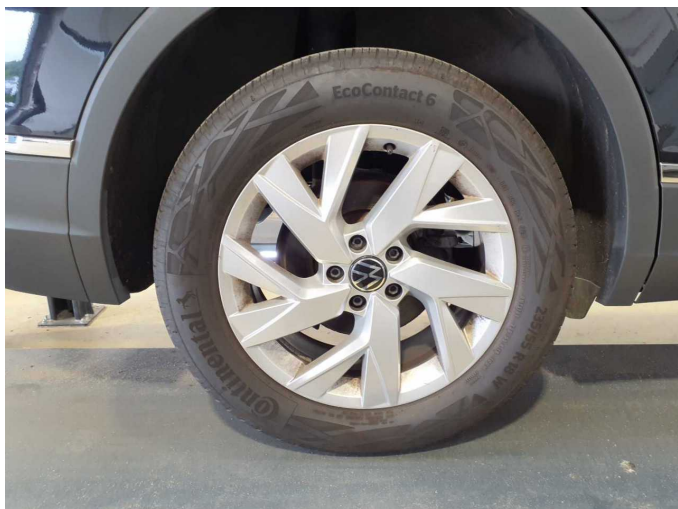
| No. | Component group | Description |
|---|---|---|
| 4 | Wheel / tyres | Tyre - right (Kein Airstop) - Differs from the original configuration - No deduction |

**Wear and tear 4:** Wheel / tyres: Tyre - right (Kein Airstop) - Differs from the original configuration - No deduction

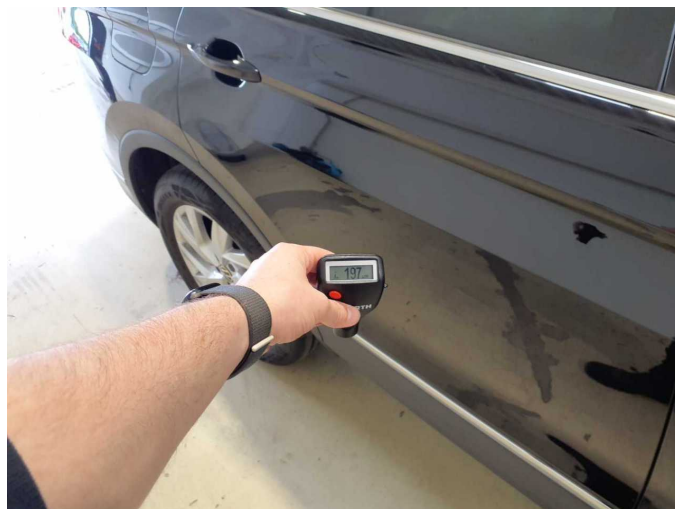
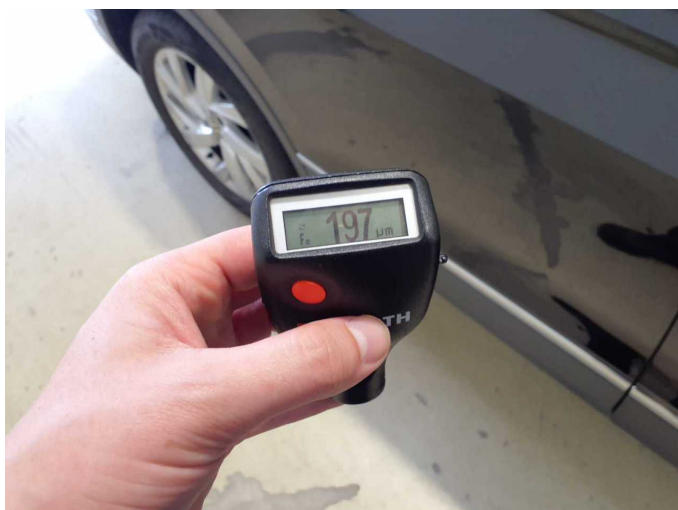
| No. | Repainting |
|---|---|
| 1 | Door - rear right side, Professionally carried out, Invoice of repair done Non-existent |

**Repainting 1:** Door - rear right side

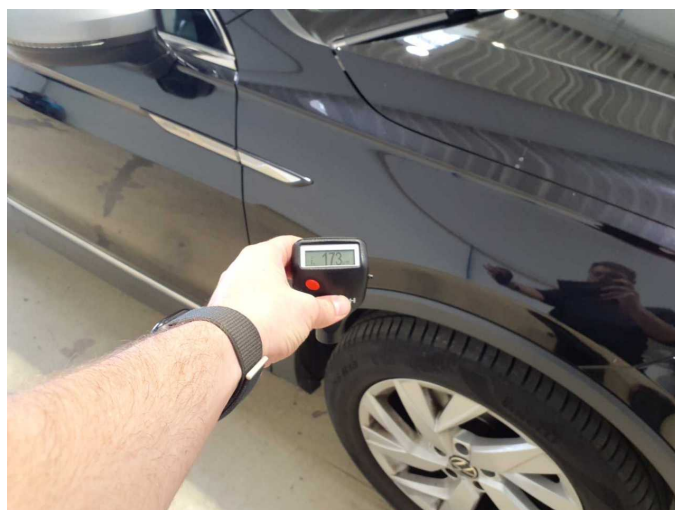
**Repainting 2:** Mudguard - right side

| No. | Repainting |
|---|---|
| 2 | Mudguard - right side, Unprofessionally carried out, Invoice of repair done Non-existent |

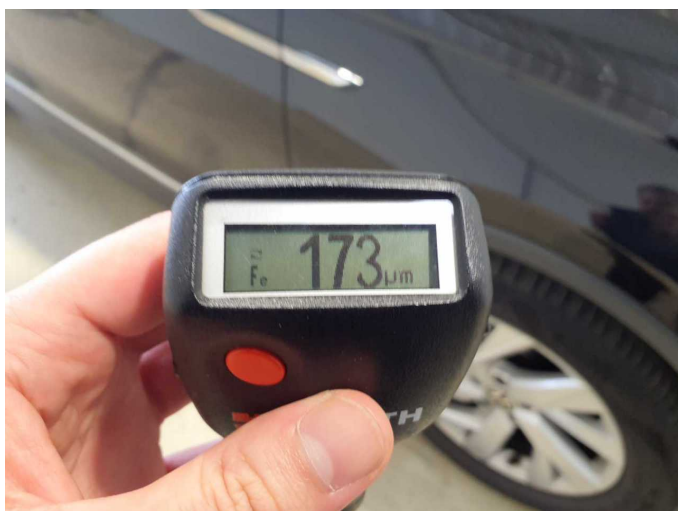
**Repainting 2:** Mudguard - right side

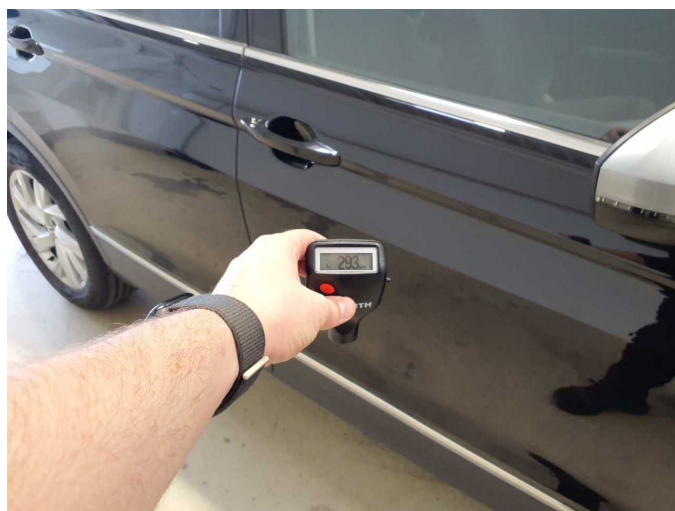
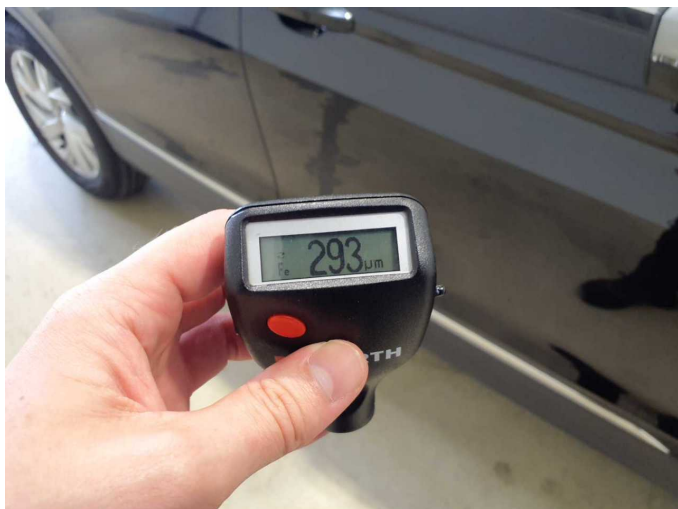
| No. | Repainting |
|---|---|
| 3 | Door - front right side, Unprofessionally carried out, Invoice of repair done Non-existent |

**Repainting 3:** Door - front right side
