Expertise

Protocol number: 46085430  
Order No. / Reference: 26530262  
Inspection date: 22 Jun 2026

Manufacturer: Ford

Model: Kuga 2.0 EcoBlue 4x4 Aut. TITANIUM

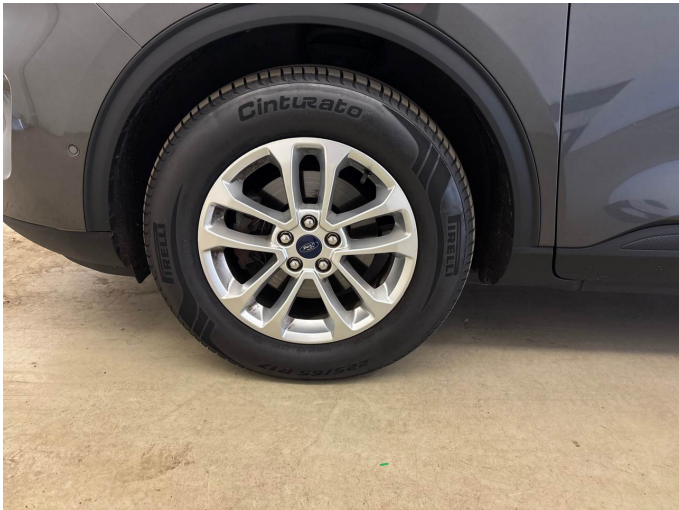
Figure 12: Mounted tyres

| # | Tyre size | Type of tyre | Manufacturer | Tread depth |
|---|---|---|---|---|
| 1) | 225/65 R17 106V | Summer tyres on Light alloy | Pirelli | 7mm / 7mm |
| 2) | 225/65 R17 106V | Summer tyres on Light alloy | Pirelli | 7mm / 7mm |

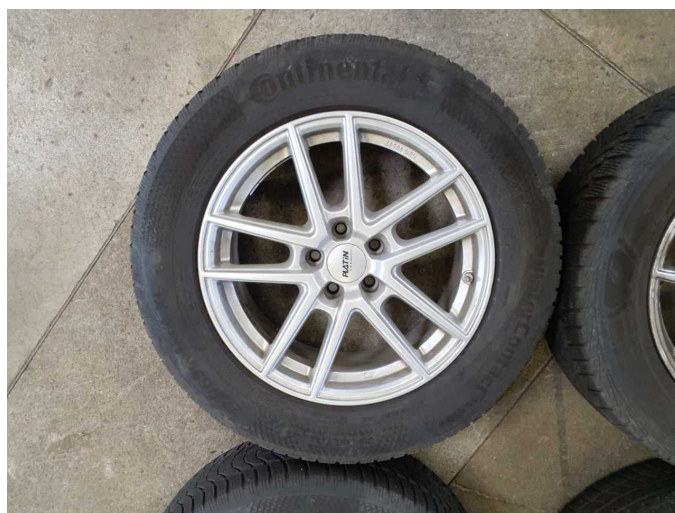
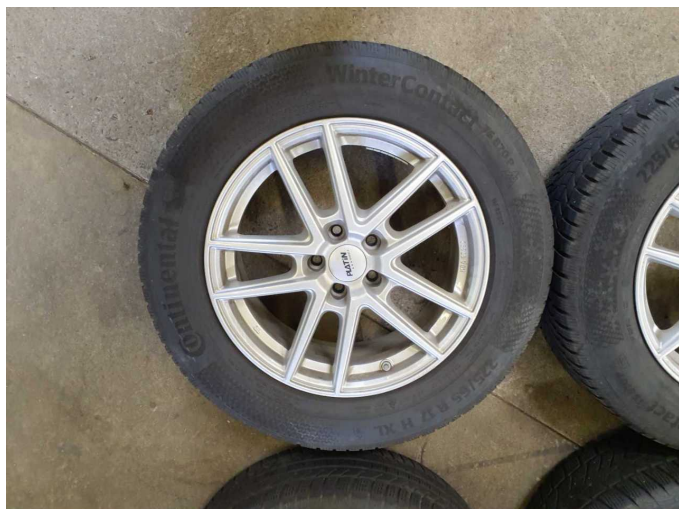
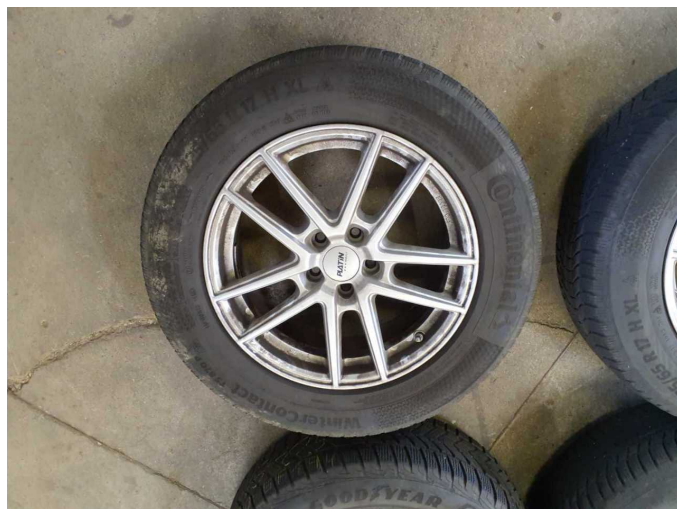
| # | Tyre size | Type of tyre | Manufacturer | Tread depth |
|---|---|---|---|---|
| 1) | 225/65 R17 106H | Winter tyres on Light alloy | Continental | 4mm / 4mm |
| 2) | 225/65 R17 106H | Winter tyres on Light alloy | Continental | 6mm / 6mm |

**Figure 18: Additional tyres**

Figure 19: Additional tyres

Figure 20: Additional tyres

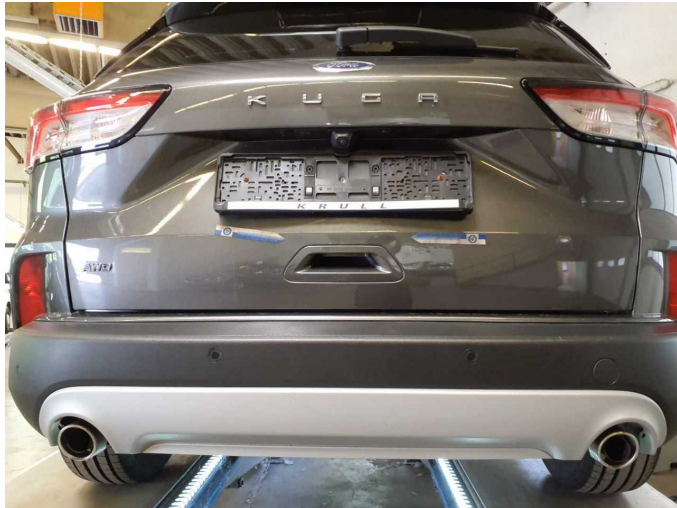
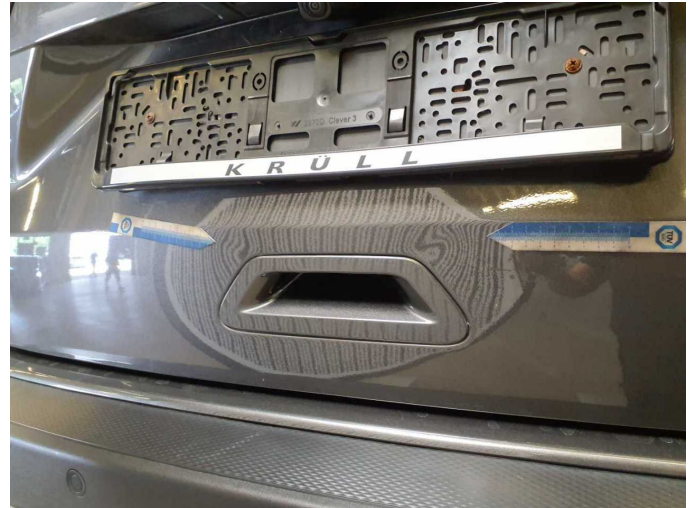
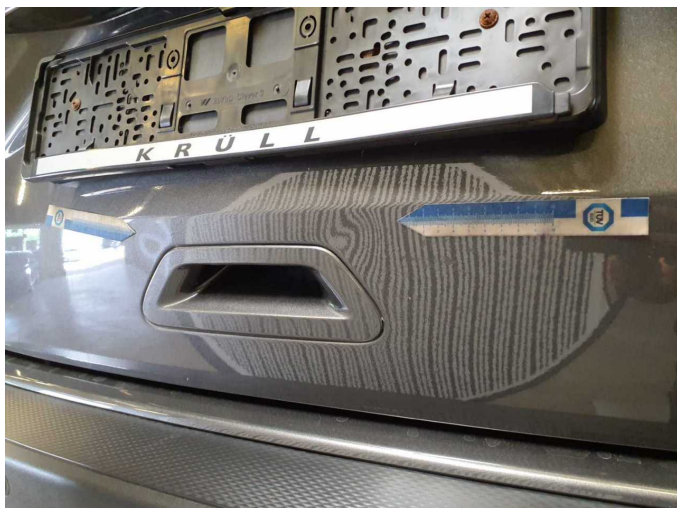
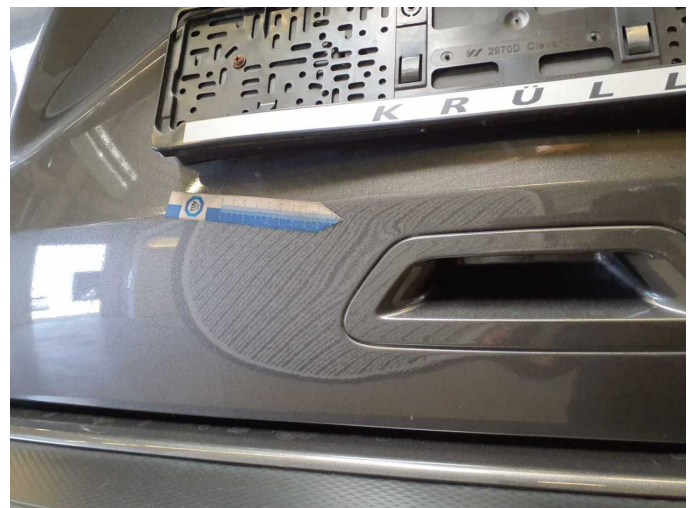
| No. | Component group | Description |
|---|---|---|
| 1 | Boot lid / rear door | Boot lid - dent(s) - Smooth repair work |

**Damage 1:** Boot lid / rear door: Boot lid - dent(s) - Smooth repair work

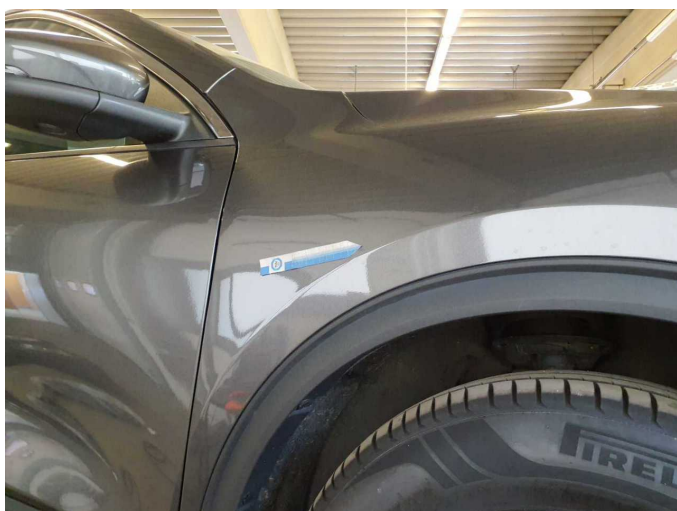
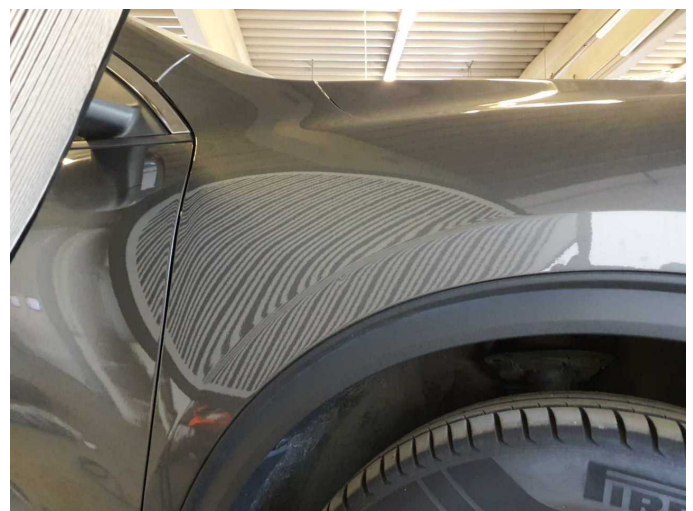
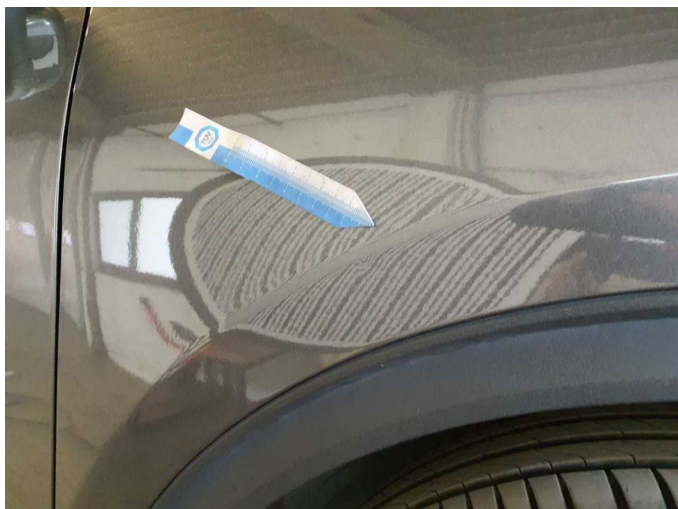
| No. | Component group | Description |
|---|---|---|
| 2 | Mudguard - right side | Mudguard - right side - dent(s) - Smooth repair work |

**Damage 2:** Mudguard - right side: Mudguard - right side - dent(s) - Smooth repair work

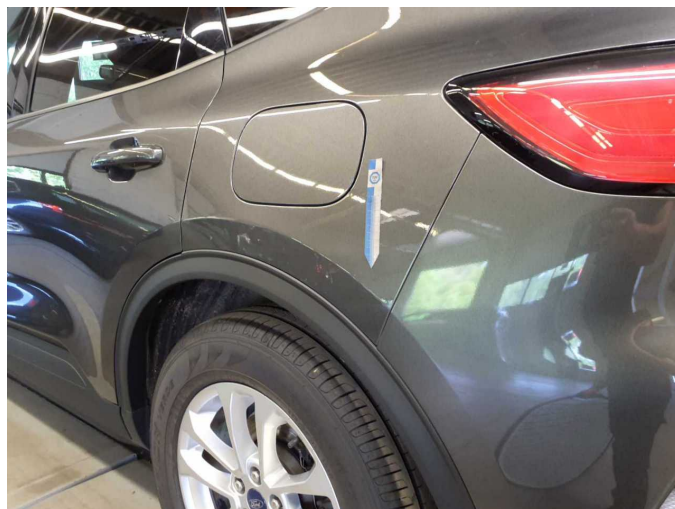
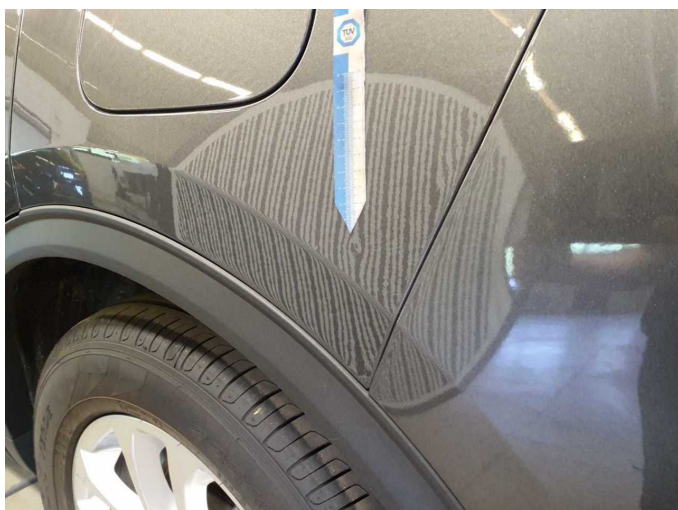
| No. | Component group | Description |
|---|---|---|
| 3 | Side panel - rear left side | Side panel - dent(s) - Smooth repair work |

**Damage 3:** Side panel - rear left side: Side panel - dent(s) - Smooth repair work

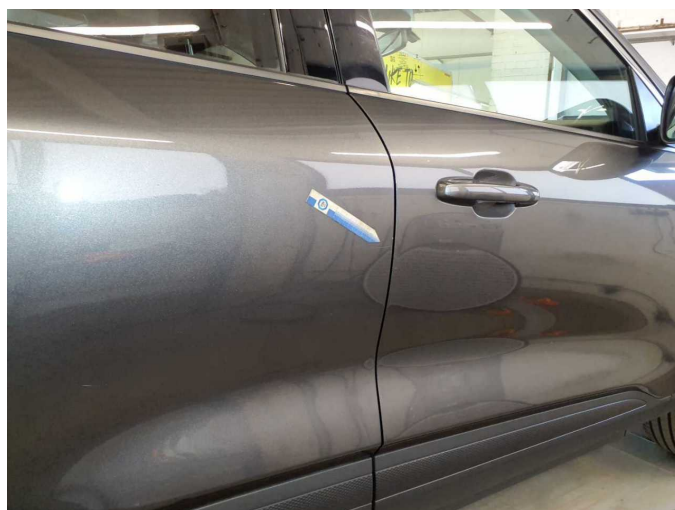
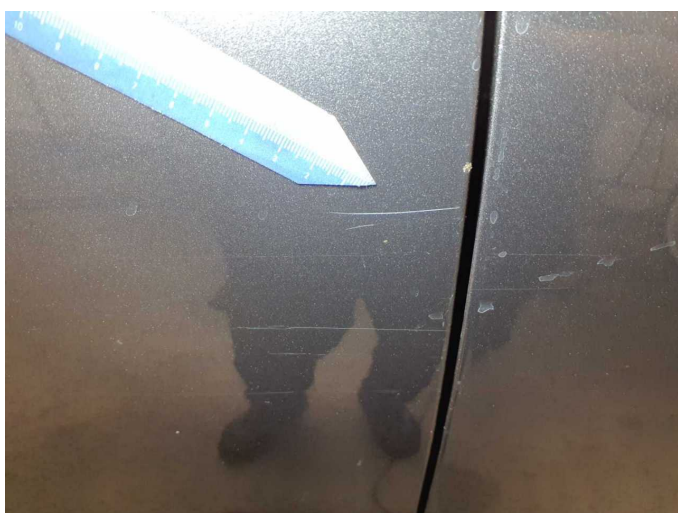
| No. | Component group | Description |
|---|---|---|
| 4 | Door - rear right side | Door - Scratch(es) - Smart repair |

**Damage 4:** Door - rear right side: Door - Scratch(es) - Smart repair

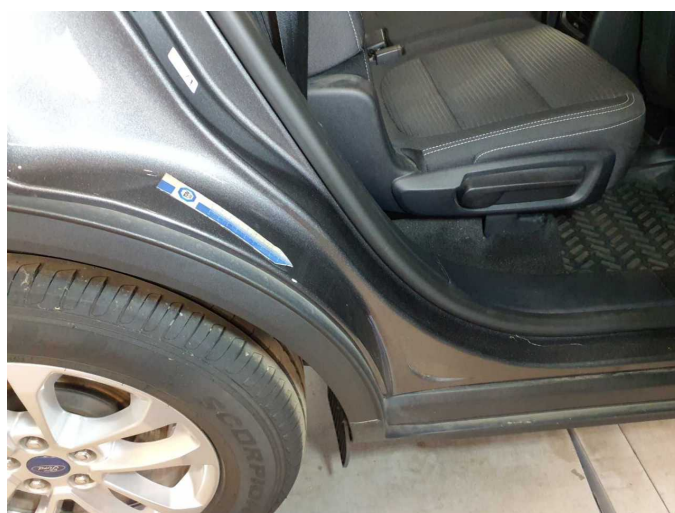
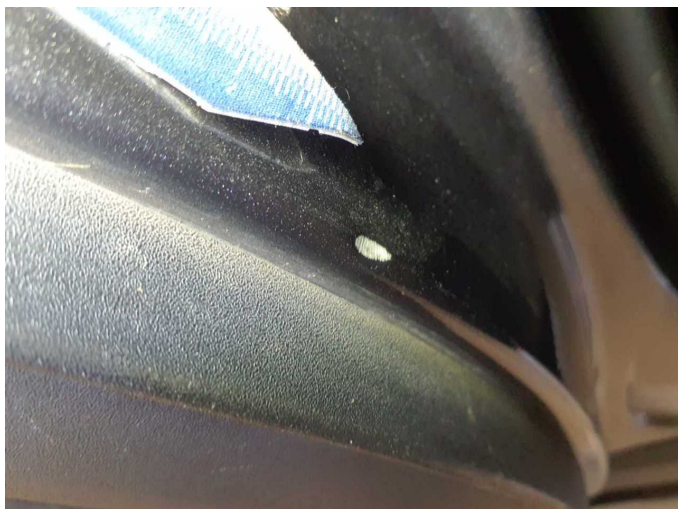
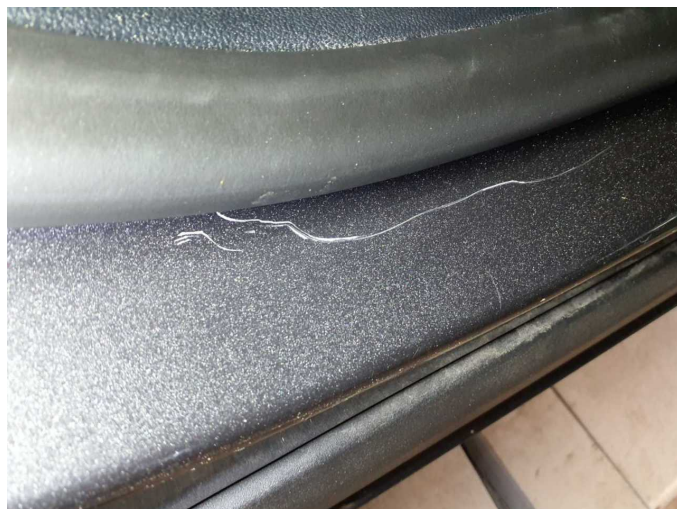
| No. | Component group | Description |
|---|---|---|
| 5 | Side panel - rear right side | Sill - Scratch(es) - Smart repair |

**Damage 5:** Side panel - rear right side: Sill - Scratch(es) - Smart repair

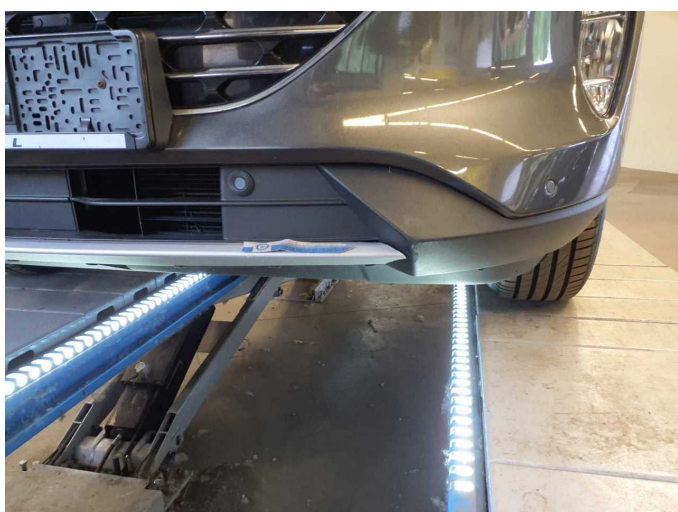
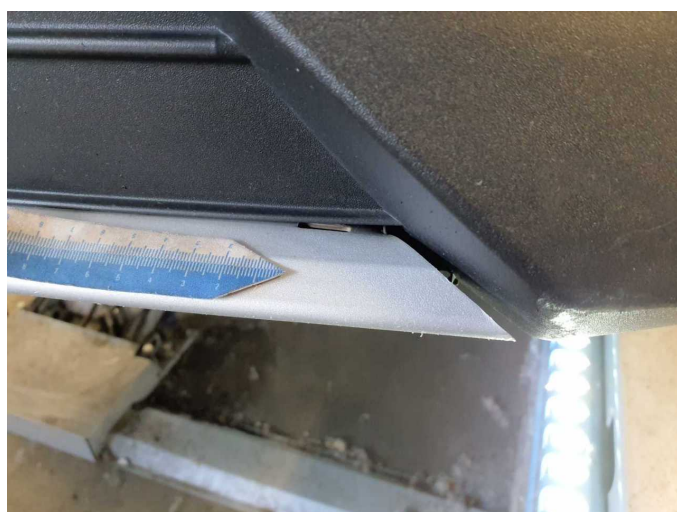
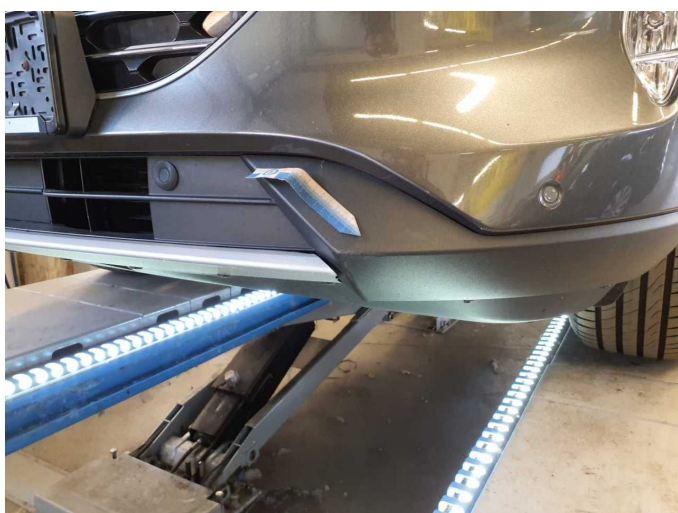
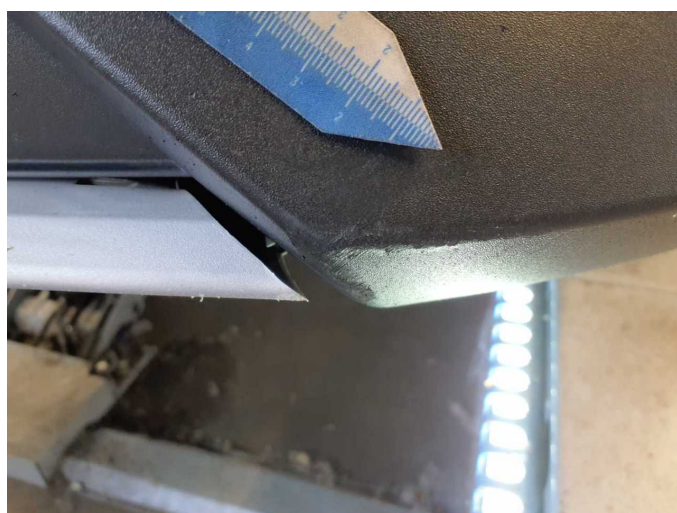
| No. | Component group | Description |
|---|---|---|
| 6 | Front bumper | Spoiler (+Blende) - Damaged - Replace |

**Damage 6:** Front bumper: Spoiler (+Blende) - Damaged - Replace

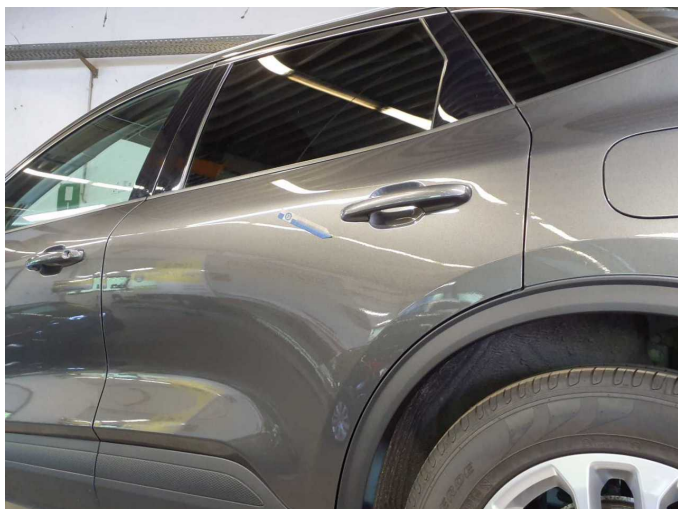
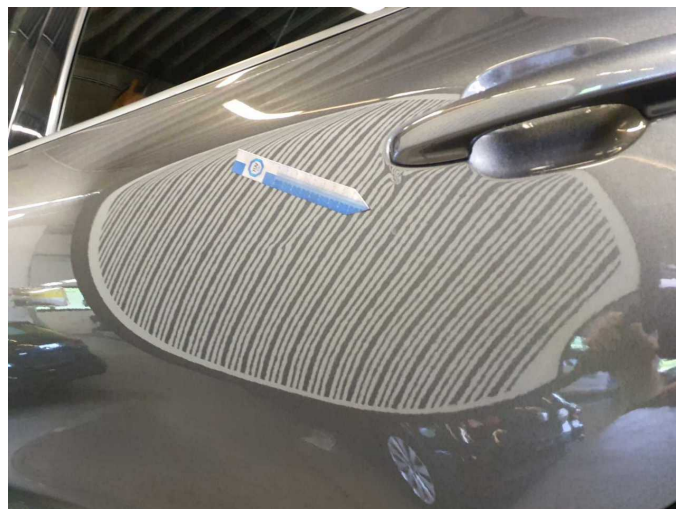
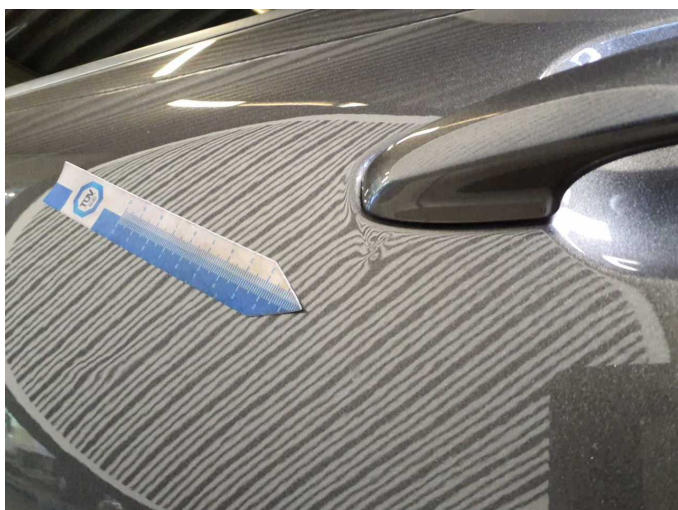
| No. | Component group | Description |
|---|---|---|
| 7 | Door - rear left side | Door - Unprofessionally repaired - Repair and paint |

| Door - rear left side | 185 µm | | |

**Damage 7:** Door - rear left side: Door - Unprofessionally repaired - Repair and paint

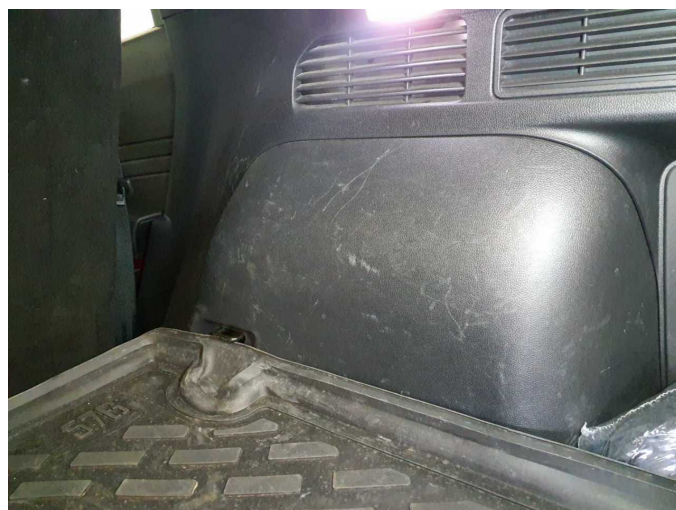
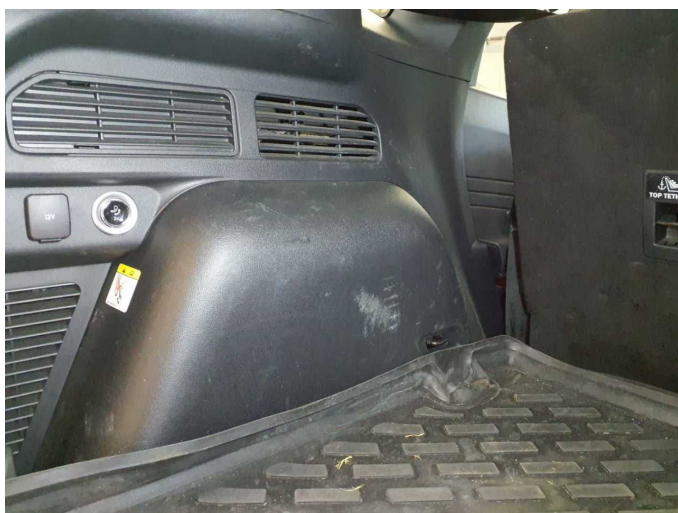
| No. | Component group | Description |
|---|---|---|
| 1 | Trim / covers | Boot lining - Scratch(es) |

**Wear and tear 1:** Trim / covers: Boot lining - Scratch(es)

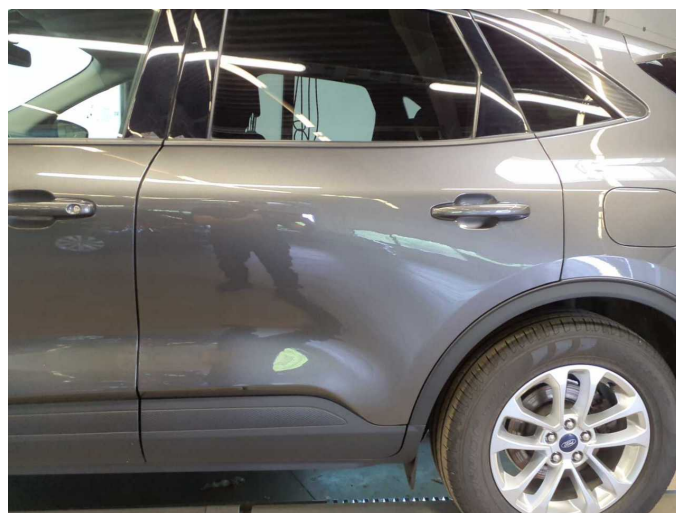
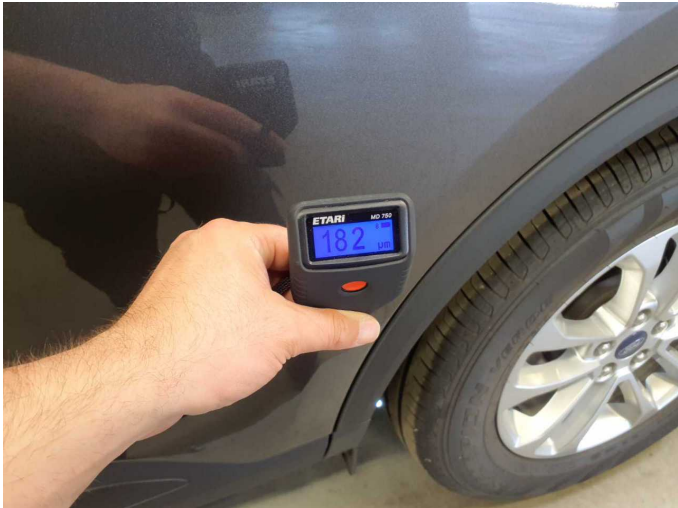
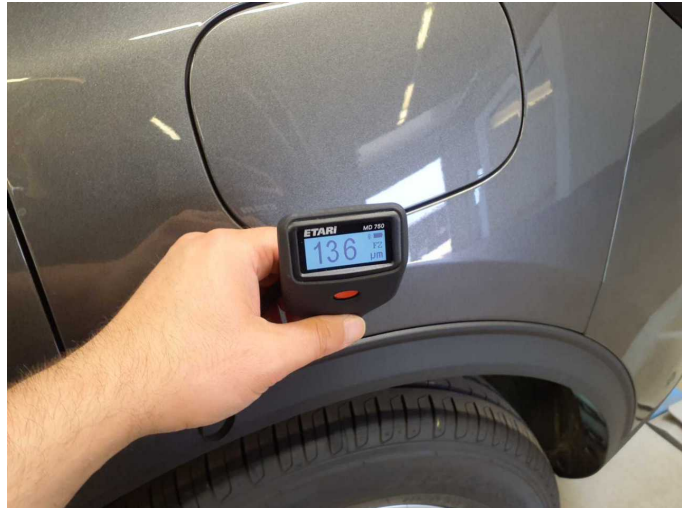
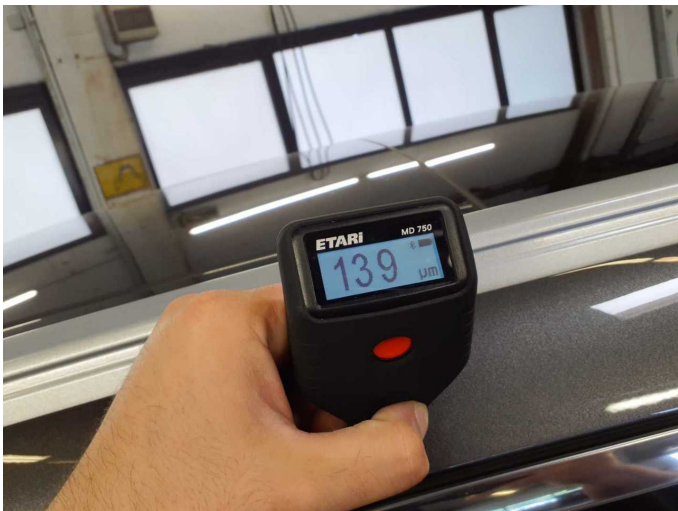
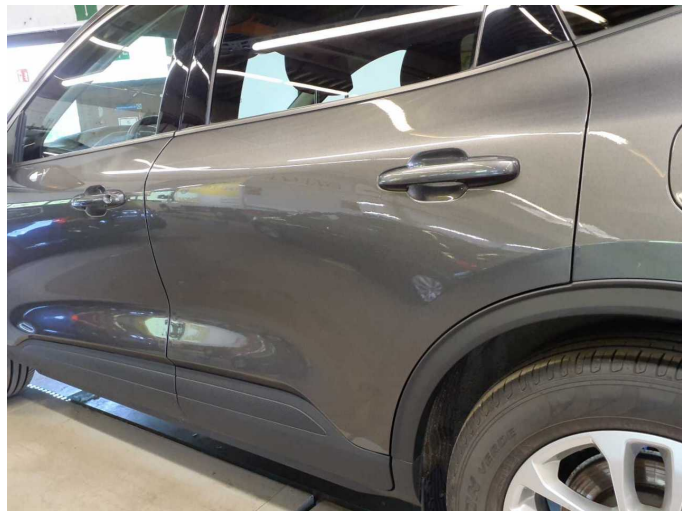
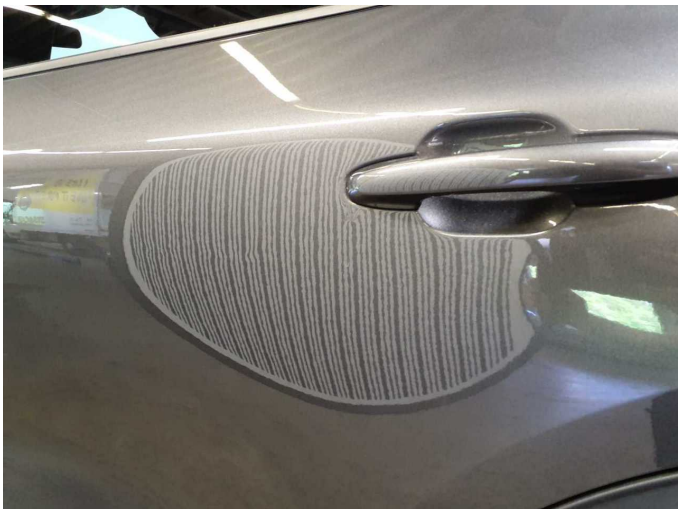
- 1 Roof rail - left side, Side panel - rear left side, Professionally carried out
- 2 Door - rear left side, Unprofessionally carried out

| Roof rail - left side | 150 µm | Side panel - rear left side | 150 µm |

**Repainting 1:** Roof rail - left side, Side panel - rear left side

Repainting 1: Roof rail - left side, Side panel - rear left side
