Expertise

Protocol number: 46253369  
Order No. / Reference: 26522343  
Inspection date: 29 Jun 2026

Manufacturer: Skoda  
VIN: TMBLN9NS0N8060480

Model: Kodiahq 2.0 TDI 4x4 DSG Style

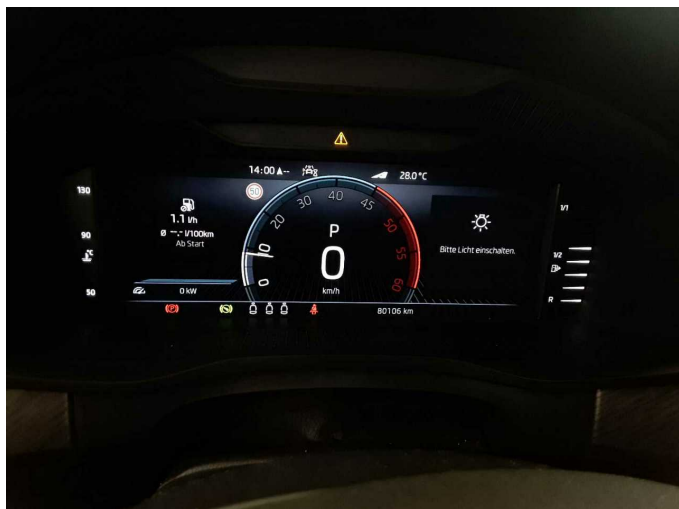
Figure 7: Instrument cluster

| Vehicle details | |
|---|---|
| Mileage (Read) | 80,106 km |

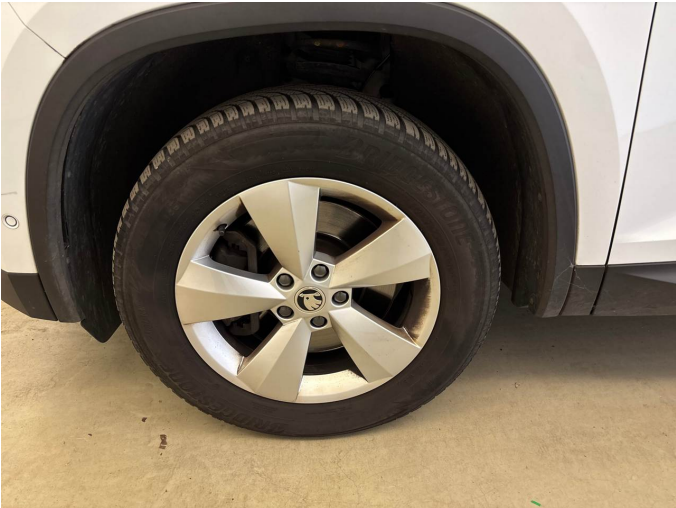
Figure 13: Mounted tyres

| # | Tyre size | Type of tyre | Manufacturer | Tread depth |
|---|---|---|---|---|
| 1) | 215/65 R17 103H | Winter tyres on Light alloy | Bridgestone | 5mm / 5mm |
| 2) | 215/65 R17 103H | Winter tyres on Light alloy | Bridgestone | 5mm / 5mm |

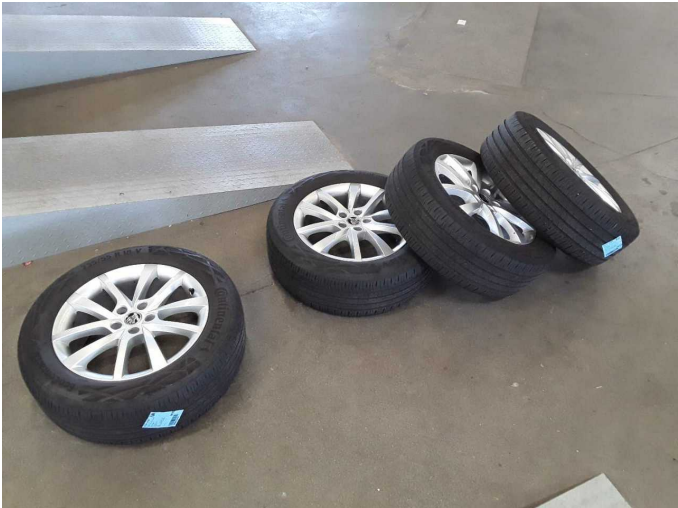
Figure 16: Additional tyres

| # | Tyre size | Type of tyre | Manufacturer | Tread depth |
|---|---|---|---|---|
| 1) | 235/55 R18 100V | Summer tyres on Light alloy | Continental | 4mm / 4mm |
| 2) | 235/55 R18 100V | Summer tyres on Light alloy | Continental | 4mm / 4mm |

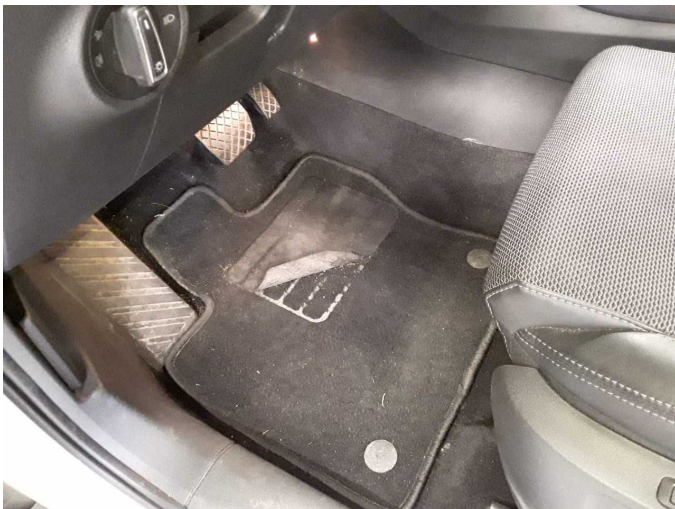
| No. | Component group | Description |
|---|---|---|
| 1 | Trim / covers | Floor mats - Damaged - Replace |

Damage 1: Trim / covers: Floor mats - Damaged - Replace

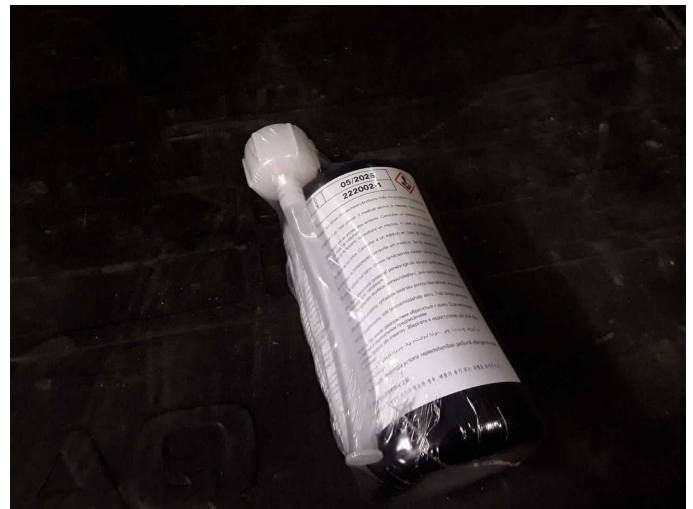
| Typ | Tyre size | Type of tyre | Manufacturer | Tread depth |
|---|---|---|---|---|
| | Tirefit | Expiration date 05/2026 | | |

| No. | Component group | Description |
|---|---|---|
| 2 | Equipment | Tirefit filler - Expired - Replace |

Damage 2: Equipment: Tirefit filler - Expired - Replace

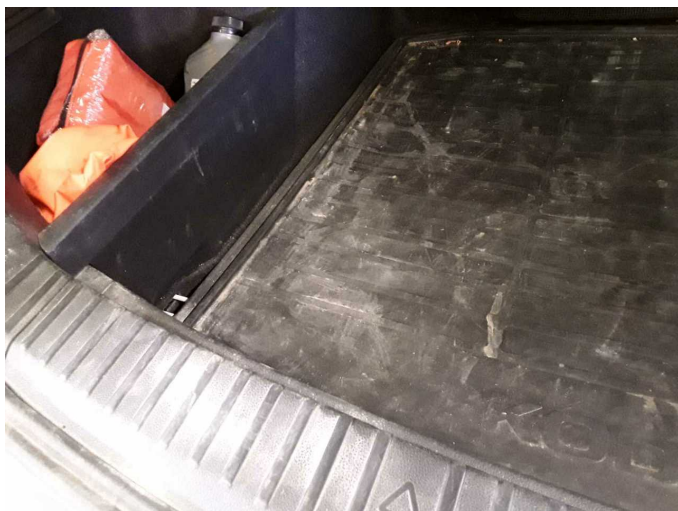
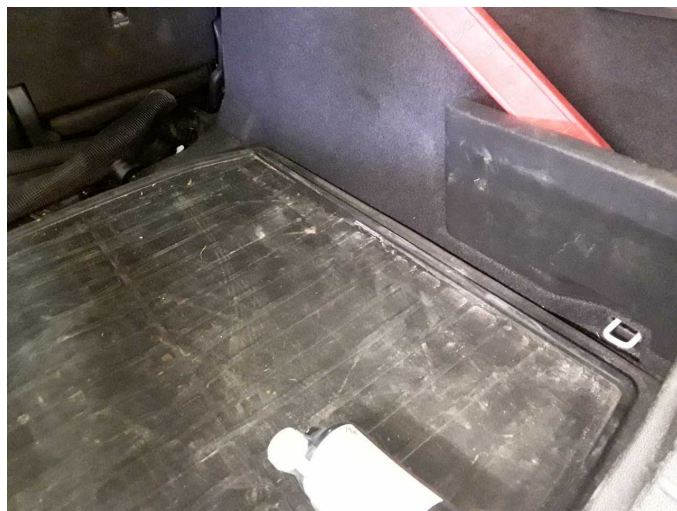
| No. | Component group | Description |
|---|---|---|
| 3 | Interior | Interior - Soiled - Clean |

**Damage 3:** Interior: Interior - Soiled - Clean

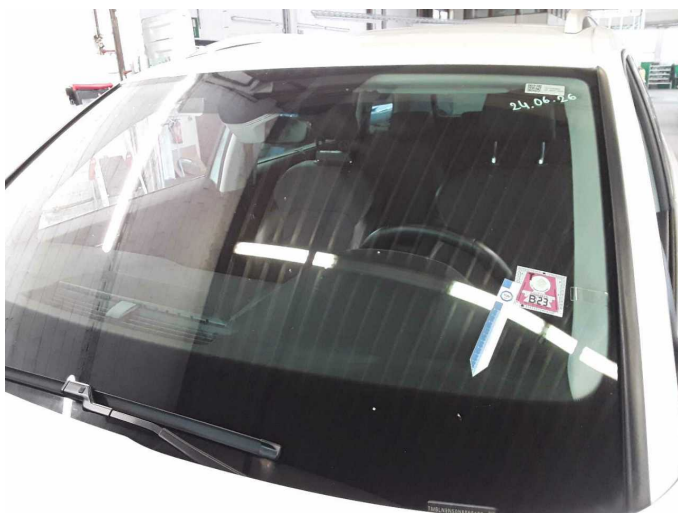
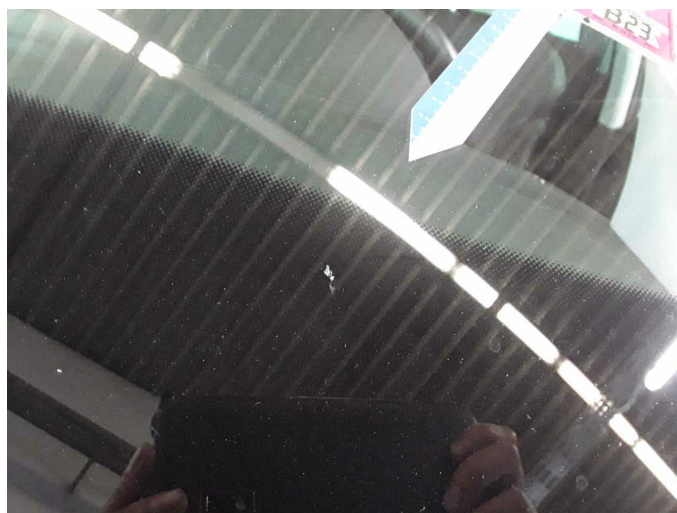
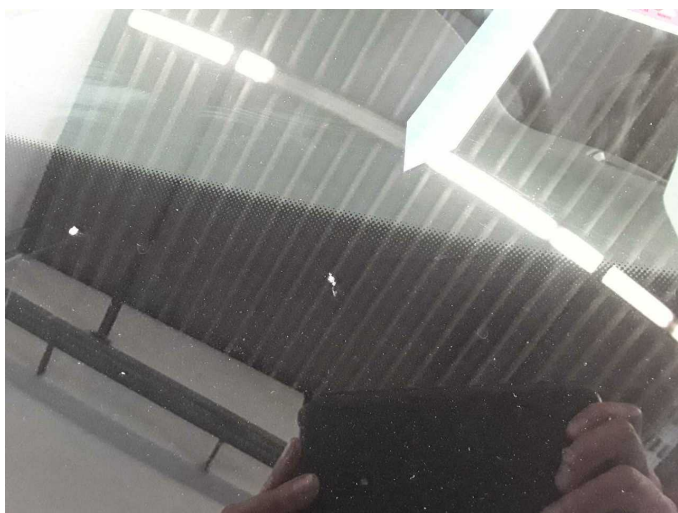
| No. | Component group | Description |
|---|---|---|
| 4 | Vehicle glazing | Windscreen (Rissbildung) - Stone chips - Replace |

**Damage 4:** Vehicle glazing: Windscreen (Rissbildung) - Stone chips - Replace
