Protocol number: 46357309
Order No. / Reference: 26536930
Inspection date: 6 Jul 2026

Manufacturer: Volkswagen

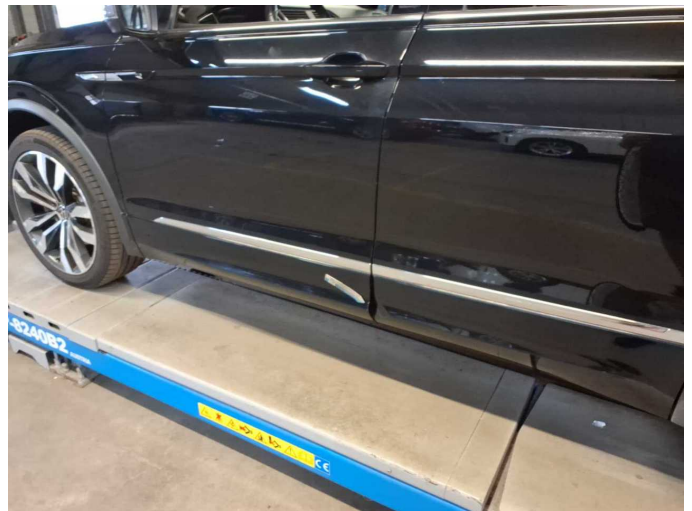
Damage 1: Door - front left side: Brightware - lower - Scratch(es) - Smart repair

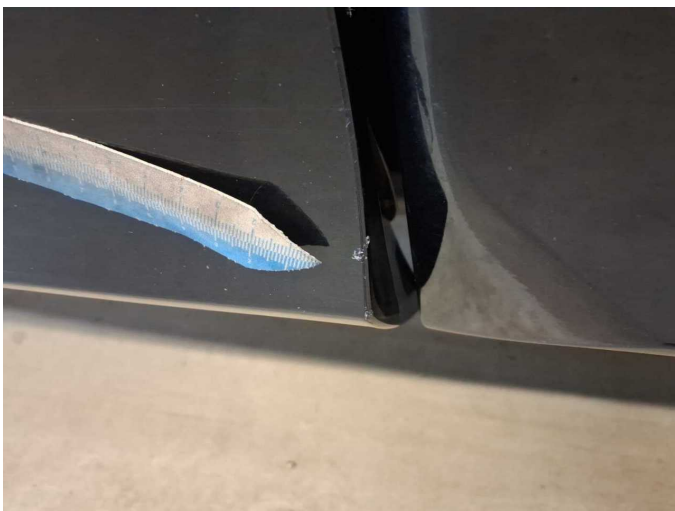
Damage 1: Door - front left side: Brightware - lower - Scratch(es) - Smart repair

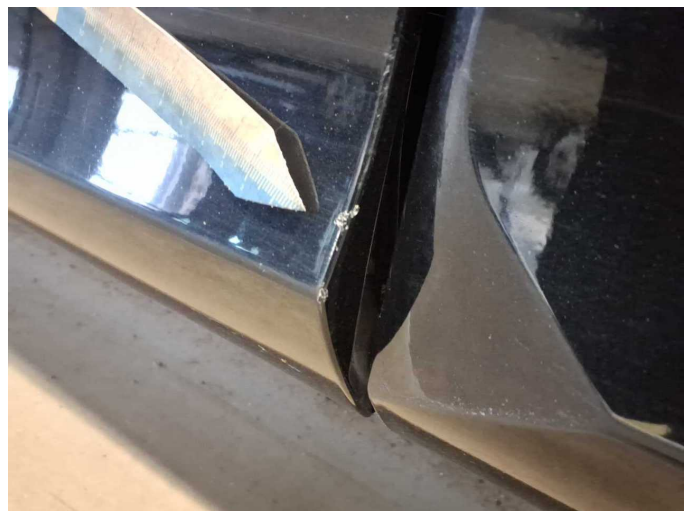
Damage 1: Door - front left side: Brightware - lower - Scratch(es) - Smart repair

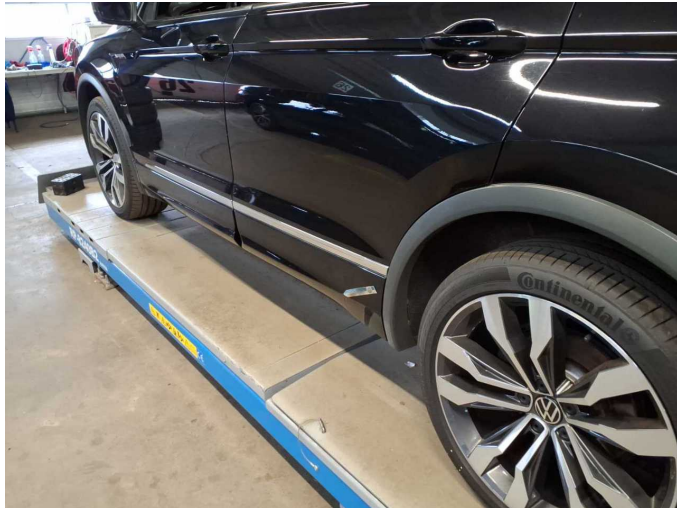
Damage 2: Door - rear left side: Brightware - lower - Scratch(es) - Smart repair

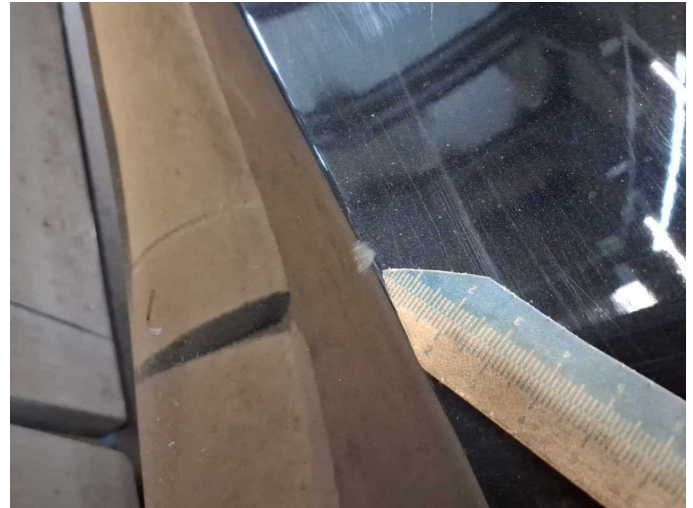
Damage 2: Door - rear left side: Brightware - lower - Scratch(es) - Smart repair

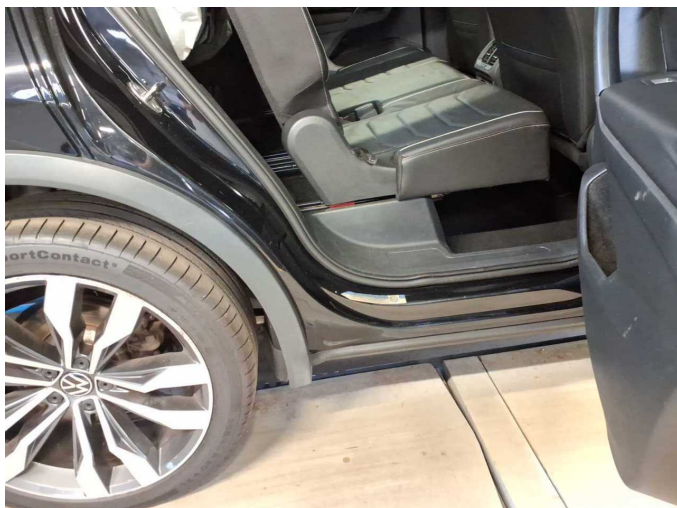
Damage 3: Side panel - rear right side: Sill - Scratch(es) - Smart repair

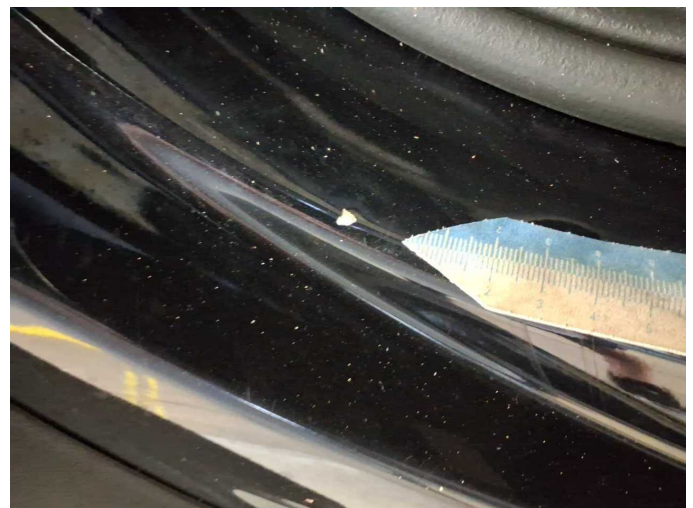
Damage 3: Side panel - rear right side: Sill - Scratch(es) - Smart repair

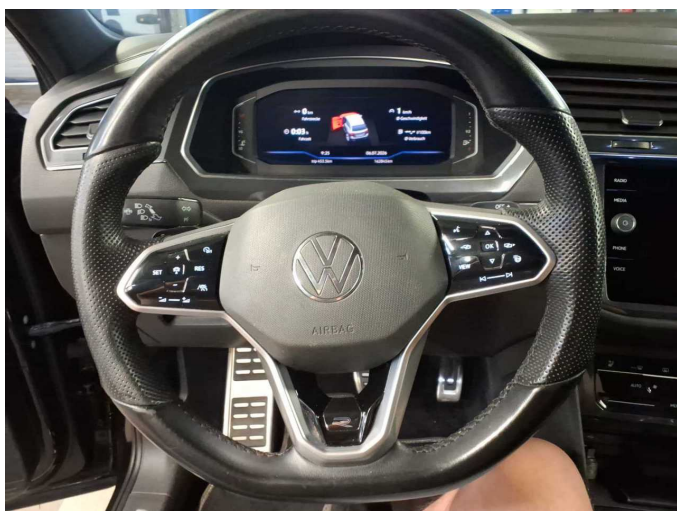
Damage 4: Steering system: Steering wheel - Abrasion - Smart repair

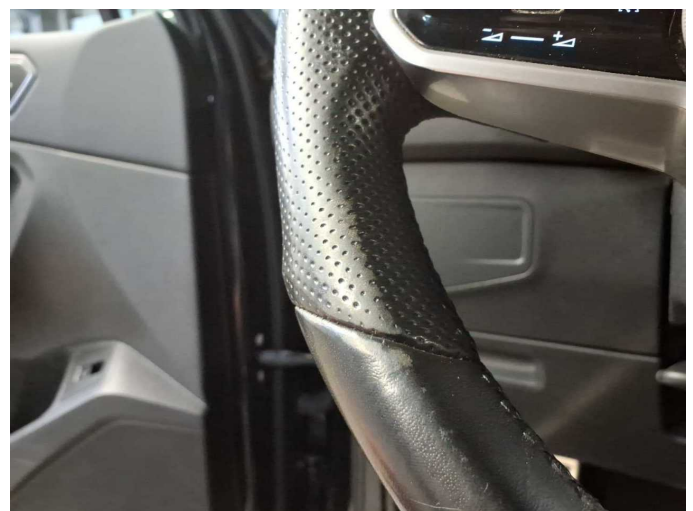
Damage 4: Steering system: Steering wheel - Abrasion - Smart repair

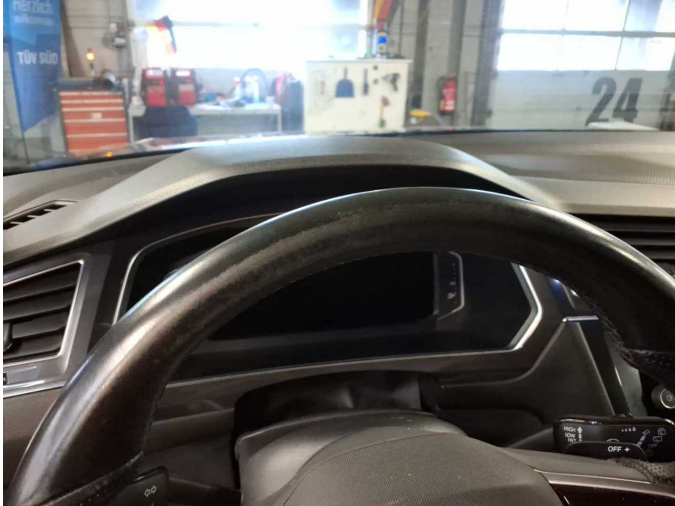
Damage 4: Steering system: Steering wheel - Abrasion - Smart repair

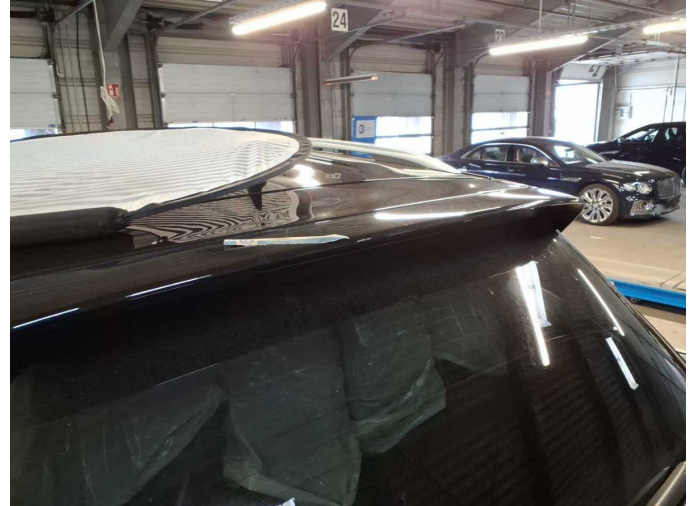
Damage 5: Boot lid / rear door: Rear spoiler - Scratch(es) - Smart repair

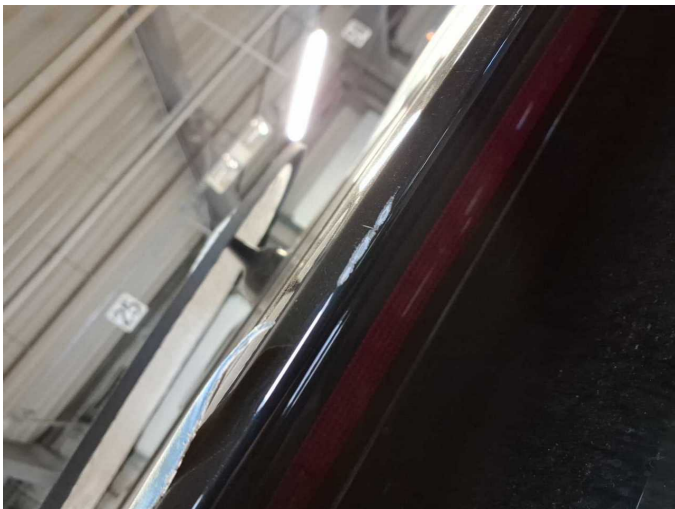
Damage 5: Boot lid / rear door: Rear spoiler - Scratch(es) - Smart repair

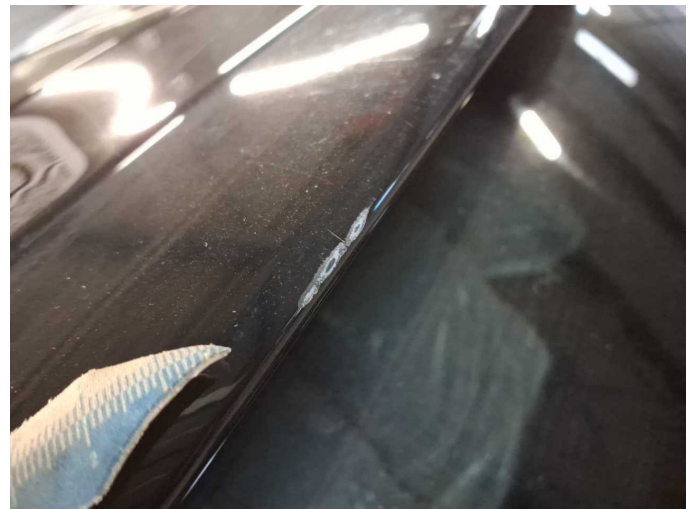
Damage 5: Boot lid / rear door: Rear spoiler - Scratch(es) - Smart repair

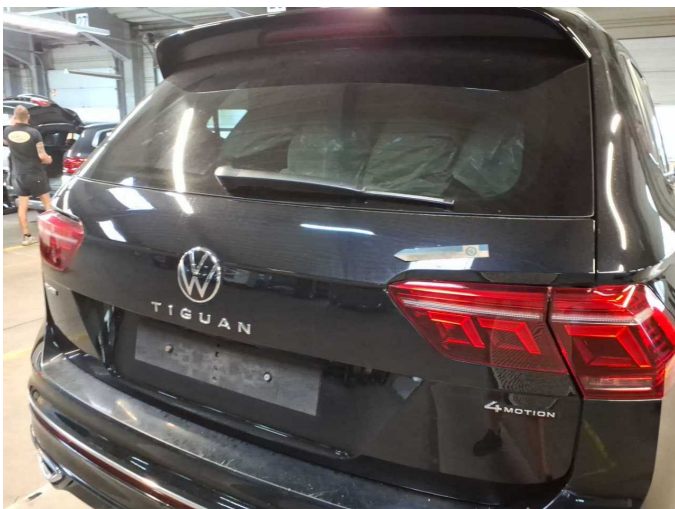
Damage 6: Boot lid / rear door: Boot lid - dent(s) - Smooth repair work

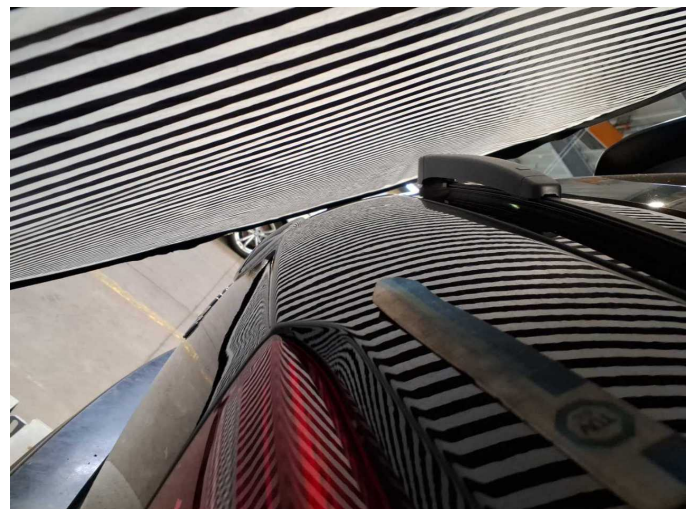
Damage 6: Boot lid / rear door: Boot lid - dent(s) - Smooth repair work

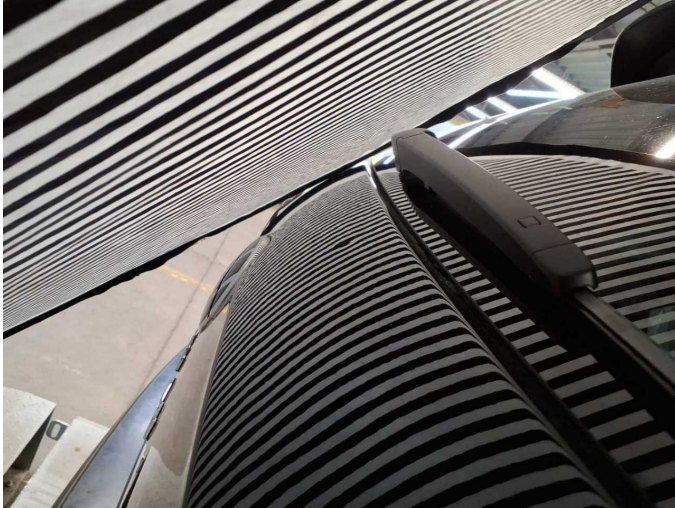
Damage 6: Boot lid / rear door: Boot lid - dent(s) - Smooth repair work

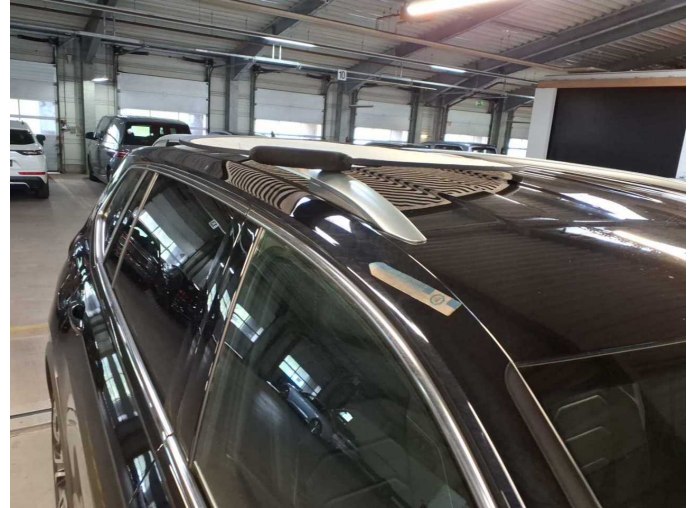
Damage 7: Roof: Roof rail - right side - dent(s) - Smooth repair work

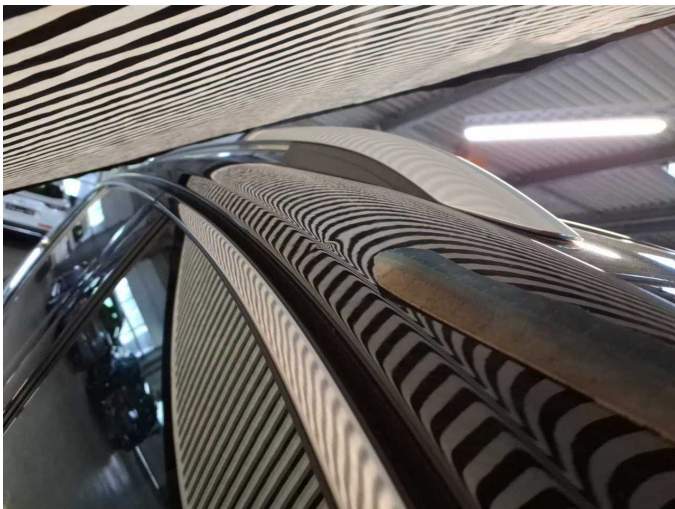
Damage 7: Roof: Roof rail - right side - dent(s) - Smooth repair work

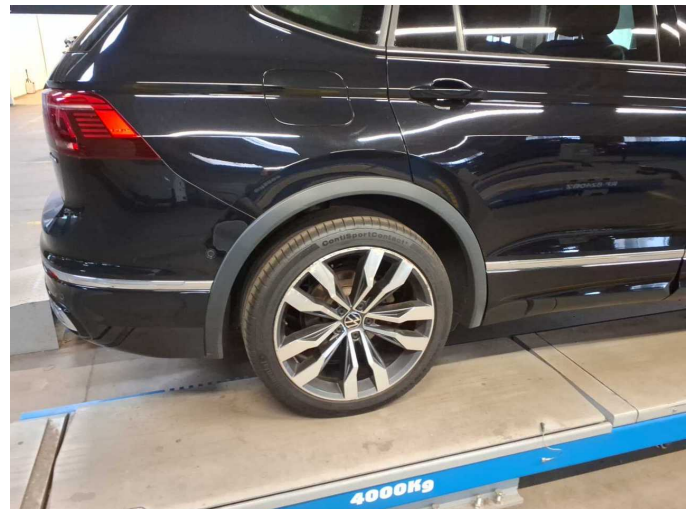
Damage 8: Wheel / tyres: Tyre - rear right side (Flanke) - Damaged - Replace

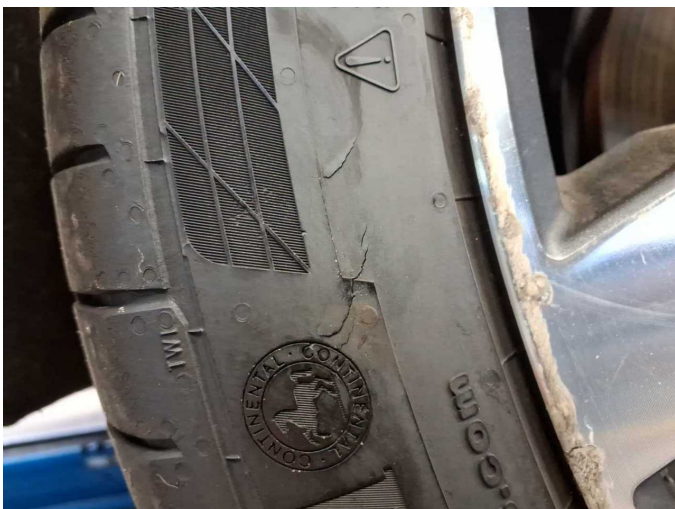
Damage 8: Wheel / tyres: Tyre - rear right side (Flanke) - Damaged - Replace

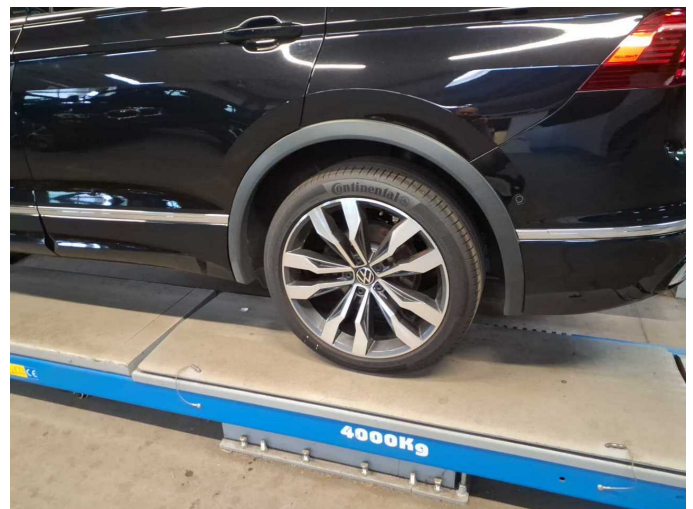
Damage 9: Wheel / tyres: Tyre - rear left side (Flanke) - Damaged - Replace

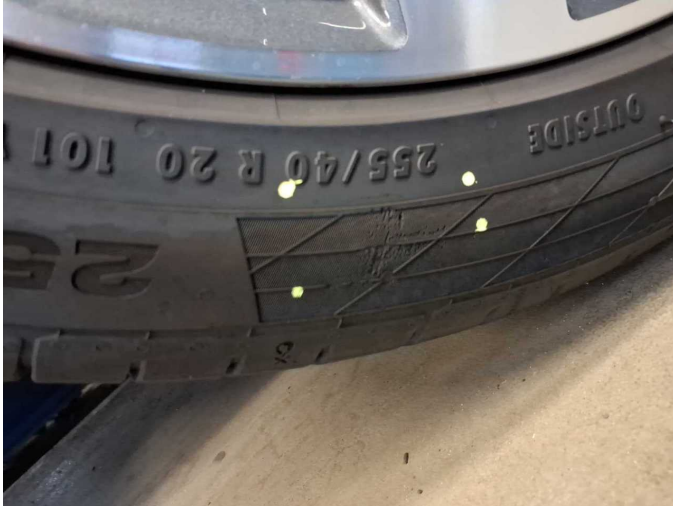
Damage 9: Wheel / tyres: Tyre - rear left side (Flanke) - Damaged - Replace

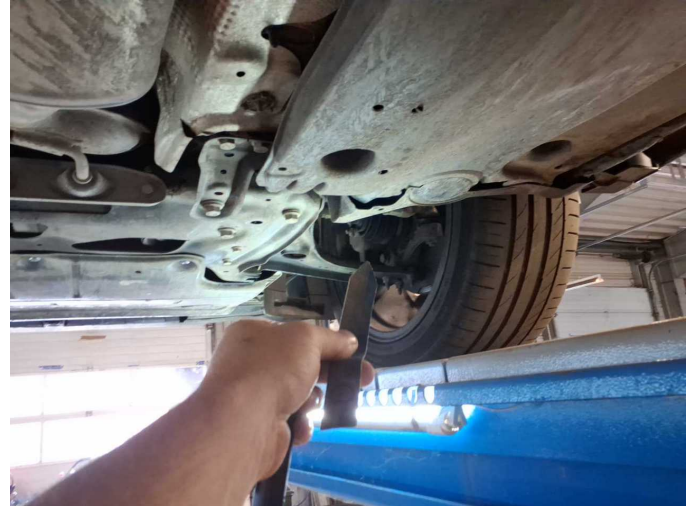
Damage 10: Drive train: Sleeve prop shaft - front right side (Fett tritt aus) - Loose - Replace

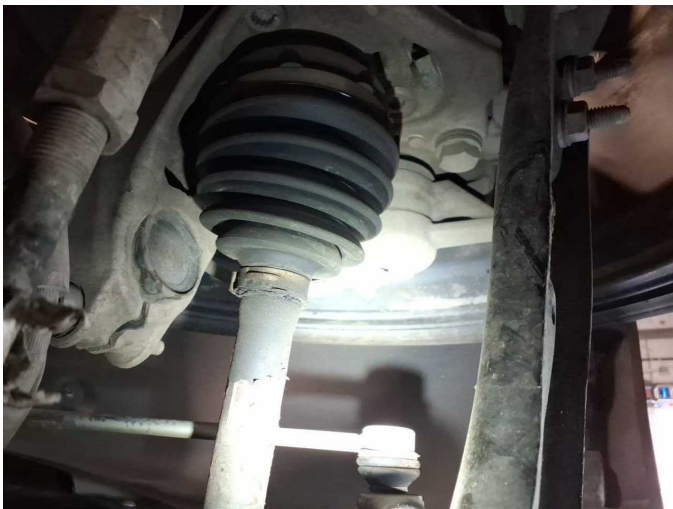
Damage 10: Drive train: Sleeve prop shaft - front right side (Fett tritt aus) - Loose - Replace

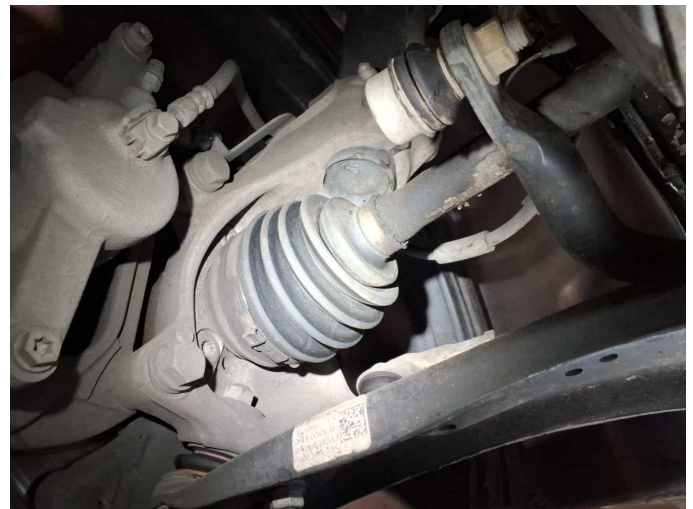
Damage 10: Drive train: Sleeve prop shaft - front right side (Fett tritt aus) - Loose - Replace

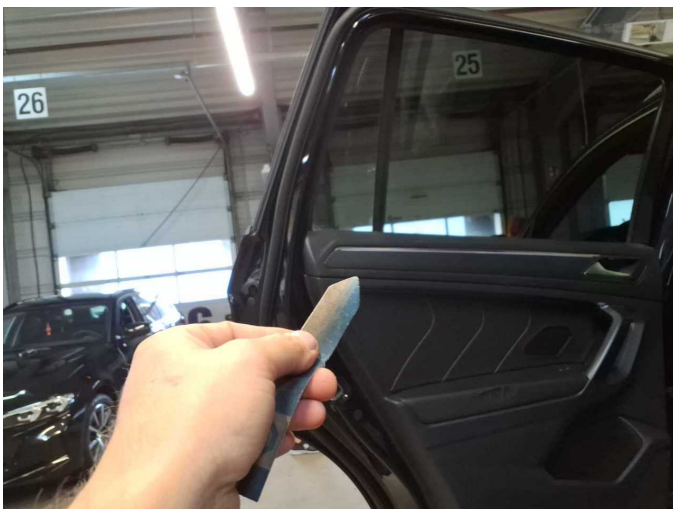
Damage 11: Trim / covers: Door trim - rear left side (Kratzer, verformt) - Damaged - Replace

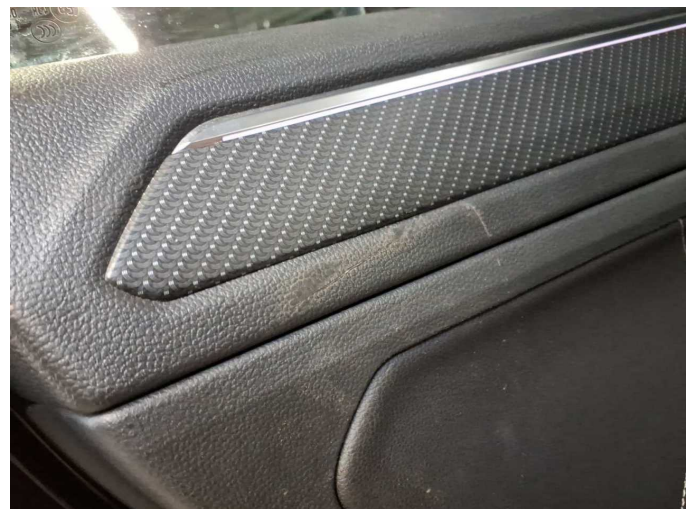
Damage 11: Trim / covers: Door trim - rear left side (Kratzer, verformt) - Damaged - Replace

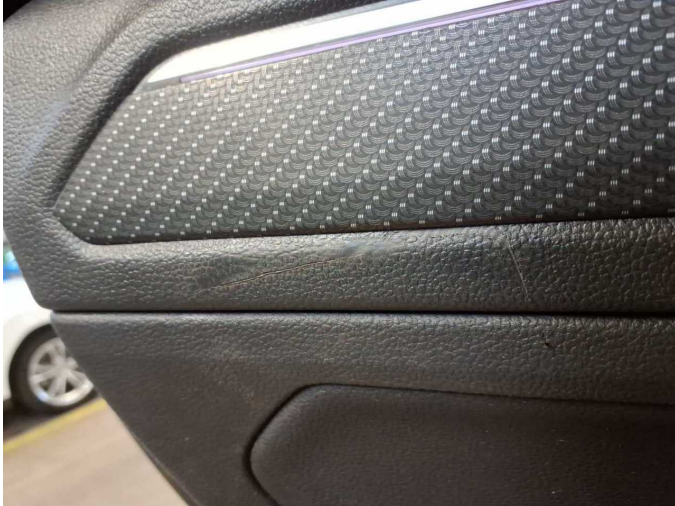
Damage 11: Trim / covers: Door trim - rear left side (Kratzer, verformt) - Damaged - Replace

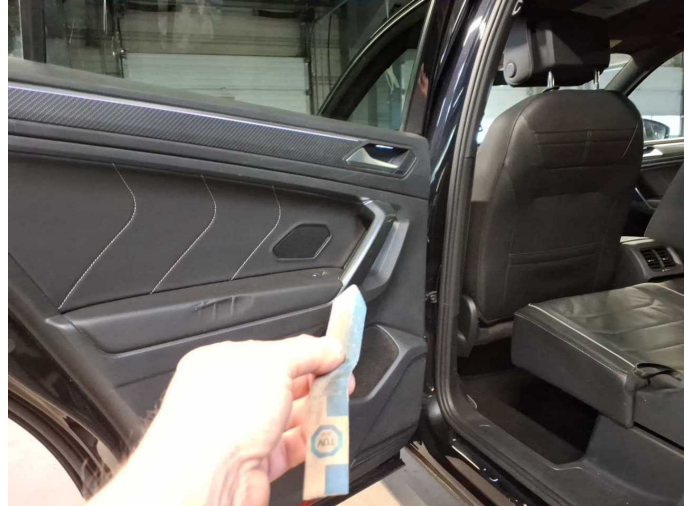
Damage 11: Trim / covers: Door trim - rear left side (Kratzer, verformt) - Damaged - Replace

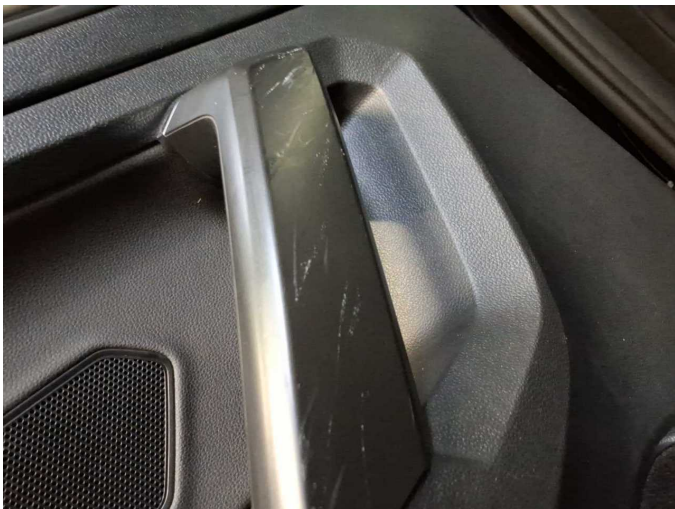
Damage 11: Trim / covers: Door trim - rear left side (Kratzer, verformt) - Damaged - Replace

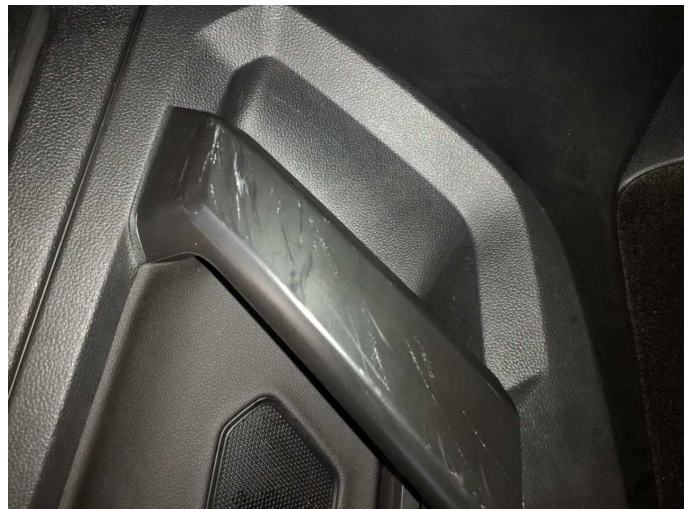
Damage 11: Trim / covers: Door trim - rear left side (Kratzer, verformt) - Damaged - Replace

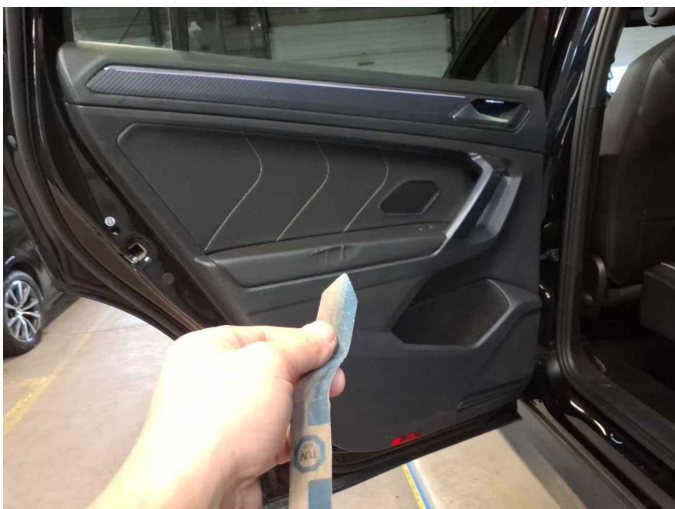
Damage 11: Trim / covers: Door trim - rear left side (Kratzer, verformt) - Damaged - Replace

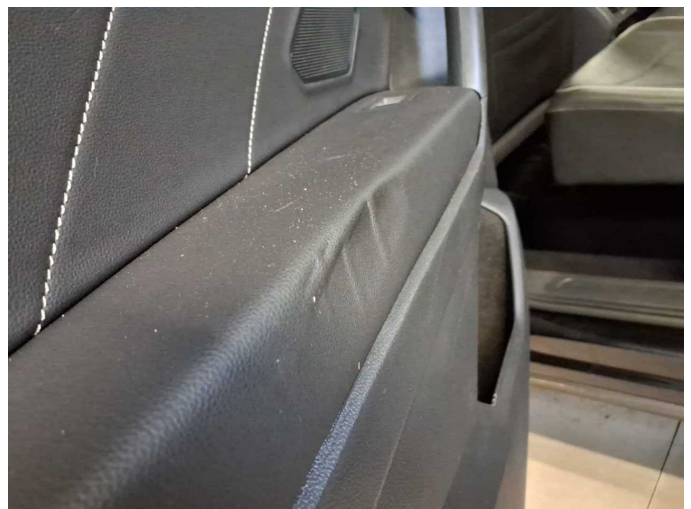
Damage 11: Trim / covers: Door trim - rear left side (Kratzer, verformt) - Damaged - Replace

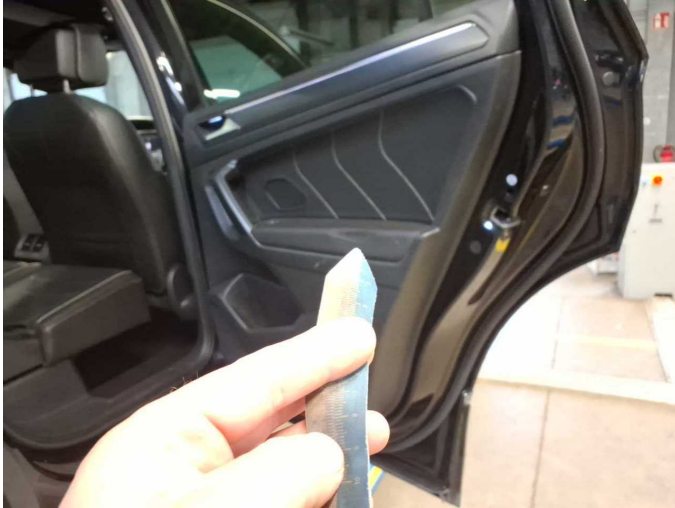
Damage 12: Trim / covers: Door trim - rear right side - Deformed - Replace

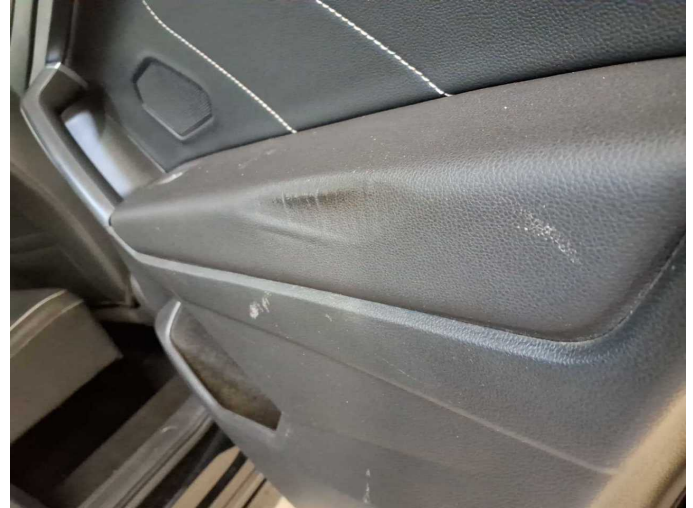
Damage 12: Trim / covers: Door trim - rear right side - Deformed - Replace

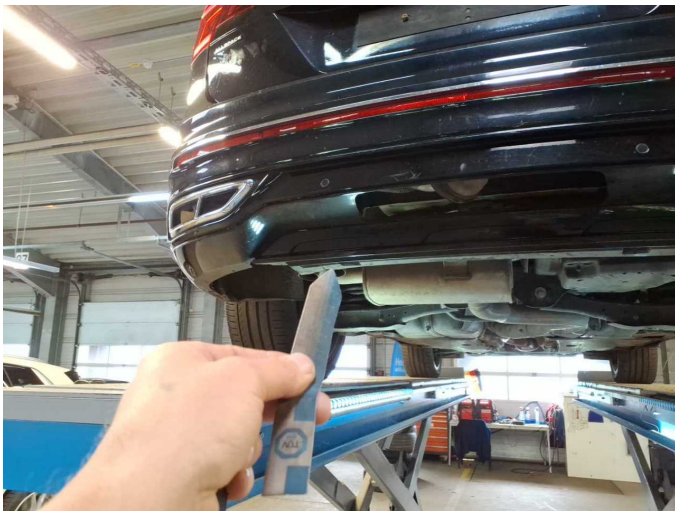
Damage 13: Rear bumper: Spoiler - Broken / torn - Replace

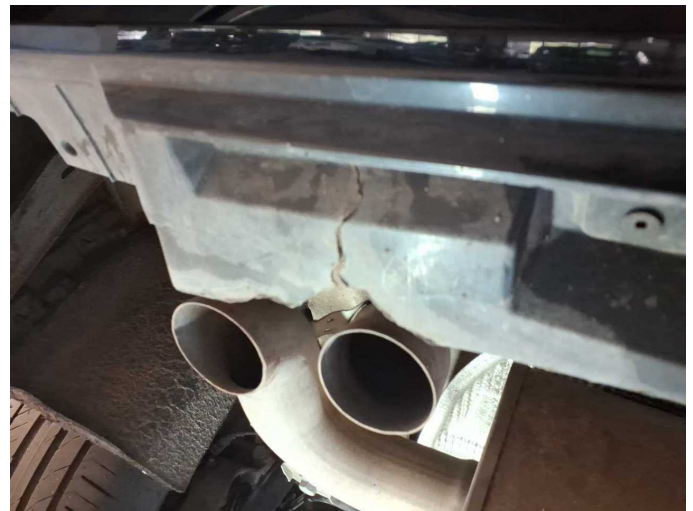
Damage 13: Rear bumper: Spoiler - Broken / torn - Replace

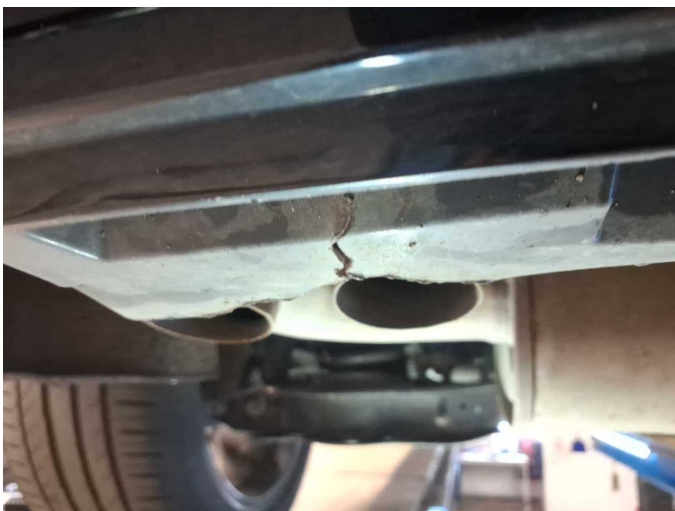
Damage 13: Rear bumper: Spoiler - Broken / torn - Replace

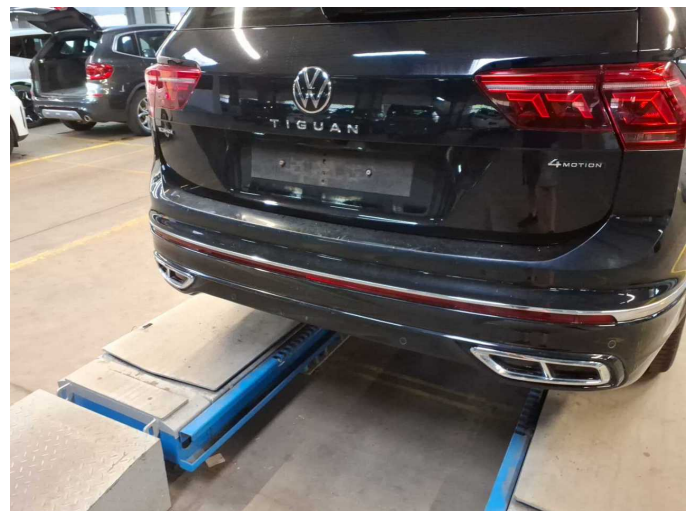
Damage 14: Rear bumper: Rear bumper (Verformt) - Scratched - Repair and paint

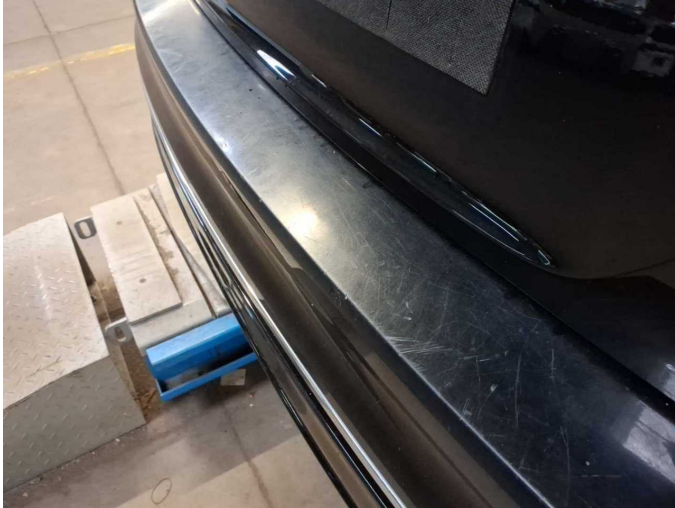
Damage 14: Rear bumper: Rear bumper (Verformt) - Scratched - Repair and paint

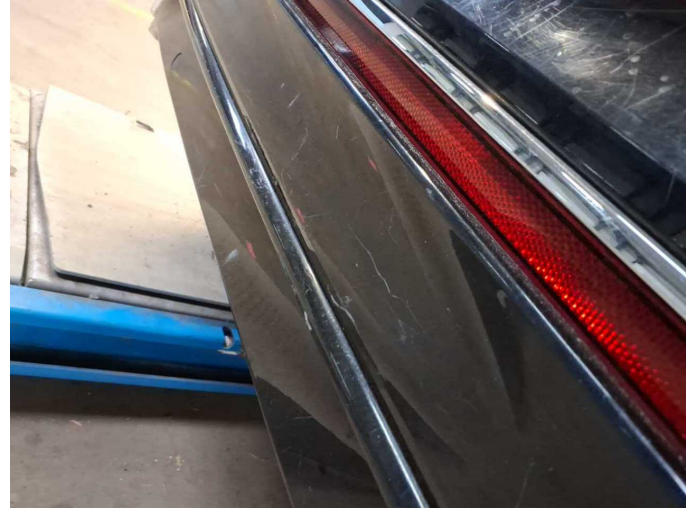
Damage 14: Rear bumper: Rear bumper (Verformt) - Scratched - Repair and paint

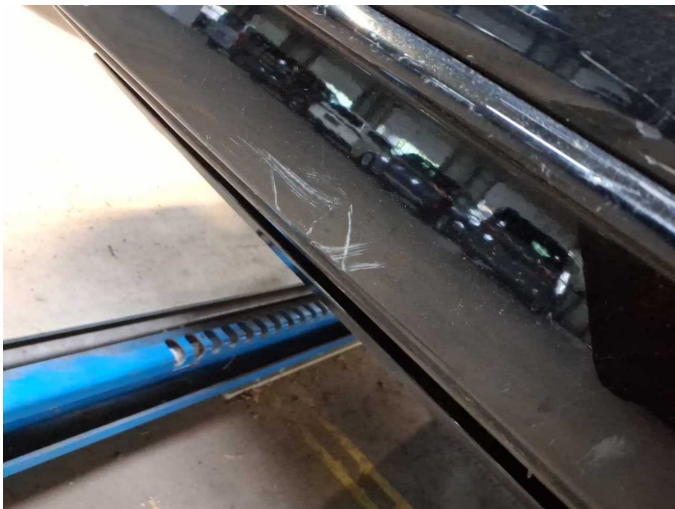
Damage 14: Rear bumper: Rear bumper (Verformt) - Scratched - Repair and paint

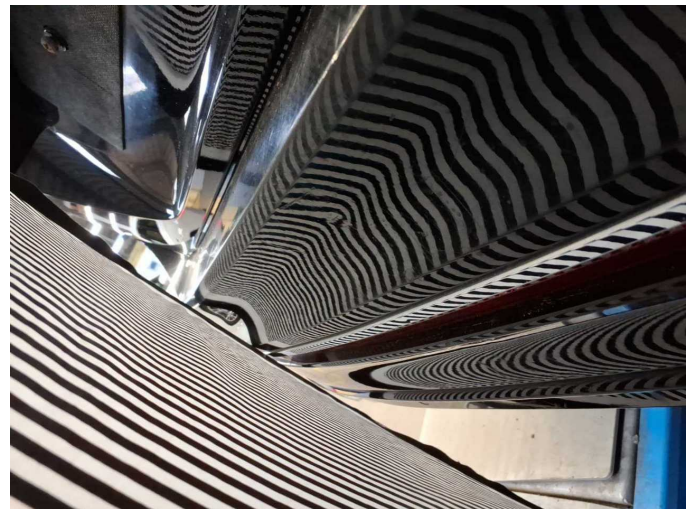
Damage 14: Rear bumper: Rear bumper (Verformt) - Scratched - Repair and paint

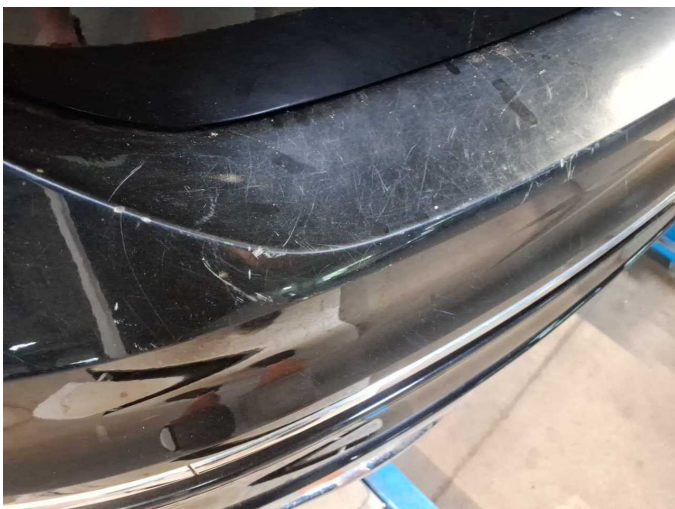
Damage 14: Rear bumper: Rear bumper (Verformt) - Scratched - Repair and paint

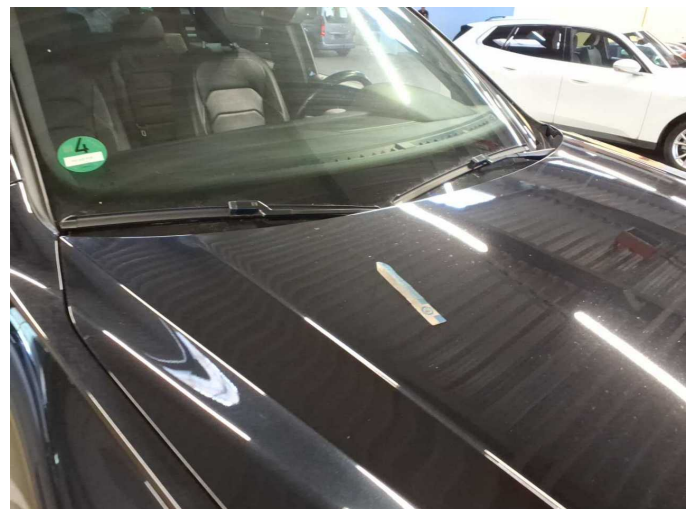
Damage 15: Bonnet: Bonnet - Dent / paintcoat damage - Repair and paint

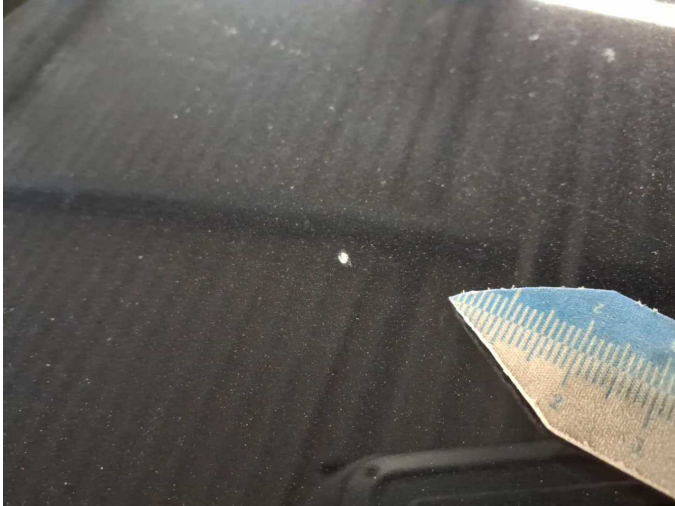
Damage 15: Bonnet: Bonnet - Dent / paintcoat damage - Repair and paint

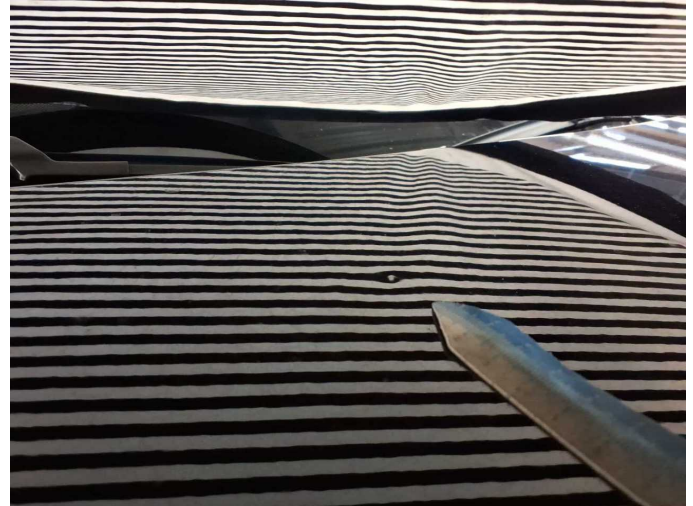
Damage 15: Bonnet: Bonnet - Dent / paintcoat damage - Repair and paint

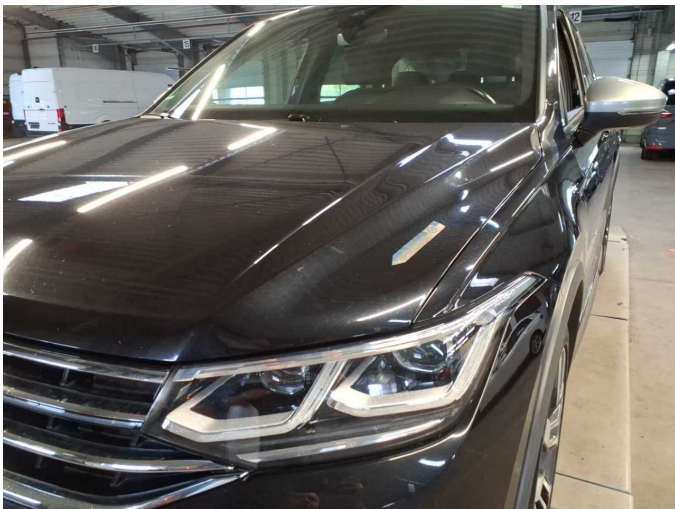
Damage 15: Bonnet: Bonnet - Dent / paintcoat damage - Repair and paint

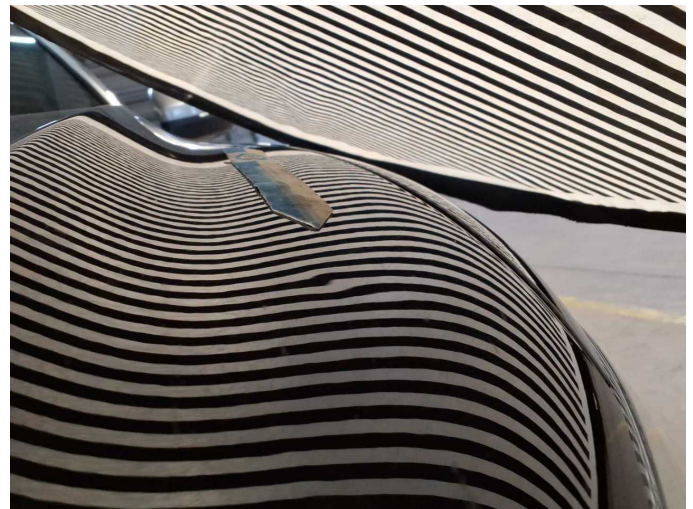
Damage 15: Bonnet: Bonnet - Dent / paintcoat damage - Repair and paint

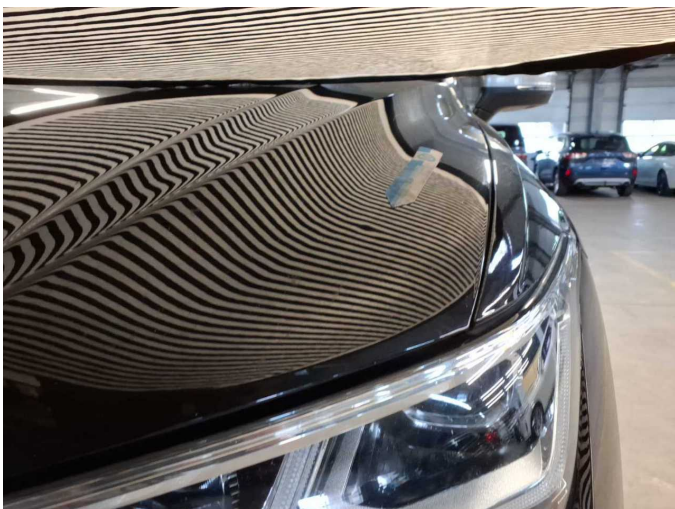
Damage 15: Bonnet: Bonnet - Dent / paintcoat damage - Repair and paint

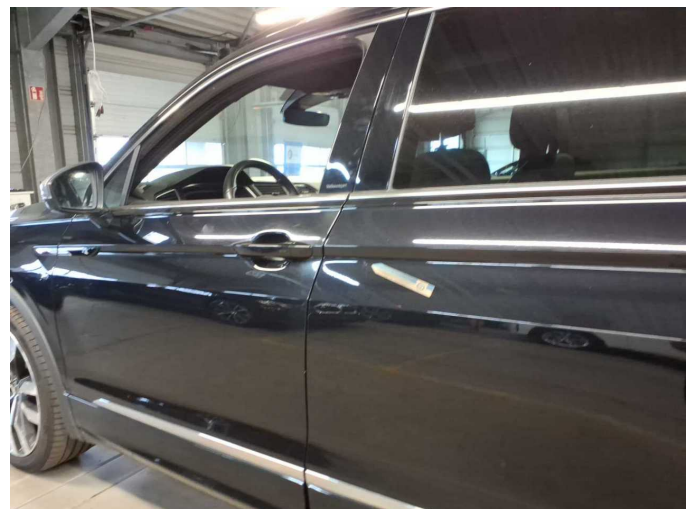
Damage 16: Door - rear left side: Door - Dent / paintcoat damage - Repair and paint

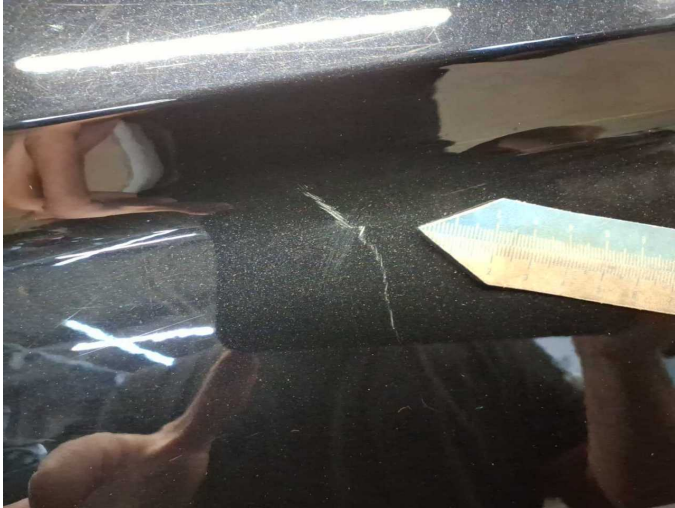
Damage 16: Door - rear left side: Door - Dent / paintcoat damage - Repair and paint

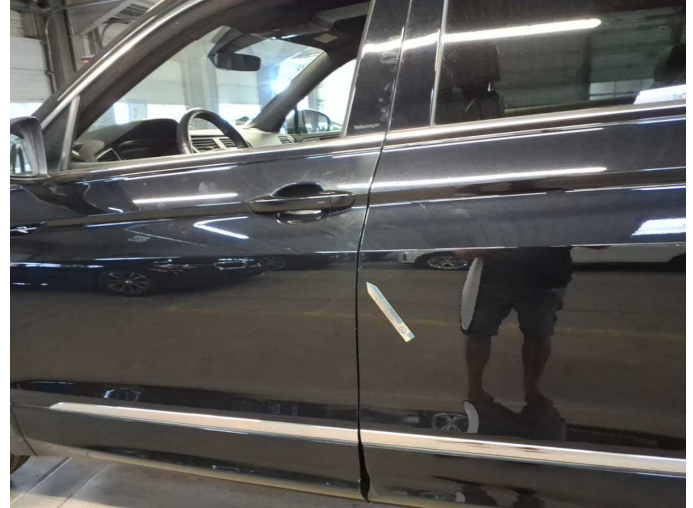
Damage 16: Door - rear left side: Door - Dent / paintcoat damage - Repair and paint

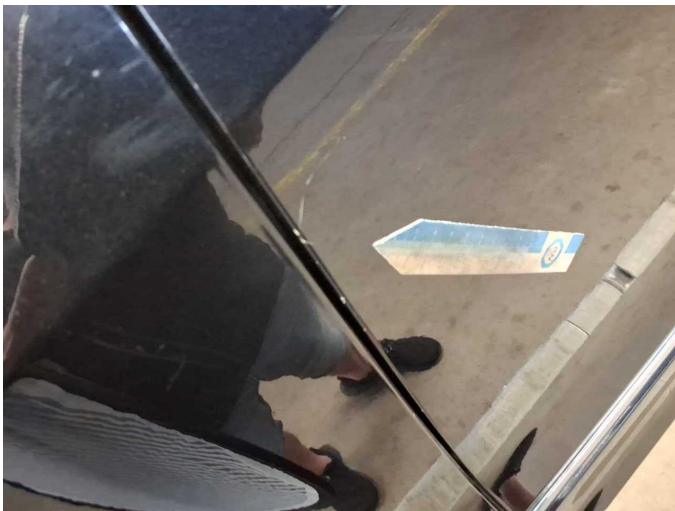
Damage 16: Door - rear left side: Door - Dent / paintcoat damage - Repair and paint

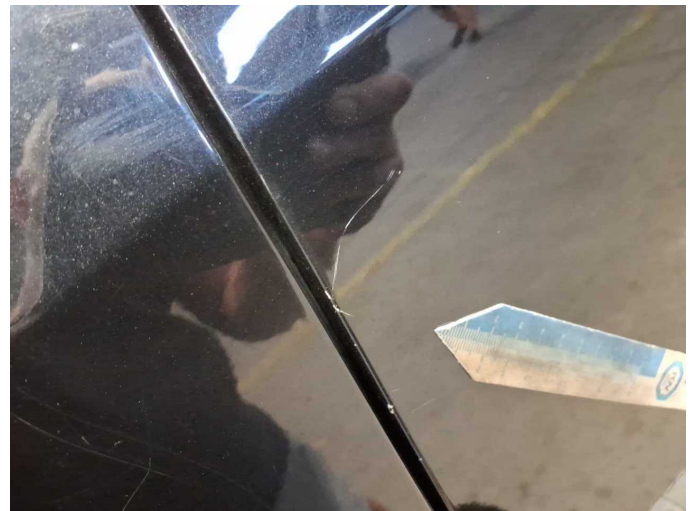
Damage 16: Door - rear left side: Door - Dent / paintcoat damage - Repair and paint

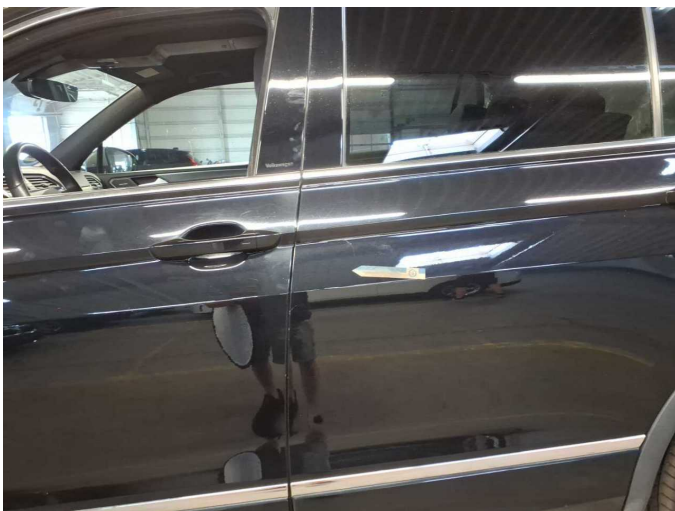
Damage 16: Door - rear left side: Door - Dent / paintcoat damage - Repair and paint

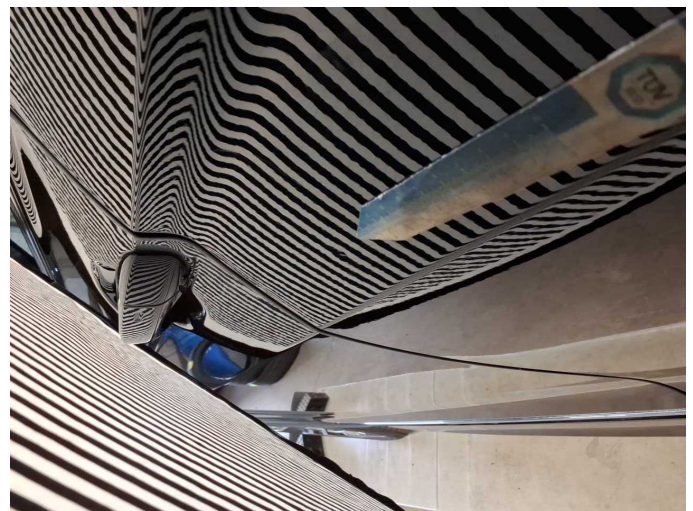
Damage 16: Door - rear left side: Door - Dent / paintcoat damage - Repair and paint

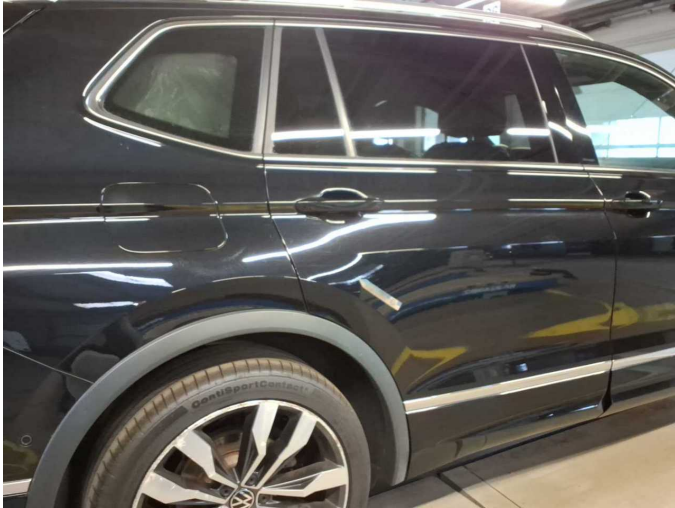
Damage 17: Door - rear right side: Door - Dent / paintcoat damage - Repair and paint

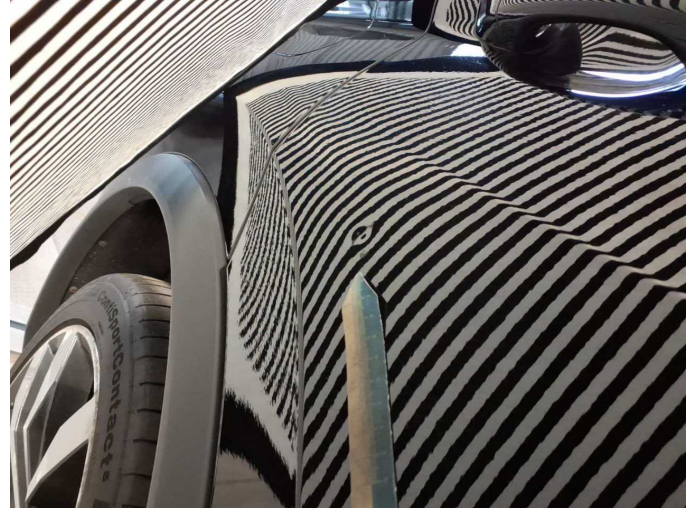
Damage 17: Door - rear right side: Door - Dent / paintcoat damage - Repair and paint

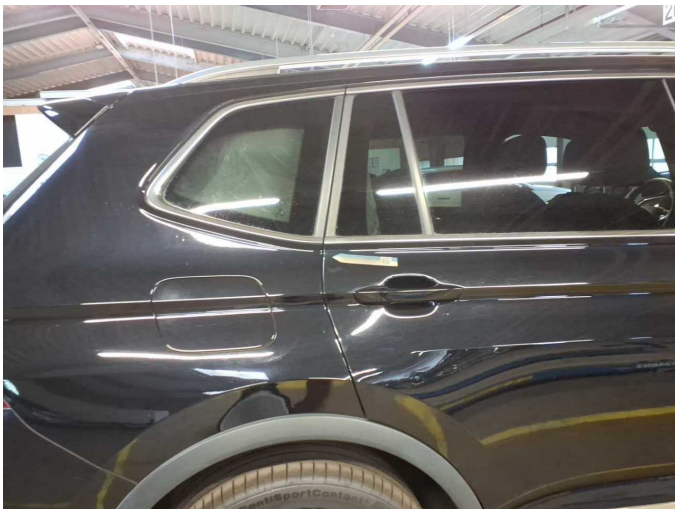
Damage 17: Door - rear right side: Door - Dent / paintcoat damage - Repair and paint

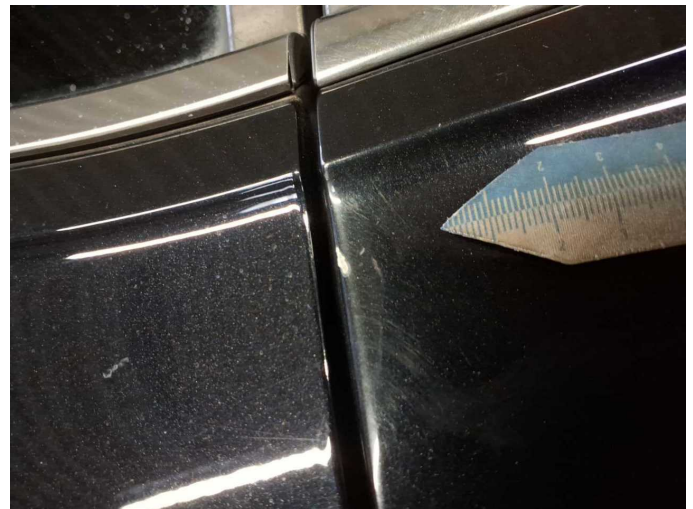
Damage 17: Door - rear right side: Door - Dent / paintcoat damage - Repair and paint

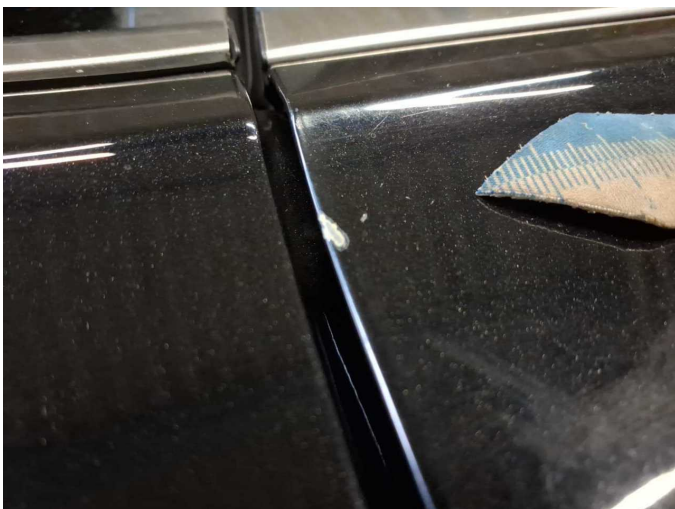
Damage 17: Door - rear right side: Door - Dent / paintcoat damage - Repair and paint
