Protocol number: 46357309
Order No. / Reference: 26536930
Inspection date: 6 Jul 2026

Manufacturer: Volkswagen

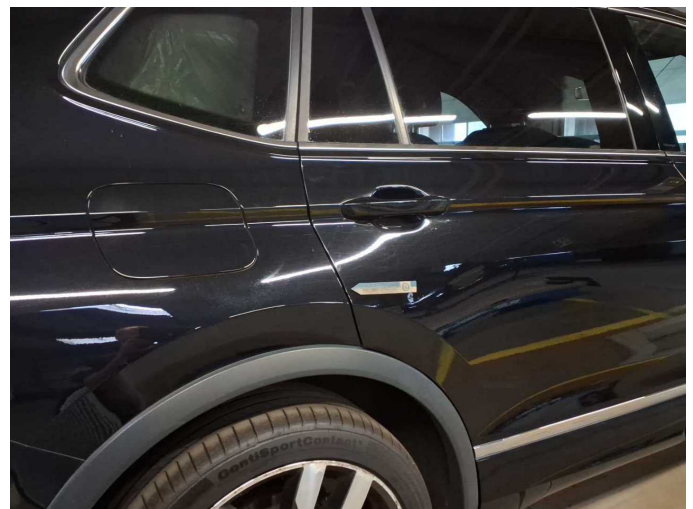
Damage 17: Door - rear right side: Door - Dent / paintcoat damage - Repair and paint

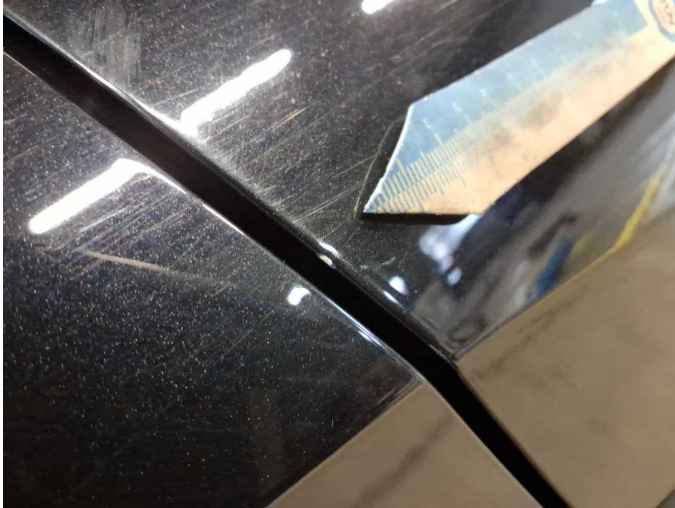
Damage 17: Door - rear right side: Door - Dent / paintcoat damage - Repair and paint

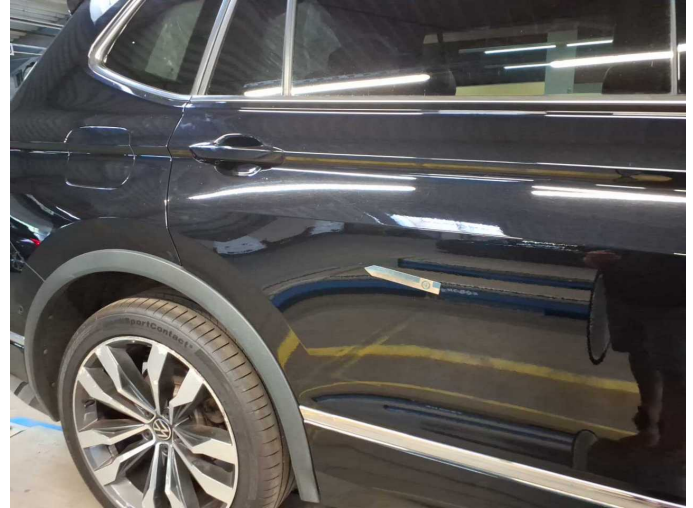
Damage 17: Door - rear right side: Door - Dent / paintcoat damage - Repair and paint

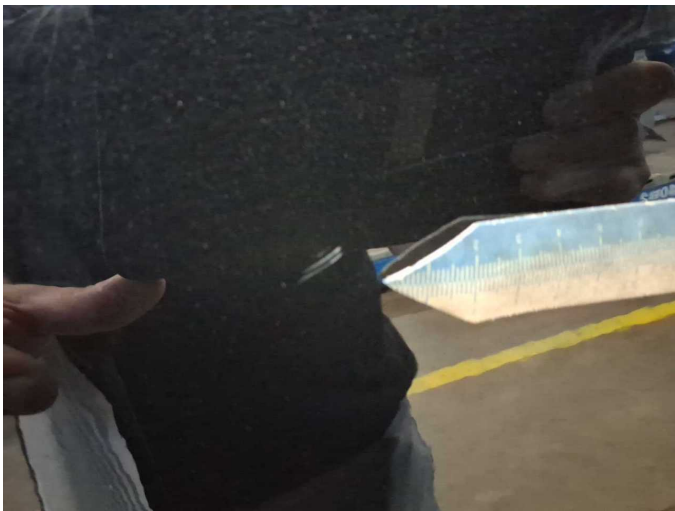
Damage 17: Door - rear right side: Door - Dent / paintcoat damage - Repair and paint

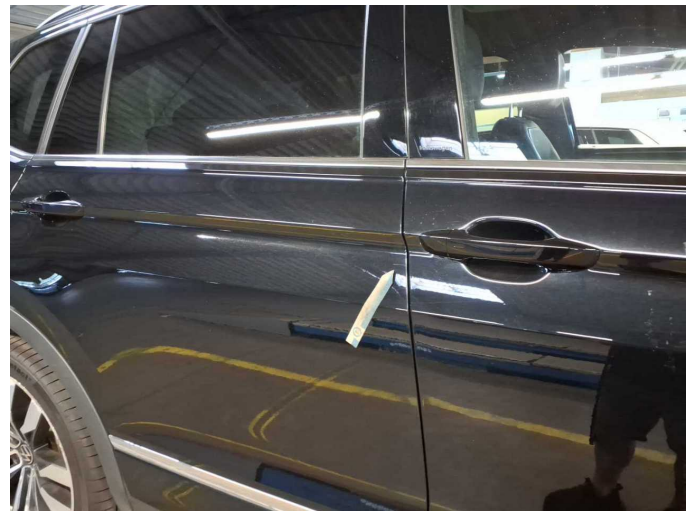
Damage 17: Door - rear right side: Door - Dent / paintcoat damage - Repair and paint

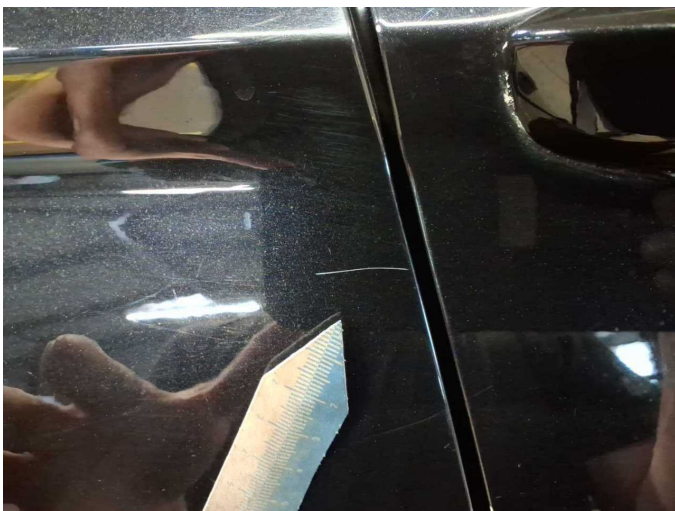
Damage 17: Door - rear right side: Door - Dent / paintcoat damage - Repair and paint

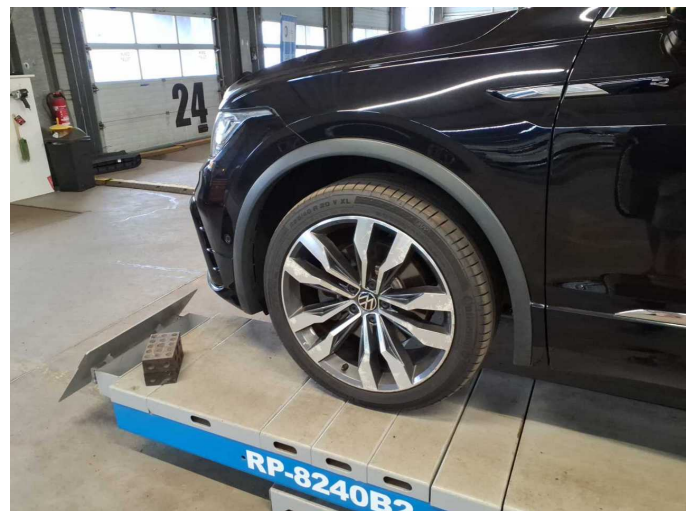
Damage 18: Wheel / tyres: Alloy rim - front left side (Oxidation) - Paint defect - Replace

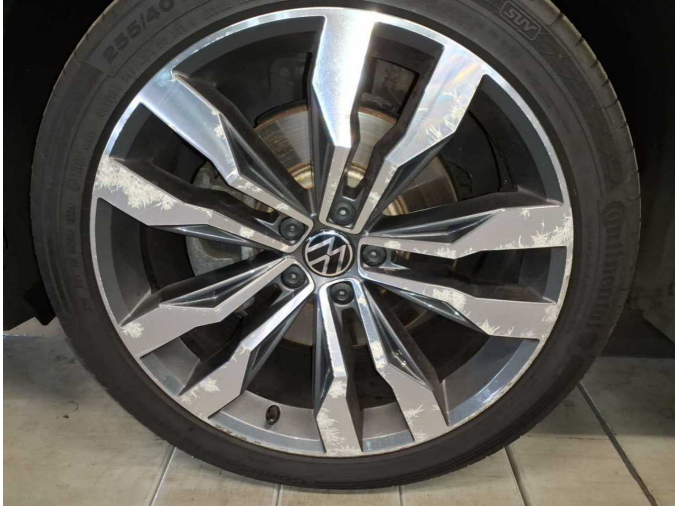
Damage 18: Wheel / tyres: Alloy rim - front left side (Oxidation) - Paint defect - Replace

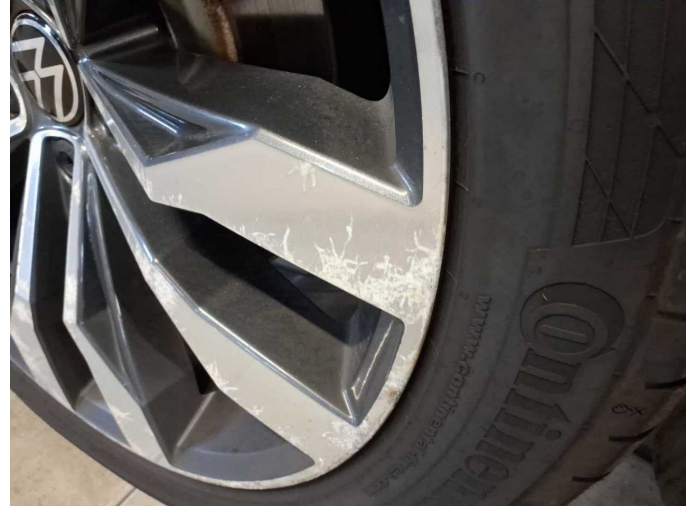
Damage 18: Wheel / tyres: Alloy rim - front left side (Oxidation) - Paint defect - Replace

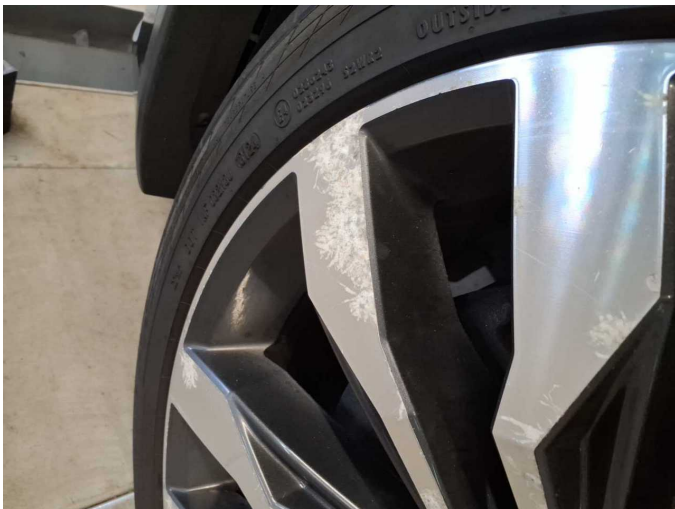
Damage 18: Wheel / tyres: Alloy rim - front left side (Oxidation) - Paint defect - Replace

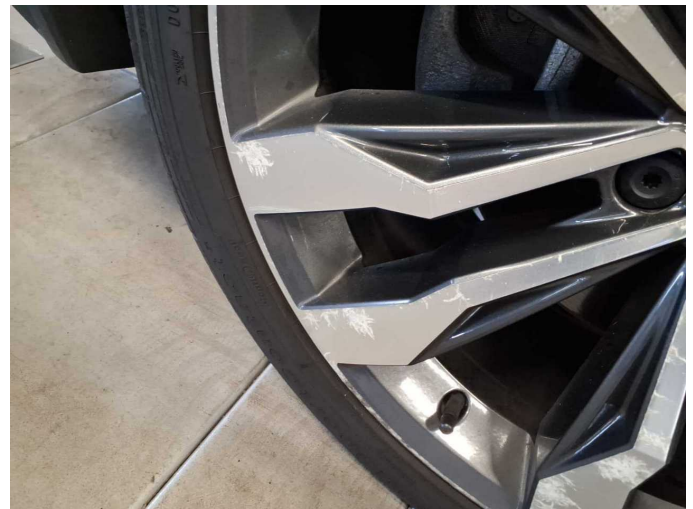
Damage 18: Wheel / tyres: Alloy rim - front left side (Oxidation) - Paint defect - Replace

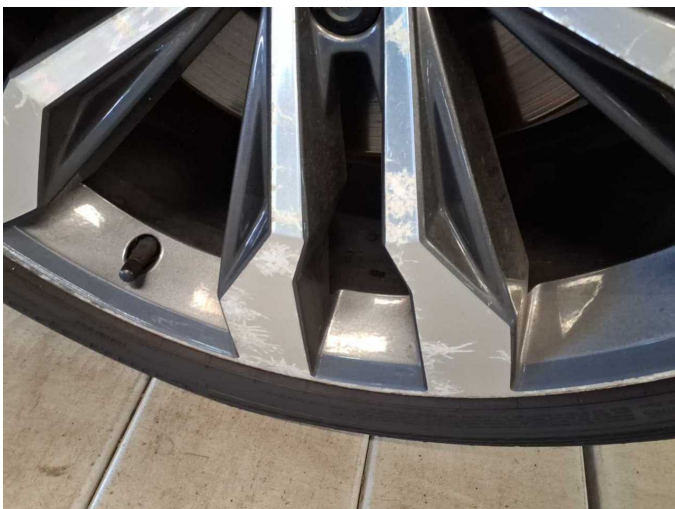
Damage 18: Wheel / tyres: Alloy rim - front left side (Oxidation) - Paint defect - Replace

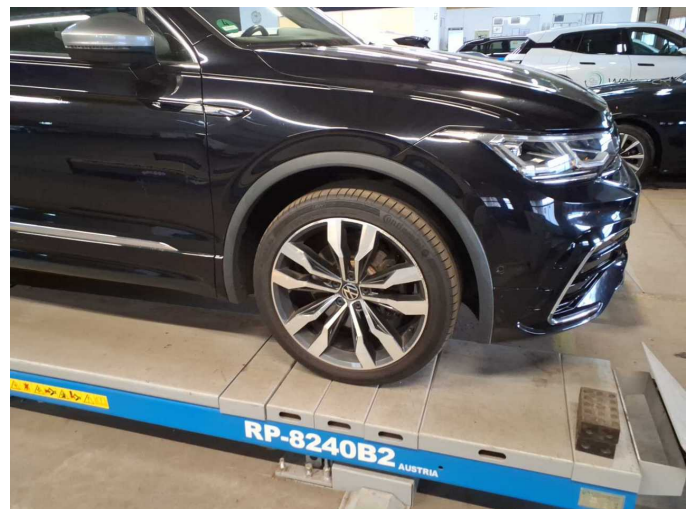
Damage 19: Wheel / tyres: Alloy rim - front right side (Materialabtrag) - Scratched - Replace

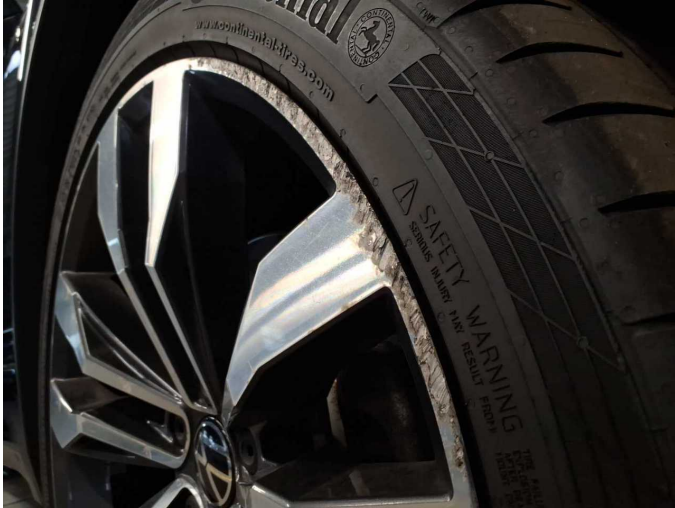
Damage 19: Wheel / tyres: Alloy rim - front right side (Materialabtrag) - Scratched - Replace

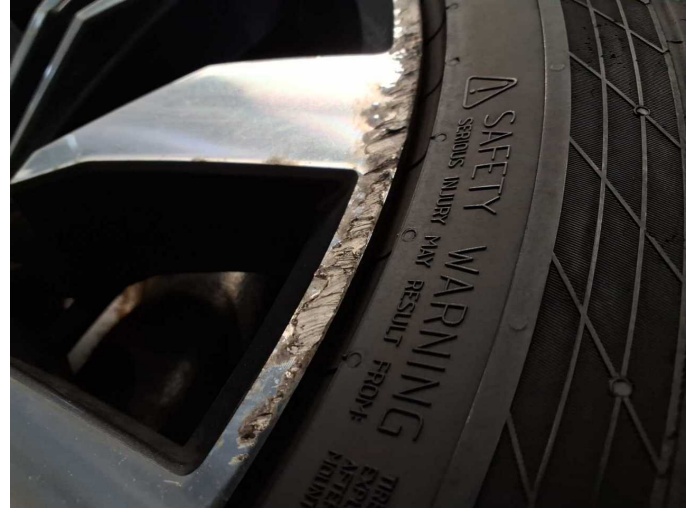
Damage 19: Wheel / tyres: Alloy rim - front right side (Materialabtrag) - Scratched - Replace

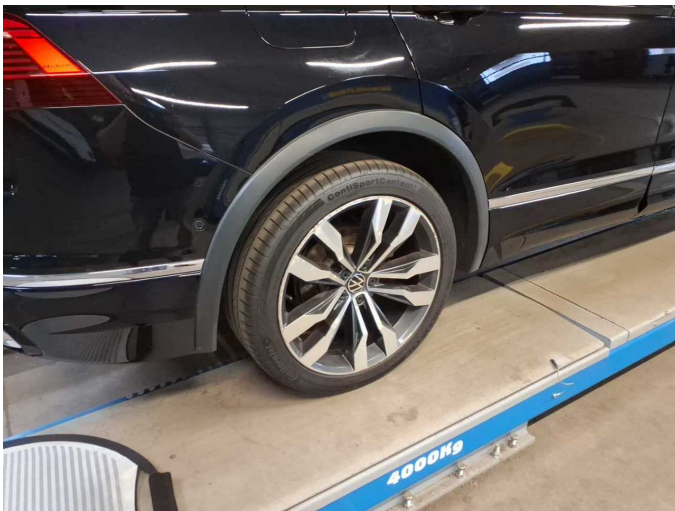
Damage 20: Wheel / tyres: Alloy rim - rear right side (Materialabtrag) - Scratched - Replace

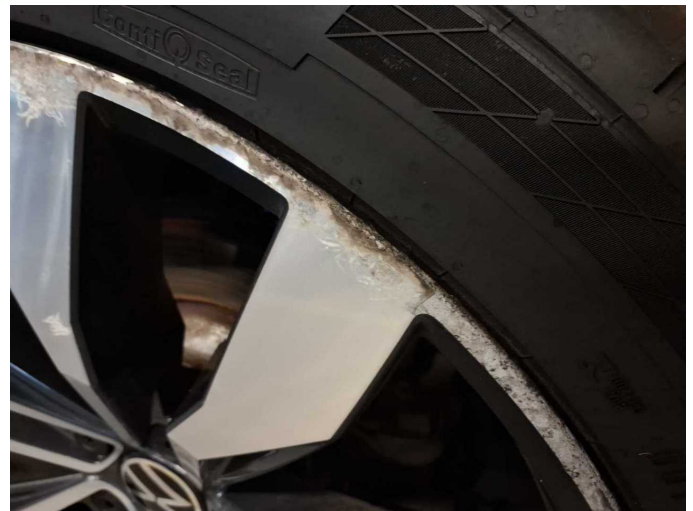
Damage 20: Wheel / tyres: Alloy rim - rear right side (Materialabtrag) - Scratched - Replace

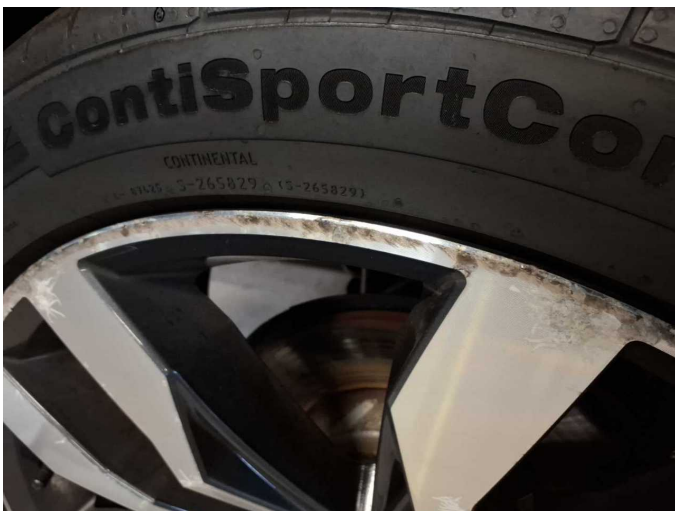
Damage 20: Wheel / tyres: Alloy rim - rear right side (Materialabtrag) - Scratched - Replace

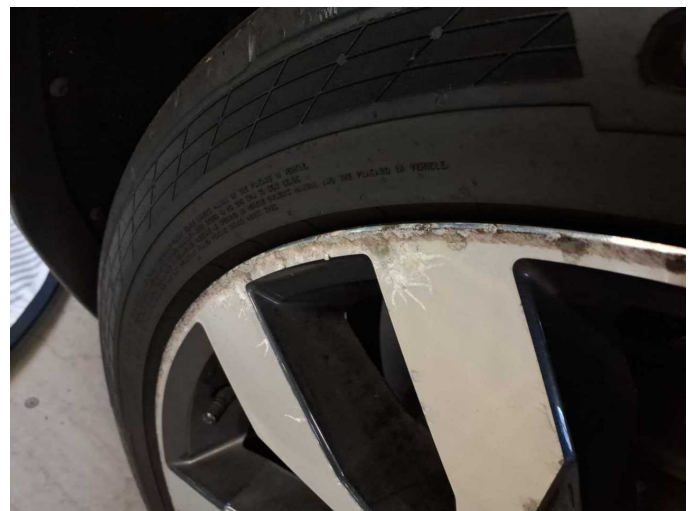
Damage 20: Wheel / tyres: Alloy rim - rear right side (Materialabtrag) - Scratched - Replace

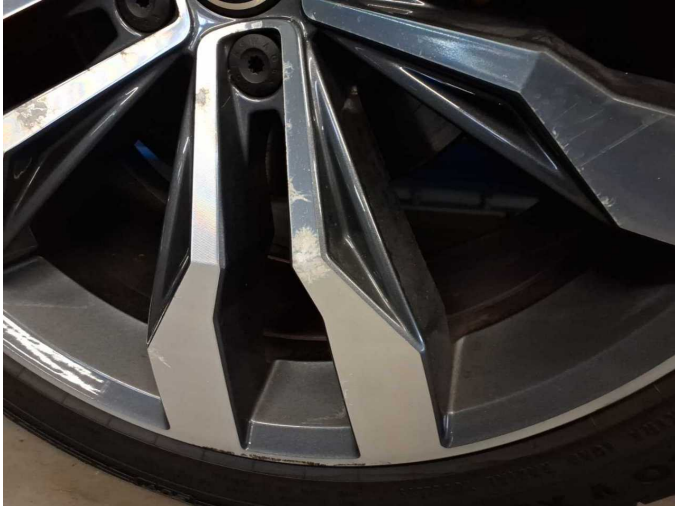
Damage 20: Wheel / tyres: Alloy rim - rear right side (Materialabtrag) - Scratched - Replace

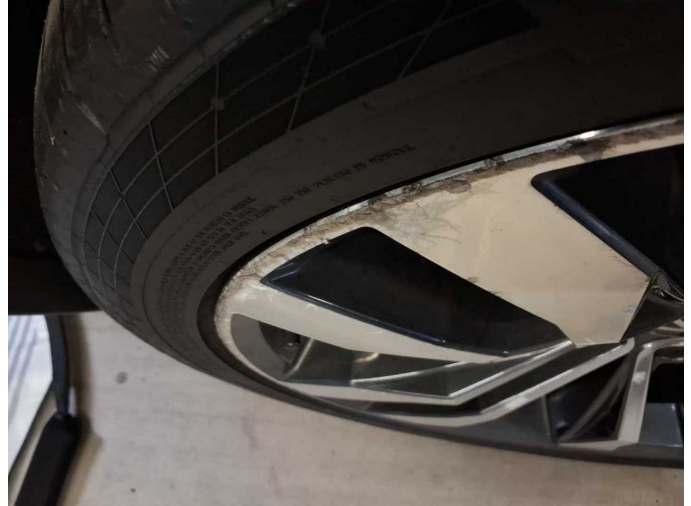
Damage 20: Wheel / tyres: Alloy rim - rear right side (Materialabtrag) - Scratched - Replace

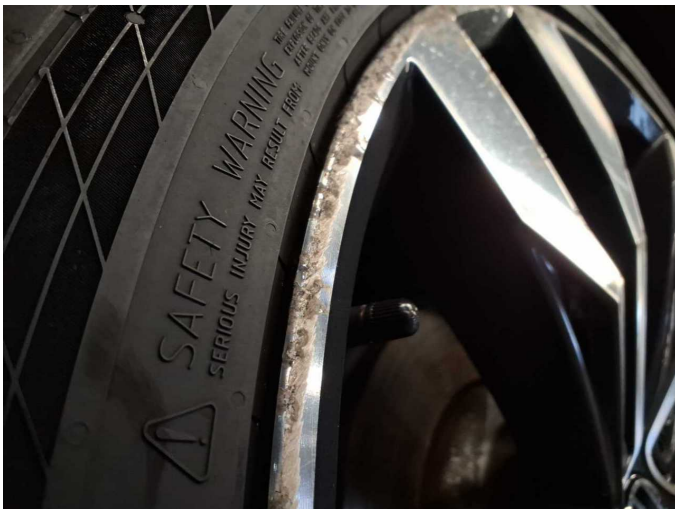
Damage 20: Wheel / tyres: Alloy rim - rear right side (Materialabtrag) - Scratched - Replace

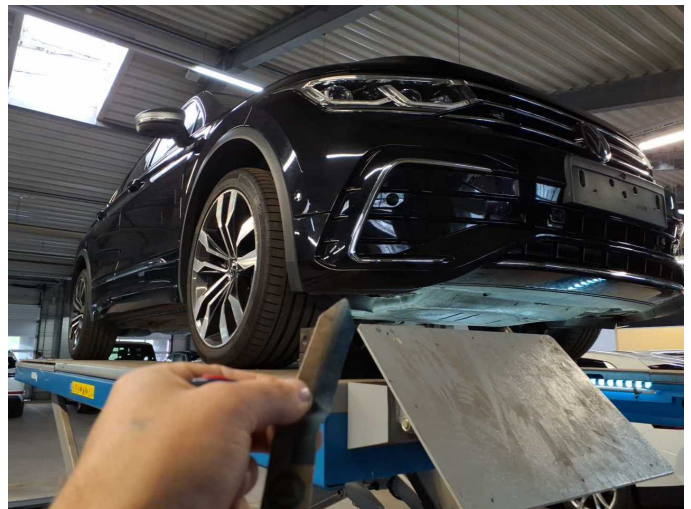
Damage 21: Front bumper: Spoiler - Scratched - Paint

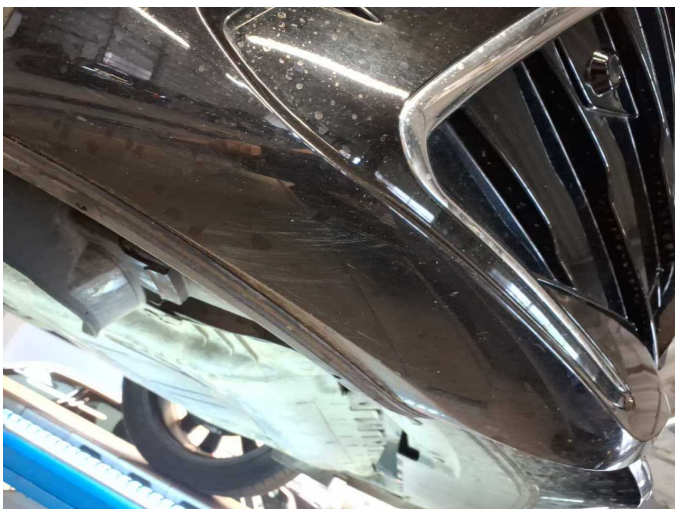
Damage 21: Front bumper: Spoiler - Scratched - Paint

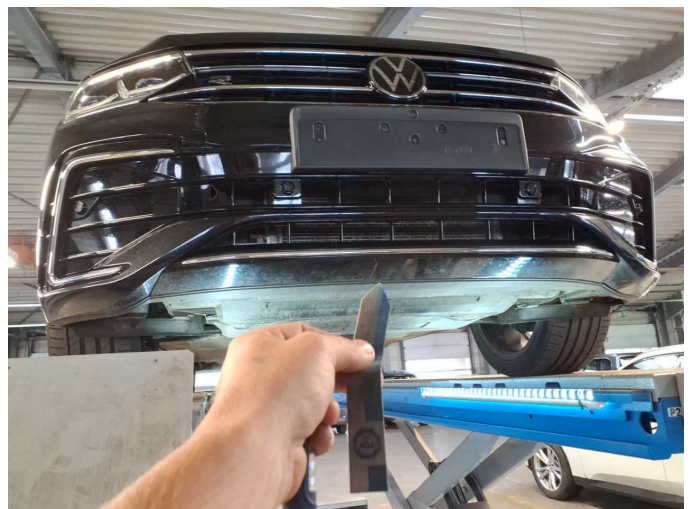
Damage 21: Front bumper: Spoiler - Scratched - Paint

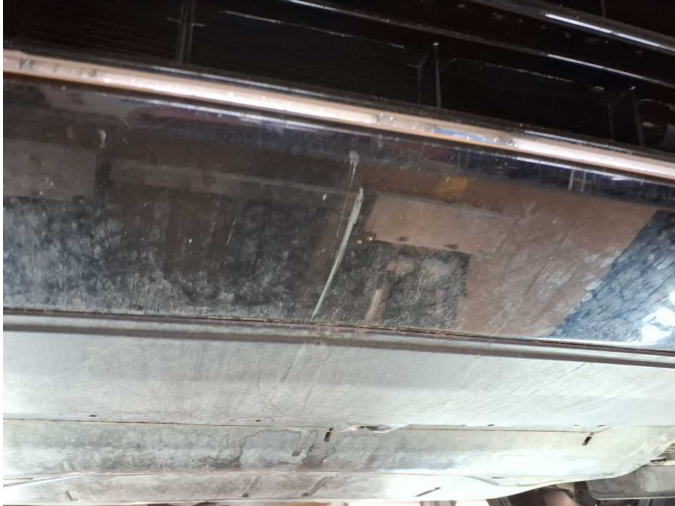
Damage 21: Front bumper: Spoiler - Scratched - Paint

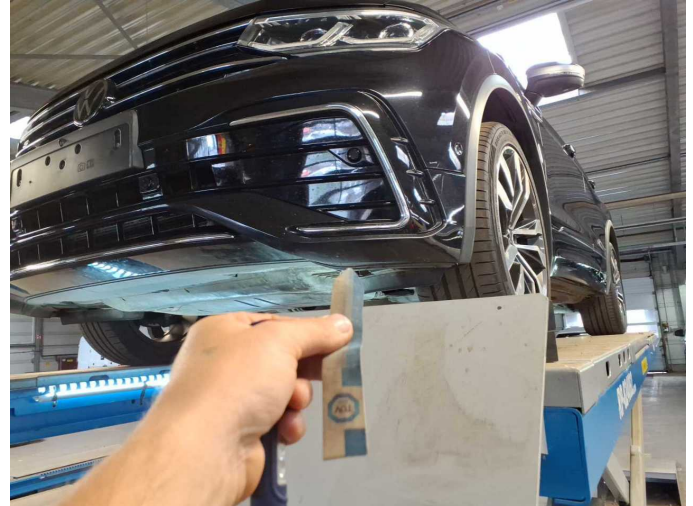
Damage 21: Front bumper: Spoiler - Scratched - Paint

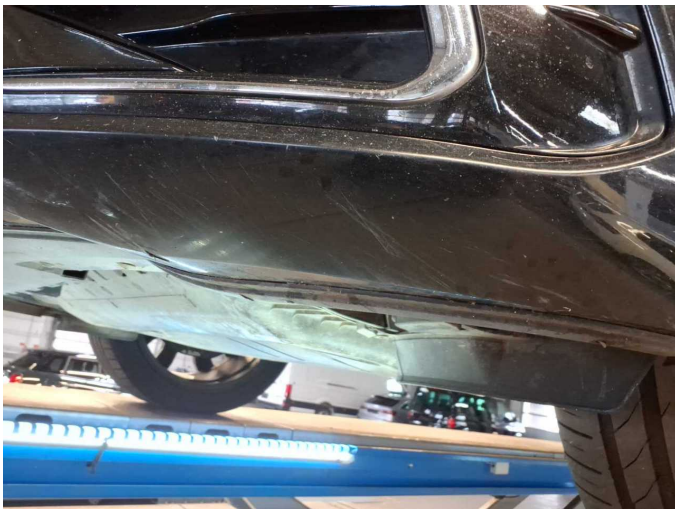
Damage 21: Front bumper: Spoiler - Scratched - Paint

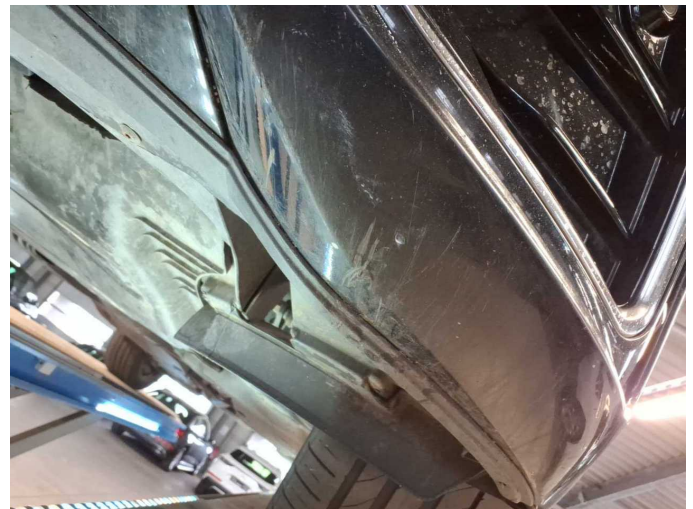
Damage 21: Front bumper: Spoiler - Scratched - Paint

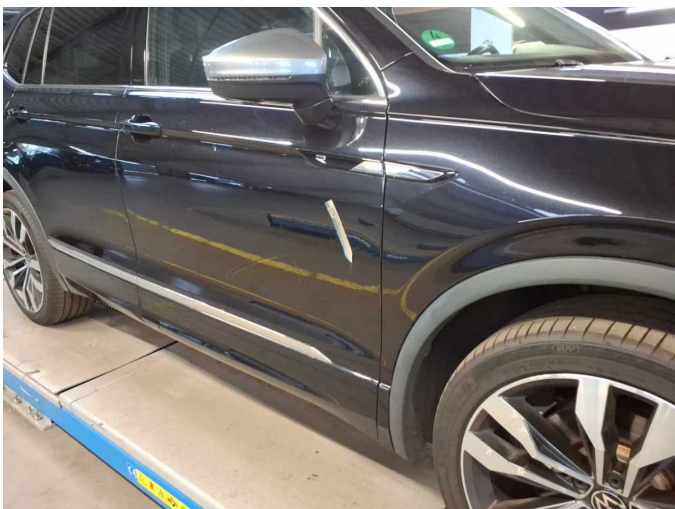
Damage 22: Door - front right side: Door (Wellig, Form nicht getroffen) - Unprofessionally repaired - Repair and paint

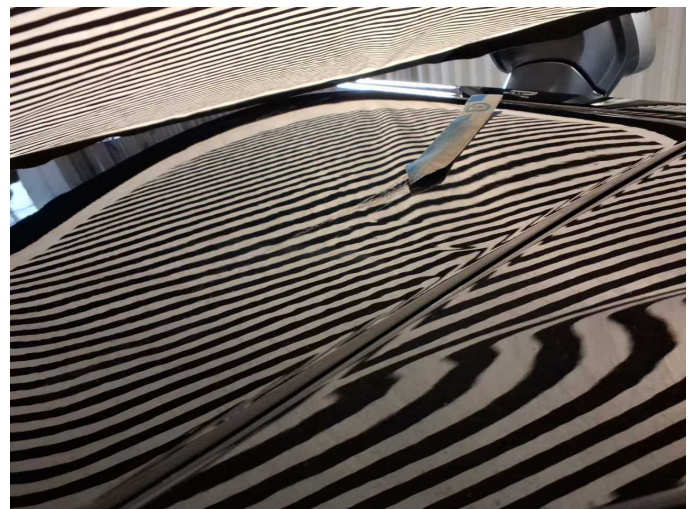
Damage 22: Door - front right side: Door (Wellig, Form nicht getroffen) - Unprofessionally repaired - Repair and paint

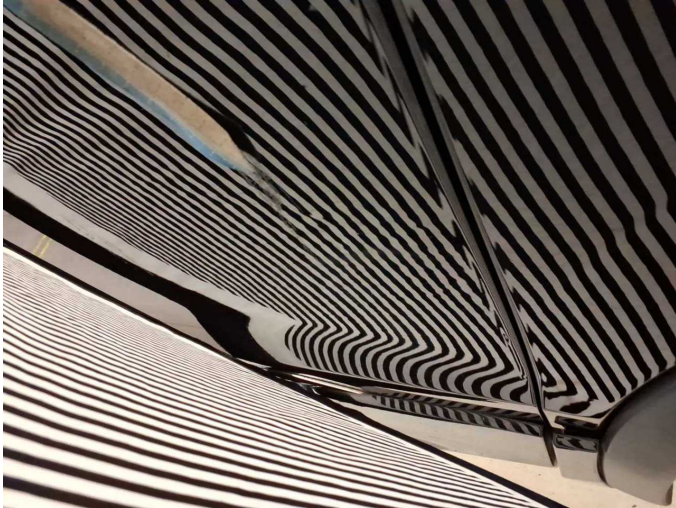
Damage 22: Door - front right side: Door (Wellig, Form nicht getroffen) - Unprofessionally repaired - Repair and paint

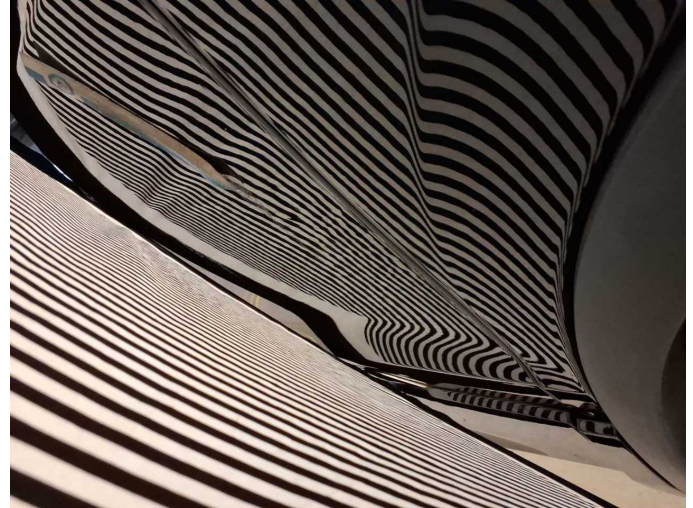
Damage 22: Door - front right side: Door (Wellig, Form nicht getroffen) - Unprofessionally repaired - Repair and paint

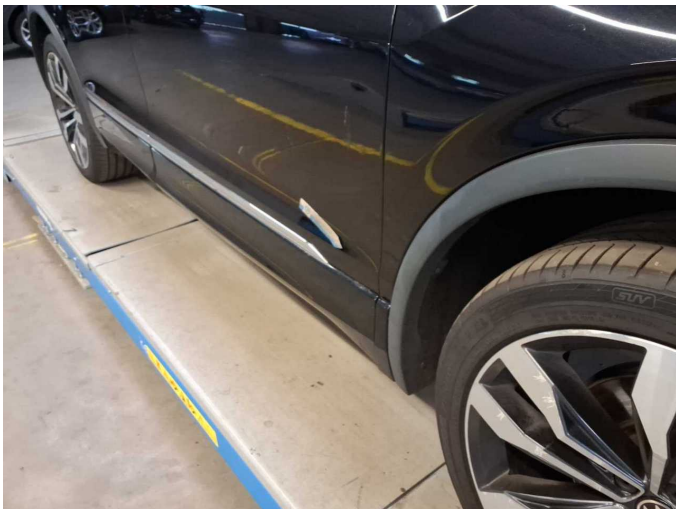
Damage 22: Door - front right side: Door (Wellig, Form nicht getroffen) - Unprofessionally repaired - Repair and paint

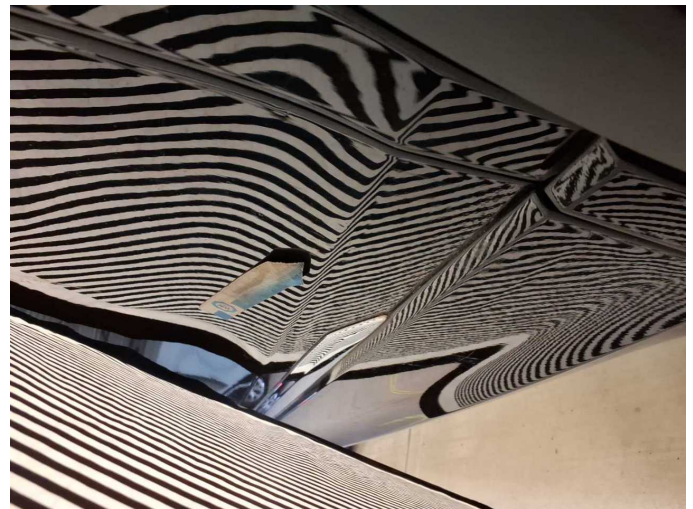
Damage 22: Door - front right side: Door (Wellig, Form nicht getroffen) - Unprofessionally repaired - Repair and paint

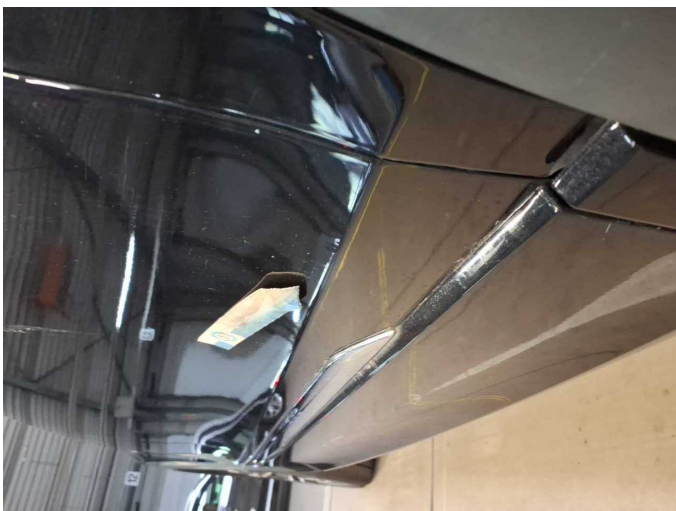
Damage 22: Door - front right side: Door (Wellig, Form nicht getroffen) - Unprofessionally repaired - Repair and paint

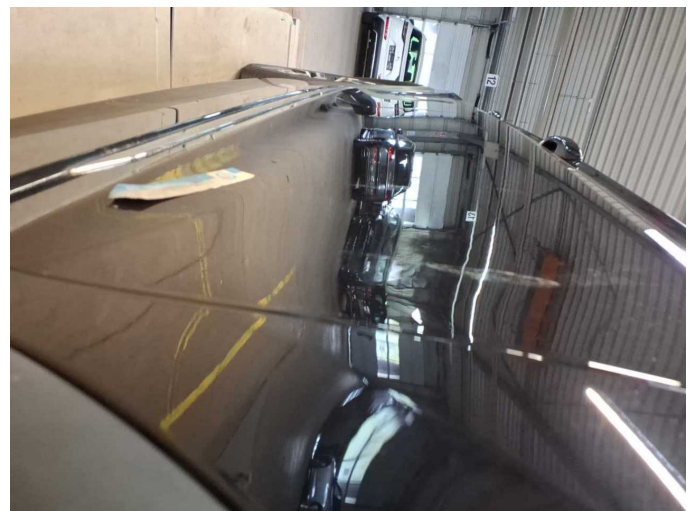
Damage 22: Door - front right side: Door (Wellig, Form nicht getroffen) - Unprofessionally repaired - Repair and paint

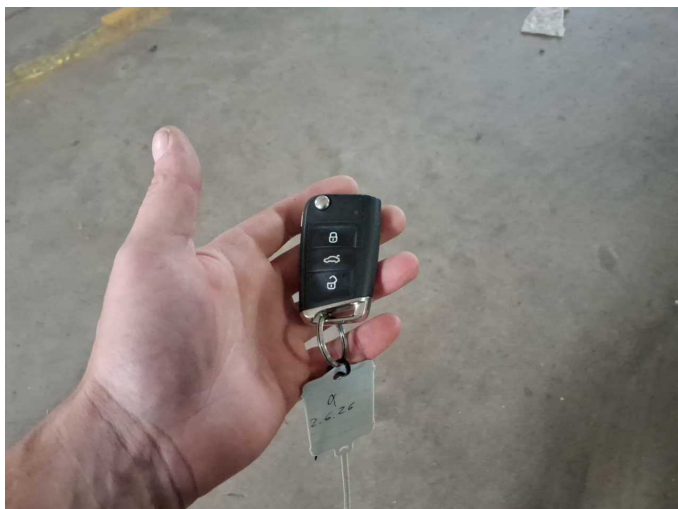
Missing part 1: Equipment: Vehicle key with remote control - Missing - Replace

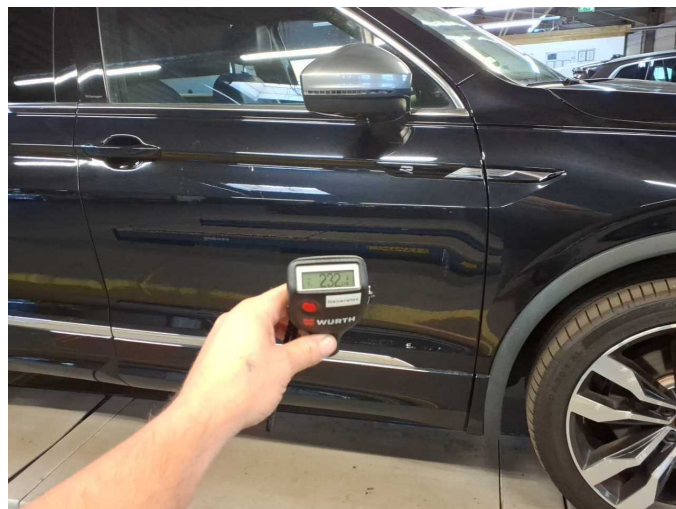
Repainting 1: Door - front right side
