Expertise

Protocol number: 46737296  
Order No. / Reference: 26657476  
Inspection date: 9 Jul 2026

Manufacturer: Volvo

Model: XC40 Recharge Single Motor Plus

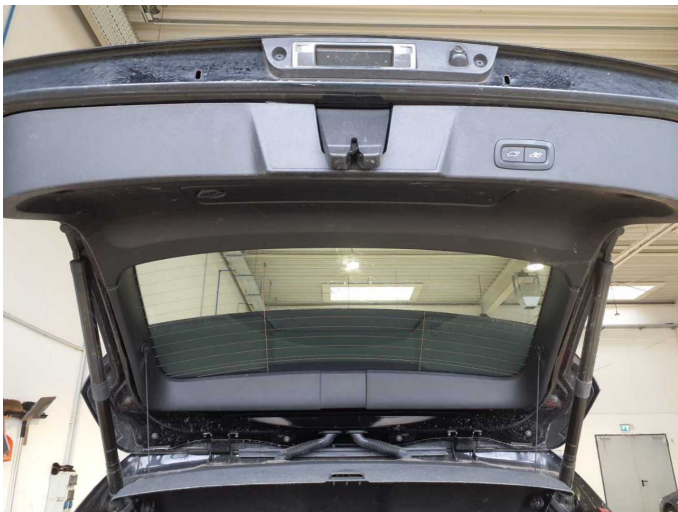
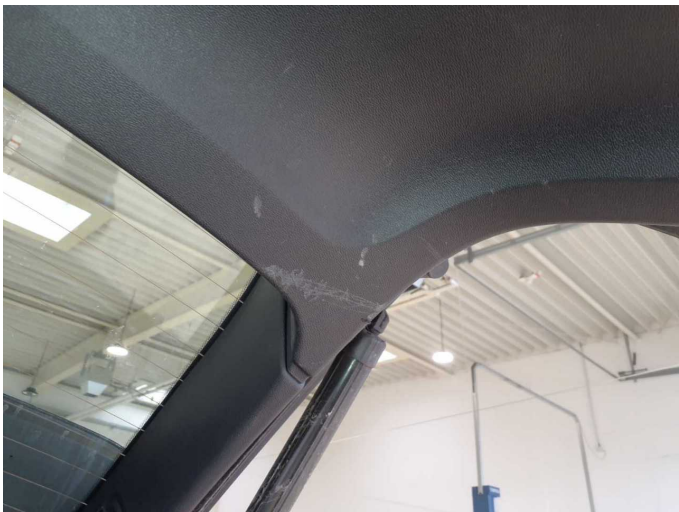
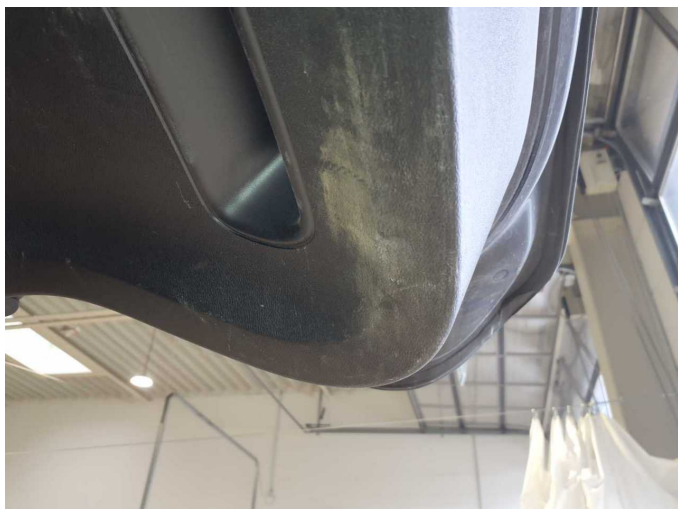
Damage 2: Trim / covers: Boot lid - interior trim - Scratch(es) - Replace

**Damage 2:** Trim / covers: Boot lid - interior trim - Scratch(es) - Replace

| No. | Component group | Description |
|---|---|---|
| 2 | Trim / covers | Boot lid - interior trim - Scratch(es) - Replace |

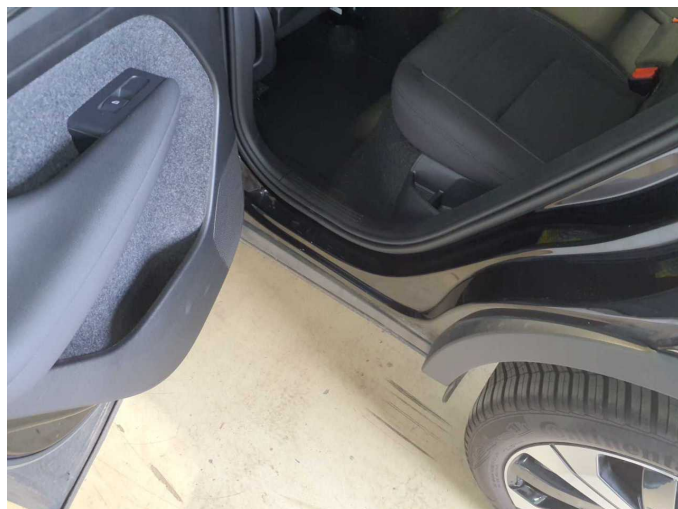
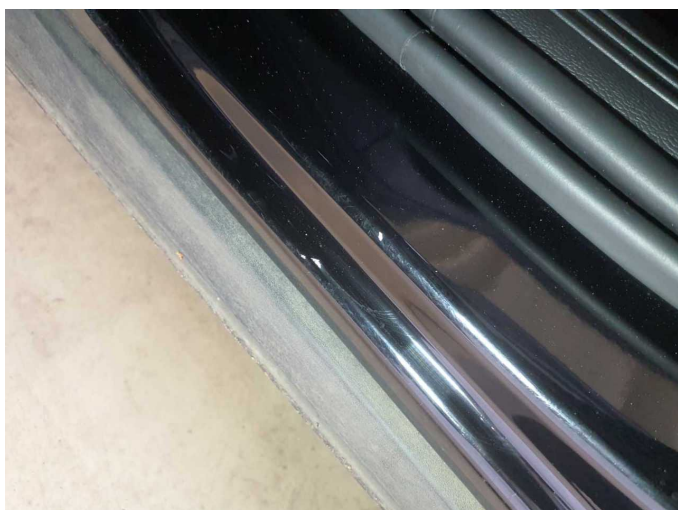
**Damage 3:** Side panel - rear left side: Sill - Scratch(es) - Smart repair

| No. | Component group | Description |
|---|---|---|
| 3 | Side panel - rear left side | Sill - Scratch(es) - Smart repair |

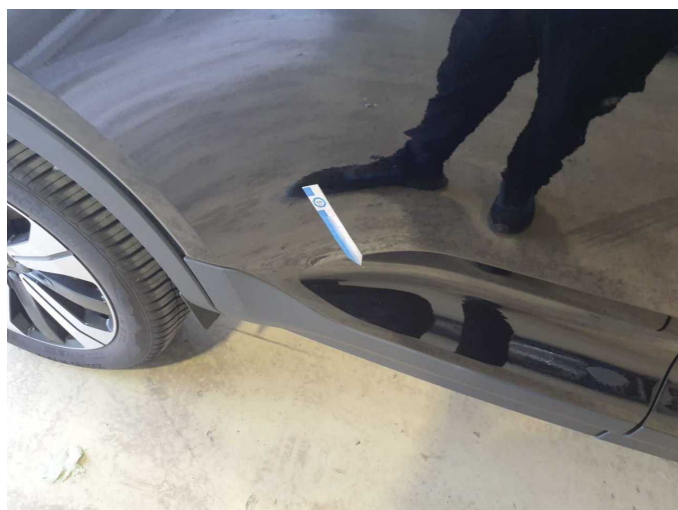
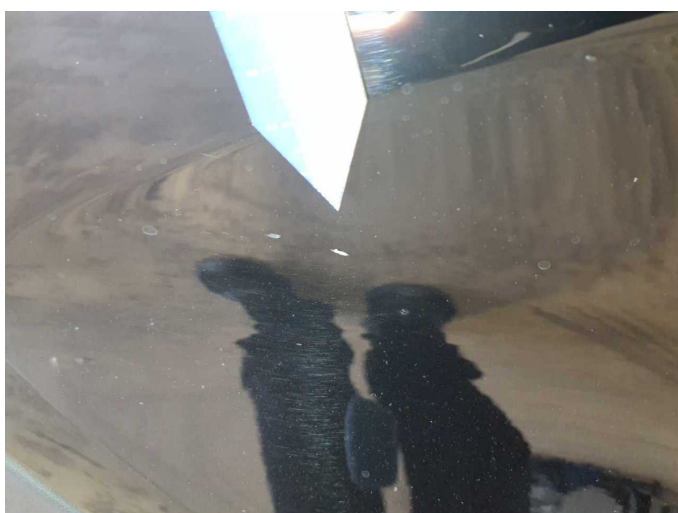
**Damage 4:** Door - rear right side: Door - Scratch(es) - Smart repair

| No. | Component group | Description |
|---|---|---|
| 4 | Door - rear right side | Door - Scratch(es) - Smart repair |

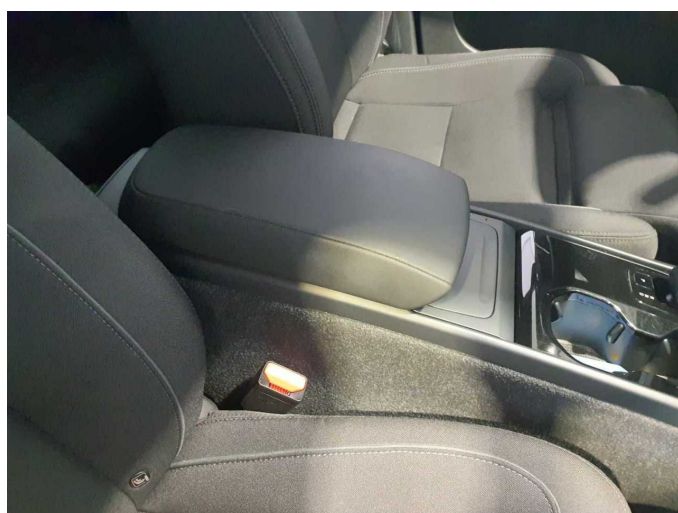
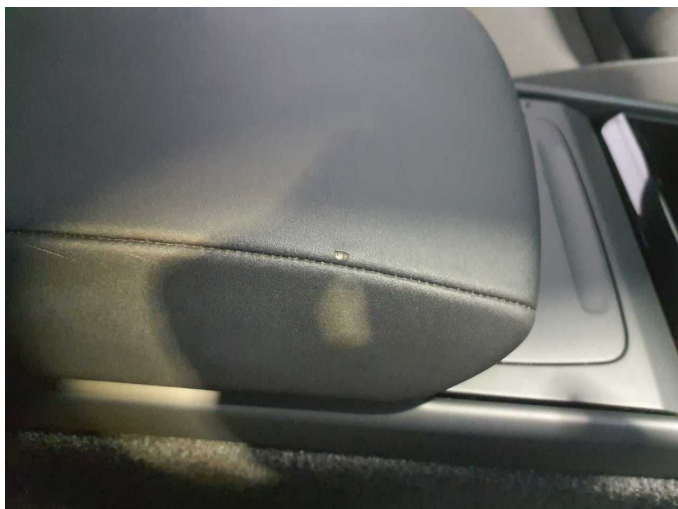
**Damage 5:** Instrument panel: Centre console - front - Scratch(es) - Smart repair

| No. | Component group | Description |
|---|---|---|
| 5 | Instrument panel | Centre console - front - Scratch(es) - Smart repair |

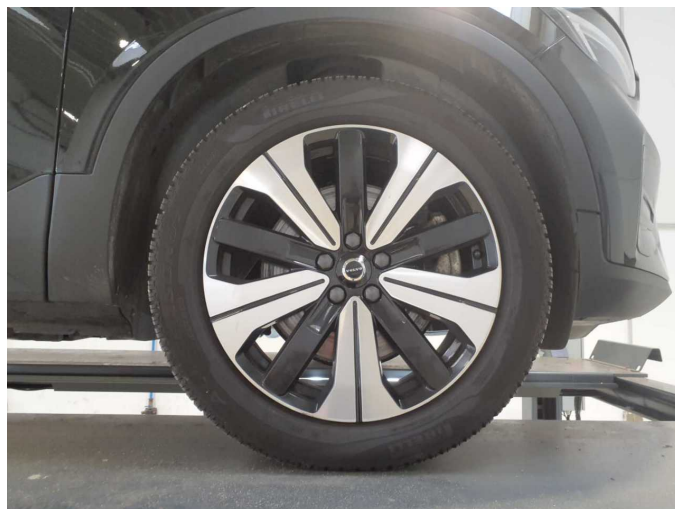
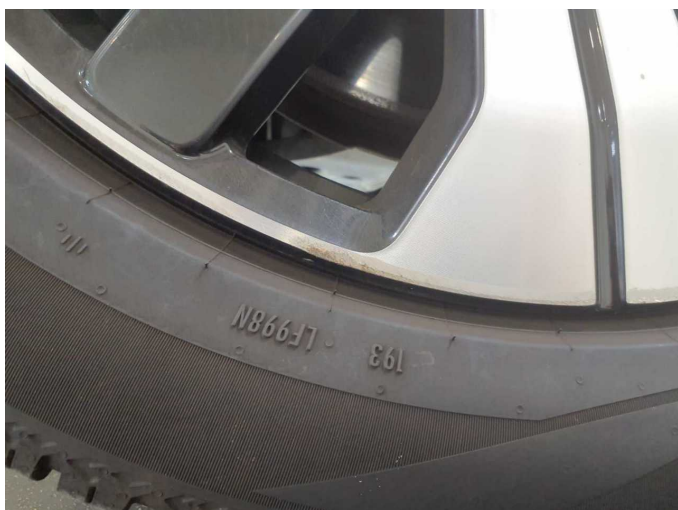
**Damage 6:** Wheel / tyres: Alloy rim - front right side - Scratch(es) - Loss in value

| No. | Component group | Description |
|---|---|---|
| 6 | Wheel / tyres | Alloy rim - front right side - Scratch(es) - Loss in value |

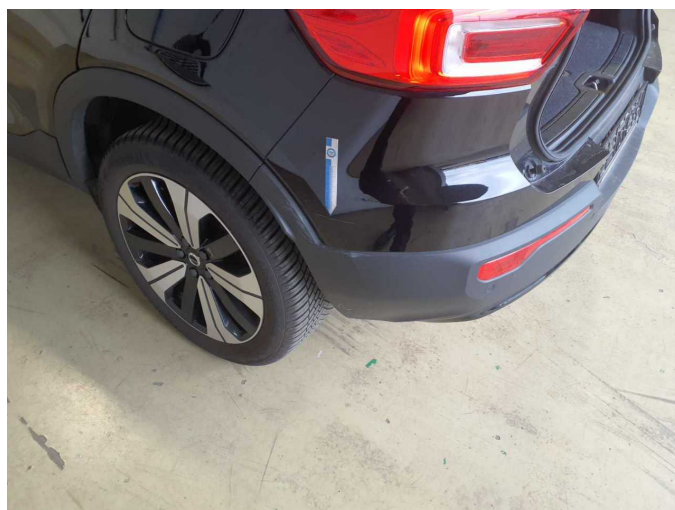
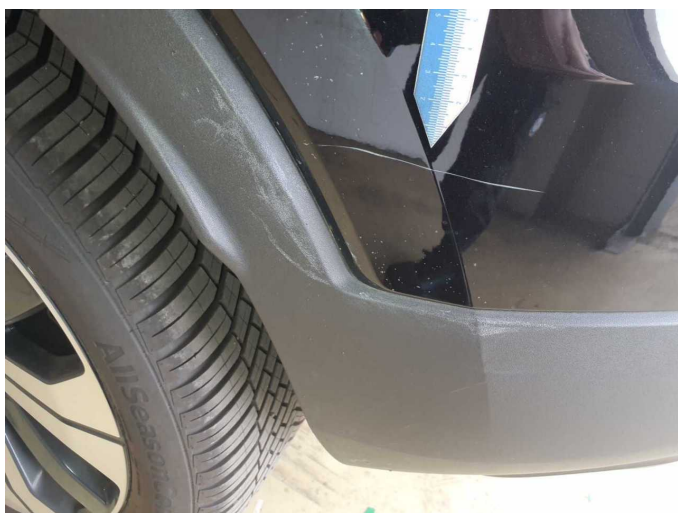
**Damage 7:** Rear bumper: Spoiler - Scratch(es) - Replace

| No. | Component group | Description |
|---|---|---|
| 7 | Rear bumper | Spoiler - Scratch(es) - Replace |

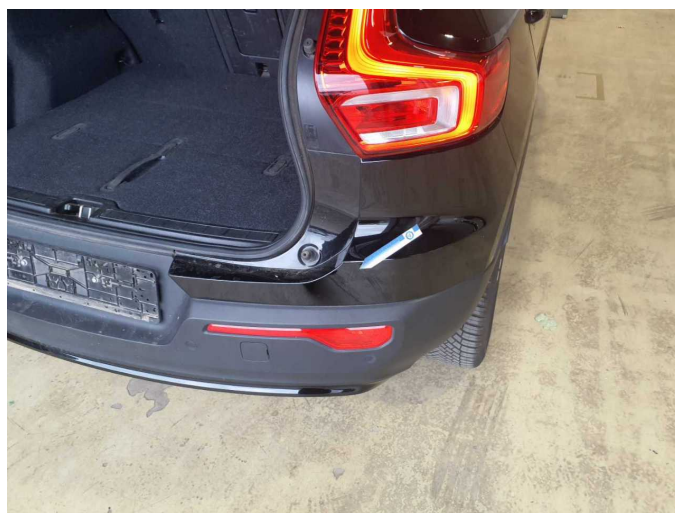
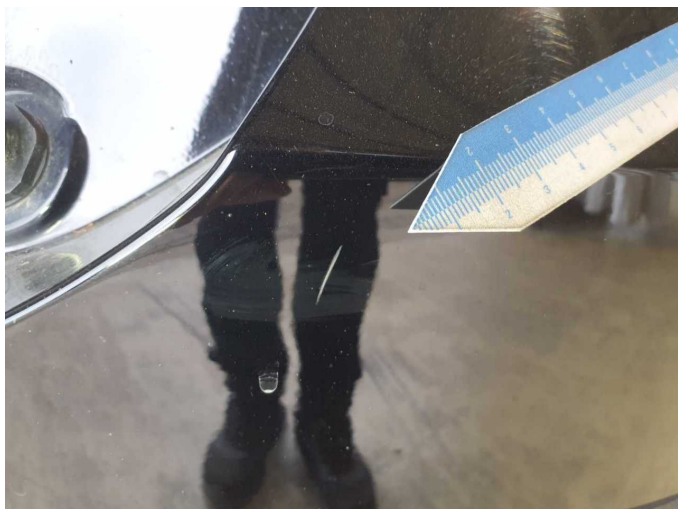
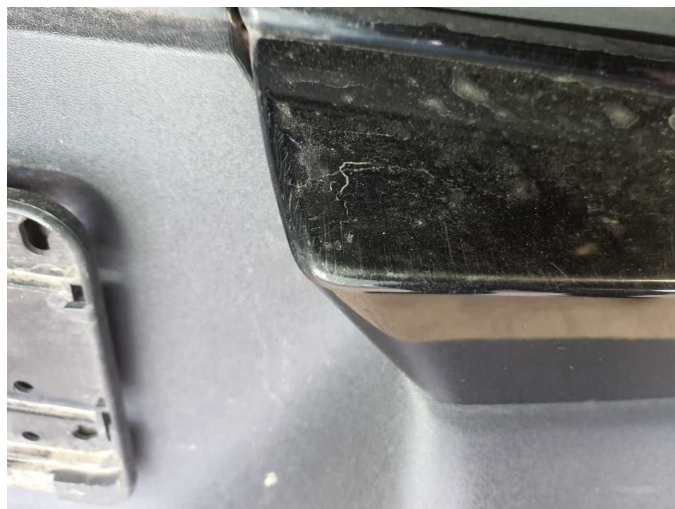
**Damage 8:** Rear bumper: Bumper - rear right side - Scratch(es) - Paint

| No. | Component group | Description |
|---|---|---|
| 8 | Rear bumper | Bumper - rear right side - Scratch(es) - Paint |

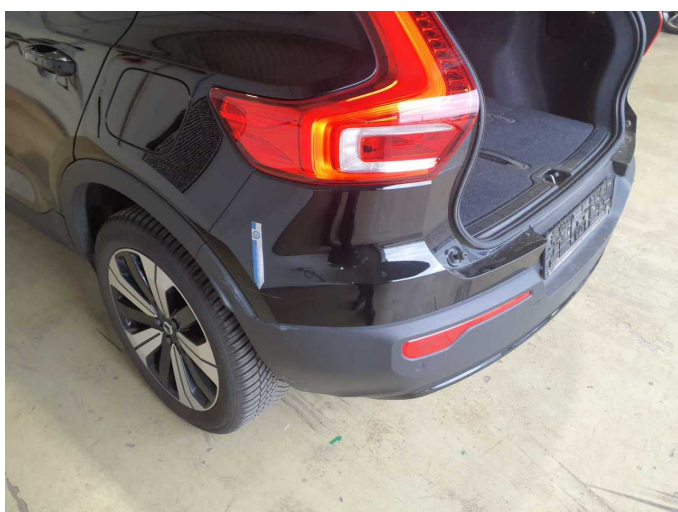
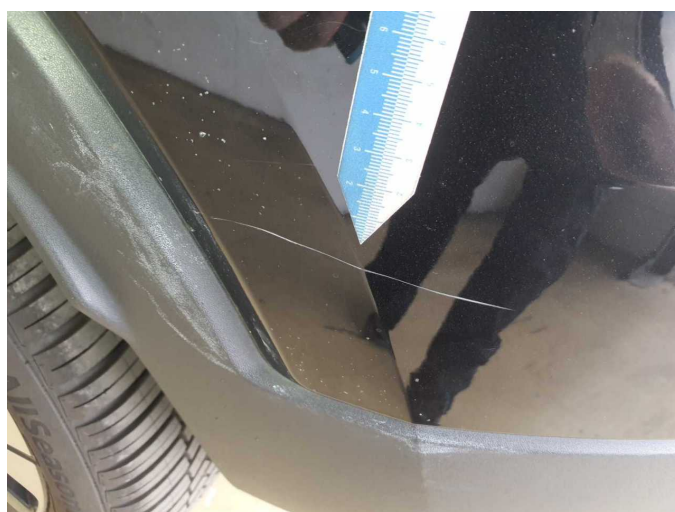
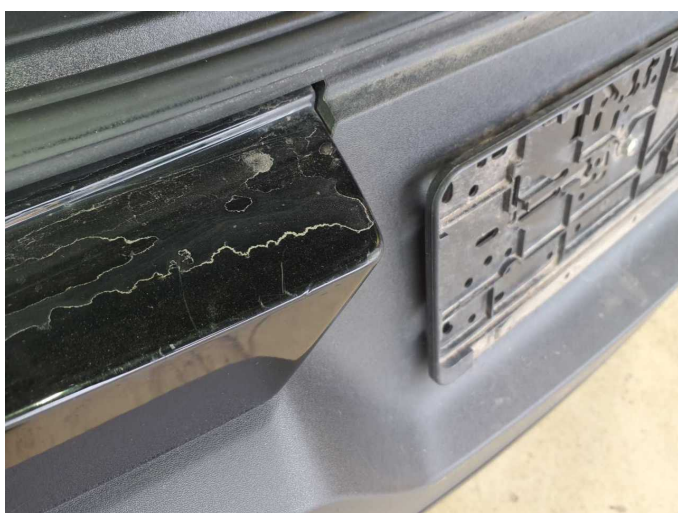
**Damage 9:** Rear bumper: Bumper - rear left side - Scratch(es) - Paint

| No. | Component group | Description |
|---|---|---|
| 9 | Rear bumper | Bumper - rear left side - Scratch(es) - Paint |

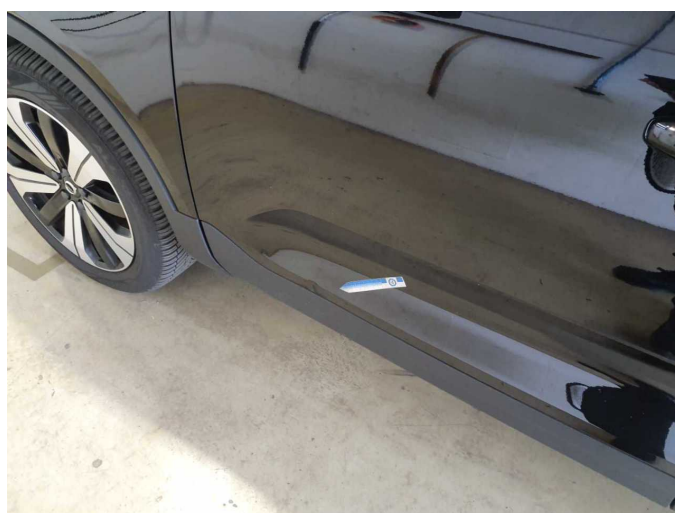
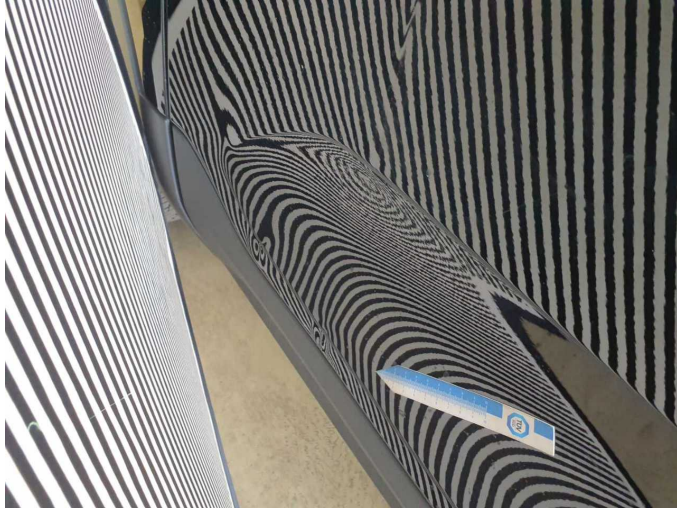
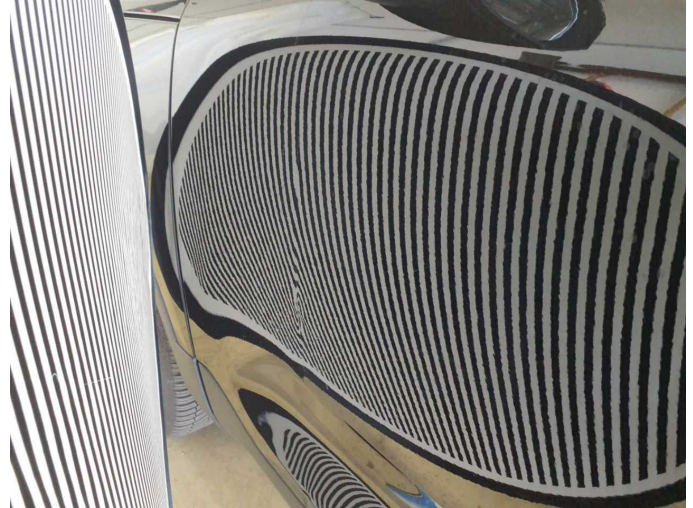
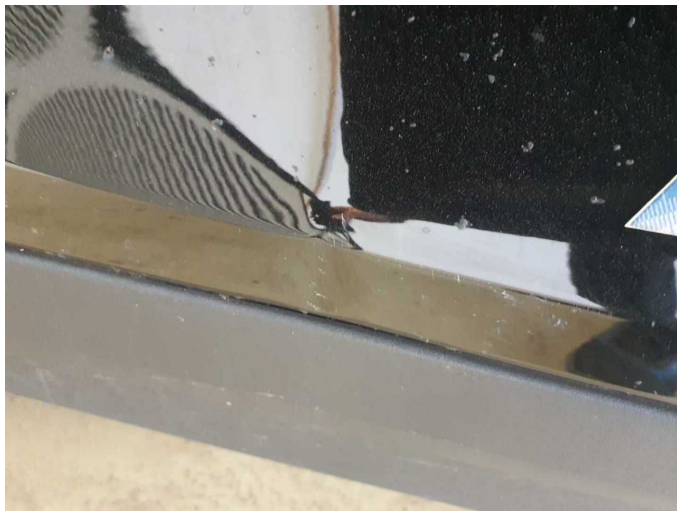
**Damage 10:** Door - front left side: Door - Dent / paintcoat damage - Repair and paint

| No. | Component group | Description |
|---|---|---|
| 10 | Door - front left side | Door - Dent / paintcoat damage - Repair and paint |

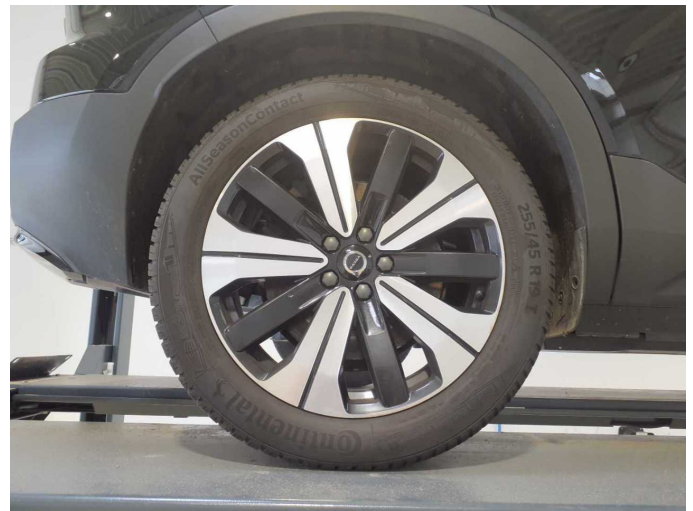
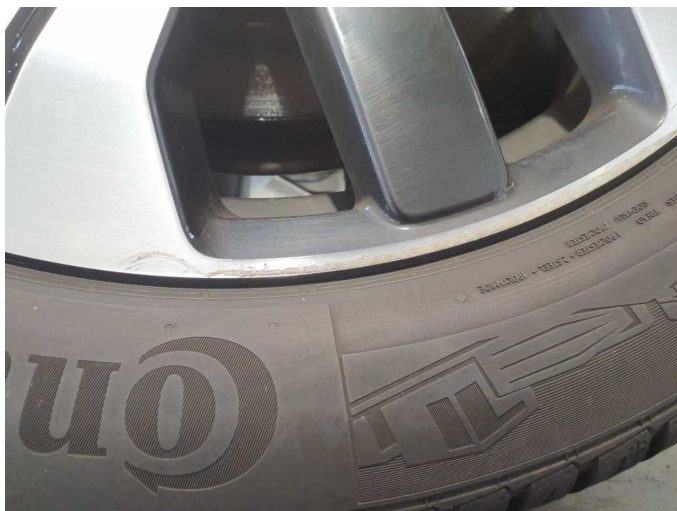
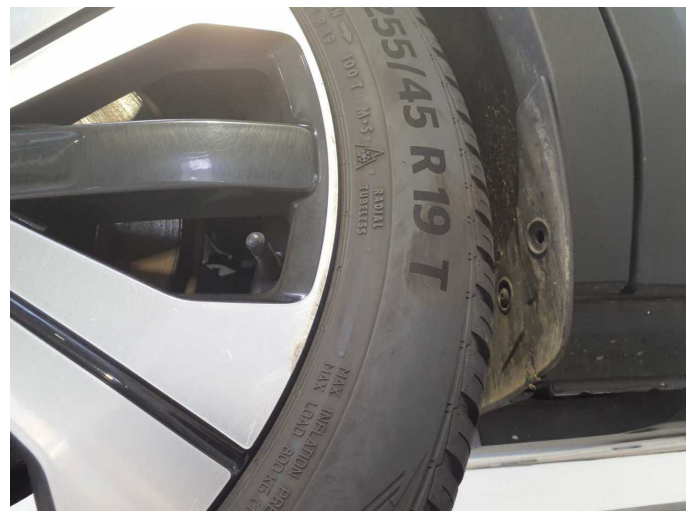
**Damage 11:** Wheel / tyres: Alloy rim - rear right side - Scratch(es) - Replace

| No. | Component group | Description |
|---|---|---|
| 11 | Wheel / tyres | Alloy rim - rear right side - Scratch(es) - Replace |

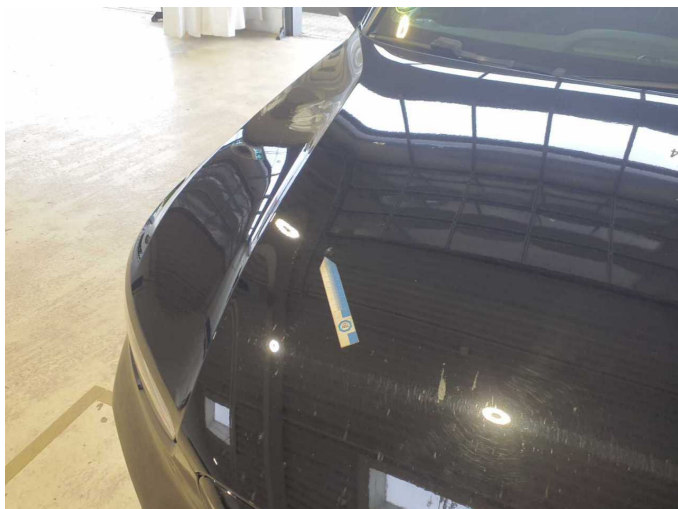
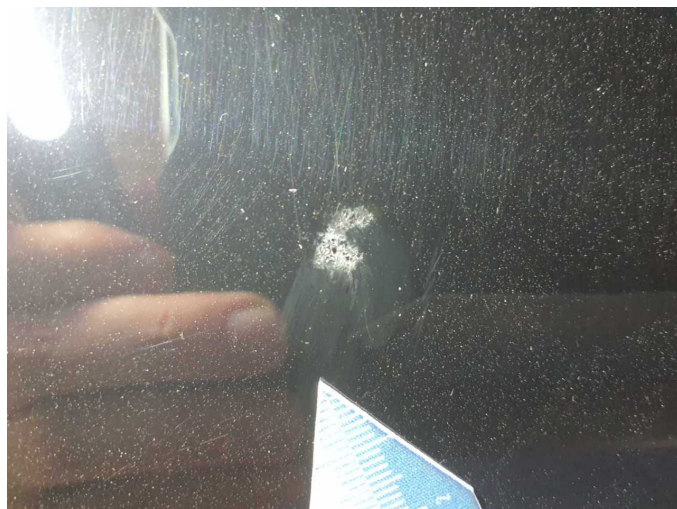
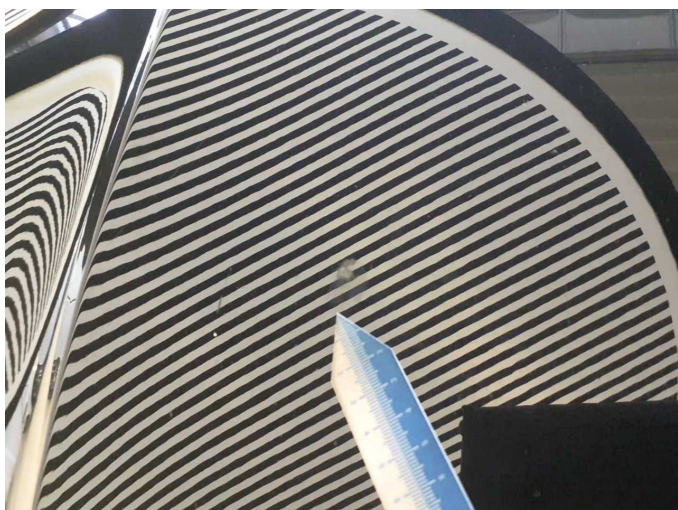
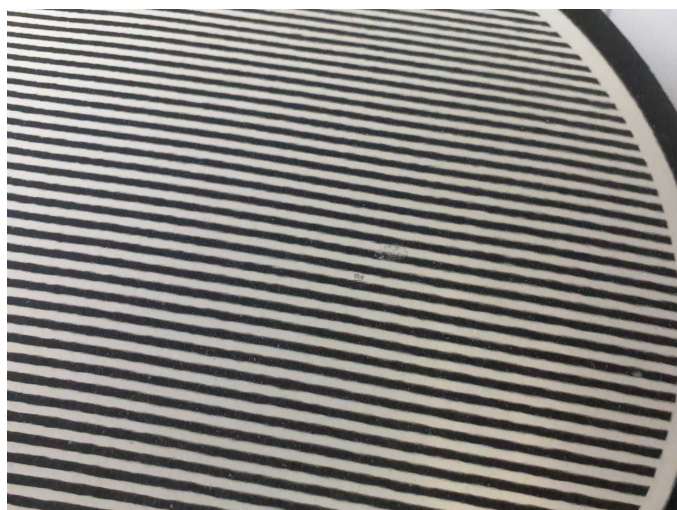
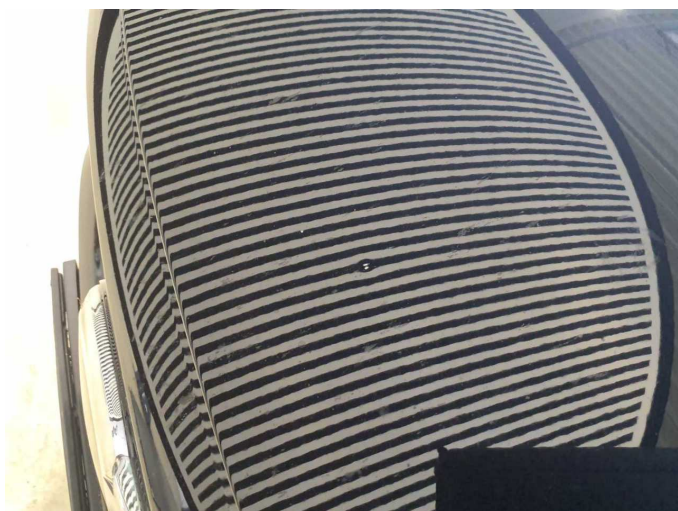
**Damage 12:** Bonnet: Bonnet (Anätzung) - Paint defect - Repair and paint

| No. | Component group | Description |
|---|---|---|
| 12 | Bonnet | Bonnet (Anätzung) - Paint defect - Repair and paint |

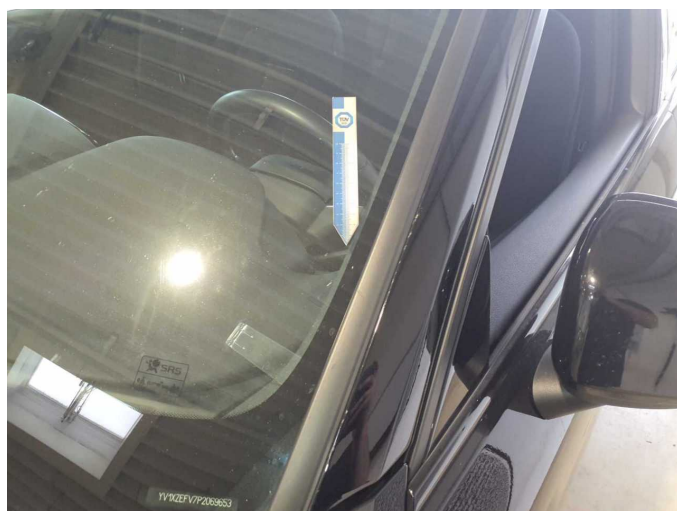
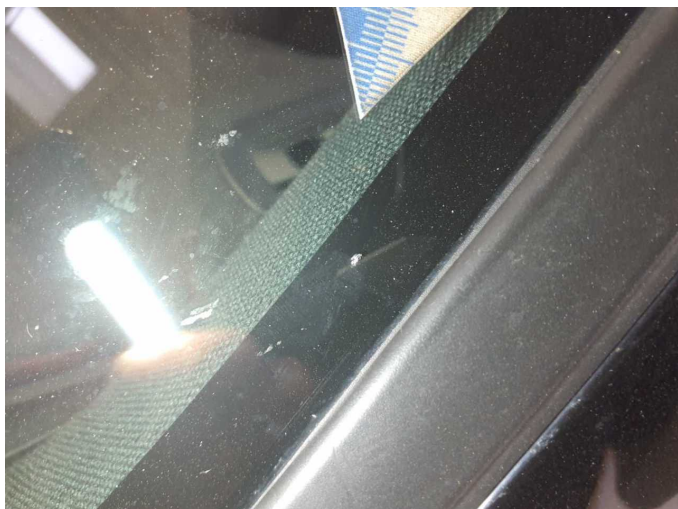
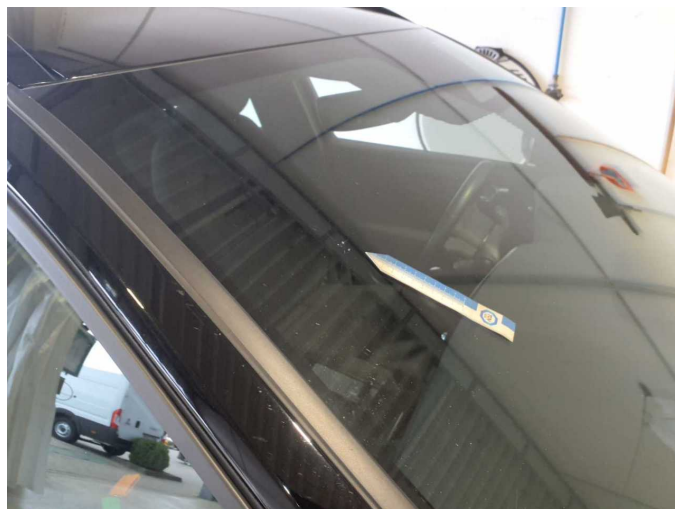
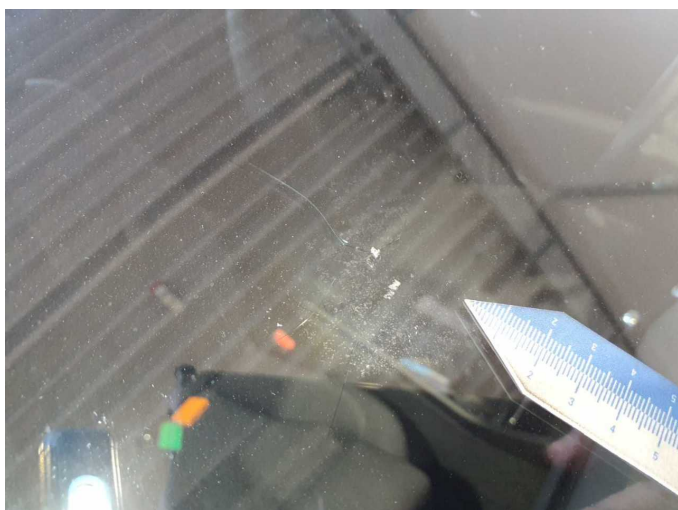
**Damage 13:** Vehicle glazing: Windscreen - Stone chips - Replace

| No. | Component group | Description |
|---|---|---|
| 13 | Vehicle glazing | Windscreen - Stone chips - Replace |

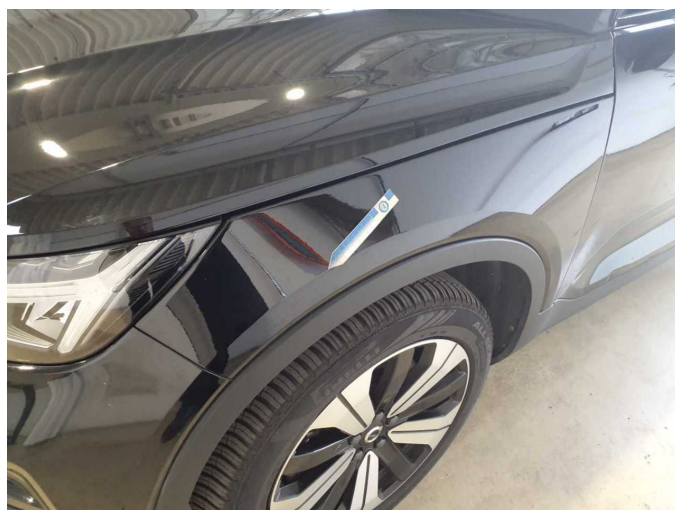
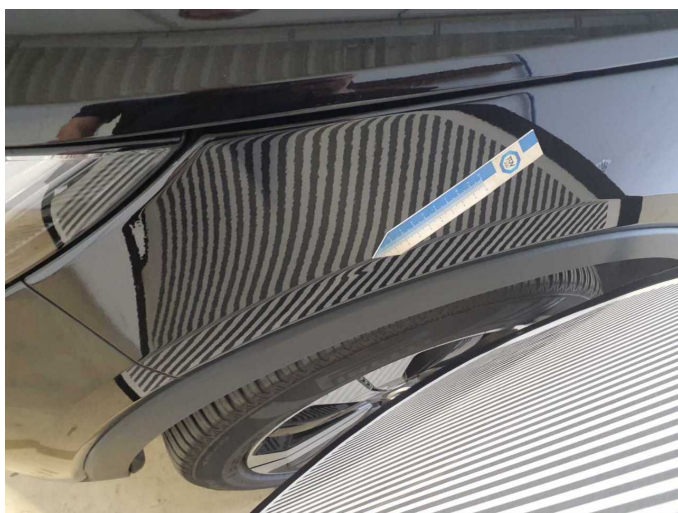
**Wear and tear 4:** Mudguard - left side: Mudguard - left side - dent(s) - No deduction

| No. | Component group | Description |
|---|---|---|
| 4 | Mudguard - left side | Mudguard - left side - dent(s) - No deduction |
